Historic Building Record and Archaeological
Watching Brief
Craig of Stenton
Dunkeld
PERTH & KINROSS
DK09

**HISTORIC BUILDING RECORD &
WATCHING BRIEF
CRAIG OF STENTON
DUNKELD**

DK09

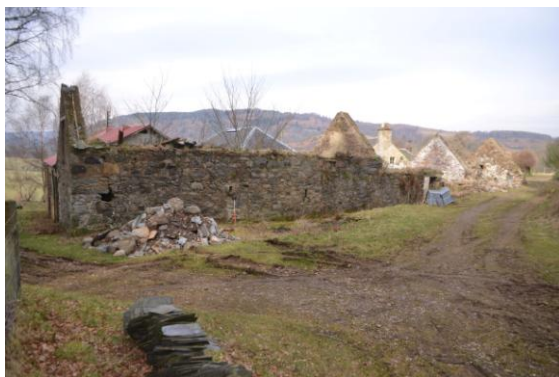
This was rectangular, aligned approximately NNE-SSW and constructed of stone rubble with lime mortar bonding. It appeared to have been fortified at some stage, with a narrow slit window- or perhaps gun port- within an embrasure in each long side. While this might seem fanciful, the location of the steading on an upland site close to Dunkeld places it well within the zone of activity for the first two Jacobite risings (1690 and 1715) and, perhaps more likely, Ceteran raids from the 15th to 18th Centuries (indeed, an early 18th C account has a certain Chalmers, of Bridge of Cally- around 10km from the site- resisting a Ceteran raid on his farm (McHardy 2004)). Whether the slits/ports represent genuine period fortification, later affectation or simple ventilation, they were unusual features of note. The port in the E long side was positioned opposite the terminal of a revetment wall, which now survived as footings but which *might* have stood tall enough to mask the entrance in the N end of the building (ie, the port may have covered the entrance “tunnel”). However, the entrance thus reached was into a two-room, single storey extension to the N, with the doorway reinforced with brick. The wall had collapsed to the N of this doorway, below the level of the hillslope. The port itself had been partially blocked or rebuilt with brick, yet the aperture itself was cased in stone. A second aperture 3.30m to the S was formed by machined bricks and concrete and probably represented a later vent. A blocked window was positioned between the older port and more recent vent, measuring 1.10m square; the vent was actually positioned in the top left corner of a blocked doorway to the left of the square window, measuring 1.60m tall x 0.90m wide, with a wooden threshold protruding from the lower wall face. The sill and part of the side casing of a window above and to the N of the older port indicated that the building had been two storey, but this had been

SE elevation, stone steading

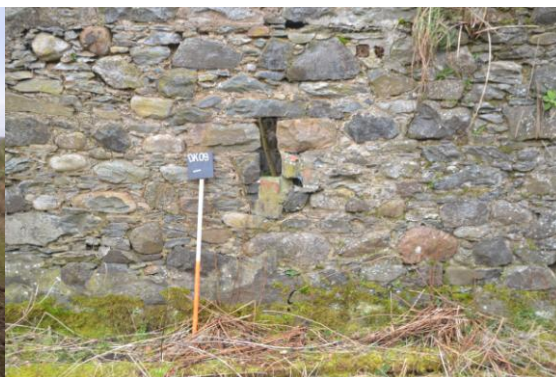
reduced to one storey and the window truncated. It was noted that the wall fabric around the older port had more small slabs and generally more mortar than the remainder of the wall face, suggesting that the port may have been inserted into the wall, while a larger square window was filled in, perhaps at the same time as the door was inserted (and this was itself filled in during a later phase). However, the counterpart port in the NW long side appeared to be part of a single phase of construction and seemed integral to the wall. It is nonetheless possible to devise a hypothetical phase sequence, in which the building was first constructed with a large, square, ground floor window on the side facing the gulley between Kemp's Hold and the ridge to the N; this, being perceived as a defensive weakness (or a source of draughts), was then blocked and a doorway inserted, covered by a gun port (or less draughty means of illumination/ventilation); the building was then extended to the N, with a new doorway, the first doorway being blocked. The SE side port measured 0.62m tall x 0.13m wide (exterior, average, somewhat uneven), 0.56m deep (wall thickness); the NW side port measured 0.72m tall x 0.10-0.13m wide, within an embrasure 0.53m wide (the SE side embrasure could not be measured safely).

Slit window/port, SE elevation

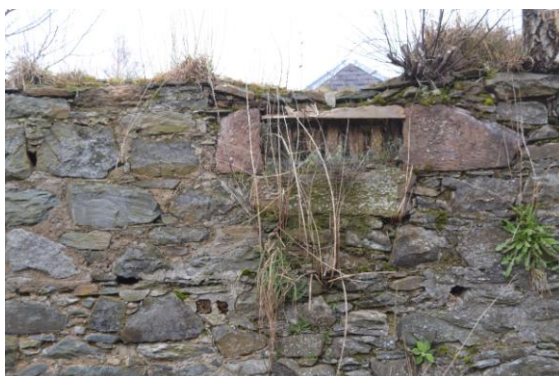
Truncated window, SE elevation of steading

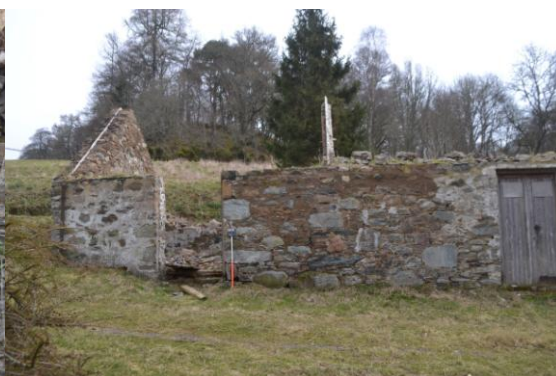
The external NW elevation, where it formed the E wall of the new brick barn (see below, approximately two-thirds of the length), had been re-pointed and featured close-fitting casing stones and shaped cill and lintel around a window at the S end, measuring 0.55m wide x 1.00m tall. To the N of this was a 1.00m wide x 2.00m tall doorway, with wooden frame, with cement on the door jamb bearing the scratched graffiti "1935". The doorway may have been a rebuilt original feature, accessing the main fortified barn, with the graffiti dating the repointing work.

N end of NW elevation

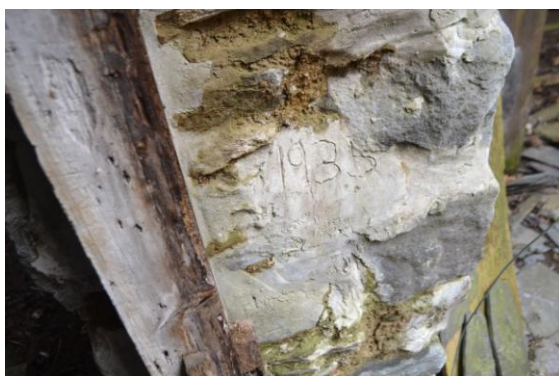
1935 graffiti

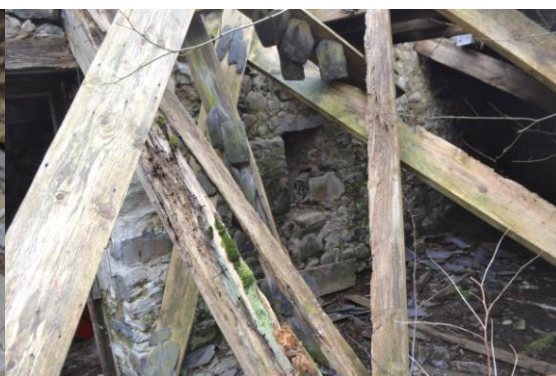
Interior of NW side "port"

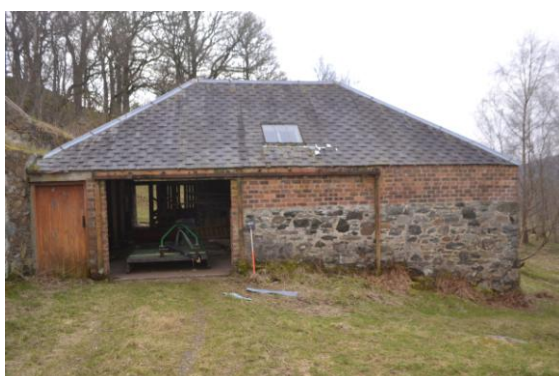
NE elevation of brick barn

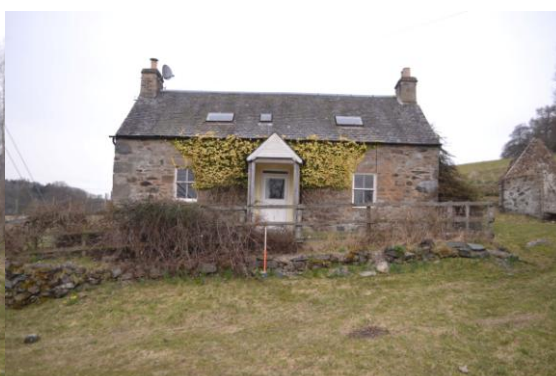
SW elevation of cottage

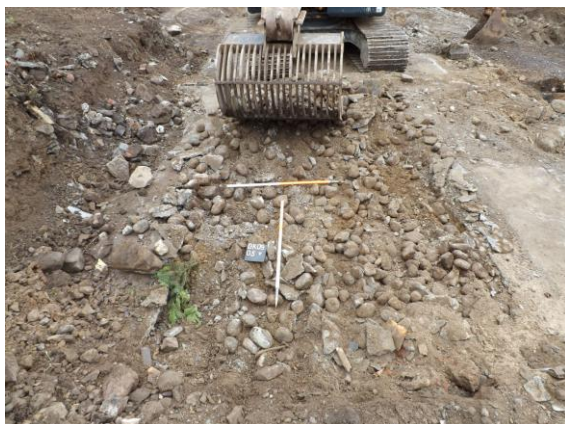
Five separate visits were made to monitor ground-breaking work. The removal of the founds and ground floors of the barn and steading exposed extremely shallow foundations, with the wall bases essentially resting on what was found to be highly compact gravel and sand (02). Much of the plateau was covered with stony silt topsoil (01), which was partially stripped off around the area of the barns to an average depth of approximately 0.10m; in places, this exposed further areas of subsoil (02), although much of the site ground level was to be built up rather than reduced. In the cottage garden, up to 1.00m of humic garden soil (03) replaced the topsoil. This was also removed. Following the removal of internal debris and silt, the steading was found to be floored with poured concrete throughout (10), similar in appearance to the concrete pad. The pad, when removed, was found to overlay a foundation layer of stone rubble (11) of the same type as found in the retaining wall running away to the S. It therefore recycled some of the same demolition rubble. The steading floor, in contrast, was set on a layer of cobbles (05) apparently imported for the purpose. These were loose when freed from the concrete and showed no signs of having been laid as an earlier floor. Beneath them was a bed of yellow sand (06). No traces of earlier floor deposits were exposed and no finds recovered.

Cobbles (05), bedding for concrete floor of steading

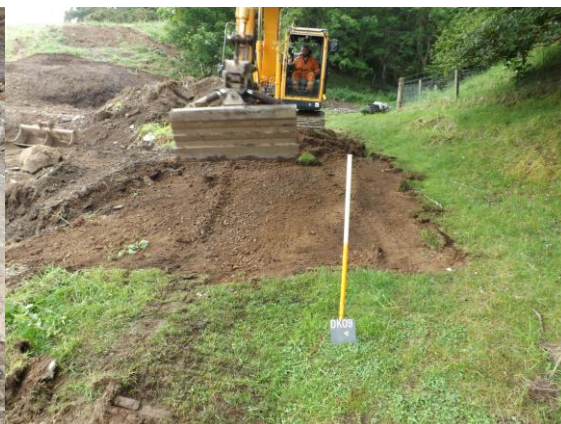
Immediately S of the steading and below the ramparts of the hillfort, an area of topsoil was scraped off down to natural (02) to form the footprint of a new garage, to be built at the S end of the new house. Subsoil (02) was found to be particularly compact and topsoil (01) particularly thin in this area (around 0.05m thick). A small brick-built drain (08) was exposed in the approximate centre of the footprint; it had probably connected with the steading and was set into the subsoil at single-course thickness. At the W end of the garage footprint, in the SW corner of the site, a deposit of stone demolition rubble (09) was exposed immediately beneath the topsoil. This was of the same type as found beneath the concrete pad and in the rough retaining wall, which petered out close by. It was probably the area of disturbance noted during the HBR. No other features were exposed in this area.

Natural gravel to S of steading

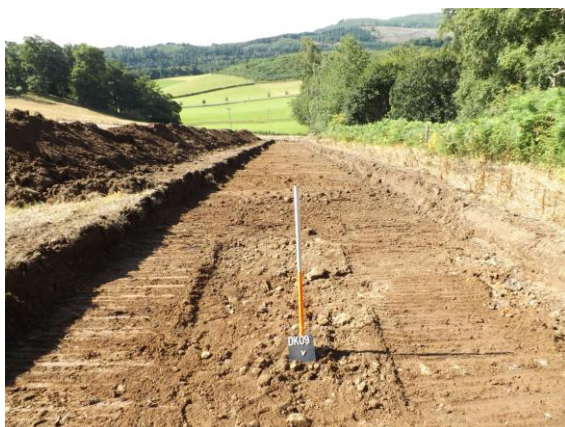
The excavation of a new access road to the SW and W of the new building footprint exposed occasional tree boles and the remains of root activity, but no archaeological features. The excavation of a pit for a septic tank to the NW of the house was partly through newly made ground, with the remainder being directly onto undisturbed subsoil. Boreholes through bedrock to prospect for a water source and the excavation of trenches for services through made ground were not monitored; those through existing ground resulted in no new features.

New access road, post-strip

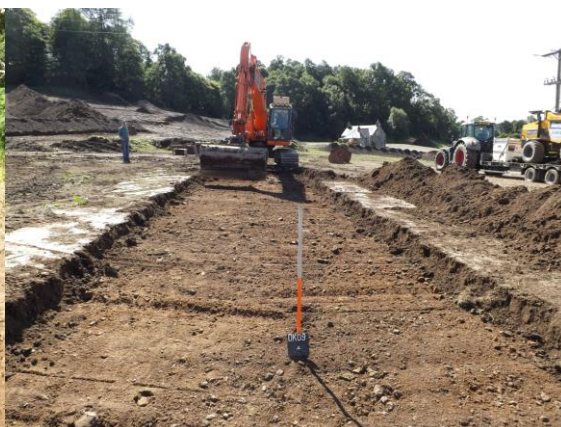
New road, approaching cottage

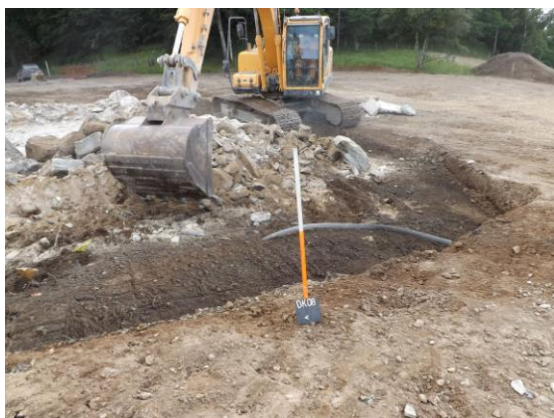
Demolition of cottage

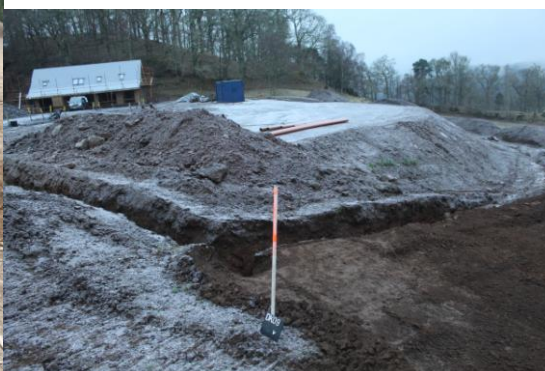
New garage in front of Kemp's Hold fort
