Historic Building Recording  
Cramflat Farm  
Luncarty  
PERTH & KINROSS  
LJ03

**HISTORIC BUILDING RECORDING  
CRAMFLAT FARM  
PERTH & KINROSS**

**LJ03**

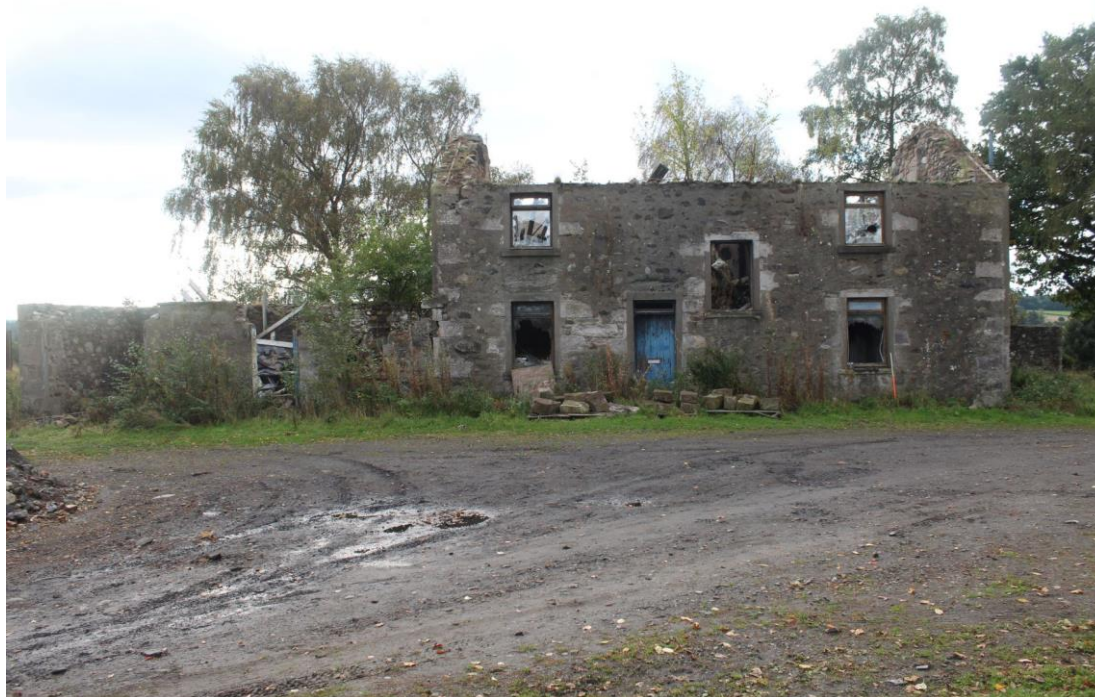
*Building 1, farmhouse*

This stood at the SW corner of the farm complex and was aligned almost E-W (in fact, between E-W and ENE-WSW; for the purposes of the survey, elevations are designated “E”, “W” etc). It had clearly suffered a fairly extensive fire, with the roof entirely collapsed in and much of the ground floor, visible from the outside, heavily charred. The interior appeared clogged with fallen rafters and the first floor structurally unsafe. In short, it could not be entered safely, making recording of the interior impossible.

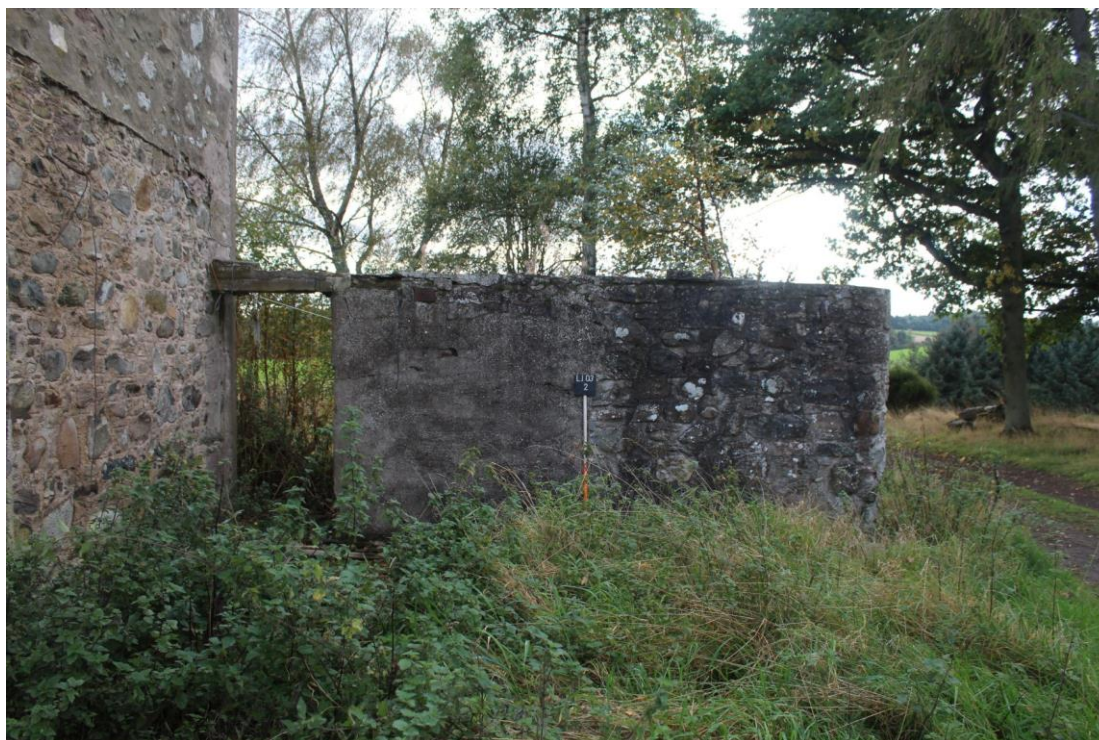
#### *Building 2, greenhouse*

This stood immediately W of the farmhouse, to which it was tenuously attached by a wooden lintel above an external door. It was derelict and entirely overgrown, with much of the glass smashed and the interior clogged with plants to the extent that it, too, could not be entered. The N and W elevations were formed from mortared stone walls, solidly constructed and standing up to 2.00m tall, with the S and E of wooden framed glass panels. The building was 4.00m E-W x 2.60m N-S.

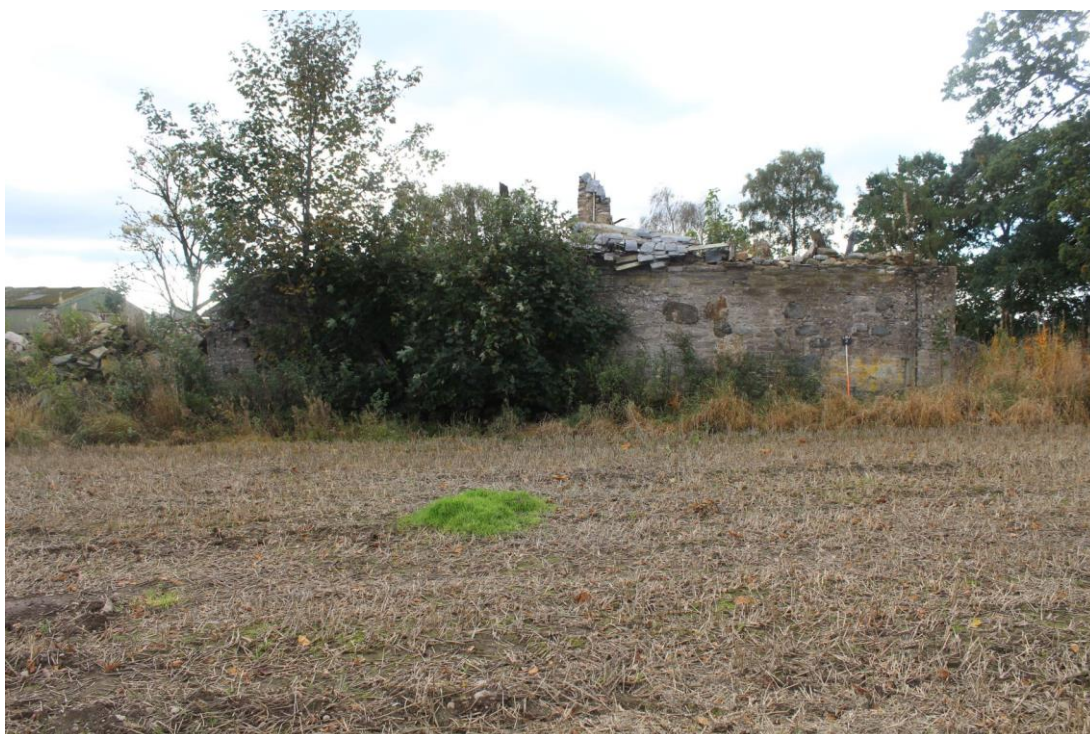
*Building 3, outbuilding*

This lay to the N of the farmhouse and may have been the last surviving remnant of the original steading (see above). It was aligned in parallel with the farmhouse (ie, E-W for the purposes of the survey) and was a simple rectangle subdivided into at least two rooms. The roof had collapsed and the W end was densely overgrown and could not be entered. The E end room lay open, with roof beams collapsed into the interior, along with numerous slate and brick fragments. It appeared unsound and was photographed obliquely. Simple, but slightly sub-rectangular in plan, it measured 12.00m E-W x 6.00m N-S, and stood up to 2.30m tall at the wallhead, 2.60m at the damaged gable apex. It was constructed of unrendered, lime mortar bonded grey sandstone rubble, with walls up to 0.40m thick, and had been roofed with grey slate. The S elevation featured a glazed window into the W side room and a ruined former doorway in the E room. No other features were visible.

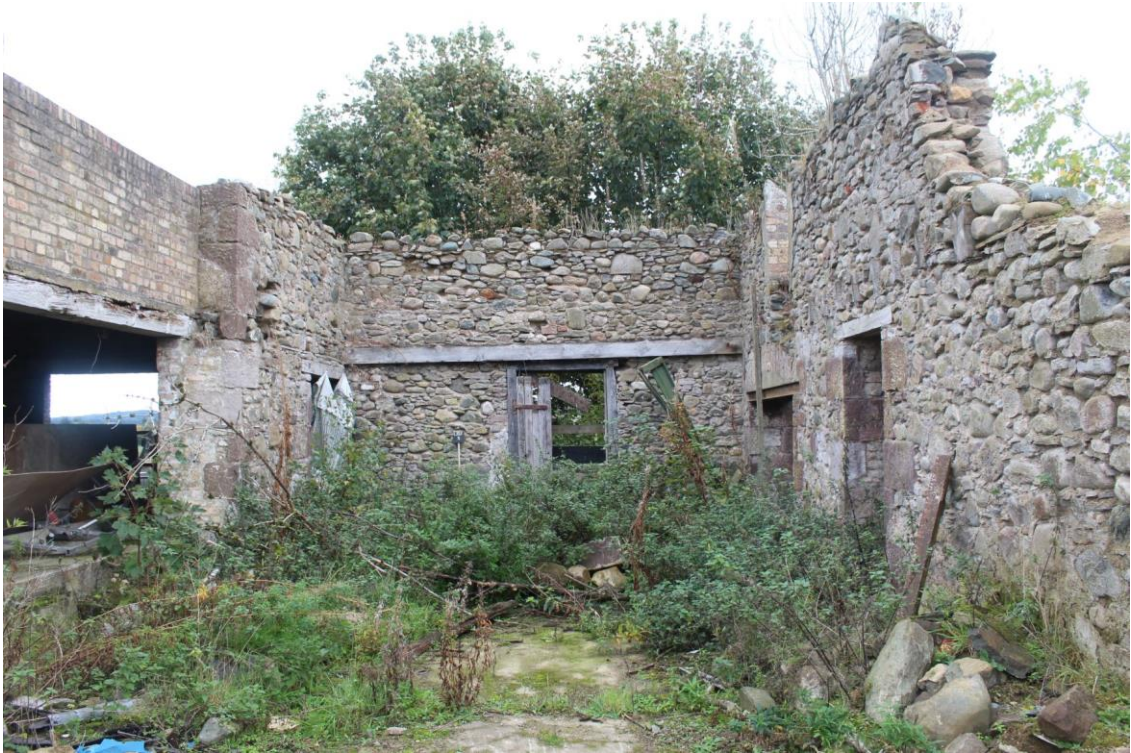
*Building 5, steading*

This was completely roofless and had been largely demolished (or had collapsed and then been partially cleared), apart from a rectangular, standing ruin in the NE corner and the N, E and S external walls. The N and S walls now formed part of buildings 4 and 6, while the E wall was effectively the E boundary of the farm. The interior was almost impenetrably overgrown, while most of the W side was covered by mounds of demolition rubble. Map evidence indicated a later 19<sup>th</sup> Century origin for this steading, which replaced an earlier version (see above). The surviving wall fabric was of lime-mortared stone rubble, with elements of brick in places. Within the ruin, entrances had been inserted in the N and S long walls, with a brick arch above a steel joist in the latter. The W ends of both long walls, were severely damaged.

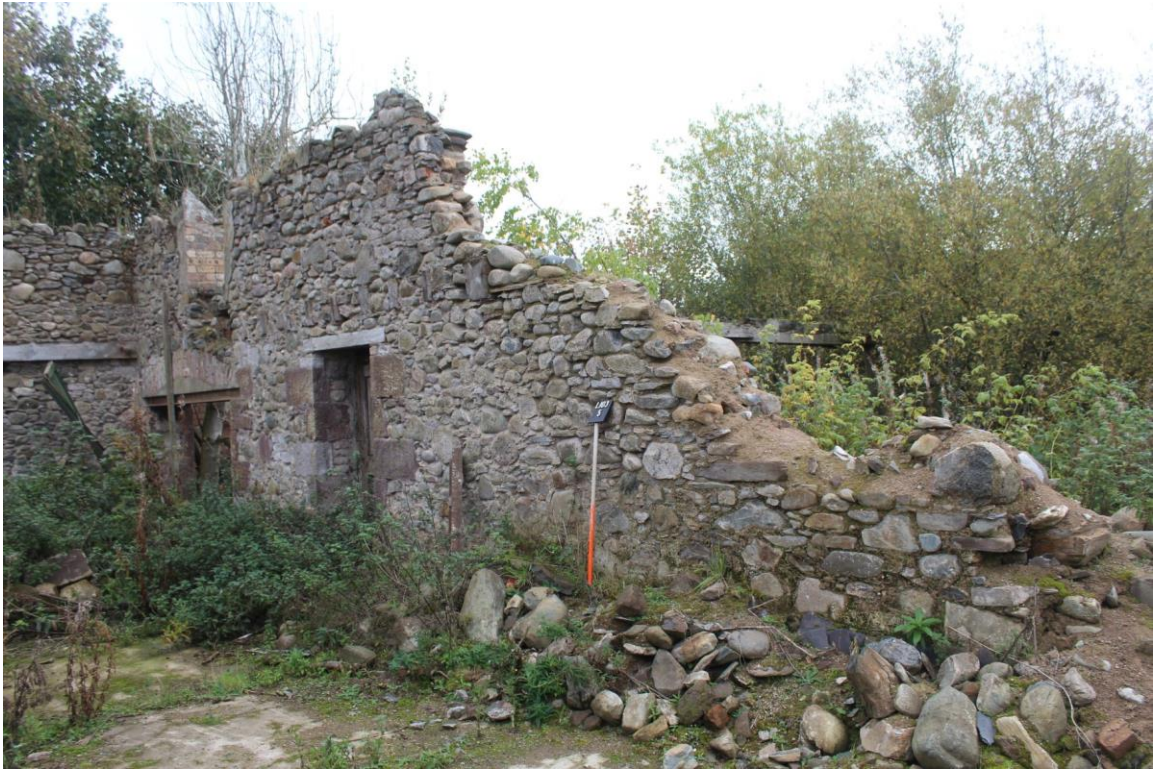
The general plan was of a roughly rectangular building, matching that of the OS 2<sup>nd</sup> Edition (see above). An interior wall, described on the architect's plan as a retaining wall, may actually have been the foundations of a dividing wall. Apart from a poured concrete floor, mainly surviving within the standing ruin, nothing else could be discerned of the interior features, which had been almost entirely obliterated.

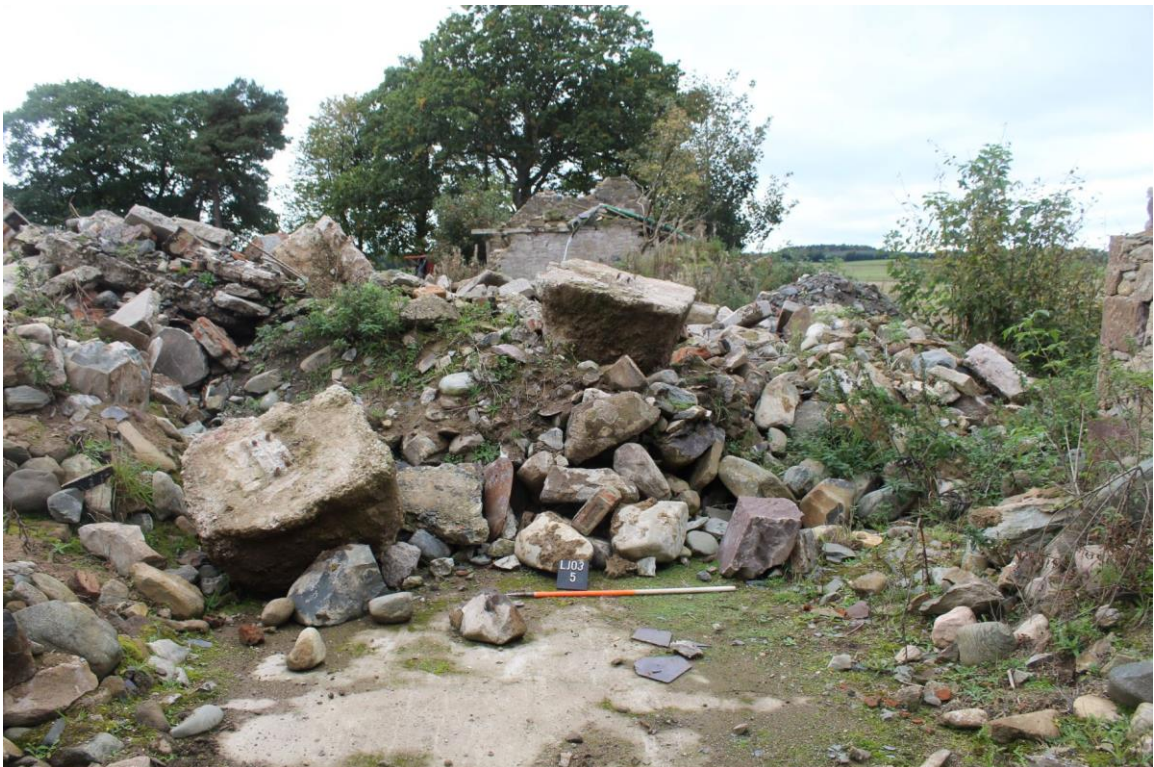
Overall, the steading measured 29.00m E-W x 25.00m N-S, these measurements somewhat approximate due to the amount of rubble and vegetation. The ruin stood to 3.50m tall at the wallhead, the roof entirely absent.

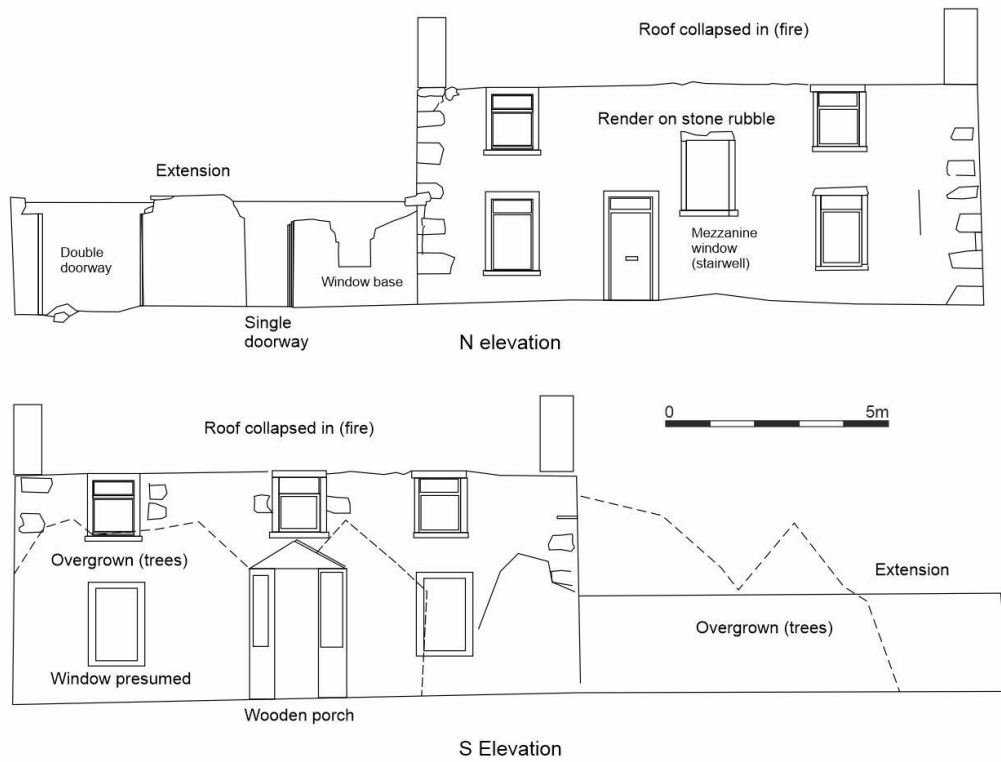
Illus 3

N elevation: This faced onto the yard and featured a groundfloor door to the E of the centre line, offset due to the presence of a central staircase, visible through a mezzanine/landing window set in the centre of the elevation. Paired ground and first floor windows were set at either end of the main building. The windows, in modern wooden frames, were glazed, but the glass had been shattered (possibly during the fire). The damaged wall of the low extension to the E, also of whin and cobble rubble with sandstone casings (and also some concrete rebuilding) featured the remains of a brick-rebuilt window at the W end, a central doorway and what appeared to have been a double-door entrance at the E end. The interior was choked with rubble and fallen roof material, but featured a brick partition to the E of the single doorway, creating a small

S elevation: This was thickly overgrown, with young trees against the wall face, but the main building featured a central groundfloor entrance within a wooden lean-to porch entering a heavily charred hallway), with two groundfloor windows at either end and three first floor windows above, evenly spaced across the elevation. The extension was featureless.

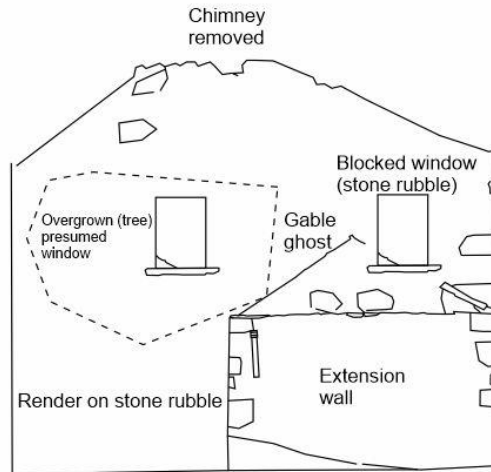
E elevation

E elevation: This included the extension, the interior W elevation of which showed a double-pitched roof gable ghost that cut across a blocked first floor window in the main building, further demonstrating the construction sequence of main building followed by extension. No other features were visible, apart from damage to the main gable that probably resulted from the removal or capping of a chimney.

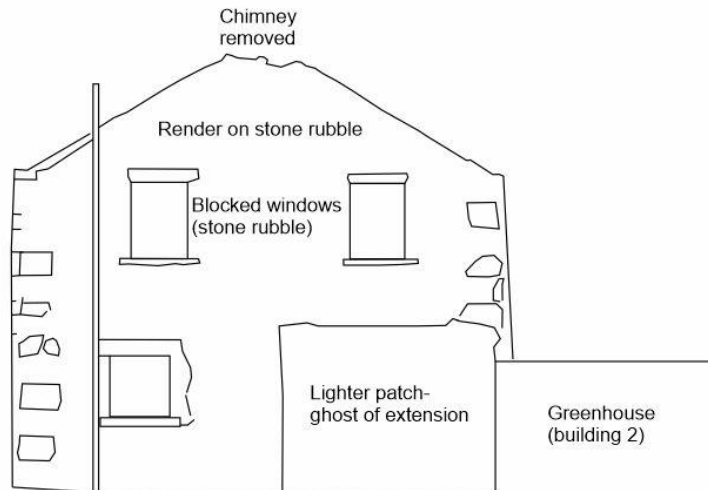
W elevation

W elevation: This featured two blocked first floor windows and a glazed groundfloor window that was, uniquely, square- all others being rectangular. The S of the ground floor also featured the ghost of a lean-to extension, as a rectangle of lighter-coloured, unrendered stonework measuring 2.30m tall x 2.80m wide; this had probably been an addition to the greenhouse (building 2) which was connected to the S of the extension by a wooden lintel.
