# AN ARCHAEOLOGICAL AND HISTORICAL SURVEY OF BLAIRADAM FOREST FIFE & PERTH AND KINROSS

Alder Archaeology Ltd was commissioned by Forestry Commission Scotland to carry out a desk-based assessment and walkover survey in Blairadam Forest, Fife. This work was carried out to enable the FCS to make informed and reasonable decisions on the future management of the cultural heritage within Blairadam Forest. The forest lies to the west of the M90 motorway, near Kelty, and measures roughly 12 square kilometres. Sites identified in the desk-based assessment were visited over several days between the 29th of August and the 28th of September 2009. The results of this survey found that many of the boundaries that once belonged to Blairadam estate can still be found hidden in the forest. The boundaries (comprising tree lined banks, ha-ha's and walls) belong to the designed landscape created by the Adam family over three generations between 1733 and 1834. It was possible in many areas to distinguish between three different phases of boundary alterations. The survey also found extensive mining remains along three different burns, some of which may date to the medieval period. The most extensive of

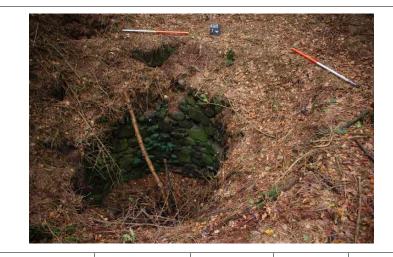
7	Pieries Burn Wood	Colliery	В	Post-medieval/ Modern	NT19NW 38	NT 1142	9511	None

Walkover Description: A circular pit lined with random rubble. Site is too dangerous to measure accurately but it is roughly 3m in diameter and 1.5m deep. The stone lining appears to be of drystone construction made with rounded weathered stones (fieldstones?).

Mitigation: Avoid damaging structure.

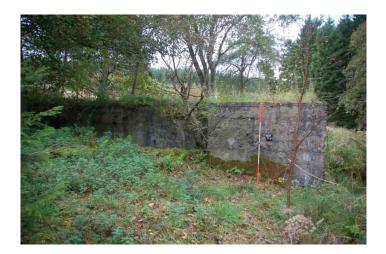
Interpretation: Remains of Blairenbathie Colliery.

Interpretation of remains would require a more detailed survey.

*Mitigation:* Avoid damage to buildings within 9.1. A detailed survey is recommended (possibly with public involvement). Interpretation panel also recommended.

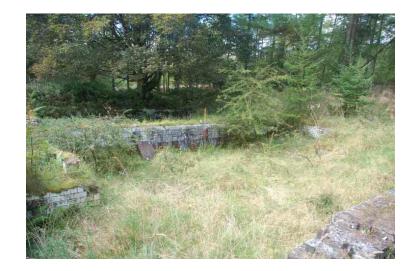
3 7774 63 7777 47	3.TT 44.4.5		
10	Pieries Burn Wood	Waterworks	C	Modern	NT19NW 47	NT 1145	9504	None

Walkover Description: The remains of Kelty Town Council Waterworks. The works lie in a clearing in the forest and consist of a rectangular structure and a circular structure. The rectangular structure is divided into three chambers or tanks by two baulks (each 0.94m wide). Each tank is 9.2m wide, 13.8m wide and 1.3m deep. They are lined with 7 upper courses of white glazed bricks and unglazed red/brown bricks below (bricks stamped J&R Howie). The circular structure is 10.8m in diameter and comprises an outer wall 0.6m wide built from white glazed bricks. The wall is mostly 1.6m high; 15 courses of brick could be counted in places. There is a rectangular bank around the circular feature.

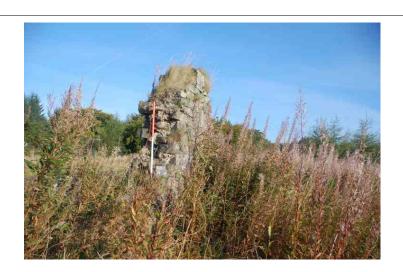
37	Void	Void	Void	Void	Void	Void	Void	Void
39	Wattie's Ford Cottage	Cottage/House	В	Post Medieval	None	NT 10446	94064	None

Walkover Description: On an area of deforested ground next the Lochornie C road, just north of Wattie's ford bridge are the remains of a ruined cottage, 10.8m long and 6.3m wide with walls 0.6m wide. The west gable wall survives up to 2.5m high and the north wall up to 2.2m; elsewhere the walls are just 0.1-0.6m high. The south and southern part of the west wall have been destroyed by tree planting and tree stumps can be seen on the original line of the wall. About 4m to the west of the western gable wall is a drystone wall and beyond a ditch and then the road. There is a causeway over the ditch and a gap in the wall which correspond to the original line of access to the cottage from the road.

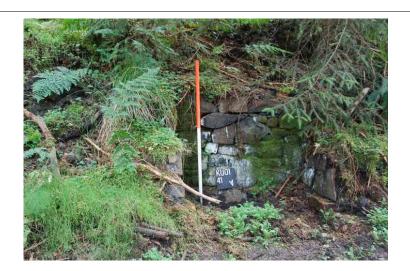
40	Wattie's Ford Bridge	Bridge	C	Post Medieval	None	NT 10420	934000	None	
70	wattie 3 i old Blidge	Diluge		1 ost wiedie van	TVOIC	111 10420	754000	TVOILC

*Walkover Description:* Sides of bridge have been recently re-faced and parapets have been re-built. Two wooden beams (bolted together through the bridge) have been added along each side, just below the top of the arch. Dimensions not taken as bridge under no threat.

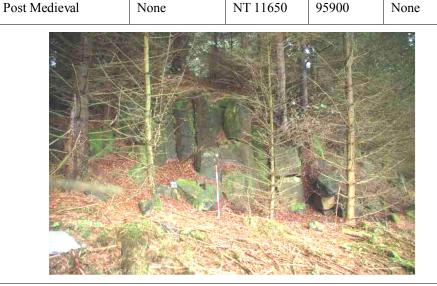
44 Stell Wood Quarry C

Walkover Description: A long exposed cliff of basalt (4m high+) showing columnar jointing. The quarry face is at least 28m long and 4m away from boundary C33 (to south). The quarry is divided in half by a tumbled roughly built rubble wall 1m wide

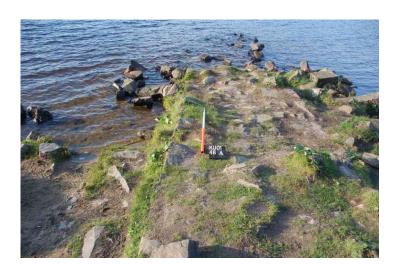
48 Loch Glow Boathouse B 19th century None NT 08946 95507

Walkover Description: On the southern bank of Loch Glow there is a low platform of levelled rubble projecting out into the water. Large squared well-pointed blocks are visible amongst the rubble. Two walls could be determined: the western one was 1.5m wide and at least 12m long; its full length could not be traced out into the loch. This wall marked the western limit of the structure and was probably an external wall. Further to the west and parallel to the first was another much narrower wall which may have been an internal division. Overall the structure measured 12m by 12m.

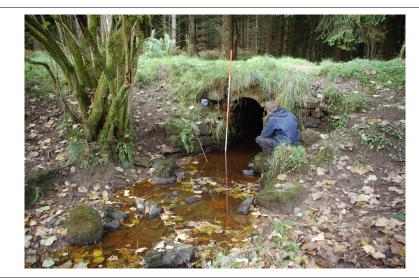
Walkover Description: A small bridge with a tall arch. Most of the voussoirs have been replaced with brick, but the lowest course on the south side is stone. Stonework comprises well dressed sandstone blocks and rougher whinstone rubble. Bridge 5.1m wide, 1.5m tall and the arch is 0.5m wide.

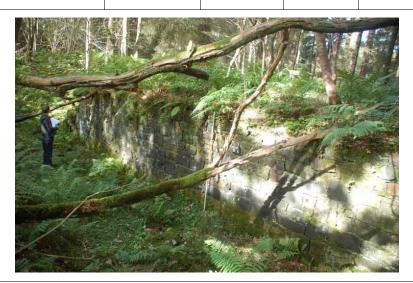
59	Blairenbathie Railway	Railway	В	Late 19th century	None	NT 12300	94940	None
	Line

Walkover Description: Line clearly visible as an embankment and in places a cutting. The original line seems to have been widened around the surface mine (16). To the east, the bridge over the estate road to Clentry has been demolished, though one brick pier still remains. The west end of the line ends at NT 12048 94801 in a narrow cutting and 21m east of this end is a 17m long length of stone revetting on the north side of the cutting. A 10.4m long section of this revetting comprises a well-built mortared wall built from squared rubble. This wall is 2.1m high and there are 8 slots (28cm x 15cm) at equal distance along the top of it (no corresponding holes were seen on the opposite bank). A wooden beam (12cm thick) sits centrally on the top of the wall and has been pinned into 3 of the slots. The revetting on either side of the wall is poorly constructed and of drystone construction; at the far east end it appears to be composed of concrete blocks that were hardened

Interpretation: The well built revetting wall may have been where coal was tipped into railway wagons. However the slots suggest that there was some kind of roof over the cutting at this point. Perhaps this is the remains of an engine shed. Interestingly this revetting is in line with a sloping ramp feature (see 135) which descends towards the Kelty burn some 50m to the north-west, so maybe we are looking at the end of some sort of conveyor belt.
