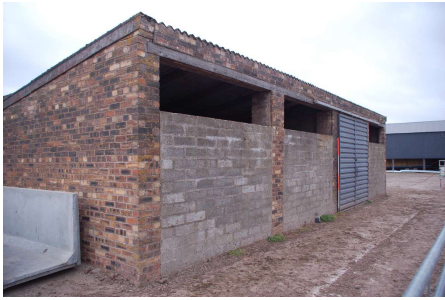
0009

Shot of the S side of the bayed building showing the blocked entrances. View NE

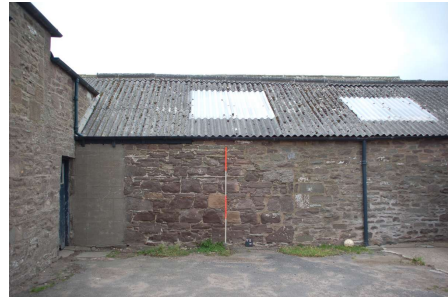
0009

Shot of the early stonework at the N end of the W wall of the byre. View E

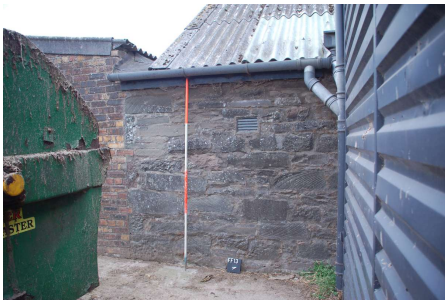
0063

Shot of the S end of the E wall of the byre showing circular sawn stonework. View W

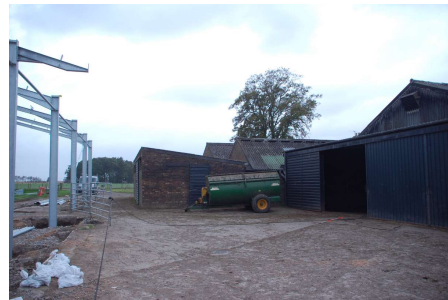
0066

General shot of the E side of the area to be demolished. View NW

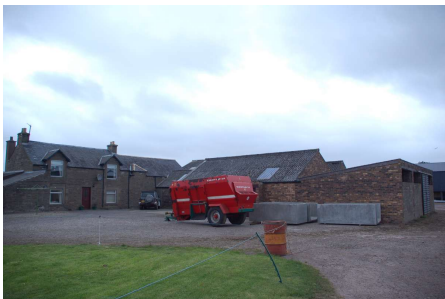
0067

General shot showing the milk processing building and the bayed building. View NE

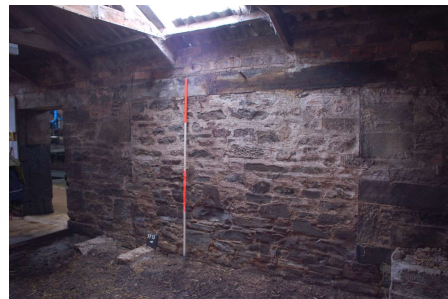
0026

View of the blocked southern doorway in the W wall of the byre. View NE

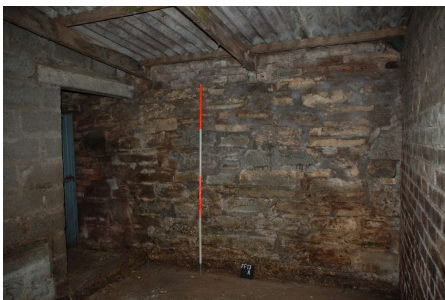
0046

View of the S wall of the byre from inside the bayed building. View N

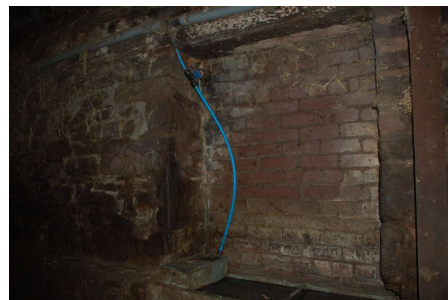
0114

Shot of the northern blocked doorway in the E wall of the byre. View SW
