NORTH CANAL BANK,
CLYDEBANK
DATA STRUCTURE REPORT

PROJECT 2500

carried out
on behalf of
AEL Enterprises Ltd

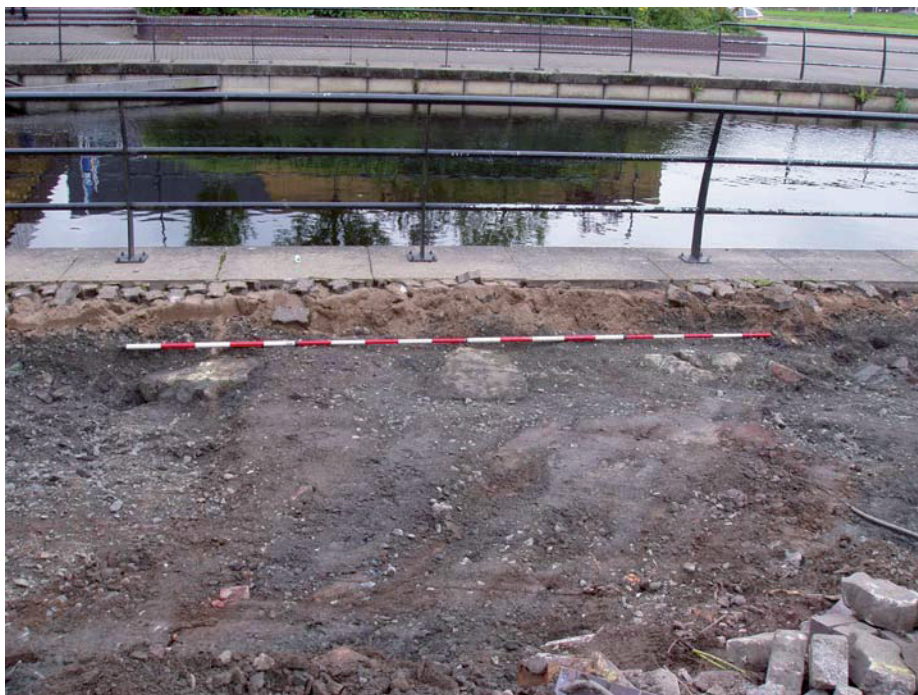
Plate 1: The linear arrangement of sandstone blocks (011) in Area 1.

Several large sandstone blocks (011) were found in a test pit to the west of the covered footbridge at the east end of Area 1, where the canal has been narrowed. These stones seemed to form a linear structure

about 5 m long that ran parallel to the present wall (where the canal had been narrowed) and on the same alignment as the existing canal wall approximately 2 m to the south. These unbonded stones, which were both shaped and unshaped, measured individually 0.4 m to 0.6 m long and 0.3 m to 0.55 m wide. The stones were cleaned, photographed and planned at a scale of 1:20. While attempting to determine if these were structural, a void was found below one of the stones. Red bricks with an obscured maker's stamp (SF 3) and smaller pieces of sandstone were also found among the sandstone blocks in a brown silty matrix (015). From the disturbed nature of these structural components, it was apparent that although the sandstones were very likely to be the remains of the original canal wall, they were no longer *in situ*. The depth to which the sandstones may be found is not known.

The renovation works at North Canal Bank, Clydebank uncovered an unbonded sandstone structure that is very likely to be the remains of the original wall on the north side of the Forth & Clyde Canal. The stones were not *in situ* and were intermixed with red brick and a brown silt deposit. Other individual sandstone blocks were found in Area 1 in contexts where modern building debris was mixed with a brown silt deposit. From these findings, it is likely that the original wall was retained while the present wall was being constructed, and was subsequently at least partially destroyed.

Having established that the remains of the original north wall of the Forth & Clyde Canal are partially extant, it is reasonable to assume that the south canal wall may also have been preserved to some degree. It is, therefore, recommended that any ground-breaking works on the south canal bank be subject to similar close archaeological monitoring.
