**32 High Street
Saxmundham
Suffolk**

Report into the Architectural and Historic Significance of the Building

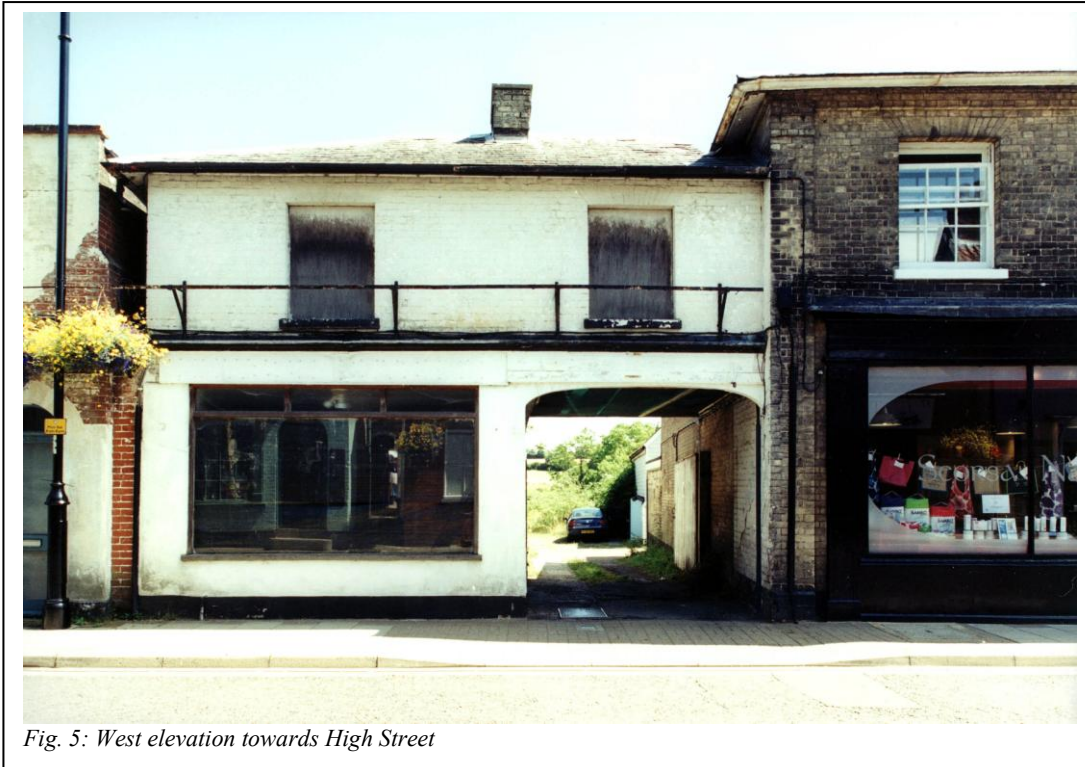
Fig. 5: West elevation towards High Street

north and clad with Welsh slate⁶. The ground floor is rendered and painted in white masonry paint and to the right of the elevation is the carriageway into Berrett's Yard under a shallow basket arch to the front only. To the left is a plate-glass display window of c. 1970 under three plain transom lights. A

blank timber fascia board runs the width of the elevation above this point and there are three 3/6 unhorned sash windows to the first floor, boarded over. A steel rail on four steel brackets formerly took the signage for the butcher's shop. The eaves of the roof overhang slightly so there is a timber soffit board and the gault-brick ridge stack has lost all of its pots. There would have been three – one each for the two first-floor fireplaces and one for the shop fire in the south wall.

6.1 As it stands the façade towards High Street, which is the most significant element in terms of the Conservation Area, actually detracts from the street scene, and combined with the neighbouring premises to the north this is a poor stretch of the street. The proposals set out in drawing No. SAXI-32HS-004 however, go as far as is possible to rectify this situation, recreating a conventional early twentieth-century shop front with a glazed door with an overlight to the right of a double-paned shop display window complete with transom lights and set over a plain stallriser. The whole is to be within a conventional cornice supported on side pilasters¹⁰. The unsightly fascia board which embraces both the present display window and the weak arch over to the carriageway is to be removed and

the two first-floor windows reinstated as 6/6 sashes to conform with the remainder of the street architecture. Since the height and scale of the new elevation will match the original it is beyond doubt that the proposed build will add considerably to the amenity of Saxmundham High Street. The rear elevation of the street range, over the carriageway, is to receive a sash window in place of the inappropriate door of c. 1970.

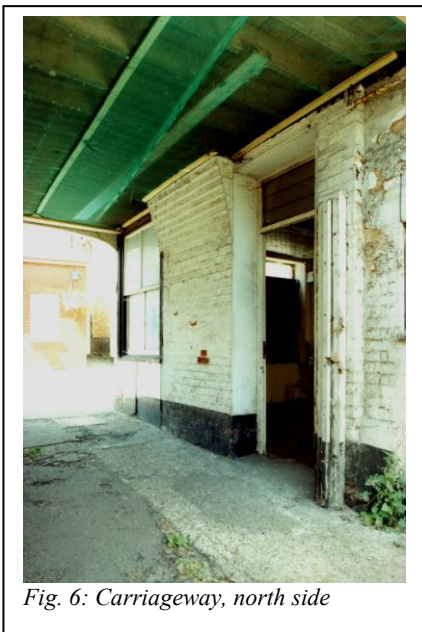
Fig. 6: Carriageway, north side

in room F1. There is of course no trace of the fire opening in the interior. The door has a triple-louvred hinged overhead, and to the west the single 2/2 unhorned sash window of c. 1900 remains the most authentic part of Section A other than the structural brickwork. A wide plank door on strap hinges closes off the Yard, hinged on the south side. The carriageway ceiling consists of twelve 6" by 1½" joists running north-south with floorboards on top, all of c. 1900. Their condition is not good and netting has been fixed in place to catch falling debris.

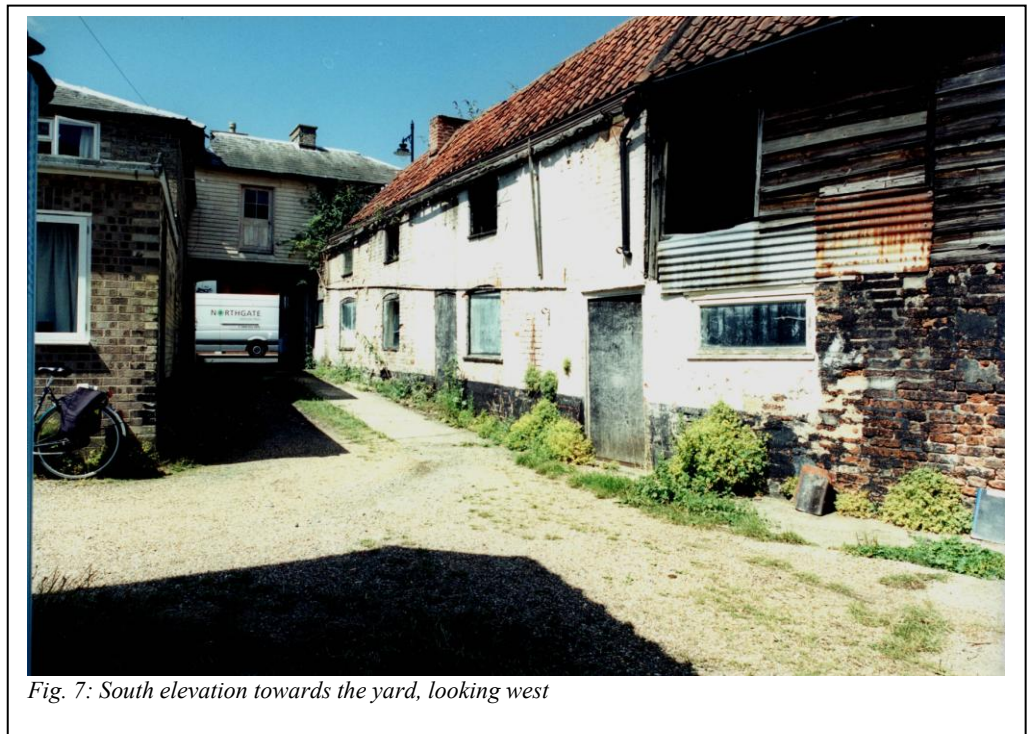
Fig. 7: South elevation towards the yard, looking west

between rooms G4 and G5. There is one stack which serves the fire opening in the wall between rooms G1 and G3 and there are two butt joins, both of which have queens closers to one side indicating that the bricklayer was building to a defined right-angle, and these joins confirm that the range was built in three phases, marked as A, B and C on the plan. Section D was, as we have noted, an open enclosure at the time of the 1840 tithe map, and section A, the street façade, was entirely rebuilt in about 1900. In the third quarter of the nineteenth century therefore, the entire range was rebuilt in two or even three distinct phases, although the precise dates of these events is difficult to determine. Rooms G6 and G7 (the carcass store room and probably slaughterhouse), room G8 (carriage house) and room G9 (outside privy) were also added in the third quarter of the nineteenth century along with sections B and C.

- 6.2 The rear wings are in a sad condition and present more of an eyesore than an asset to the yard, but the proposals suggest a new build adhering to the existing cranked footprint but with a far more interesting elevation, taller than the original to allow two full storeys (as is essential) and with an interesting stepping down of roof levels. The mixture of door designs and window types further enlivens the elevation, and it is difficult to see grounds for objection: residential and retail use is combined, and not only will the yard once more become a vibrant corner of Saxmundham, but also be a very pleasant place to live. This is a far cry from the present situation and the conclusion is that the proposals for the rear wing further enhance the Saxmundham Conservation Area.

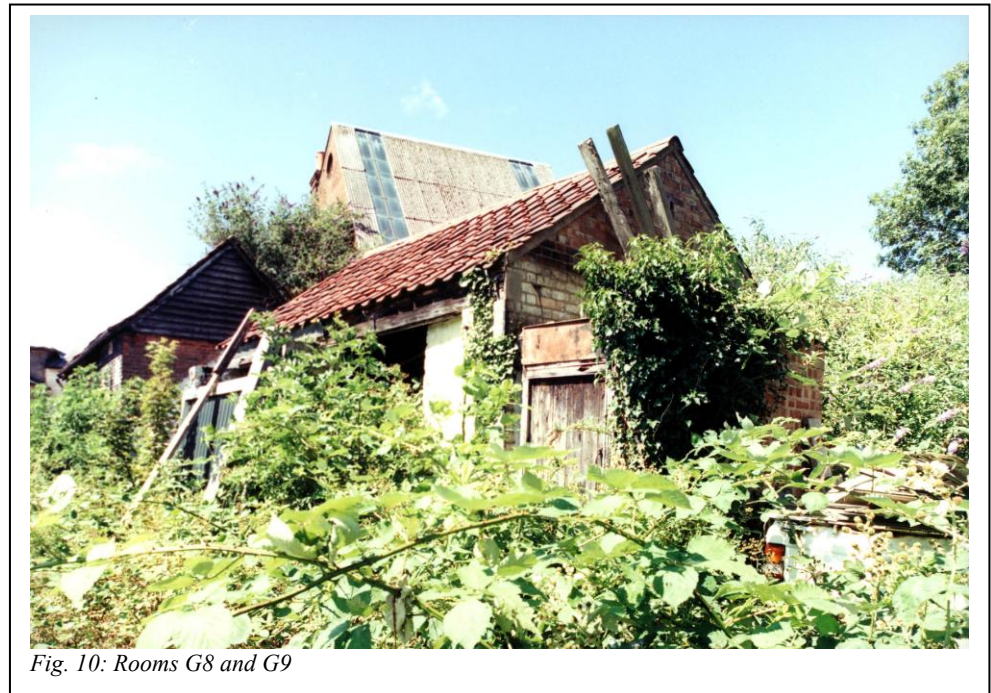
- 2.10 It is impossible to gain access to the former carriage house because of excessive vegetation and physical barriers erected to prevent access. The building was added in the late nineteenth century over the private gardens shown on the 1840 Tithe map and is of Flemish-bond red brick under a gabled pantiled roof. The east gable head however is of Fletton bricks and was rebuilt in c. 1950, in Flemish bond. To the south is a full-width doorway under a timber lintel, without the door, and there are no windows. The roof, like all the roofs of the complex, is a simple common

rafter structure. Room G9 is a detached external toilet in Fletton brick under a flat roof, with a plank door and a frosted glass window with a top-hung opener in the south elevation. The door is hung on butt hinges and has a Suffolk latch.

Fig. 10: Rooms G8 and G9

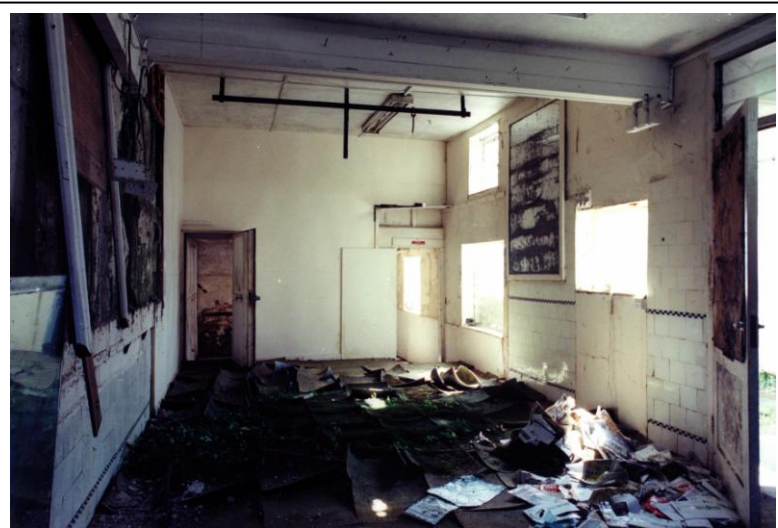
Fig. 11: Room G1, the retail area, looking east

- 4.2 Internally the entire retail area at the front of the complex (G1) is in very bad condition, with ferns, lichen and mosses growing out of the carpet tiles, and a thick stem of ivy is splitting open the north external wall, where the dry lining is falling in places. Damage from damp is extensive, to the point where this room is beyond economic restoration, unless there are overriding factors such as significant architectural or historic interest, or townscape value. The remainder of the interiors of the ground floor, rooms G2, G3 and G4, are in poor decorative and structural condition.

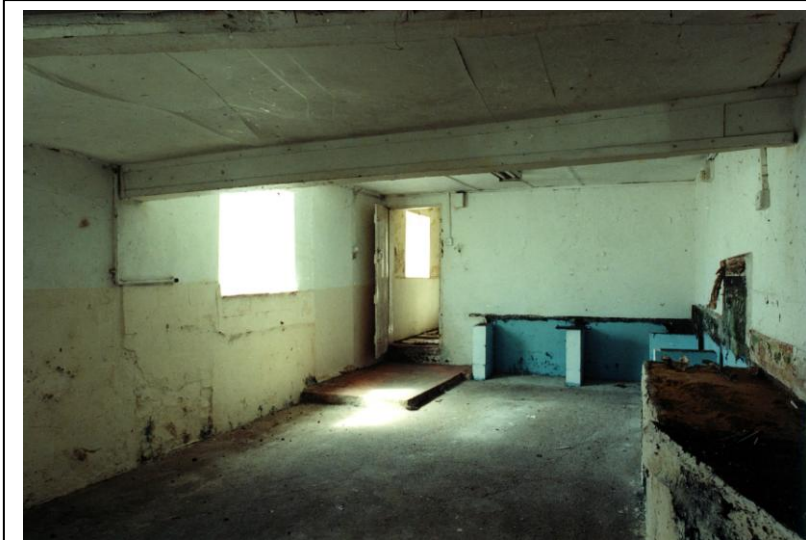
3.2 Room **G4**, the butchery room, is very plain, with a concrete floor and no original fittings. The chimneypiece within the north wall was finally removed in 1982 when the work benches were extended and the only item of any interest is the chamfered bridging beam of the third quarter of the nineteenth century, and that is not of particular architectural value. Room **G5** was added after the date of the

Fig. 12: Room G4, the butchery room, looking west

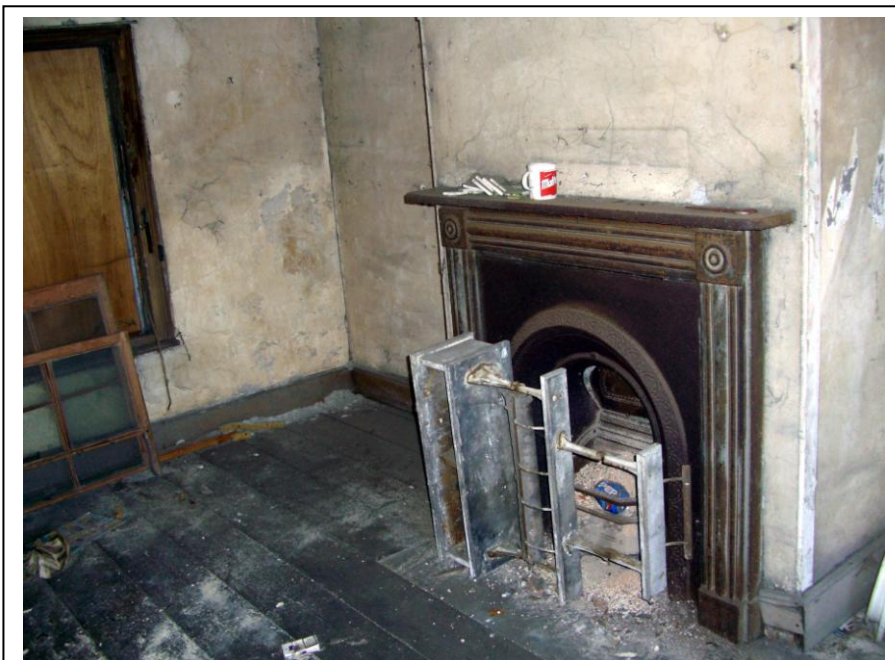
Fig. 13: Room F1, over the carriageway, north and west walls

3.4 The **first floor** consists today of three spaces in the street range: rooms **F1 and F3** with the small staircase landing between them (**F2**). Because the staircase was removed in c. 1970 (and the roof over the space it had occupied collapsed in the 1990s), the two principal rooms fell out of use. There would in any case have been much less reason to make alterations than to the ground-floor rooms, so the interiors are virtually complete examples of simple domestic spaces of about 1900. All of the fittings remain, including the sash windows

to the street elevation, but all are of the simplest, cheapest, kind and are replicated in hundreds of thousands of terraced houses in towns and cities throughout the country. The floors are extremely dangerous and in places the

ceiling plaster has fallen away to reveal the construction details of the main roof: common rafters, tie beams and one tier of through purlins.

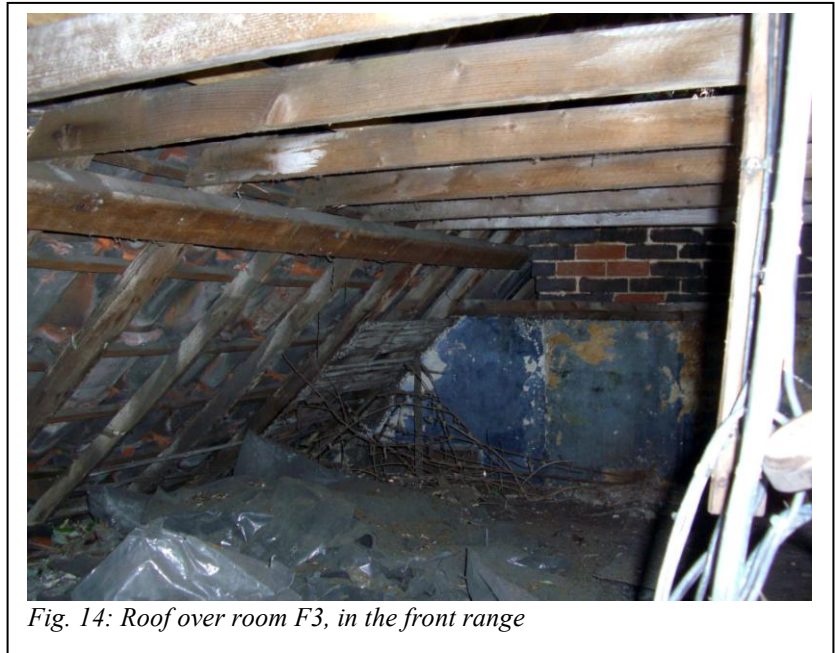
Fig. 14: Roof over room F3, in the front range

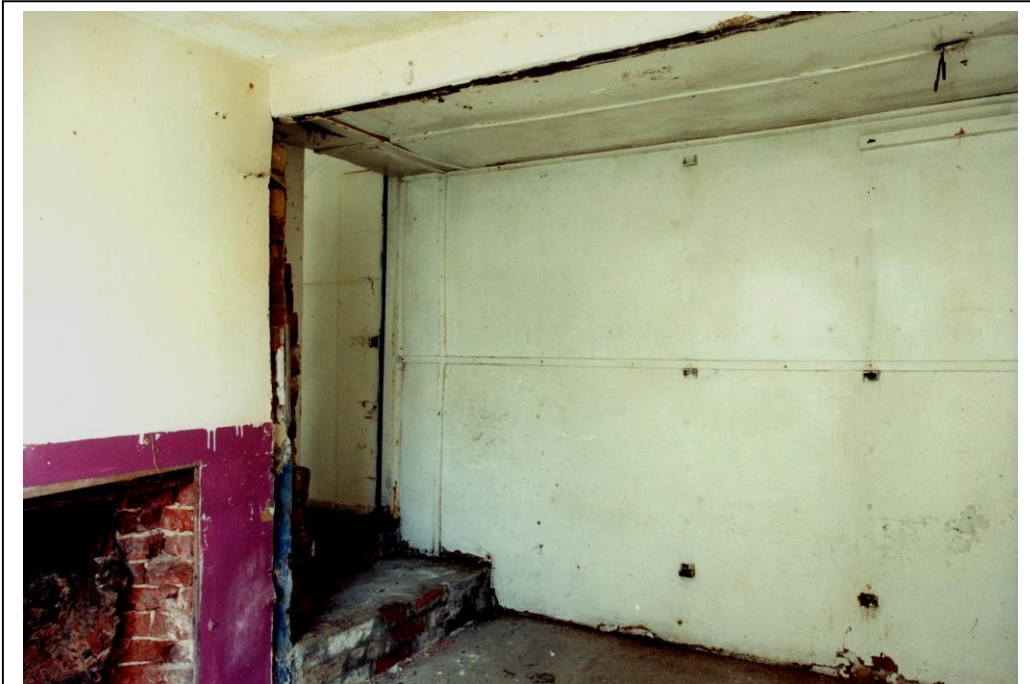
This room was built in the middle of the nineteenth century as either the back parlour or the kitchen for the use of the owner of the shop, and as such was provided with a fire opening in the west wall. The window to the yard has unfortunately been replaced by a c. 1970 plate-glass window. In the mid 1950s a radical alteration was made in order to provide Sidney Newson with a cold-store, which had become efficient enough to be installed in the majority of butchers' and fishmongers' shops. This involved partitioning off the north third of the room, which was then given a concrete floor and a new opening knocked through into room G1. The partition has been removed.

Fig. 19: Rooms G2 and G3, looking north-west

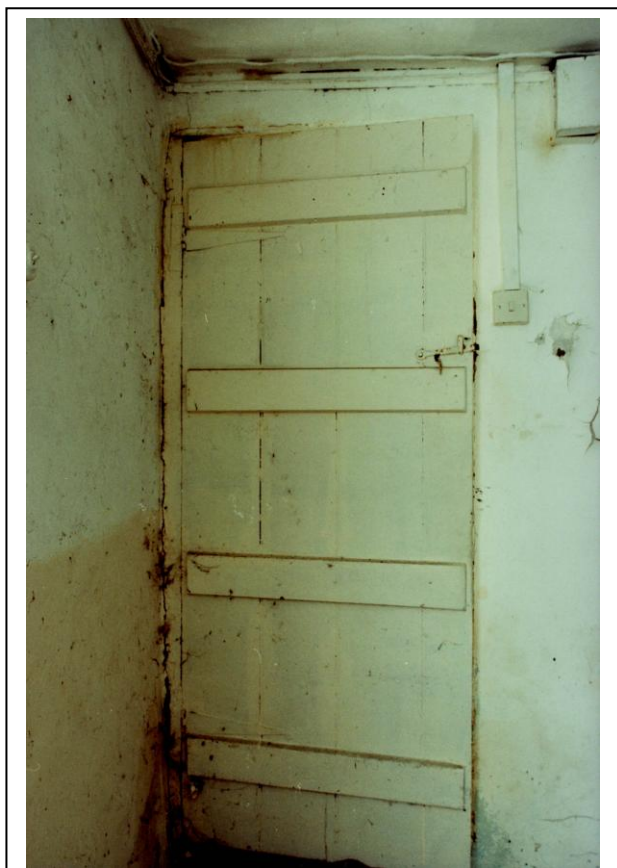
The butchery room, where the carcasses were prepared for sale after having hung for the relevant time in rooms G6 and G7. For this the long stone benches were required against the north wall, and these were extended to take in the west wall of the room in 1982, on composition blocks. This required the removal of the chimneypiece set in the north wall.

Fig. 20: Room G4 – door into room G3

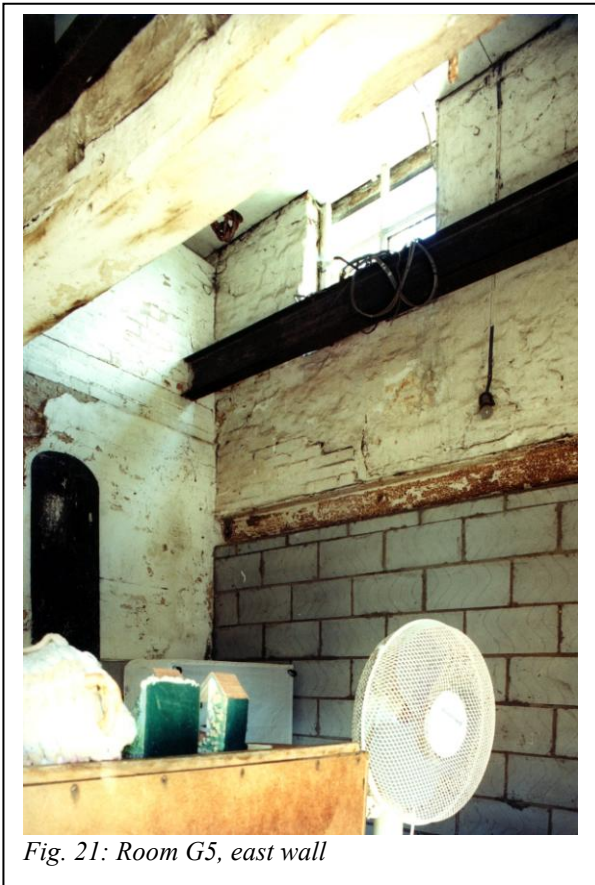
G5 is the animal shelter, where the beasts bought at the market were led and housed until slaughter time, and there would have been a hay-loft above. The doorway to this remains in place above the stable door in the south elevation, but the floor inside has disappeared. According to the 1840 Tithe Map, there was only a walled enclosure in this position, and immediately east of that was the fence delineating a garden which ran down to the River Fromus. The present building was constructed about 1850.

Fig. 21: Room G5, east wall

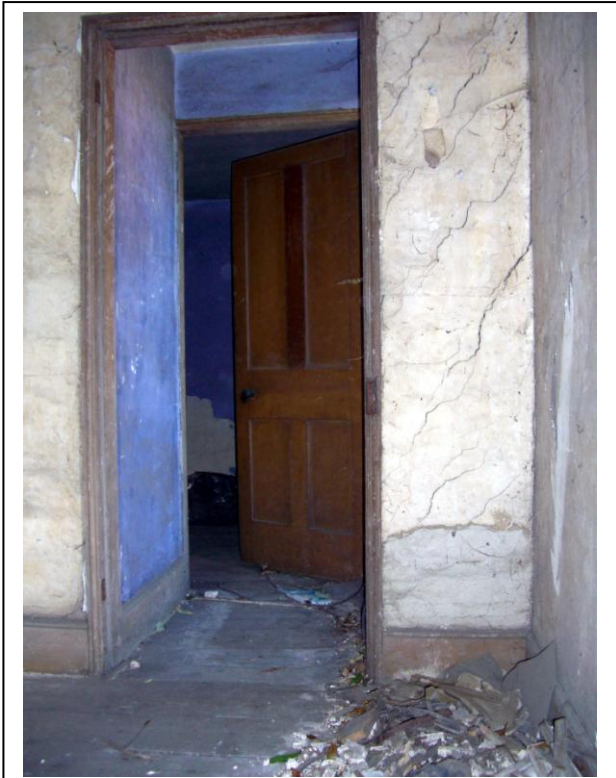
The sitting room for the domestic accommodation, over the carriageway. It is distinguished from the principal bedroom (room F3) by the design and size of the fire insert. In common with all of the street elevation the date is c. 1900 when this part of the building was rebuilt.

Walls:	Flemish-bond brick to the west and north walls South wall is common with the north wall of No. 30 High Street Studwork and weatherboarded east wall	c. 1900 Early C19 c. 1900	3 4 3
Ceiling:	Flat and plastered, with areas of plaster missing	c. 1900	3
Floor:	Floorboards run east-west, on joists which are decaying and collapsing	c. 1900	3

Fig. 22: Room F1, looking north to room F3
