# Barn and adjacent buildings to the north-west of Golding's Farm, Sotterley, Suffolk

An Archaeological Record

January 2010

SCC HER ref: SOT012

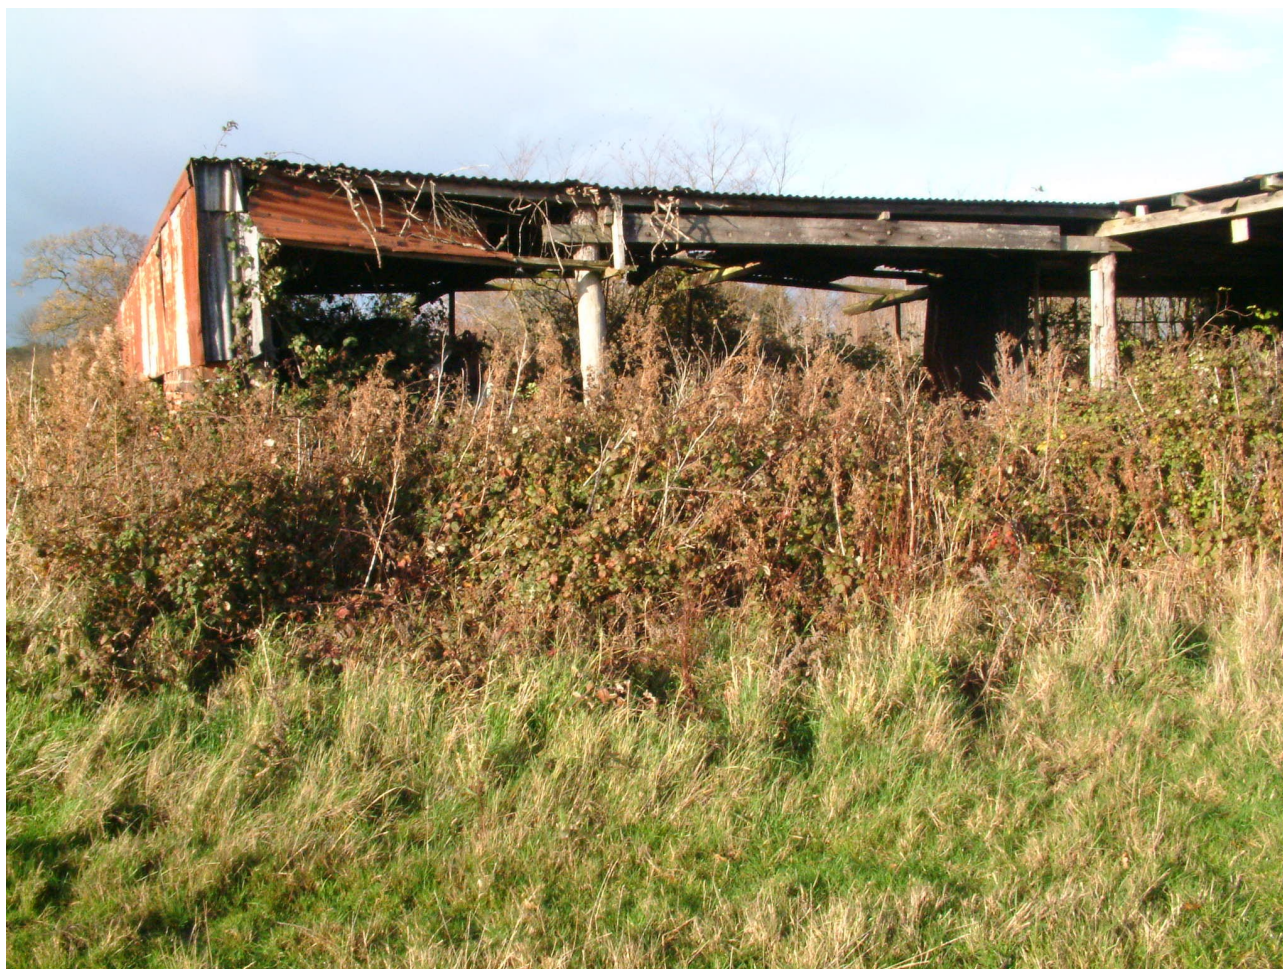
The irregular shaped sheltered area immediately to the west of the barn is a modern late 20<sup>th</sup> Century construction, consisting of a flat corrugated iron roof supported on re-used telegraph poles and softwood joists. Its plan consists of two rectangles set at right angles to each other and joined at one corner. It abutts the barn at its north-east corner. The dilapidated state of this structure reflects the quality of its construction.

Photo 1.3      The southern part of the Western Shelter from the east

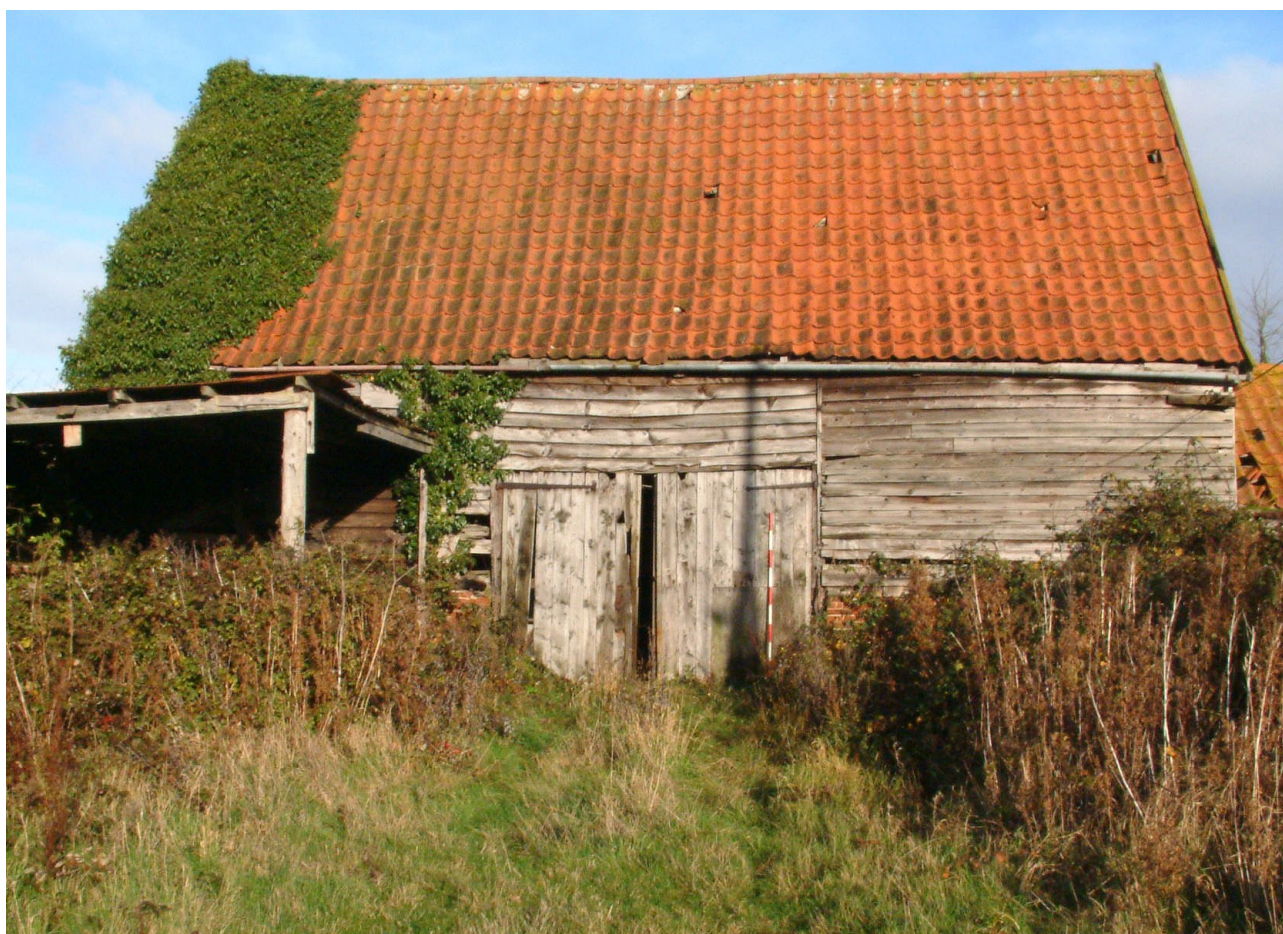
Photo 2.1      The front of the Barn from the south

The frame is a mixture of oak and elm with a predominance of the latter. Primary braces run diagonally across the walls, cutting the studs into short lengths. It is covered with weatherboarding, which is now softwood, but some original elm boards survive along the north-west wall. The frame shows signs of long-term neglect not long after its construction, which also could be an indicator of the serious nature of the post-1814 recession.

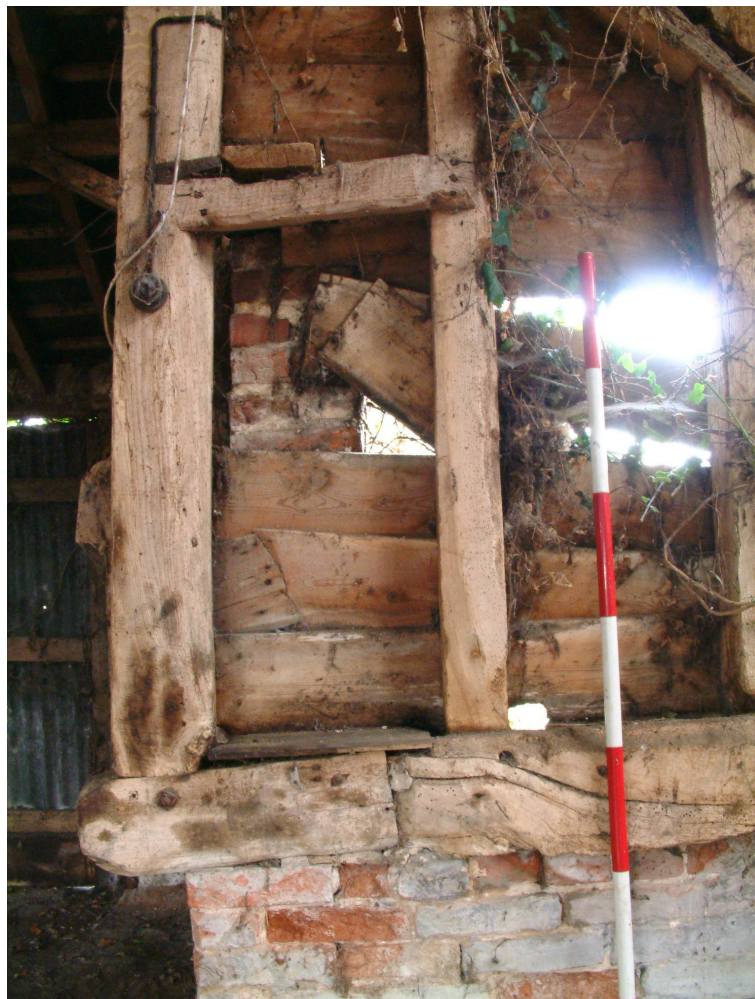
The primary timbers that flank the front barn entrance to support the main doors stand directly on the ground. At one time, the rear pair must have done the same, but they have been curtailed and set onto the sole-plate. This in turn has had to be extended and then cantilevered to support them. This is a very rare if not unique detail. It is structurally quite unsuitable and excessive loading is being placed on the cantilevers.

Photo 2.15 Altered primary timber post and rear sole-plate by the rear central bay

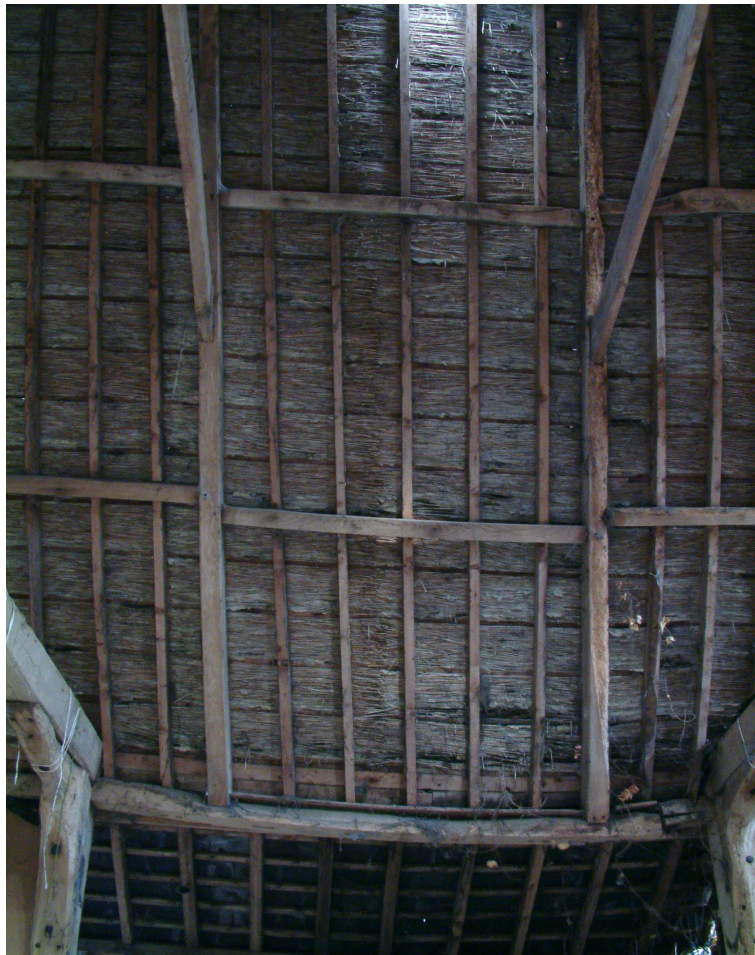
When the carpenter constructed the roof, he made no attempt to set the principal rafters on the primary timber posts of the frame below, which previously had been the usual practice. The consequence of later building the lean-to is that some studs were removed and there has been some sagging of the wall-plate over the rear central bay where it is unsupported. This has put some strain on the face-halved scarf joint [see photo 2.22]

Photo 2.22 Butt-purlin roof with sagging rear wall-plate over the rear central bay

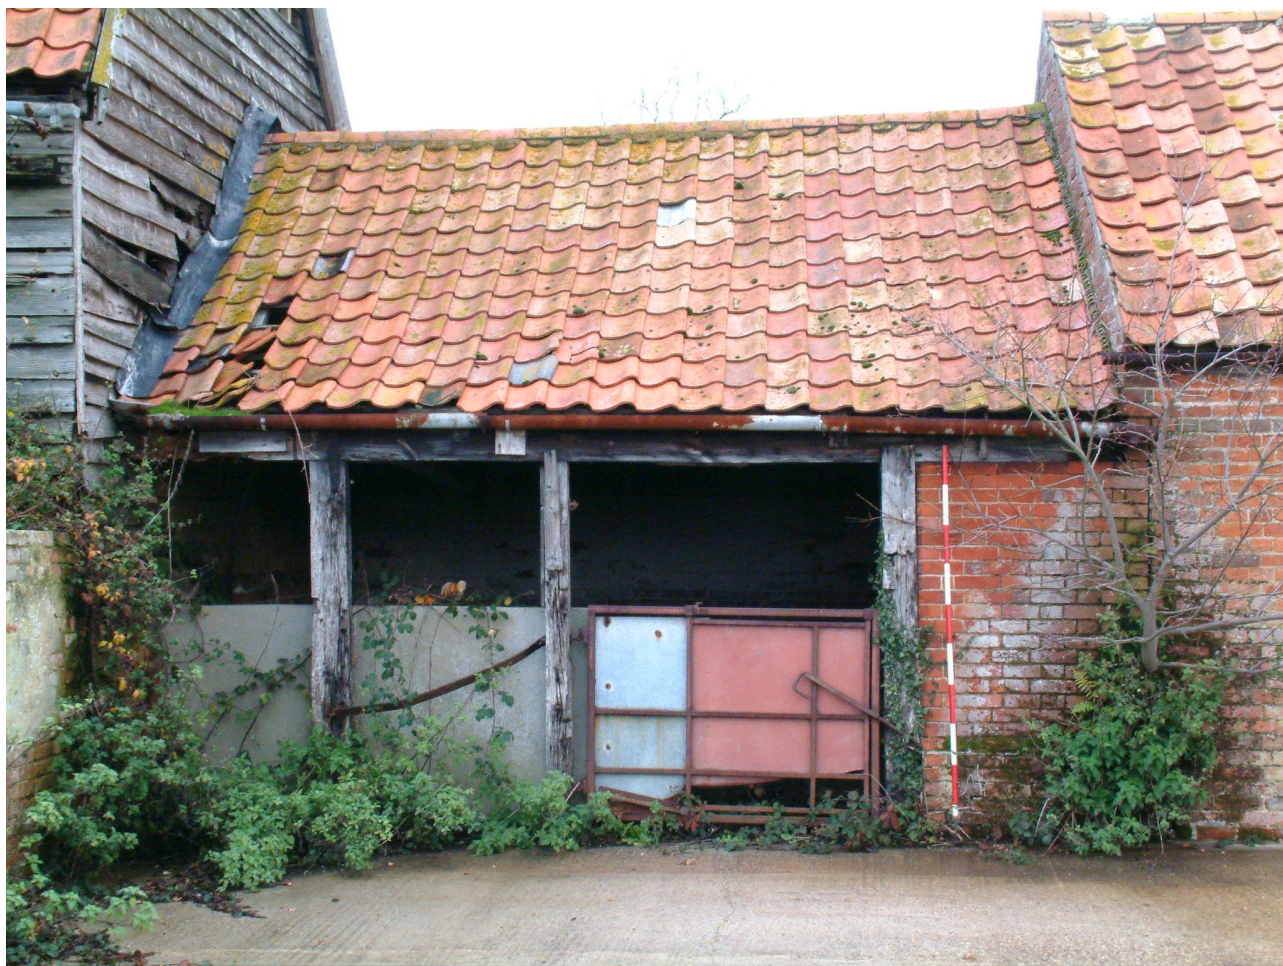
This is a smallest building on the site. It was inserted between Building 4 and the barn where once there had been a gap. Three re-used oak posts support the front wall-plate. Three portions of the front wall were at one time completely open to the yard, but have been partially filled in with iron bars and concrete. The eastern, fourth portion is filled with brickwork. However, this is butt-jointed to Building 4, showing that they were not created at the same time.

Photo 3.1      Later building inserted between the barn and Building 4

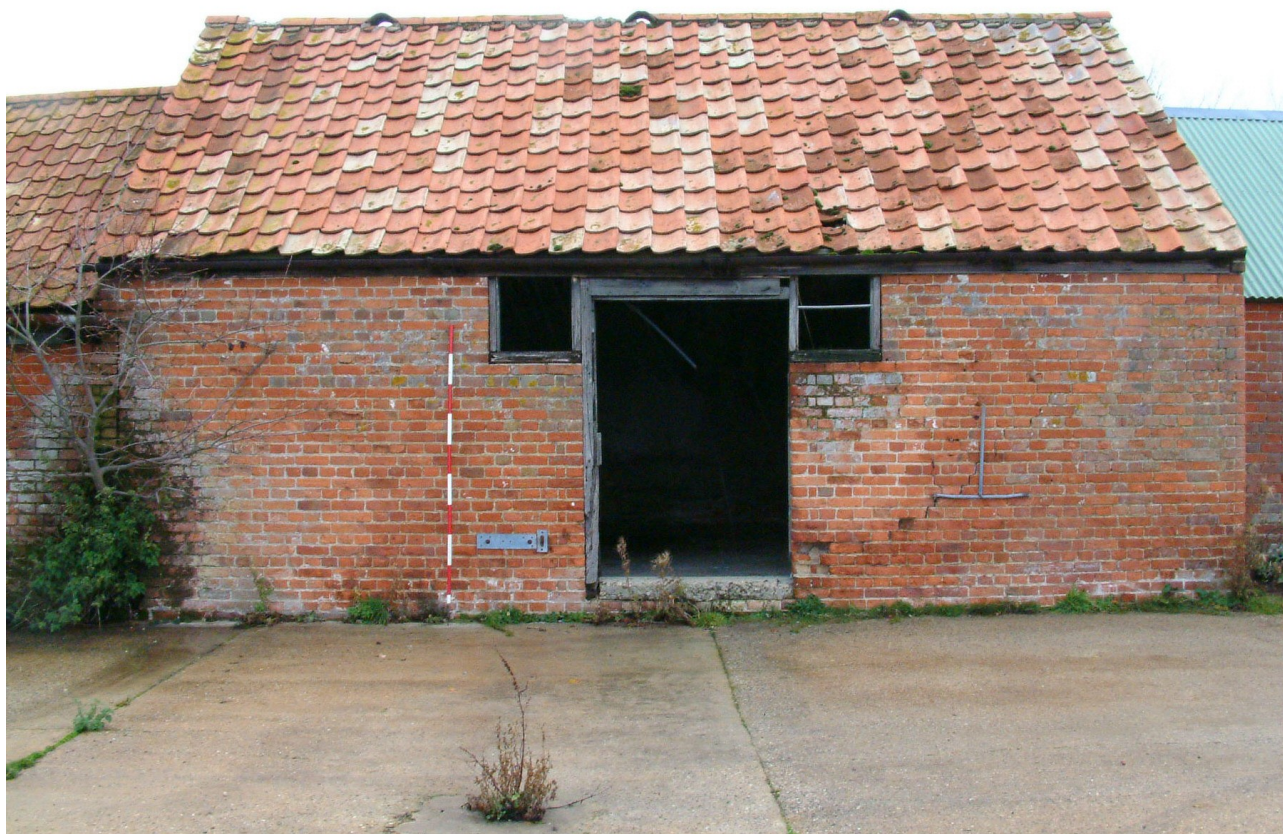
Photo 4.1      The south front of Building 4

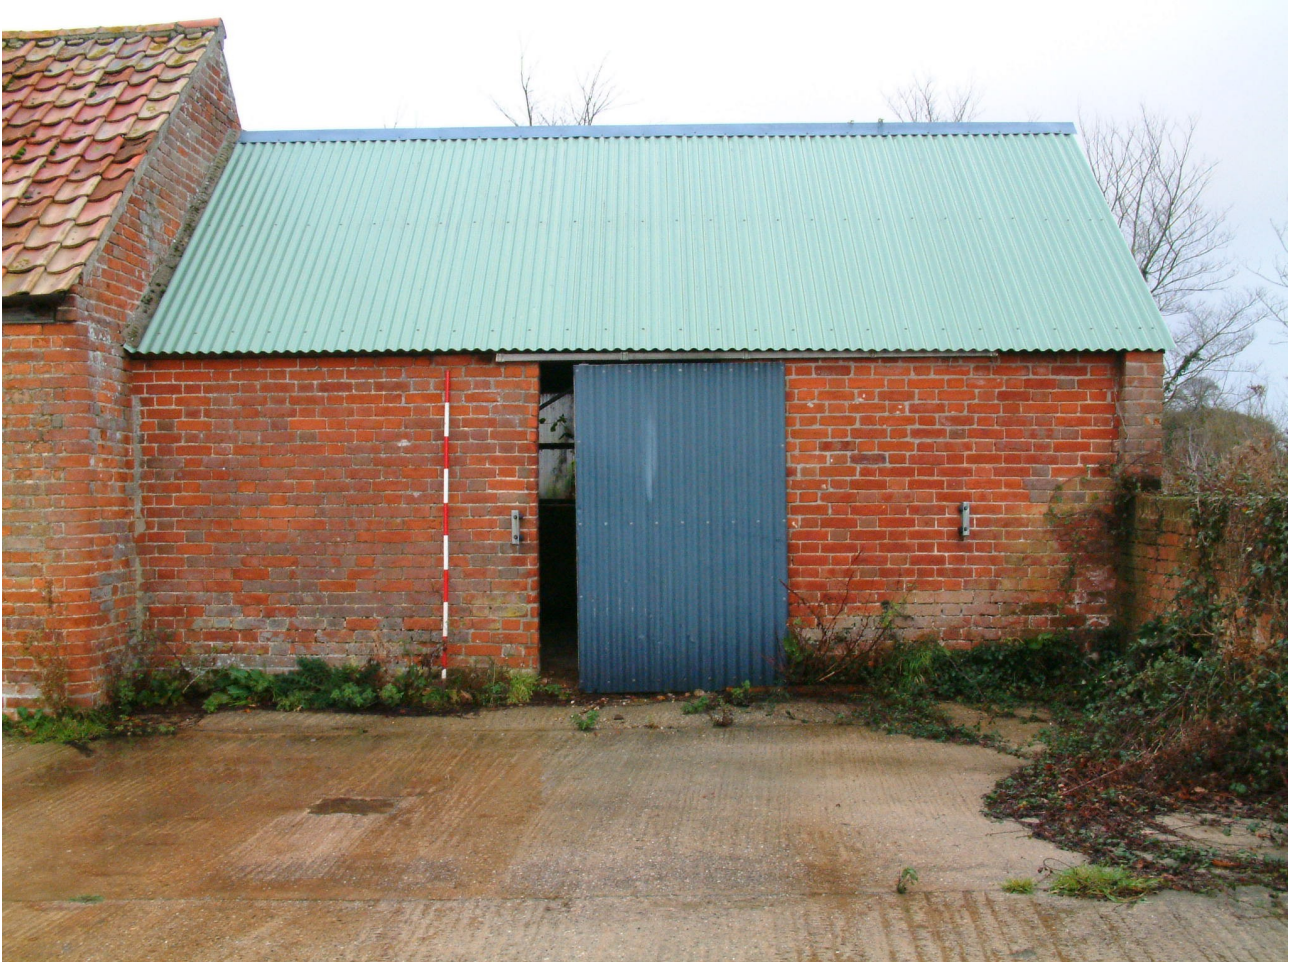
Photo 5.1      The southern annex, Building 5, from the south

The present door, clearly not original, is a sliding variety, though it looks as if this may well have replaced one of a similar form. There is a single large window, which is in the centre of the back wall. The opening is original but the earlier frame has been replaced with a softwood one and corrugated plastic 'glazing'. This suggests that the latest use of this building was just for storage.

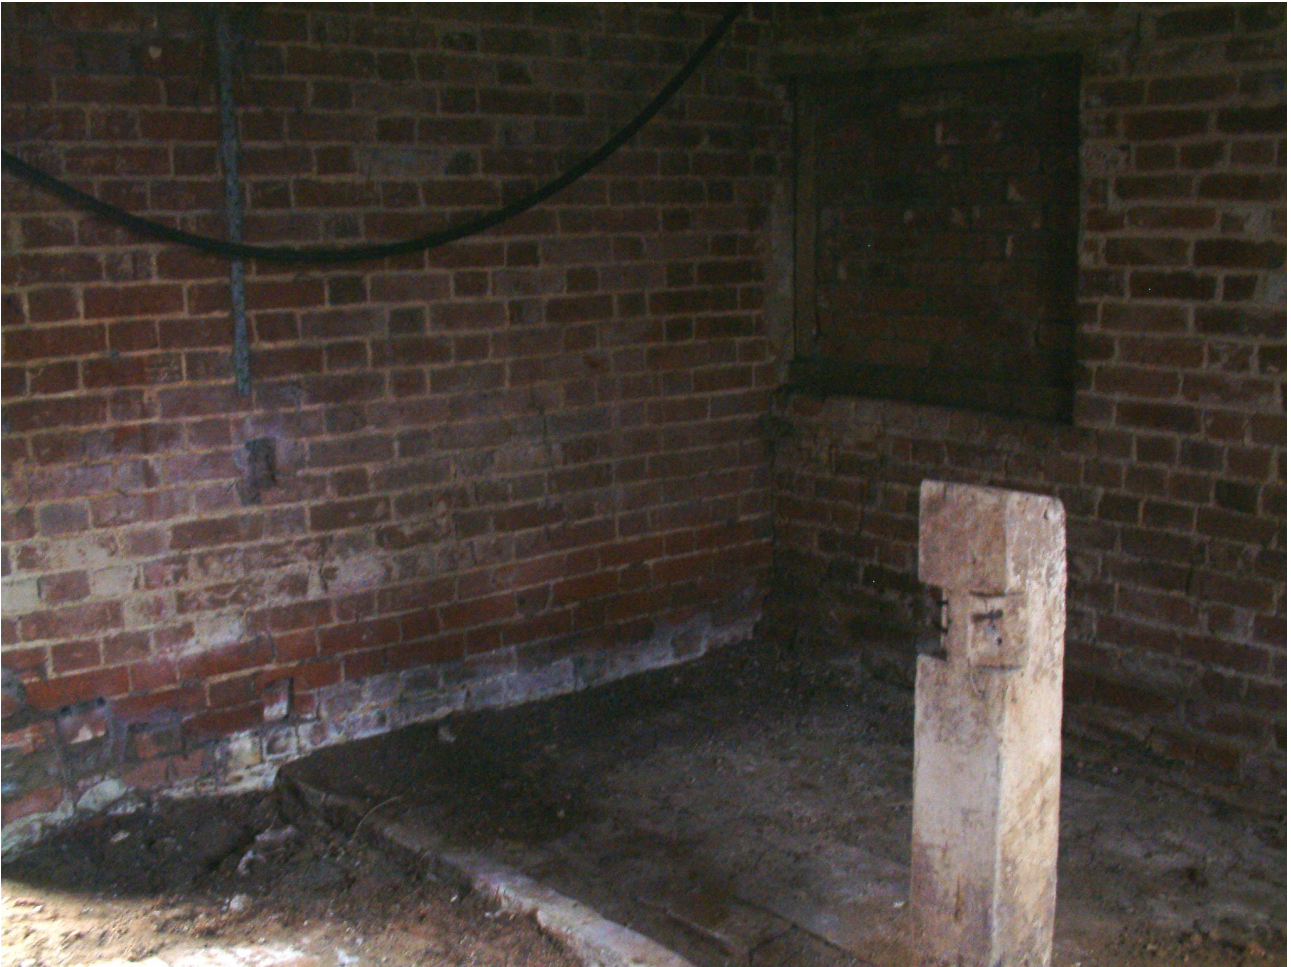
An earlier use of this building, perhaps the original one, is indicated by the evidence for timber rails across the building on the left just inside the doorway. The brick floor is raised in this portion of the building and there is a central oak post that clearly has had timber rails fixed to it. Photo 5.2 shows this post and the mortices in the front brick wall for the rails. They are matched on the rear wall, suggesting a continuous barrier. There must have

been a gate somewhere within these rails to allow the movement of livestock, but it is not clear exactly where this was. Also in the photograph, there is a blocked hatch with oak jambs. Presumably, this was there to allow the passing of straw or feed through from the adjacent building into this fenced off area.

Photo 5.2 The remains of the fence with the blocked hatch in the west wall

Curiously, the west wall is built in Flemish Garden Wall bond, which is different to the front wall of this building and also to the English bond used in Building 4 next door. This suggests that this wall and its hatch is a survivor from an earlier phase. The front wall appears to butt up against the western one, which supports the idea of it being later. The 1927 Ordnance Survey [Appendix 2] shows the buildings in a continuous line here and in a different arrangement to the present one. The needs of this farm were never static and the frequent alterations to the buildings reflected this.

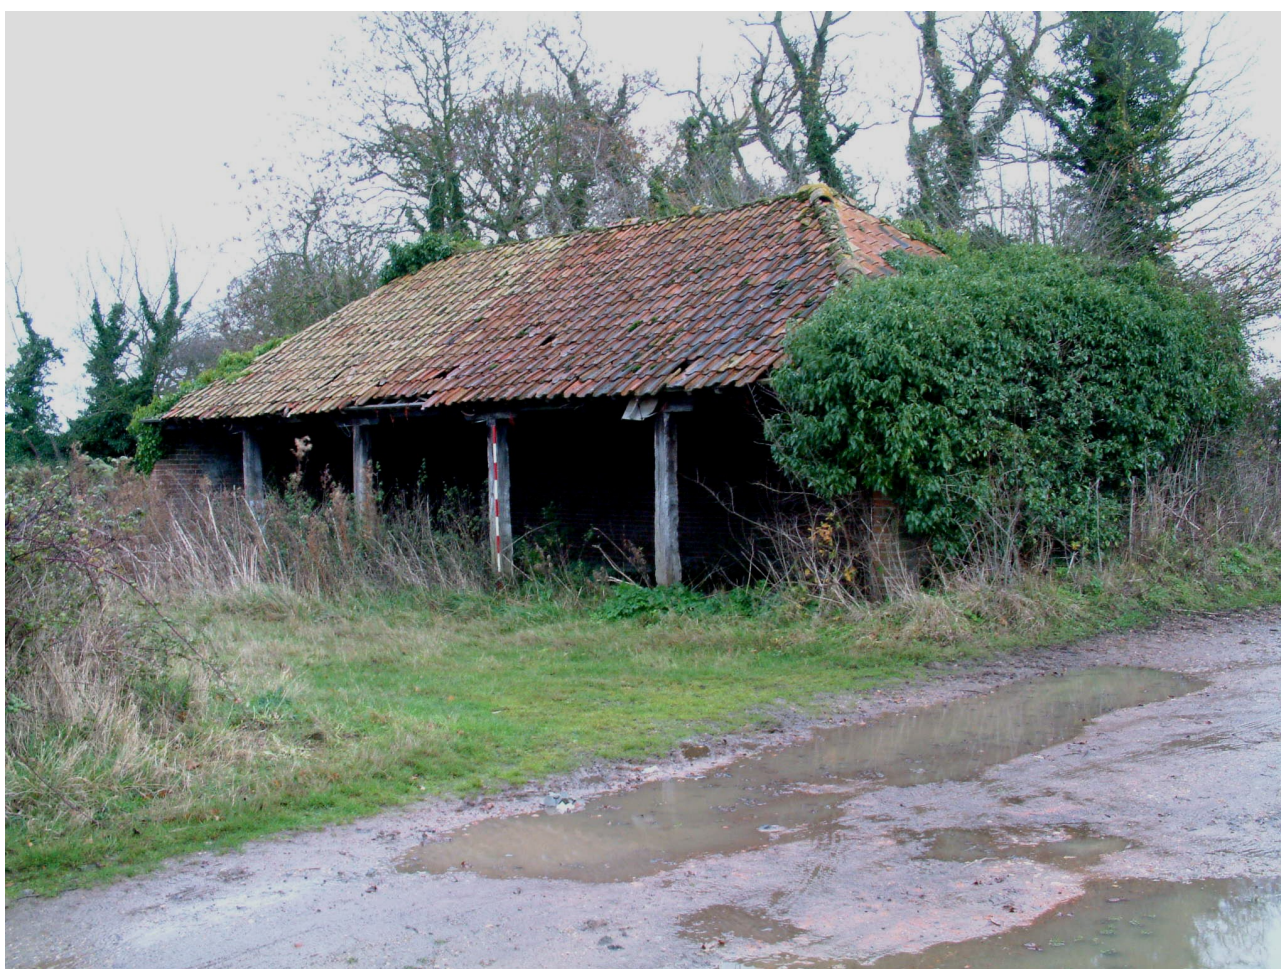
Photo 6.1      Shelter Shed from the south west

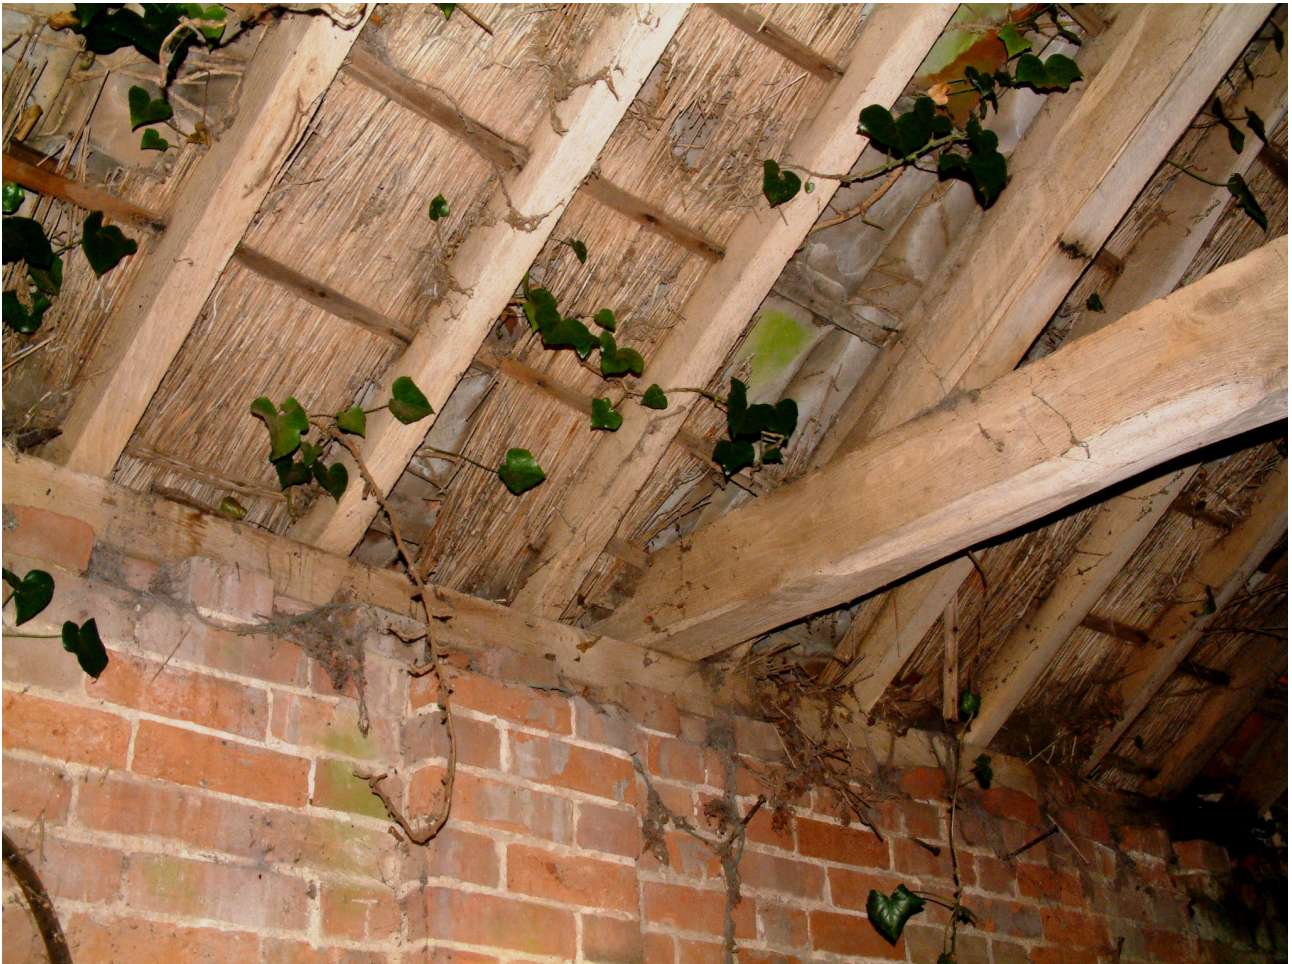
The brick walls use English Garden Wall bond for the lower courses and a chamfer 1.22m [4ft] high and Flemish Garden Wall bond above. The internal dimensions above plinth level are 13.3m [43ft 8"] long and 6.05m [19ft 10"] wide. This strong wall is 9" [225mm] wide at its narrowest. At the top immediately below the wall-plate, it has an alternating pattern of half bricks that form a dentil decoration. Additional brick supporting piers are set along the back wall at around 2.3m [7ft 6"] intervals.

Photo 6.8 Inner face of brick eastern wall with pier, dentil decoration and roof

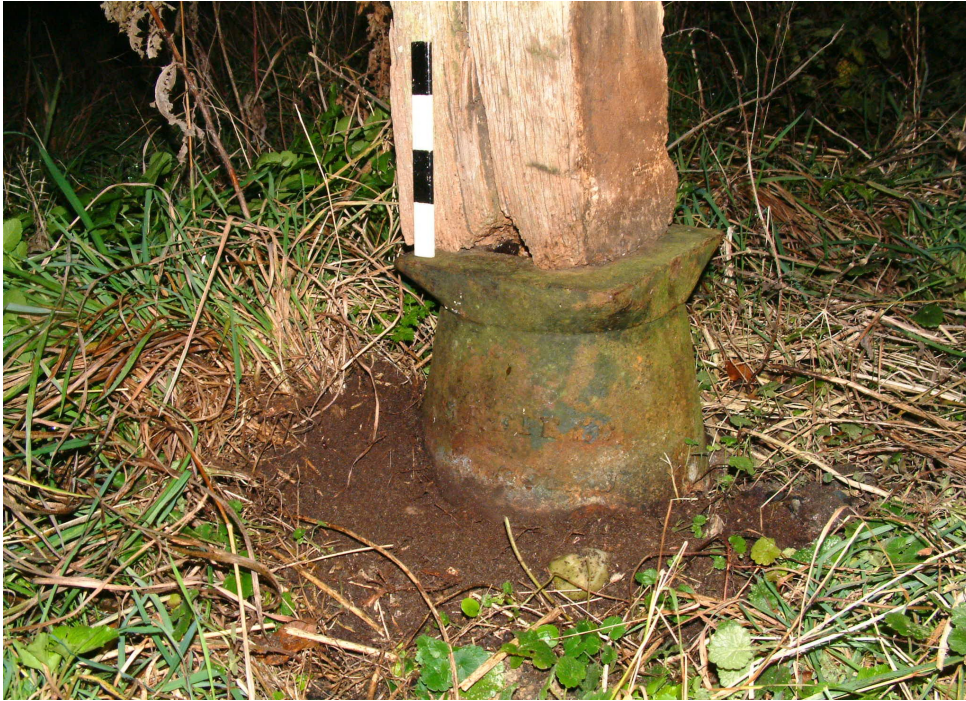
The west side is completely open except for four oak posts, that have large timber pads at their top to support the wall-plate. Each post sits on a cast iron pedestal, shaped rather like an inverted bucket with a broad top, to prevent rot of its foot. A tenon projects into a mortice in the top of the pedestal, which stops the post from slipping off the smooth surface. This has not been the best of details as the timber that touches the iron is unable to dry quickly after rain and has clearly decayed in places [See photo 6.7 overleaf].

Photo 6.7 Iron pedestal supporting one of the western oak posts. 20cm scale.

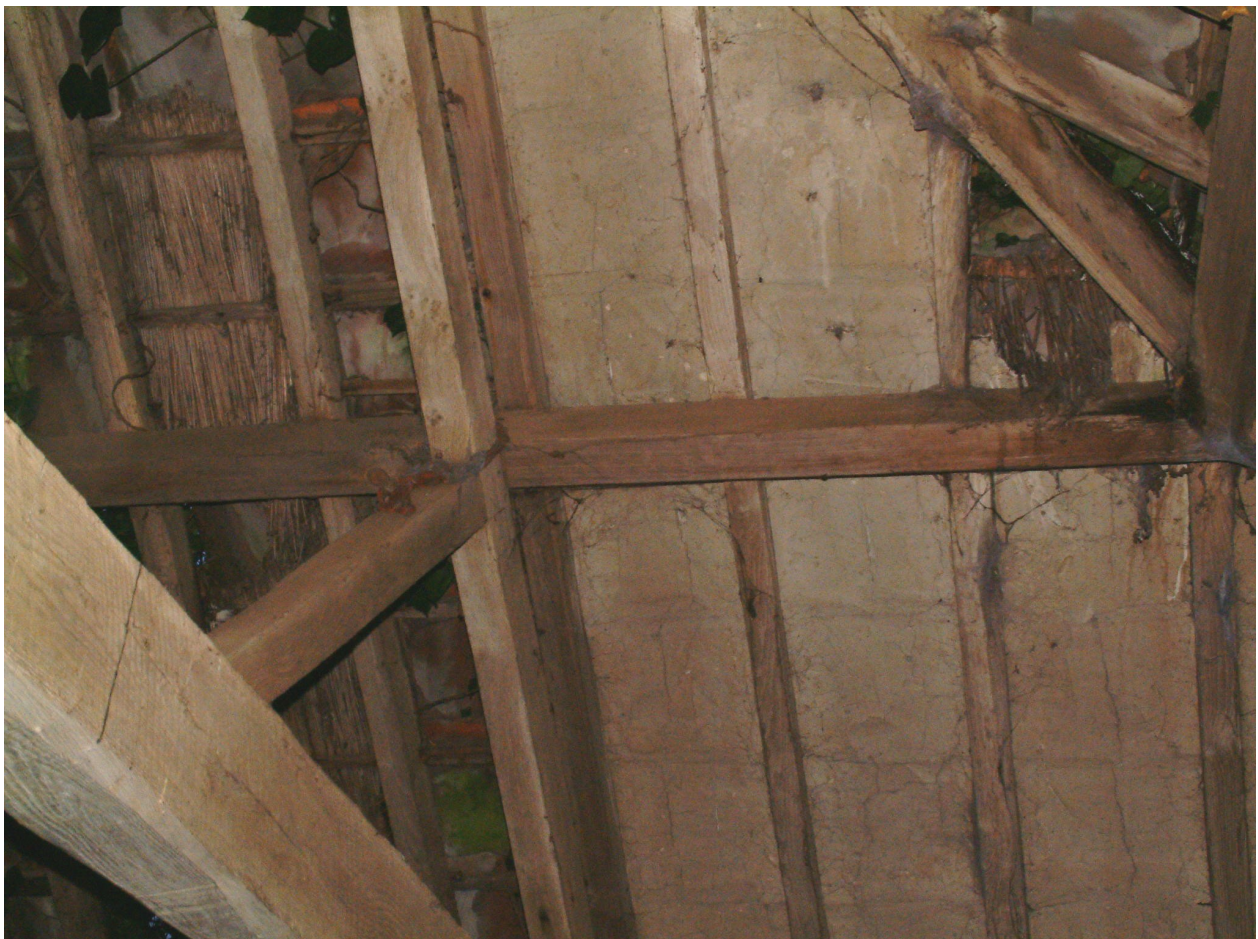
The roof is built of oak rafters and purlins with king post trusses and raking struts. Iron tie rods hold them together. To prevent the wind from blowing between the ill-fitting pantiles, their undersides have been plastered onto reeds laid vertically and held by the tile battens.

Photo 6.11 The plaster and reed undercoating of the pantiles
