Pentney Abbey, Pentney, Norfolk

Archaeological Monitoring Report

(Continuous observation of ground works)

(March 2011)

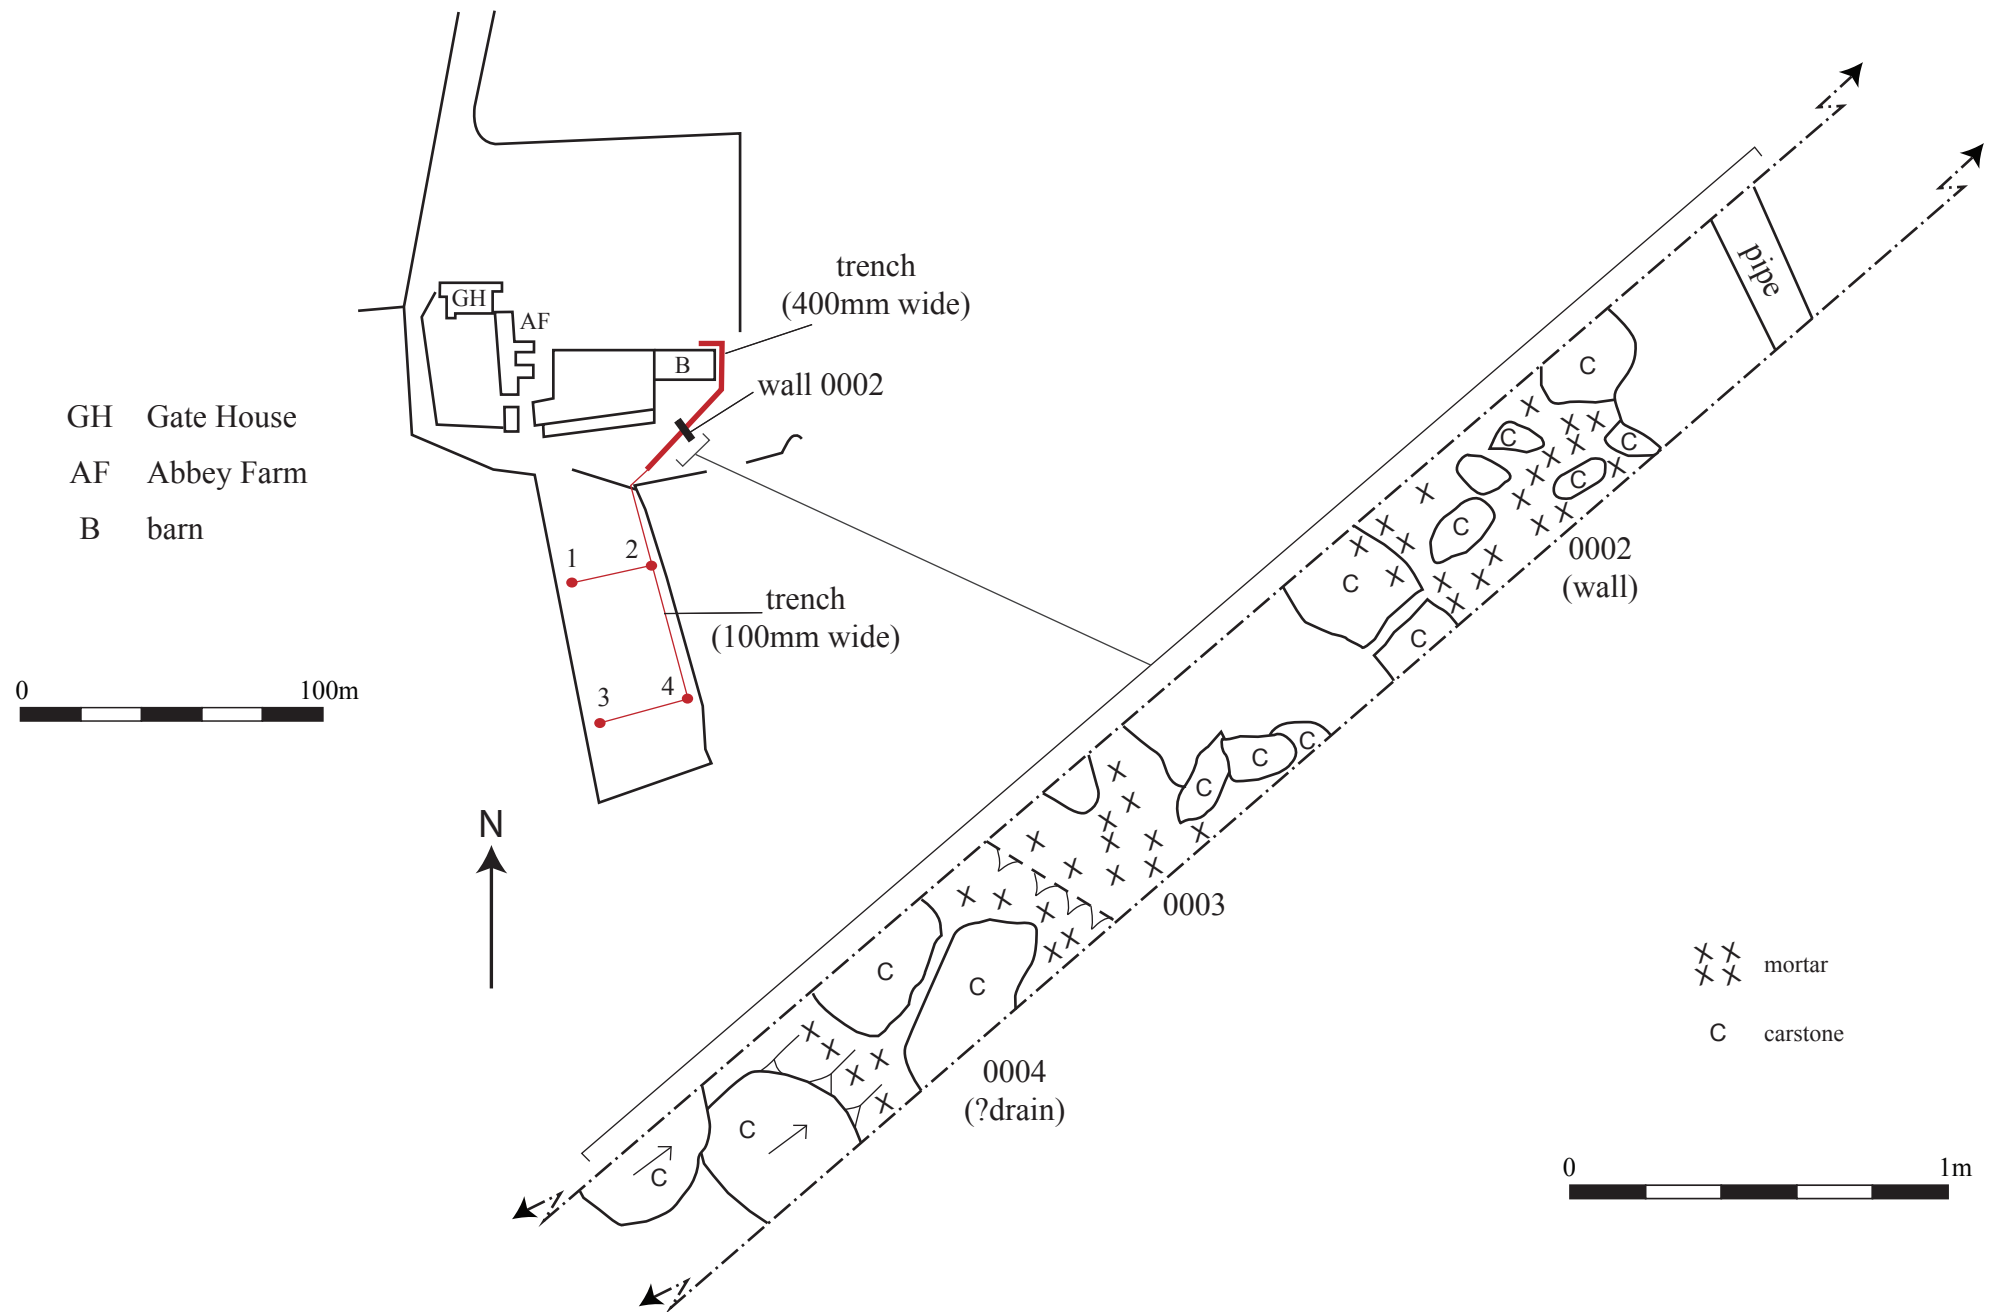
Fig. 2: Location of monitored trench and plan of features 0002-0004
 (map extract after Ordnance Survey©Crown copyright 2010 All rights reserved LN 100049722)

the west of this pipe (see Fig. 2 plan detail) two large blocks of carstone were then exposed under the 150mm topsoil cover. As these stones appeared to be mortar bonded, and therefore of potential structural significance, mechanical removal of topsoil was then undertaken slowly and carefully to cause minimum disturbance. This area of masonry within the 400mm wide trench continued under 150/200mm of topsoil for some 3.5m and hand cleaning revealed a north-west/south-east aligned, 1m wide, wall foundation (0002) made up of mortared carstone blocks (see images 5 & 6) which was left in situ. To the west of this wall (0002) the topsoil layer was somewhat deeper at 300mm and lay over a partially fragmentary mortared surface incorporating small carstone fragments (0003). This mortared surface had what appeared to be a shallow step down close to its western side before it sloped down to a depth of c400mm below two large, though not bonded, blocks of carstone (0004-see image 7) which were not totally exposed in the trench and which, again, were only covered by 150mm of topsoil. Finally more carstone blocks formed the western edge to the mortared surface. These carstone blocks (0004) were also left in situ as any investigation or disturbance in such a narrow trench would most probably have caused damage to what are clearly structural features of medieval, priory period, date without gaining any useful information in such a narrow trench. The cable and pipe will be lagged and laid over these features. The remainder of the 400mm wide trench to the corner of the paddock did not reveal any archaeological features of finds.

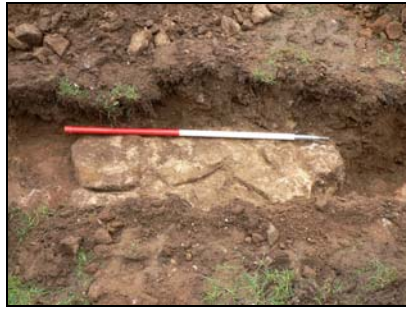
5. Wall 0002 from south

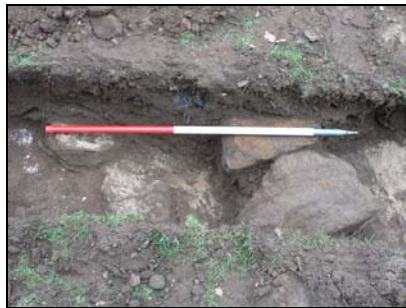
7. Possible drain 0004 from south
