Rebecca Shaw Archaeological Services

**Kirk Wynd Cemetery Wall
(Langholm Old Parish Church and Burial Ground),
Dumfriesshire:
Archaeological Monitoring Works**

**by Claire Shaw
13th July 2017**

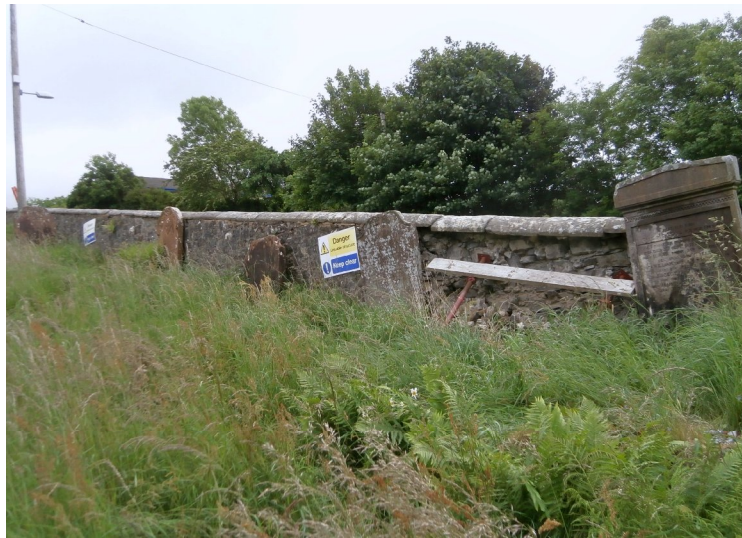
In recent years it had been noted that the wall in question had been showing signs of movement and deterioration. Not only was it bowing slightly but there had also been a partial collapse on its interior façade making it structurally unsafe.

Figure 4a – image showing the partial collapse of the wall prior to dismantling works

The proposed works involved the partial demolition of the unsafe section of the cemetery wall that defines the south eastern extent of the graveyard. The specifics required a 30m section of the wall to be reduced to ground level with new foundations to be excavated and the wall to be rebuilt with traditional lime mortar. The original works will required a strip of between 0.3m and 0.5m to be excavated back from the interior face of the wall in order to allow for the rebuild. As the ground within the graveyard is higher than the Kirk Wynd (between 0.8m – 1.2m in height), mostly due to inhumations within the graveyard, there was potential to locate archaeological remains (specifically human remains) during the down taking works. In addition, within close proximity to the wall there were five headstones that required to be temporarily removed as a means of keeping them safe during construction work.

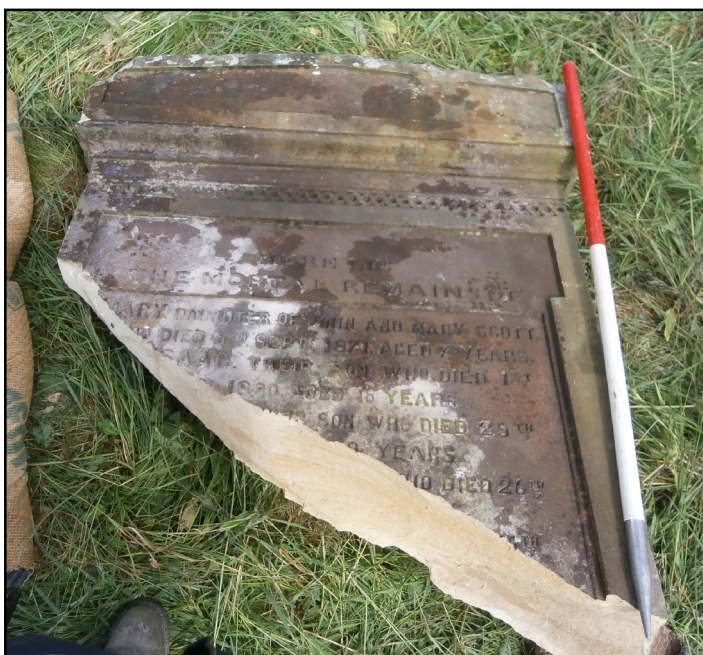
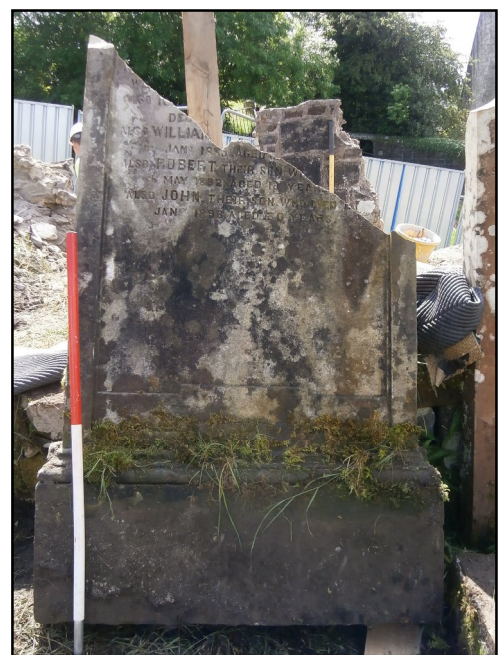
Prior to the demolition of the wall, a total of five headstones were located either adjacent to, or in close proximity to the section of the wall which was to be demolished. Due to the substantial size of each headstone, a scaffold tower was erected with a winch and pulley system as a means of carefully lifting and moving each stone. In addition great care was taken to protect each headstone from damage from the strapping during the lifting procedure. This was done by wrapping each headstone with some padded material. Assessment was made of each stone in regards to its strength as a means of deciding if the headstone was strong enough to be laid flat or if it required to be stored vertically during the construction works. Out of the five stones, only one was deemed too weak to be laid down and appropriate posts were erected to support it. During the removal of the fourth headstone in the sequence (family name Scott) there was a structural incident with the erected scaffold tower and the headstone in question was accidentally broken. The two fragments of the headstone were inspected (Figure 4b) and all small chips from the stone were collected to assist with the repair of this headstone.

Figure 4b – broken headstone (family name Scott)

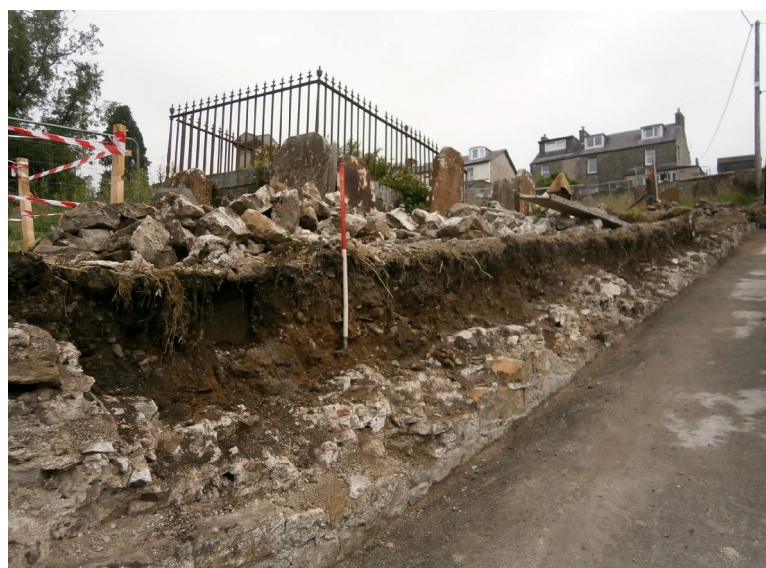
During a site visit from Dumfries and Galloway Council clerk of works, it was concluded that the current wall foundations were solid enough to build on and there was no need to grub out the existing foundations and excavate the soil behind the wall to accommodate new foundations.

Once the wall (101) was dismantled (Figure 4c) the soil behind the wall was straightened up and in doing so it could be seen that this soil was disturbed ground containing bottles, rubbish, plastic and fragments of modern pottery (102). Within deposit [102] a single human bone was recovered, which was subsequently re-buried in the same location.

modern repairs, indicated by cement within some areas of the wall, which made these areas difficult to demolish by hand. The soil located immediately behind the wall had clearly been disturbed as during the removal of the headstones and demolition of the wall, it was found to contain fragments of modern pottery, glass bottles and plastic. This indicates that the wall had more than likely been subject to previous significant repair.

Figure 4c - general image after partial demolition of the wall, leaving the existing foundations
