Corfe Hills Roman Road, Poole, Dorset

Archaeological Observations and Recording during Drain Repairs,
September 2014

Report No. 53422/3/1

Scheduled Monument No: 1018195

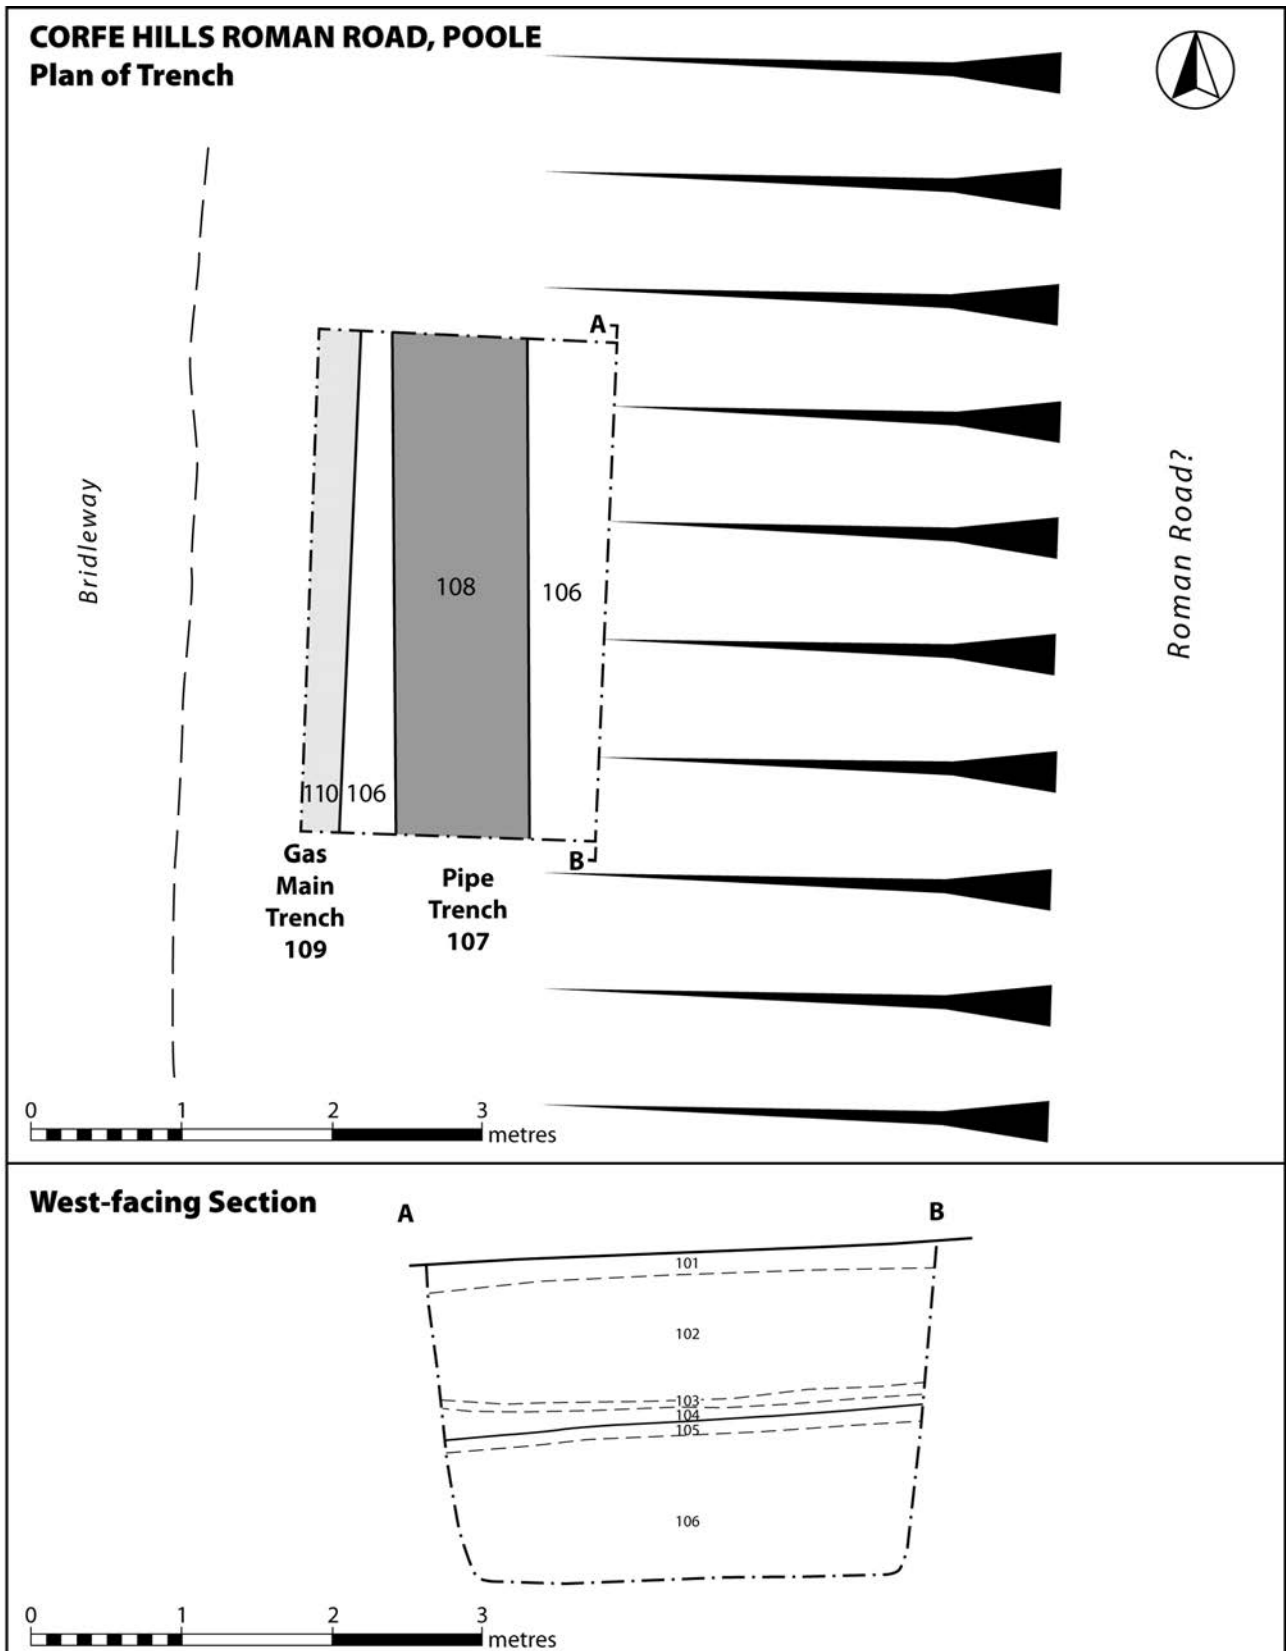
Figure 3: Plan and section of Drain Repair Trench.

A rectangular trench measuring approximately 3.5 m by 2.0 m across and up to 2.15 m deep was dug by machine on the edge of the linear earthwork of the Roman Road agger (Figure 3).

The drain trench (107) was 0.9 m wide and 1.95 m deep with vertical sides and flat bottom, with the concrete drain at the base. It cut through layers 102, 103, 104, 105 and 106. It was filled with dark reddish-brown clayey sand (108) with frequent flint gravel and occasional large lumps of concrete and tarmac.

A vertical sided, flat-bottomed trench (109) containing a plastic gas main was found along the western edge of the trench. The trench measured over 0.3 m wide and about 1.1 m deep. It cut through layers 102, 105 and 106. It was filled with mid greyish-brown sand with flint gravel and occasional fragments of tarmac (110).

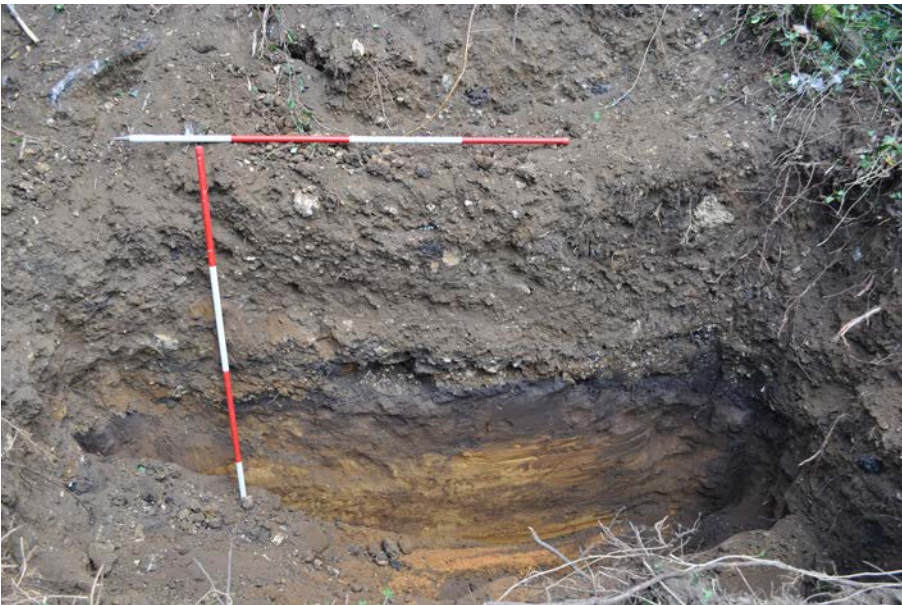
Plate 2: West-facing section of drain repair trench. 2 m scales.

Natural yellowish-reddish brown sand (106) was encountered at a depth of between 1.0 and 1.2 m below the present ground surface. The upper part was darker brown and slightly harder than lower down (Plate 2).

On top of the natural sand was a 0.07 m thick layer of very dark brown sand (105), which had a sharp, slightly wavy boundary with the natural sand 106 below. This may be the remnants of a buried soil.

Immediately overlying the buried soil 105 was a 0.08 to 0.15 m thick layer of compact brownish-red clay (104) with frequent angular flint gravel, moderate larger flints and lumps of pale grey and red clay. Unlike the clayey gravel deposits above, this layer did not contain any modern material and may be the *in situ* remains of the base of the Roman road agger.

Overlying possible agger deposit 104 was a 0.05 to 0.15 m thick layer of dark grey sandy loam (103) with frequent flint gravel and occasional small fragments of tarmac. This layer may represent a topsoil development over layer 104, or is a more topsoil-rich part of layer 102 above. The larger part of the earthwork disturbed by the drain repair trench comprised a layer, up to 0.85 m thick, of compact dark reddish-brown clayey sand (102) with frequent flint gravel and occasional pale yellow clay lumps. It also contained large broken pieces of tarmac, lumps of concrete, kerbstones and limestone fragments, throughout the full depth of the deposit.

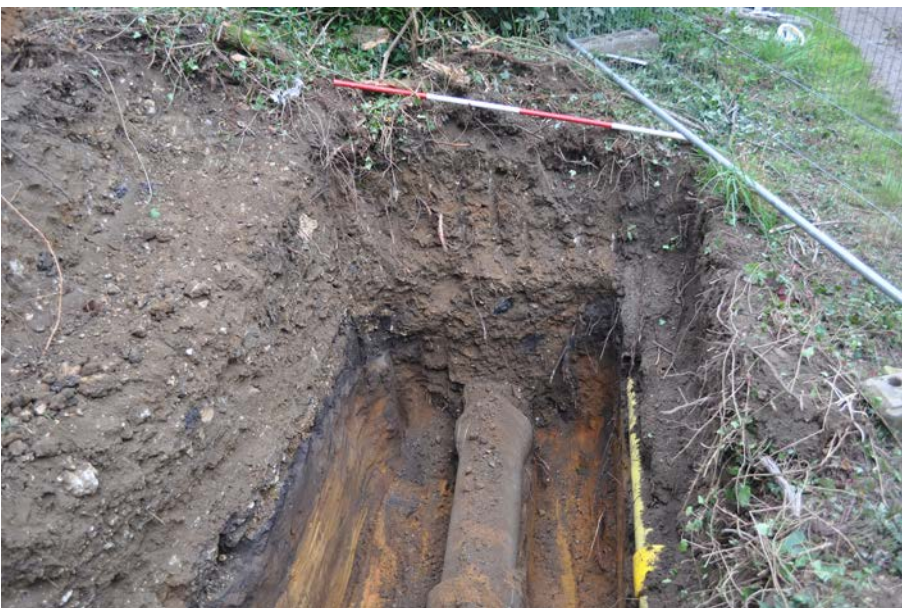
Plate 3: Drain repair trench viewed from north. 2 m scale.

The drain repair trench was cut along the edge of the linear earthwork that is assumed to be the remains of the agger of the Roman road. In this area, however, the earthwork appears to have been disturbed, with large quantities of tarmac, concrete and kerbstones incorporated down to a depth of about 0.85 m. These modern materials were incorporated within a compact clayey sand and flint gravel deposit (102), which is similar to the make up of the agger recorded elsewhere on the line of this road (Smith 1932), so may be a disturbed, reworked part of the Roman road structure. The date of this disturbance is probably later 20th century in date and appears to be stratigraphically earlier than the insertion of the drain and the gas main.
