Church of St Andrew, West Stafford, Dorset

Archaeological Observations and Recording during Re-ordering Works

Archaeological Observations and Recording during Re-ordering Works, May 2015

Report No. 53435/3/1

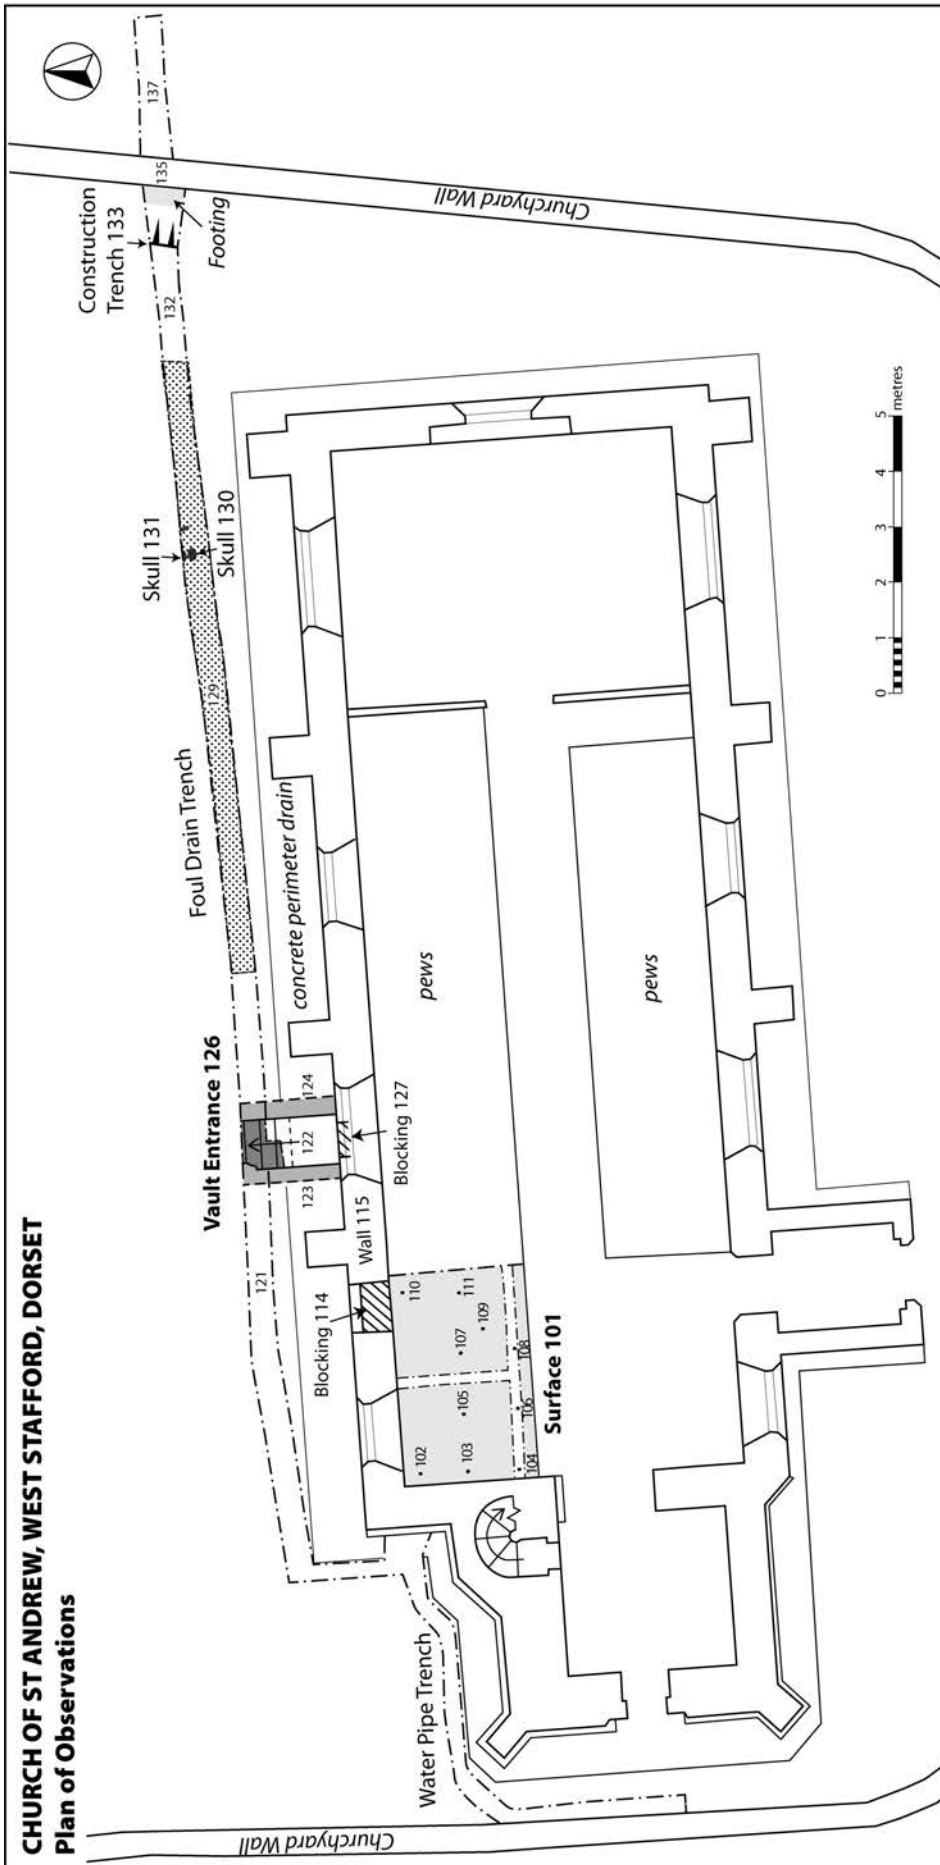
Above soil layer 113 was a rough lime mortar surface (101) on a bed of angular small limestone rubble (112), which lay at a height of between 0.10-0.13 m below the level of the stone flags in the central aisle (Figure 2; Plates 1-4). This mortar screed continued into the threshold of the north door beneath its stone blocking (114) and also appeared to continue below the stone flags of the central aisle. A series of ten square and rectangular void holes 30-40 mm across were visible in the mortar surface (Plate 2). These appeared to form three parallel rows, except for one hole (109) not in this alignment (Figure 2). The holes were about 0.35 m deep.

Figure 2: Plan of Observations (The church plan is schematic and does not show all architectural details).

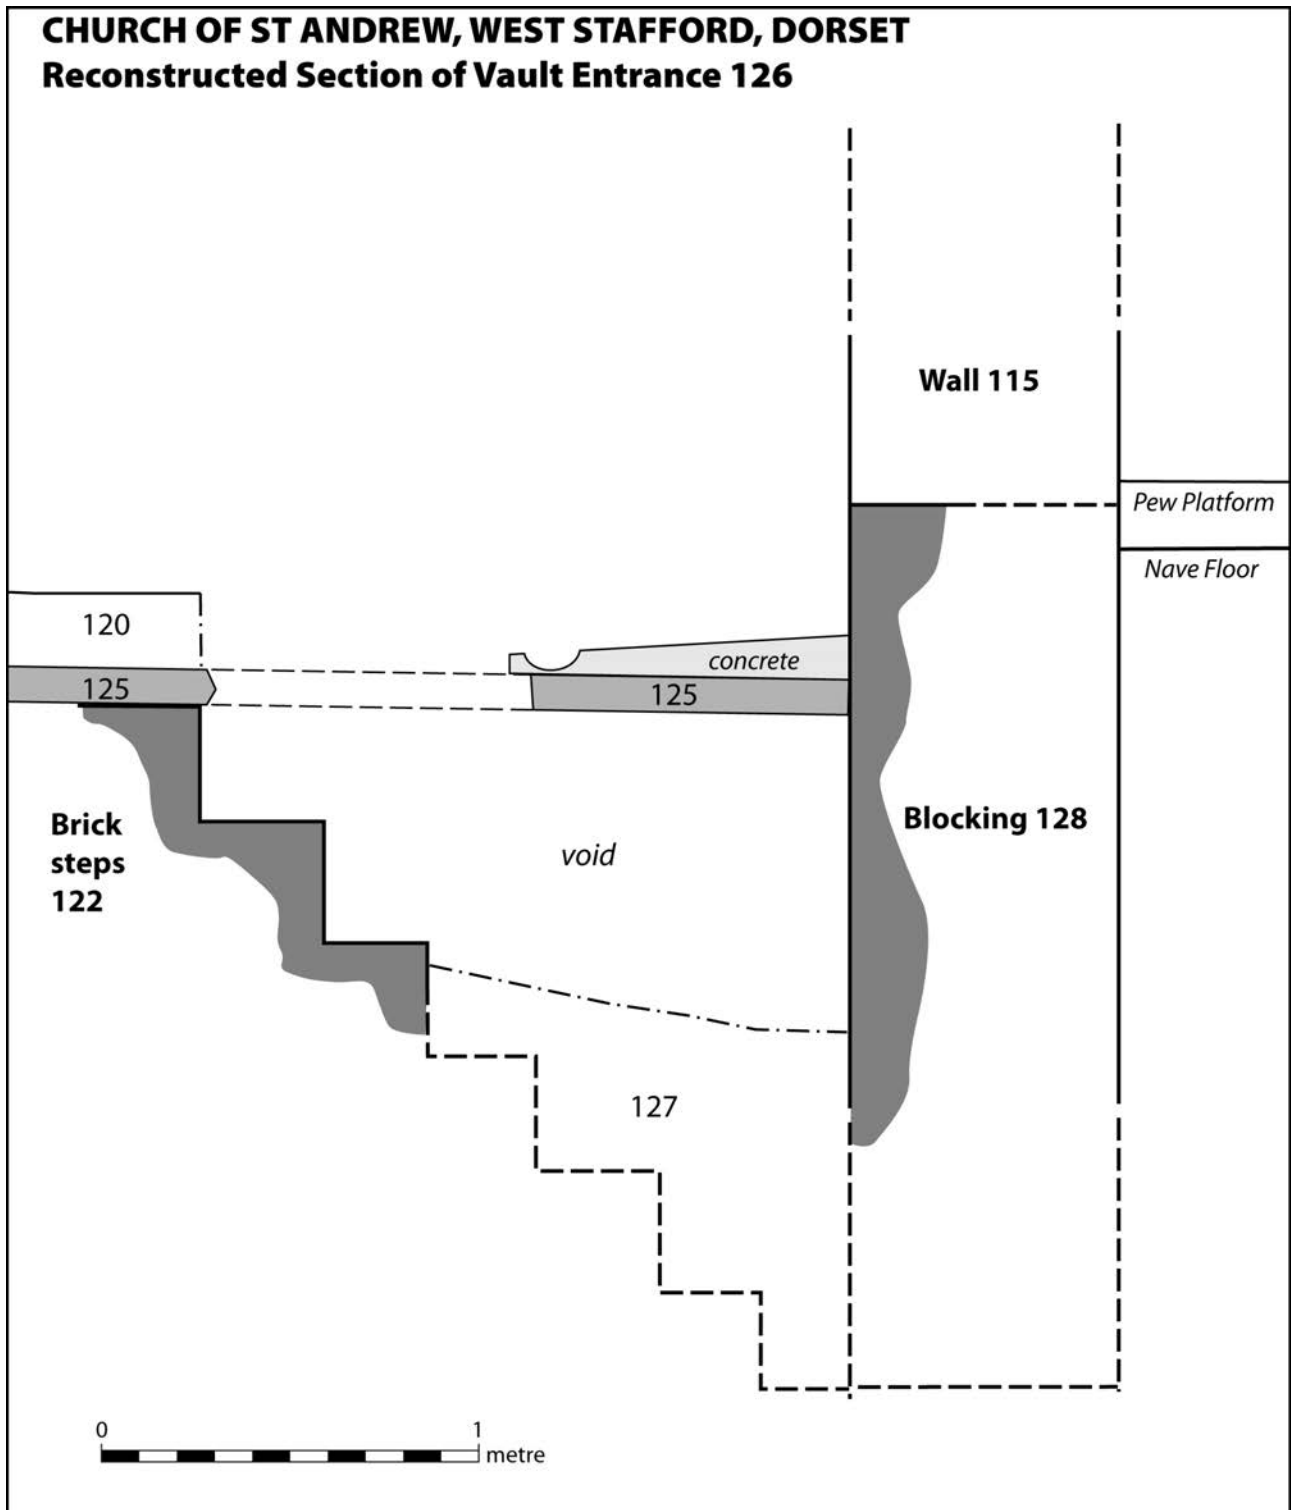
Midway between the first and second buttress (from the west) of the north wall of the nave, the remains of a blocked entrance to a burial vault (126) was exposed (Figures 2-3; Plates 5-8). This consisted of a flight of brick-built steps (122) starting about 1.75 m out from the nave wall 115. Parts of three steps 0.84 m wide were exposed (Figure 2, Plates 6-7) and another 3-4 steps are projected to continue down below the limit of the excavation (Figure 3). The steps (122) were built of unfrogged red brick, of eighteenth/early nineteenth century character, bonded with grey charcoal-rich lime mortar. The sides of the steps were revetted with unmortared limestone rubble walls (123, 124) about 0.4 m wide and containing occasional fragments of worked limestone. An opening 0.76 m wide had been inserted through the nave wall.

Figure 3: Reconstructed Section through Vault Entrance 126.

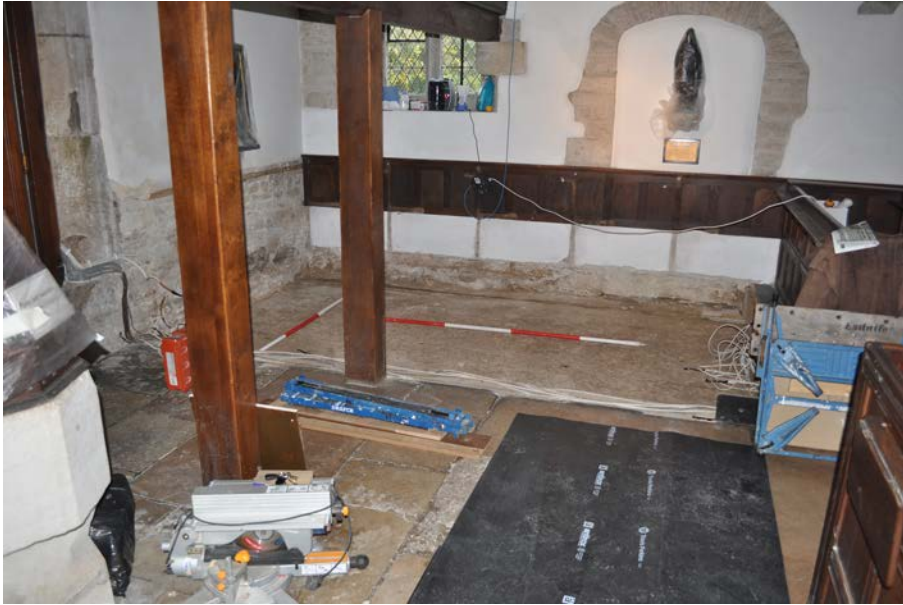
Plate 1: View of surface 101 in NW corner of Nave. 2m scales.

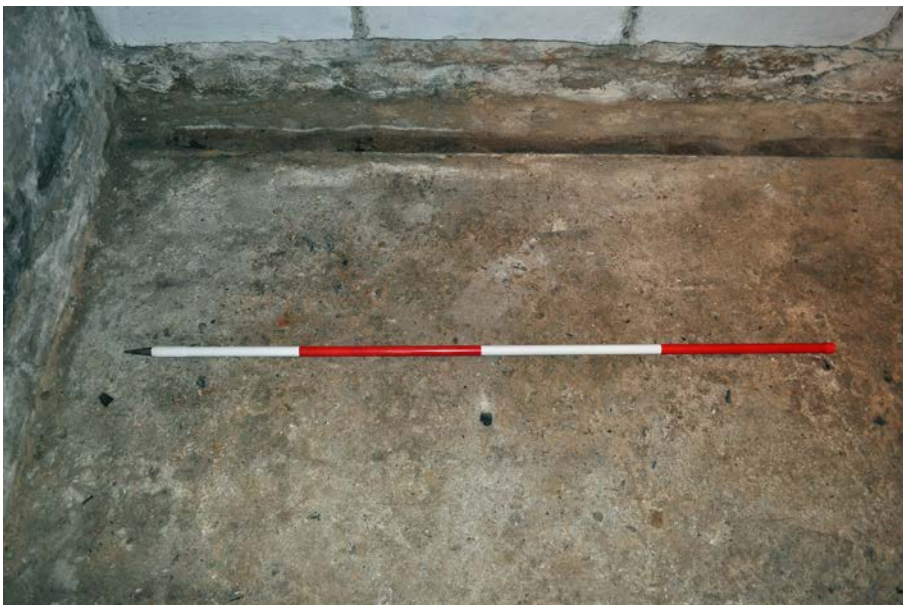
Plate 2: Western end of surface 101 and holes 103, 105 and 107. 2m scale.

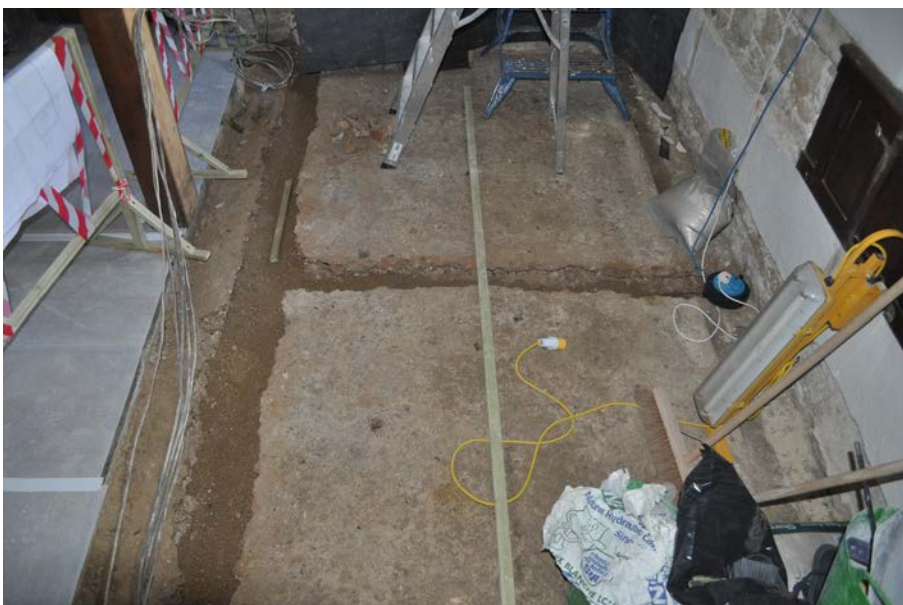
Plate 3: Surface 101 after excavation of conduit channels.

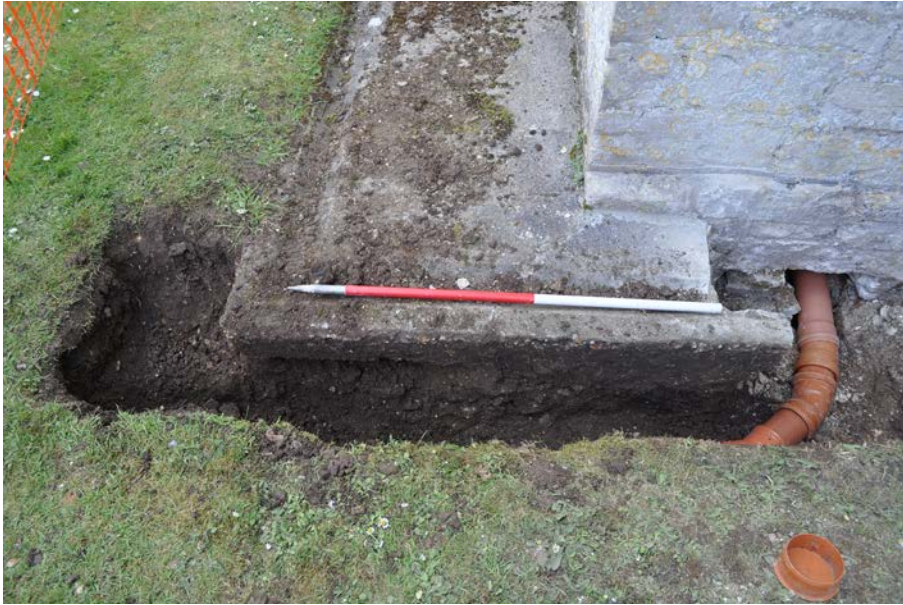
Plate 4: Foul drain through west wall of nave and west end of drain trench. View from west. 1m scale.

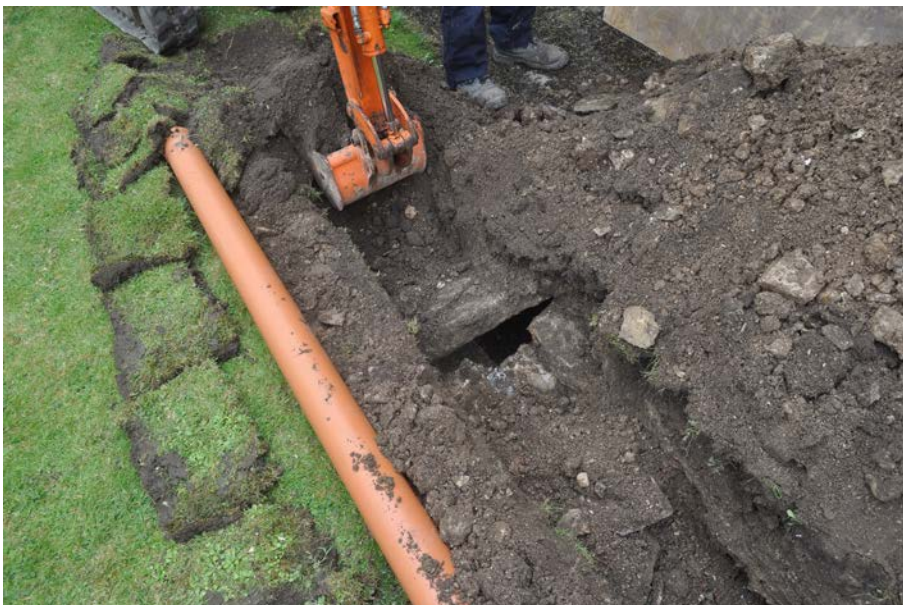
Plate 5: Vault entrance 126, with capstone 125 partially dislodged by machine. View from north west.

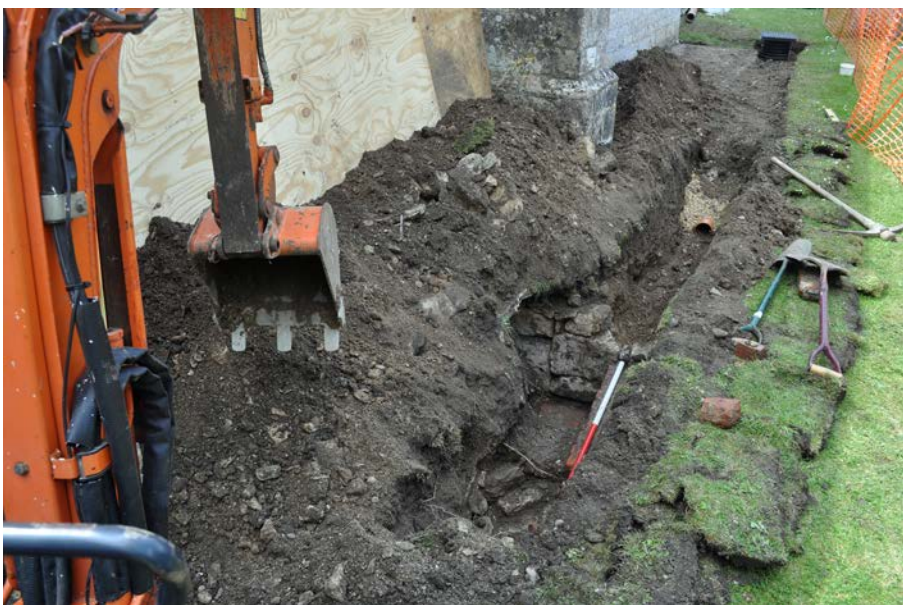
Plate 6: View of vault entrance 126 with 1m scale on steps 122 and revetment wall 124 behind. View from north east.

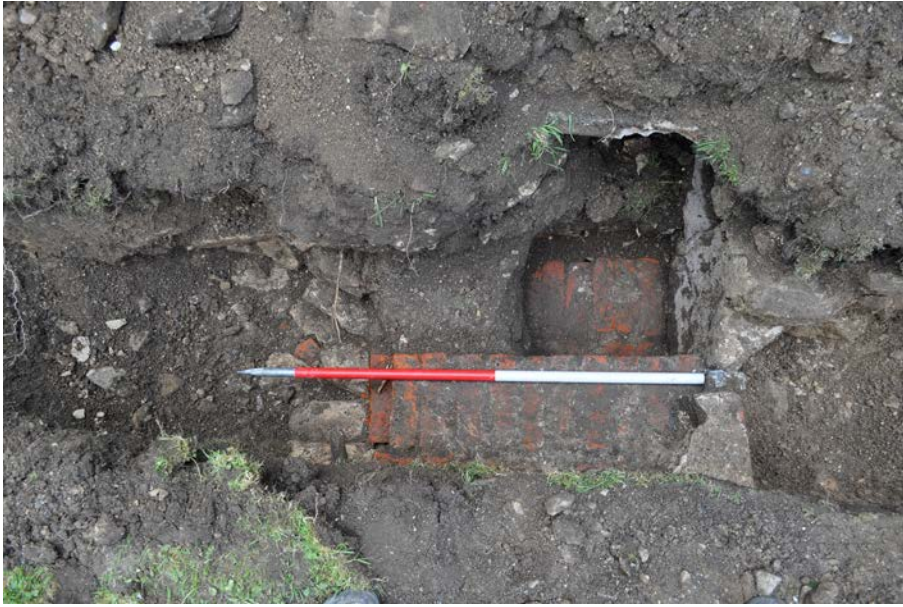
Plate 7: Vault entrance 126 showing brick steps 122. 1m scale. View from north.

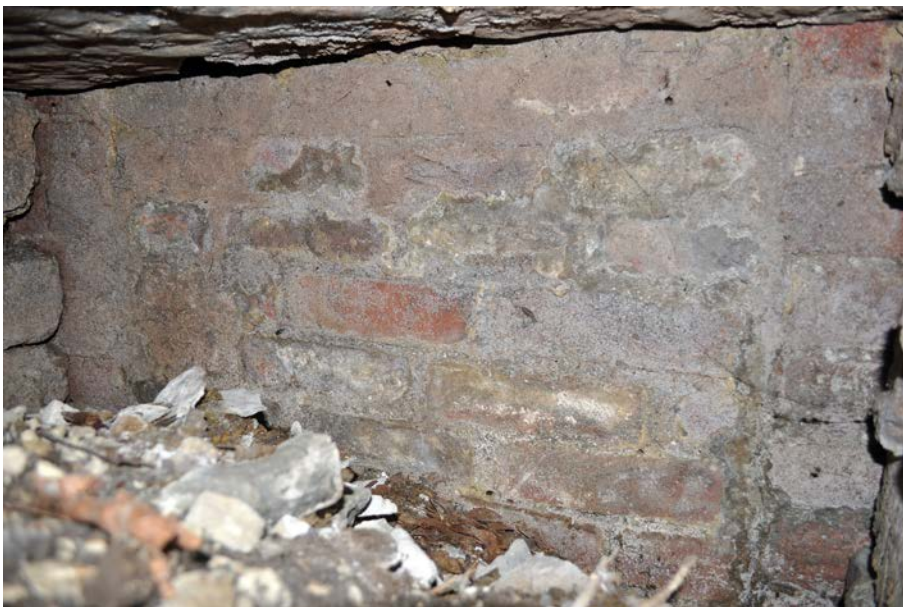
The opening in the wall was blocked with a mixture of mortared brick and limestone blocks (128) (Plate 8). The steps were covered by limestone slabs (125) supported on iron straps. The upper part of the vault entrance was void, but the lower part had silted up (127).

Plate 8: Blocking 127 in north wall of nave, within vault entrance 126. Viewed from north west.

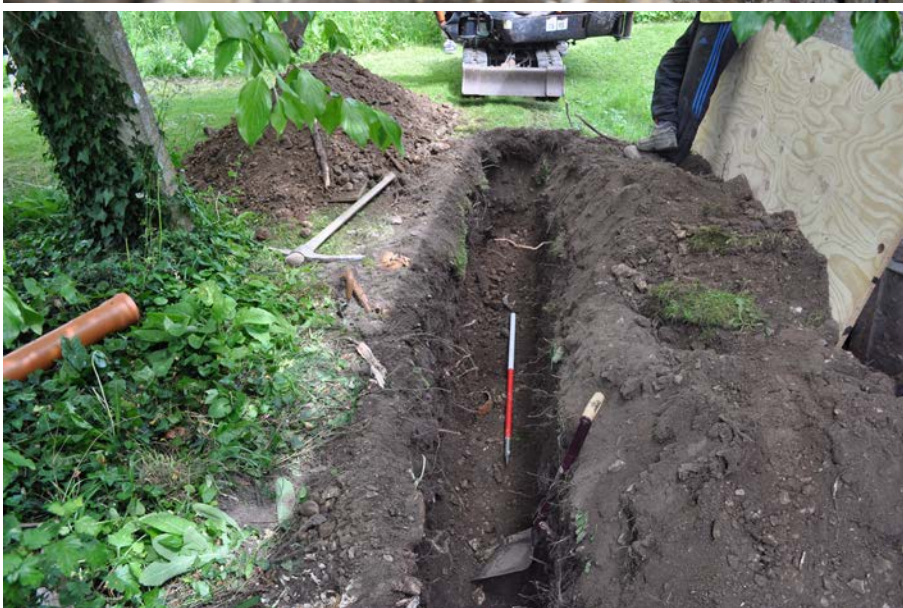
Plate 9: Foul drain trench near east end of church. 1m scale. View from west.

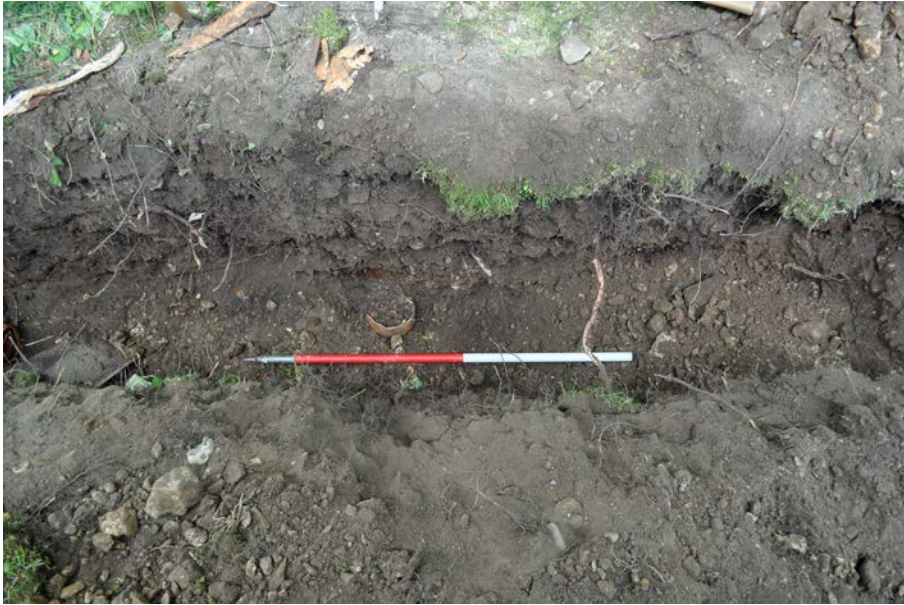
A layer of dark yellowish-brown clayey sand with very frequent flint gravel and small chalk lumps (129) was found above layer 121 in the eastern part of the trench. The western edge of this layer was encountered between the second and third buttress (Figure 2) and it got thicker towards the east where it was over 0.7 m thick. This layer continued up to about one metre past the east end of the chancel (Figure 2). There was significantly more loose human bone in layer 129 than in layer 121, including part of two adult skulls (130, 131) (Figure 2; Plate 10).

*Plate 10: Skull 130. 1m scale.
View from south.*

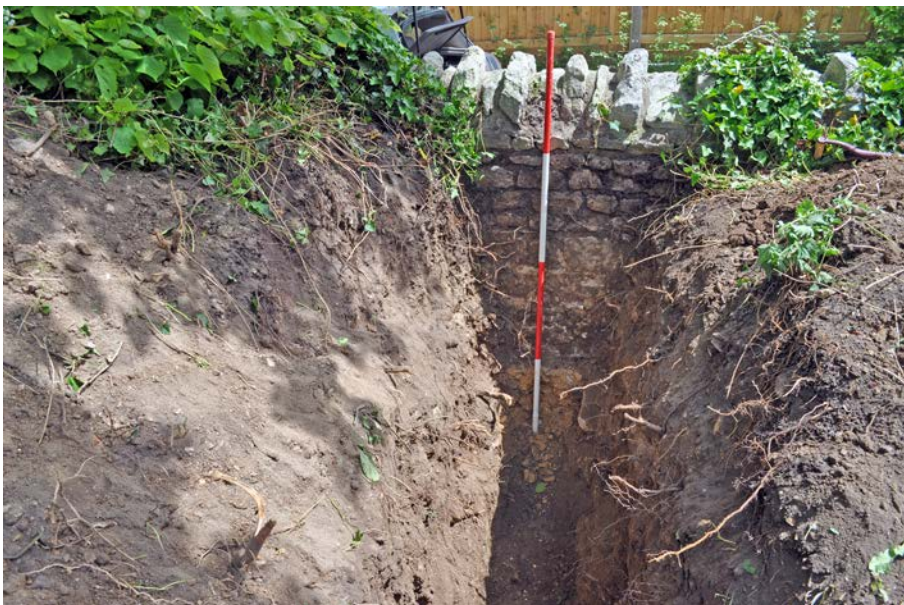
The rear face of the east churchyard wall was exposed (Plate 11). The wall (135) consisted of eleven courses of limestone rubble brought to courses, bonded with pale yellow sandy mortar, and a cock-and-hen coping. It was constructed in a construction cut (133) about 1.1 m wide with a sloping side and flattish concave base, with a 0.34 m thick footing of mid yellowish-brown sandy lime mortar and flint gravel aggregate, which projected 0.36 m beyond the west face of the wall. The remainder of the construction cut was filled with dark yellowish-brown clay loam (134) with flat limestone rubble near the base and lenses of sandy mortar throughout.

*Plate 11: Rear face of
churchyard wall and footings
135. 2m scale. View from
west.*

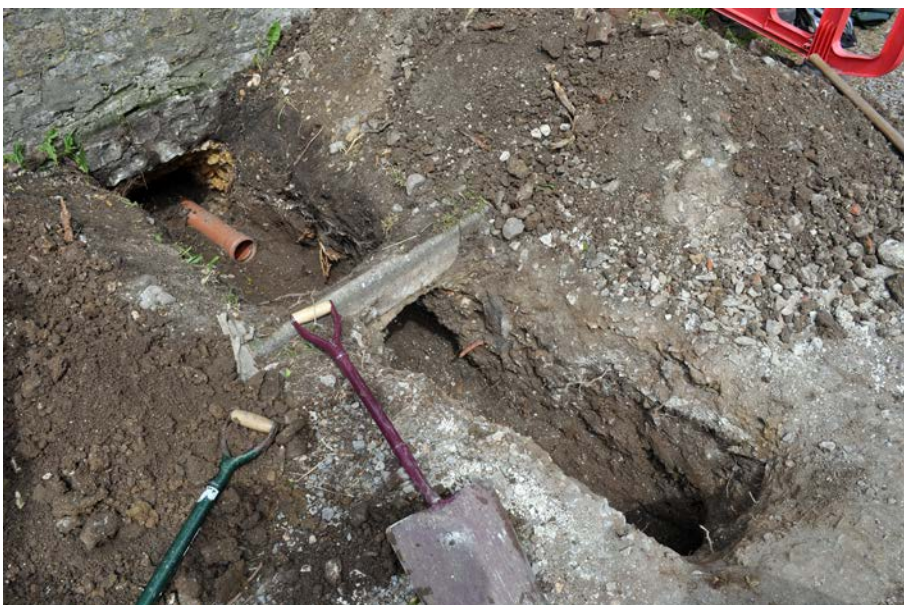
In the trench in the lane to the east of the churchyard there was a disturbed layer of fairly compact mid brown clay with moderate flint gravel and occasional brick and tile fragments, modern glass, limestone pieces and chalk rubble (137), over 0.5 m thick (Plate 12). This layer was present below the topsoil in the verge next to the lane and also appeared to continue beneath the surface of the lane.

*Plate 12: Trench east of
churchyard. View from south
east.*
