# Church of St John the Baptist, Woodsford, Dorset

## Archaeological Observations and Recording of Works to Churchyard Wall

Report No. 53445/3/1

December 2016

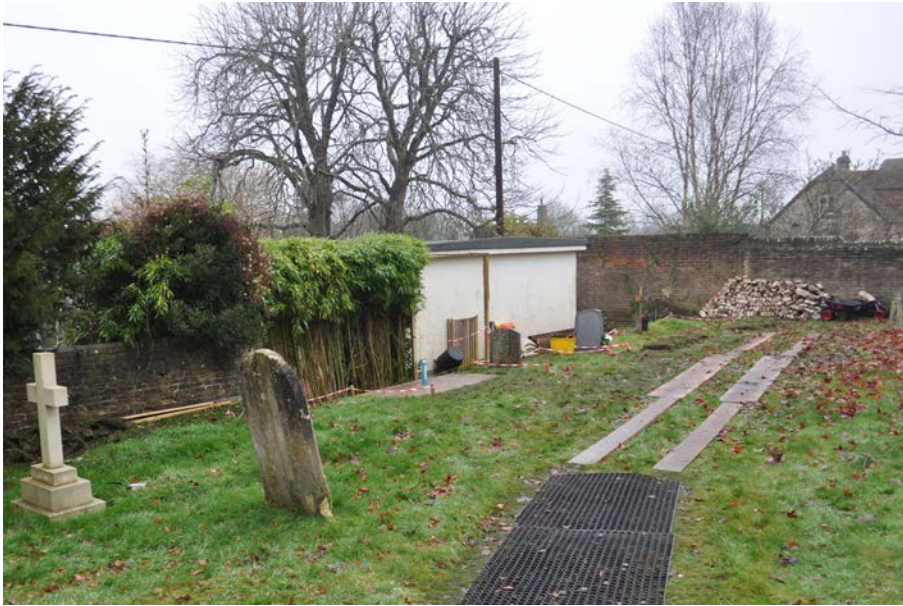
*Plate 1: General view of site after removal of churchyard wall, viewed from west.*

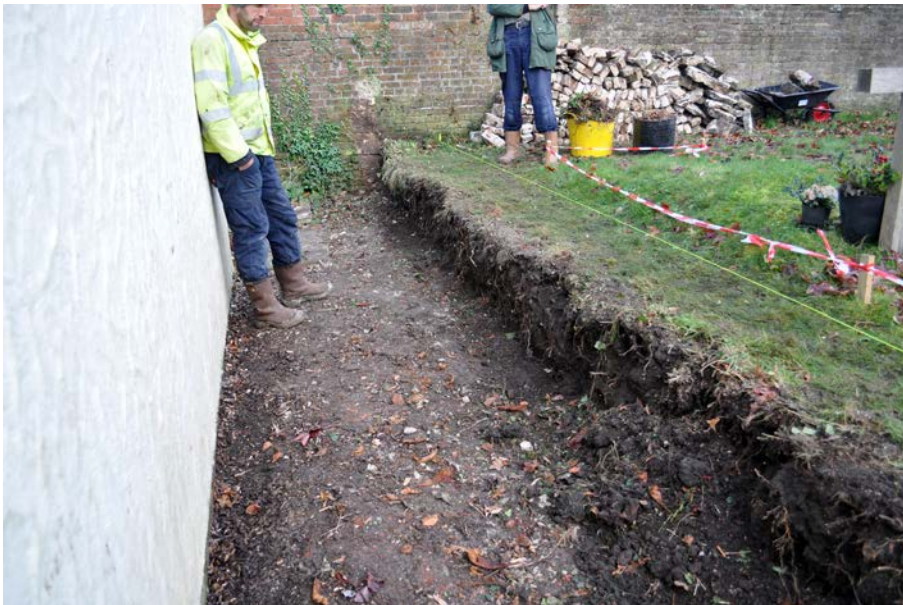
*Plate 2: View of east part of area after removal of churchyard wall.*

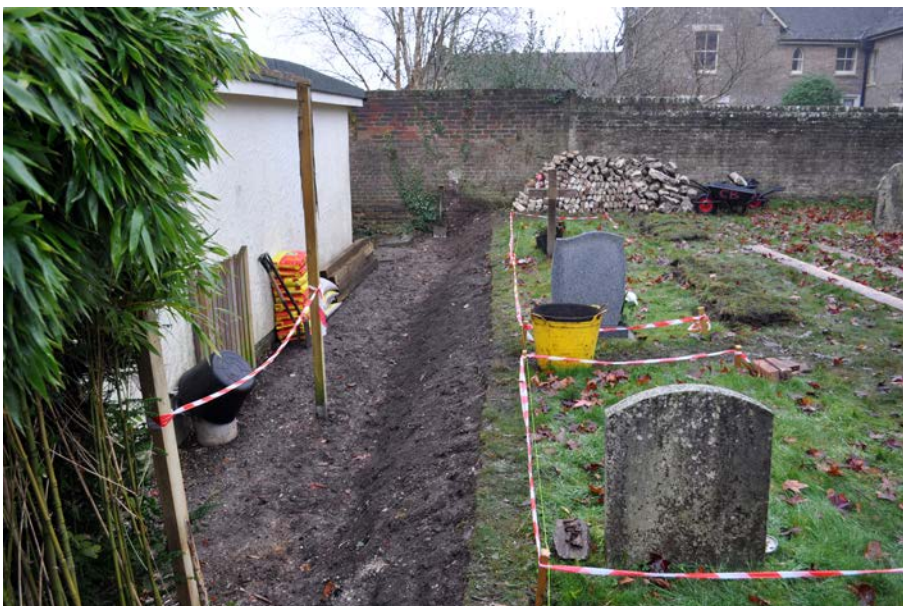
*Plate 3: View east along site after battering of churchyard soil, prior to erecting fence.*

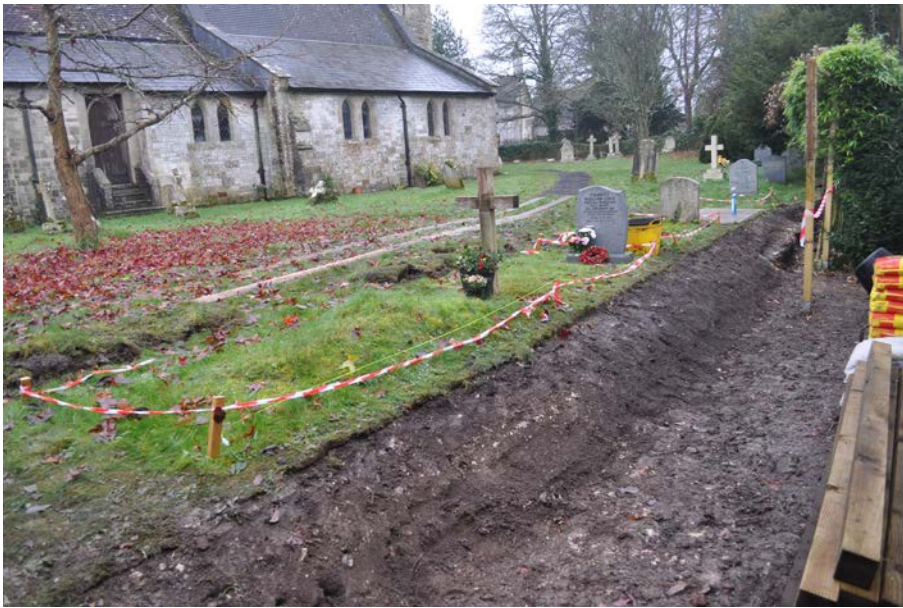
*Plate 4: View west along trench during battering of churchyard soils.*

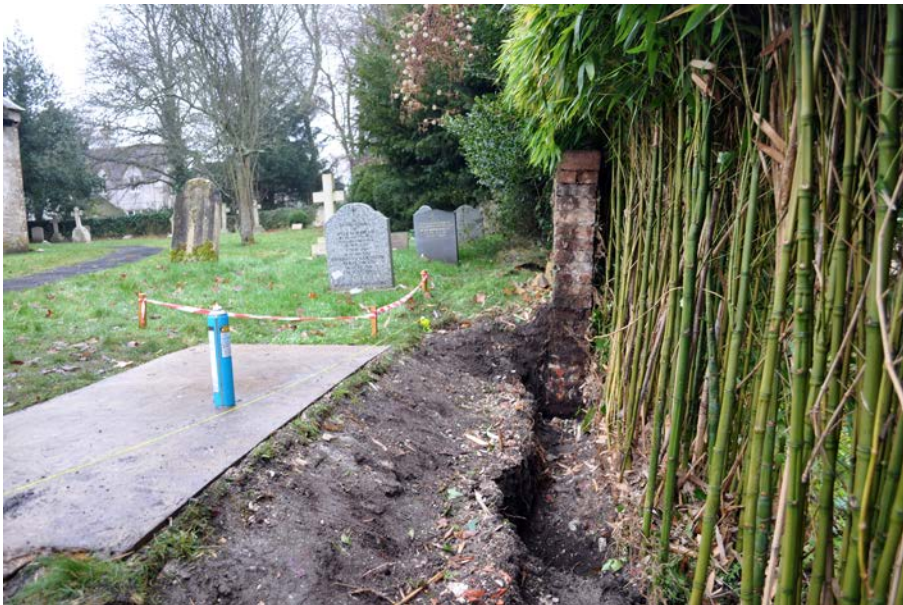
The section of the churchyard boundary wall removed during this project was a 0.24 m wide Broadmayne brick wall laid in common bond with a chamfered brick coping and bonded with lime mortar. It was up to about 1.4 m high and was founded on a layer of large stone rubble up to 500mm across, just below ground level to the north of the churchyard. It was butted against the boundary wall with Woodsford Farm to the east and had a straight joint to the churchyard wall to the west.

*Plate 5: West end of trench showing straight joint at end of surviving churchyard wall.*

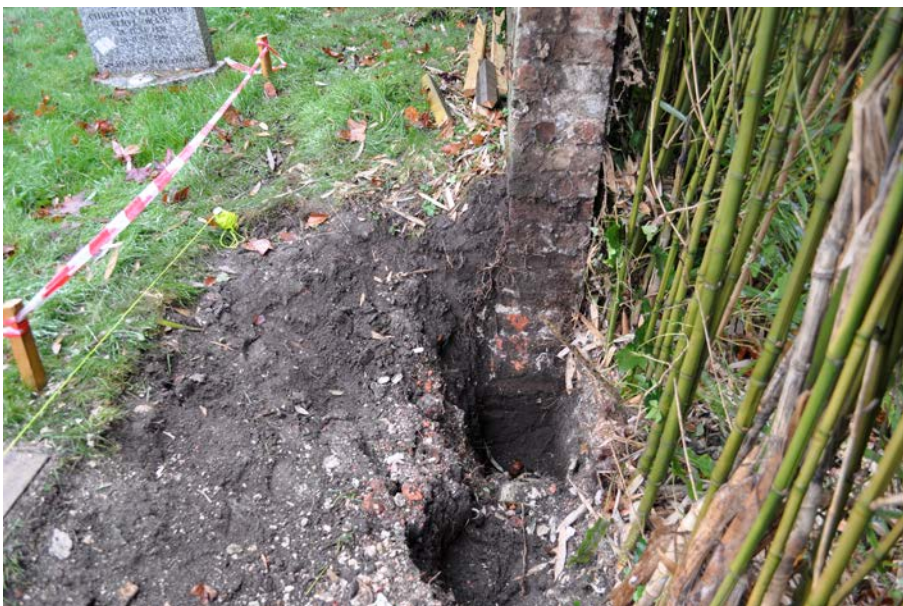
Overlying the natural sand 104 was a 0.25 m thick layer of dark brown very slightly sandy clay soil (103), which lay beneath wall 105. It was very similar to a 0.15 m thick layer of dark brown slightly sandy clay (102) with moderate flint gravel at the base of the exposed sequence of churchyard soils. Both 102 and 103 may be part of the same deposit. Overlying this was an intermittent layer containing some mortar, brick and stone debris (101), which may be a localised deposit, disturbed by the construction of wall 105. It was sealed by a 0.2 m thick layer of turf and topsoil (100), which forms the current surface of the churchyard.

*Plate 6: Fence posthole against churchyard wall showing deposits below wall.*
