Alma Cottage, 4 Watery Lane, Studland, Dorset

Archaeological Recording during Internal Alter- ations

Report No. 53491/3/1

December 2018

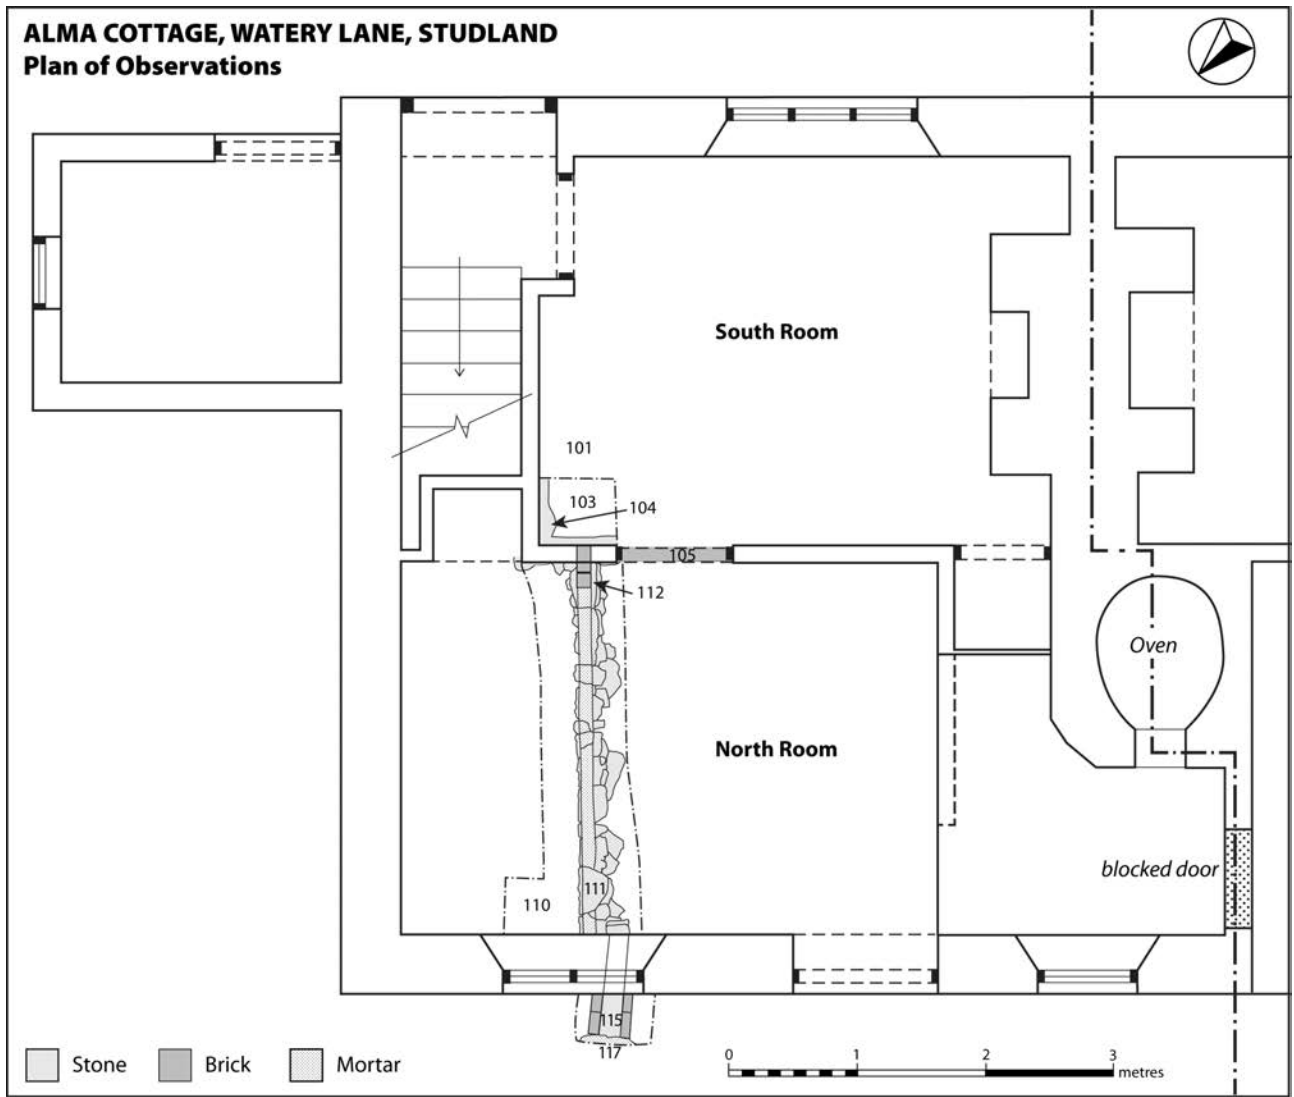
Figure 2: Plan of Observations.

Traces of a wall running across the eastern part of the north room had been partly exposed by the builders (Plate 5). The whole length of this wall was then cleaned up and the spoil removed from both sides to expose the base. A 0.5 m square test pit was dug in the north-east corner of the south room (kitchen) to investigate whether the wall beneath the north room continued into this area (Figure 2; Plates 2-3). The builders had also dug outside the north wall of the cottage to check drainage runs and the area where the drain runs through the north wall was cleaned up (Figure 2; Plates 10-12).

A drain (115) exiting through the north wall was found just to the west of structure 111 (Figure 2; Plate 9). It is formed by leaving a gap in the stonework and is lined with mortar along the sides and base. Externally the drain has a flat limestone base, with sides formed by two layers of bricks set on edge and capped with flat limestones (Figure 3; Plates 10–12).

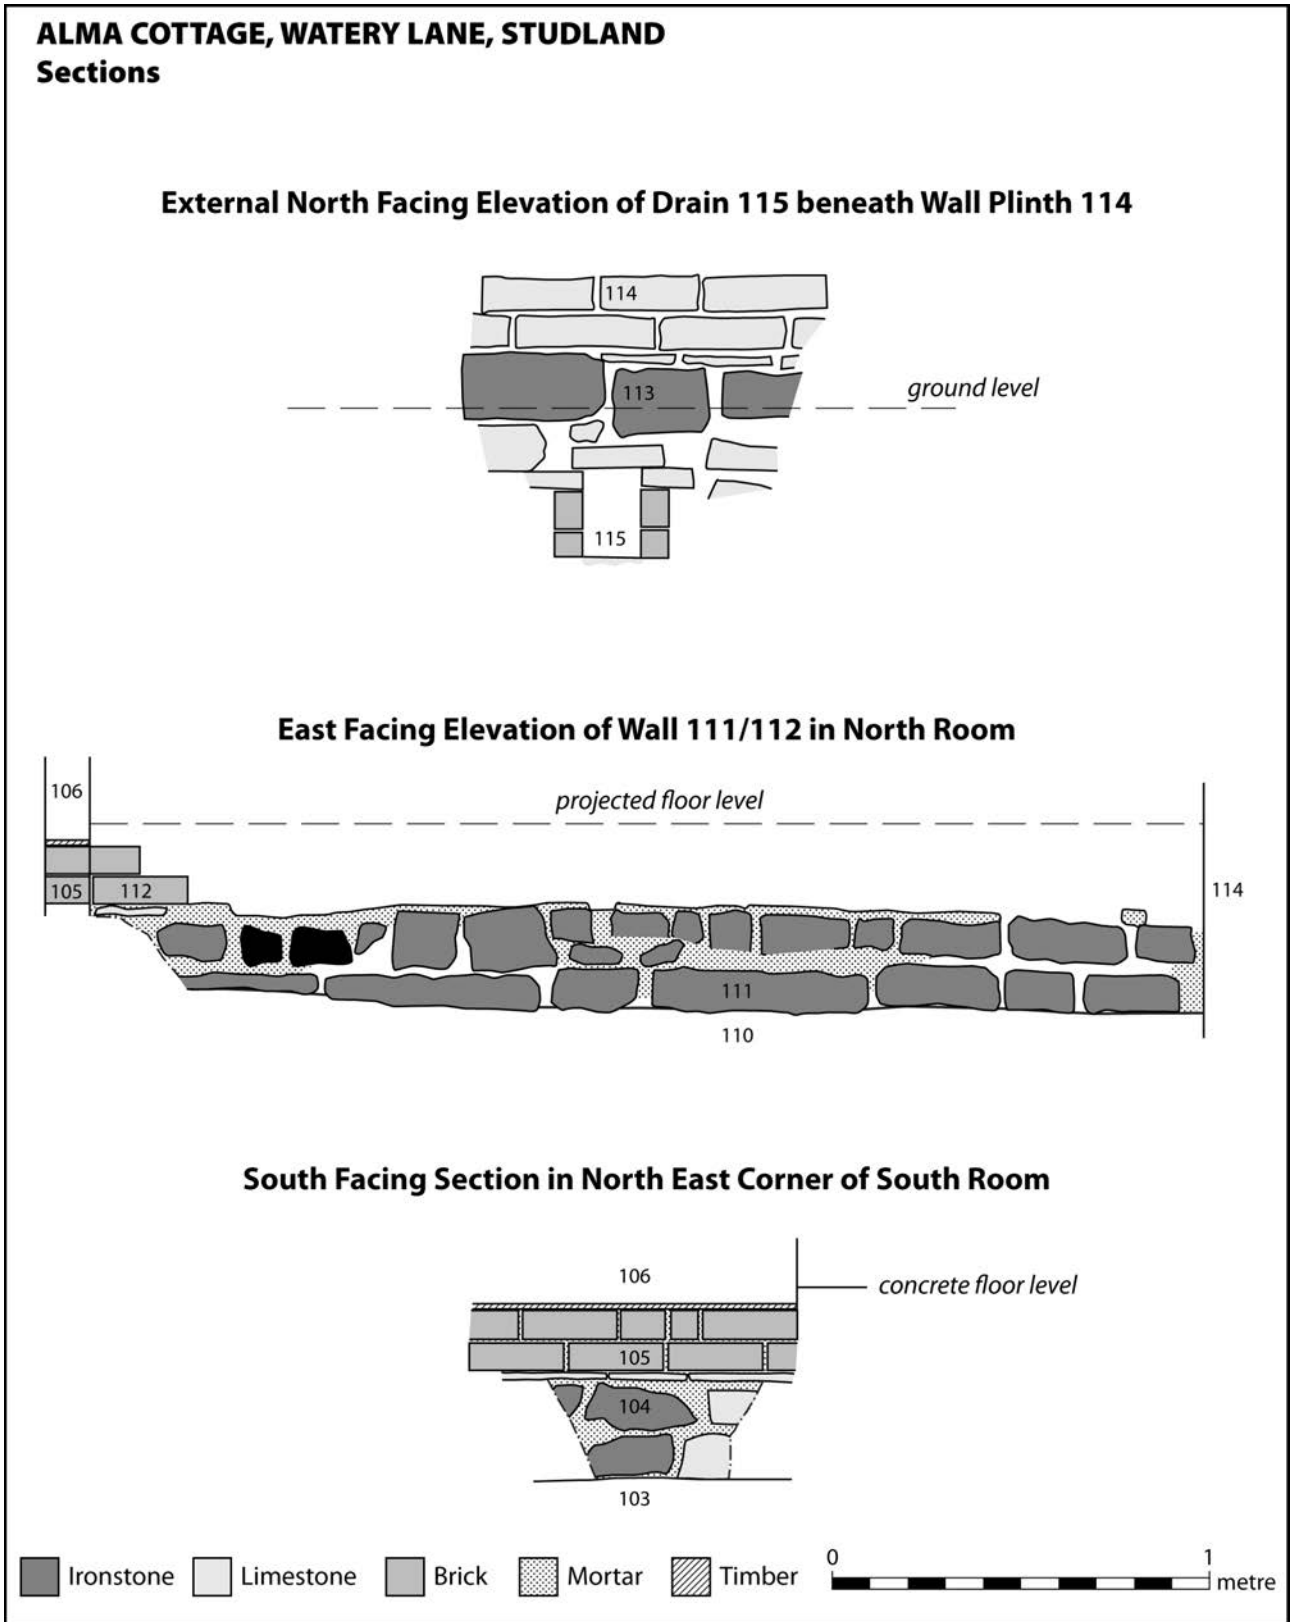
Figure 3: Sections and Elevations.

A firm dark grey silty sand subsoil (103, 110) lies at a depth of 0.45 m below the floor level of the south room and 0.5 m below the floor level of the north wall (Figure 3). This deposit was not excavated, but a hole dug by the builders into layer 110 in the north-east corner of the north room produced some sherds of medieval pottery.

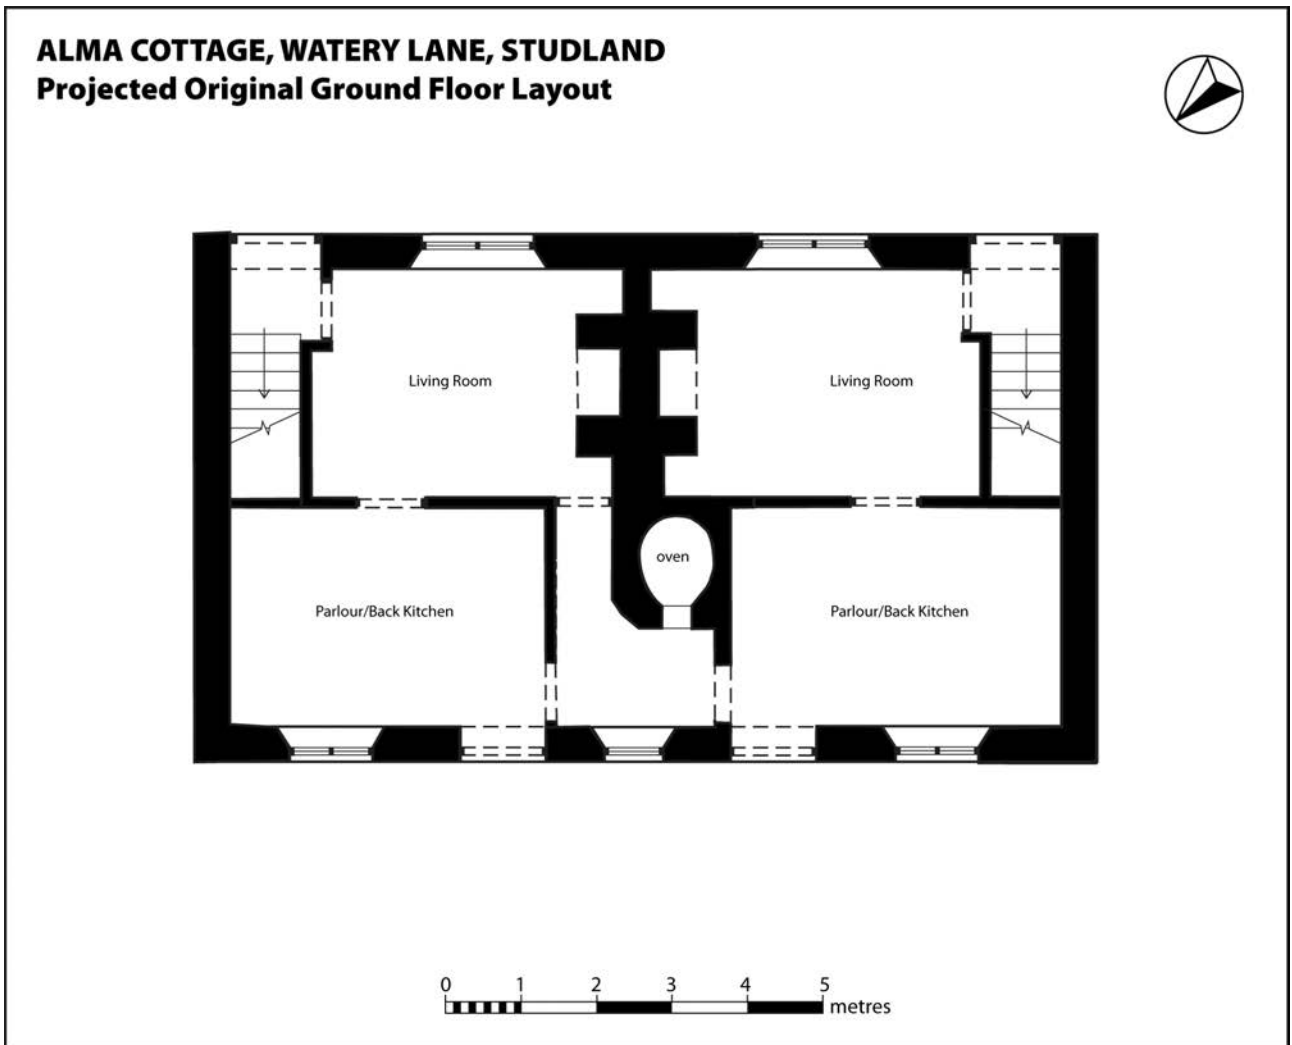
Figure 4: Suggested Original Plan of Cottages.

Edwards' (2017) suggestion that the north room was originally unheated appears to be correct as no trace of a hearth or flue was observed and the evidence from the exposed part of the footings of the partition wall between the north room and the bread oven 'lobby' confirms that the north room was divided off from the bread oven with a door near the north end mirroring the blocked door in No. 5 (Figure 4). The fact that the north room was not heated and the discovery of a drain running out through the north wall lends credence to the suggestion that the north room was originally the parlour or back kitchen and the southern room was the main living and kitchen space (Edwards 2017). The bread oven appears to be a facility shared between the two cottages accessed from the north rooms of both Nos. 4 and 5. This is a not uncommon feature in estate cottages of this date (Edwards 2017). A suggested original layout for the ground floor of Nos. 4 and 5 Alma Cottage is shown in Figure 4.

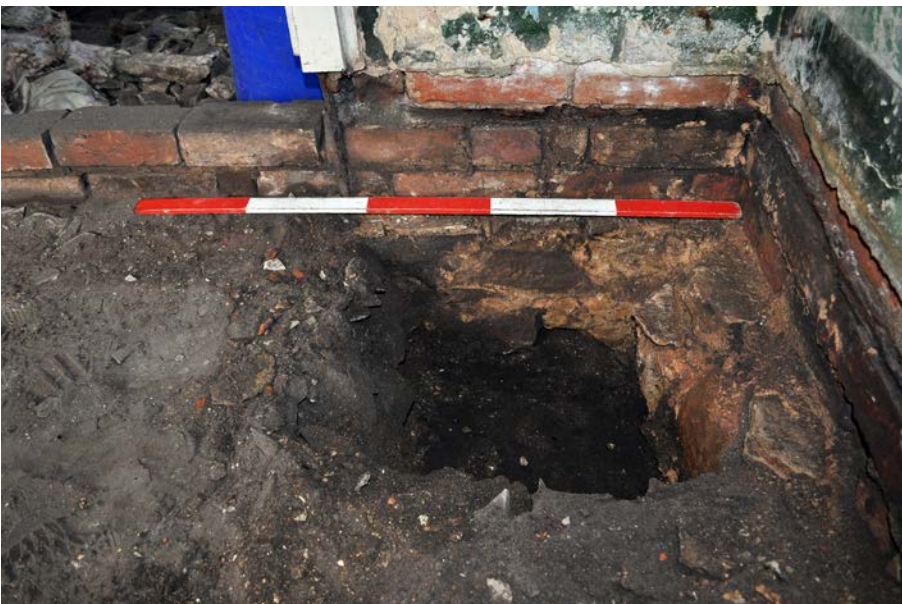
The subsoil 103 was covered by a thin spread of decayed mortar debris (102), over which was a 0.38 m thick deposit of stone and brick rubble in a loose fine dark greyish-brown silty sand matrix (108) (Plates 2–3). Above this rubble layer was the existing concrete floor (100).

Plate 2: Sondage dug in NE corner of South Room showing mortared stone footings 104 and brick footings 114 above, looking north. 1m scale.

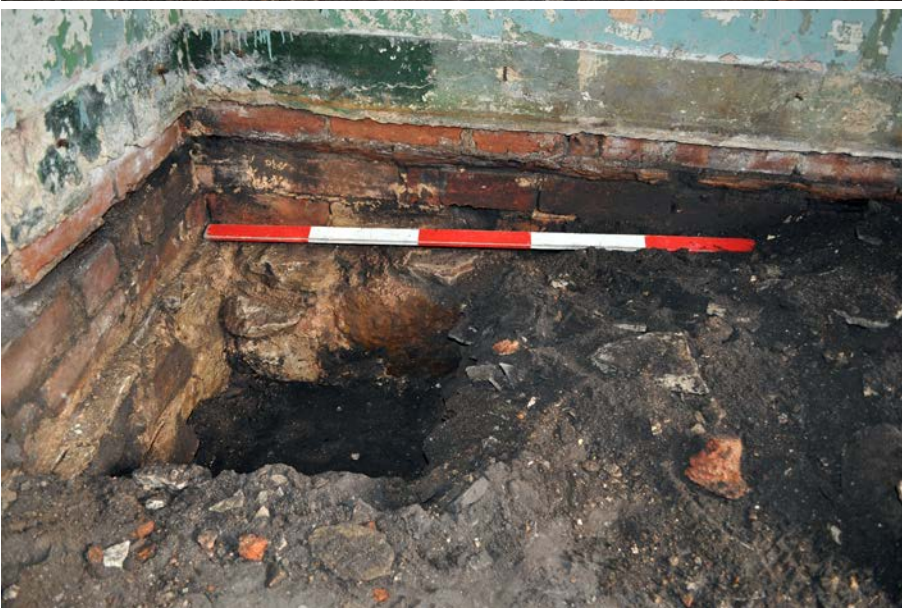
Plate 3: Sondage in South Room looking east showing stone footings 104. 1m scale.

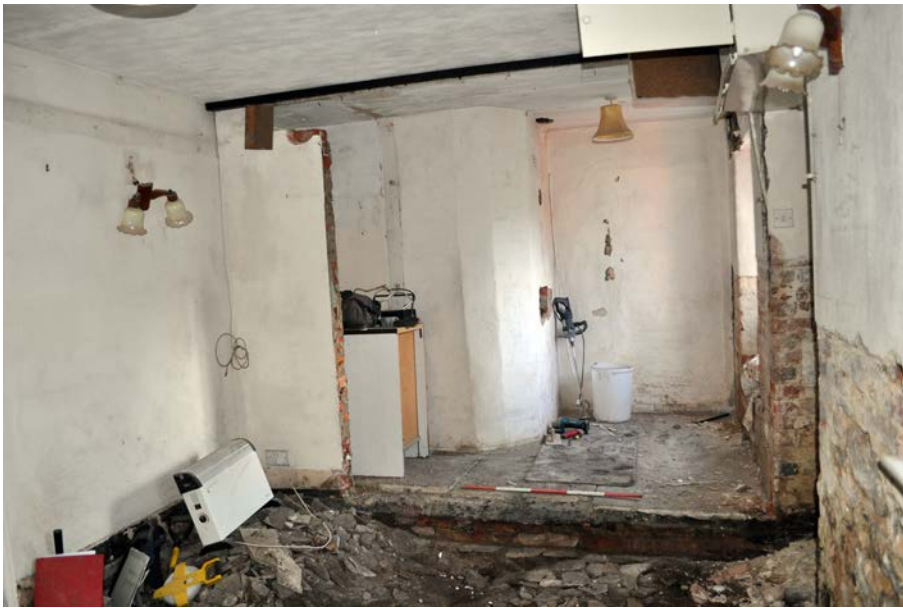
The subsoil 108 was covered by a thin spread of decayed mortar debris (109), over which was a 0.38 m thick deposit of stone and brick rubble in a loose fine dark greyish-brown silty sand matrix (101) (Plate 4). The floor overlying this rubble infill had been removed before recording.

Plate 4: North Room looking west with bread oven and blocked doorway visible in background, together with dwarf wall beneath floor. 1m scale.

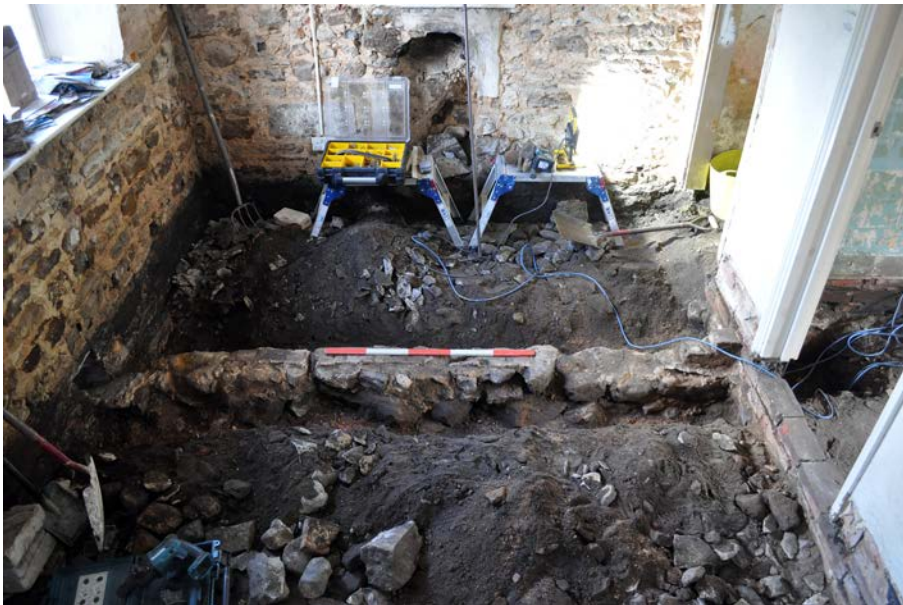
Plate 5: North Room looking east with exposed Structure 111. 1m scale.

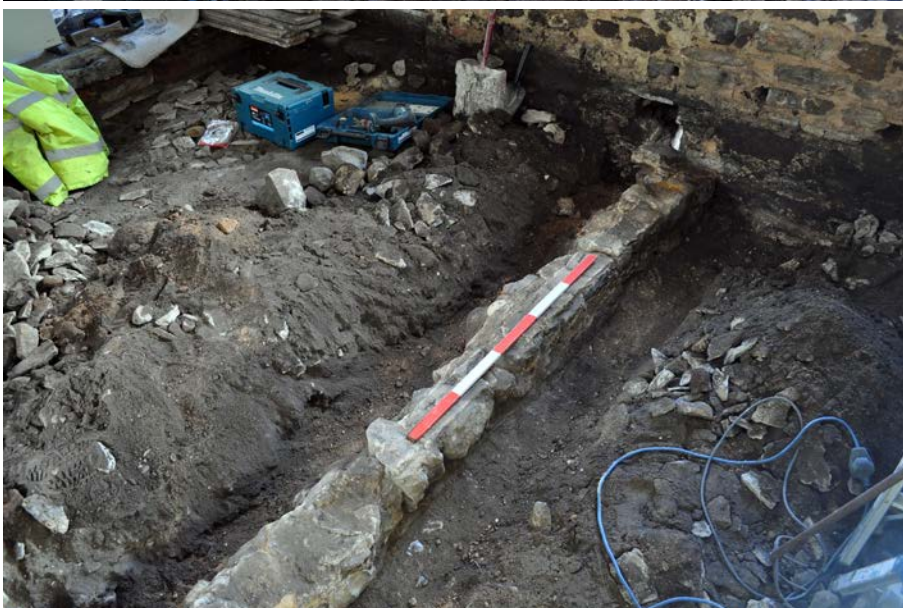
Plate 6: Structure 111 looking WNW with drain 115 visible through external wall. 1m scale.

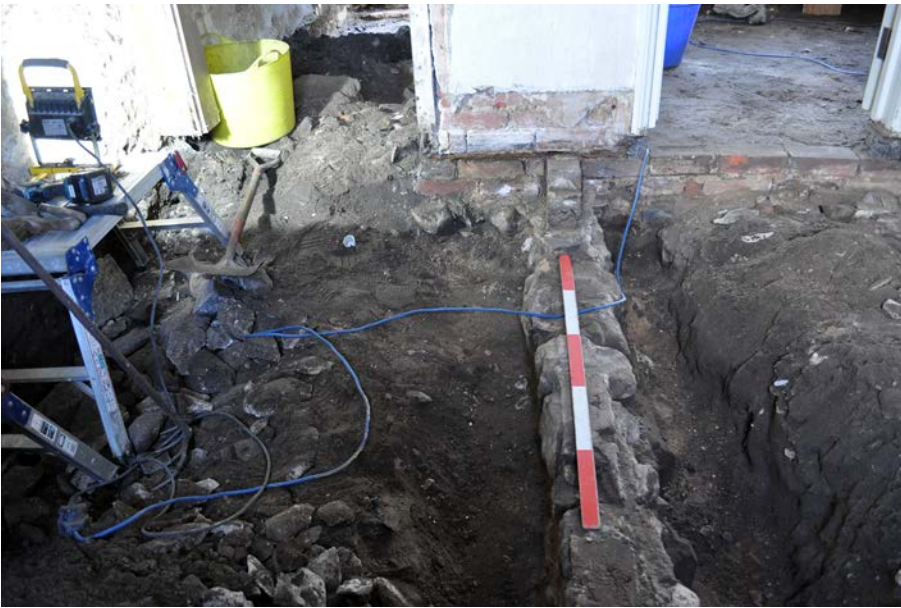
Plate 7: View south along Structure 111 towards internal wall between the north and south rooms. 1m scale.

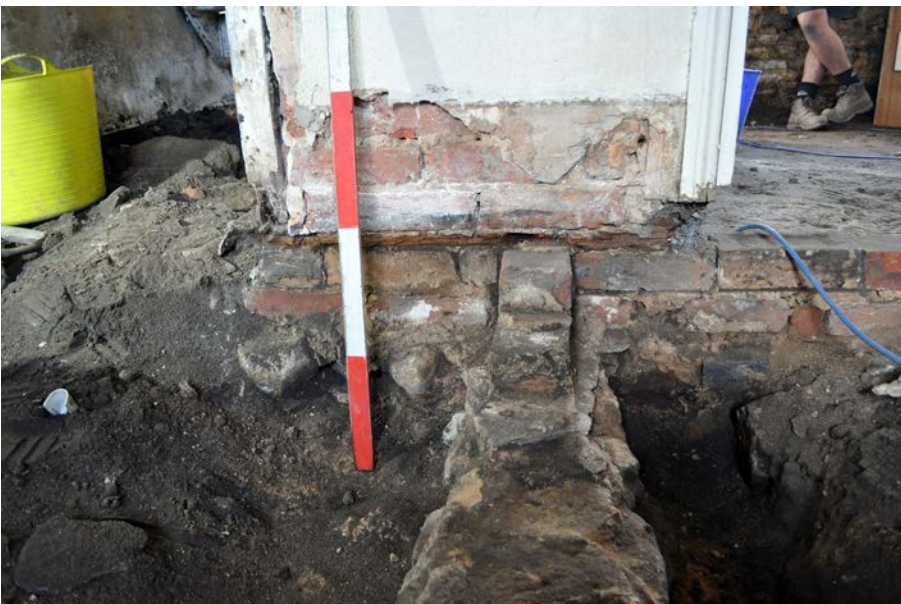
Plate 8: Detail of relationship between structure 111 and internal wall between North and South Rooms. 1m scale.

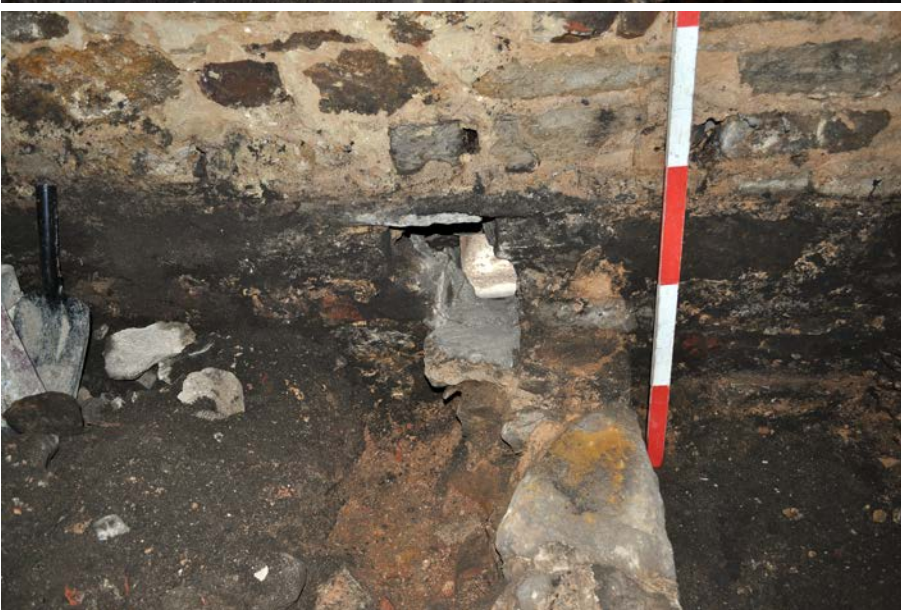
A footing (111), similar to those of the internal walls, was found in the east part of the north room. It consisted of two courses of ironstone rubble, with occasional flint, bonded with lime mortar, set directly on top of subsoil 110. On top of this was a slick of mortar containing impressions of a former brick footing. At the south end, some of the bricks (112) survived indicating that the brick was two courses high and was of one build with the internal wall footing 105 (Figure 2–3; Plates 5–8). The north end of 111 butted the north wall of the cottage (Figure 3). The structure is roughly faced to the east and is aligned with a line scored into the mortar on the internal face of the north wall of the cottage (Plate 9).

Plate 9: Drain 115 through north external wall and Structure 111 to right with vertical line scored in north wall just visible to left of scale. 1m scale.

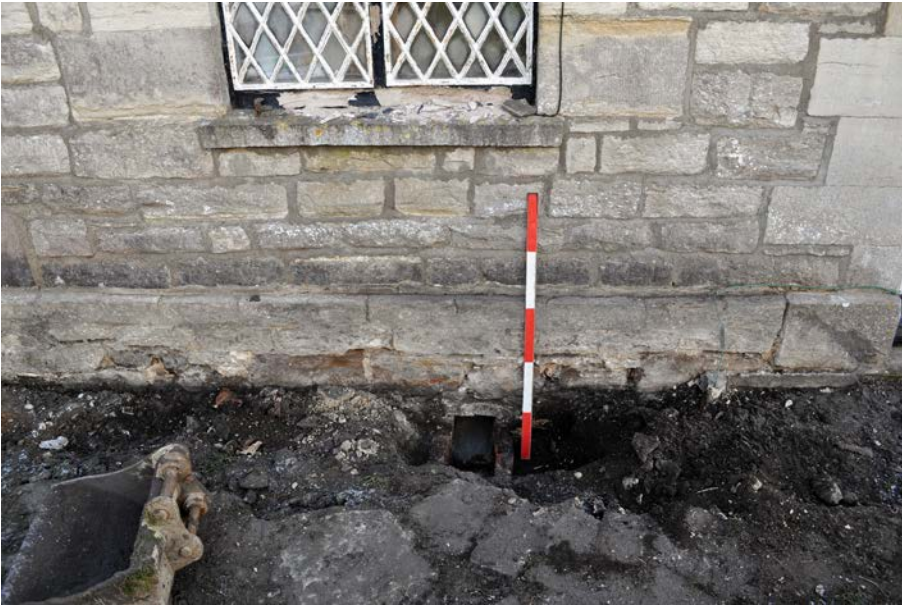
Plate 10: External view of drain 115. View from north. 1m scale.

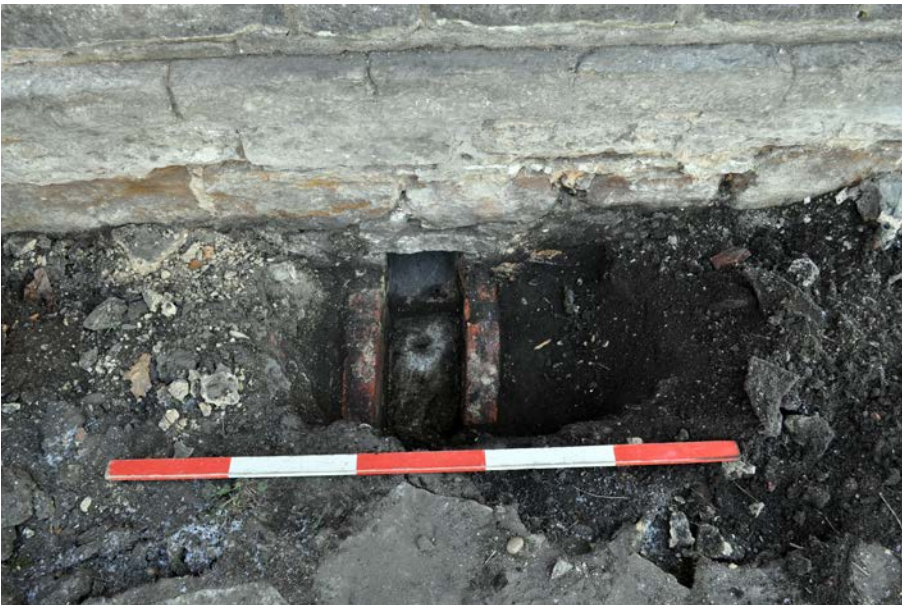
Plate 11: Drain 115 through north wall footings. View from north. 1m scale.

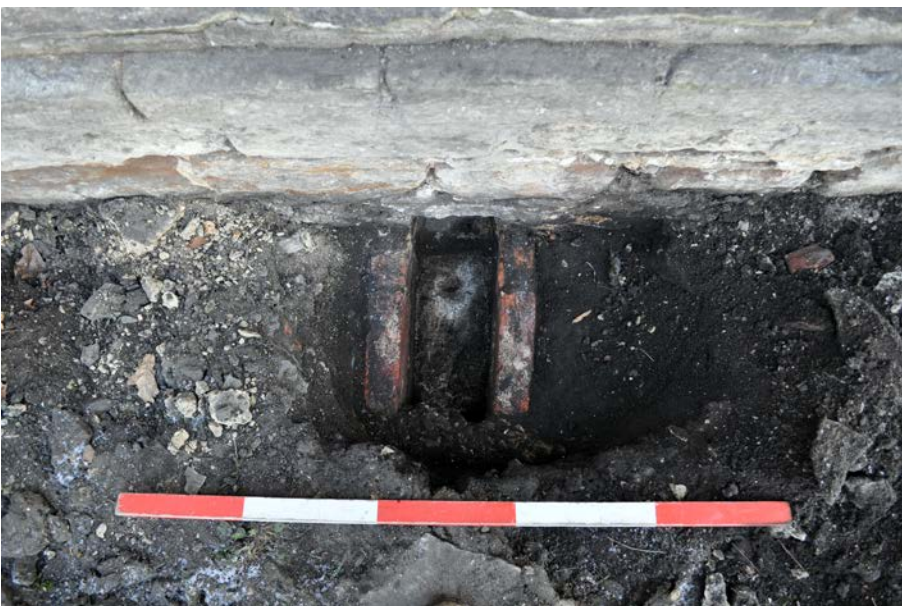
Plate 12: Drain 115 with concrete 117 at end of drain. View from north. 1m scale.
