**BURNGATE PEARCE'S QUARRY, LANGTON MATRAVERS,
PURBECK, DORSET**

Assessment and Recording

Report No. 53246/5/1

June 2007

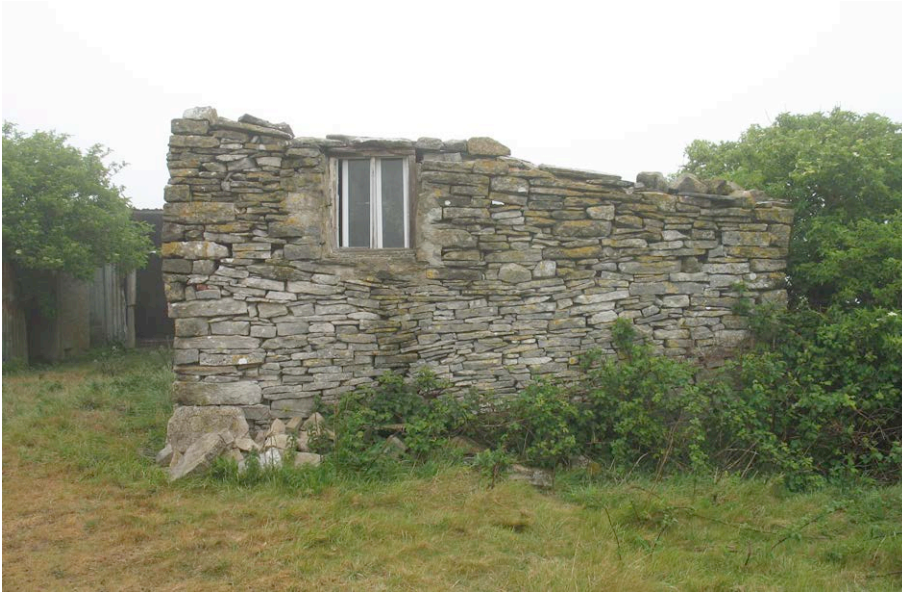
A small window has been inserted in the south wall (Plate 1), while the west wall has two windows (likewise poorly inserted) and two doorways (Plates 2 & 6). Weak timbers support a lean-to roof of corrugated iron, held down by stones placed on the top (Plate 4).

Plate 1: Building A – exterior view of south wall.

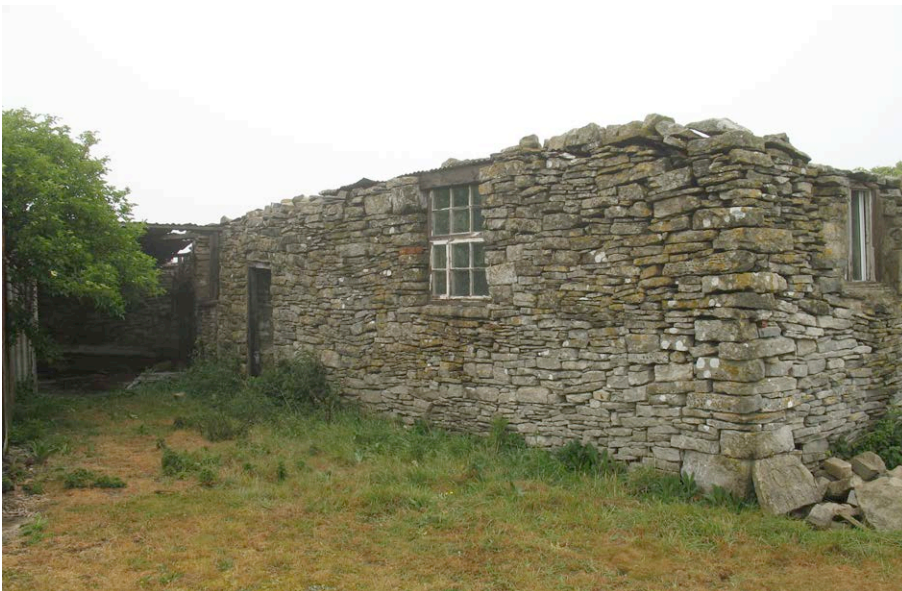
Plate 2: Building A – exterior view of west wall.

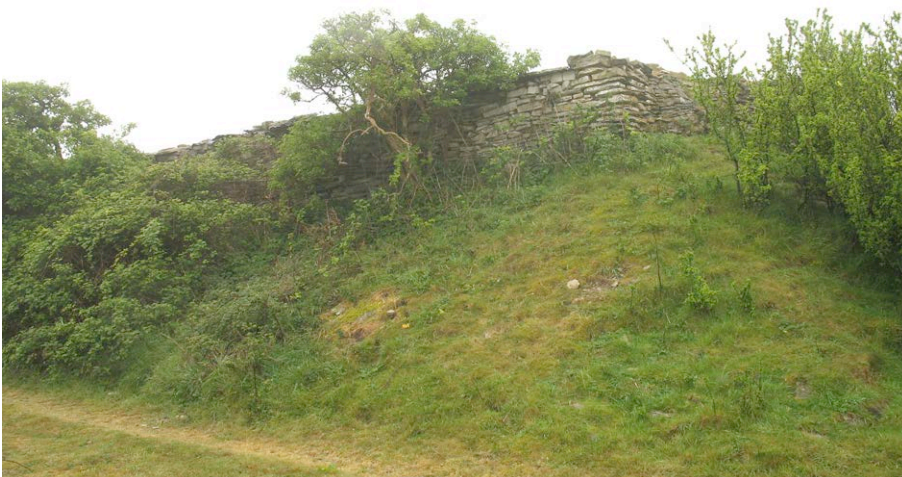
This is the largest building and seems to have remained in this form since at least 1928, while its older, northern end was in existence by 1901 (and indeed 1887). The walls are of stone, both lime-mortared and dry-stone construction, but it has served its function, although some walls are now bowing outwards. There has been an attempt to course some stones while much of the walling is of a random and haphazard construction (Plates 1-2). The north wall was built back into the waste tip, which gave support and also protection from the north wind (Plate 3).

Plate 3: Building A – exterior view of northeast corner.

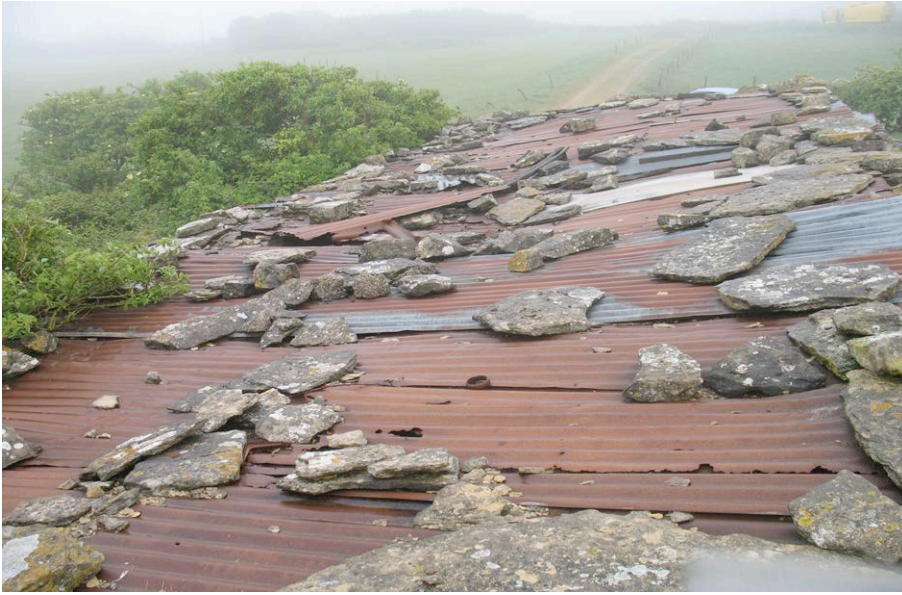
Plate 4: Building A – exterior view of roof.

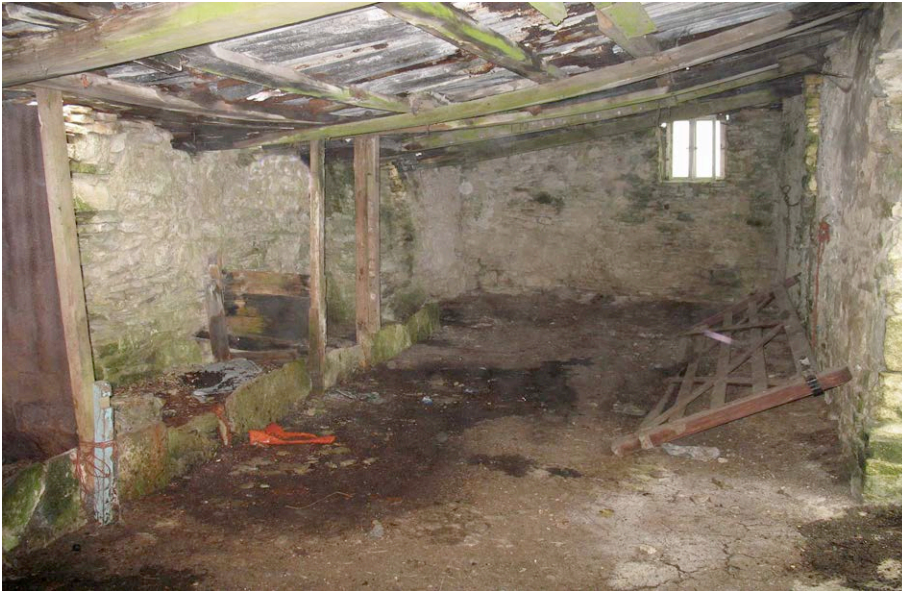
The interior has evidence that the building was later used as an animal byre, with stone slabs forming feeding troughs along the east wall (Plate 5). A drainage channel leaves the building at the south west corner. The walls have been lime-washed in the past.

The conversion of the quarry site for agricultural activities should not be ignored, since this covered a significant period of the site's history. While the surviving evidence is in a poor condition, the stone slabs forming the mangers or feeding stalls in Building A are of special interest.

Plate 5: Building A – interior view.

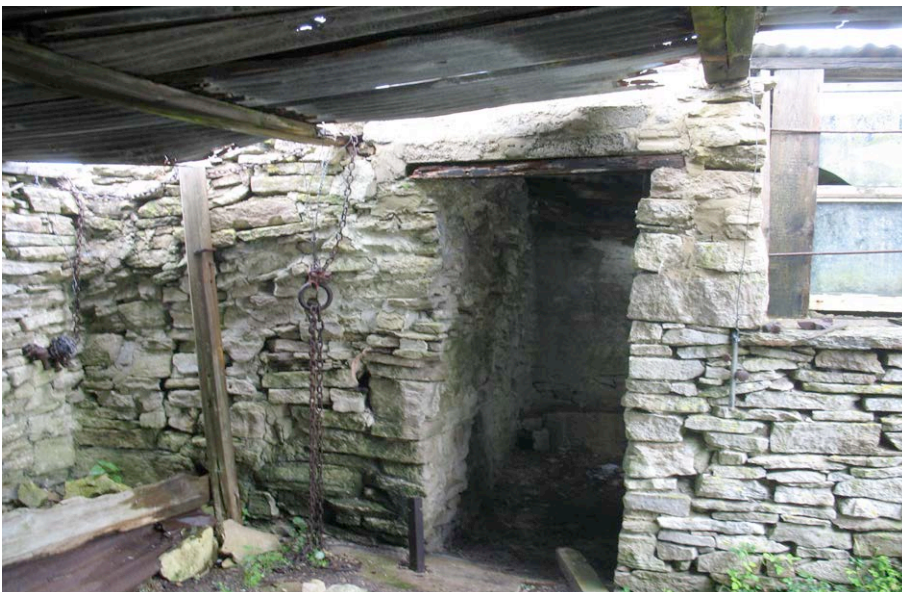
Plate 6: Building A – doorway leading from Building B.

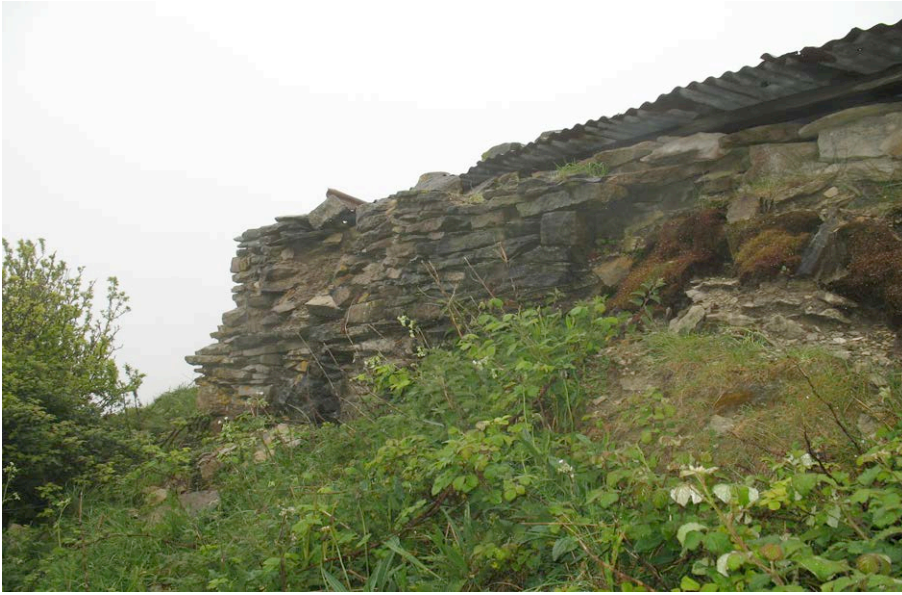
This is an open-fronted quarr shed, facing south east, and one of three in existence by 1887 (Phillips, 1986, 160). The north, east and west walls appear to be original, as also seen on the 1901 map. Again, it has been used as an animal byre. The stonework is extremely random and a lean-to corrugated iron roof gives protection from the weather (Plate 9). Inside, one stone in the east wall has a good example of twin wedge-pits, while there is a poorer one in the west wall. As with Building A, this building backs into the remains of the original waste tip to the north (Plates 7-8).

Plate 7: Building B – exterior view of north wall.

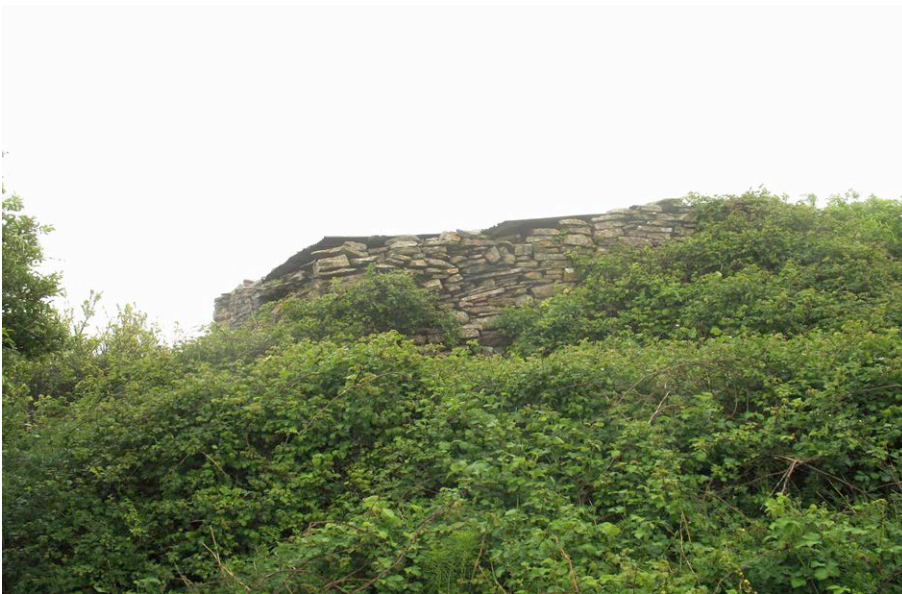
Plate 8: Building B – exterior view of northwest corner.

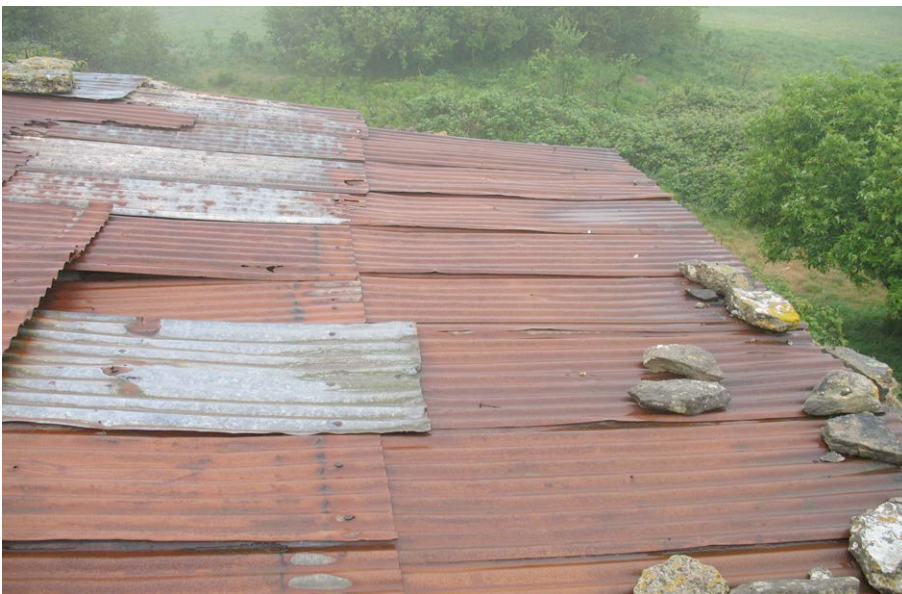
Plate 9: Building B – exterior view of roof.

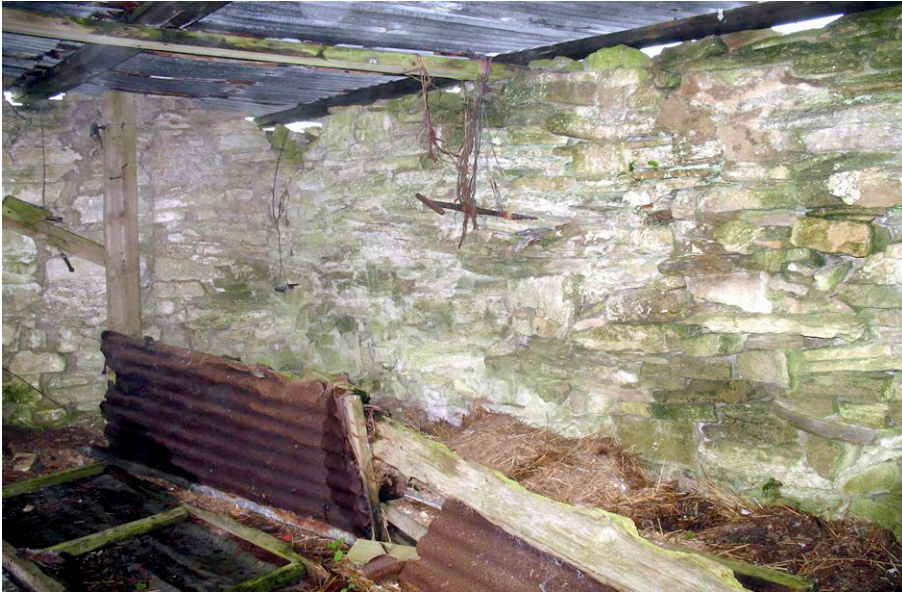
Plate 10: Building B – interior of north wall.

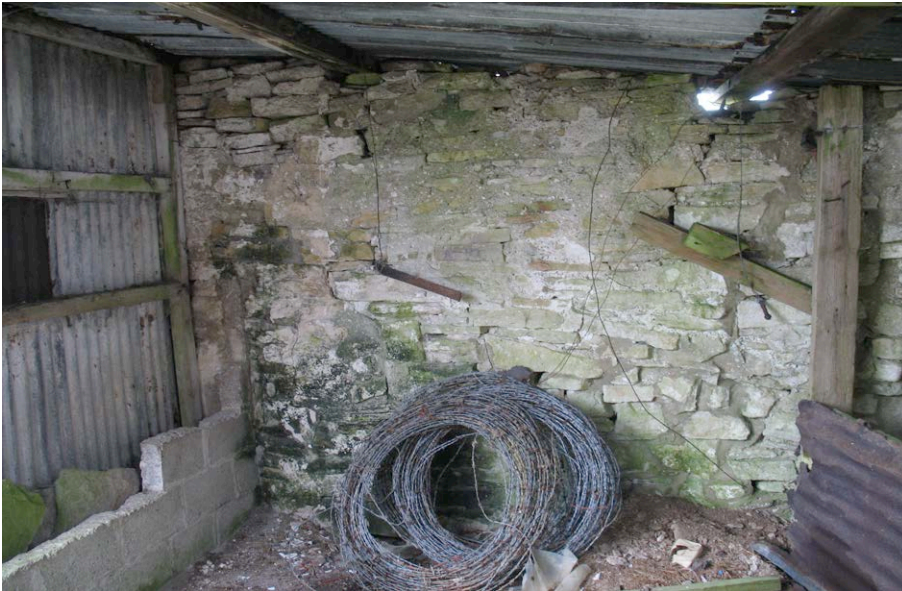
Plate 11: Building B – interior of west wall.

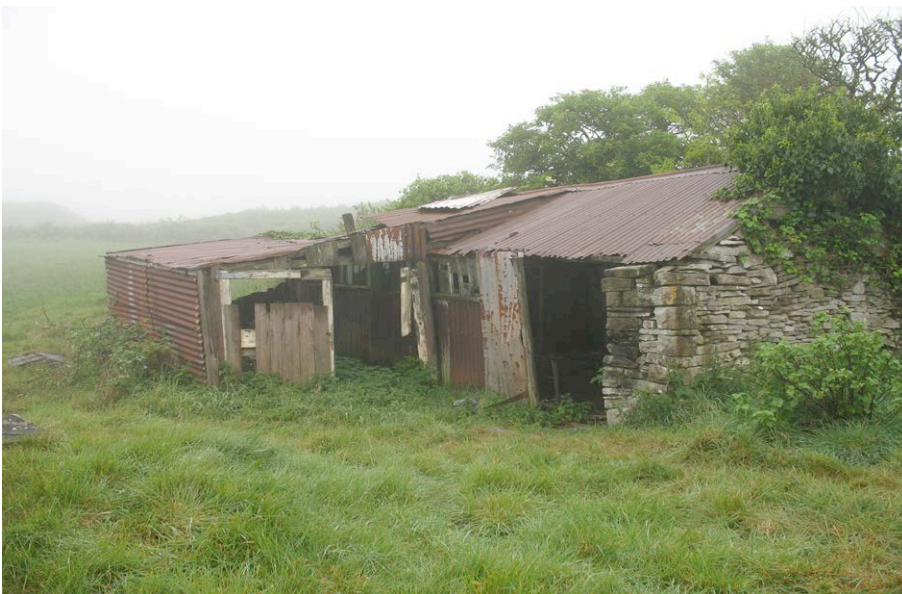
This is mainly a timber-framed construction with corrugated iron walls and roof, all in a poor condition (Plates 12-15). The main part of the building was here in 1954 but a smaller extension on the east side was made sometime between then and 1987. Like the other buildings there is evidence that this has been used for keeping livestock. However, the most interesting feature is the stone wall at the north end, the style of which suggests it is from an earlier structure (Plates 13-14). The Ordnance Survey map evidence suggests that it is the former southern wall of the western of the two quarry buildings shown on the 1903 map. Therefore, the former quarry building lay to the north of the present agricultural building. The inner, south face of the wall has a stone with wedge-pits.

Plate 12: Building C – view from the northeast.

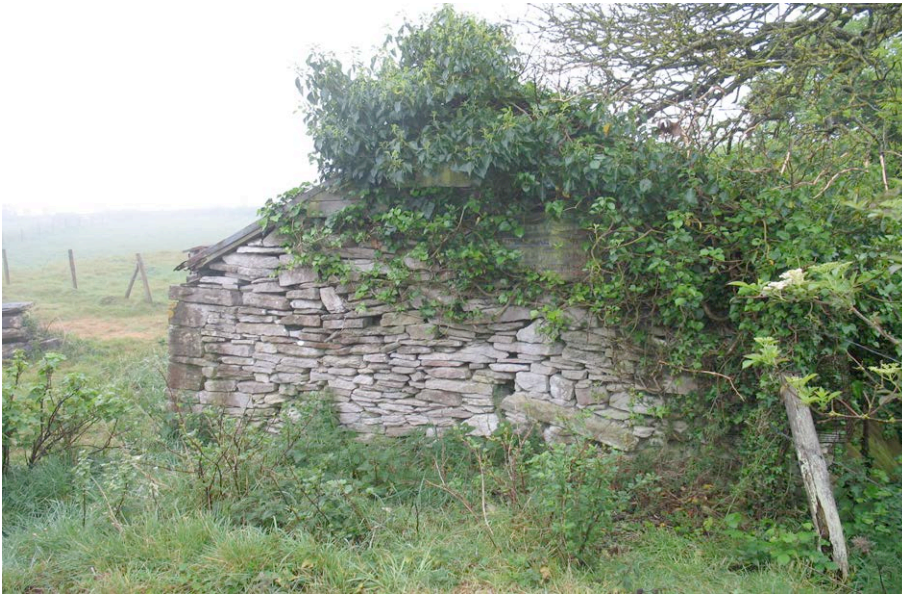
Plate 13: Building C – exterior view of north wall.

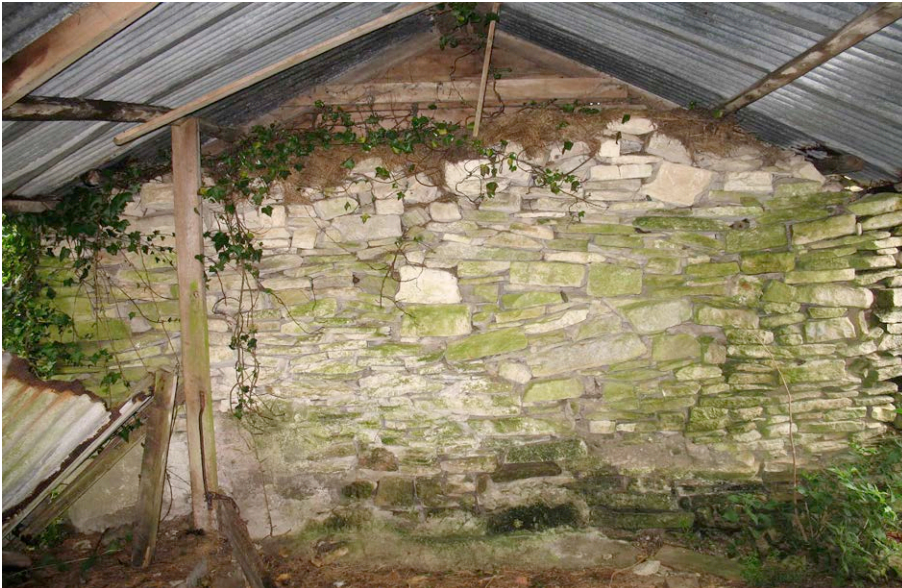
Plate 14: Building C – interior view of north wall.

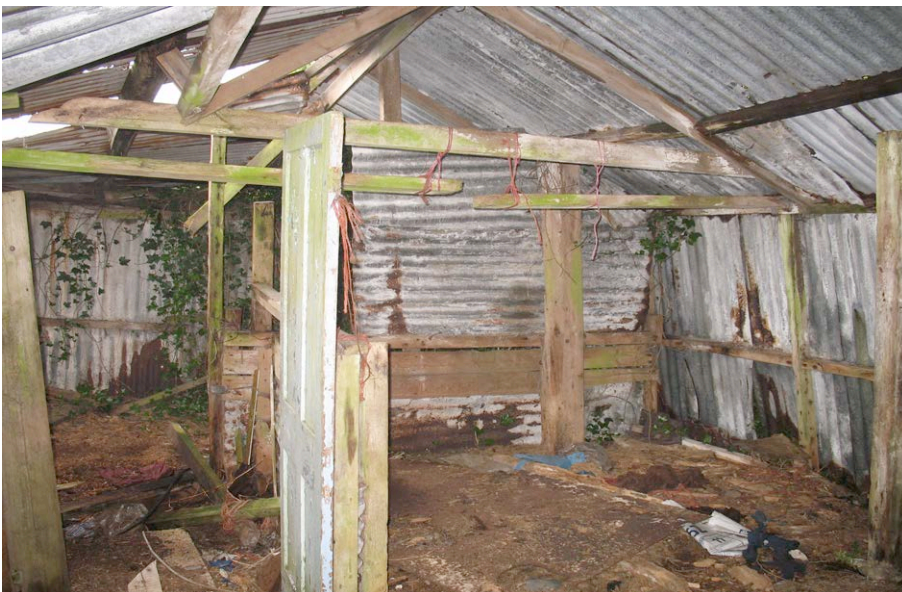
Plate 15: Building C – interior view.

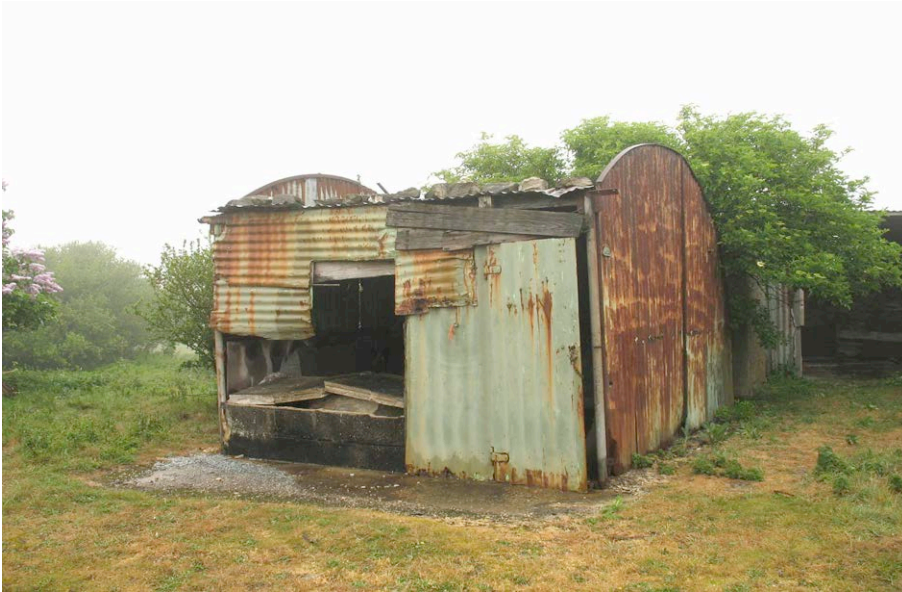
A purpose-made corrugated iron hut under a curved roof and mounted on a concrete base, containing inside a small milking parlour for two or three cows (Plates 16-17). The nameplate 'REFLEX BRISTOL' on the corrugated iron exterior indicates the name of the manufacturer or supplier. This prefabricated unit may have originally been a mobile milking 'bail' but is greatly altered and is in poor condition. The roof has collapsed.

Plate 16: Building D – view from the southeast.

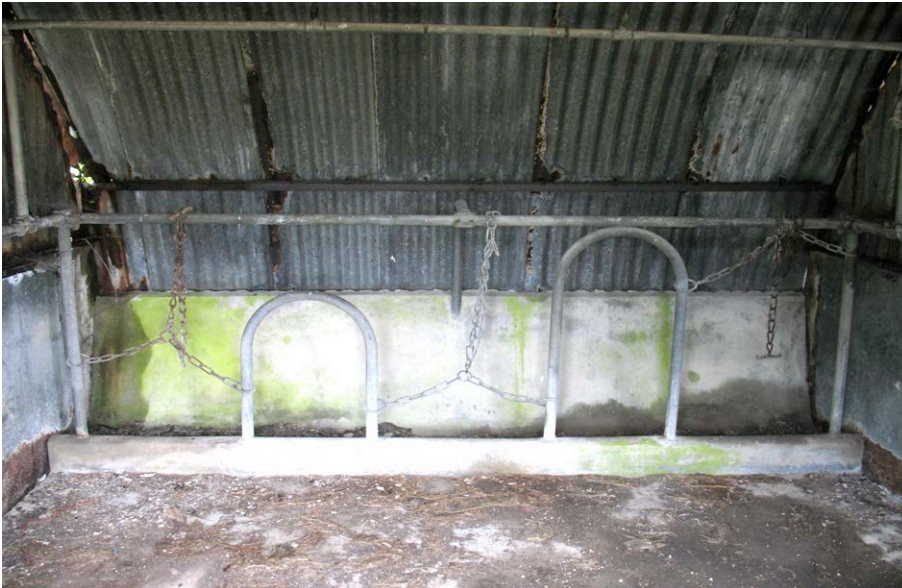
Plate 17: Building D – interior view.

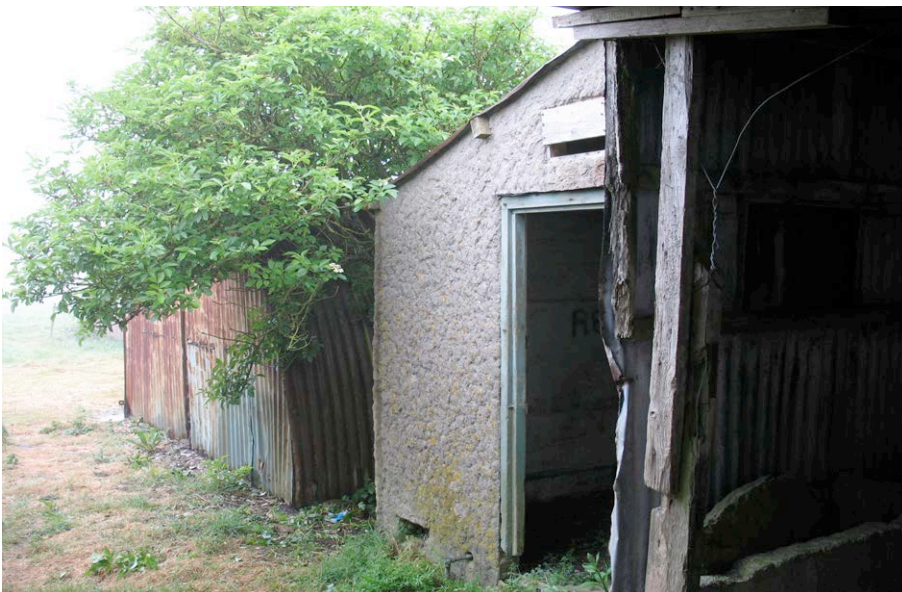
A small building with brick and corrugated iron construction, cement rendered inside and with textured rendering outside (Plates 18-19). This was possibly for a dairy cooler. It has a single door and shares a wall with Building B. In poor condition.

Plate 18: Building E – view from northeast.

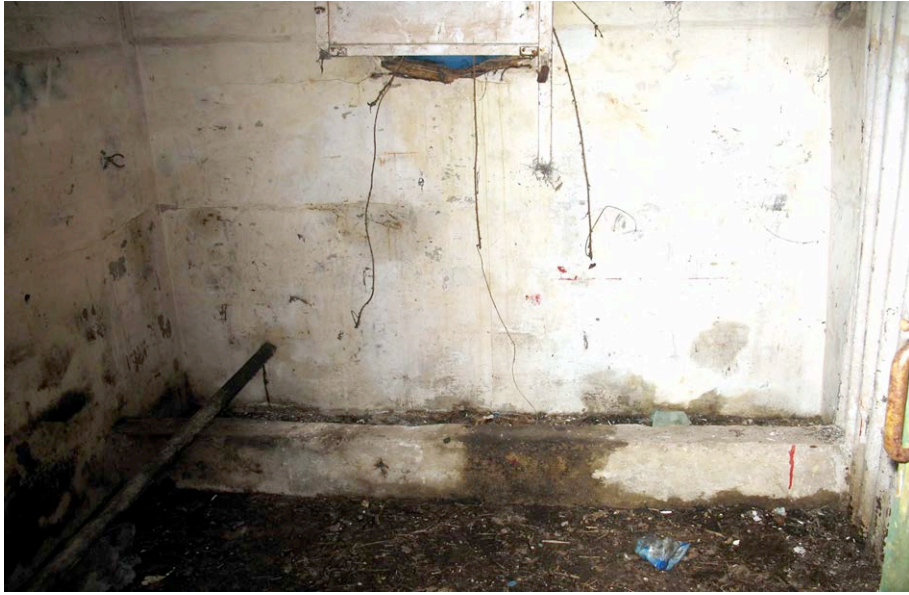
Plate 19: Building E – interior view.

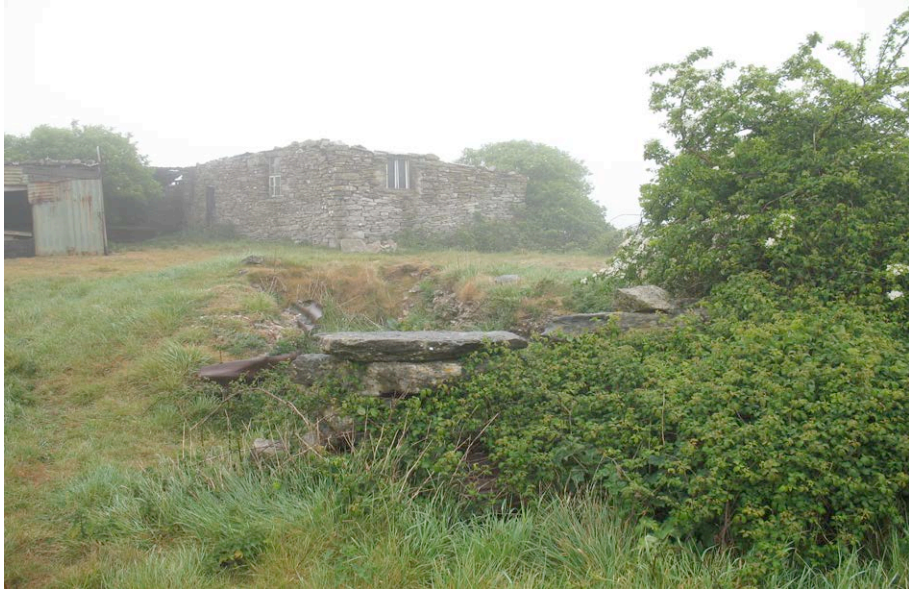
There are large stones built along the south side of this structure (Plate 20), which contains a pit, and is said to have been used for maintaining motor vehicles and, therefore, not related directly to stone quarrying. The large stones have come from the site and could be in their original position if part of a loading platform.

Plate 20: Structure F – view from south.

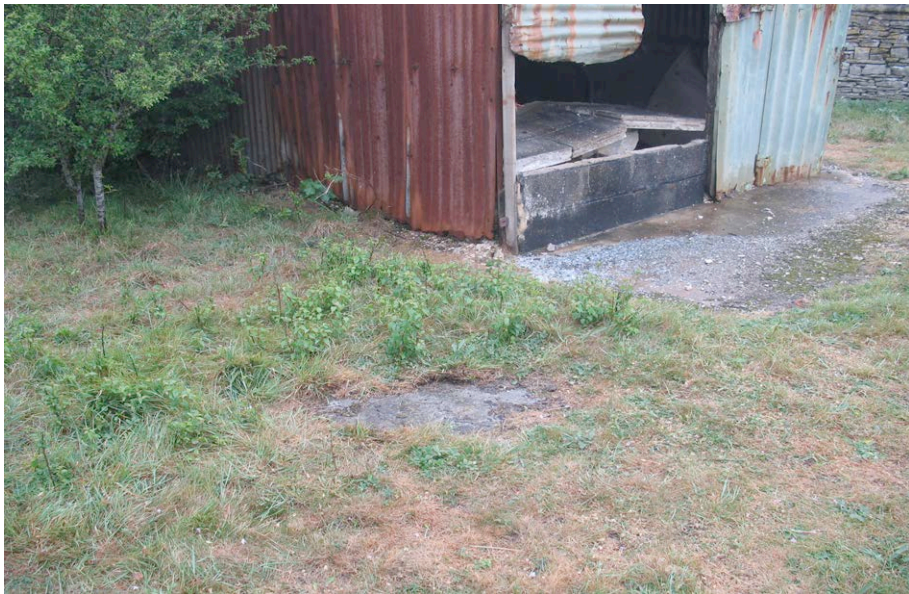
Plate 21: Stone slab near top of shaft.

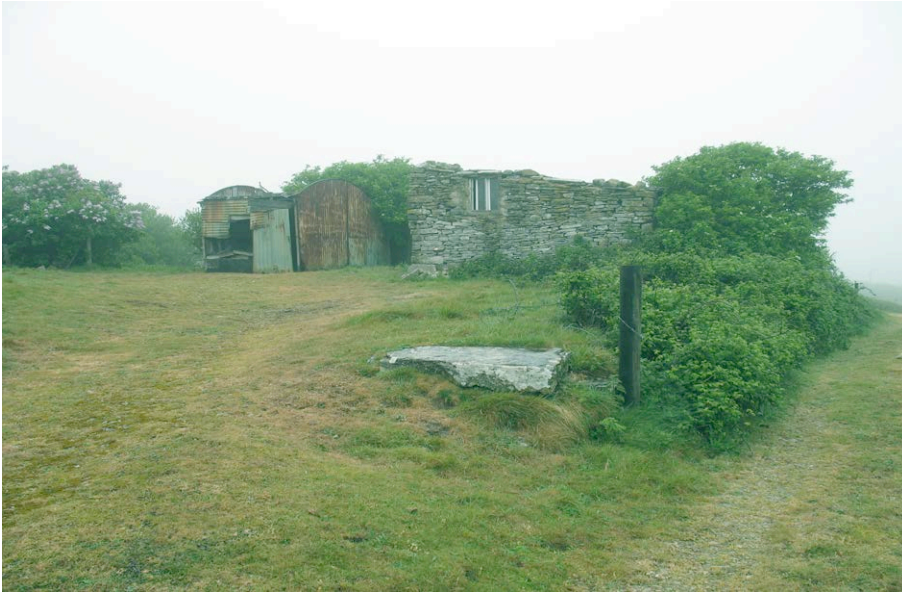
Plate 22: View of loading platform from southeast.

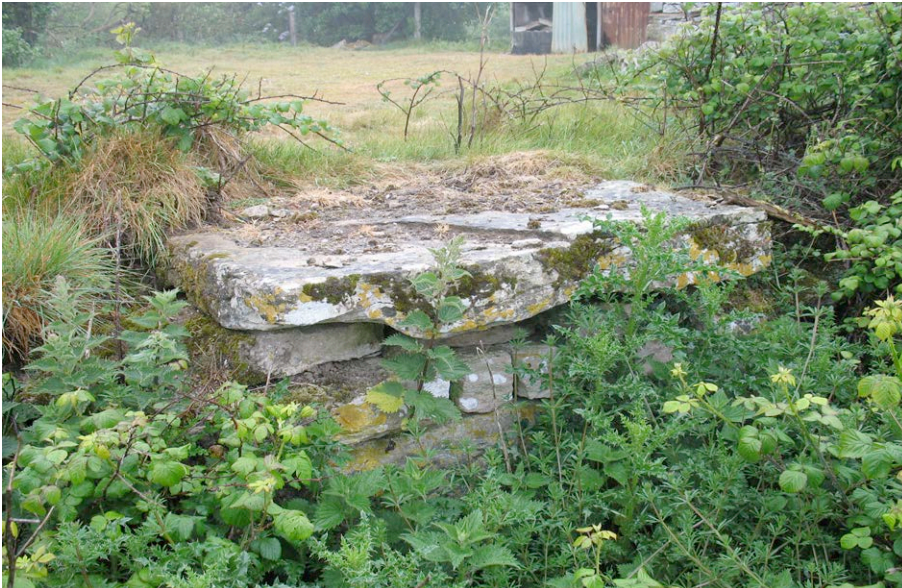
Plate 23: Detail of loading platform.

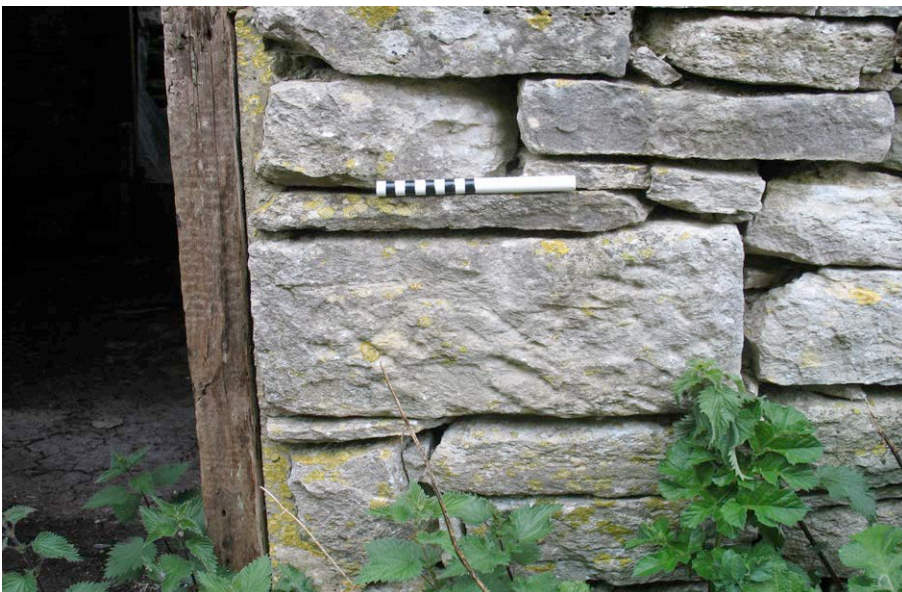
Plate 24: D1 – crudely dressed stone with punched tool marks (Figure 3).

M D1 Building A, exterior west wall: crudely dressed stone with punched tool marks

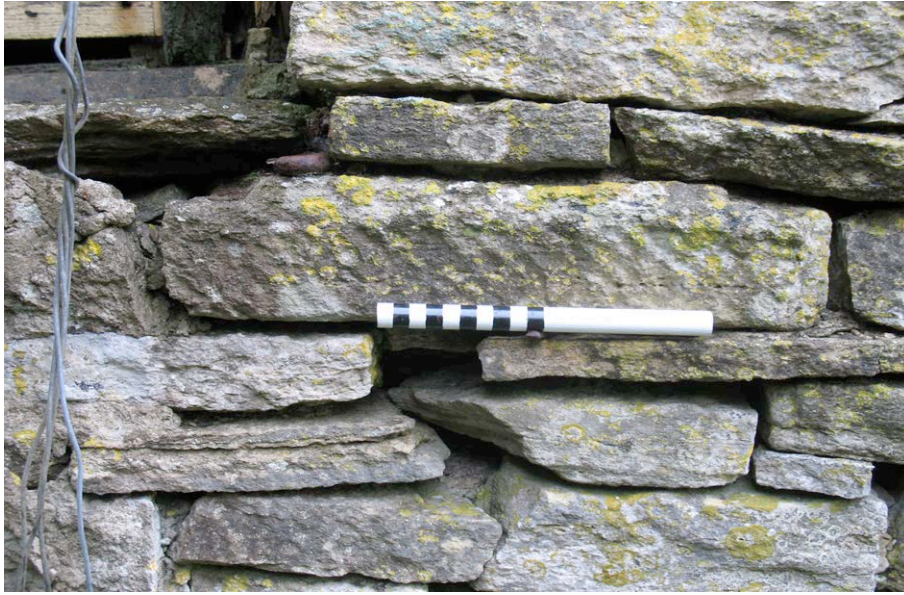
Plate 25: D2 – dressed stone (Figure 3).

M D2 Building A, exterior west wall: dressed stone

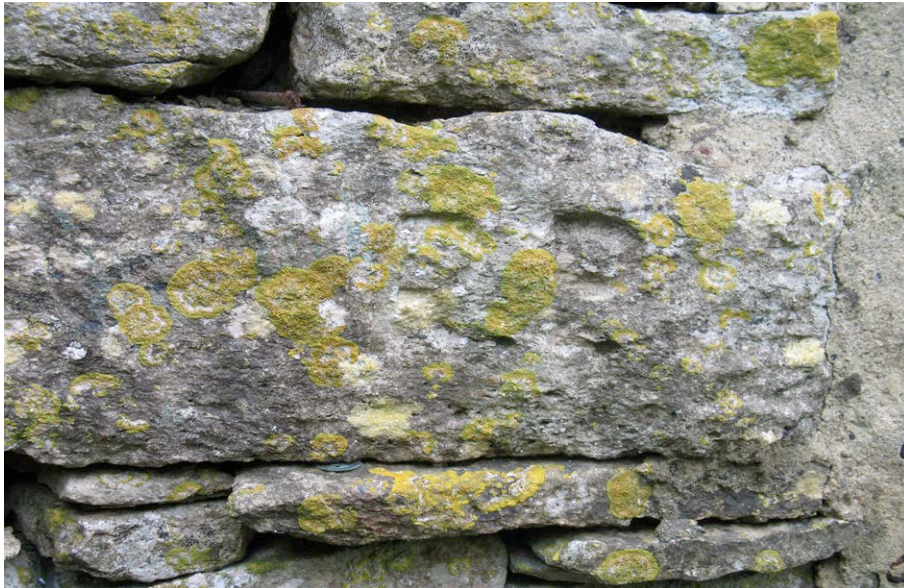
Plate 26: PP – stone carved with letters PP (Figure 3).

M P Building A, exterior west wall stone carved 'P.P.' Letters are 6cm high.

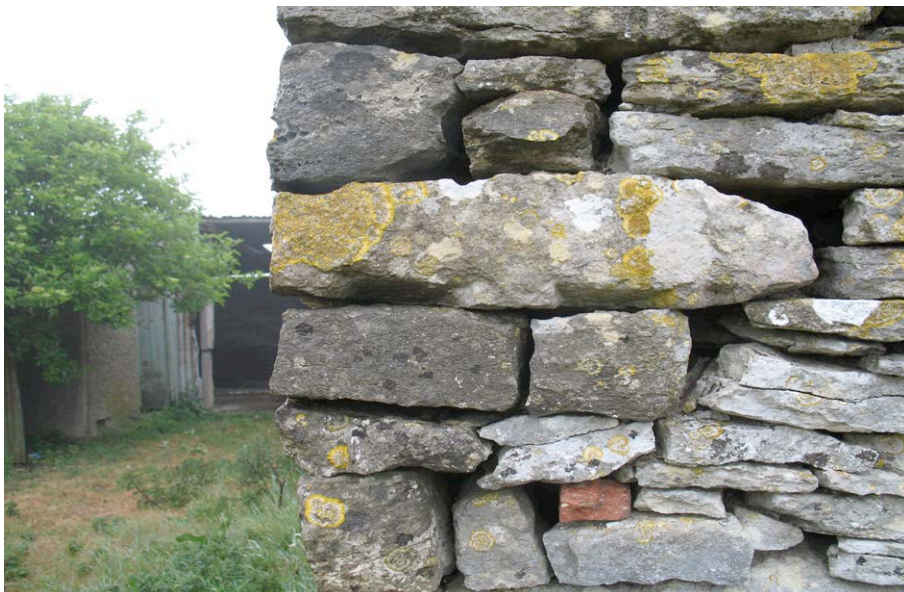
Plate 27: W1 – pair of wedge pits on underside of stone (Figure 3).

M1 Building A, exterior south wall: pair of wedge-pits on underside of stone

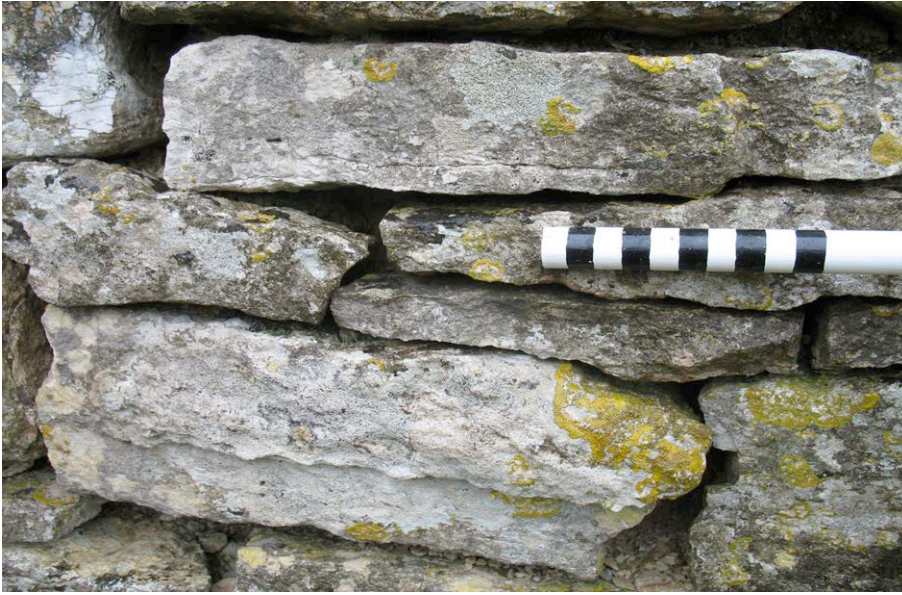
Plate 28: L3 – long channel, inverted, in lower stone (Figure 3).

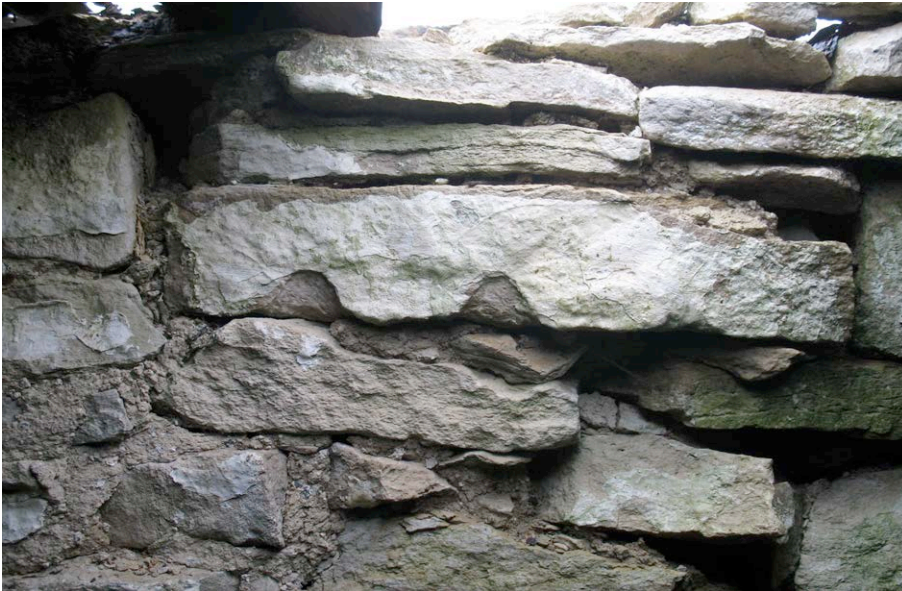
Plate 29: W9 – pair of small wedge pits, inverted (Figure 3).
