**WATER MAIN REPAIR, POOR LOT, KINGSTON RUSSELL,
DORSET**
Archaeological Observations and Recording

Report No. 53253/3/1

July 2007

Environmental Services Team
Wessex Water
Claverton Down Road
Claverton Down
Bath
BA2 7WW

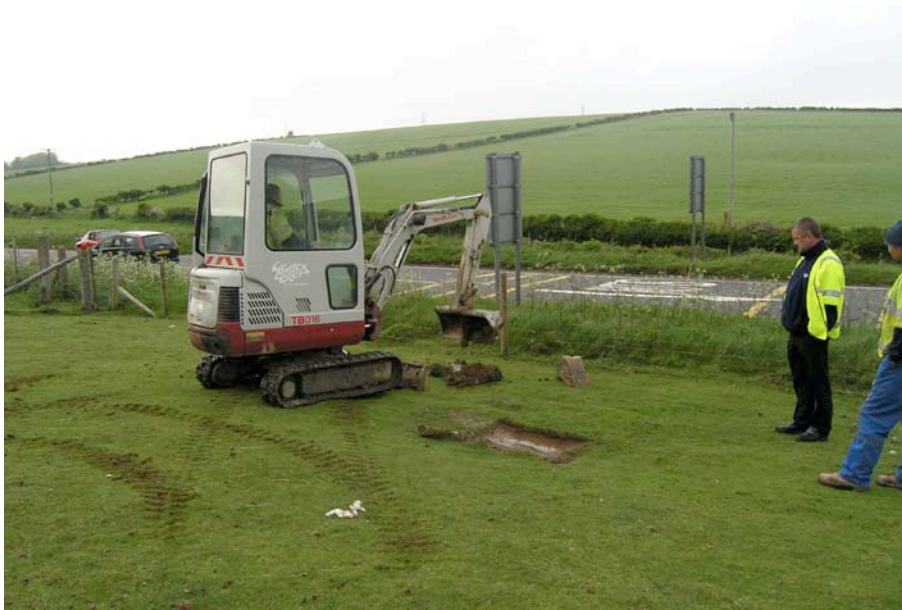
The location of the burst water main was adjacent to the A35, just to the north of the Poor Lot Barrow group within the northwestern corner of a pasture field (Plate 1). It lies on the lower northern slopes of Black Down in a coombe running east-west, at a height of approximately 125 m above Ordnance Datum. The underlying geology is mapped as Upper Chalk.

Plate 1: General view of area of pipe burst, viewed from southeast.

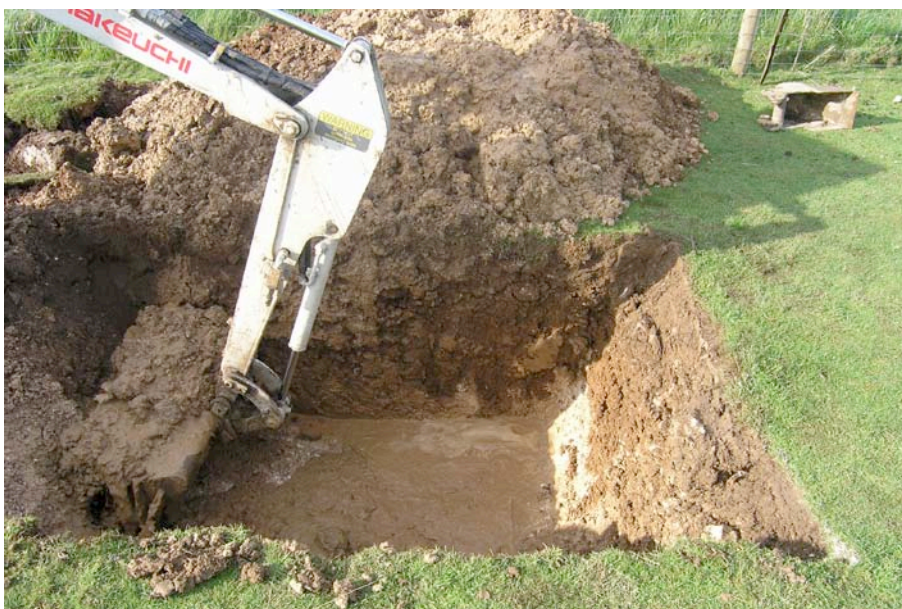
At the base of the trench the coombe rock natural was exposed (Plates 2–6). The upper surface of the coombe rock was affected by a number of solution features filled with reddish-brown clay (Plates 2–6). The natural was sealed by a layer of dark reddish-brown clay colluvium with moderate to frequent manganese-stained flint fragments, up to 0.5 m in thickness (Plates 5–6). This was sealed by a 0.3 m thick layer of dark reddish-grey-brown silty clay loam topsoil with occasional to moderate flint fragments.

Plate 2: View of trench during excavation – from south.

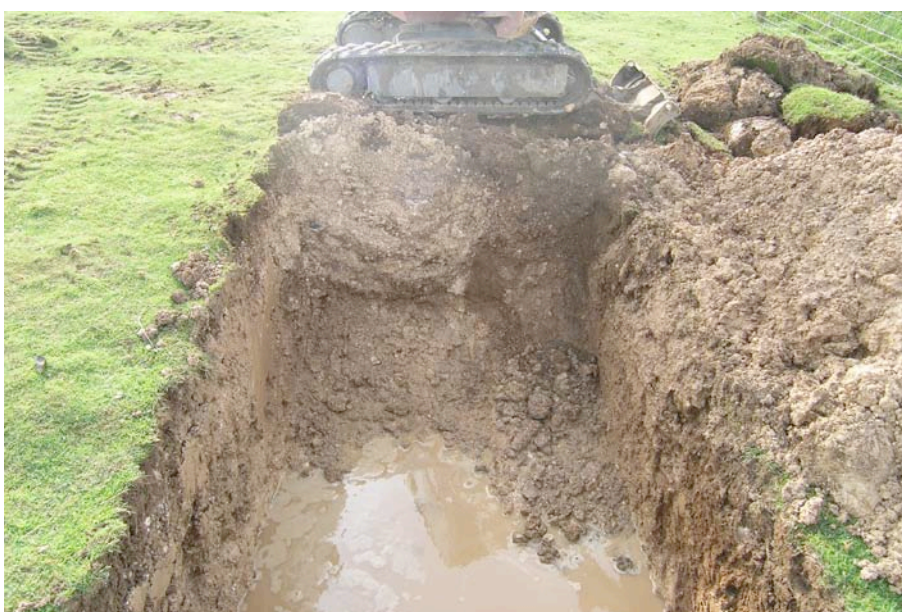
The water main ran along the southern side of the trench in a one metre wide steep-sided trench, backfilled with mixed chalk and soil (Plates 3 & 6).

Plate 3: View of trench during excavation, with pipe trench visible to left. View from east.

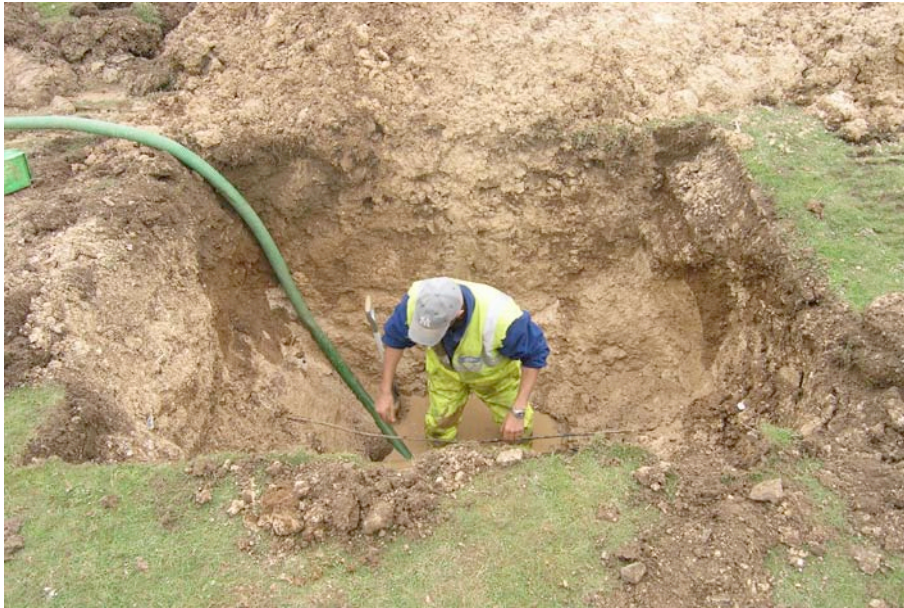
Plate 4: View of south-facing section of trench.

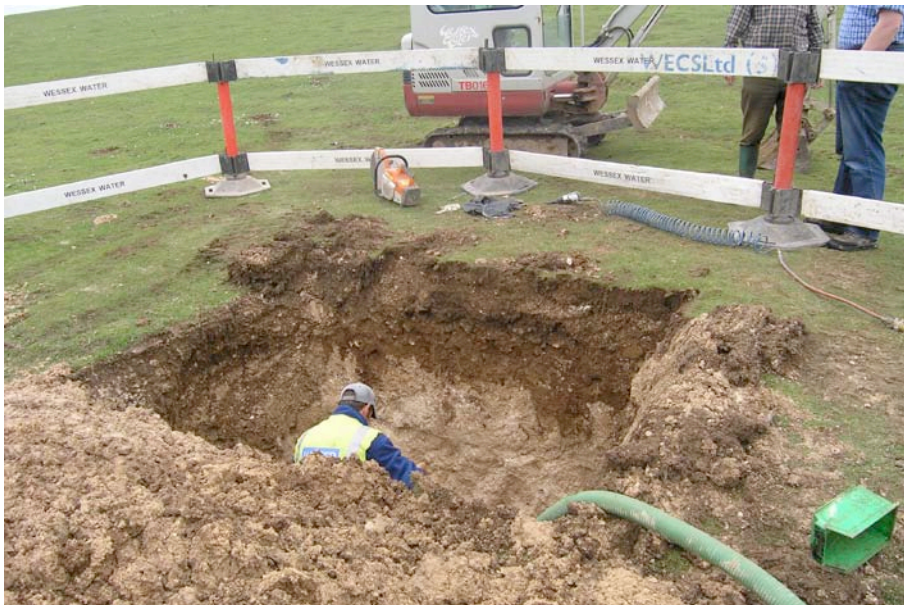
Plate 5: View of north-facing section of trench.

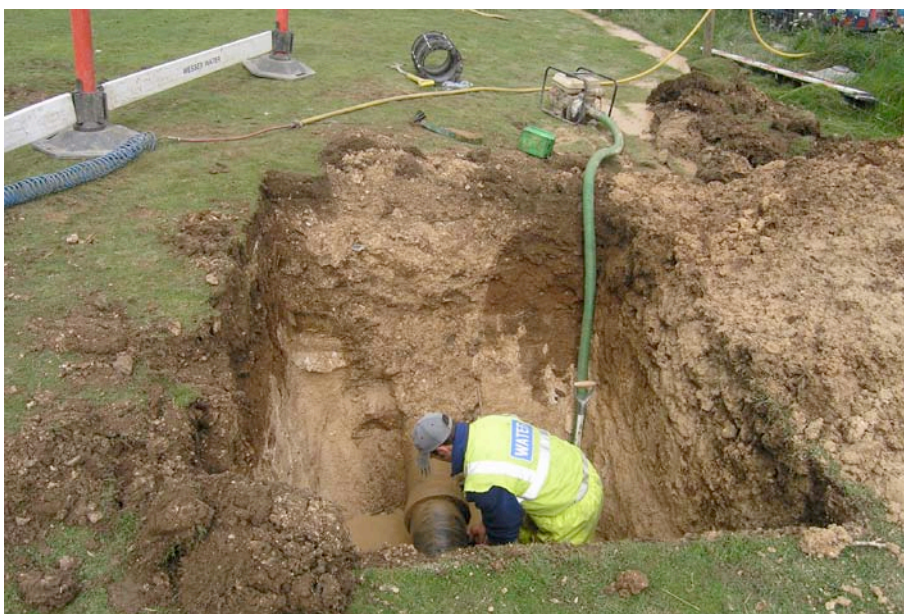
Plate 6: View of east-facing section of trench, showing pipe trench.

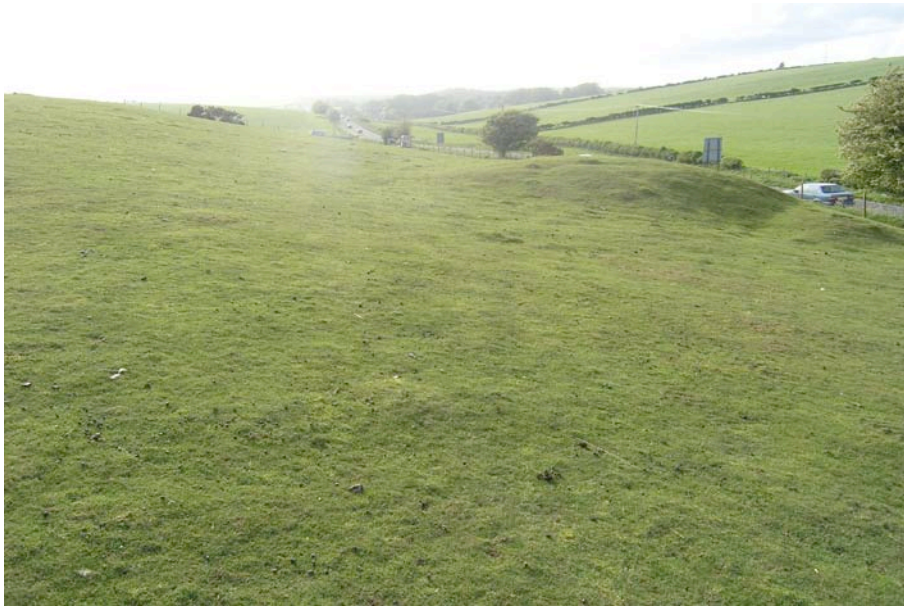
The excavation was carried out by a small rubber-tracked excavator, which was tracked across the pasture field from Wellbottom Lodge to the site through the Poor Lot Scheduled Monument area, avoiding the visible earthwork remains of the barrows. The tracking of the machine left shallow track impressions but did not break the turf (Plate 7). The pump and other equipment were initially brought to the site by 4x4 around the top of the scheduled area. Subsequently all equipment was taken onto the site across the fence to the north, running along the side of the verge to the A35 road.

Plate 7: View westwards towards site with the nearest barrow to the site in middle distance and showing digger track marks in foreground.

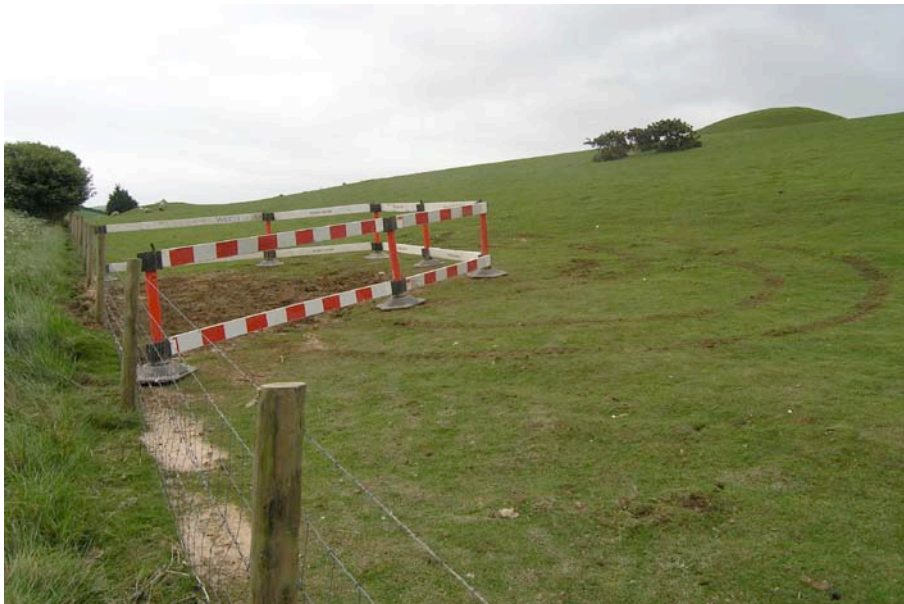
The spoil from the site was stored adjacent to the trench and at the completion of the works the trench was backfilled and compacted by the machine (Plates 8–9).

Monitoring of the works and subsequent ground inspection after completion of the repairs indicated there was no damage to the Scheduled Monument.

Plate 8: View looking east towards the Scheduled Area after backfilling.

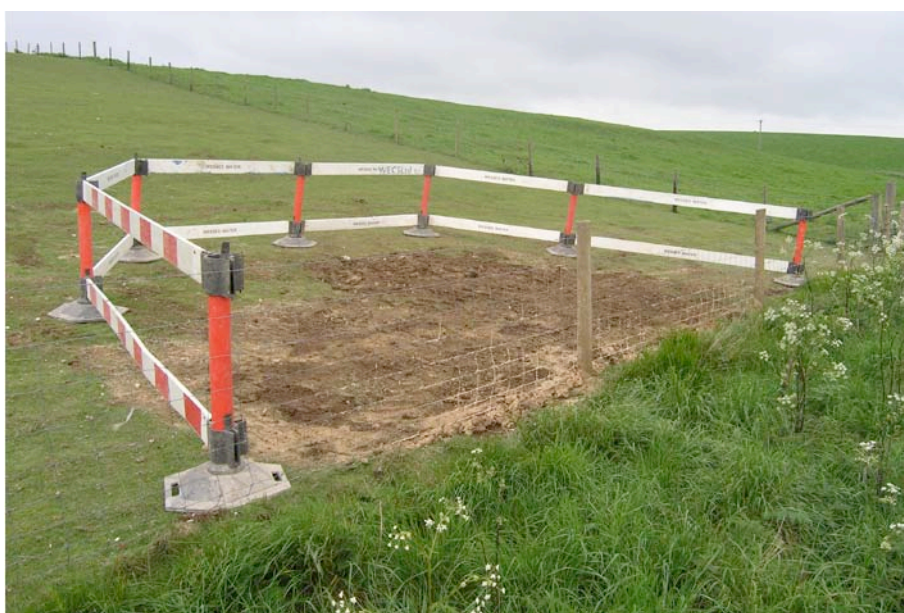
Plate 8: The site after backfilling, looking southwest.
