**'SERVICE ROOM', WALNUT FARM HOUSE, COWGROVE,
PAMPHILL, DORSET
Building Survey and Recording**

Report No. 3074.1

May 2002

Building Survey and Recording

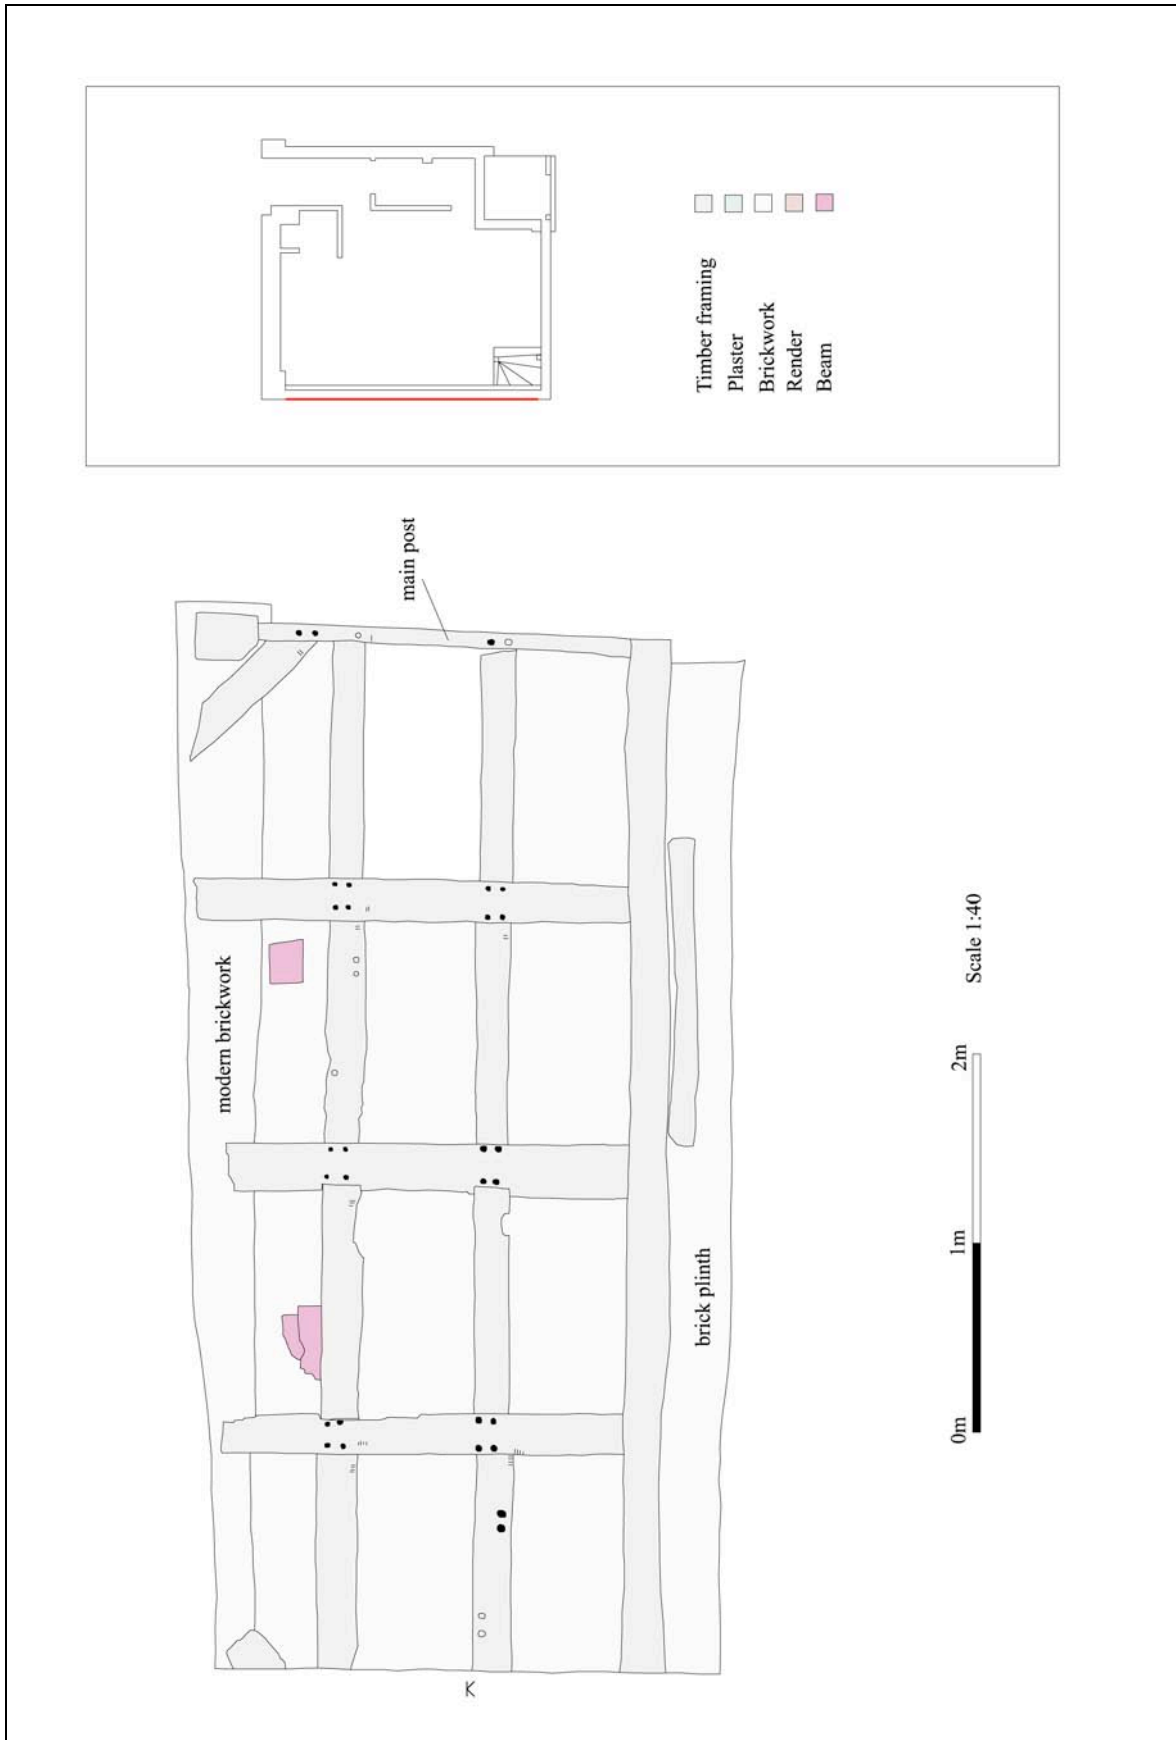
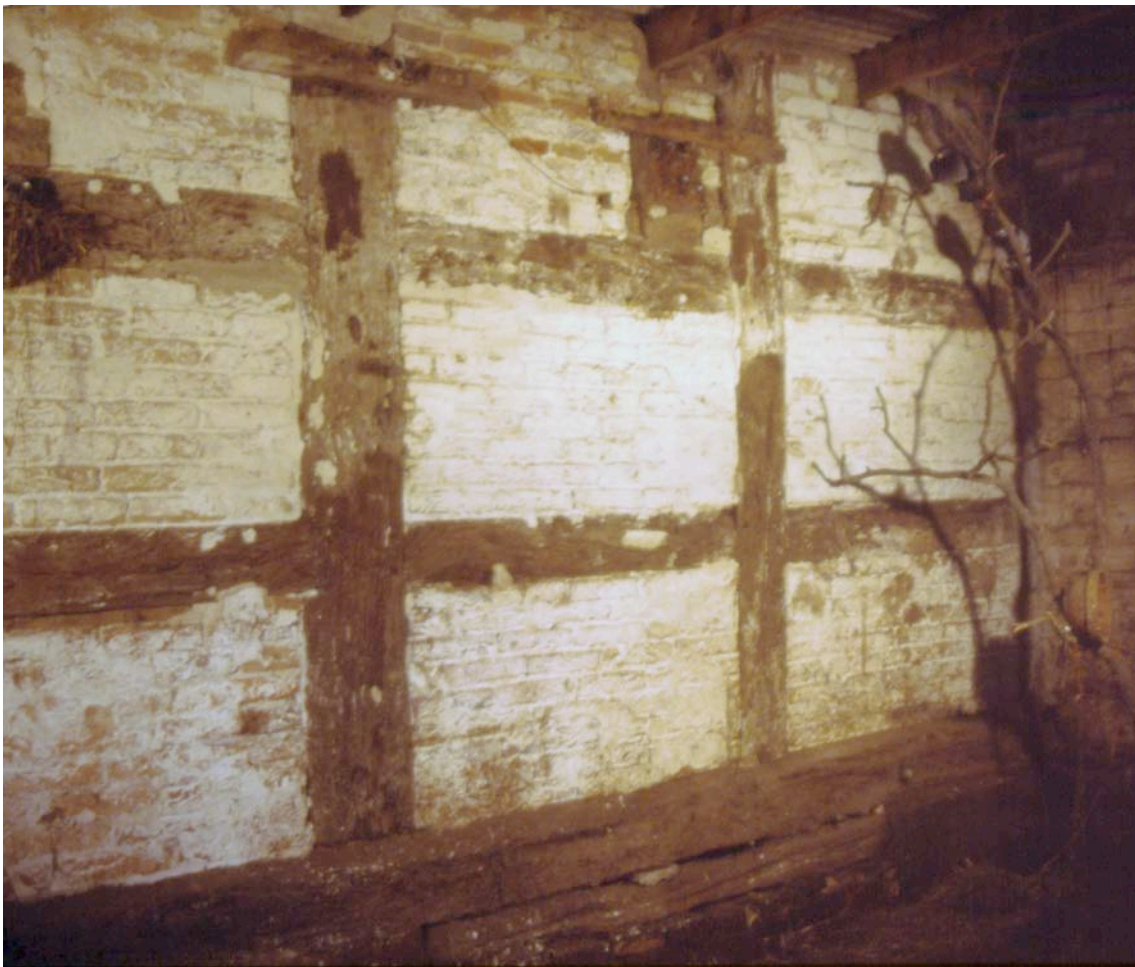
Figure 2: West Wall, External Elevation

This elevation currently provides the best view of the timber frame. The assembly marks could be seen in several places and the lower portions of the angle braces could be seen towards the existing roof level. The sill beam was in a poor state and sits upon a heavily damaged beam, which may indicate a double sill arrangement. It is possible that this arrangement was necessary to overcome the natural slope in the ground at this end of the building. Such a slope would have been advantageous for drainage should this end of the building been used for livestock.

The frame had a brick infill and was supported on a brick plinth. The brickwork, which probably dates to the early 19th century, was red brick set in a lime mortar and was constructed from 9 x 4 x 2 inch bricks and was bonded in stretcher bond with occasional headers. The brickwork had been limewashed and subsequently rendered, most of the render had peeled away from the brickwork. Modern brickwork could be seen in the upper courses, probably dating to the removal of the first floor and subsequent re-roofing.

Unusually the upper face of the main post at the north end of the west elevation had an empty mortice, which would suggest that the building continued west in some form although nothing similar was recorded in the main post at the south.

The rails were in a fairly poor state but some of the assembly marks (approx 50%) were noted. There were several peg holes indicating empty mortices. It is not clear, due to the brick infill, if these peg holes represent the positions of studs or braces within the frame. It is, however, possible that the damage to the rails had removed further peg holes in some places thus concealing evidence of possible other timber framing elements.

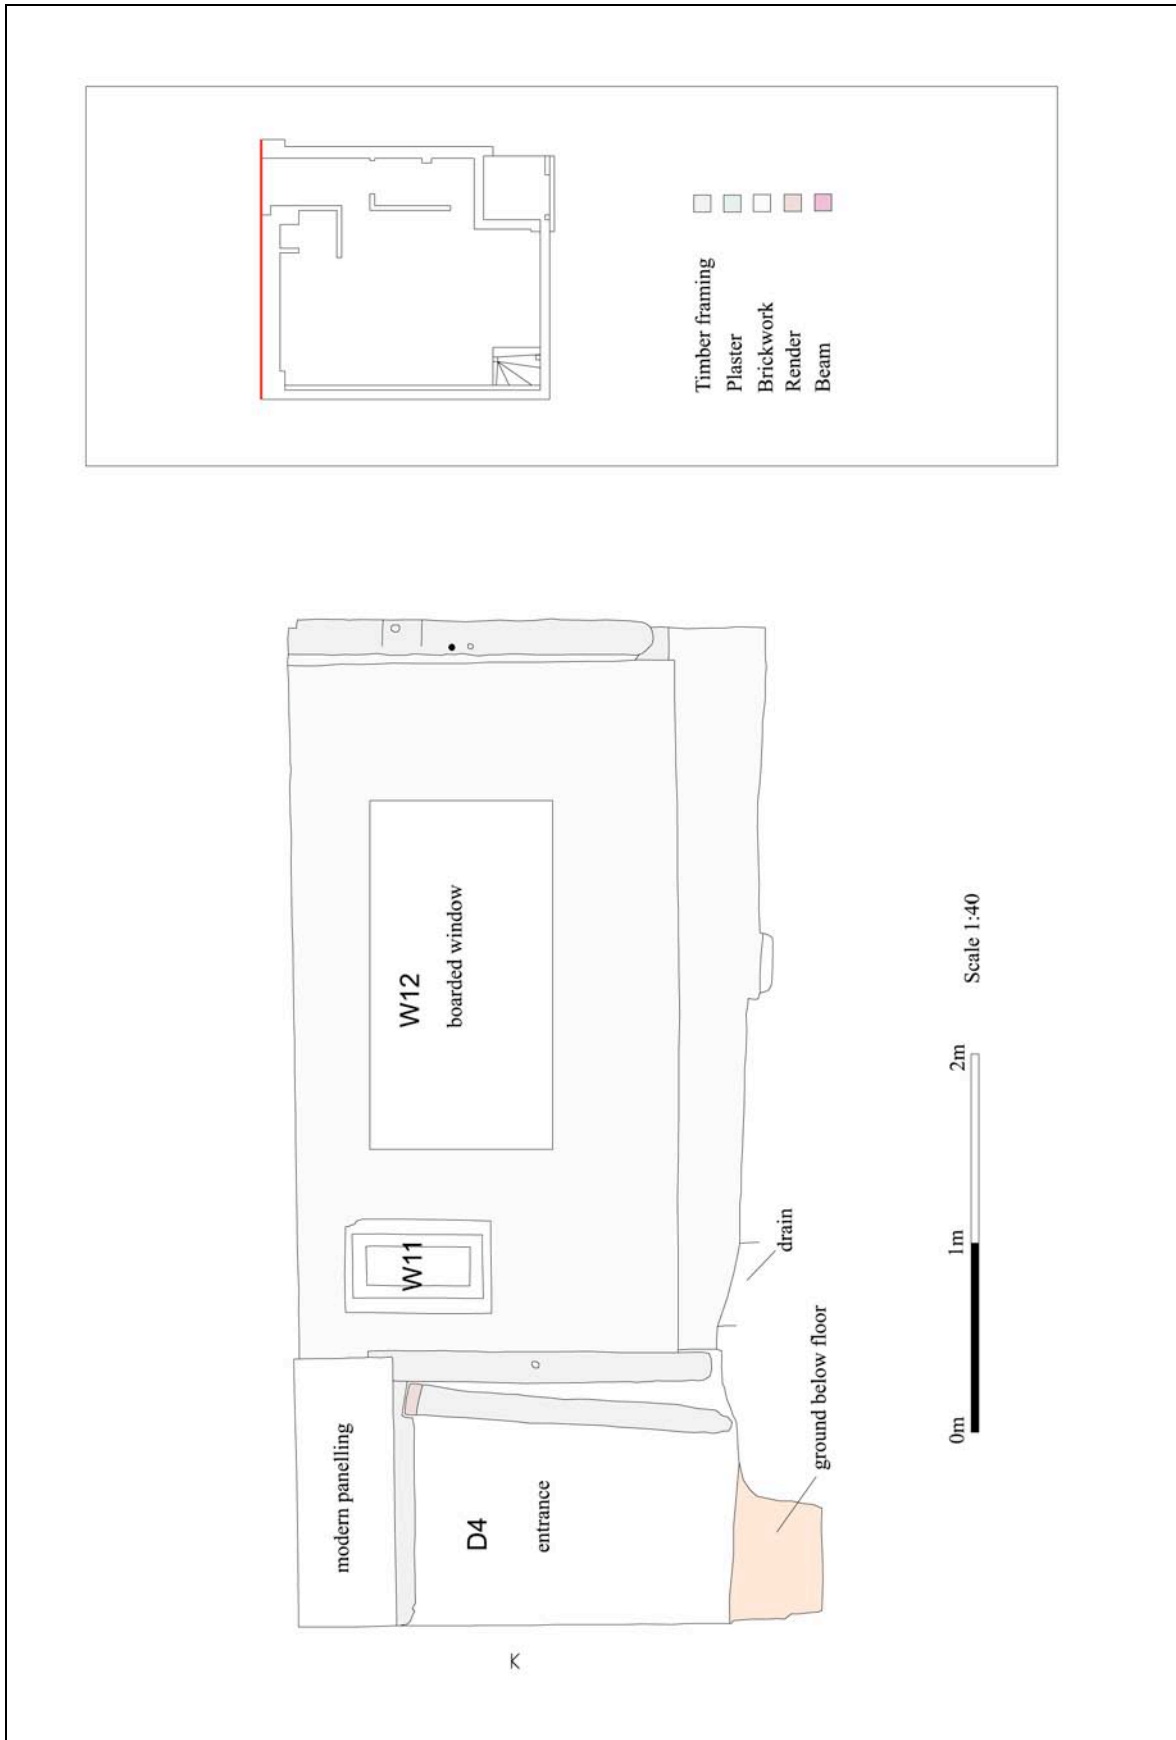
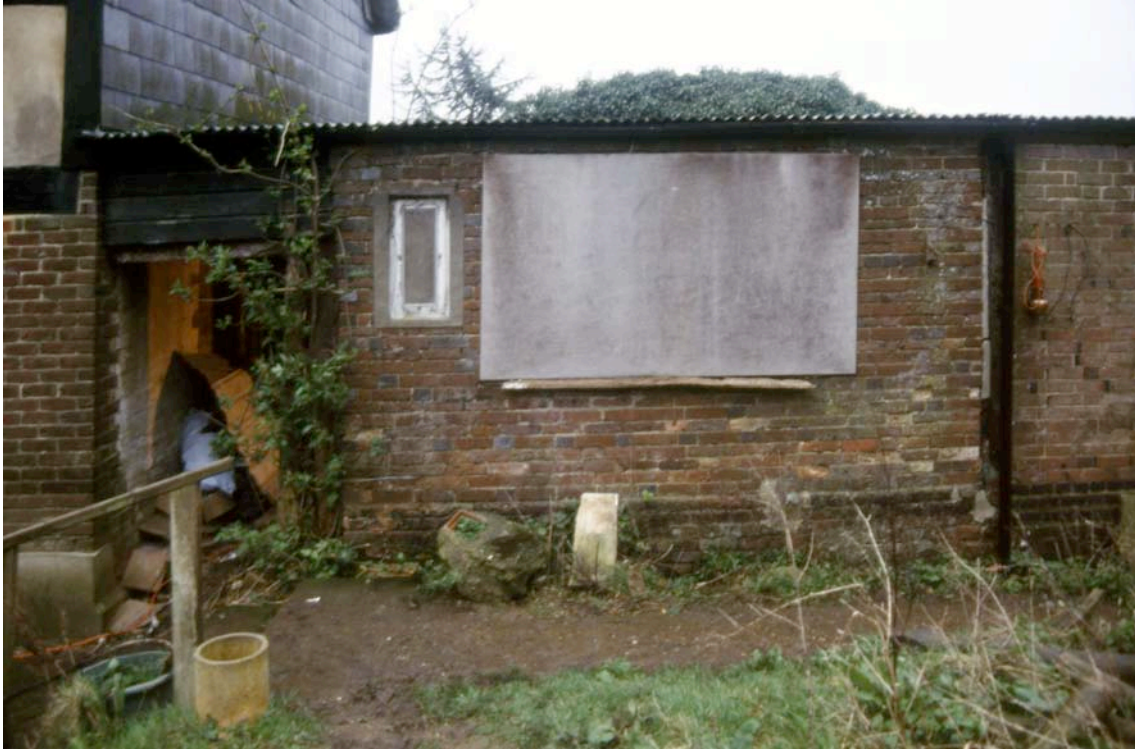
Figure 3: North Wall, External Elevation

The elevation was constructed mainly of rendered brick and had a brick plinth. A main post at the west end and elements of a post and doorway [D4] are all that remained of the timber framing in this elevation. The door frame had evidently deteriorated since the Vernacular Building Survey, the remaining door jamb now leaning at a slight angle. The head of the door frame remained but was in very poor condition. The post supporting the door frame had a peg hole indicating the position of a cross rail. The main post is in poor condition and the depth of the mortice (see west external) was not clear due to the damage. Peg holes for a cross rail remained in this post. The area above the door was clad in modern tongue and grooved panels. The tiling at the door entrance was partly damaged. The main window [W12] had been completely boarded over (see internal details). A small rectangular metal window [W11] was seen between the doorway and the larger window.

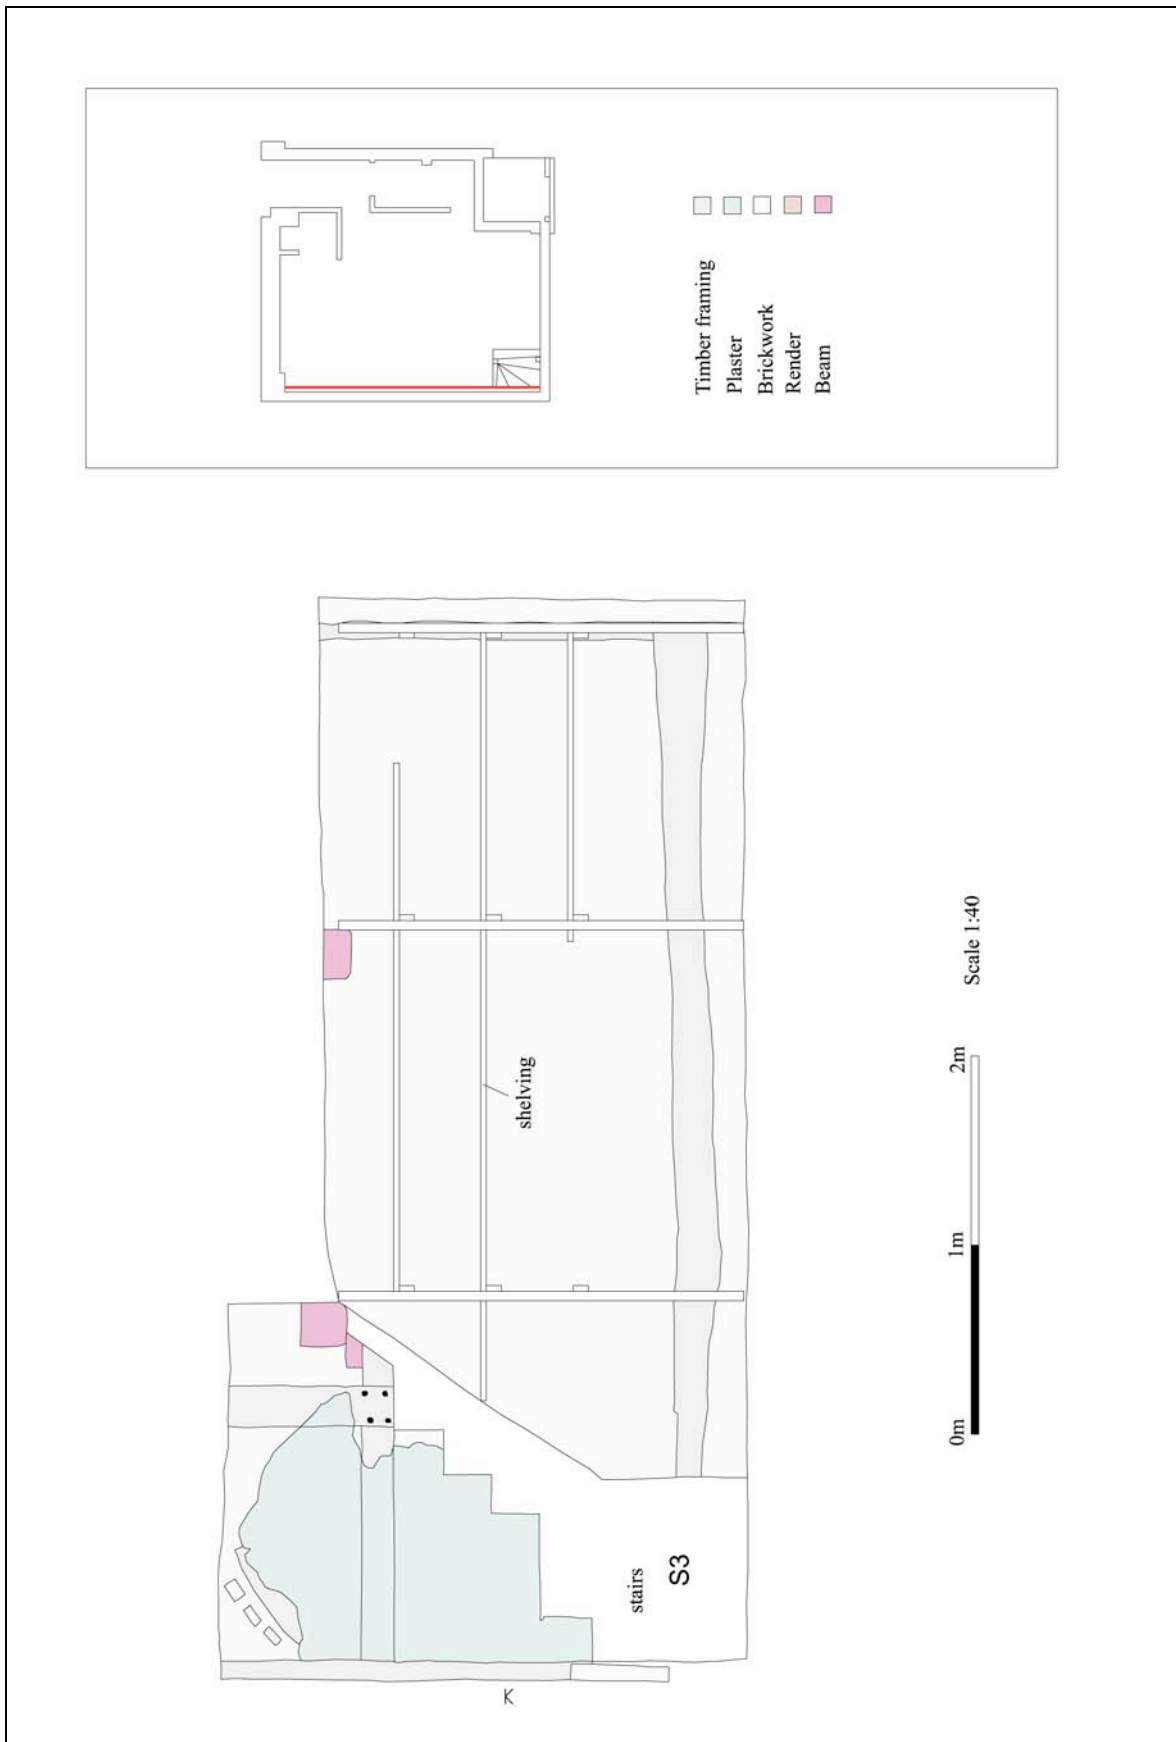
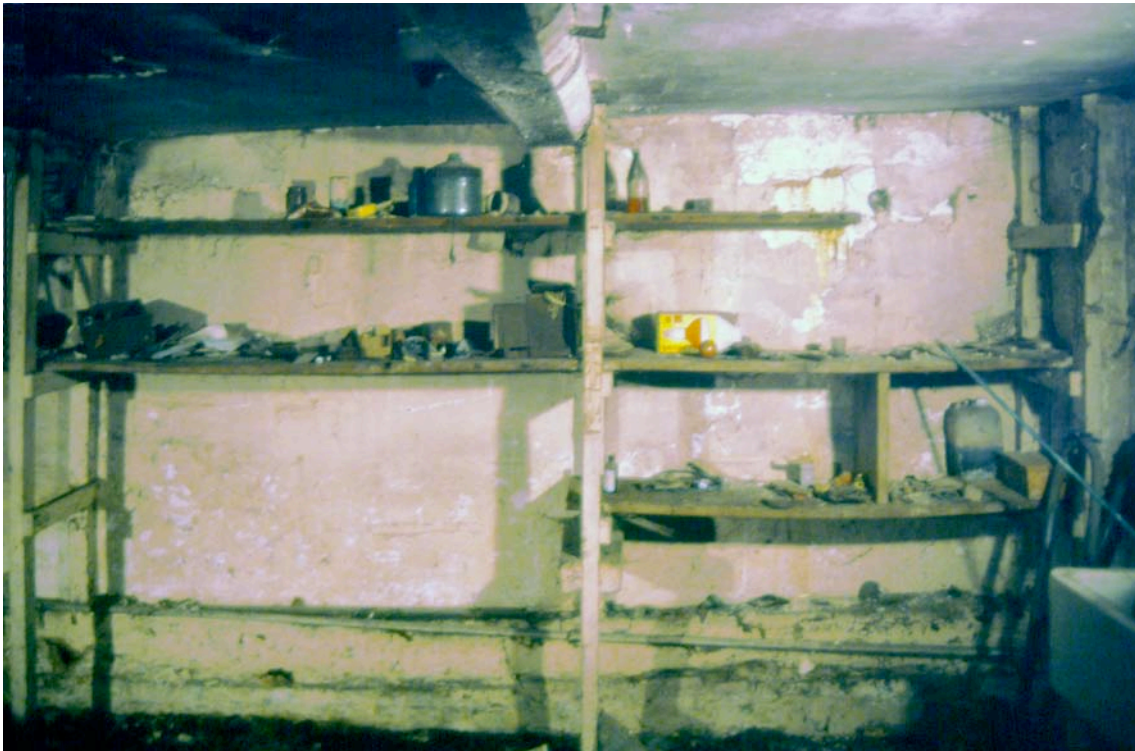
Figure 4: West Wall, Internal Elevation

The internal elevation of the west wall contains a later staircase [S3] and is lined with shelving. The staircase was accessed through a beaded T&G plank door on ledge and braces [D15]. The door had strap hinges and a thumb latch. The staircase rises to the replaced first floor from a quarter turn. The stair risers were 0.24 m (9 in) in height and the treads were 0.22 m (8 in) deep and both were constructed of softwood. Behind the staircase door damage to the render revealed part of the timber framing (though this is seen better on the external face). The under stairs are backed with lath and plaster.

The wall was lined with roughly constructed shelving (Plate 6). Although the tenant Mr Galpin has indicated that these shelves were used for the storage of cheese, the building surveyors found them to contain a mixture of poisons, motor spares and light bulbs.

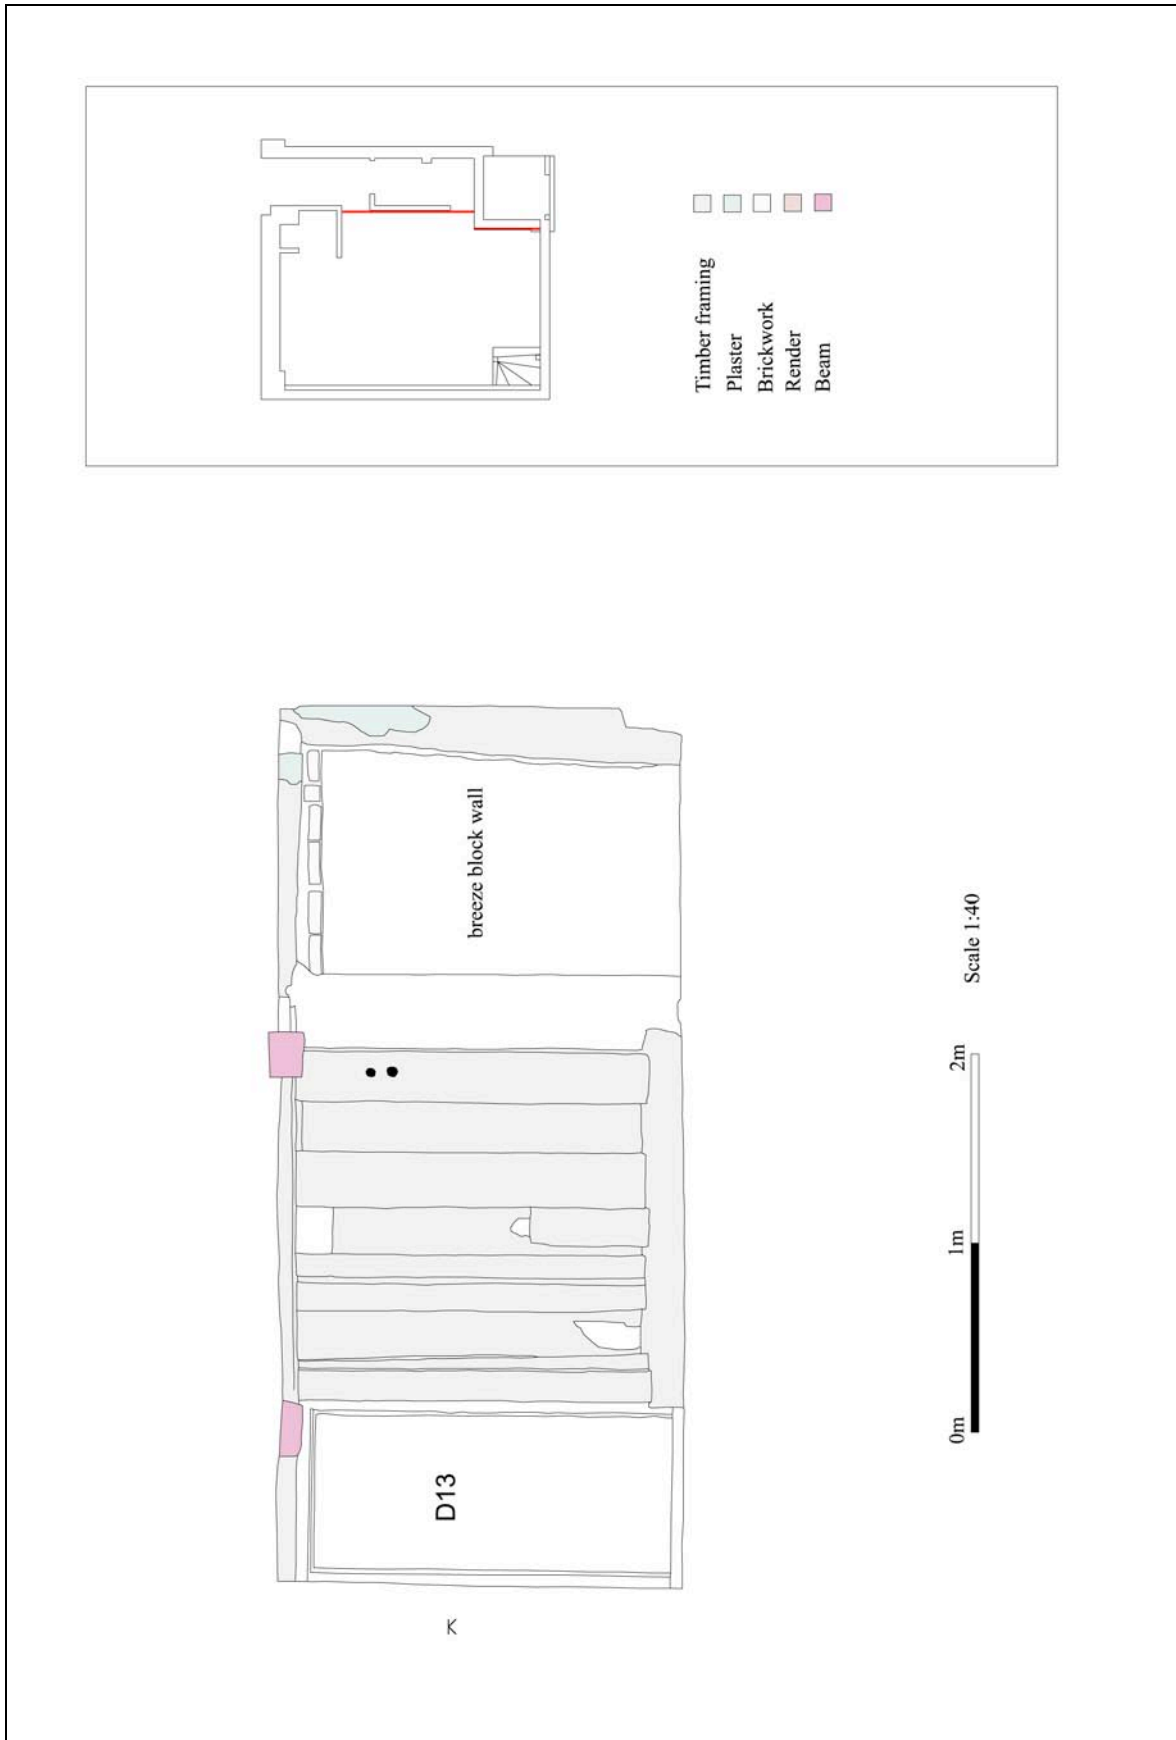
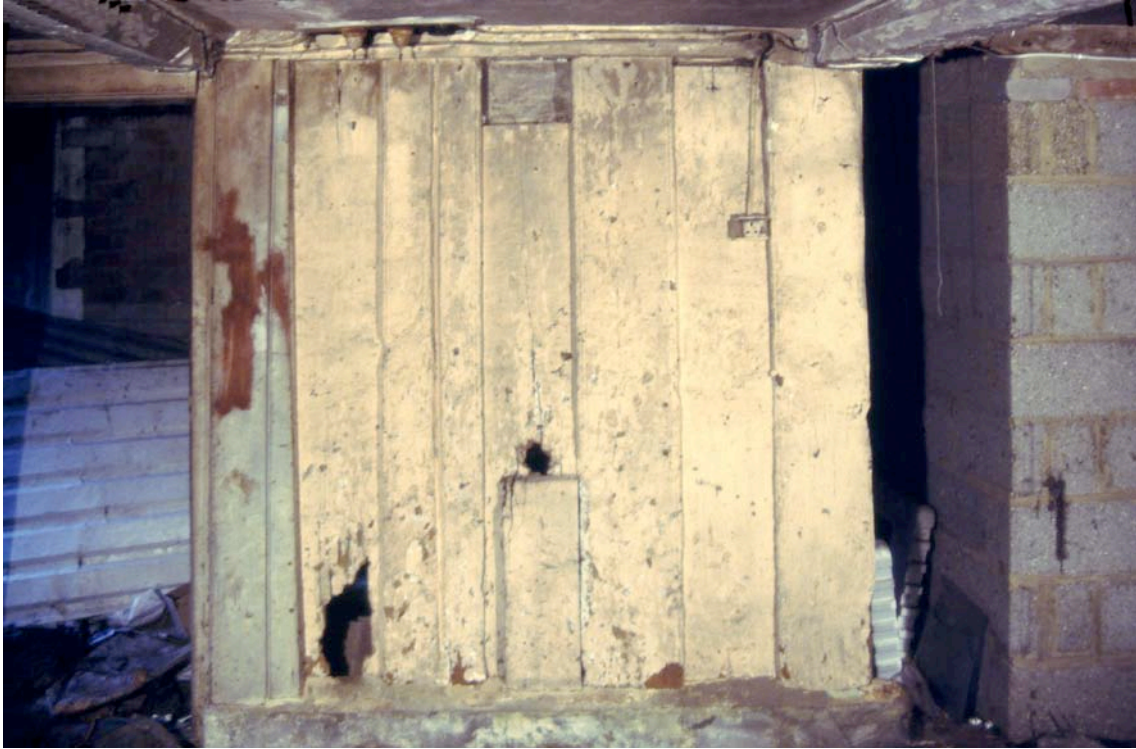
Figure 5: Plank and Muntin Screen, Internal Elevation

A plank and muntin screen survived within the service room. Such a screen is a rare survival, especially given the condition of this part of the building. The screen was not without damage;

there were some areas of damage toward the foot of the screen and a square opening at the top of the screen, which was covered by a metal grille. The full extent of the screen is uncertain; it may have extended to the south wall. An empty mortice approximately 0.3 m to the south of the current end of the screen would seem to indicate the presence of a post and by association the possible position of a door. The screen was constructed from 10" planks in a grooved tie beam. The planks were pegged into the top. The sill of the screen is hidden by render.

The service room is insecure and has open access, which might pose a threat to the plank and muntin screen within it.

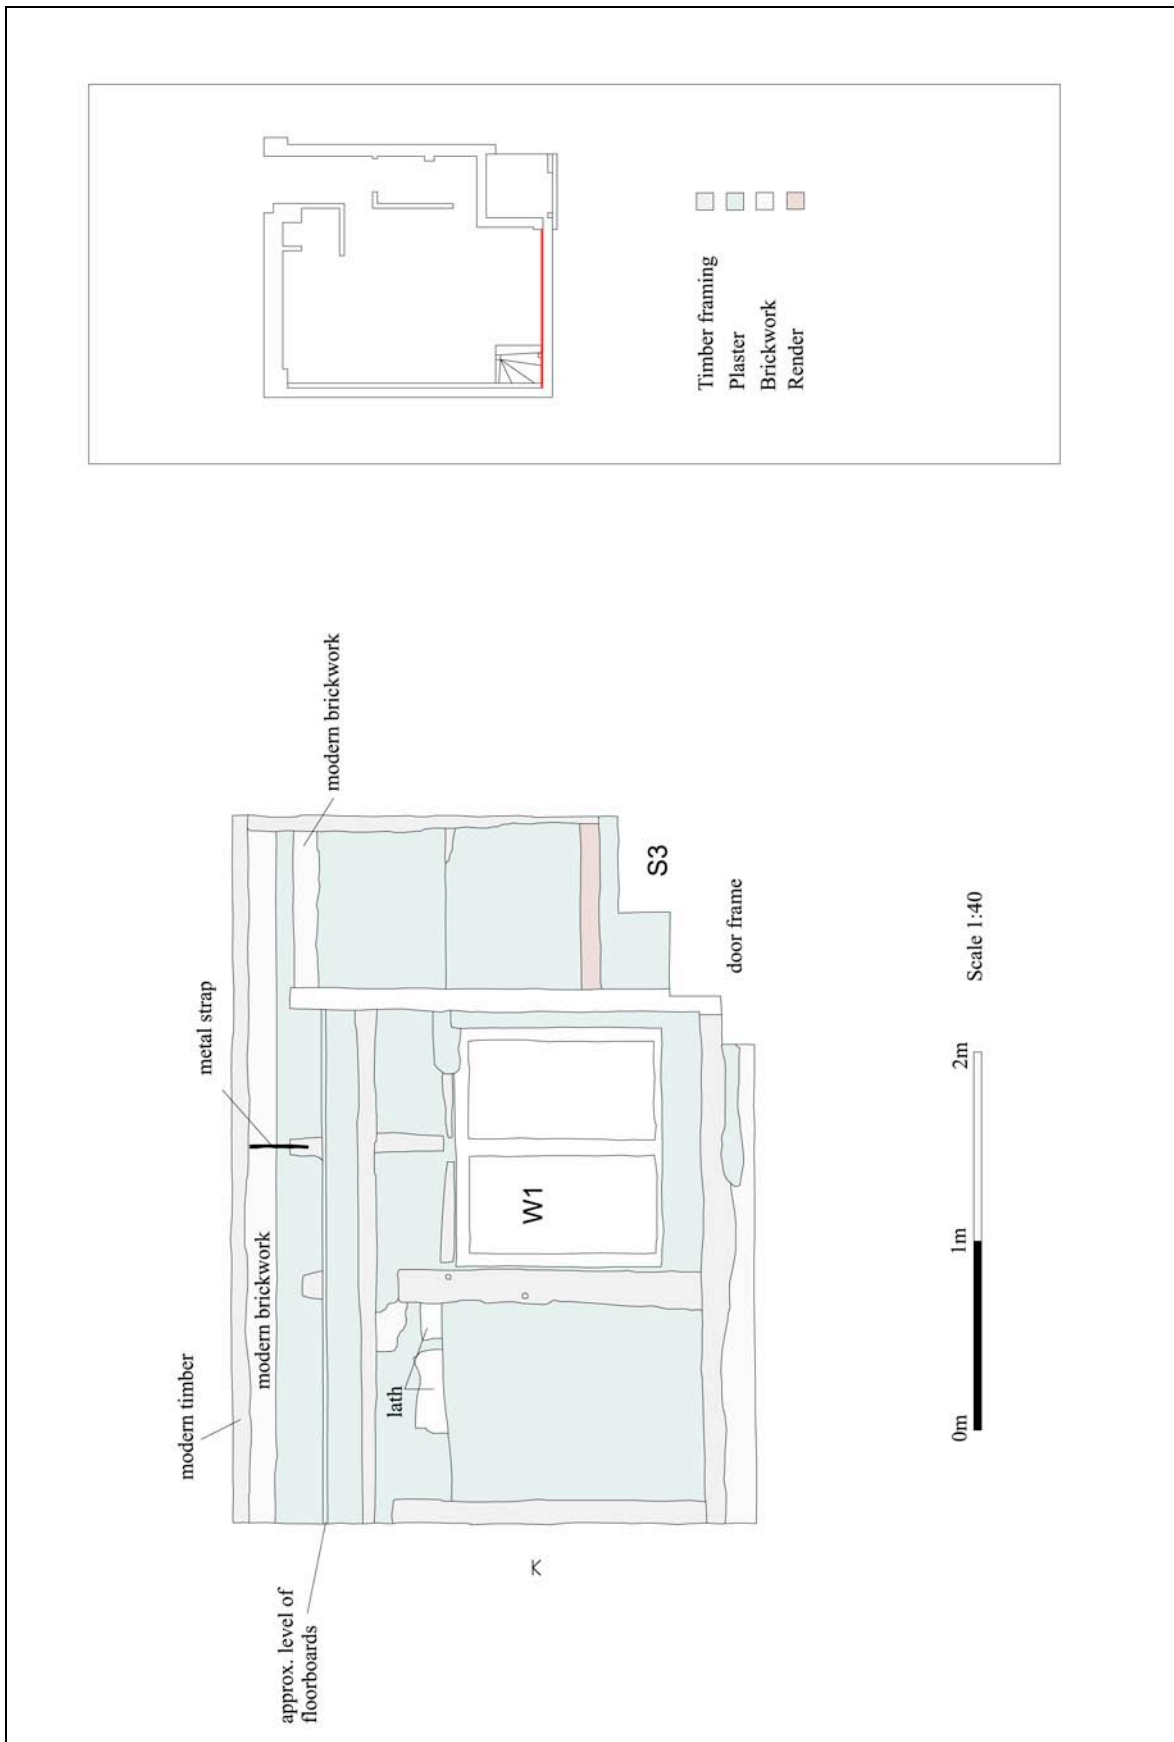
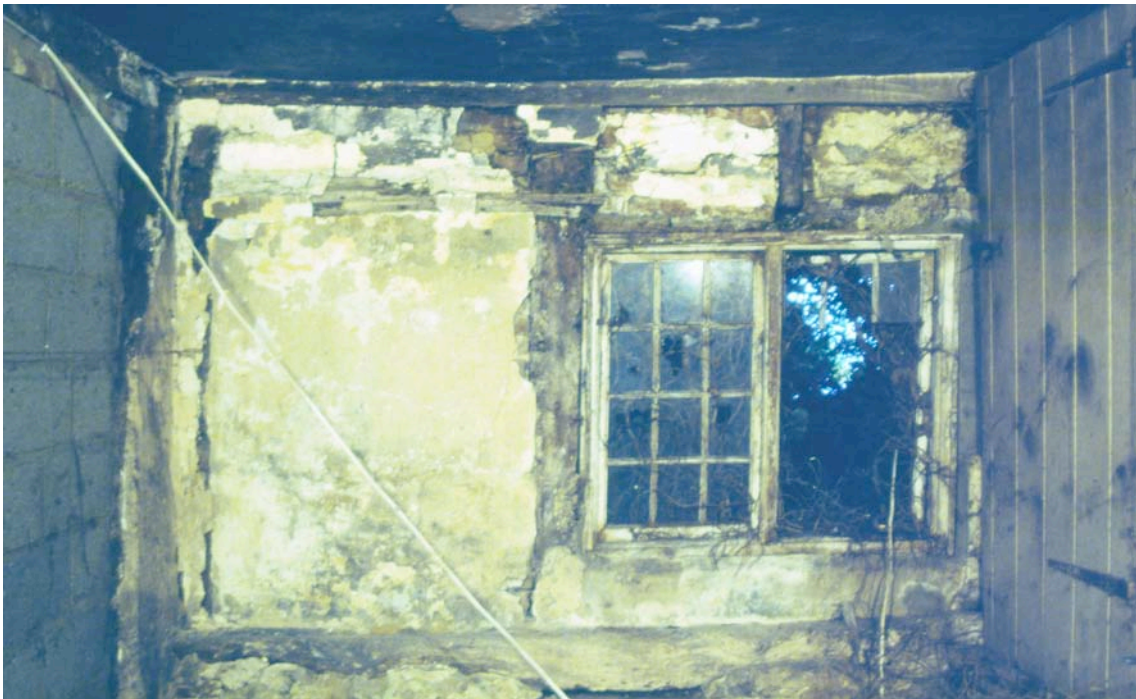
Figure 6: South Wall, Internal Elevation

The elevation was basically timber framed with a lath and plaster infill. There were also areas of render and brickwork. The main post at the east end could be observed beneath peeling plaster and render. The sill beam could also be seen but was in poor condition. The sill sat on a brick plinth. Another post to the west of the main post could be seen with empty peg holes, a possible indication of cross rails. A stud and rail above the current window may have been an indication of an earlier window. Some small areas of lath and plaster were exposed on this elevation.

A cross rail was identified 1.68 m above the sill. Evidence of another rail could also be seen at the west end of the elevation where a rendered main post was also identified.

The wall had a two light window [W1] with 12 panes per light. The window had ovolo glazing bars, which were largely missing in one of the lights. The window had been badly damaged and was overgrown on entry to the site.

The elevation had been replaced above first floor level with modern brickwork and new wall plate appeared to have been added.

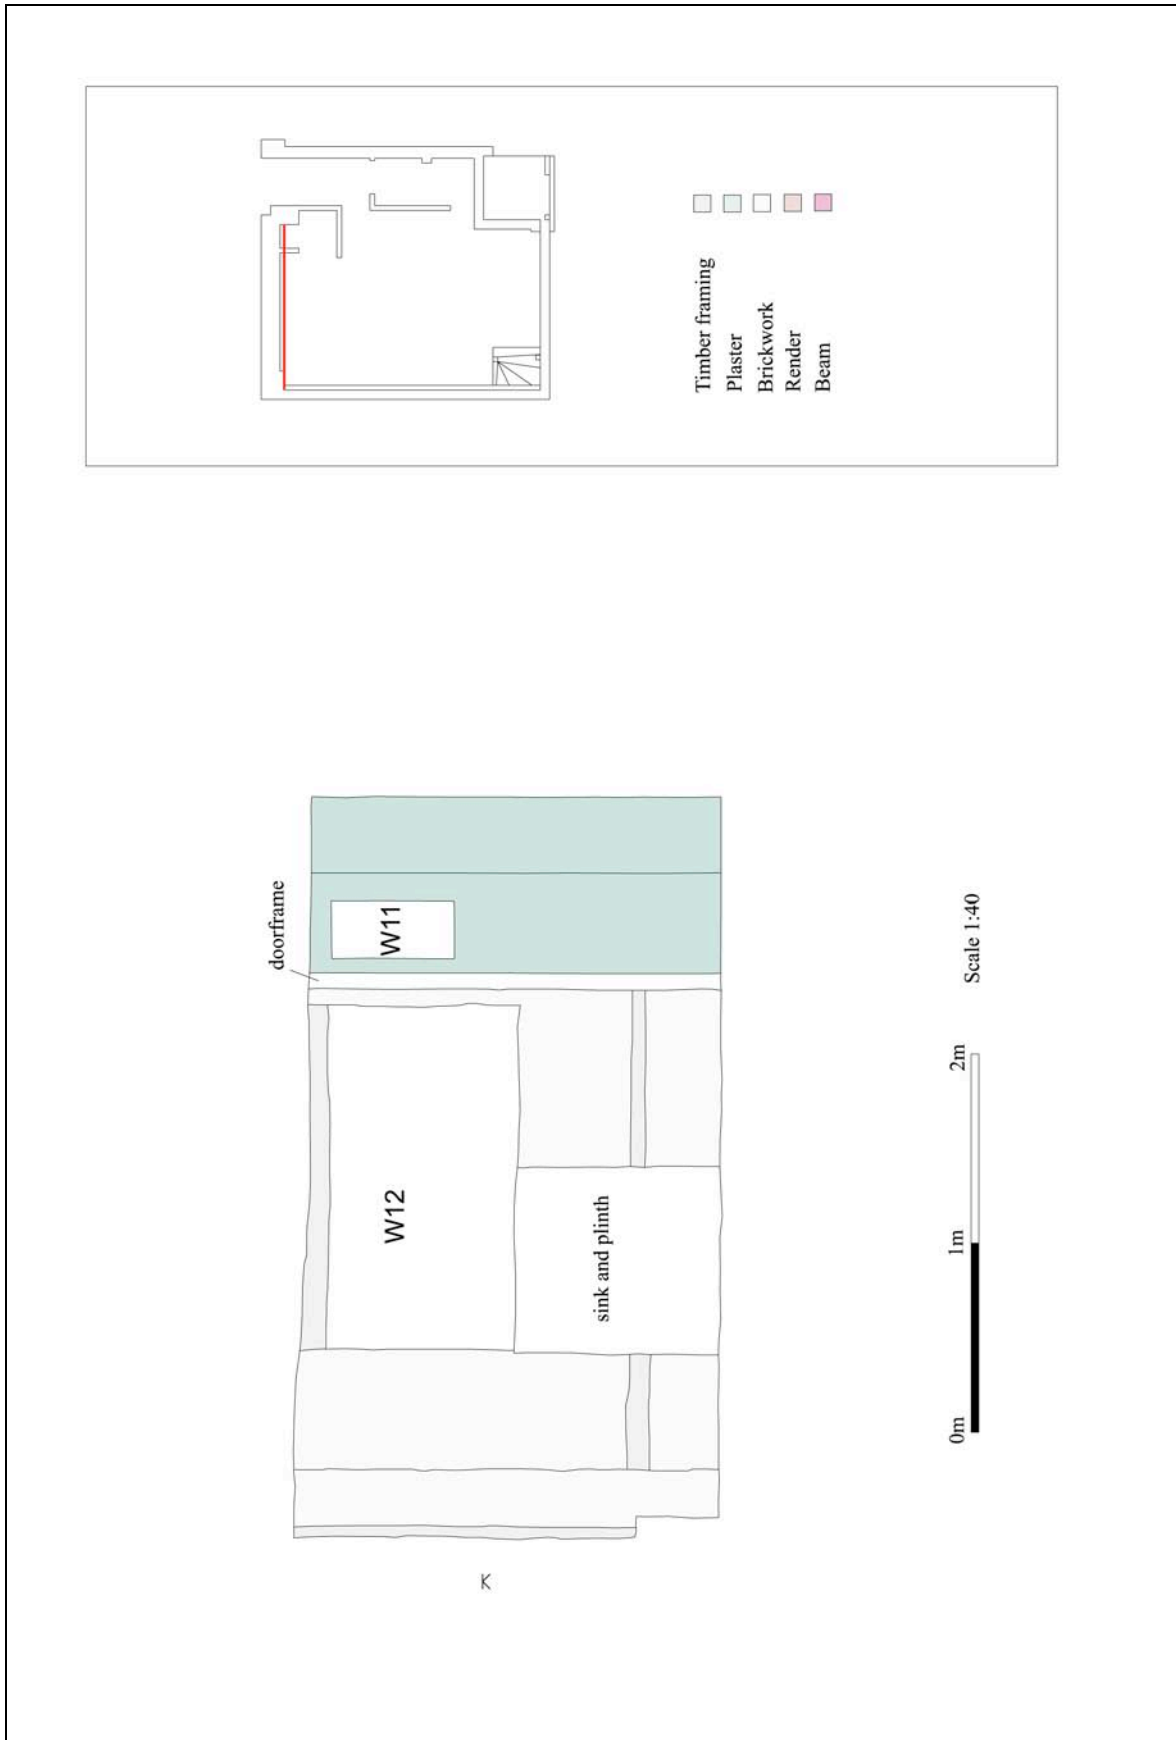
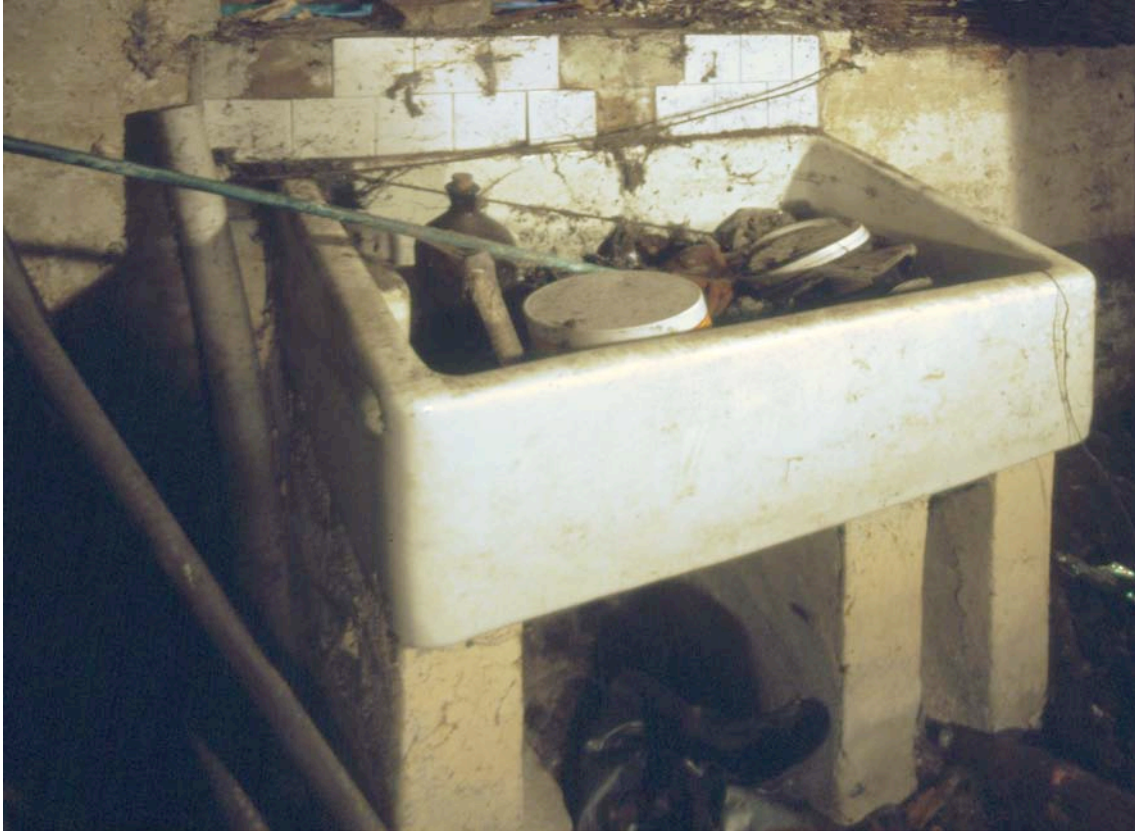
Figure 7: North Wall, Internal Elevation

The elevation was constructed from brick. The north wall window [W12] was boarded over externally and very little remained when the building recording was undertaken. The Vernacular Building Survey describes the window as a three light window with central casement, four panes per light. The window had a wide cambered brick arch with wooden infill under. At the time of the Vernacular Building Survey the window had two arched T&G plank wooden shutters. The north wall was rendered over and little can be seen of the original building. At the head of the large window in the position of a lintel could be seen a damaged timber beam. This may have been a rail belonging to the original timber frame.

A large white butler sink sat beneath the remains of the window (Plate 8). A narrow modern casement window [W11] was at the east of the elevation.

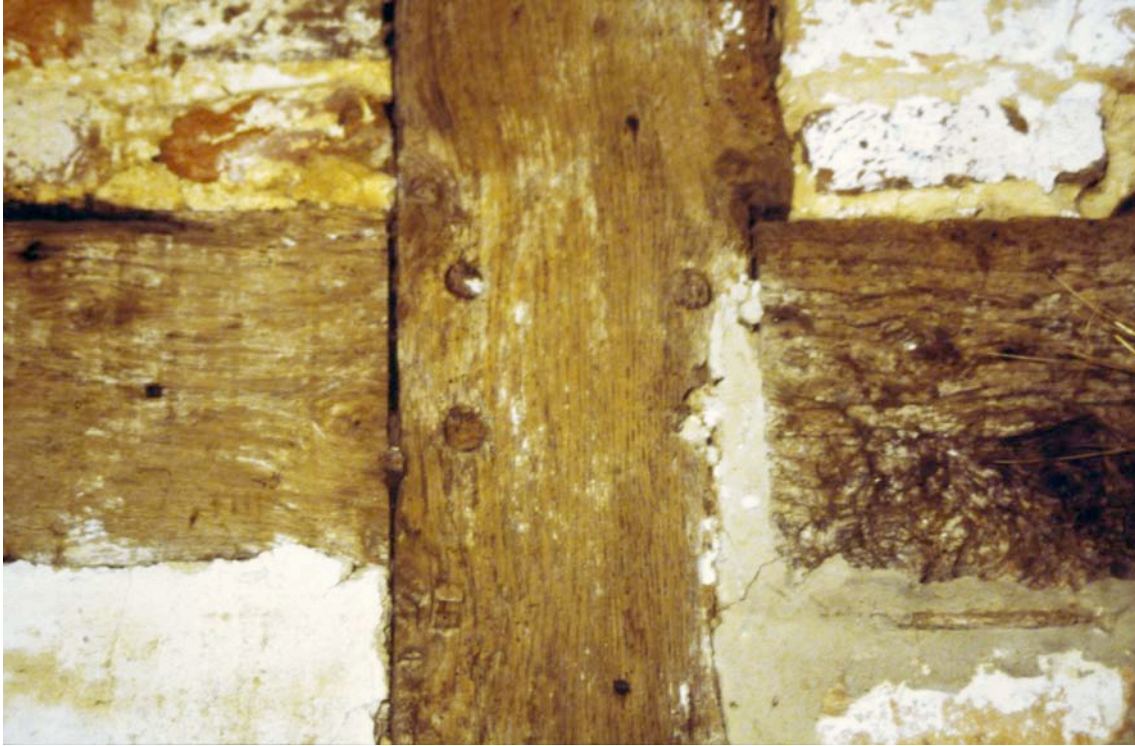
Plate 3: Detail of timber framing of west external elevation showing assembly marks.

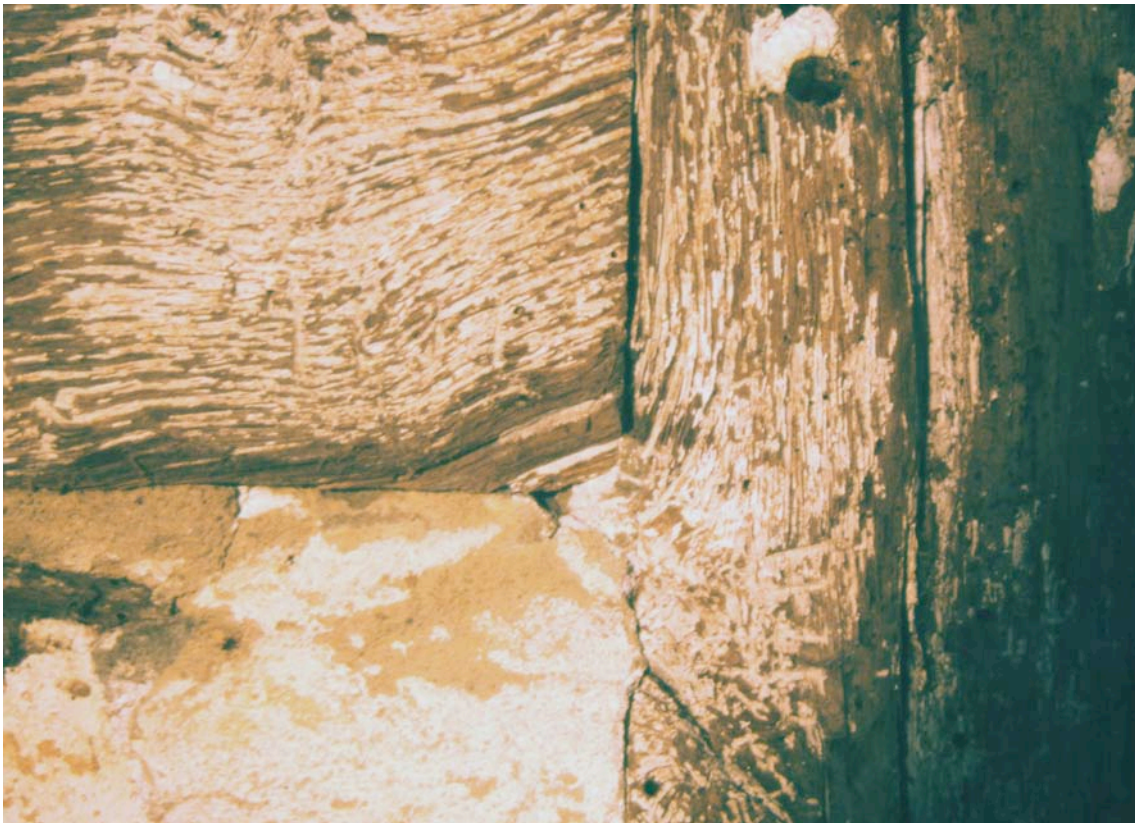
Plate 4: Detail of timber framing of west external elevation showing assembly marks

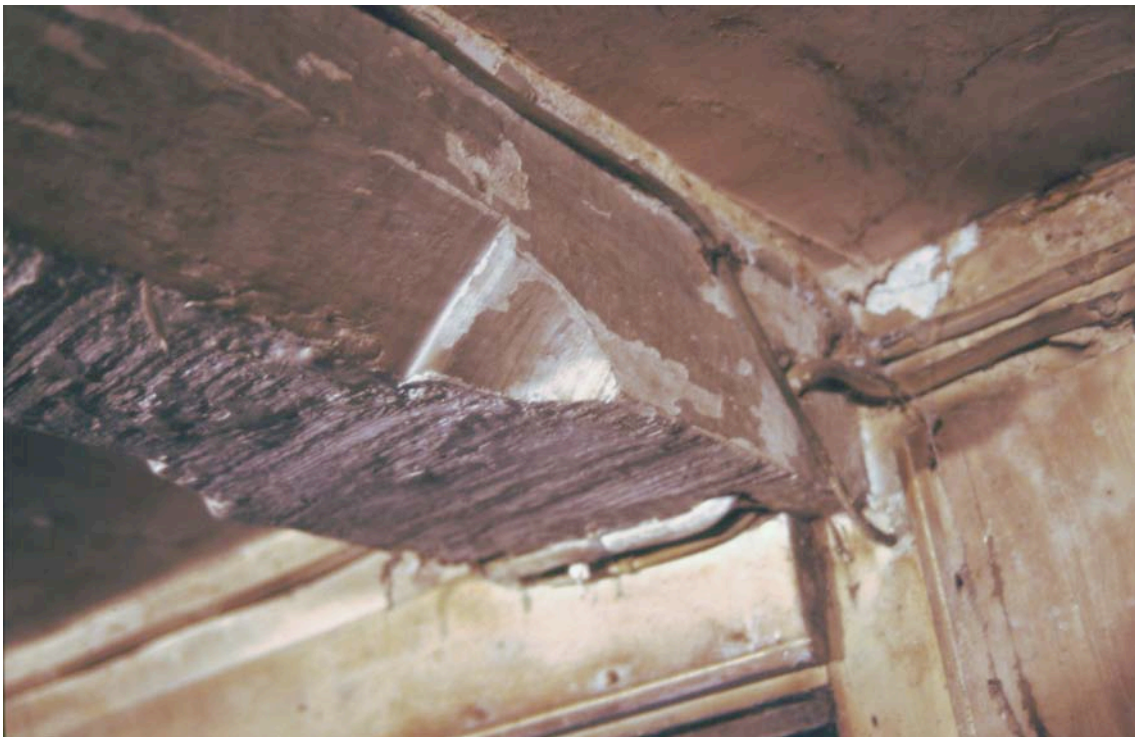
Plate 10: Detail of ceiling beam.

The ceiling was supported by two axial beams support the ceiling. For a variety of reasons these beams are of interest. They have almost certainly been moved from their original position. The beams are chamfered and have quirk and tongue chamfer stops. One of the beams had recesses cut for two studs on its north face, suggesting a partition. As the beams had been moved the position of the partition cannot be accurately identified. The upper faces of the beams could not be seen and joist positions were not identified. One beam had been cut so that it butted the plank and muntin screen (Plate 9).
