A1 Dishforth to north of Leeming Improvements, North Yorkshire

Cultural Heritage

Detailed Survey of the Built Heritage

Report No: 1584/12

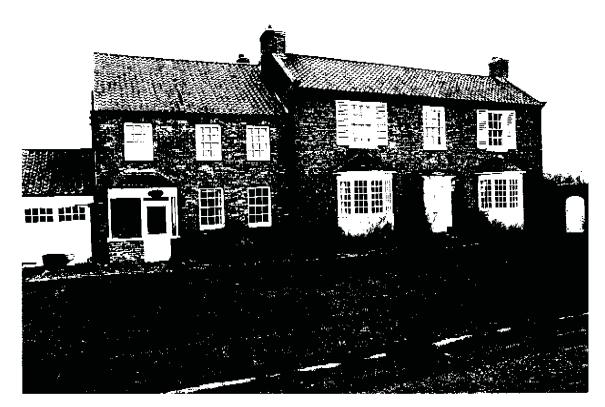
3.1.9 As its name suggests, Georgian House almost certainly dates from the mid 18th century and is a medium-sized house of some quality (plate 1). It is of double depth with a central stairhall plan (figure 5), with a symmetrical facade to the west (figure 6). This elevation faces west across a short garden towards the access road representing the original line of the A1. On its north side, Georgian House adjoins New Inn Farmhouse. The present New Inn Farmhouse dates from 1937, and is a rebuilding of an earlier house, according to the present occupier of New Inn Farmhouse (pers comm, M Trewhitt).

Plate 1. Georgian House and New Inn Farmhouse, from the west

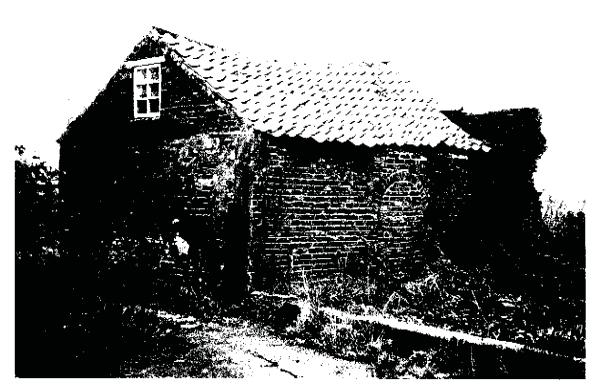
- 3.1.30 A second, detached outbuilding lies to the east, aligned east-west, measuring 5.2m by 4.2m (plate 2). The north, west and south walls are built of hand-made bricks but the east wall is of rubble to eaves height, with brick above; the roof is of pantiles. This building appears to date from the 18th or early 19th century and contains evidence for a number of alterations including the blocking.

Plate 2. Loosebox to the rear of Georgian House, from the south

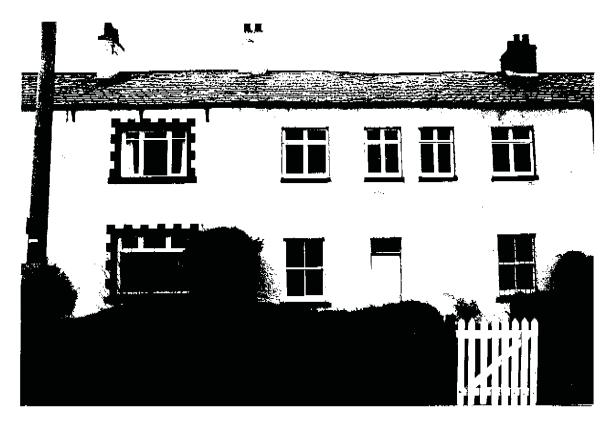
Plate 3. No 1 Hopetown Terrace (bay 4) from the west

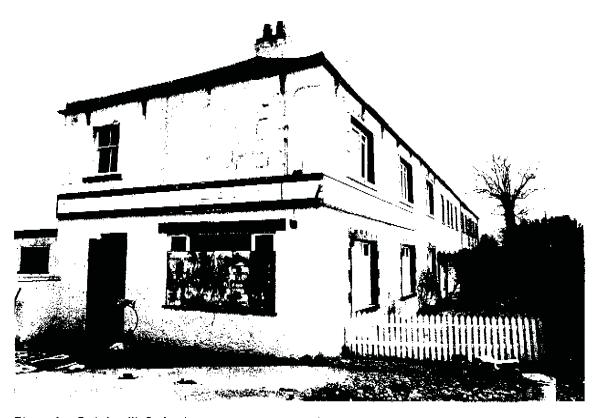
- 3.2.10 The north end wall of the terrace, which is 7.5m long, is also pebble-dashed, and contains a large window (probably inserted) and doorway containing a modern glazed door to the ground floor, with a small window over (see plate 4).

Plate 4. Quickgrill Cafe, Hopetown Terrace from the north

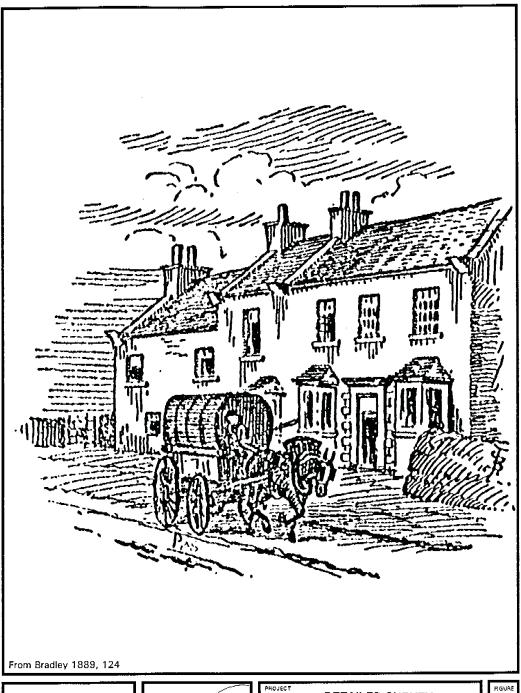
4

- 3.1.7 A late 19th century illustration of the building from the south-west (see figure 4) shows Georgian House largely as it is seen today, with a fourth bay to the north, and a lower two-storey building adjoining beyond, flush with the face of the main building. The illustration is titled "The New Inn, Leeming Lane" and it is recorded that this inn was the principal of two such coaching inns at Hopetown, but had been converted into a farmstead. In its days as a coaching inn it had served the Telegraph, Leeds and Newcastle coach, among others; for much of this time it was in the hands of the Caldwell family⁴.

- 3.1.33 The illustration of 1889 (figure 4) suggests that Georgian House had a fourth bay to the north of the present end wall, although the exterior face of this elevation does not now appear to display any evidence for having been altered. The internal arrangements of the house, specifically the central passage running to the north, now occupied by a WC, suggest that it originally communicated with adjoining buildings. Presumably this would have provided accommodation for any servants and the innkeeper, as well as perhaps food preparation facilities.

LATE 19TH CENTURY
ILLUSTRATION OF GEORGIAN HOUSE
