Scott's Quay Structural Survey Report, 20th October 2012

Mark Smith CEng CEnv CWem mCIWEM

A condition survey of the quay wall was undertaken in August 2012. This report records the observed condition and makes recommendations for maintenance and reinstatement with associated cost estimates.

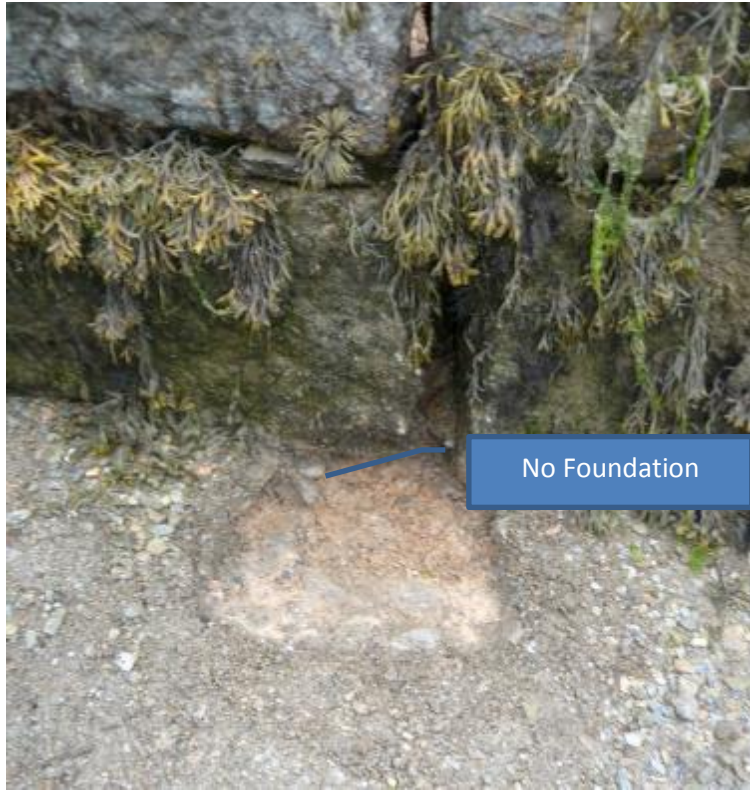
Image 1

No Foundation

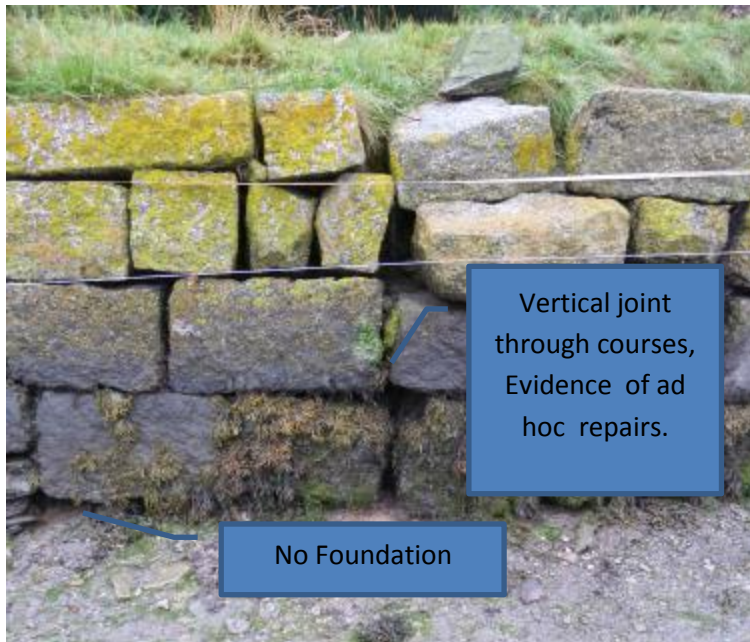
Image 2

Vertical joint
through courses,
Evidence of ad
hoc repairs.

No Foundation
