**Hemingby, St. Margaret's Church
Electricity Cable Trench
Beside the Churchyard Path**

Archaeological Watching Brief

Report prepared for East Midlands Electricity plc
by James Albone BSc PIFA.

LAS Report No. 314

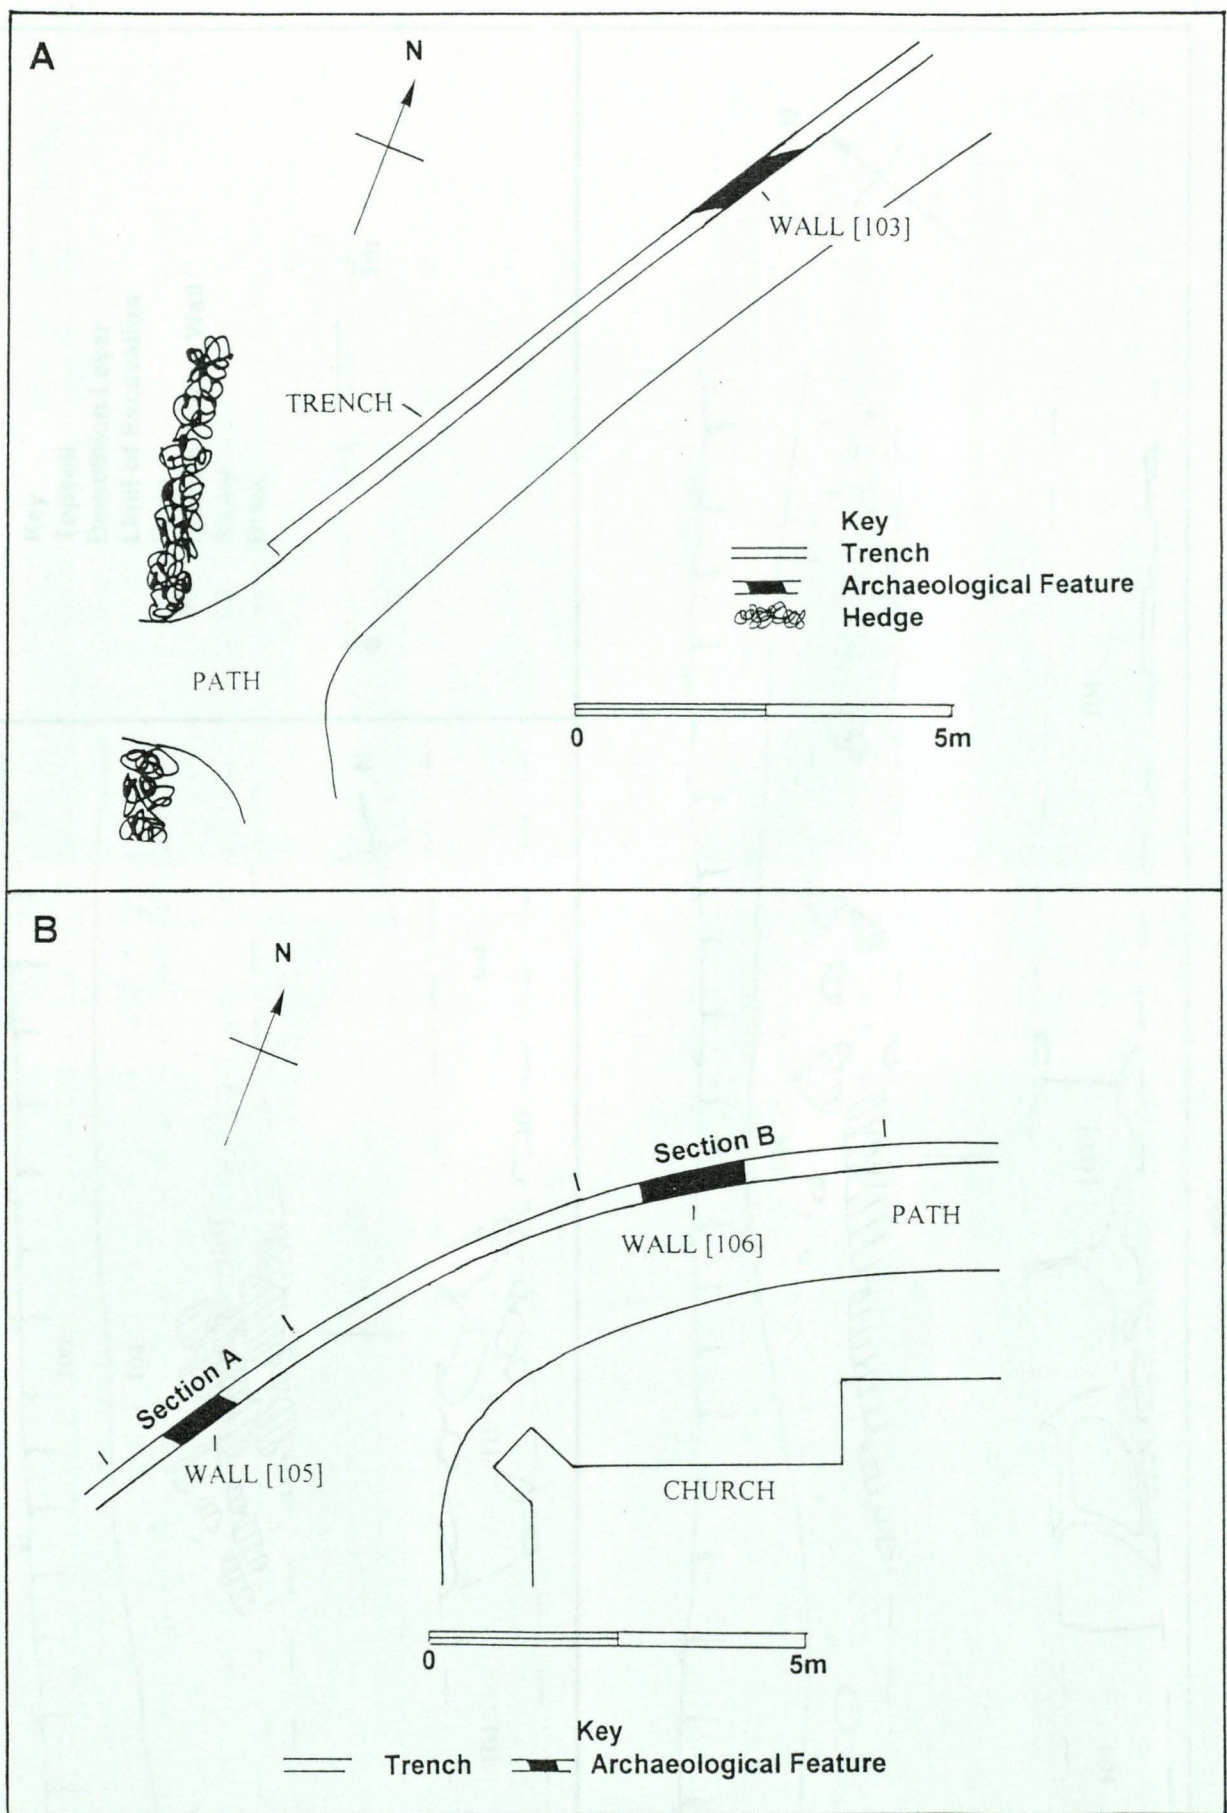
Wall **103** was very badly damaged by the mechanical excavator. It consisted of flint rubble and sandstone foundation although a block of dressed sandstone was present in the material removed from the trench. It appeared to be the foundations of a SW to NE aligned wall c.0.4m thick. Due to its poor preservation no section was drawn of this wall.

Fig. 3 Location of archaeological features in the cable trench. A: wall foundation 103; B: wall foundations 105 and 106 (McDaid after Albone).

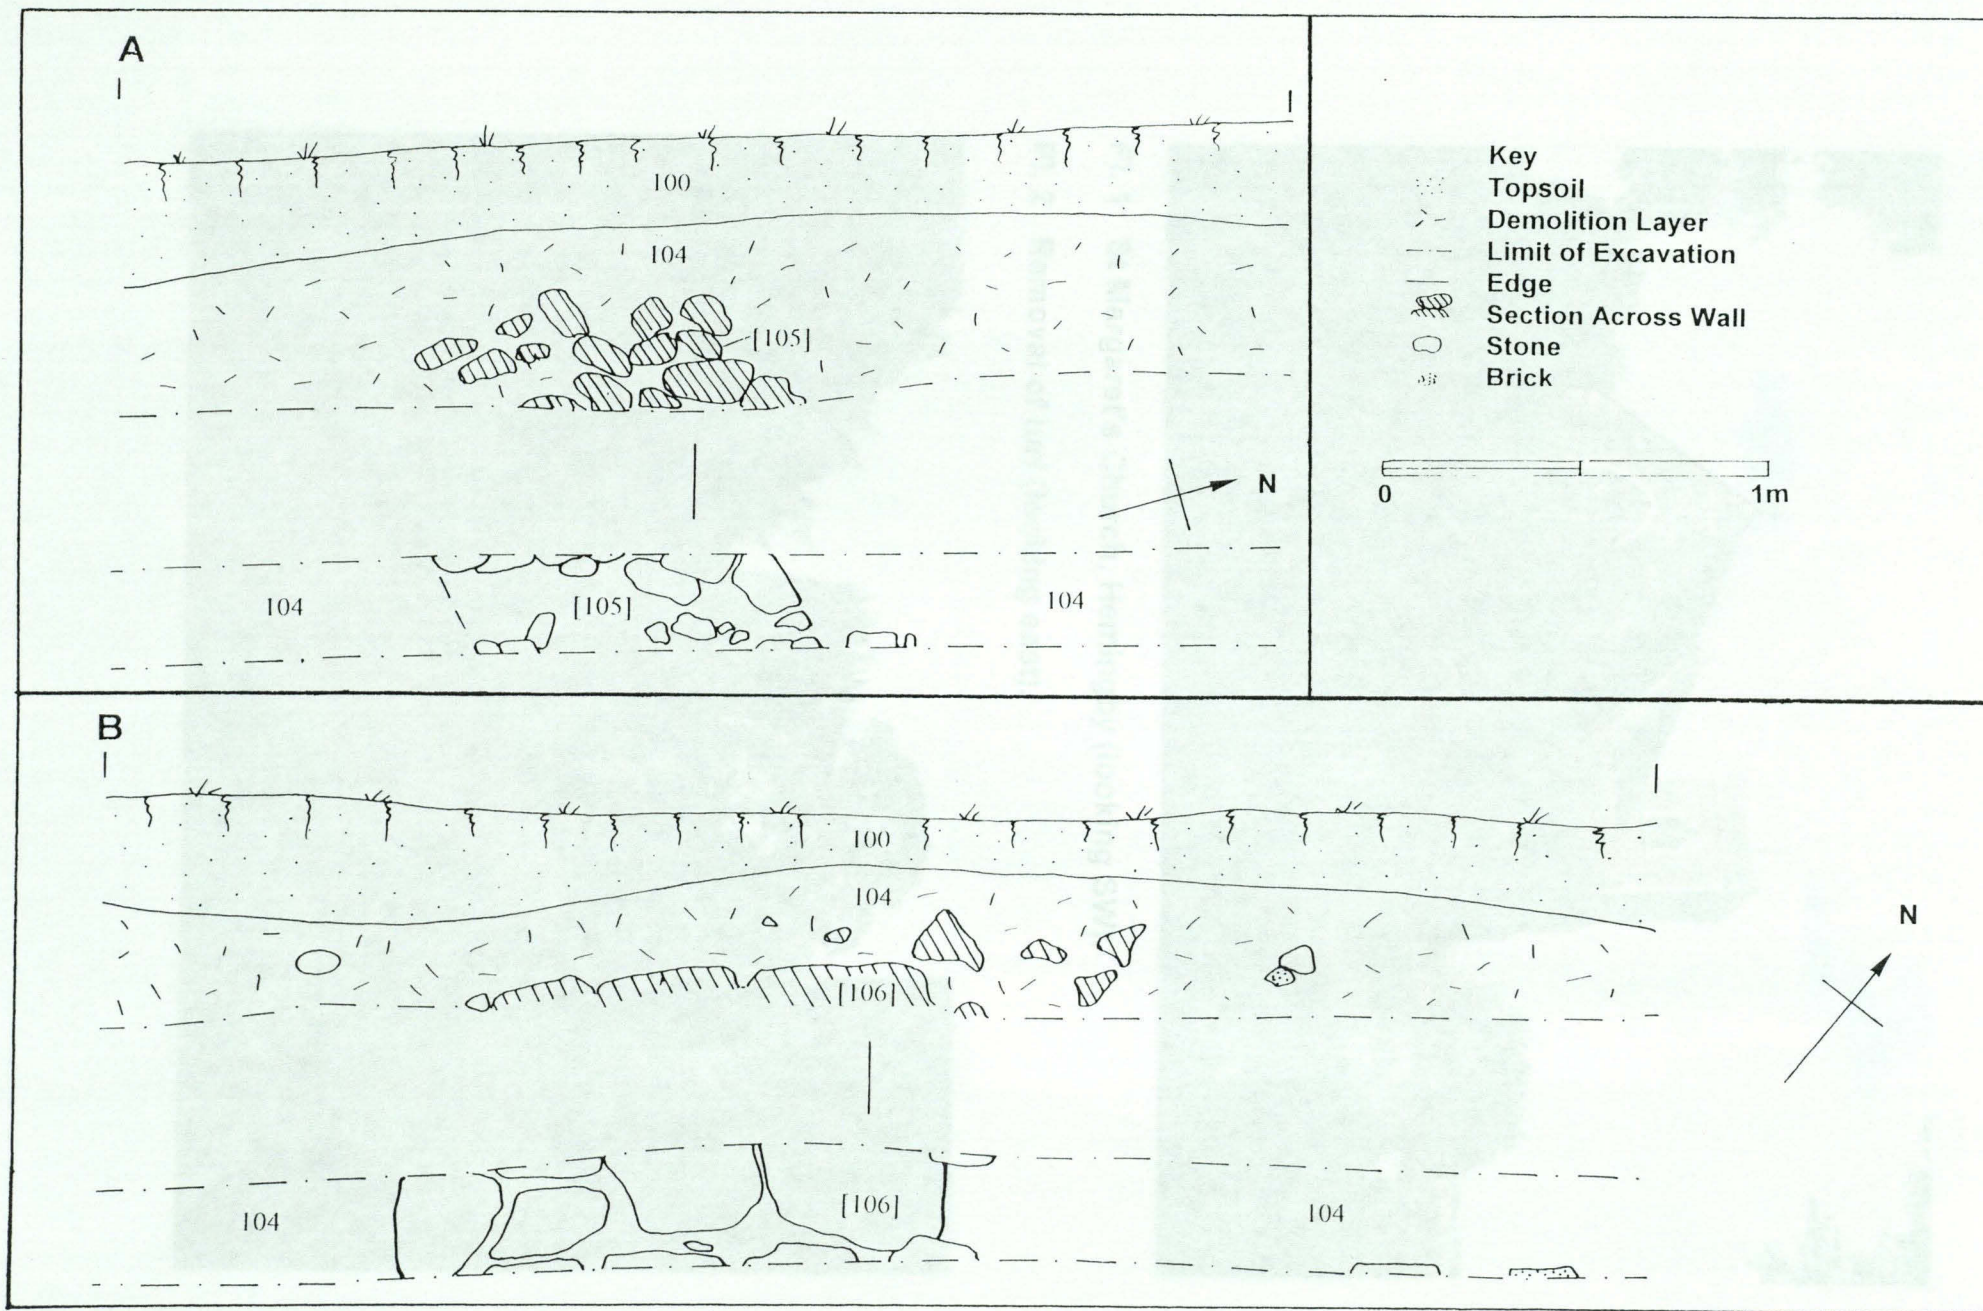
Wall **105** was aligned west to east and was 0.8m. thick. This wall foundation consisted of blocks of sandstone with some flint (Pl. 5).

Wall **106** was aligned NW to SE and survived to a thickness of 1.4m (Pls. 6 and 7). This wall foundation consisted of large dressed sandstone blocks. The absence of any other structural remains in the trench to the east of this wall may indicate that it was the eastern end wall of a building.

Fig. 4 Sections and plans across wall foundations in the cable trench.
A: wall foundation 105; **B:** wall foundation 106 (McDaid after Albone).

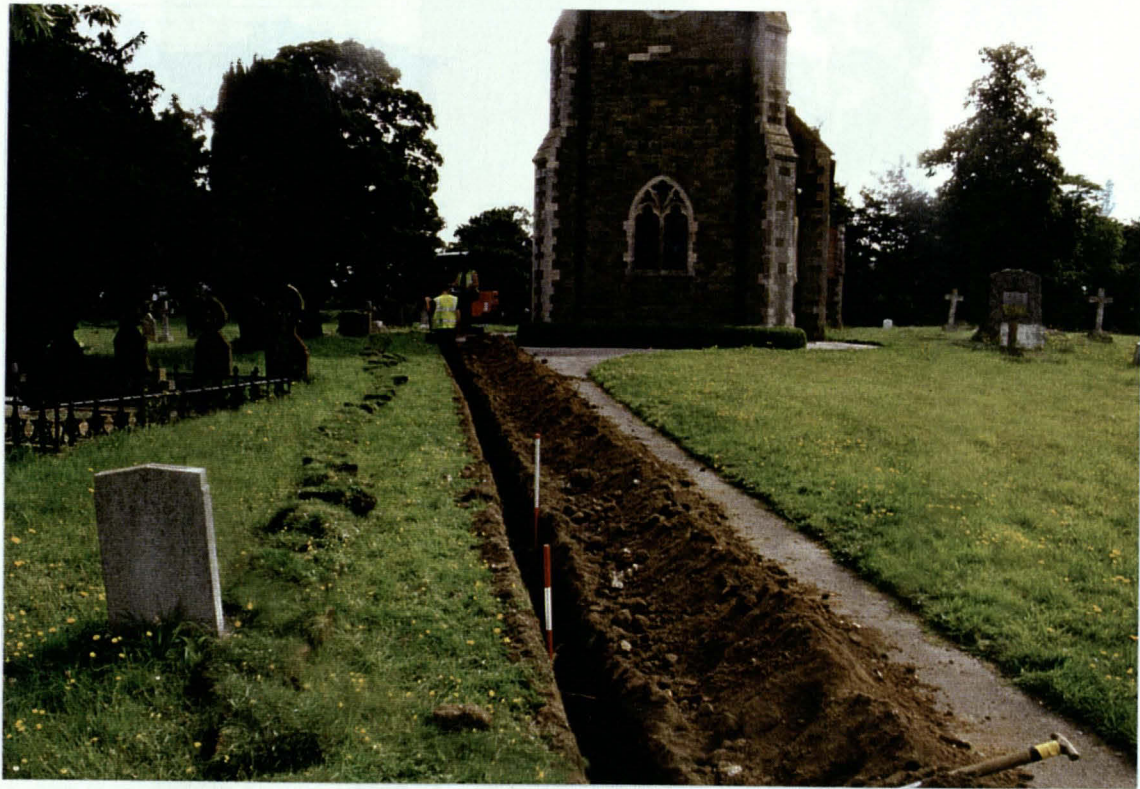
Pl. 3 Line of wall foundation 103, looking east (marked by red/white scales).

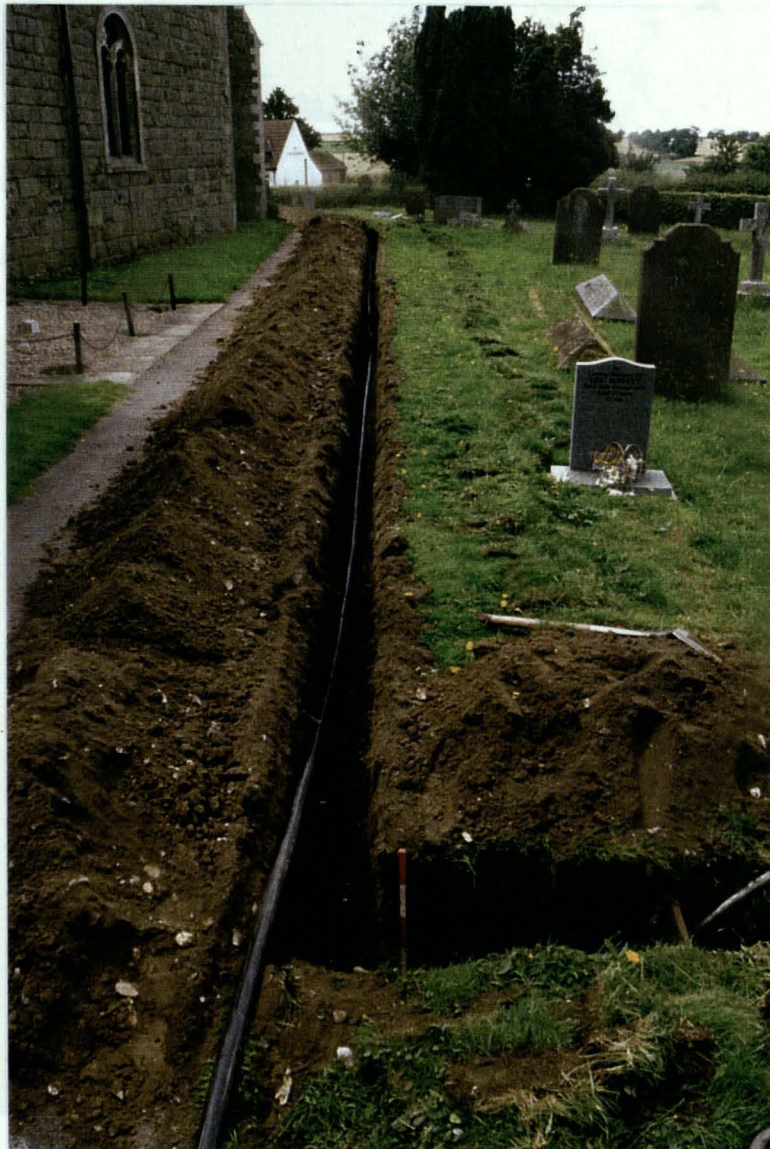
Pl. 5 Wall foundation 105, looking NE (scale divisions v0.1m, h0.2m).

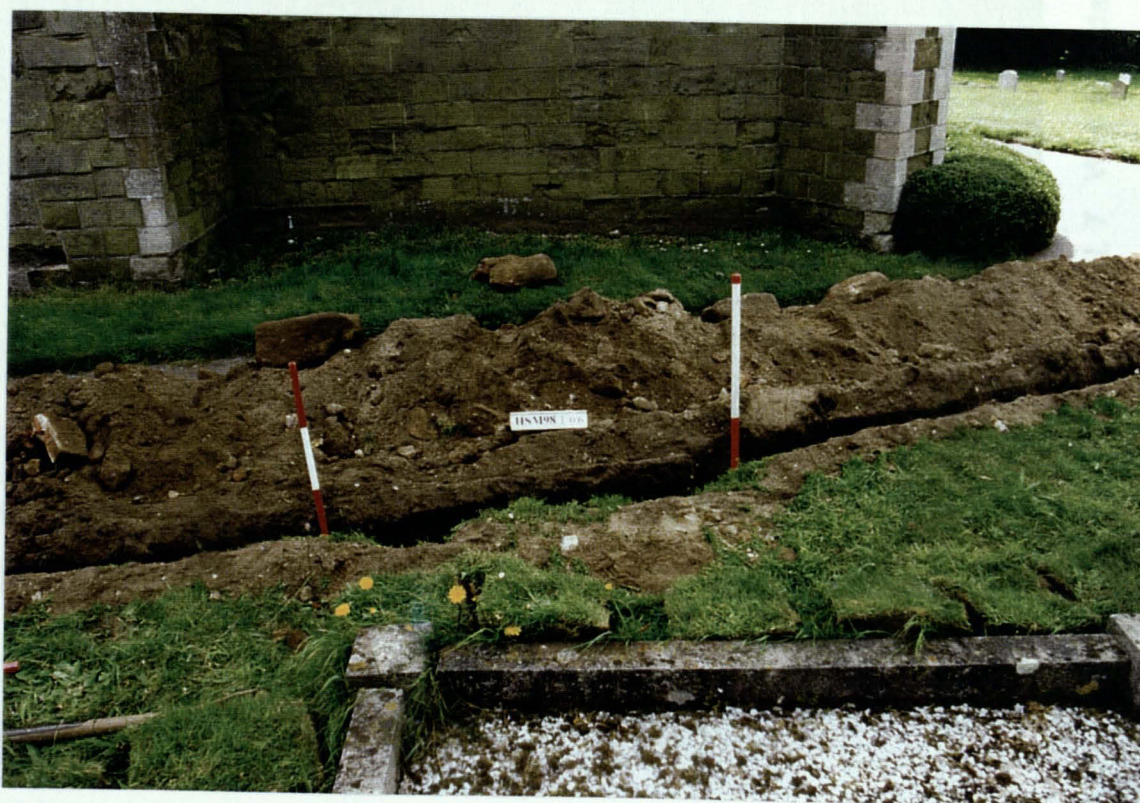
Pl. 6 Wall foundation 106, looking north (scale divisions v0.1m, h0.2m).

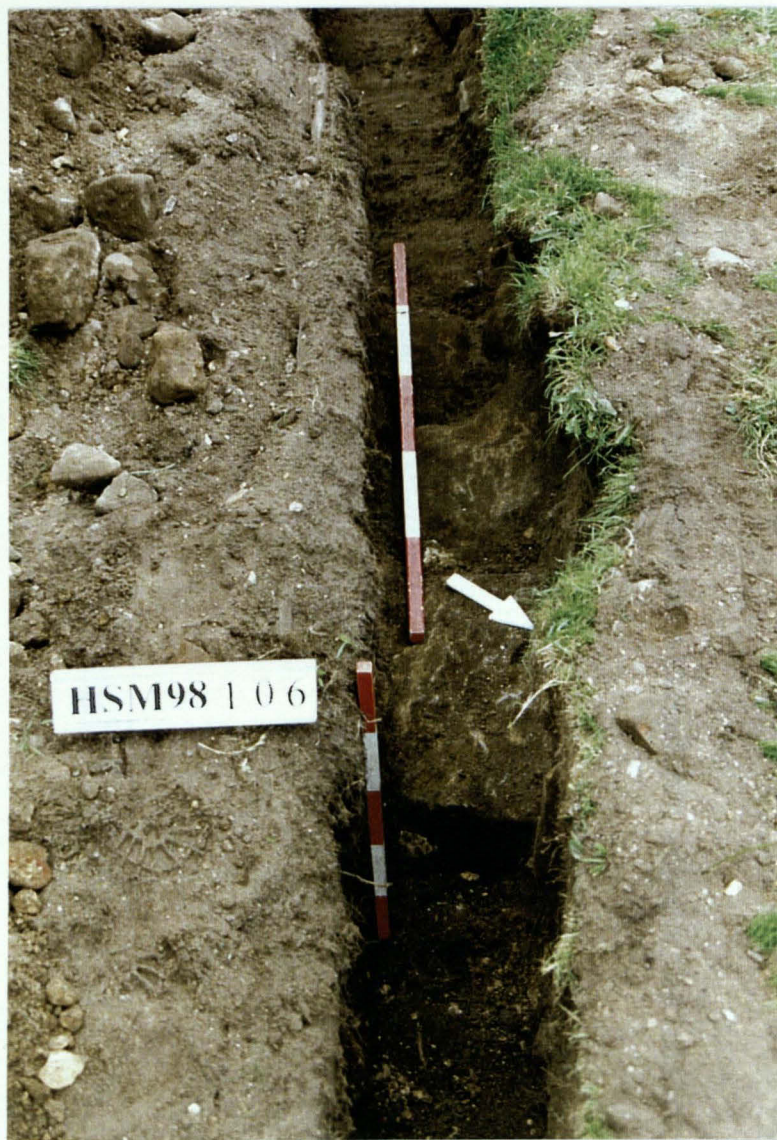
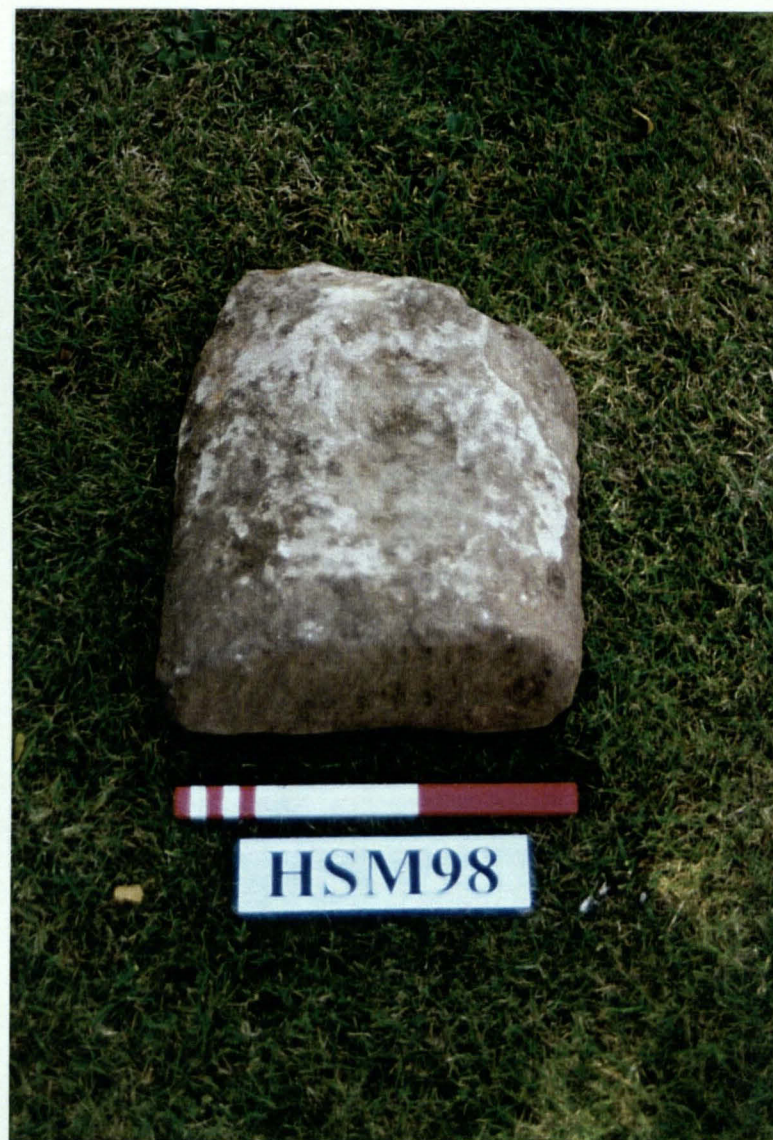
A piece of sandstone recovered from **104** was dressed and shaped, possibly having been used as a coping stone (Pls. 8 and 9). Mortar was present on its curved surface suggesting that it had been re-used in the walls of an earlier building.

Pl. 7 Wall foundation 106, looking west (scale divisions v0.1m, h0.2m).

Pl. 8 Worked stone fragment from demolition deposit 104, showing dressed end (scale divisions 0.01m and 0.1m).

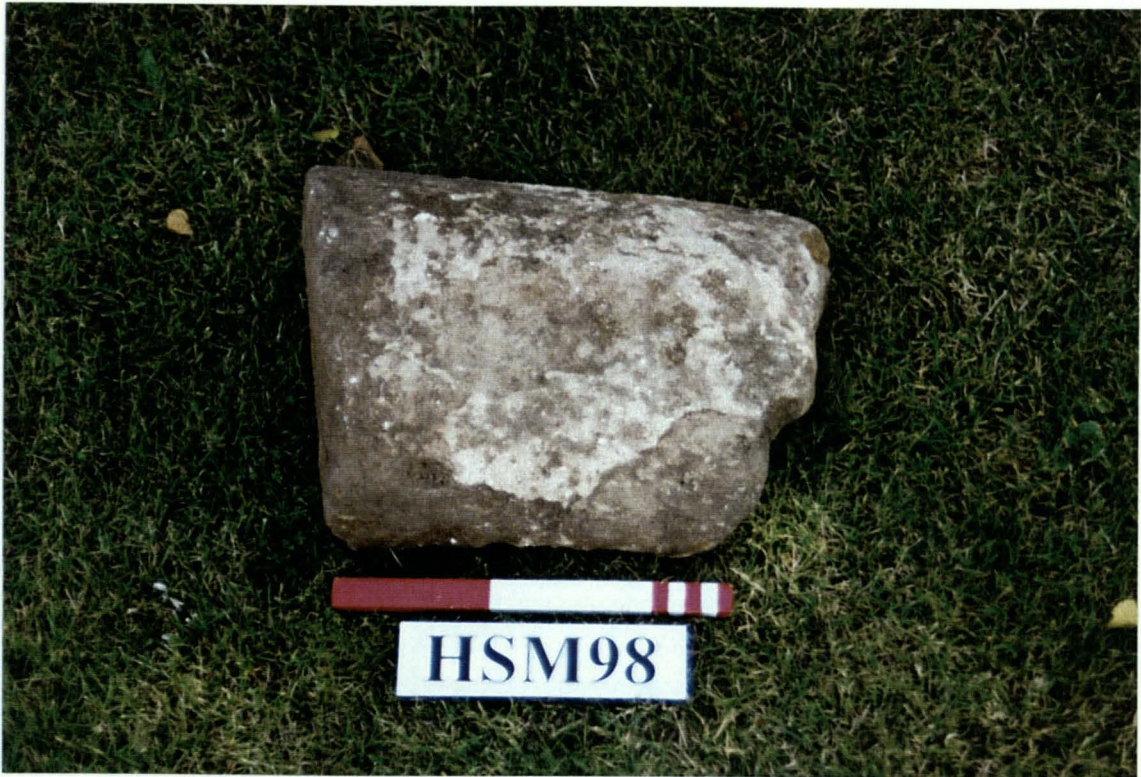
Pl. 9 Worked stone fragment from demolition deposit 104 (scale divisions 0.01m and 0.1m).
