Allington Sub Zone

Allington, Sedgebrook, and Hougham Replacement Mains

Archaeological Watching Brief

LAS Report No. 415
May 2000

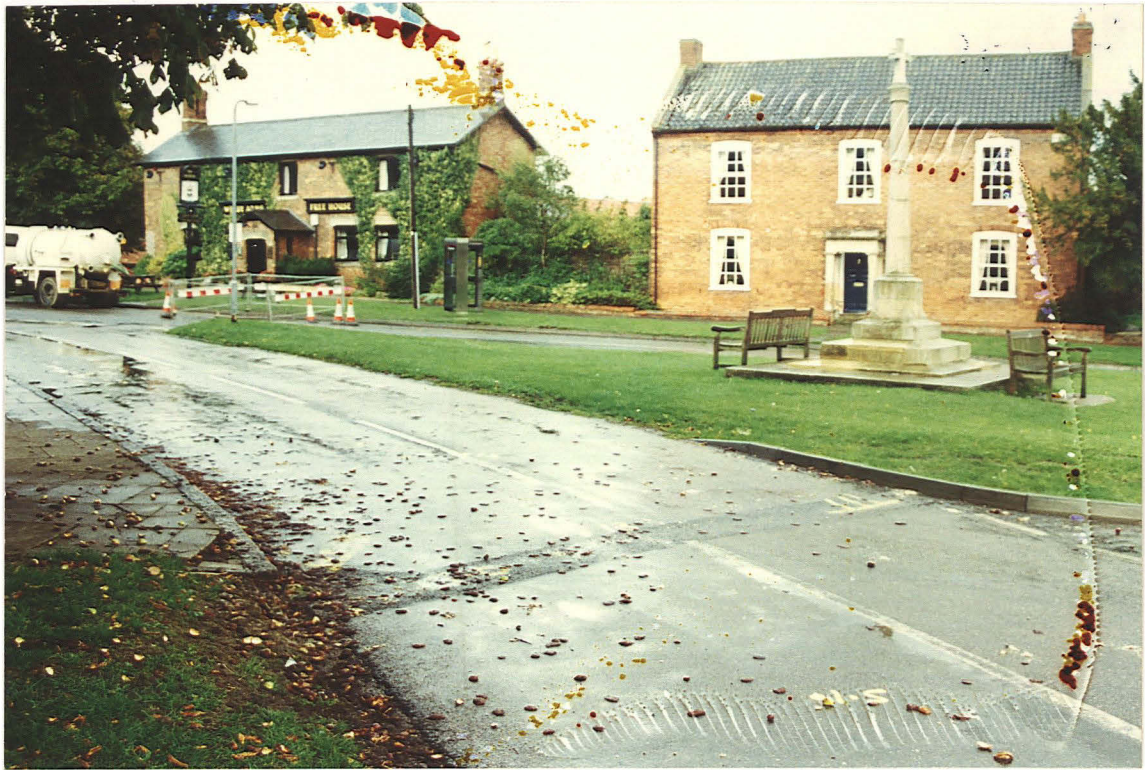
1. Part of a medieval village cross is at the junction of Sedgebrook Road and Bottesford Road (opposite the Welby Arms public house) (Pls. 1 and 2). Trenching close to the cross was monitored particularly closely as the cross is a Scheduled Ancient Monument SAM 22658. No moling or trenching affected the management area of 1m around the monument.

Pl. 1 Allington village crossroads, with the medieval cross. Looking east to the Welby Arms from Bottesford Road.

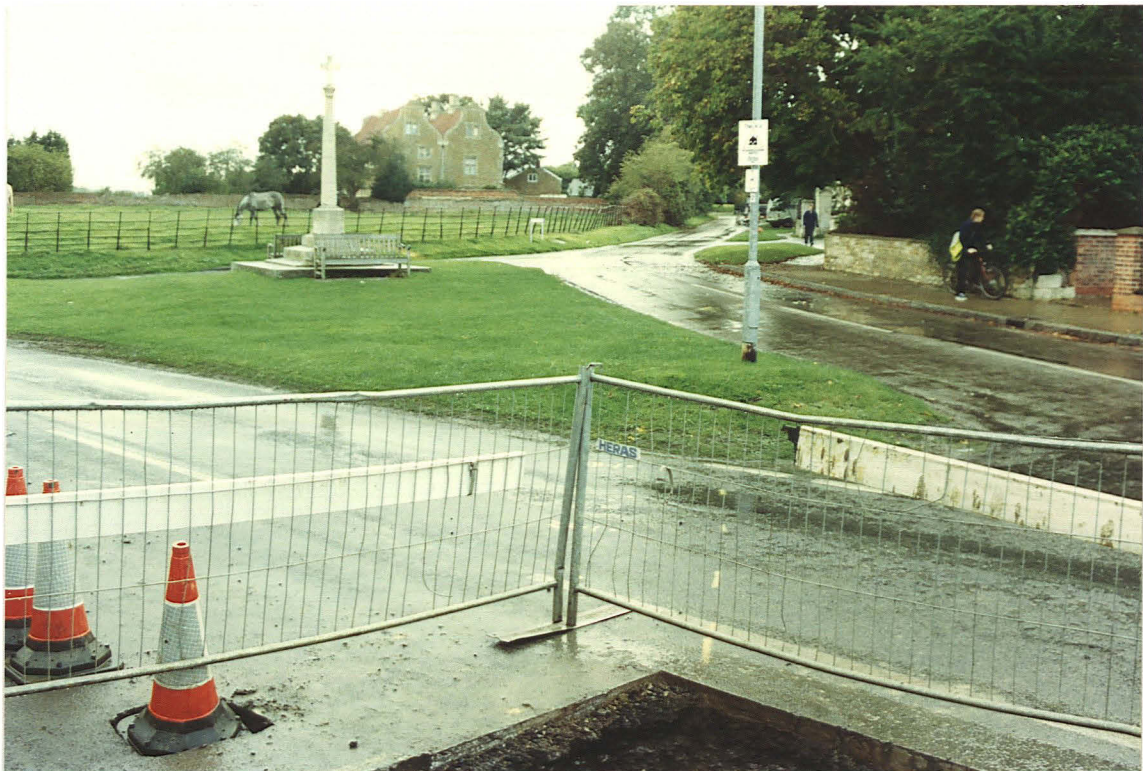
Pl. 2 Allington village crossroads (looking SW to Bottesford Road).

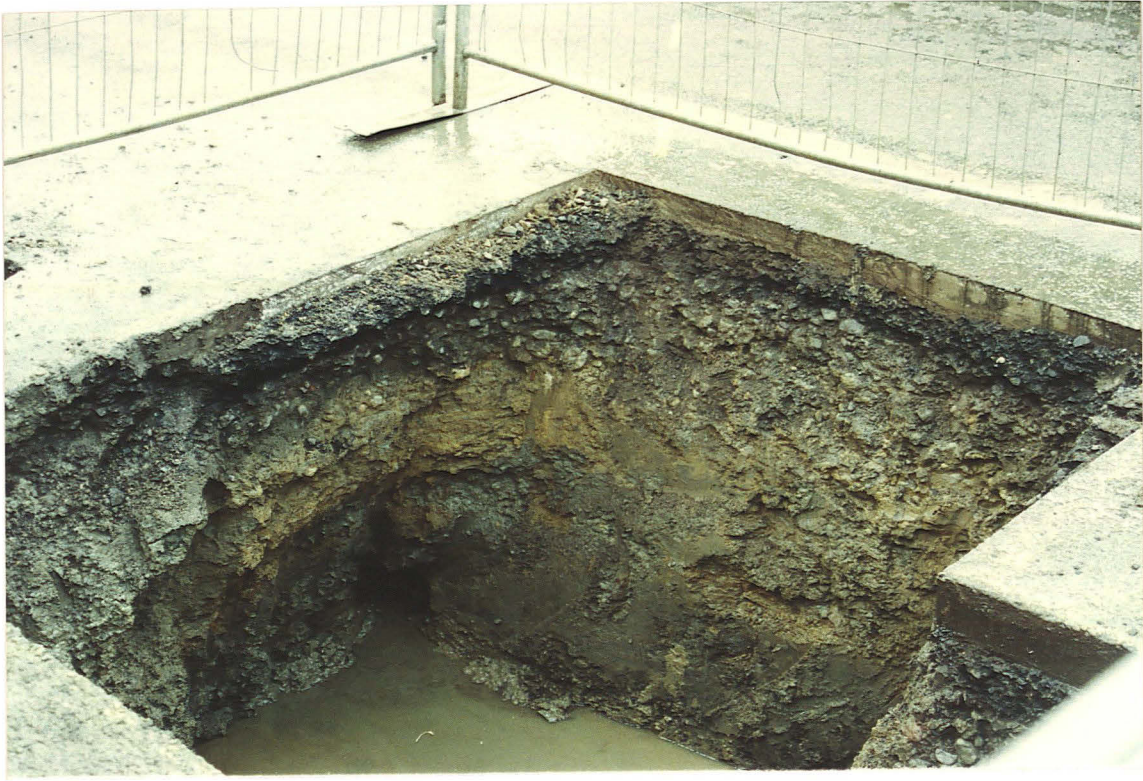
2. Beneath the tarmac of the modern road was a layer of gravel and grey clay, 0.2m thick (Pl. 3). This could be a post-medieval road or yard surface. It covered 0.45m of yellow clay, with grey clay at the trench base.

Pl. 3 Deposits in the trench face at 2, east of the village cross at Allington.

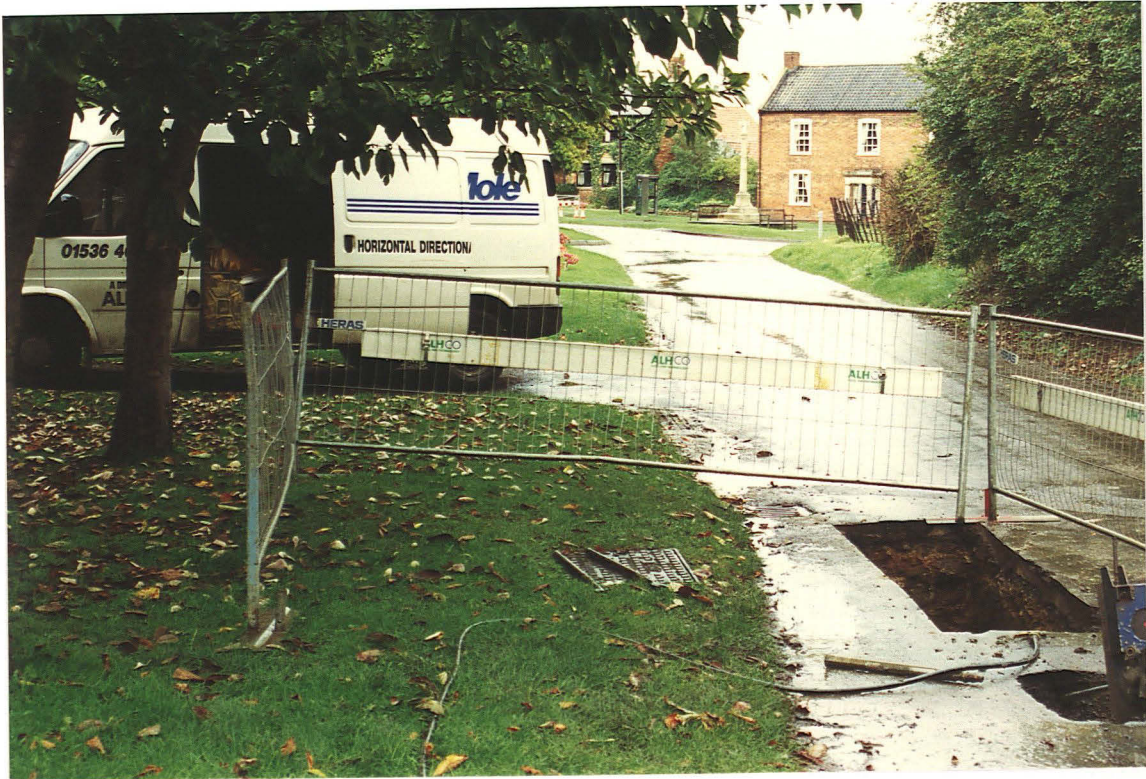
3. Opposite The Old Manor House, a trench exposed the gravel and limestone metalling of an earlier road surface, overlying a grey clay which could be a former topsoil (Pls. 4 and 5). Beneath the dark layer was a light brown compact material incorporating limestone, with a grey clayey shale at the trench base.

Pl. 4 Location of 3, in Bottesford Road, Allington (looking NE to the village cross).

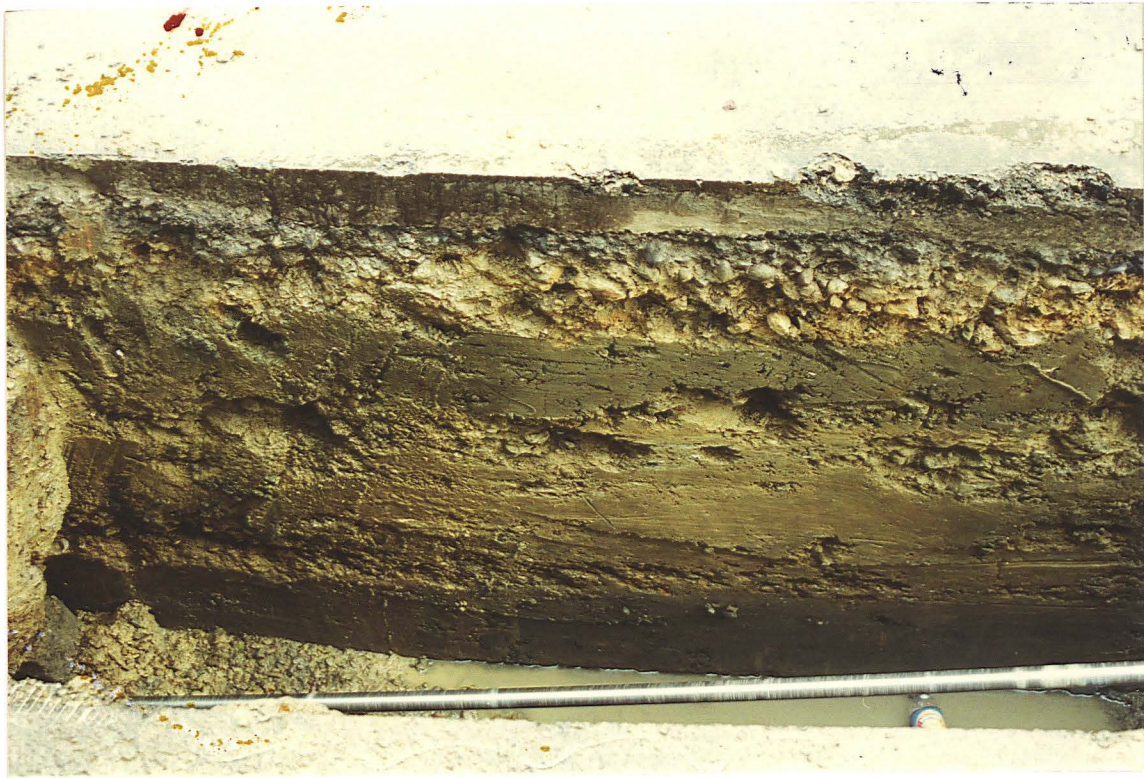
Pl. 5 Gravel metalling and buried dark brown clay in the trench at 3.

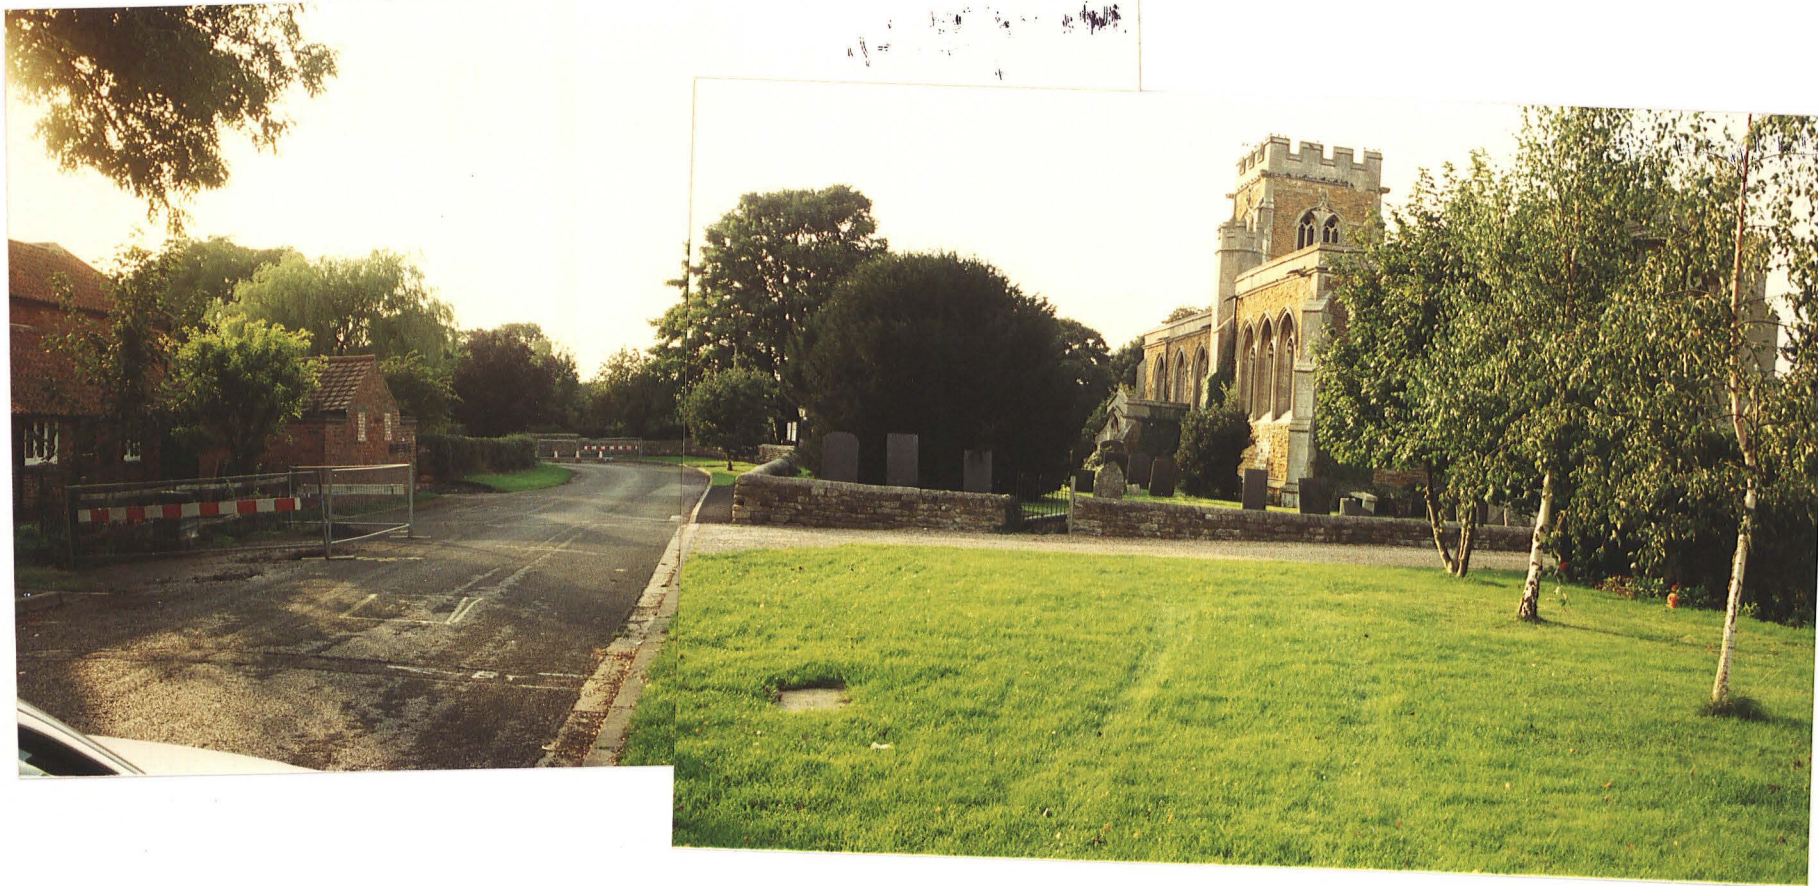
10. An access pit, 0.75m x 3m, was excavated on the bend in the road SW of St. Lawrence's Church (Pl. 6). The tarmac road surface was bedded on 0.2m of brick rubble; below this was 0.5m of dark brown clay loam with stone lumps, with ironpanned sand below.

11. To the SW of the church, the road was also bedded on a 0.1m thick layer of brick rubble, with dark brown loam below. The loam could be the fill of a roadside ditch, over which the present road has extended.

Pl. 6 Church Lane, Sedgebrook, showing St. Lawrence's Church and the trenches at 11 (left foreground) and 12 (on bend in the road). Looking west.

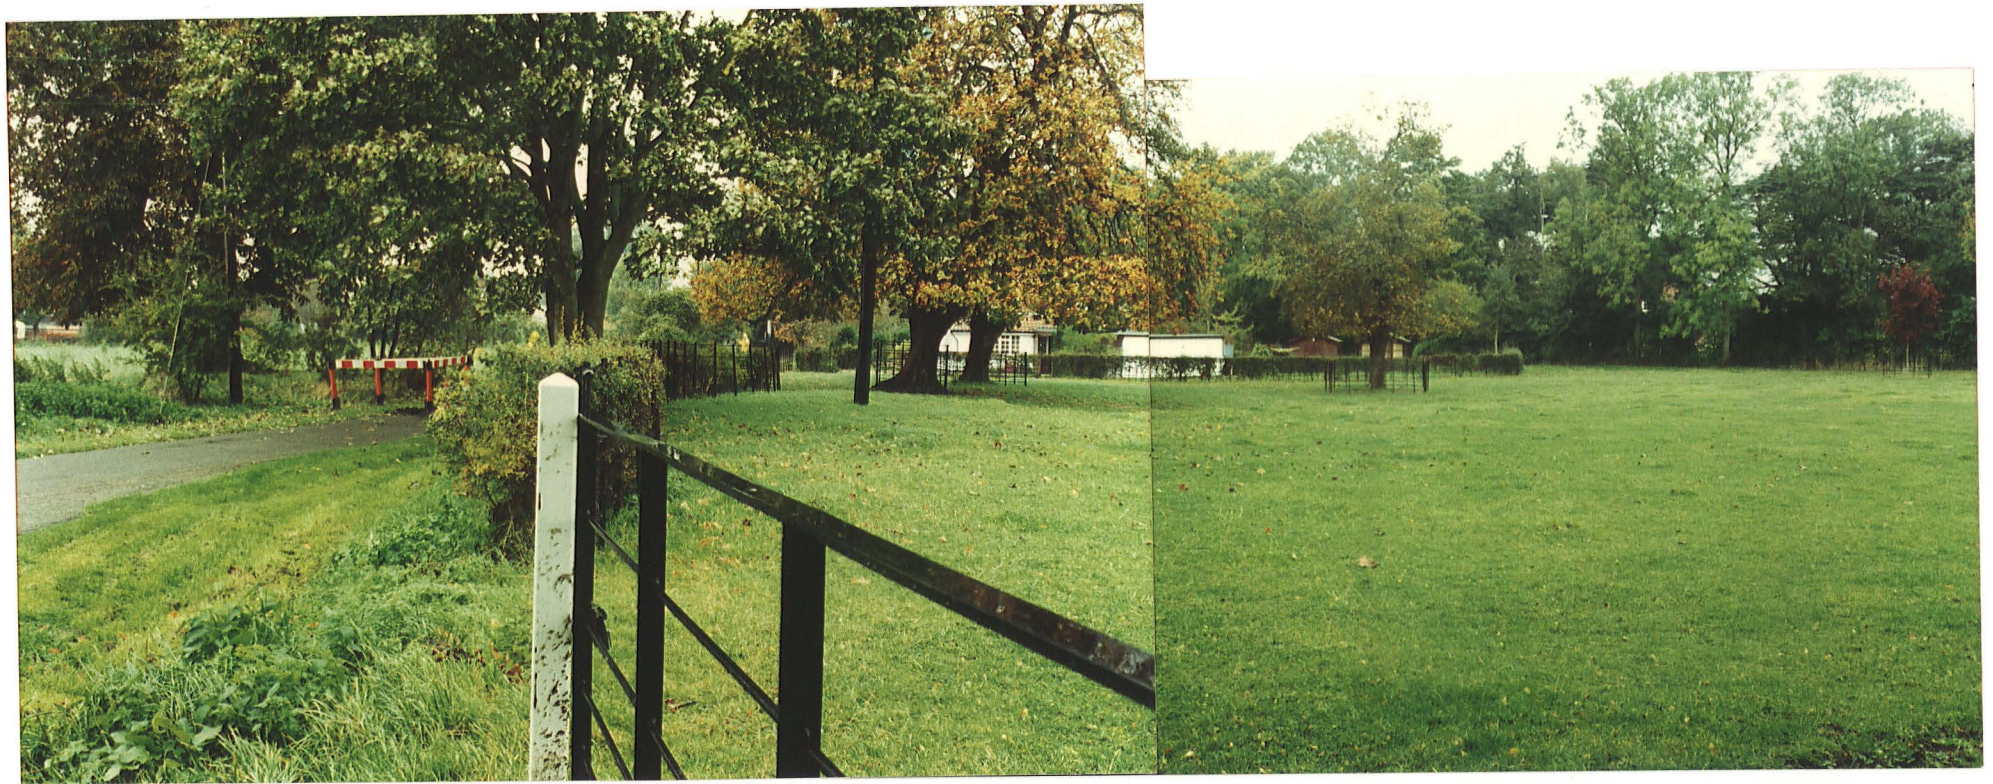
12. Outside White Lodge, the modern road surface covered a layer of brick rubble and an underlying thin spread of white chalk rubble (Pls. 7 and 8). This was interpreted as a 0.25m thick former track, leading to the church. Below it was 0.55m of dark brown loam, with yellow sandy clay at the trench base. These deposits are probably natural alluvium from the River Witham, 100m to the south.

13. During the monitoring visit, slight earthworks were seen in the pasture field to the NE of Church Lane, between White Lodge and All Saints' Church (Pl. 7). Given the proximity of the church, these may be from a medieval settlement. The field may have formed part of a park, and house names of White Lodge and The Old Coach House suggest buildings associated with a hall.

Pl. 7 Church Lane, Hougham, showing trench 12 and the pasture field with slight earthworks 13. Looking north to White Lodge.

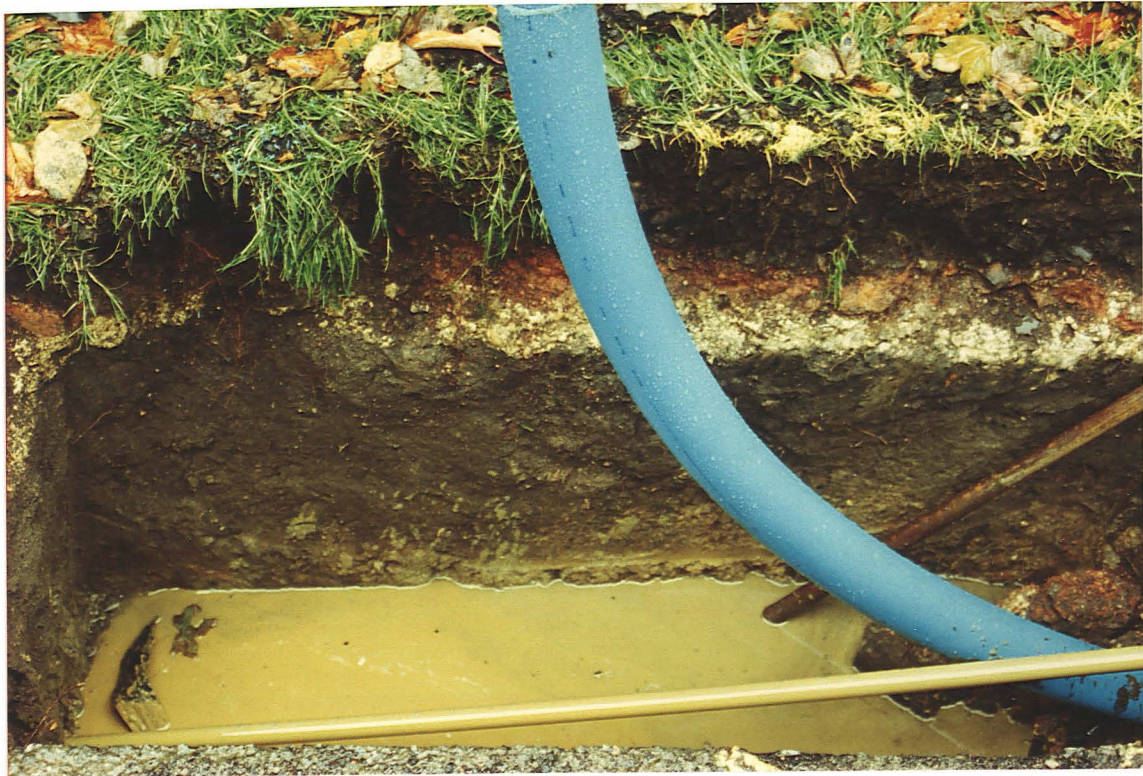
PI. 8 Brick rubble and chalk/limestone track metalling, 12, Church Lane, Hougham.

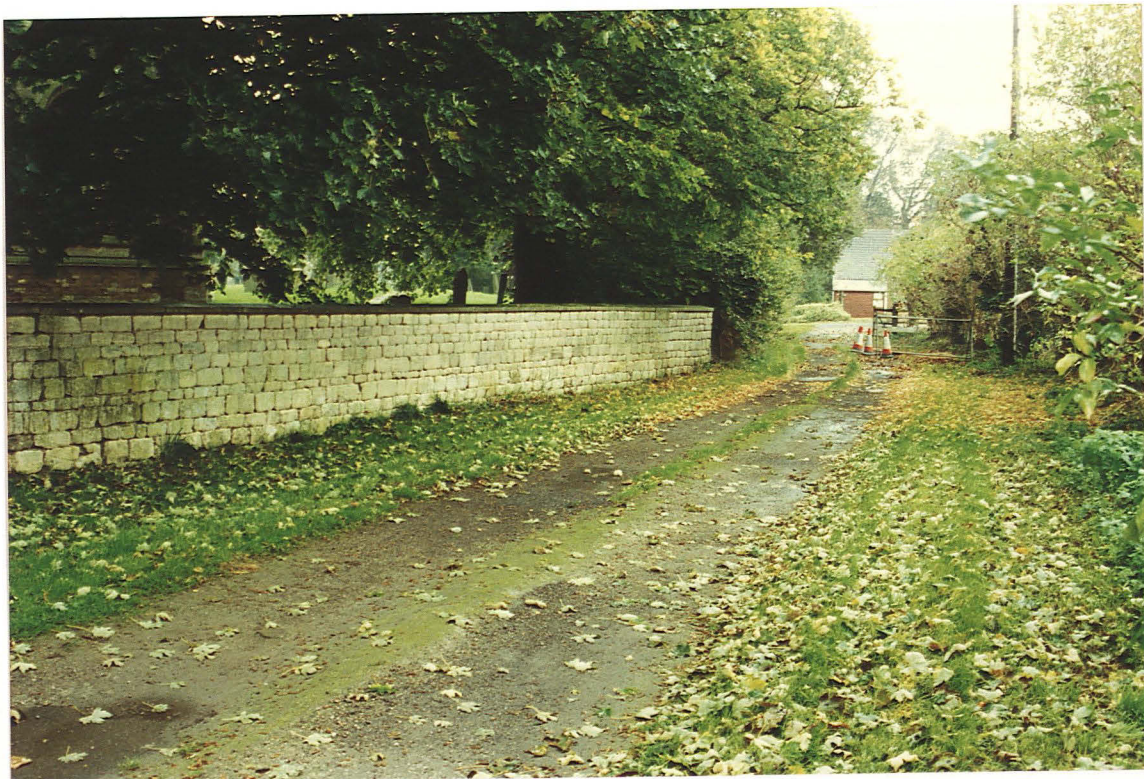
14. SW of All Saints' Church, a small trench excavated in the track leading to Weir House revealed a spread of stone rubble about 0.5m below the present surface, separated from track material by brown stony clay (Pls. 9 and 10). The rubble appeared to be demolition material from the church, either filling a former ditch or covered by alluvium.

PI. 9 Position of 14, Church Lane, Hougham (looking south).

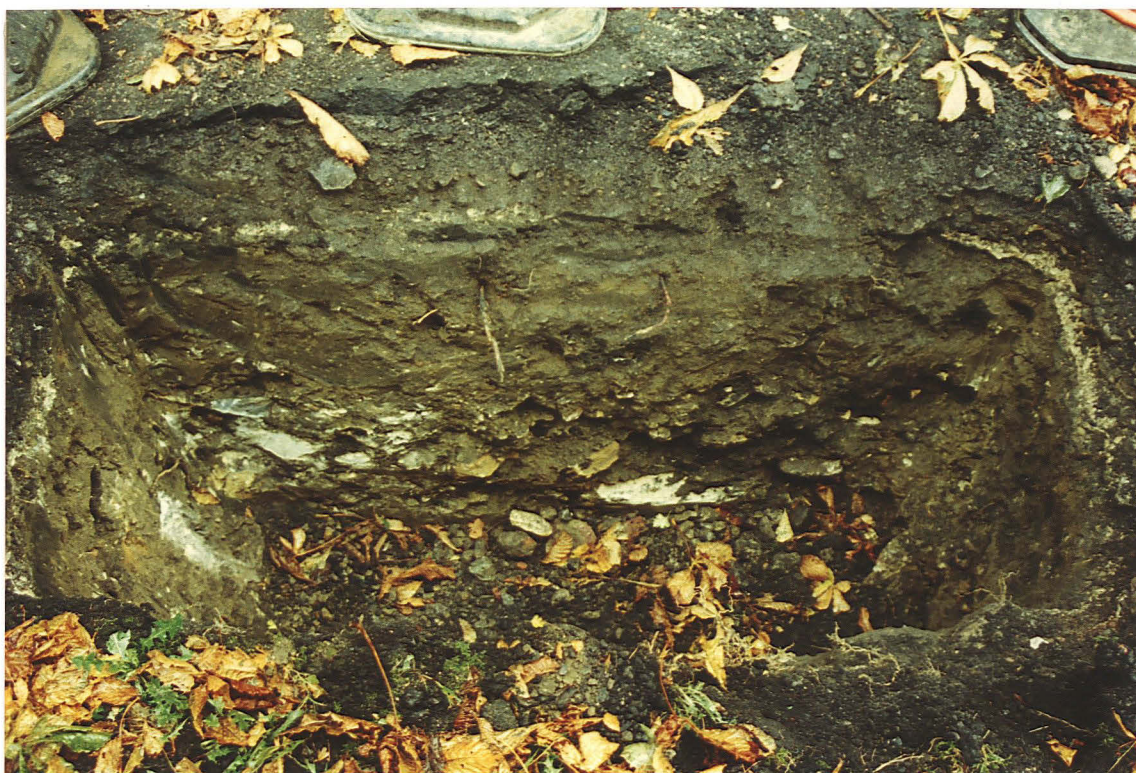
Pl. 10 Limestone rubble at the trench base, 14, possibly derived from demolition rubble from the adjacent All Saints' Church, Hougham.
