**St Lawrence's Church,
Snarford, Lincs**

Archaeological Investigation and Recording

**Report for
The Churches Conservation Trust**

**LAS Report No. 422
June 2000**

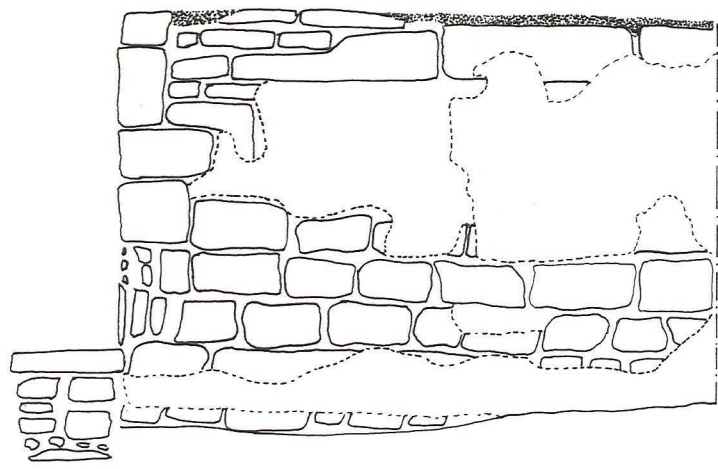
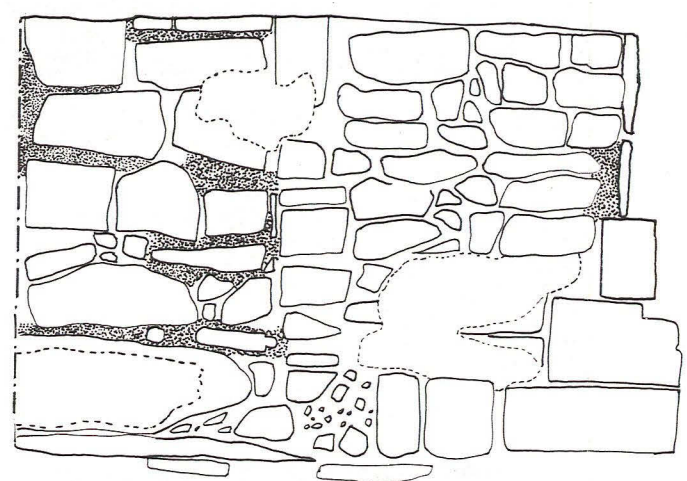
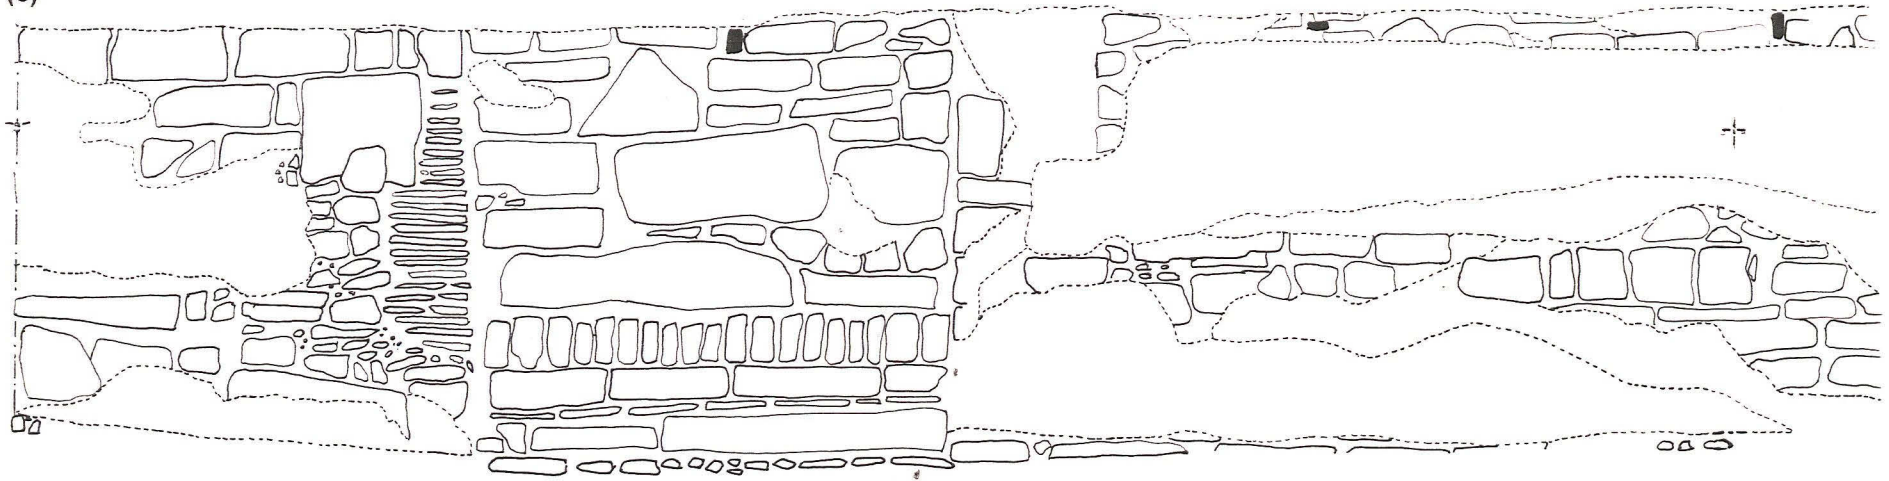
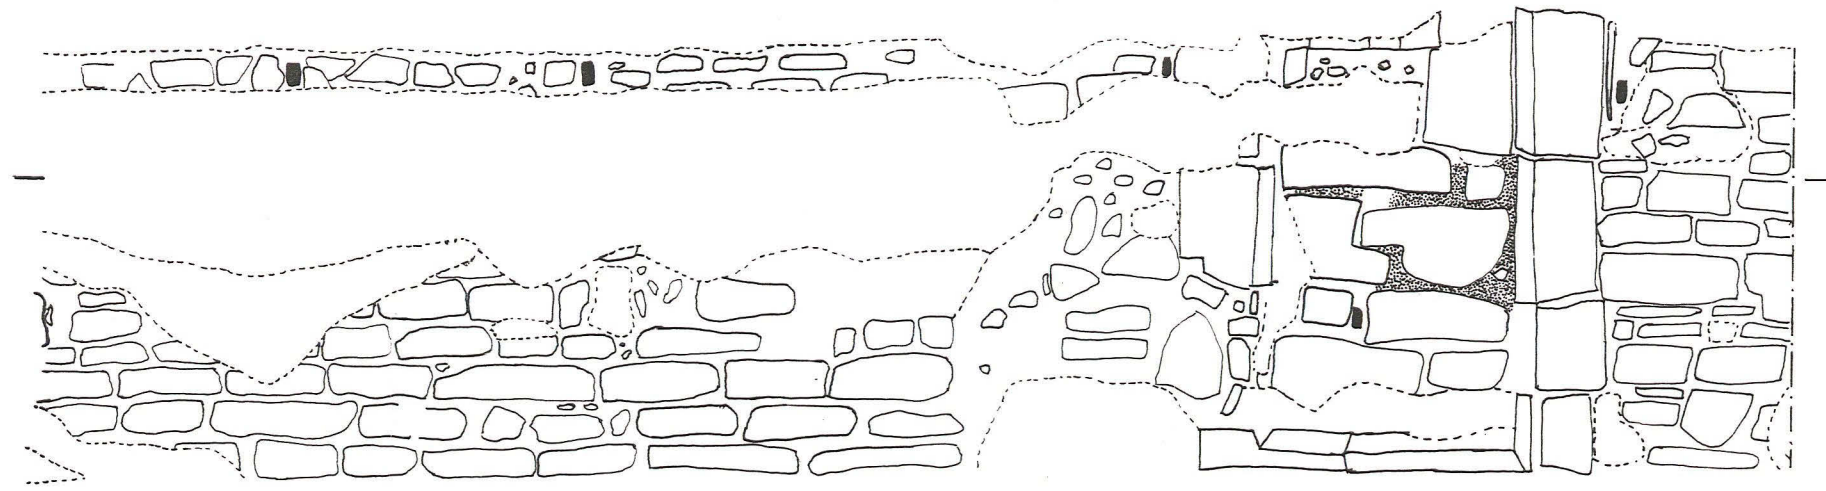
Fig. 3 (a) East-Facing Wall of North nave; (b) West-Facing Wall of North nave;
 (c) South-Facing Wall of North nave.

The removal of the wood panelling also revealed three blocked openings. Two of these were located along the northern wall, and one in the corner of the eastern wall (Fig. 4).

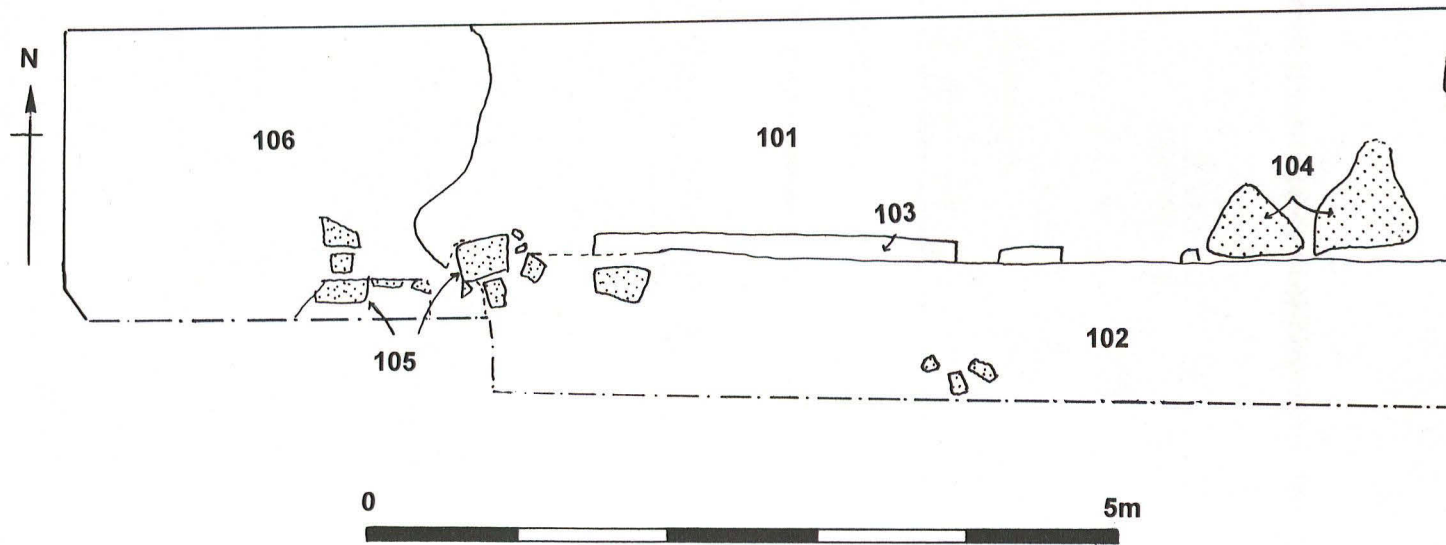
Fig. 4 Plan of floor surface in the north nave following the removal of the loose material

The removal of the loose debris from the north side of the nave revealed a series of floor deposits and an area of disturbance thought to be caused by grave cuts adjacent to the centre aisle (Fig. 3; Pl. 8 & 9).

Most of the nave floor is covered by a compact layer of orange-brown sandy silt (**101**). This layer also contained debris from earlier building work.

An area of disturbed material, measuring approximately 0.85m wide, was recorded adjacent to the aisle (**102**). This was a very mixed, loose deposit of grey-brown sandy silt containing frequent brick, stone, tile and plaster. Human bone was also recovered from this material. This area of disturbance is probably caused by a series of grave cuts.

Immediately north of this deposit was a narrow band of darker material (**103**) measuring 0.18m in width, surviving intermittently along the length of the aisle. **103** runs parallel with the aisle, and is thought to be the traces of an earlier pew platform.

Two patches of plaster (104) remain in situ on the floor at the eastern end of the nave. It is possible that these are the remnants of a former floor surface which has now been almost completely destroyed.

A number of large stones remain in situ towards the western end of the nave (105). The ground is disturbed at this end where a number of tree roots have pushed their way into the church. A deposit of compact grey-black silty loam (106) containing tree roots was visible here (Pl. 10).

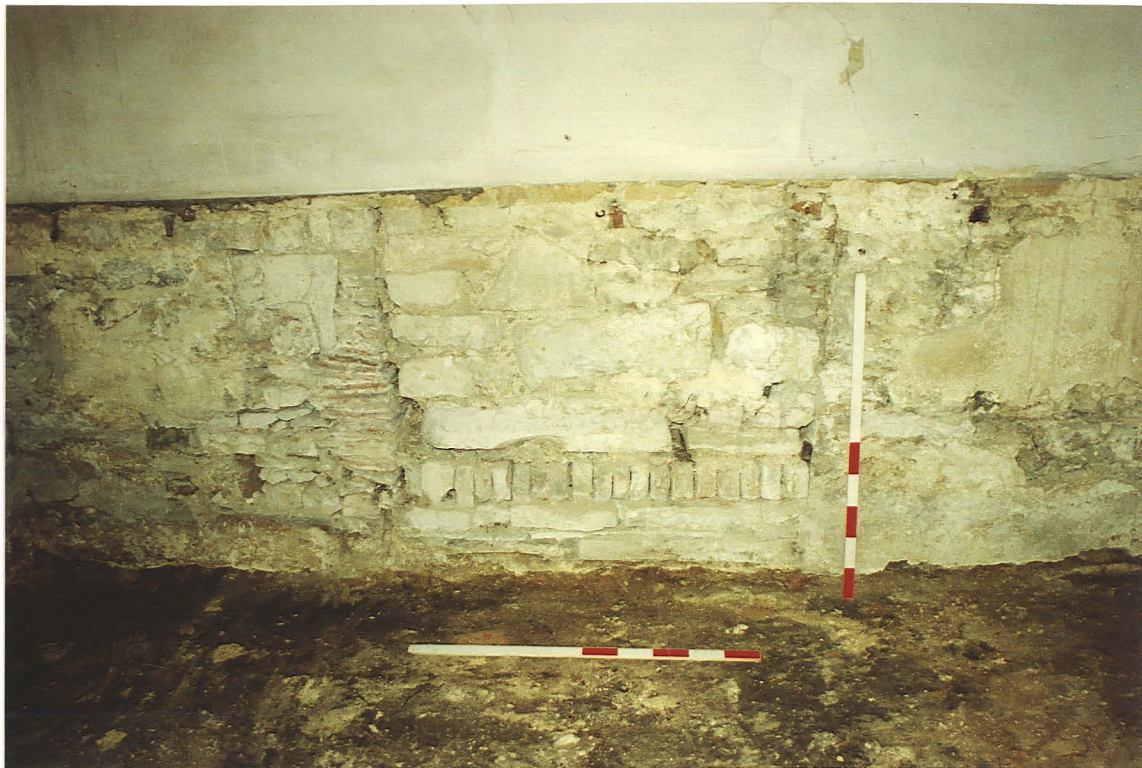
Opening 1 is located in the north wall of the nave, directly opposite the existing entrance to the church (Pl. 11 & 12). This blocked entrance is clearly visible in the exterior wall face, and closely resembles the existing south door opening, although the moulding has been removed (Pl. 13). Opening 1 measured 1.28m in width, and has been blocked with a number of large dressed stones and a row of red bricks. A block of flat roof tiles have replaced the left door jamb. The present doorway dates to the 14th century, so it can be assumed due to the symmetry of these doorways that Opening 1 also dates to this period. This entrance is shown blocked on a drawing of the exterior of the church commissioned by the Reverend James Marshall Bury in 1874.

Pl. 11 Opening 1, blocked doorway in north wall of the nave

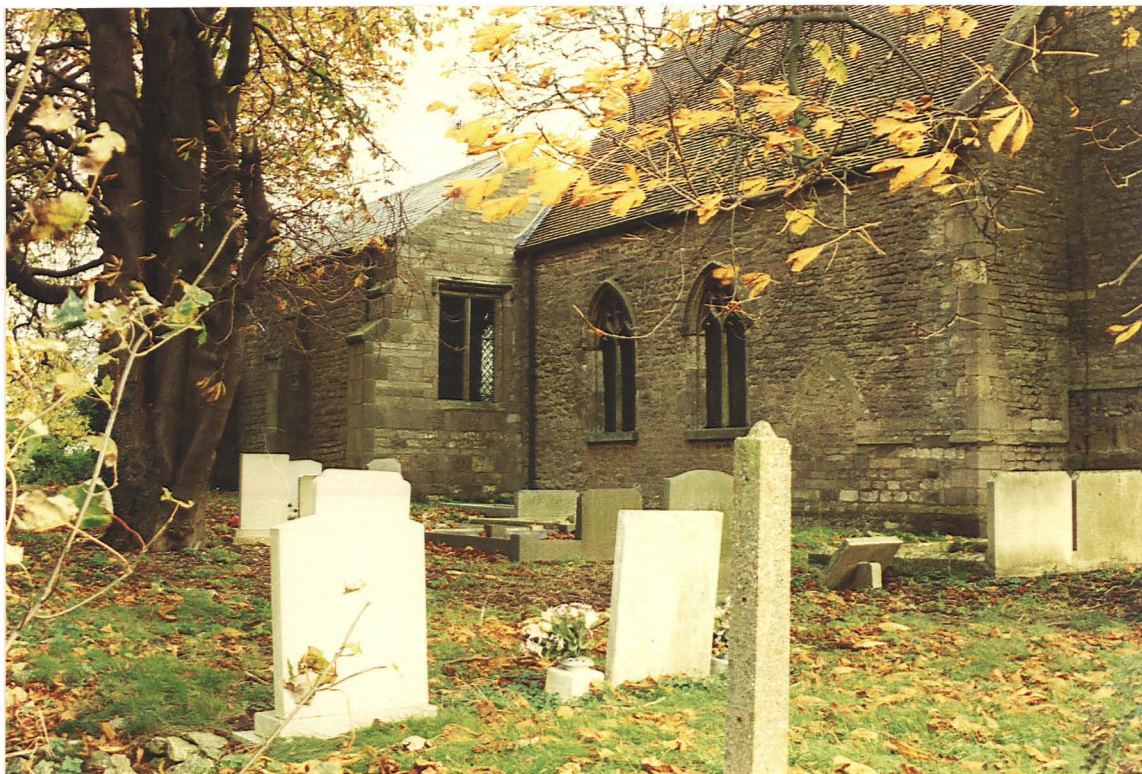
Pl. 12 Opening 1 clearly visible in the wall face

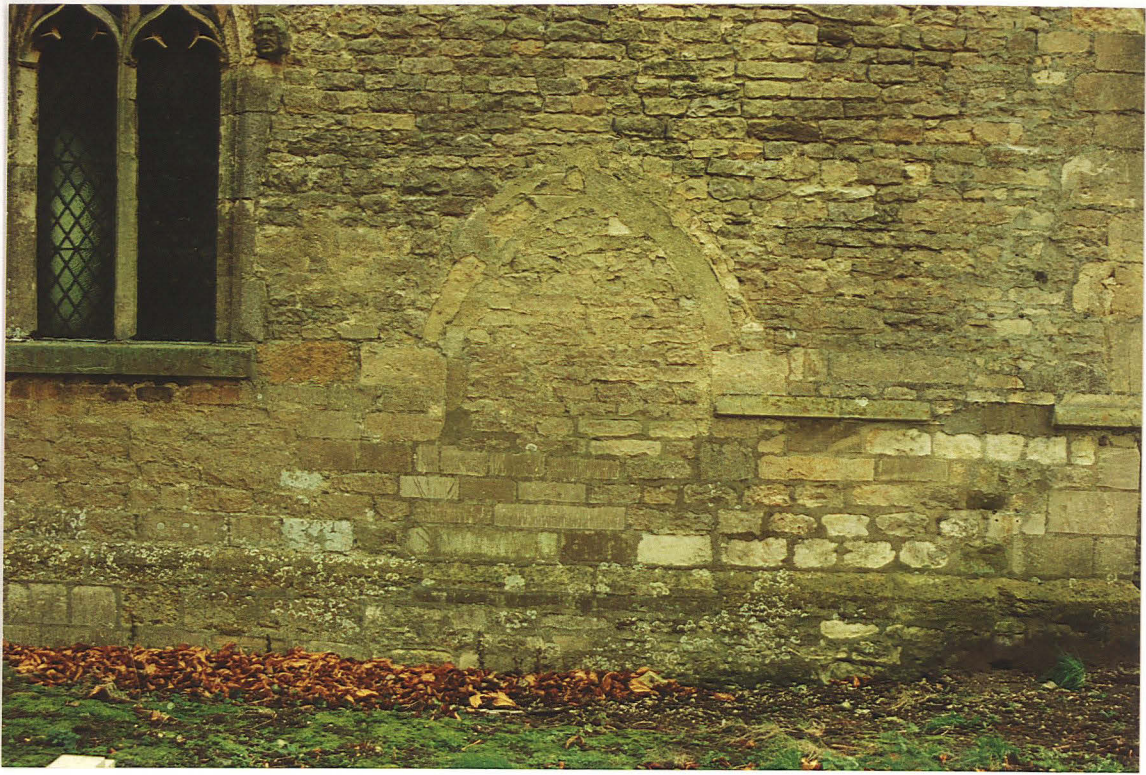
Pl. 13 Opening 1 visible in exterior wall of Snarford Church

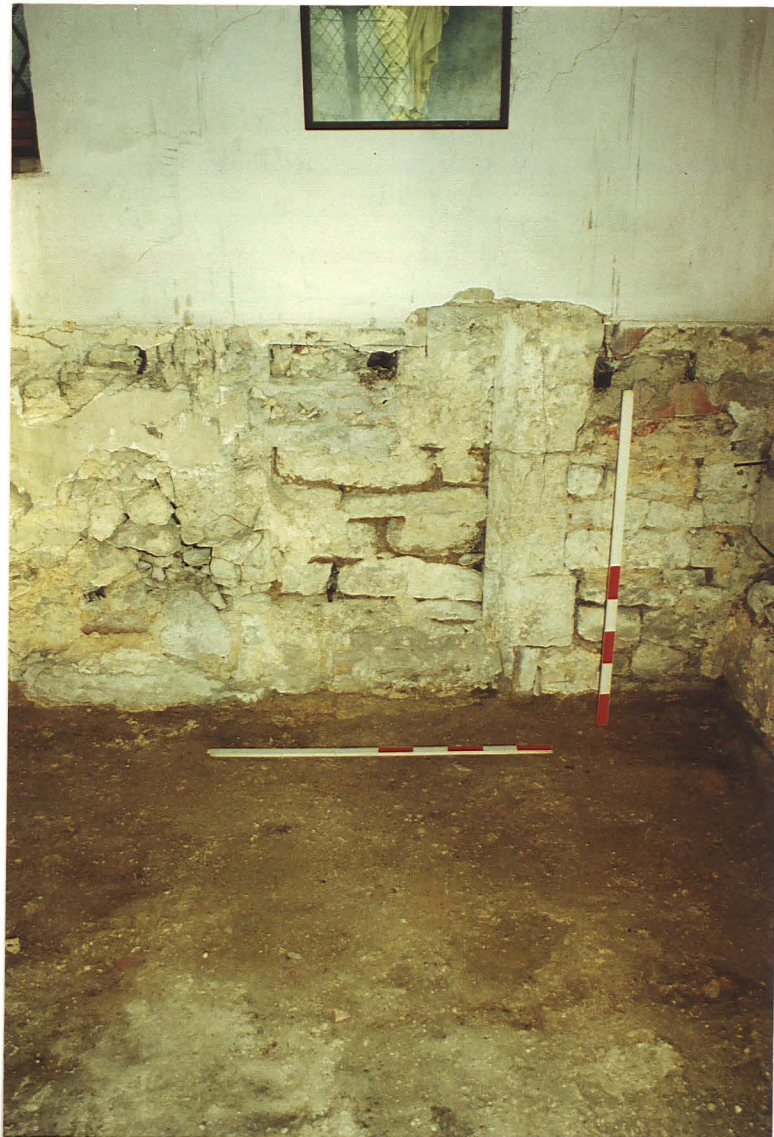
The second opening in the north wall of the nave (Opening 2) was located 0.52m away from the east wall (Pl. 14). This opening measured 1.12m in width (including the door jambs), and also represents a former entrance. The chamfered door jamb at the eastern edge of the doorway has survived well, although the western jamb is more fragmentary. A chamfered threshold was visible at floor level, and despite being slightly broken, had survived well (Pl. 15). Opening 2 had been blocked with large dressed stone blocks and mortar (Pl. 16). Once again, this blocked entrance can be seen in the exterior wall of the church, but not clearly. Modern pointing was recorded here, indicating that repairs have been carried out here subsequent to the initial blocking of the doorway. No records stating the date when this opening was blocked have been recovered, nor is it known whether this entrance dates to the fourteenth century when the church was rebuilt. The opening either blocked or unblocked is not visible on the 1874 drawing.

Pl. 14 Opening 2 in north wall of nave

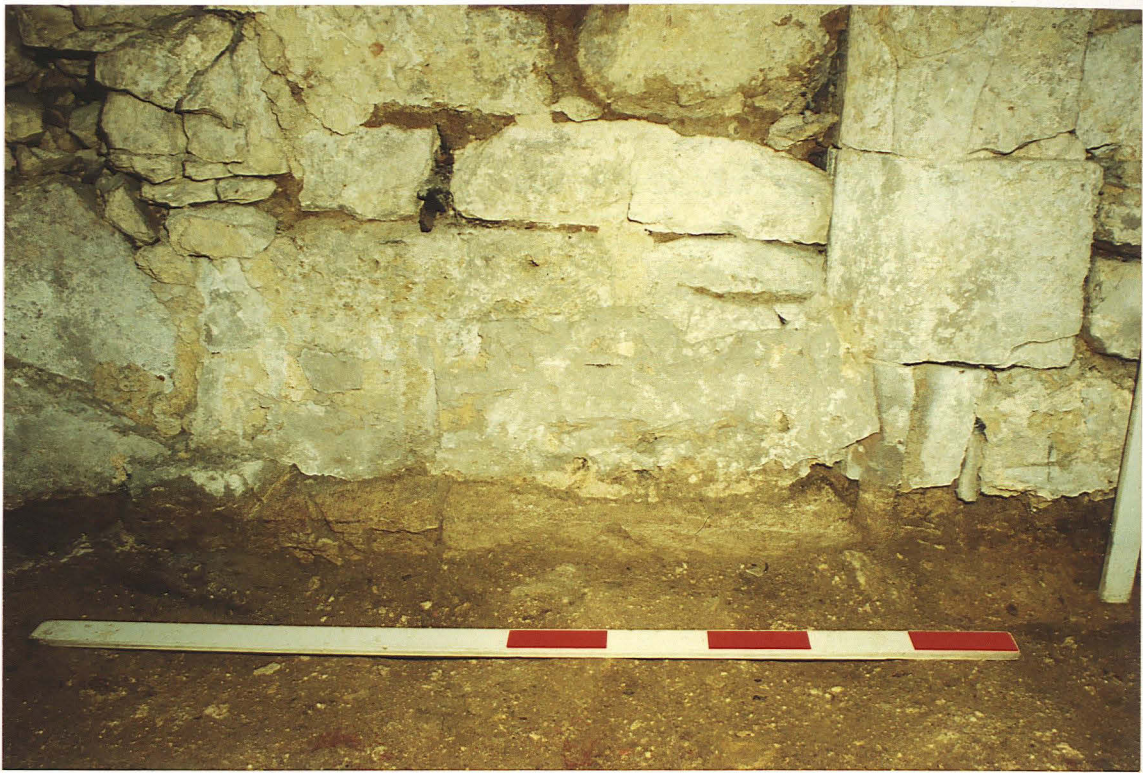
Pl. 15 Chamfered door lintel at base of Opening 2

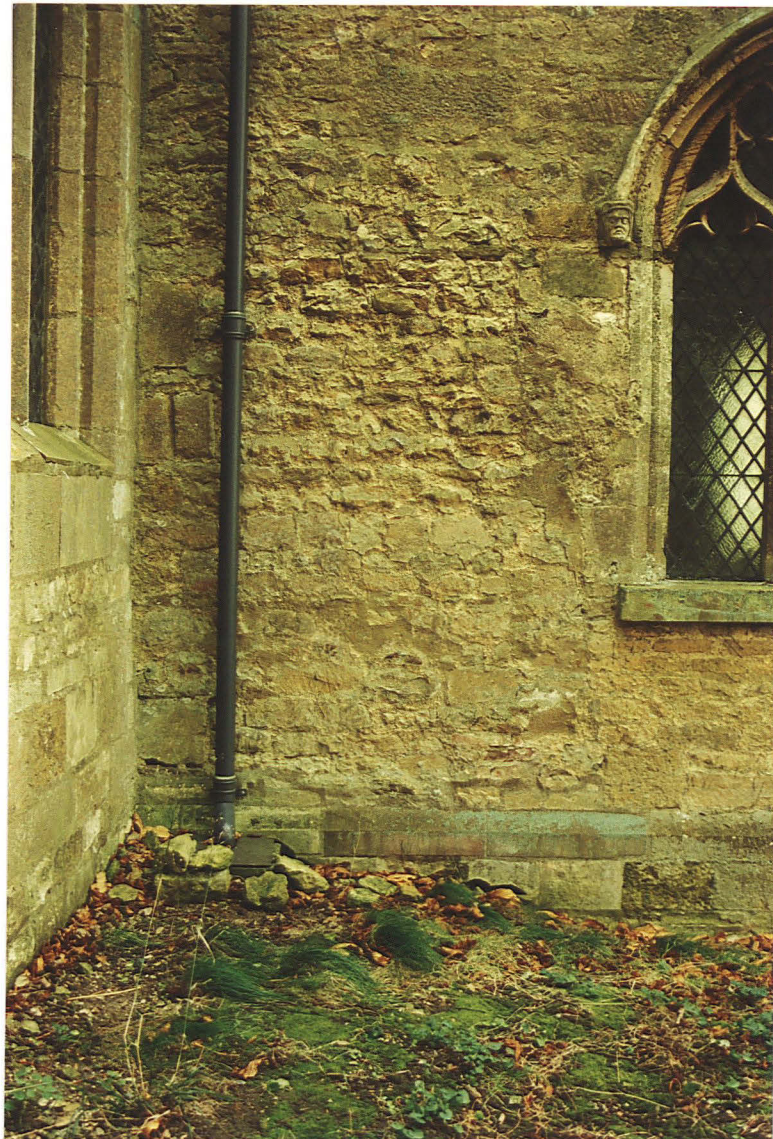
Pl. 16 Opening 2 seen in exterior wall of the church

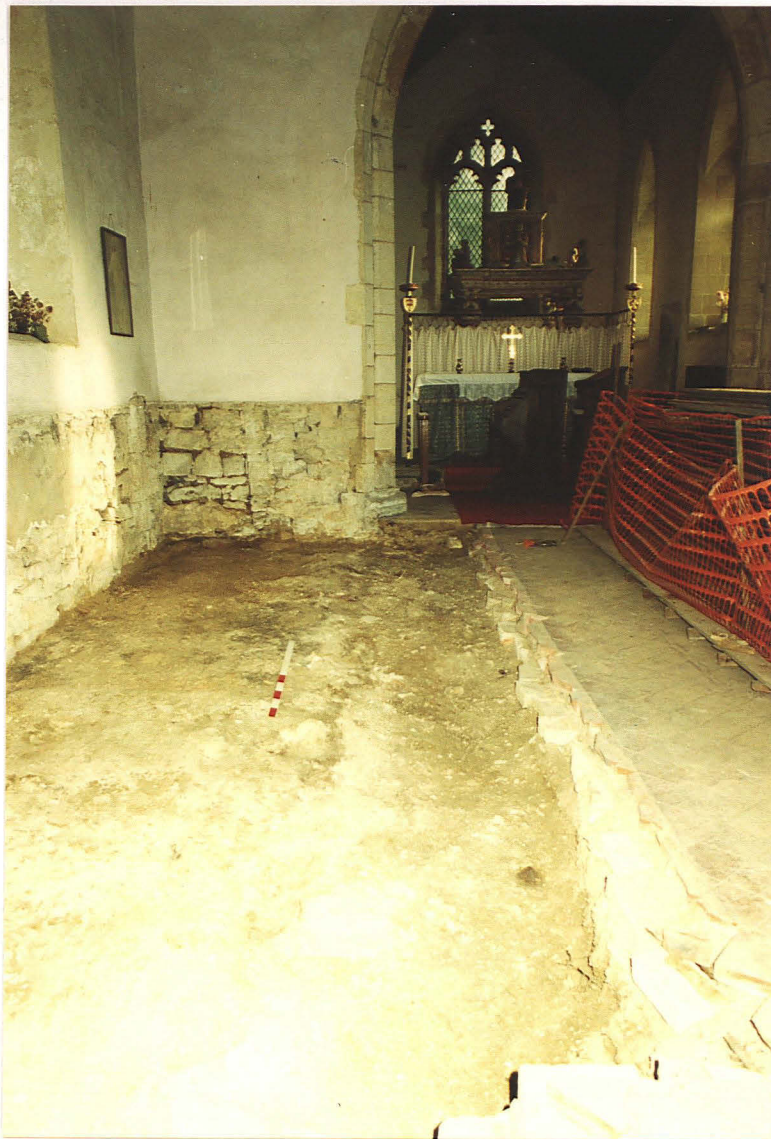
Opening 3 is situated in the eastern wall between the nave and the chancel and butts up to the corner with the northern wall of the nave (Pl. 17 and Pl. 18). This opening measured 0.70m, with the fragmentary remains of the southern jamb remaining. It had been blocked using a combination of large dressed stone blocks, small stone fragments and mortar. This opening is not visible on the east side of the nave wall (Pl. 19). As for Opening 2, modern pointing was visible. The position in the corner is awkward but may have provided access to a rood screen. Faculty records together with a series of drawings dating to 1874 show a stove in the corner of the nave, with a dotted line leading to what is considered to be a possible flue for the escape of heat and fumes. It is possible that this opening was reused as a chimney or flue.

Pl. 17 Opening 3 visible in corner of east wall, butting against northern wall of nave

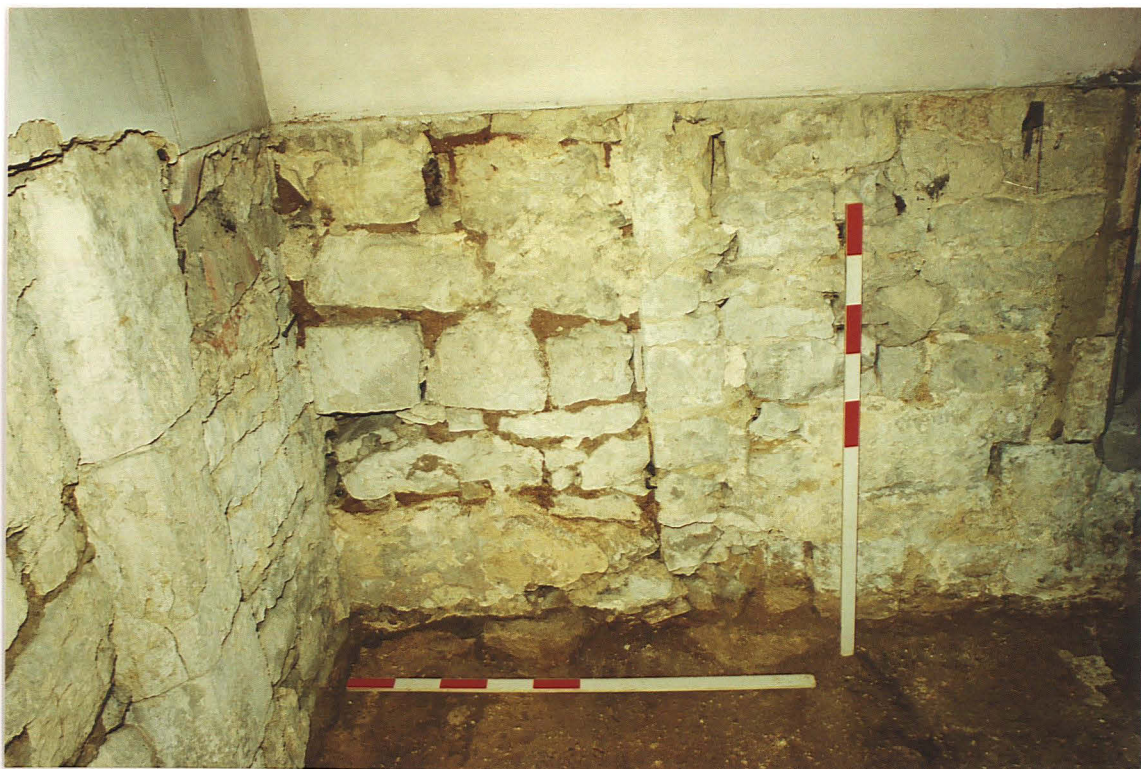
Pl. 18 Opening 3 in east wall

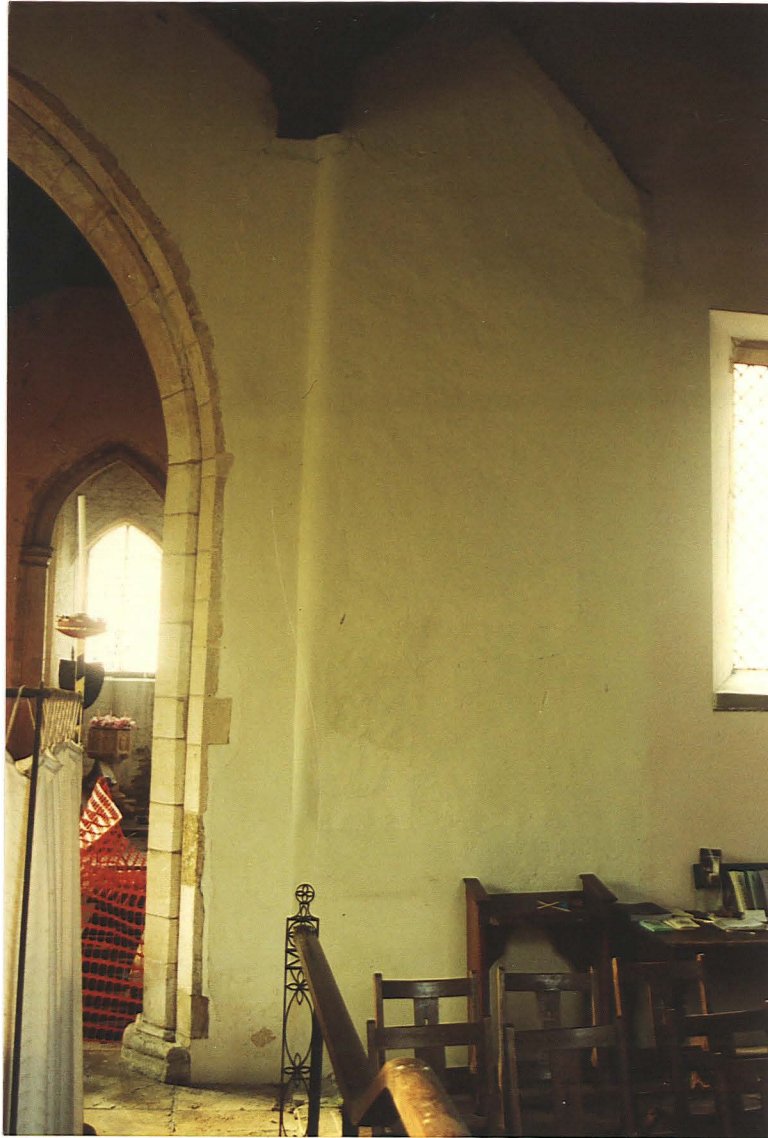
Pl. 19 East side of nave wall, Opening 3 is not visible here
