**All Saints Parish Church, Laughton, Lincs  
Archaeological Watching Brief**

Report prepared for  
Laughton Parochial Church Council

**LAS Report No. 490**

**December 2000**

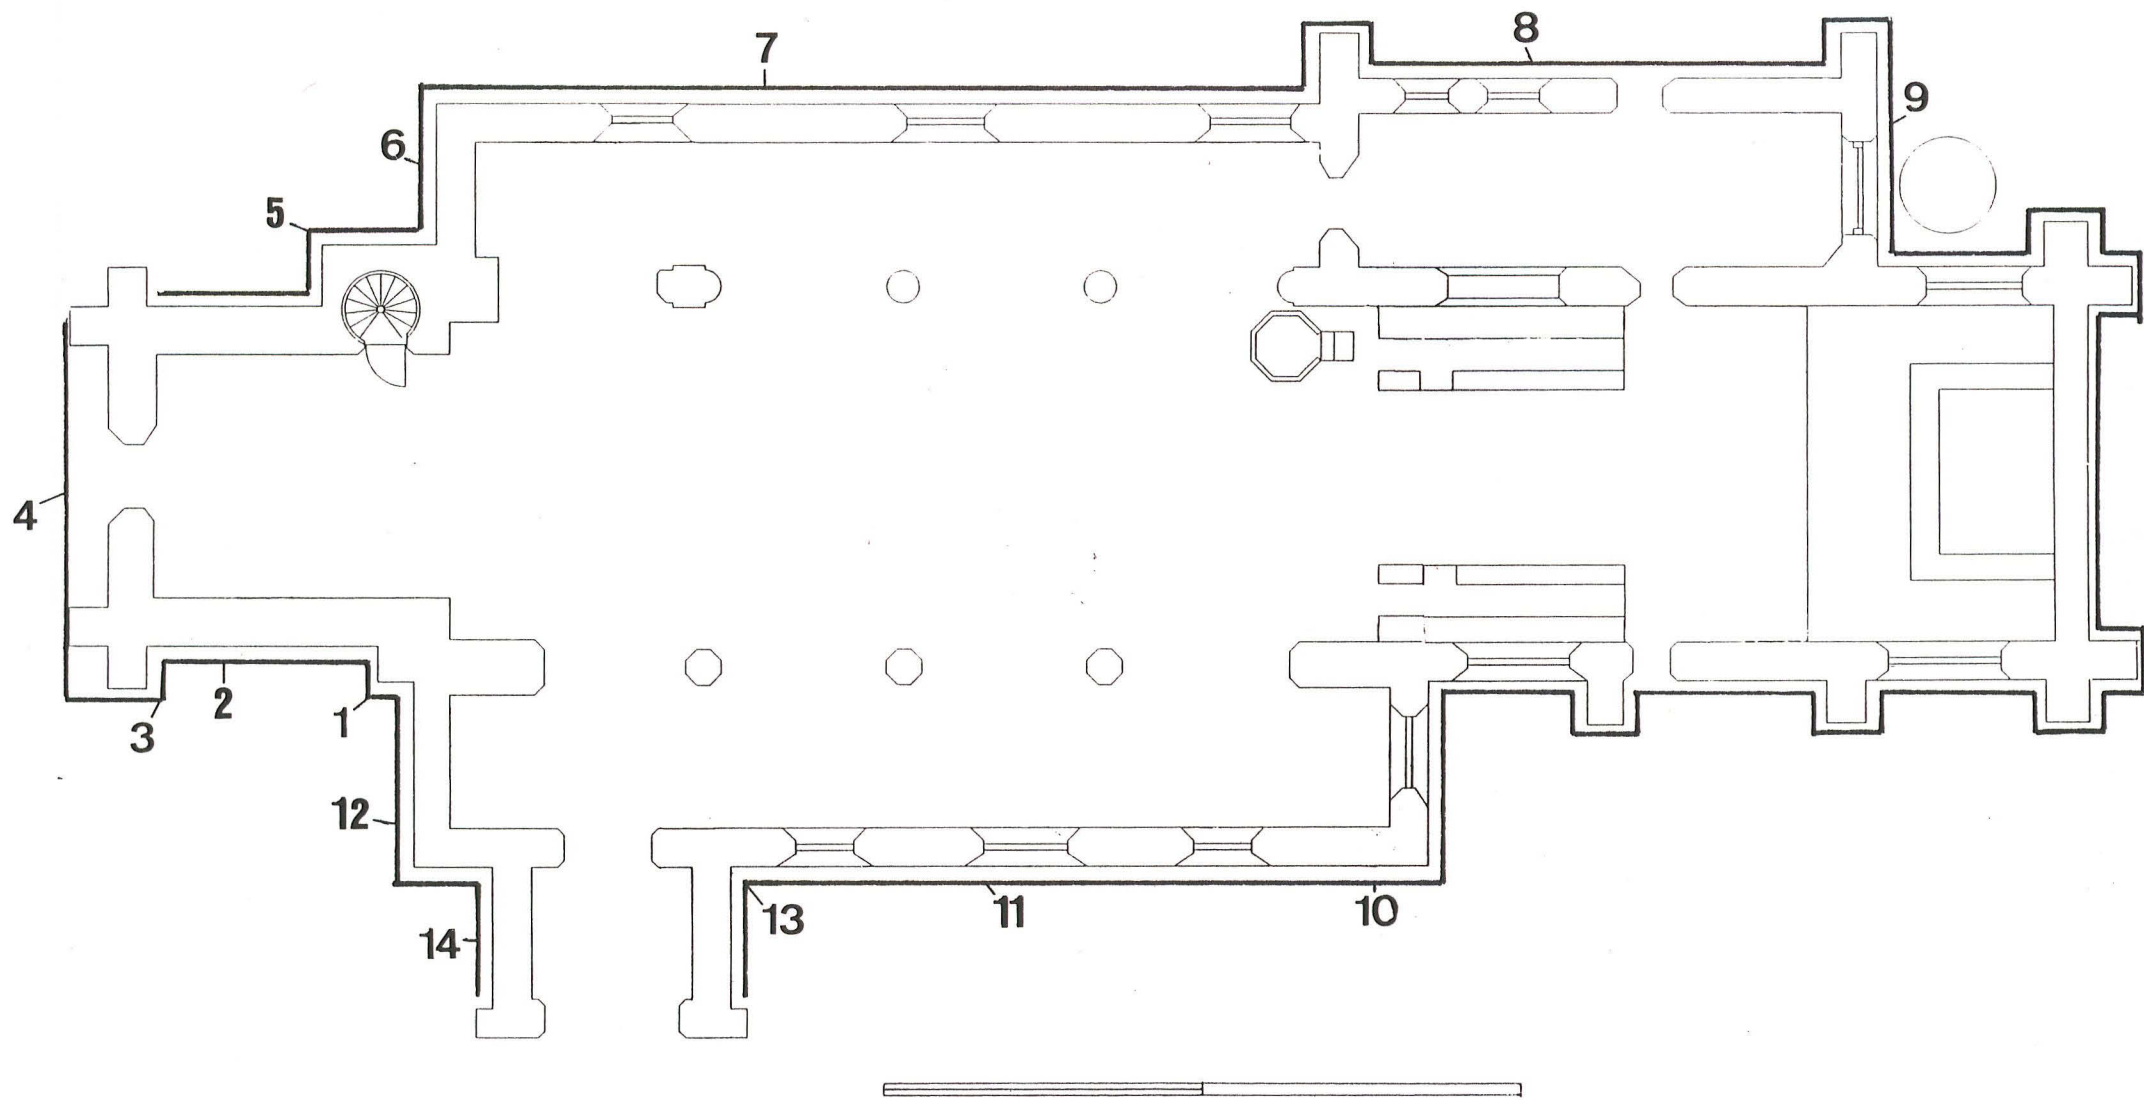
Fig. 3 Plan of Laughton Church showing position of observations made during the watching brief.

Context numbers were assigned by LAS for recording observations seen during the excavations for the new drains. These numbers were used on finds, and on the plan and section drawings included in this report. A trench was dug round the full perimeter of the church.

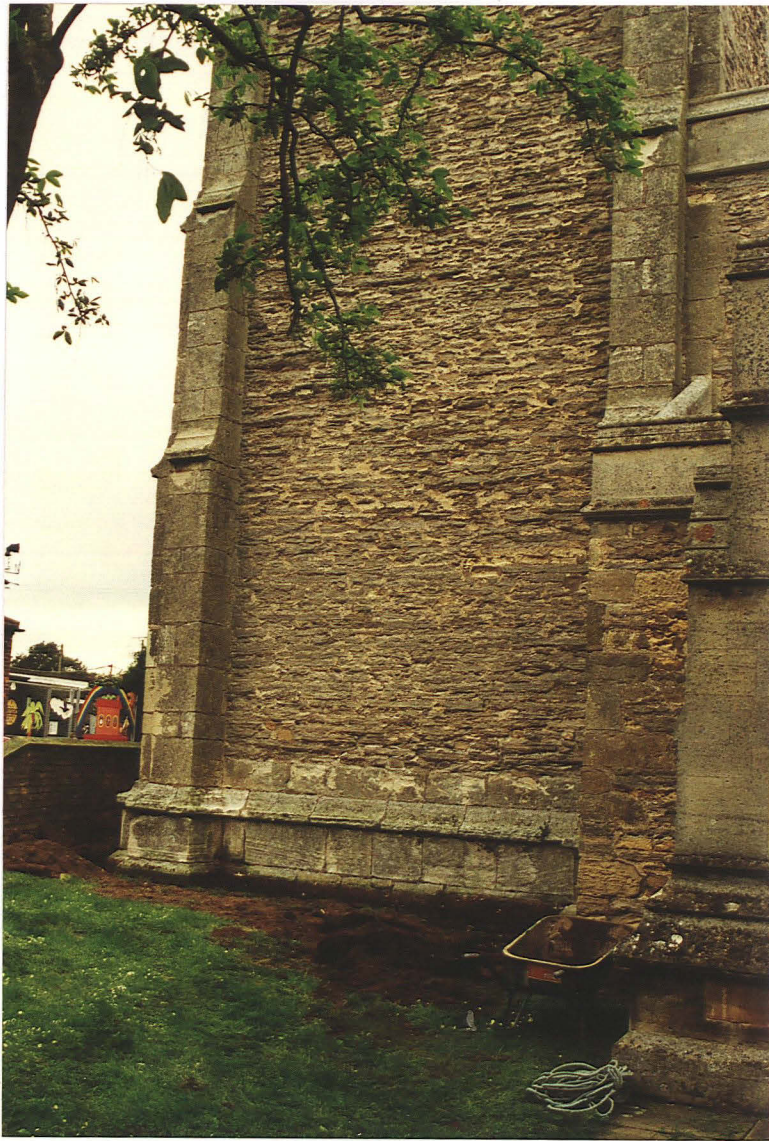
The main body of the tower is constructed in narrow courses of limestone with ashlar quoins and angle buttresses. There is a moulded ashlar plinth at the base of the tower with a chamfered course at ground level. On the south side of the tower (Pl. 1), foundations of large flat stone slabs beneath the buttress at the angle between the tower and the south aisle were recorded (1). They were off-set 0.5m to the south, and 0.65m to the west of the above-ground plinth (Pl. 2). The tower south wall foundations (2) (Pl.3) comprise three off-set courses projecting 0.35m south at the east end, but tapering to a 0.2m at the SW corner buttress (3). The well-prepared masonry of foundation (2) probably reflects a slightly mis-aligned foundation trench.

Pl. 1 South side of Laughton church tower showing excavations in progress.

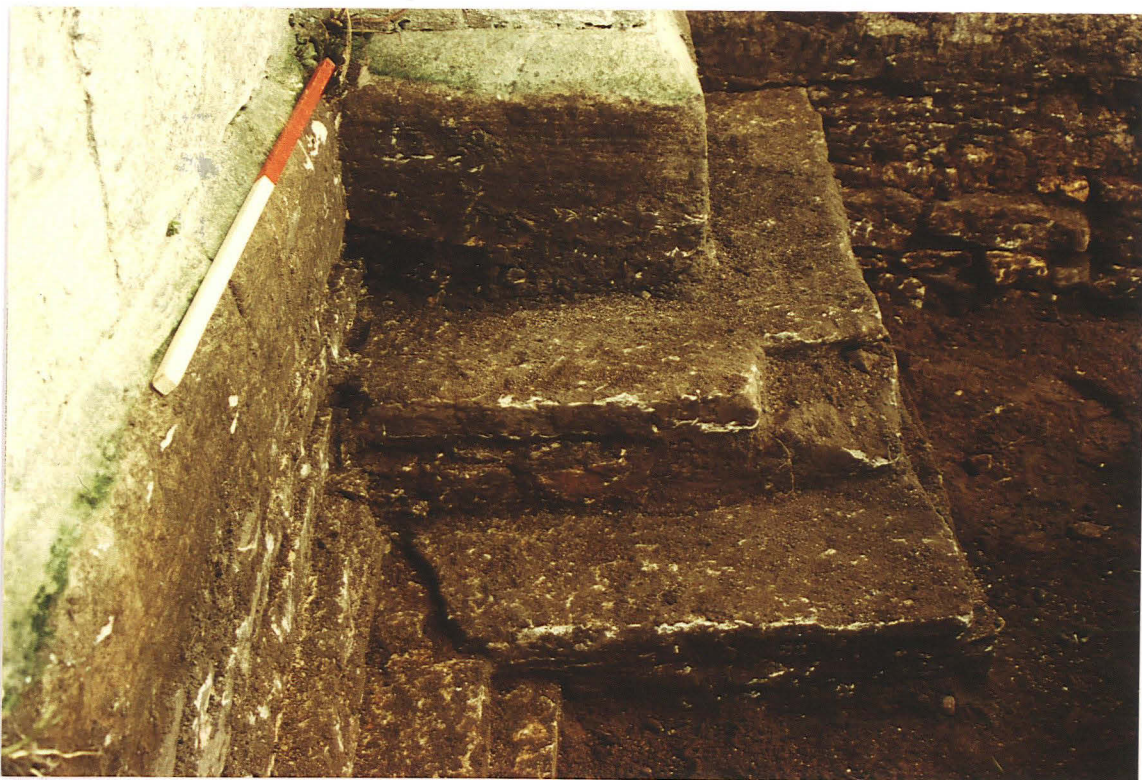
Pl. 2 SE tower buttress foundations and south aisle wall top right

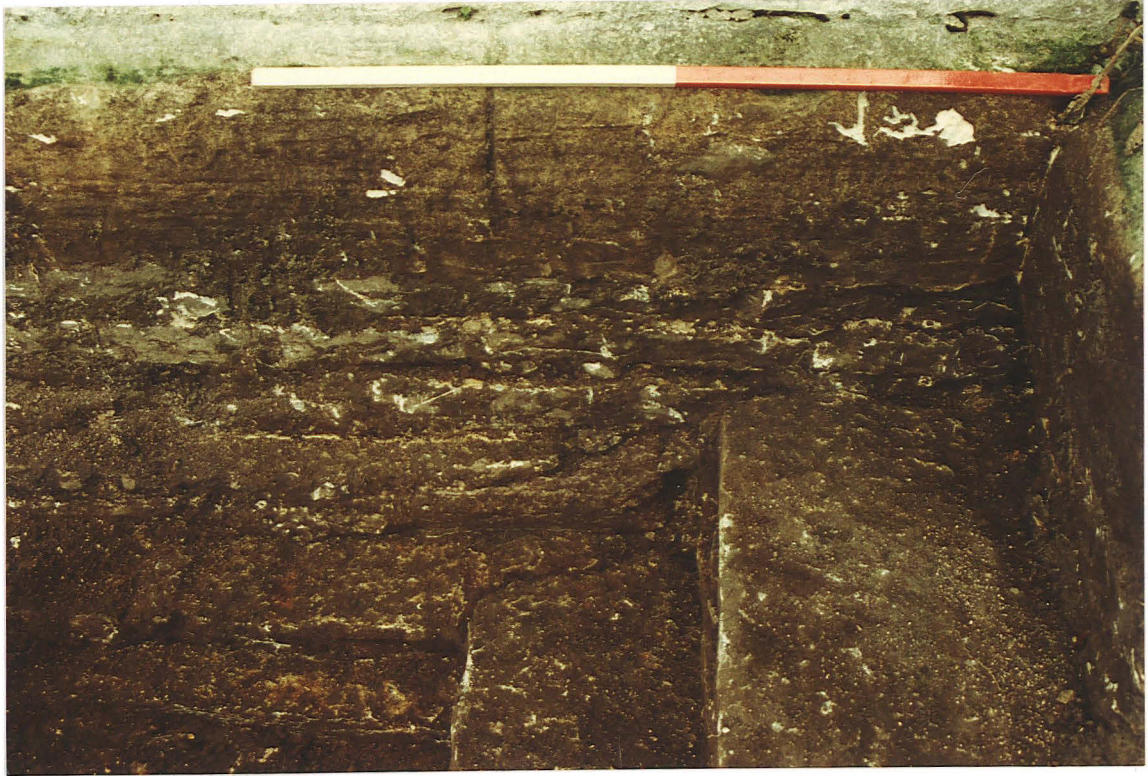
**Pl. 3 Junction of SE tower buttress and tower south wall foundations**

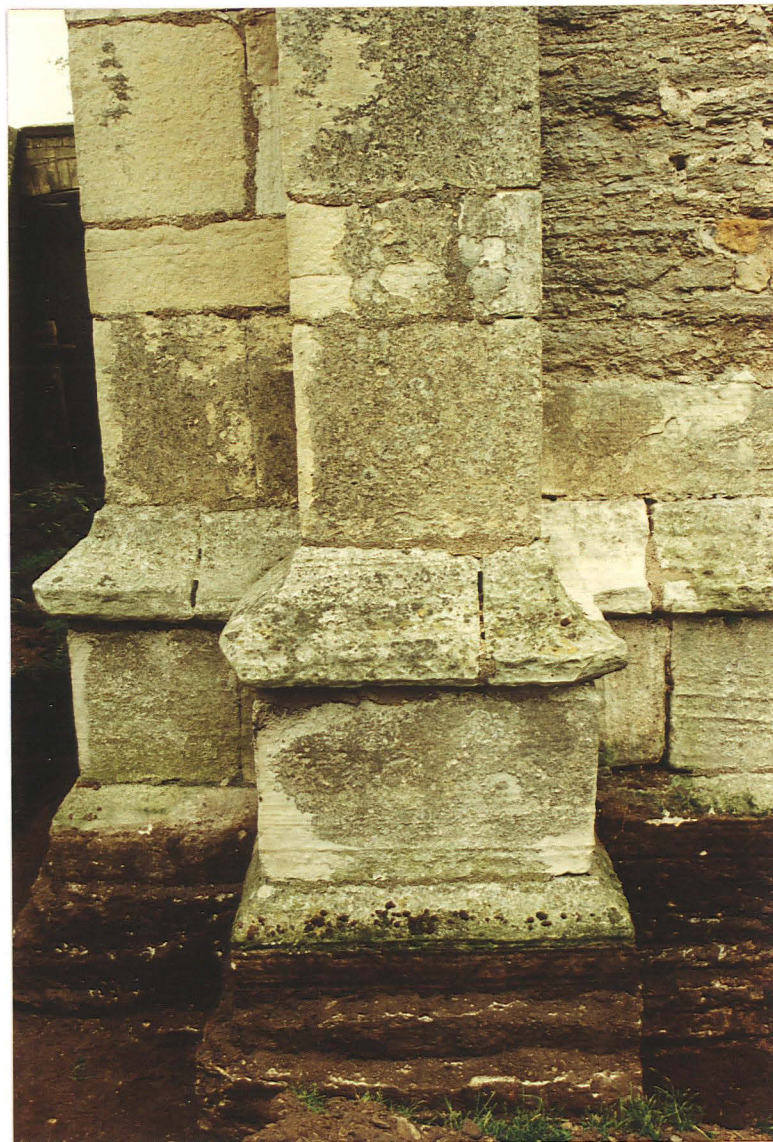
The buttress foundations at the south-west angle of the tower are off-set to the south and west by between 0.1m and 0.2m (3) (Pl. 4). One sherd of medieval pottery was found in the disturbed ground through which the new drain trench cut. Human skeletal remains were exposed at the base of the trench, but were covered and left in place. A small number of bones were collected from the spoil for reburial.

**Pl. 4 Angle buttresses at SW corner of tower with off-set foundations**

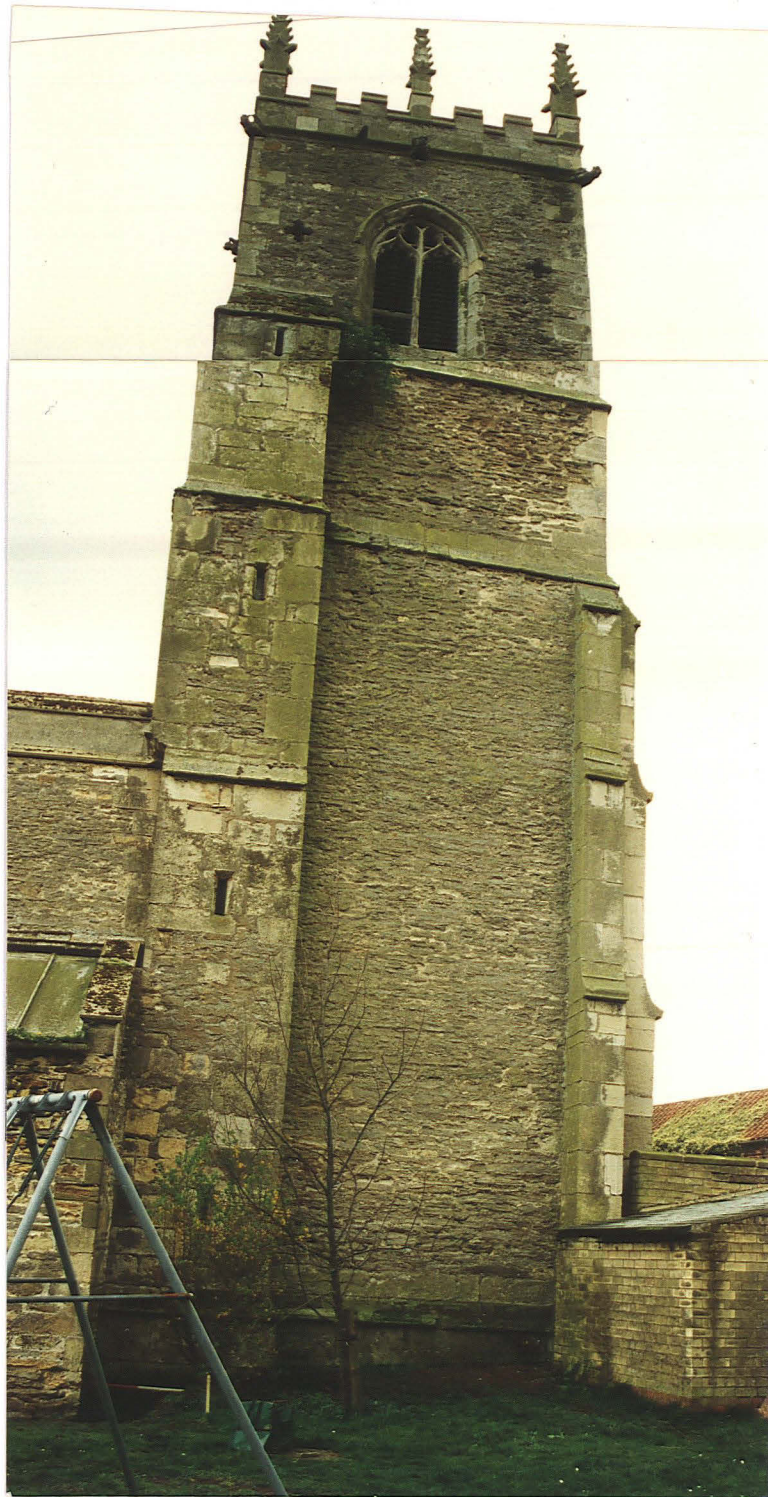
The NW angle of the tower is obstructed by a brick wall and shed. A separate 0.6m wide and 0.8m deep trench was dug along the northern side of the church. At the NE corner of the tower, is a stair turret (5) which is constructed in ashlar blocks (Pl. 5) but the plinth continues round. Below ground level, its foundation comprises a five-course off-set (Pl. 6).

PI. 5 North side of Laughton church tower with stair turret in NE angle

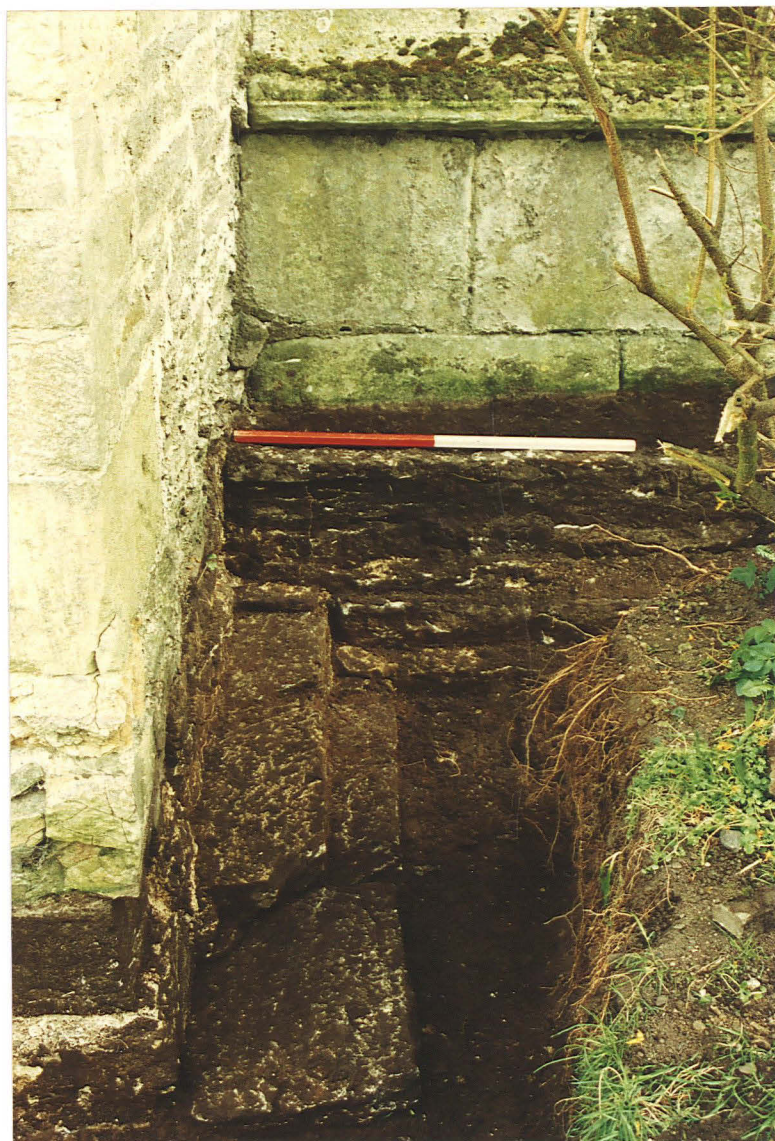
set 0.45m wide (6) . The large stones of the aisle foundations appear to be earlier than those of the stair turret (5) while the aisle wall itself appears to butt the stair turret wall. This suggests that the north aisle has been rebuilt on earlier foundations which predate the stair turret.

**Pl. 6 Stair turret foundations sitting over the broad foundations beneath the north aisle west wall**

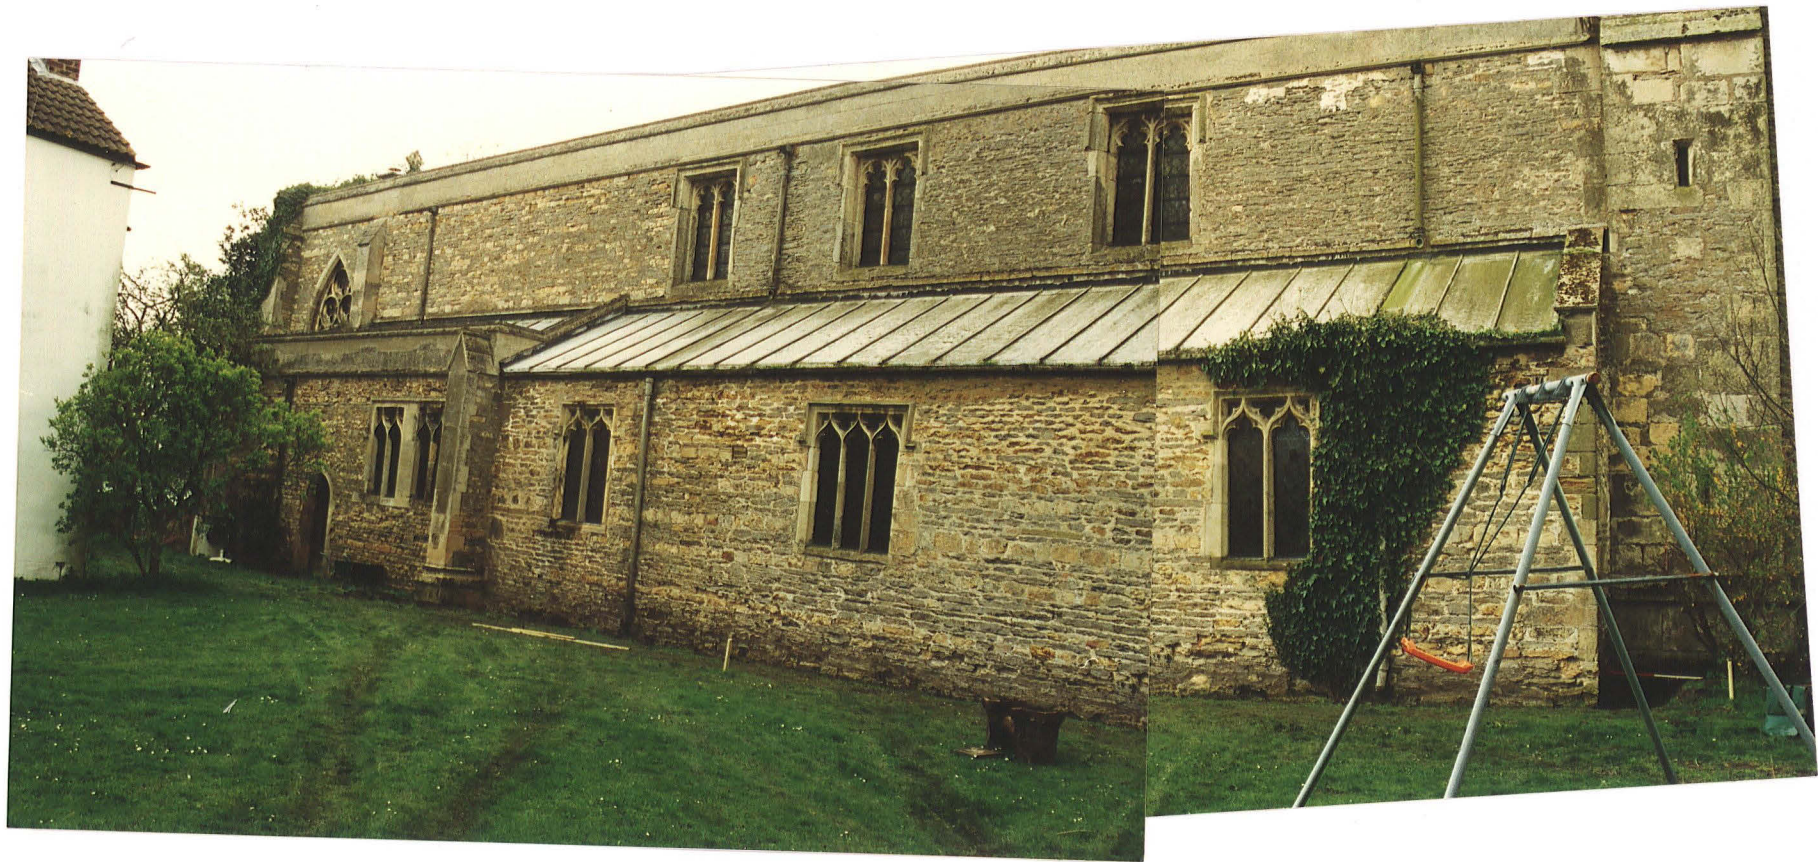
The north aisle of the church forms the southern boundary of a private property (Pl. 7). The foundations beneath the aisle west wall are two courses of large flat slabs of stone forming an off-

**Pl. 7** General view of the north aisle and vestry (left) with the nave clerestory above

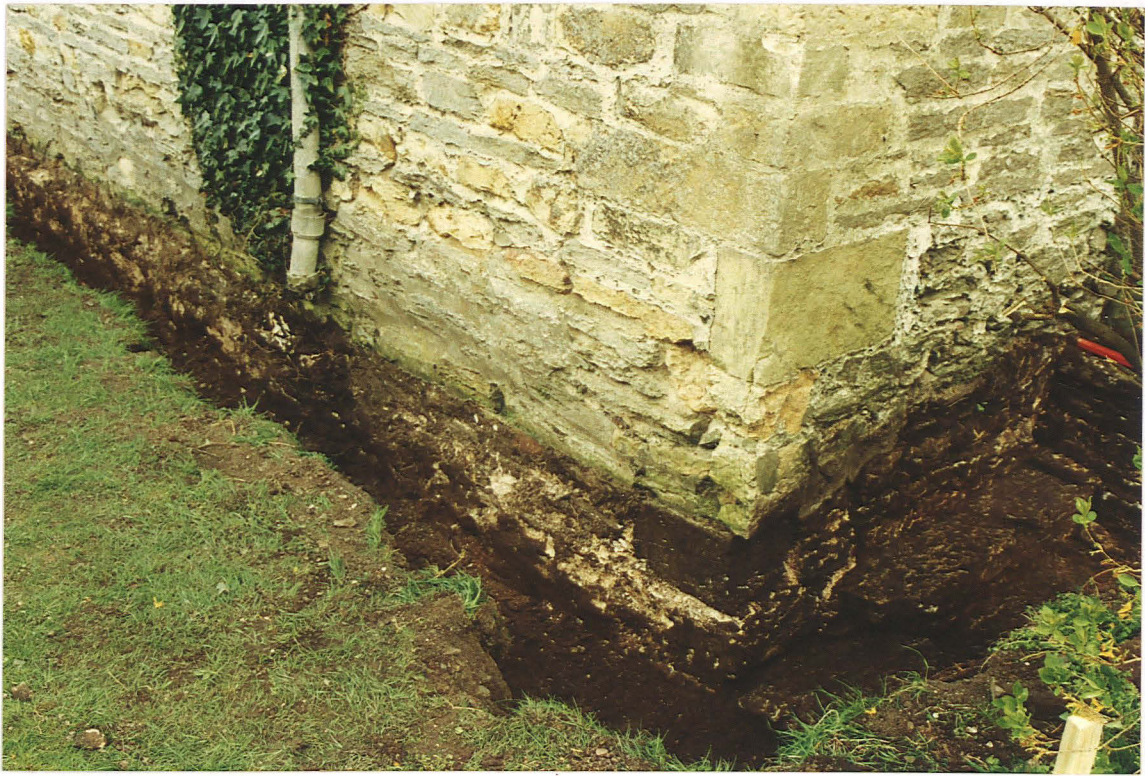
The foundations along the aisle north wall (7) comprise much smaller stones and are quite different in character to those beneath the west wall (Pls 8 and 9). It is possible that the present aisle is slightly broader than an earlier version. This interpretation fits with the fact that the north arcade is Norman while the windows of the north aisle are 15<sup>th</sup> century confirming a rebuild of an earlier aisle.

**Pl. 8 NW angle of the north aisle showing different character of the foundations along the north and west walls**

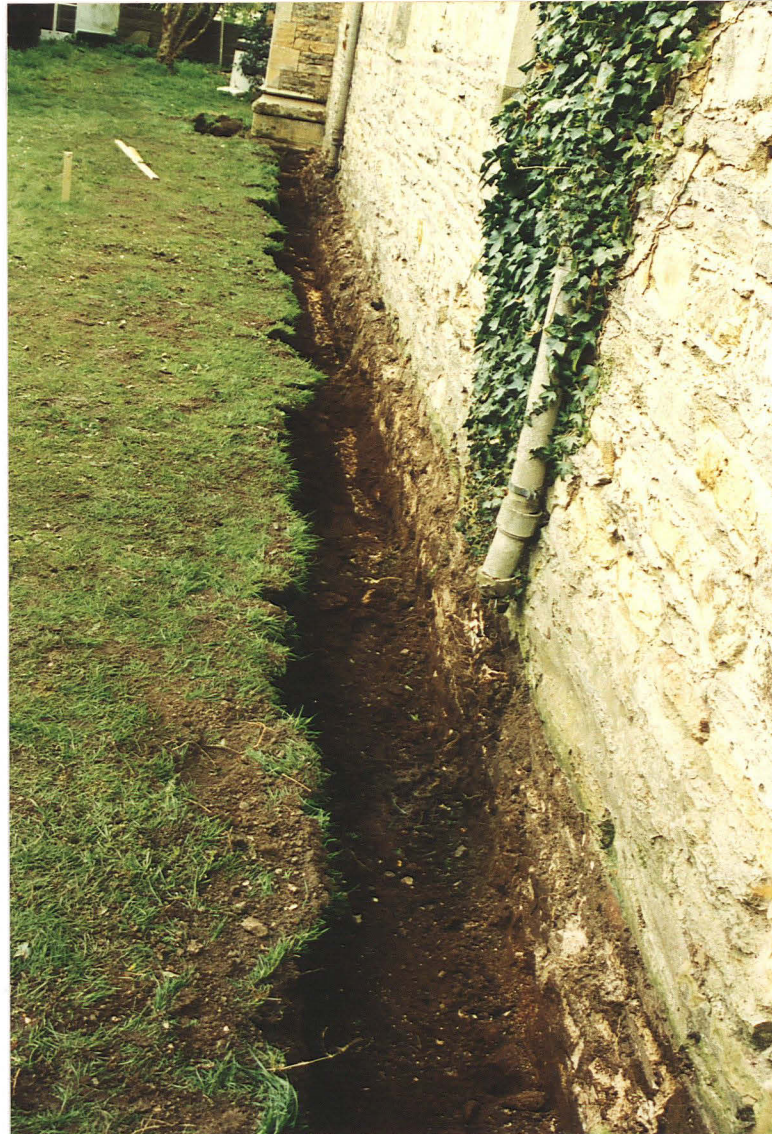
**Pl. 9 View looking east along north aisle north wall showing neat, off-set foundations of small sized stone**

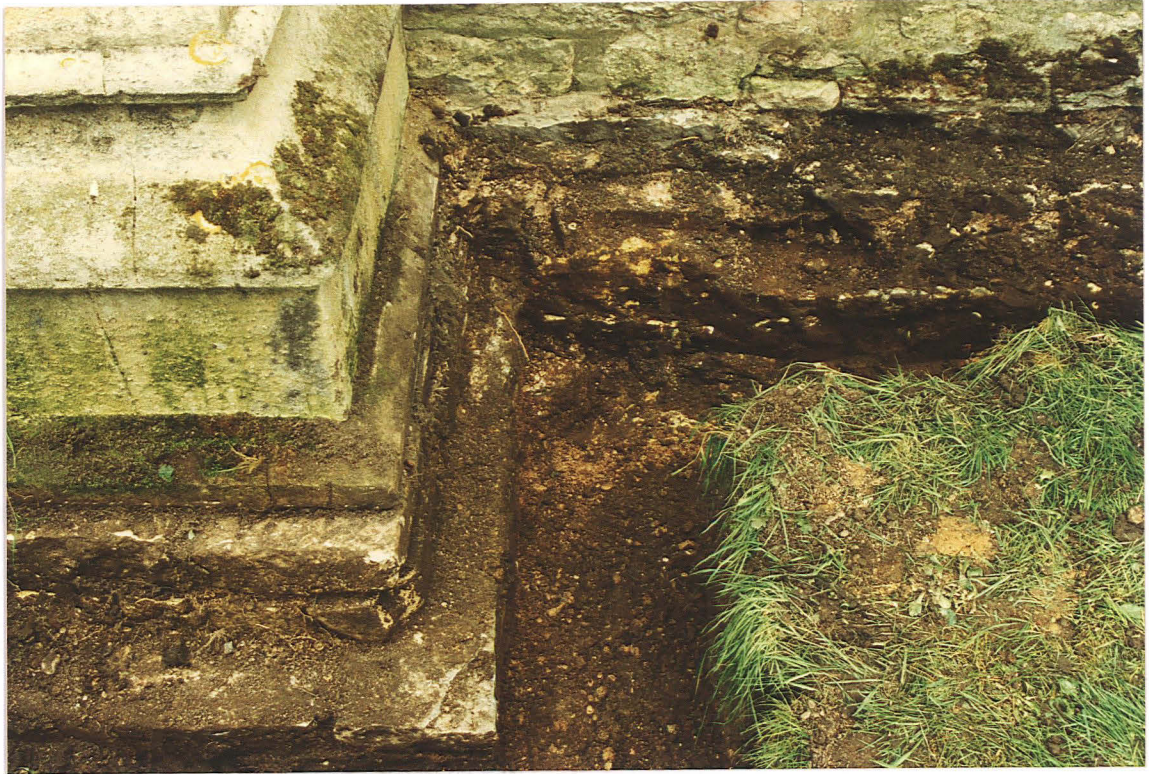
At the eastern end of the north aisle is the nineteenth century vestry/organ chamber (8) which projects slightly beyond the aisle wall alignment. The windows imitate the fifteenth century style of those in the north aisle. Access is through entrances in the east wall of the north aisle and the chancel north wall. The buttress at the junction with the north aisle wall belongs to the Victorian work of the vestry (Pl. 10).

**Pl. 10** Added buttress at junction of north aisle and vestry

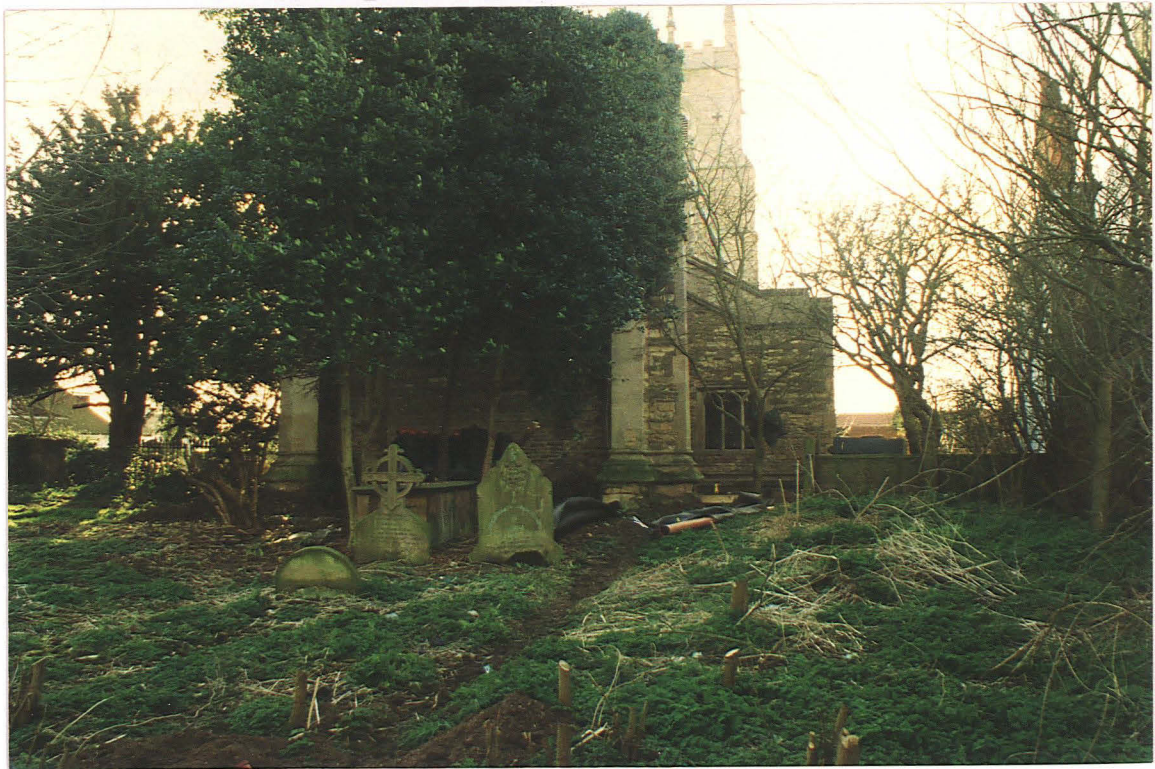
A new oil tank was sited in the angle between the vestry/organ chamber and the chancel (Pls. 11 and 12). Neither the foundations for the tank support, or for the new drain trench around the walls, revealed any features beyond the walls. The east wall of the vestry (9) has a moulded plinth and a chamfered course at ground level, similar to that around the tower which looks very worn in places and is probably reused. The wall butts the chancel south wall (which has neither plinth or chamfer on this elevation).

**Pl. 11** General view of east end of church showing chancel and vestry

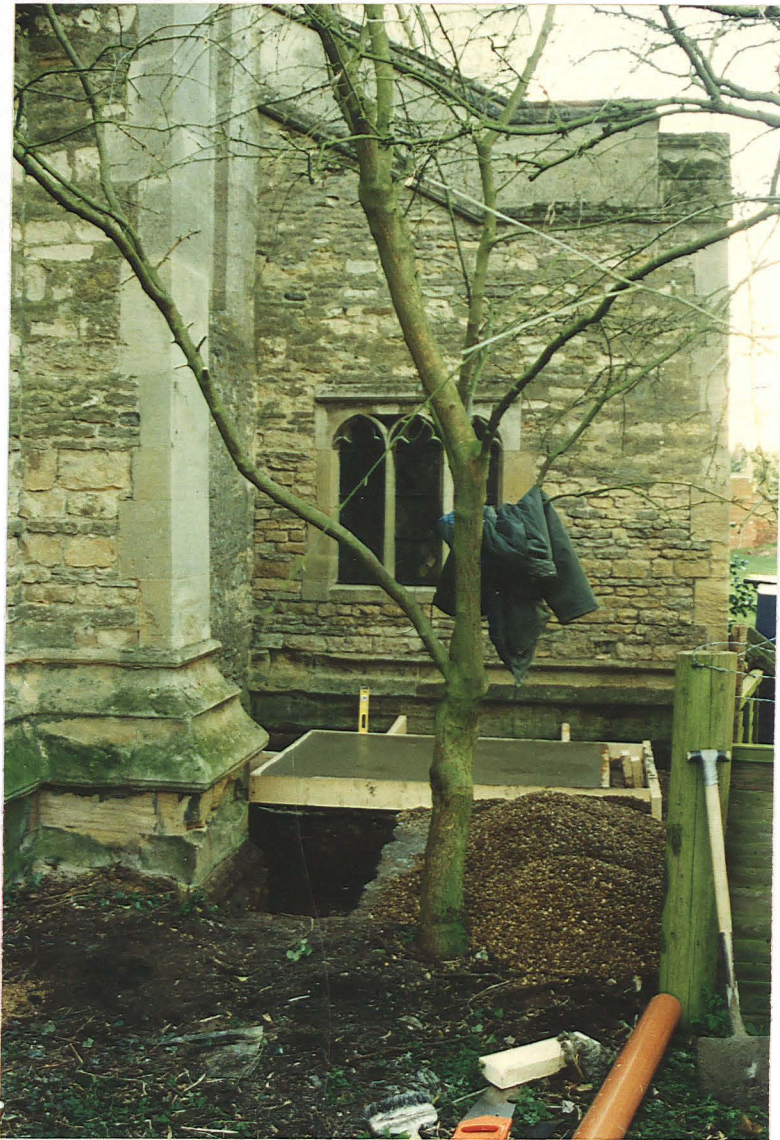
Pl. 12 Concrete base for oil tank in north of chancel

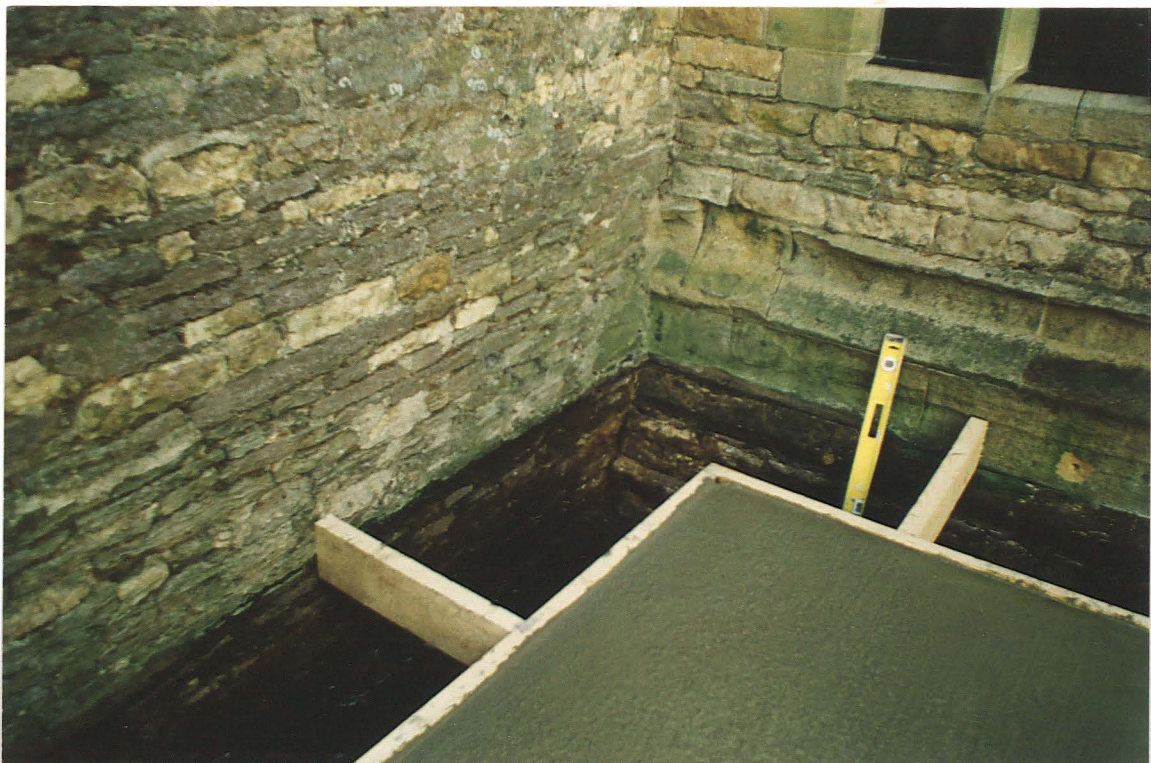
Pl. 13 Detail showing vestry wall (right) butting chancel north wall (right)

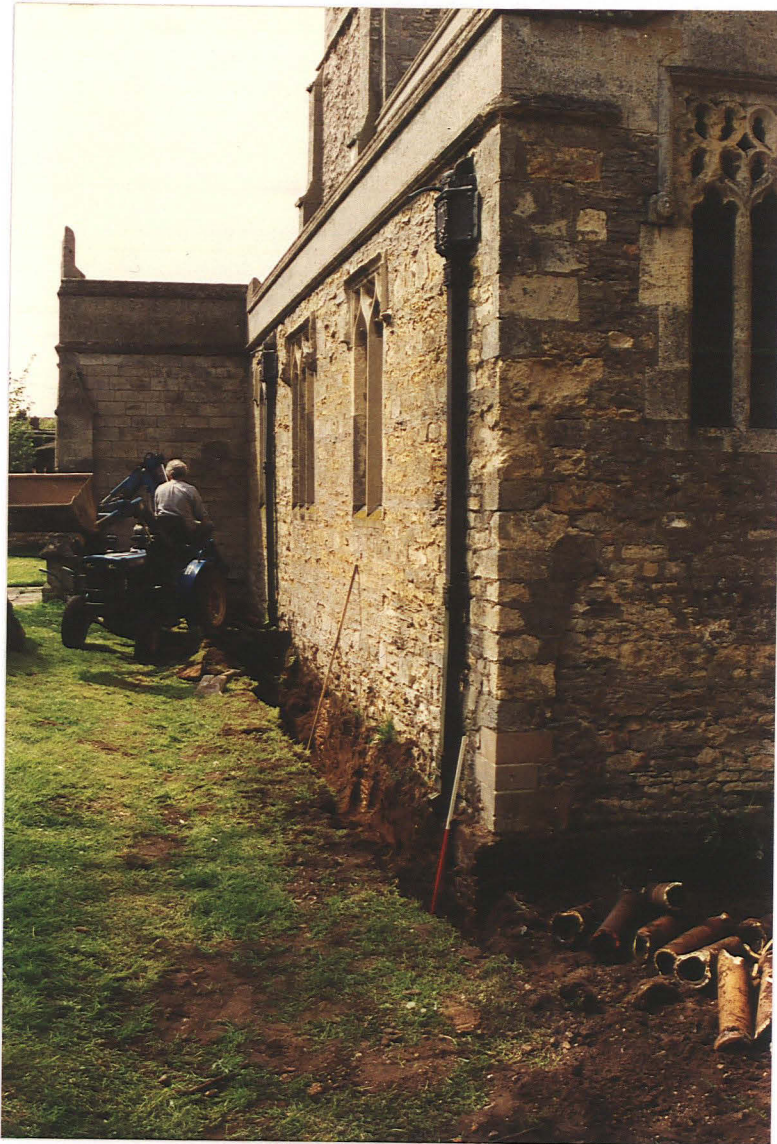
The trench was excavated slightly to the south of the wall, in order to avoid accidental damage to the masonry. At intervals, small areas of the foundations above the level of the trench base were cleaned (Pl. 14). These revealed that, although at the eastern end of the aisle the wall rests on the edge of its foundation, the foundation gradually projects as the porch is approached. On closer examination, two distinct types of construction were observed.

Pl. 14 General view along south aisle south wall

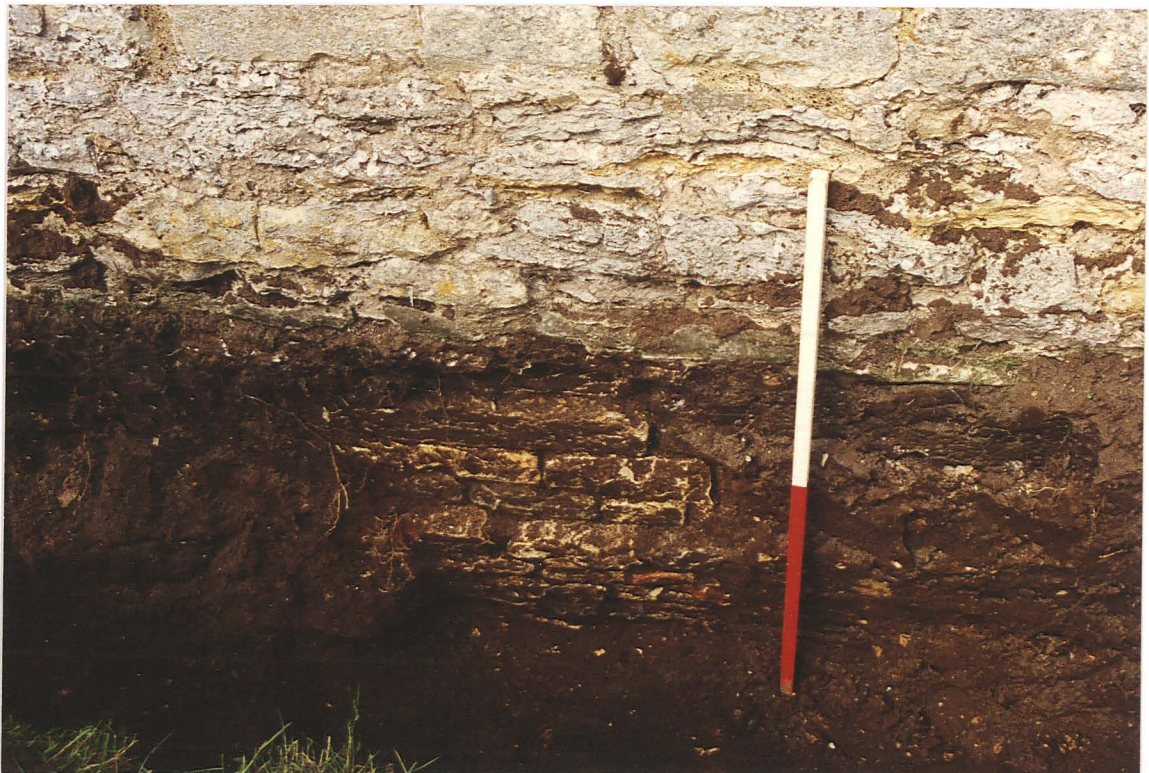
At the east end the foundation (10) is of regular rectangular blocks of limestone (Pl. 15). About 0.5m below the present ground level is a chamfered course, offset about 0.05m from the wall. Just

Pl. 15 Detail of south aisle south wall foundations east of the windows

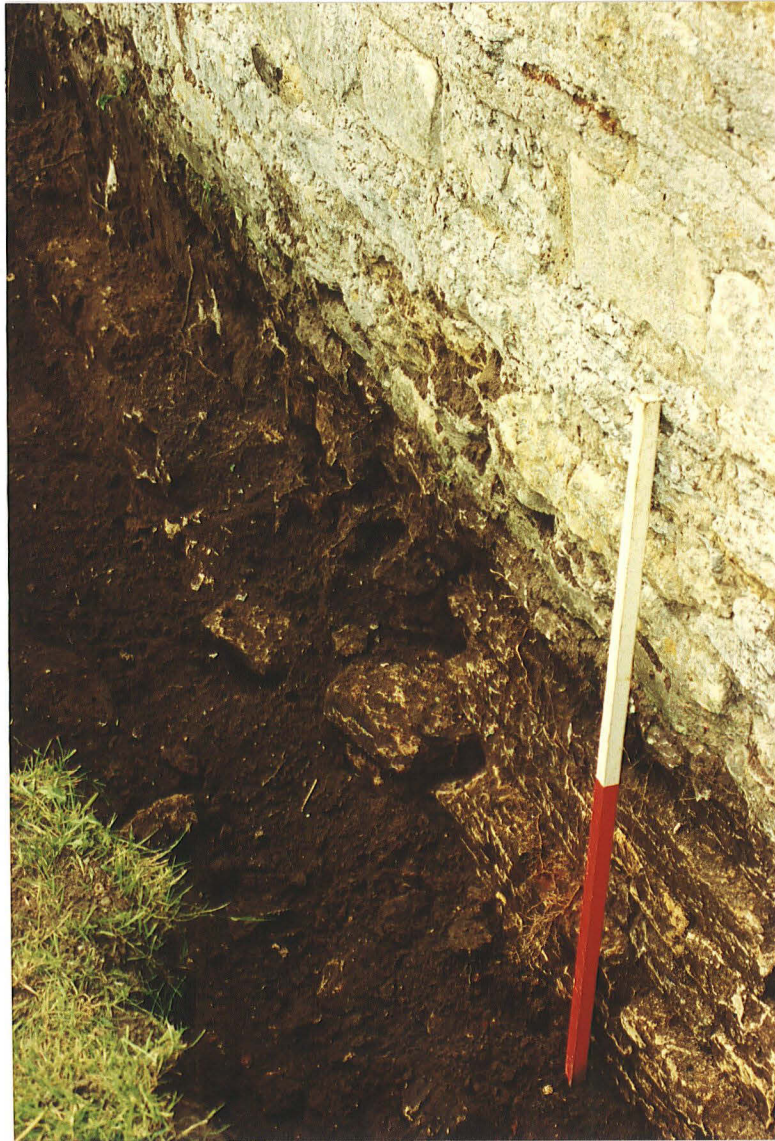
west of the east window, 5m from the corner, the character of the foundation changes and becomes broader and more the rubble coursing more irregular (11) (Pl. 16). It is on a slightly different alignment to the present wall, and protrudes 0.3m from the aisle wall near the porch (Pl. 17). Its stones are bonded with a light brown clay loam. The drainage trench was not sufficiently deep or wide to reveal any associated construction trench. Above ground level, mortar had been used to join the rubble foundation crudely with the overlying wall, offering a further hint that the existing wall incorporates *in situ* fabric of an earlier wall.

**Pl. 16 Junction of rubble and coursed foundations beneath south aisle south wall**

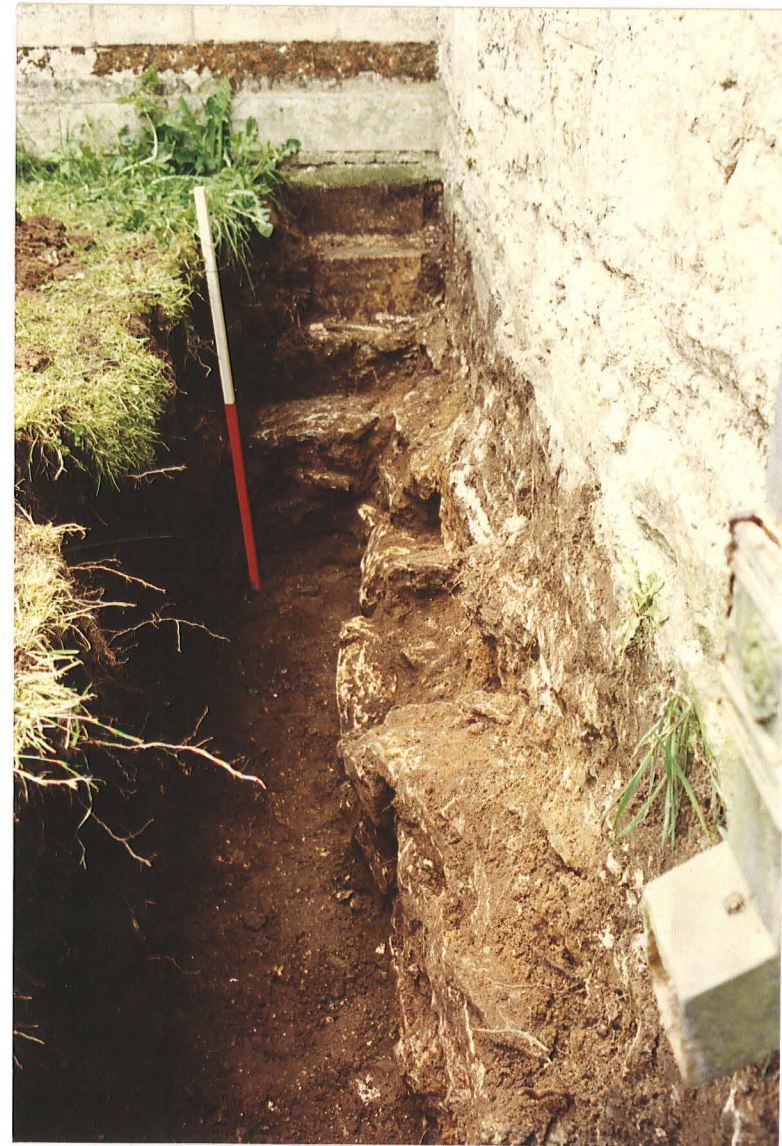
**Pl. 17 South aisle rubble foundations looking west towards south porch**

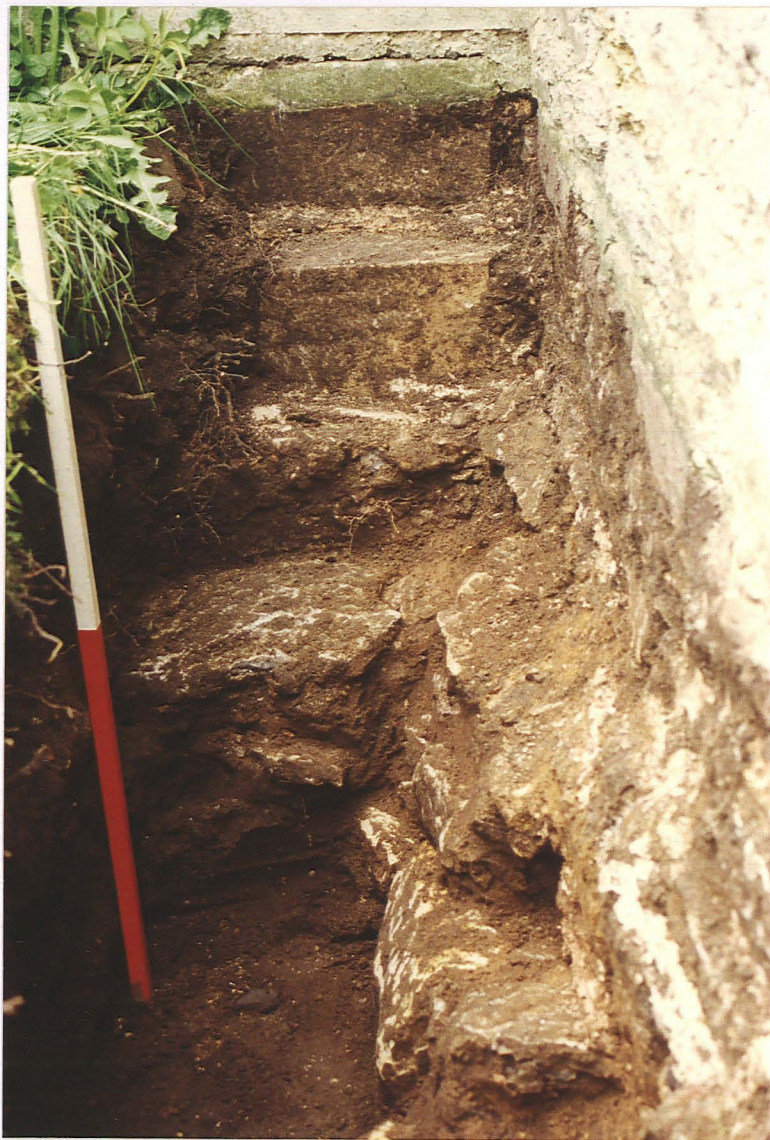
The porch was built in the 19<sup>th</sup> century (Pl. 19), probably replacing an earlier porch because lower courses of the foundations beneath its east wall (13) appear to be contemporary with foundation (11) (Pl. 18). Some cut and dressed masonry blocks in the porch wall face, near the corner, are probably re-used blocks from earlier demolition rubble.

Pl. 18 Detail of porch and south aisle foundations which appear to be contemporary, with two later courses above

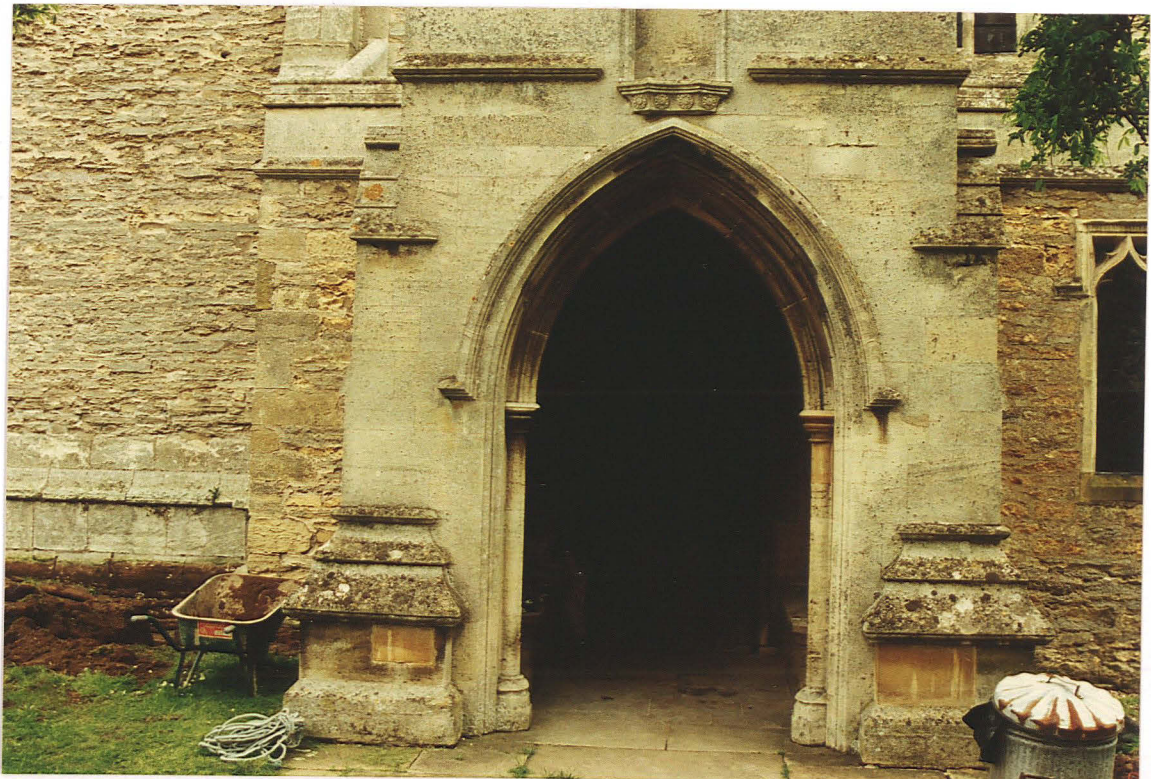
Pl. 19 The south porch

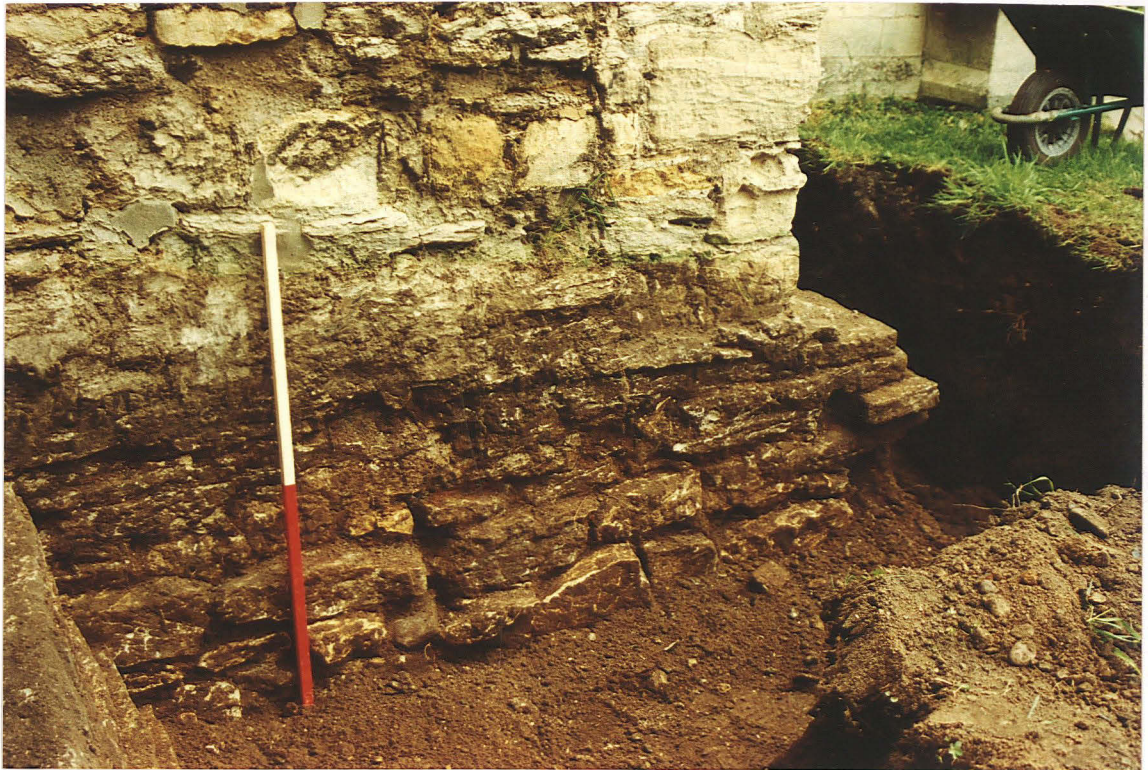
To the west of the porch, the aisle foundation (12) is similar to that seen at its eastern end, with no evidence of the rubble noted at (11) (Pl. 20).

Pl. 20 South aisle west wall foundations
