All Saints Churchyard, Heapham, Lincs
Installation of Services

Archaeological Watching Brief

LAS Report No. 489

December 2000

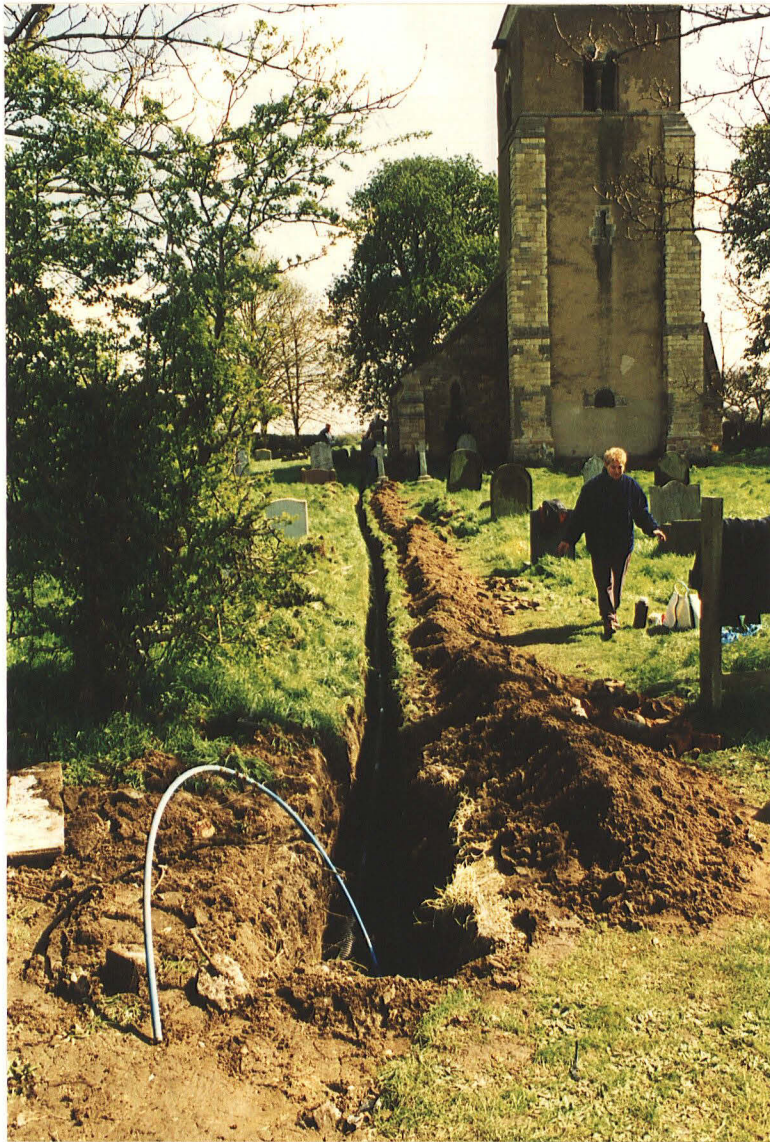
A trench 29m long, 0.3m wide and 0.45m deep, containing both the water pipe and electricity cable duct, was excavated from the NW corner of the north aisle, across the churchyard, to the road (Pl. 3).

Pl. 3 Service trench with water pipe and cable duct installed (looking east).

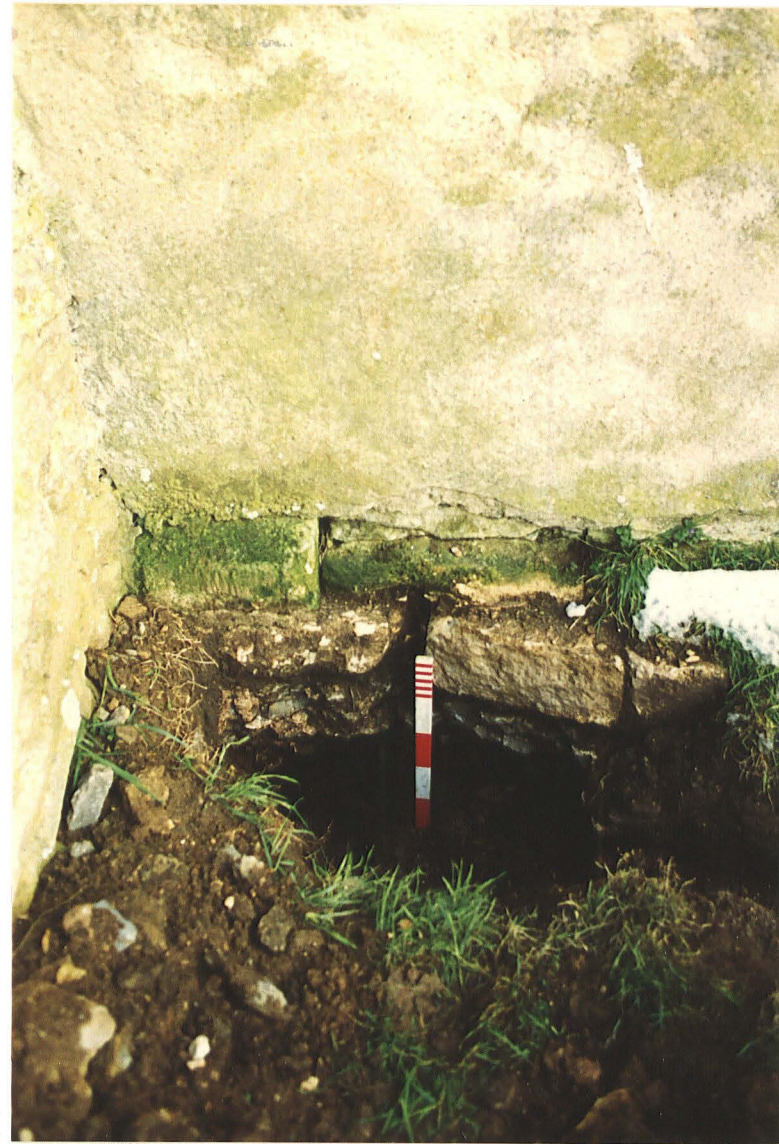
The trench revealed the tower wall foundations to a depth of 0.75m below the surface. At ground level was a plain chamfered plinth, resting on the offset rubble foundation (Pl. 4). The buttresses at the NW and SW angles of the tower are additions. Concentrations of chalk from the buttress foundations were seen in the trench (Pl. 8).

Pl. 4 Detail of the tower wall foundations exposed by the trench (looking south, scale 0.5m).

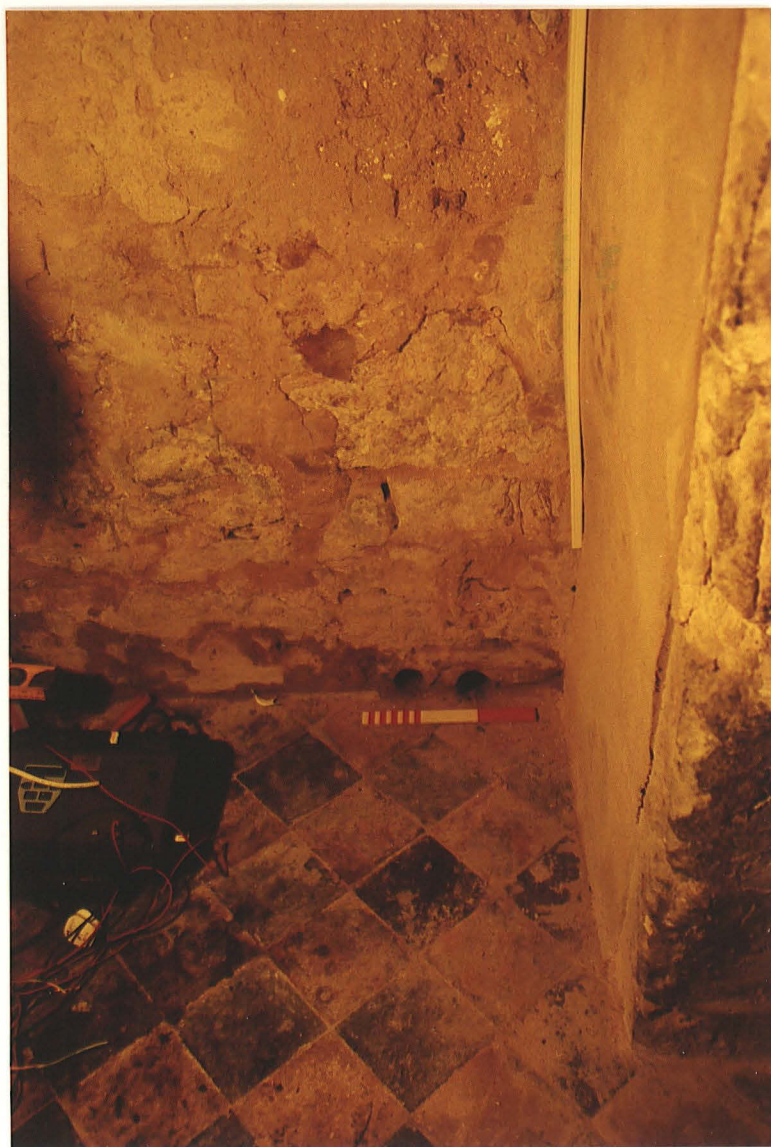
At the entrance to the churchyard (in the NW corner), the trench crossed a deposit of brick rubble and hardcore. The 0.25m thick topsoil layer 1 was a dark brown sandy soil, overlying a brown sandy loam which extended below the trench base. The subsoil contained infrequent pieces of limestone. One floodlight position was located south of this trench. The trench turned south and ran along the west wall of the aisle for 4.75m. Two 30mm diameter holes were then drilled through the base of the tower wall, for the electricity cable to enter and leave the building (Pls. 4-5). The holes caused minimal disturbance to the building's fabric.

Pl. 5 Two holes drilled through the tower north wall for the new services (interior view, looking north; scale 0.3m).

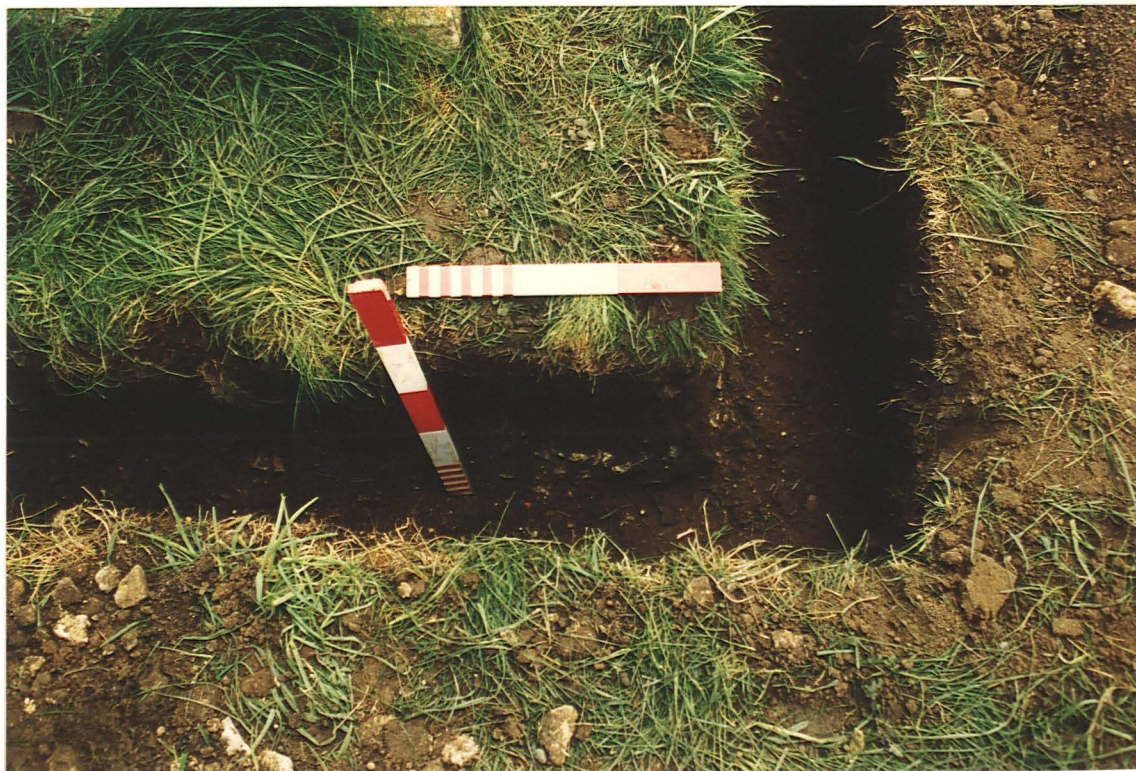
No archaeological features were disturbed during excavation of the service trenches nor were any remains identified during the watching brief, except for the chalky material associated with construction of the buttress at the NW angle of the tower.

Pl. 8 Chalk rubble foundation for NW tower buttress, exposed beneath the turf (looking south; vertical scale 0.5m, horizontal 0.3m).
