St. Germain's Church, Scothern, Lincs.

Archaeological Watching Brief

Report prepared for Scothern Parochial Church Council

LAS Report No. 514 March 2001 Hem 606

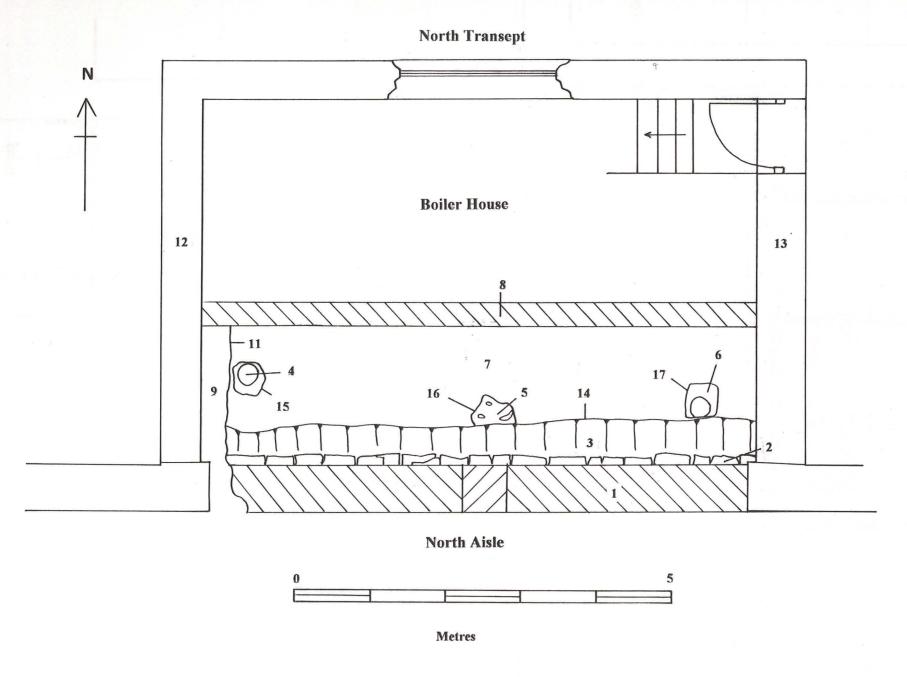
Fig. 2 Plan of the archaeological features recorded in the north transept (W. Booth, after N. Field).

Context numbers were assigned by LAS for recording purposes within the transept. The context numbers used in the report are in bold; they are indicated on the plan and photographs in this report.

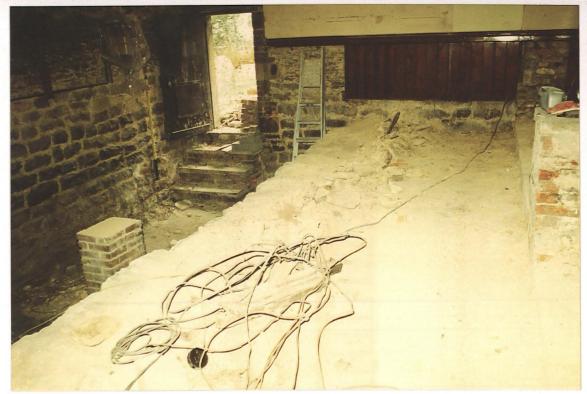
Brickwork courses from the partly removed north aisle wall, **1**, were exposed. This wall was 0.70m wide is likely to be the wall rebuilt under the Faculty of 1796. It sat on stone foundations, **2**, probably the remains of the medieval aisle wall (Pls 4 and 5). A shallow depression running parallel to the wall foundations was probably a foundation trench, **14**, associated with construction of the brick wall **1**. On top of the demolished wall **1**, was an eight-course high brick-built square pier, the base for a cast iron column providing support for the transept roof (Pl. 5).

- PI. 3 Interior of the north transept, after removal of seating, showing the boiler room (left) retaining wall 8 (centre) and the north aisle wall (right). Looking east.
- Pl. 4 Foundation trench 14 along north side of north aisle wall 1, showing stone foundation 2. Looking east.

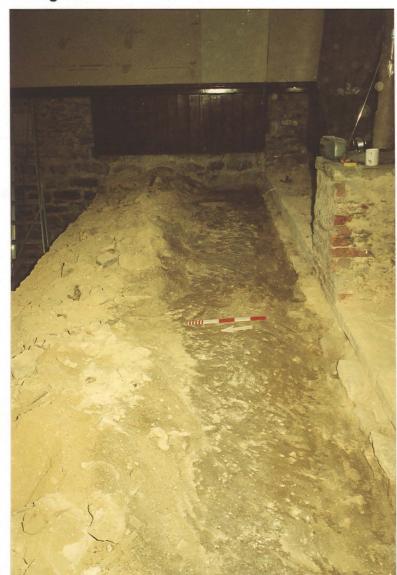
Pl. 5 Foundation trench 14 along north side of north aisle wall 1, showing stone foundation 2. Looking west.

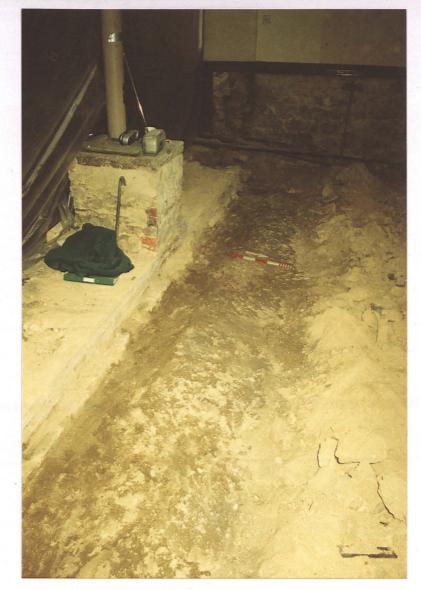
The west and east walls of the transept abutted the rebuilt north aisle wall. The foundation trench for the transept west wall, 11, had, in fact, cut through the demolished north aisle wall, proving that the north aisle rebuild and the construction of the transept were two separate events (Pl. 6). Its fill, 9, contained a single piece of stone moulding, possibly a fragment of window surround from the medieval church. No evidence for a construction trench was found for the transept east wall.

Pl. 6 Foundation trench 11 along north transept west wall. The trench cuts through the foundation of the demolished north aisle wall 1. Looking west.

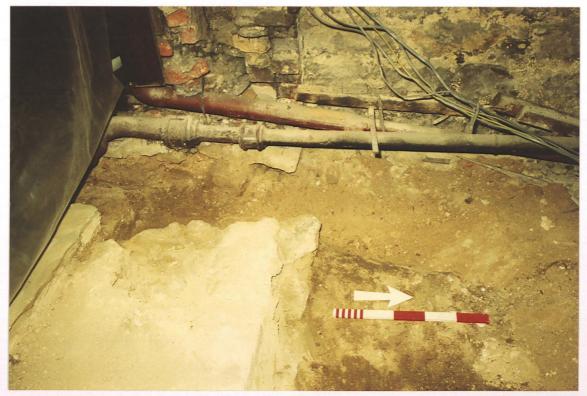
Across the centre of the transept was a mortared stone rubble retaining wall **8**, 0.36m wide (Pl. 7). This wall abutted the transept west and east walls. (Pl. 8). A single course of brickwork was seen above the stone courses during the monitoring visit but, as there was mortar on top of the brick course other brick courses had probably been removed. To the north of the wall the ground had been reduced by 1.2m, creating a cavity the full width of the transept, 7.35m x 2.65m in area, with the central heating boiler at the west end. There was (and is) external access only, via a door in the east wall of the transept, leading down four steps (Pls 2 and 3). Within this area were two brick piers which had originally supported the raked seating above.

- Pl. 7 Retaining wall 8, looking NW.
- Pl. 8 Junction of the retaining wall 8 and the west wall of the north transept.

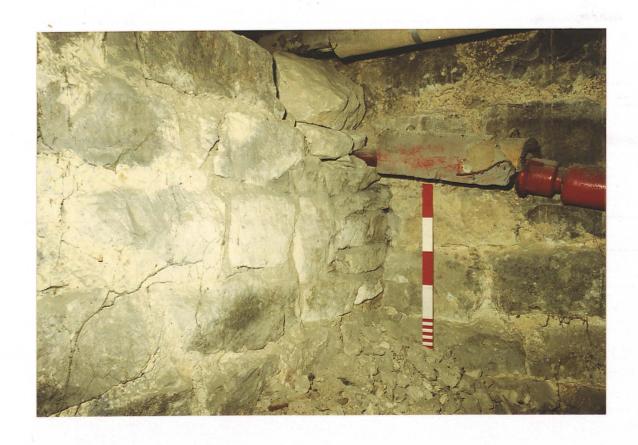
Three post-holes were visible at this level, and are therefore most likely to date from about 1840 or later. Post-hole 17, was against the edge of the north aisle wall construction trench 14. Removal of its soft fill, 6, revealed a clear circular hole where a scaffold pole had been removed. This probably marks the position of a scaffold upright associated with the 1796 rebuild of the aisle, or the later construction of the transept (Pls. 9 and 10). Finds from the fill of the posthole included two pieces of roof tile and a piece of wall plaster but they could not be closely dated.

- PI. 9 Scaffold post-hole 17/6 beside foundation trench 3 for the north aisle wall, before excavation (looking west, scale 0.5m).
- PI. 10 Scaffold post-hole 17/6, after excavation (looking north, scales 0.5m and 0.2m).
