St. Peter's Church, Navenby, Lincs.

Archaeological Watching Brief

Report for Navenby PCC

LAS Report No. 527 August 2001

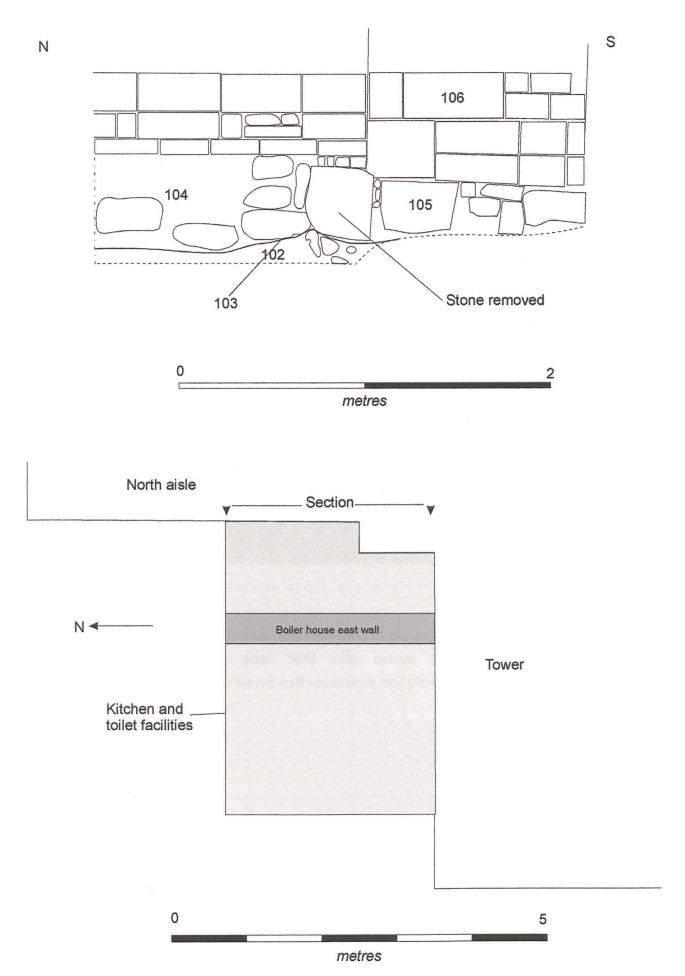
Fig. 2 St. Peter's Church Navenby. West facing elevation and plan of footprint of new kitchen and toilet facilities.

The foundations of the north aisle west wall were revealed. This north-south aligned wall (106) was contained by foundation trench 103 which was 0.50m deep and contained foundation stones 105 (Pl. 3 & Fig. 2). The foundations were also filled with a mid reddish brown silty clay with frequent limestone fragments, moderate sub-angular stones and occasional mortar fragments and charcoal flecks (104). No human remains were disturbed during the groundworks. The tower wall foundations were visible only the corner by the angle buttress (Pl. 1) where there were two narrow offset courses, 0.50m below the former ground level. These foundations were earlier and neater than those of the north aisle.

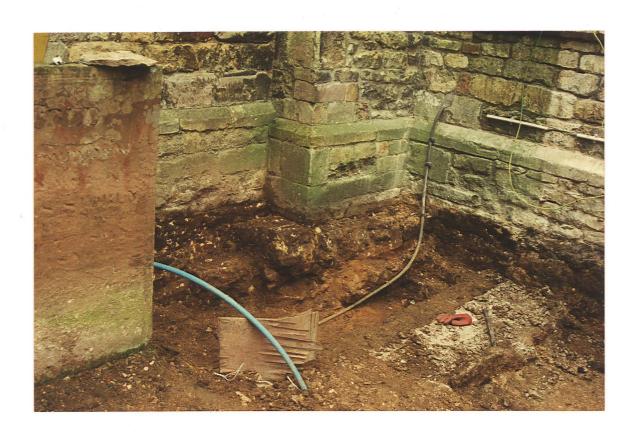
Navenby is a village on the cliff edge, 14km south of Lincoln (Fig. 1). The extension was on the NW side of the church (Pl. 1), occupying the space between the boiler room and the angle between the north aisle and the tower.

PI. 1 General view of the site after lowering of the ground, ready for construction of the extension. North aisle (left) with corner buttress, tower north wall (right). Demolished boiler house wall foundation has glove resting on it.

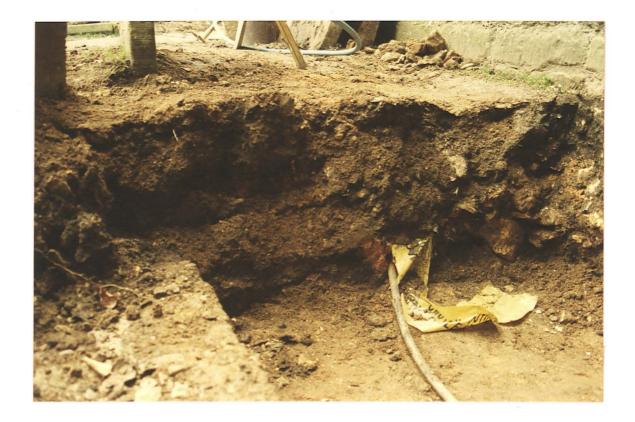
The area had been cleared prior to the arrival of the archaeologist. A dark brown silty clay topsoil, **101**, (Pl. 2) had an average depth of 0.10m. Below **101** was **102**, a mid grey brown silty clay and rubble 'make-up' layer with rounded and sub-angular stone and occasional charcoal flecks. The foundations of the boiler house east wall (**107**) were also revealed (Pl. 2).

Pl. 2 West facing elevation, showing foundation stones beneath north aisle west wall.

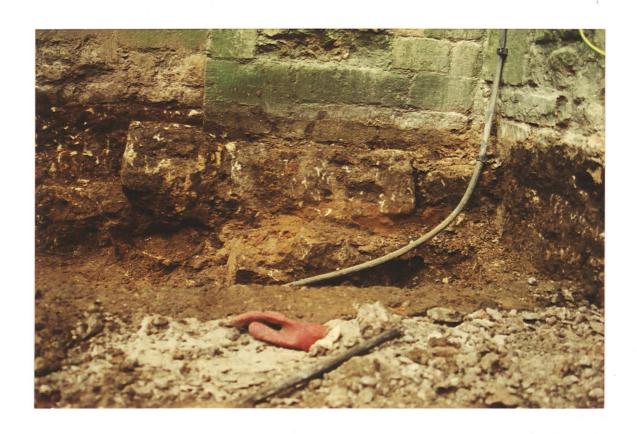
Pl. 3 South facing section of trench, showing disturbed ground and electricity cable, with boiler house foundation in foreground, left.
