**St Michael's Church Burwell, Lincs
Archaeological Watching Brief**

Archaeological Watching Brief

LAS Report No. 570

January 2002

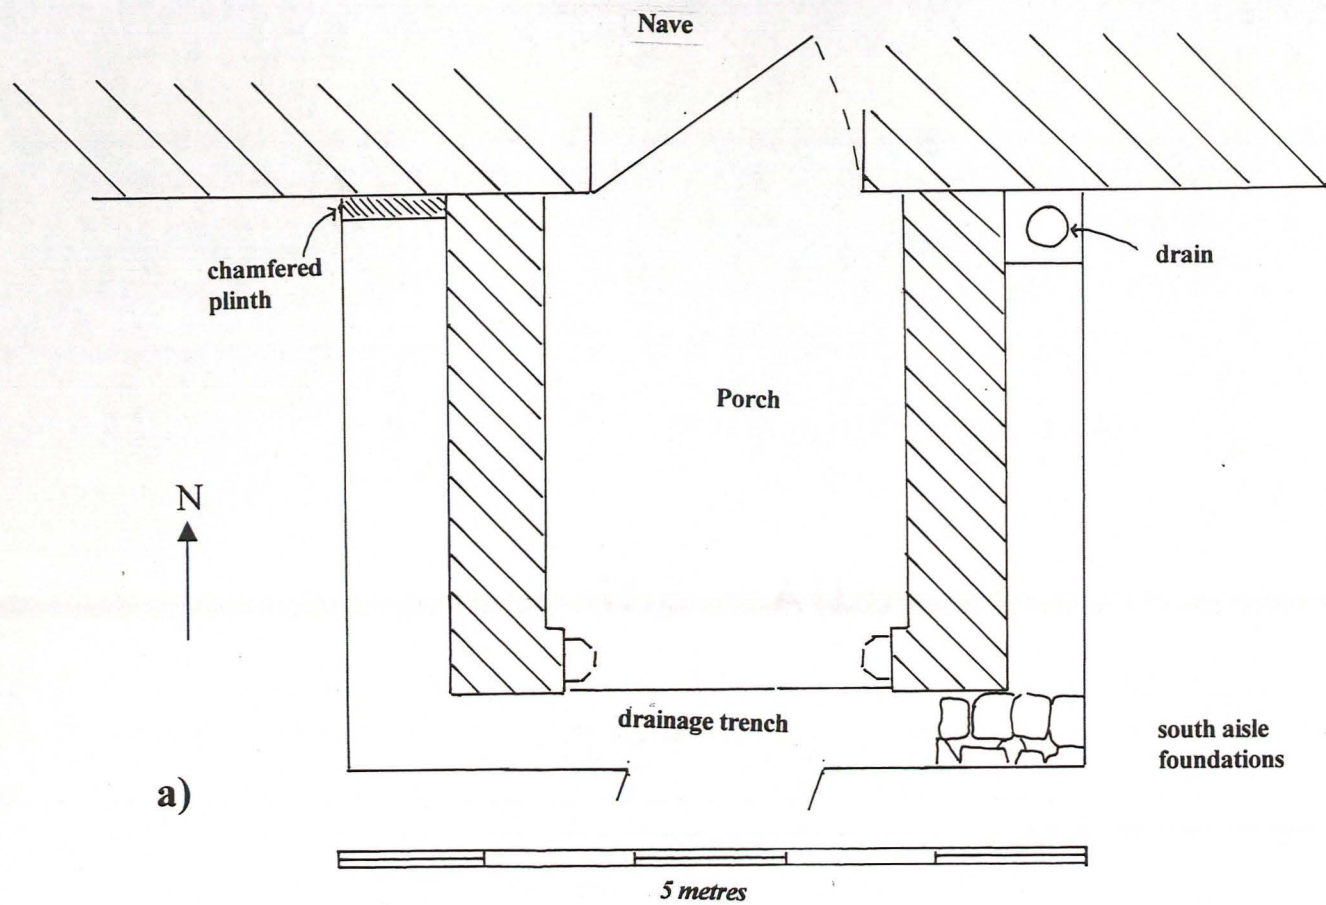
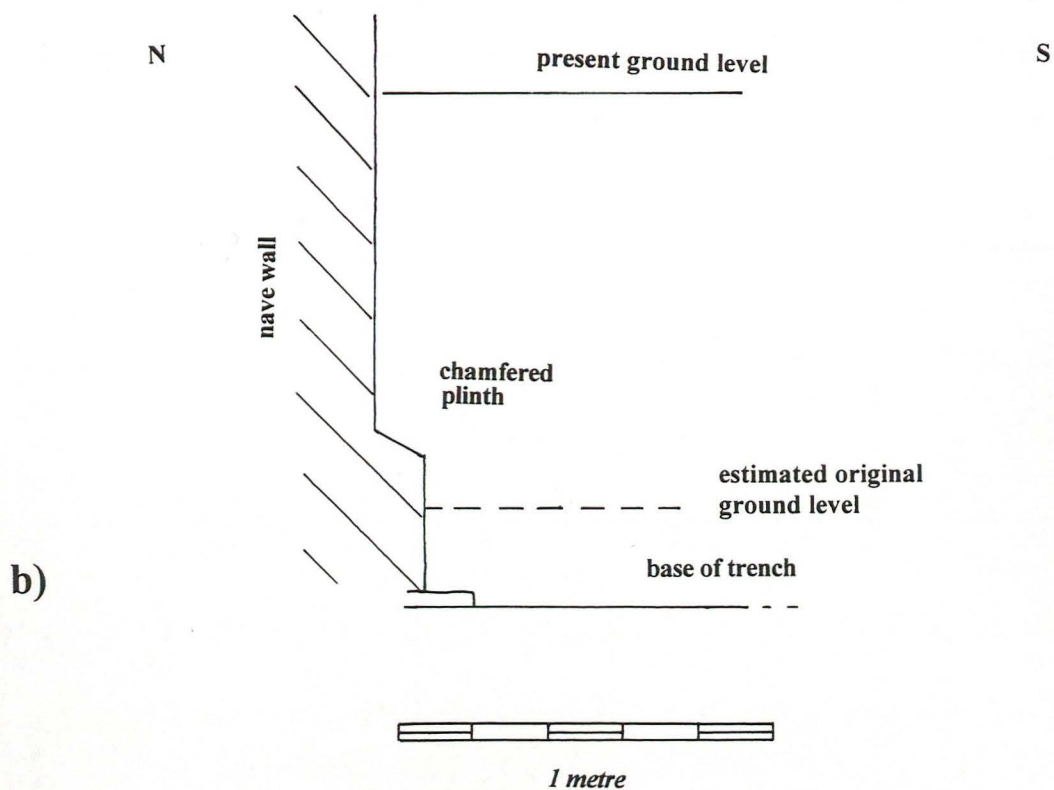
Fig. 3 a) St Michael's Church Burwell. Detail plan of porch area and excavated trenches (1:50 scale). b) Section showing profile of nave wall (1:20 scale)

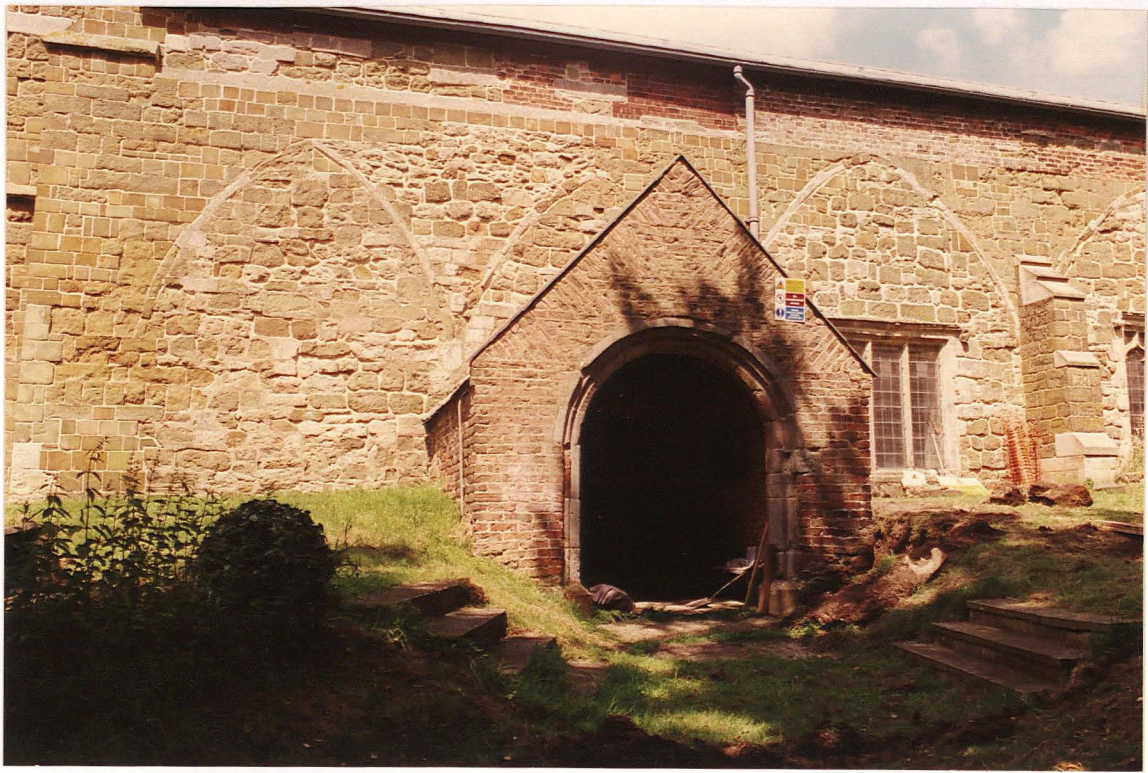
The present porch is built in brick with a tumbled gable, suggesting an eighteenth/early nineteenth century date (Pl. 3). The bricks are hand-made and fairly narrow (228 x 110 x 60-64mm) confirming a manufacture date before the mid-nineteenth century. It has a Welsh slate roof which must be nineteenth century (Welsh slate was not imported into Lincolnshire before this date) but need not be an original covering. The porch may be contemporary with the rebuild of the upper stage of the tower, and the raising of the nave, which are also in brick. The nave roof was repaired in 1911.

Pl. 3 The south porch.

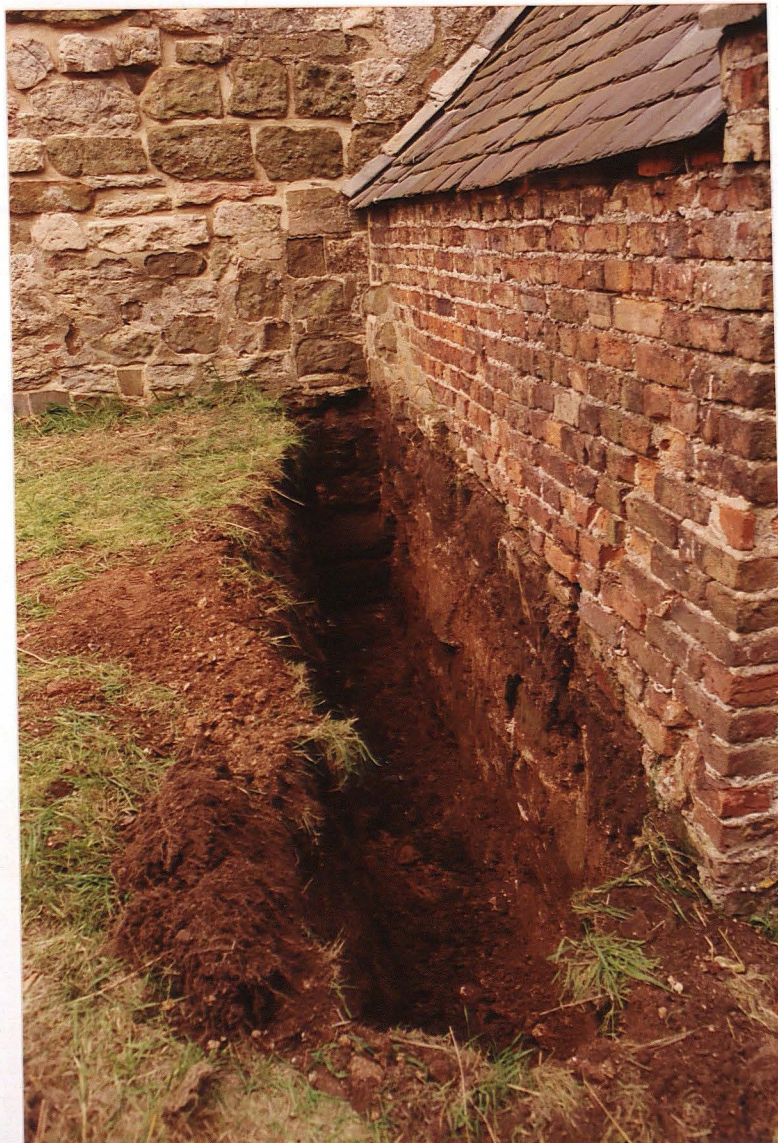
The trench was dug to a depth of 1.20m below existing ground level. At the north end of the trench the nave wall plinth was exposed at a depth of 0.70m. It was a simple chamfered plinth in sandstone 0.06m high and 0.14m wide sitting on coursed stone 0.36m high to the base of the foundations. It runs beneath the blocked arcade and presumably belongs to the original nave wall (Pls 4 and 5).

The trench excavation exposed the lower levels of the porch west wall, which had originally been constructed in sandstone. The rebuild in brick commences at the current ground level which means that the soil build up probably relates to the demolition of the south aisle. The trench returned along the south wall of the porch where the foundations of the south aisle were exposed by the contractors. This part of the trench was not seen by the author.

Pl. 4 Drainage trench on west side of porch showing sandstone wall beneath the rebuild in brick.

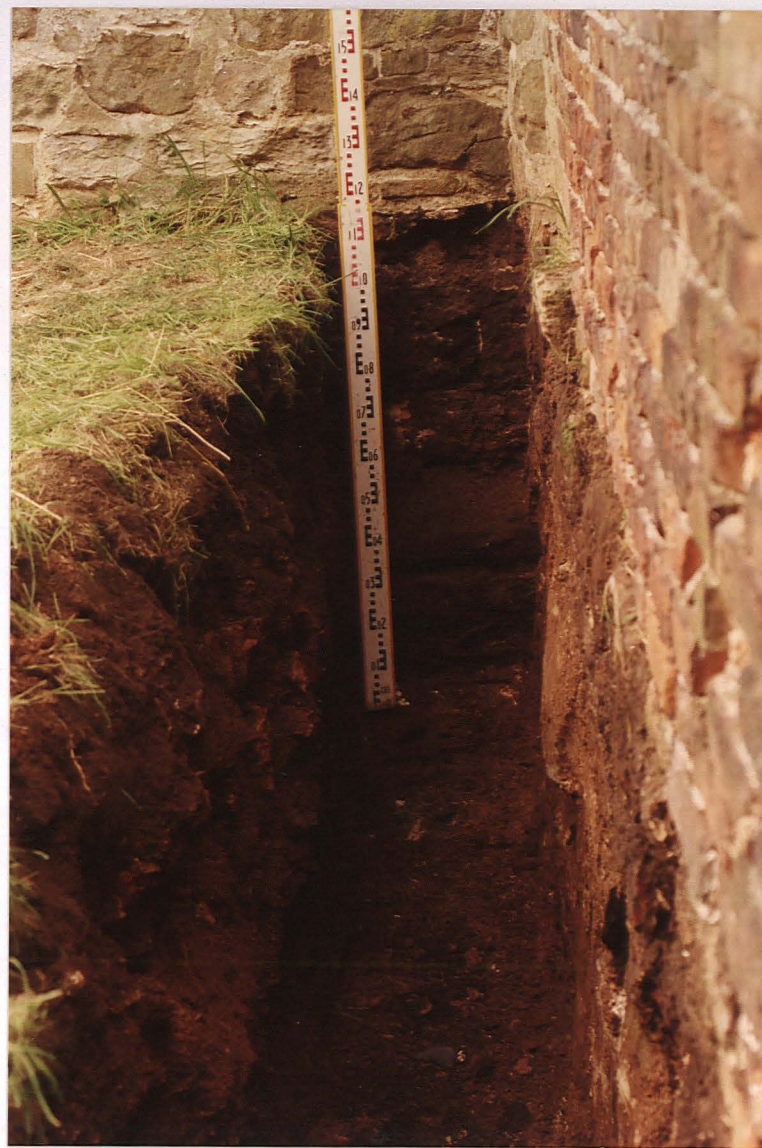
PI. 5 Detail of west trench showing chamfered plinth of nave wall. The scale is resting on the offset footing, where the original ground surface must have been, indicating a soil build up of 1.1m.

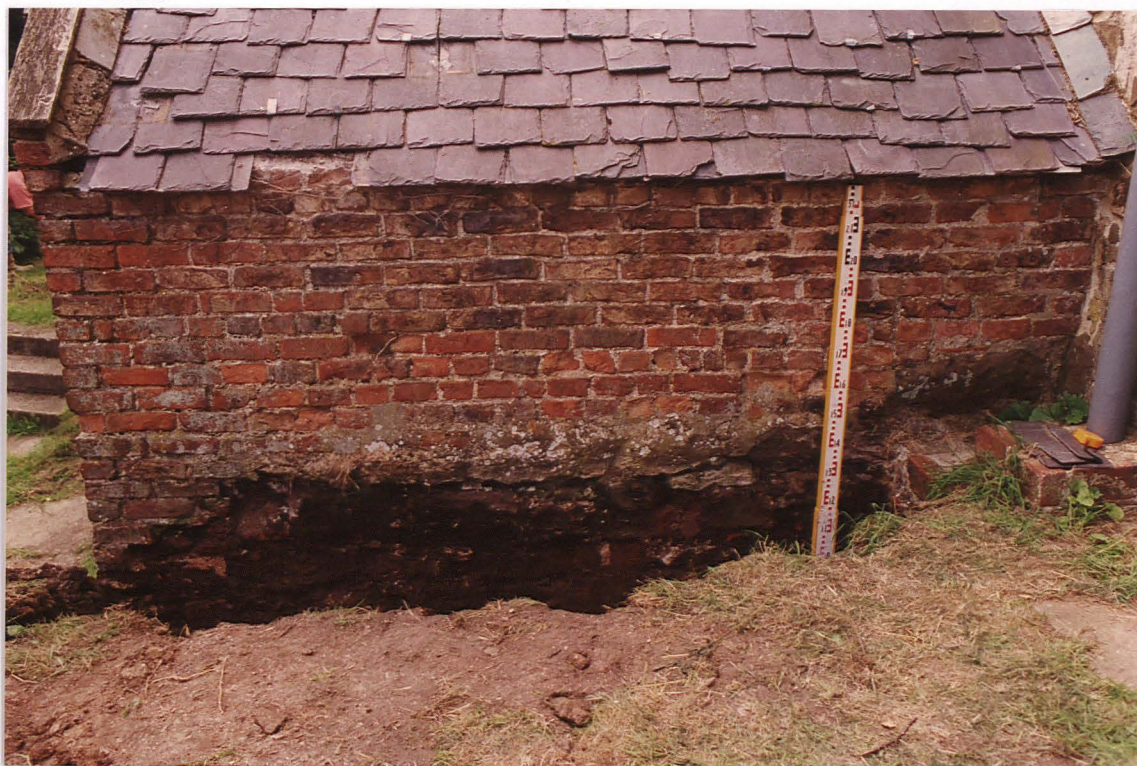
The trench was dug to a depth of 1.30m below the existing external ground level and was 0.50m wide. Its base was 0.30m below floor level in the nave. The junction of the porch with the nave wall was not seen because a downpipe and drain were in the way (Pls. 6 and 7).

As on the west side of the porch the excavations revealed the junction of the earlier stone porch and the later brick rebuild, which coincided with the raised ground level.

PI. 6 Drainage trench on east side of porch showing sandstone wall beneath the rebuild in brick.

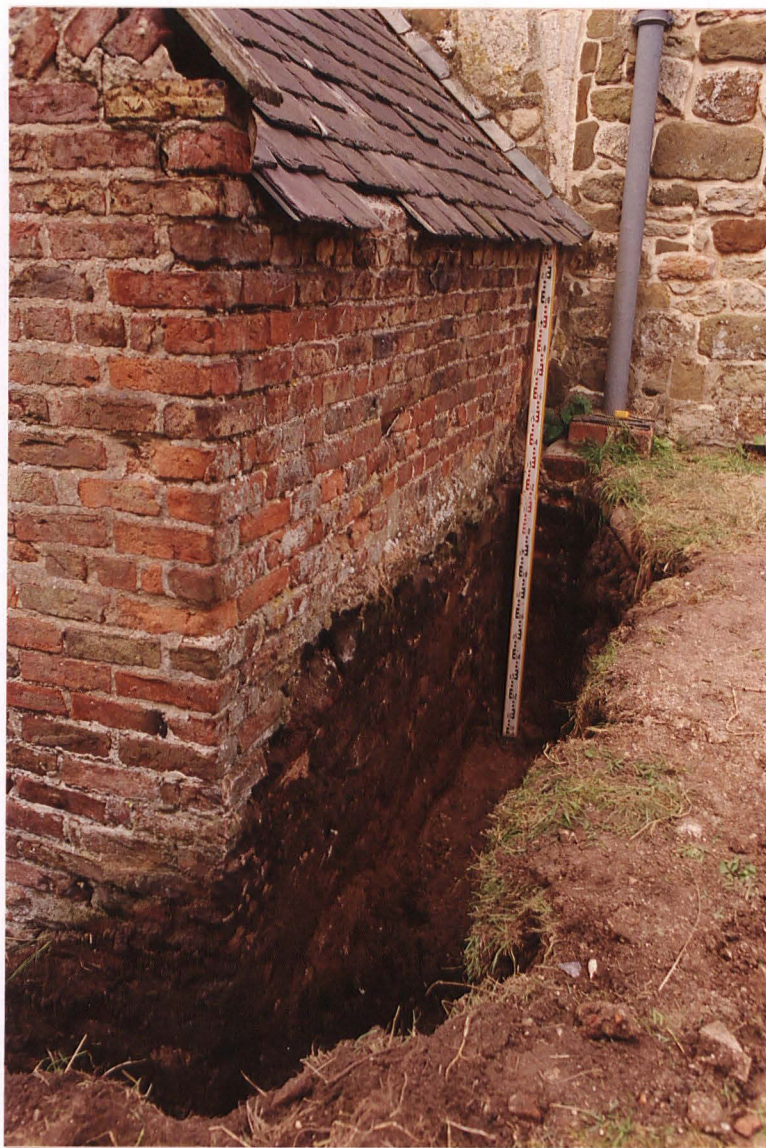
PI. 7 Detail of east trench. The drain beneath the downpipe obscures the nave wall. The build up of soil on this side of the porch is c.1.25m.

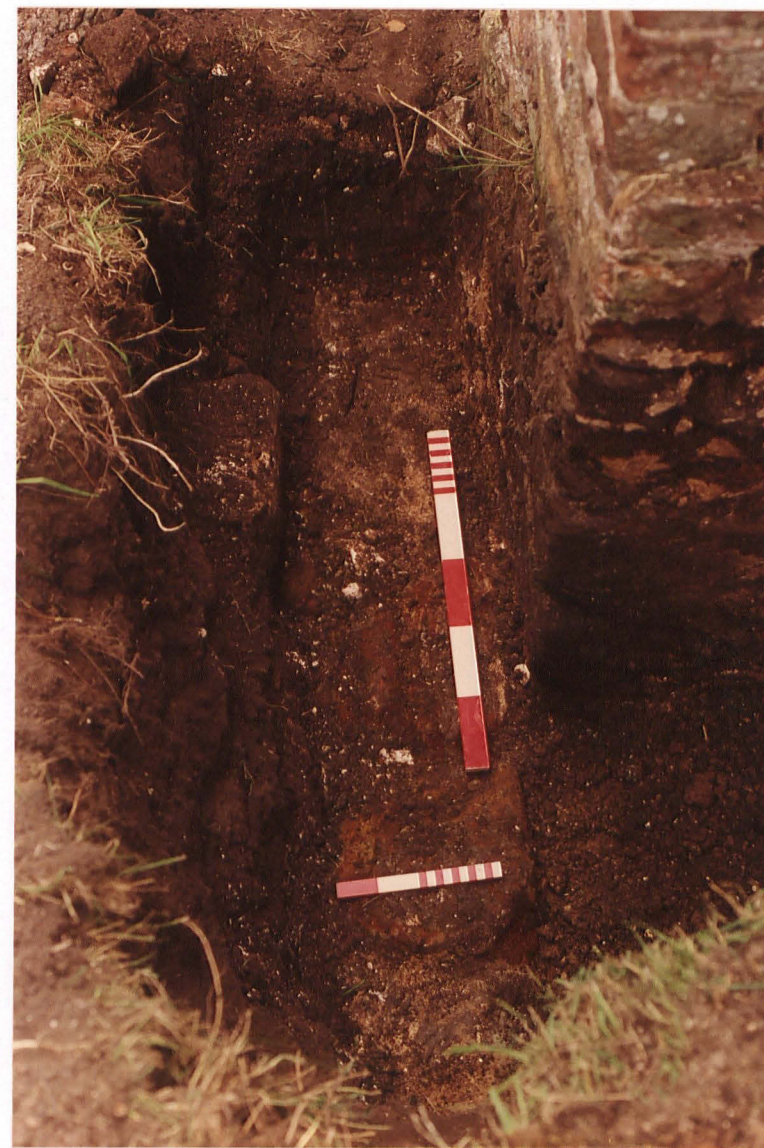
At the south end of the trench four large, squared, blocks were exposed which ran along the south side of the porch wall (Pl. 8). The building contractors reported that a further three large sandstone blocks had been removed from the trench before the arrival of the archaeologist.

PI. 8 Trench along south wall of porch, showing the south aisle foundations adjacent to the porch wall, looking west . Scales 0.50m and 0.20m

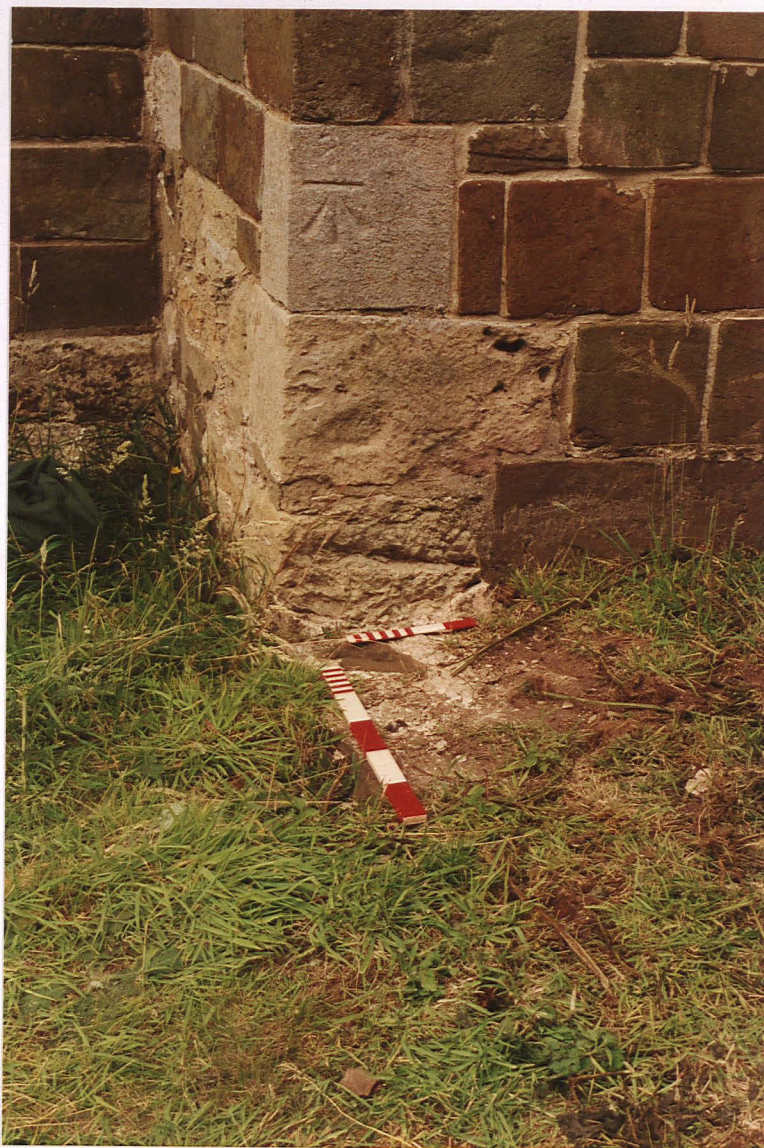
In spite of the small-scale works, monitoring of the excavations has confirmed the position of the aisle south wall. Part of the west wall, where it joins the south-west angle of the nave is still visible beneath the turf (Pl. 9) and an estimate of its extent based on the west wall thickness has been made, giving internal dimensions of 14.50m long and 3.60m wide (16.50m x 4.60m external) (Fig. 2). The four arches of the south aisle are of two sizes, the two eastern arches being wider and taller. It has been suggested that they are either of slightly different date in construction or that the south aisle was partly separated to form a chapel (CPW 1980).

Pl. 9 Foundations of the south aisle west wall visible at the south-west angle of the nave.
Scales 0.50m and 0.20m.
