PLOT 1, MAIN ROAD, BURWELL,
LOUTH, LINCOLNSHIRE

ARCHAEOLOGICAL WATCHING BRIEF REPORT

MRBL 01
TF 53545 37960
2001.179
W/025/0224/01

Report prepared for J Stainton (Architect) on behalf of Mr & Mrs Norbron
by S.A. Savage

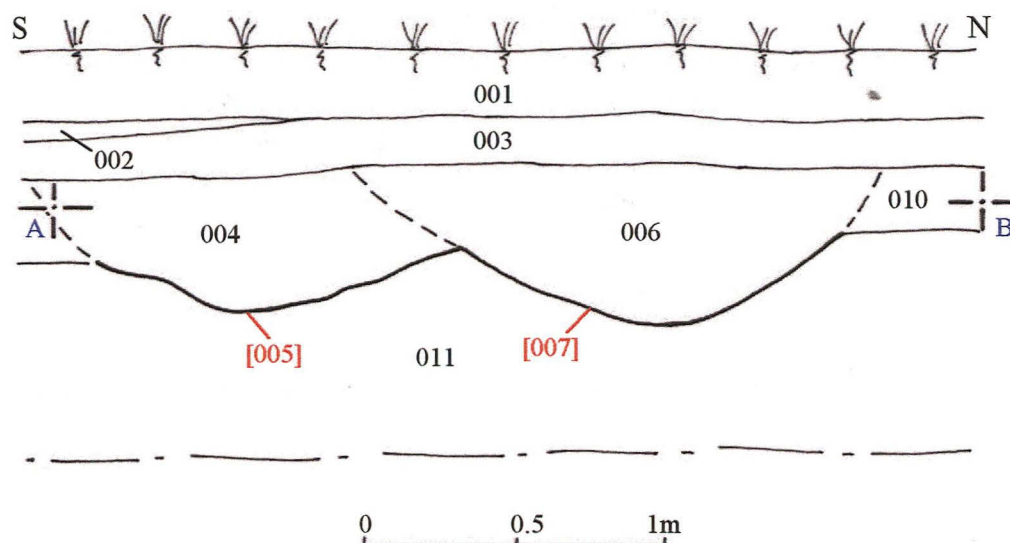
Fig. 6 East facing section in SW corner of house plot, showing pits [005] and [006]. (Scale 1:25)

Two shallow pits were observed in the western section of the house plot. These were located approximately half way along the west trench (fig. 6). The pits, [005] and [007], contained very similar fills: a mid-brown clay containing very occasional small rounded pebbles and angular flint, numbered 004 and 006 respectively. Fill 006 appeared very slightly darker than 004, and pit [007] appeared to cut 004. The lack of clarity of the boundary between the pit fills and the surrounding boulder clay, however, coupled with the very clean nature of these fills, suggests the pits may in fact be the product of solution activity within the chalk, rather than true archaeological features. The pits contained no datable material.

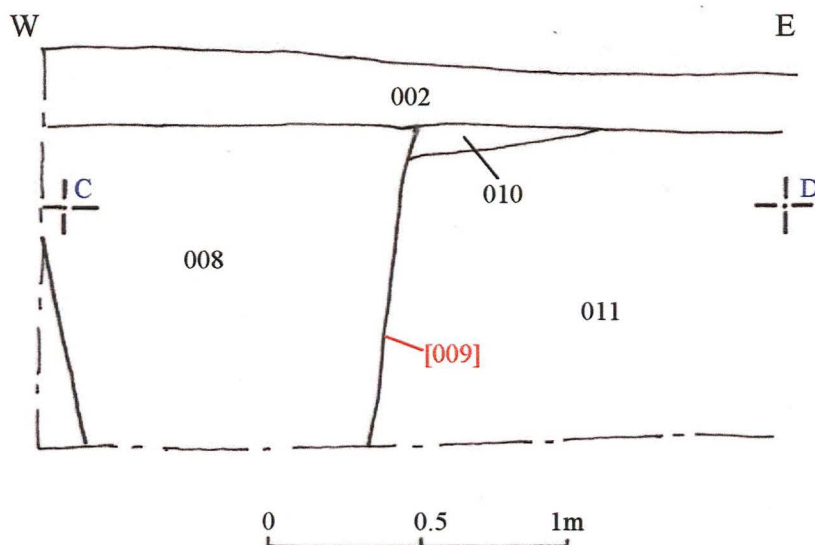
Fig. 7 South facing section showing rubbish pit/latrine [009]. (Scale 1:25)

One other cut feature was encountered within this area (fig. 7). This was at the west end of the trench for the wall dividing the lounge from the hall. It was a steep sided pit, [009], which may well have been rectangular in plan; the east and west sides being parallel, but the north and south sides lay outside the excavated trench. It contained a firm, dark greenish brown silty clay fill (008), which contained occasional charcoal flecks and animal bone. It seems likely that this feature was a rubbish pit or latrine associated with a street front property of post-medieval date.

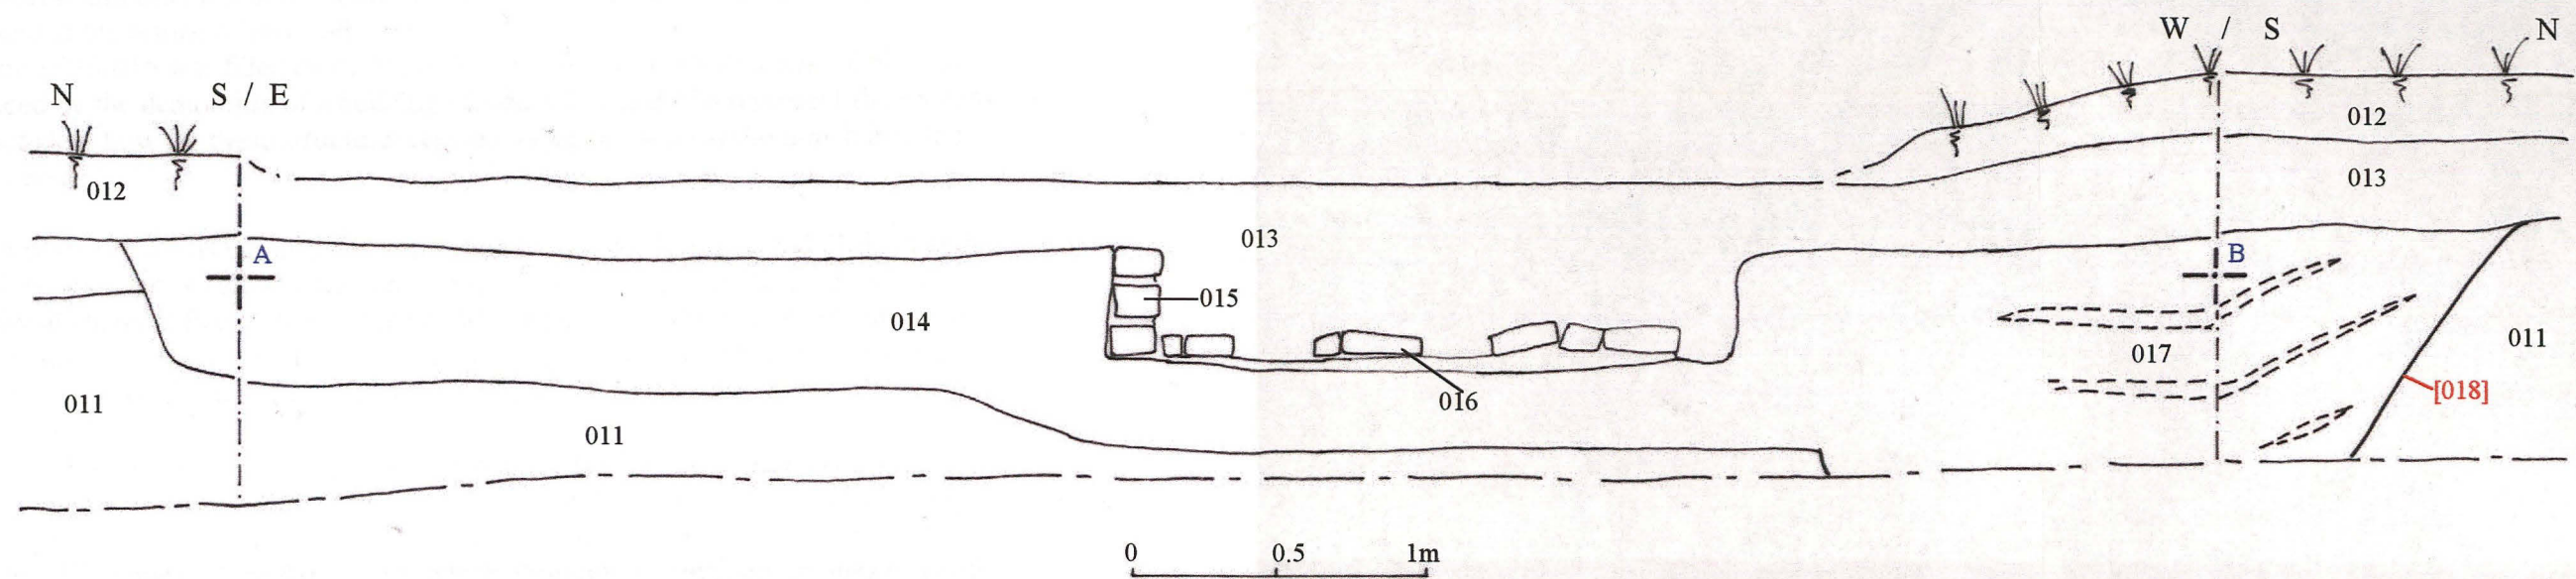
In the trench excavated for the south wall of the garage (fig. 8) the remains of a wall and floor were encountered. The floor (016) was constructed of handmade floor bricks (230 x 115 x 50mm) and was 0.5m below modern ground level; it was oriented north-south, and bedded on a thin layer (0.05m) of friable, semi-bonded lime mortar. The remains of a wall were seen along the east edge of floor 016. This wall (015)

Fig.8 North facing section along south wall of garage showing structural remains of wall 015 and floor 016, levelling layer 014, and pit/ construction cut [018]. (Scale 1:25)

consisted of three remaining courses of handmade bricks (260 x 140 x 80mm), set in a lime mortar and oriented north-south: a void on the west side of floor 016 probably represented the return of this wall.

Structure 015/016 was filled by rubble 014, and it seems likely that this rubble was produced by the demolition of a building of which 015 and 016 represent the remains. It is not clear how far these structural remains extended beyond the trench into the garage area.

Structure 015/016 was cut into a layer of dark brown sandy clay (014). This material contained abundant small and medium rounded and sub-angular chalk pebbles and occasional charcoal flecks. It appeared to lie within a cut, which may represent the construction trench of a building located further to the south, but at the west side could not be distinguished from the fill of a deeper pit (017).

In the southwest corner of the garage plot, a steep sided pit was partially revealed (018). Only the northeast side of this pit was seen in the base of the foundation trench where it appeared east-west oriented, with a rounded northeast corner. Pit [018] was filled by 017, a material similar to 014, which although it contained tip lines of small rounded chalk pebbles on the west side, became indistinguishable from 014 to the east. It seems likely that the filling of pit [018] coincided with the deposition of 014, and the subsequent construction of 015/016.

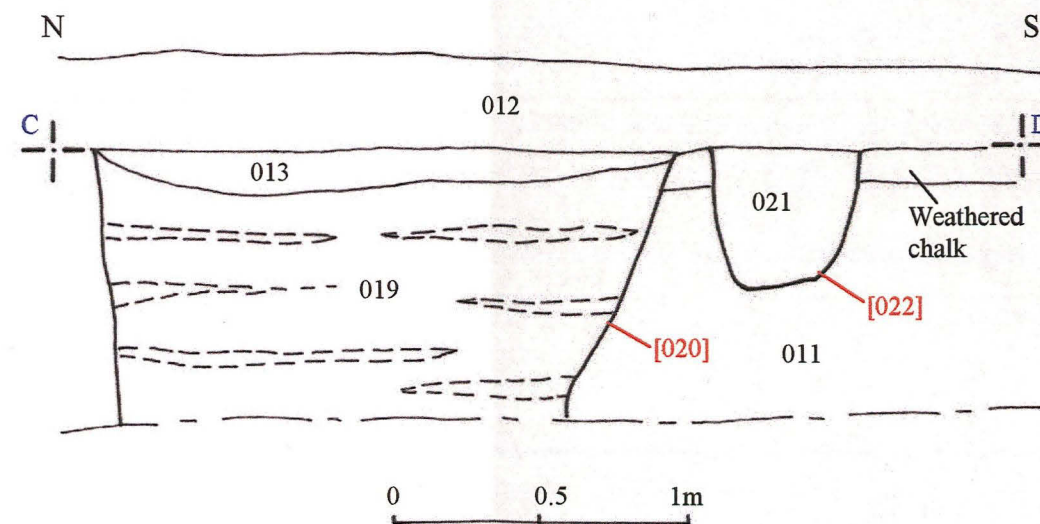
Fig.9 West facing section along east wall of garage showing pit [020] and ?posthole [022]. (Scale 1:25)

In the east foundation trench for the garage (see fig. 9) another pit was encountered, along with a smaller pit or posthole. Pit [020] was seen on both sides of the foundation trench and was 1.92m long and 0.9m deep with very steep sides. It was filled by 019, a friable, dark brown sandy clay containing lenses of chalk and pea-gravel up to 0.05m thick. No datable material was recovered from this pit.

Adjacent to pit [020], but only seen in the eastern section of the foundation trench, was a smaller steep sided pit [022]. This contained 021, a rubble fill, in all respects similar to 013, which suggests the removal of a structural element such as a post during the demolition of 015/016.

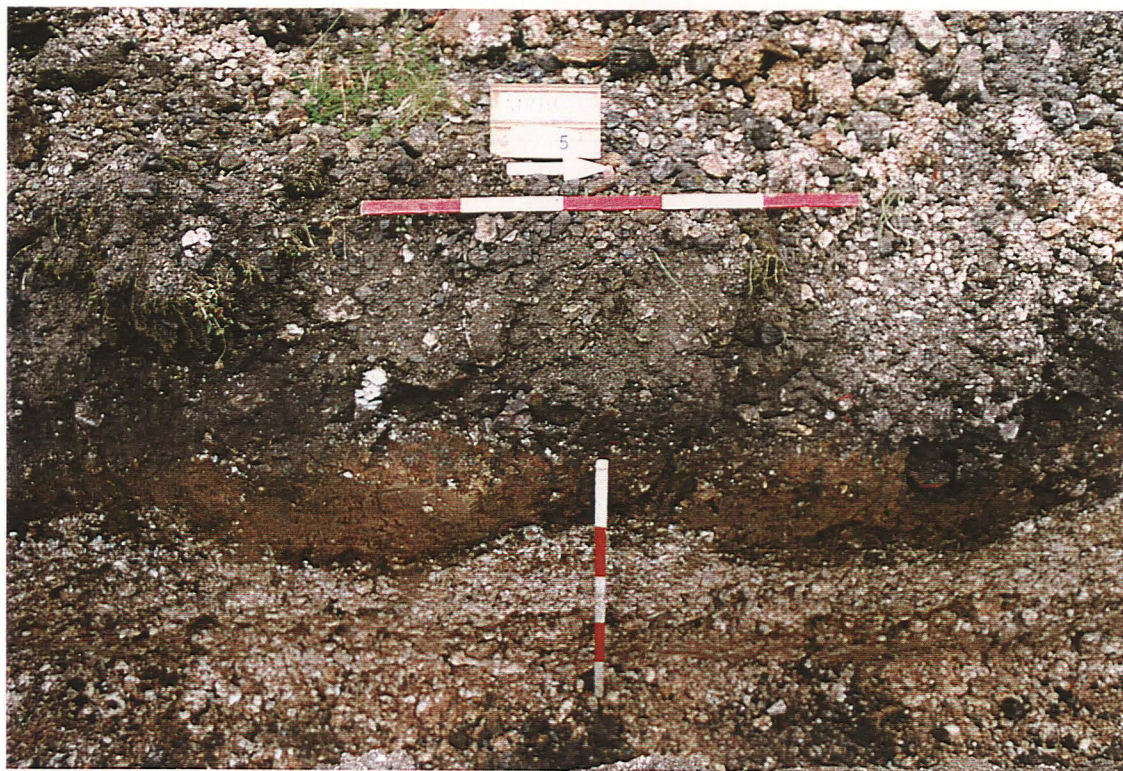
Plate 3. Pits [005] and [007], in the western section of the house plot, looking west.

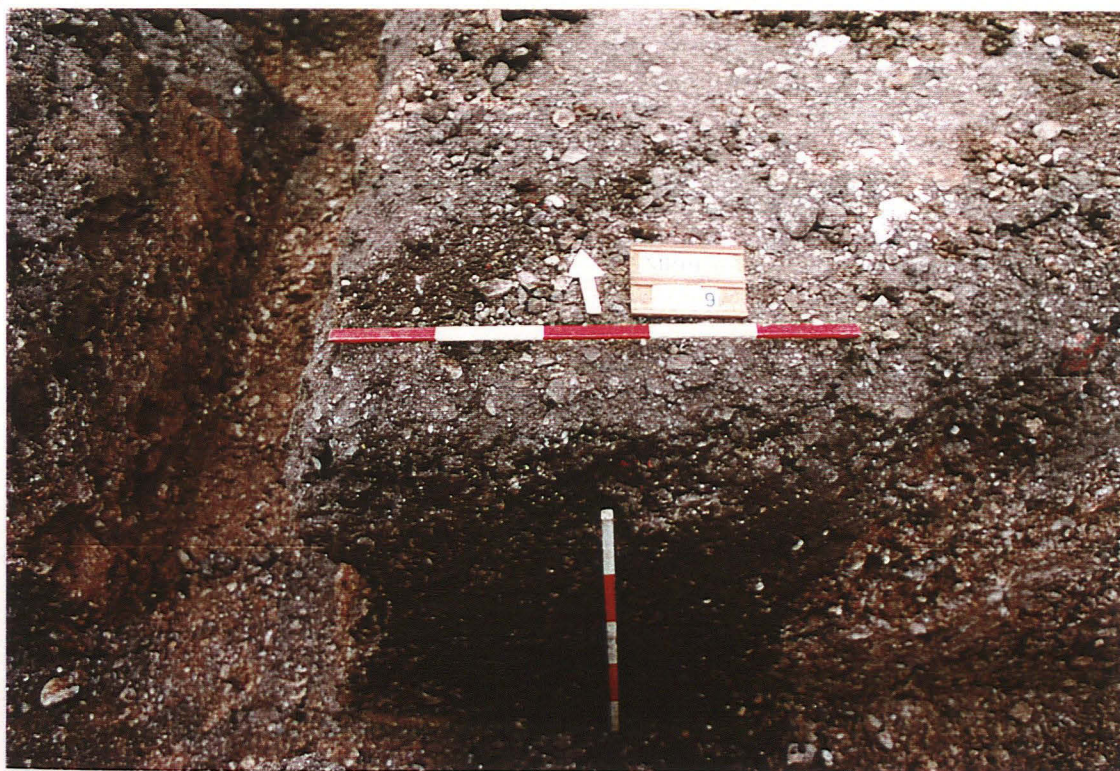
Plate 4. Latrine/rubbish pit [009] located at the at the west end of the trench for the wall dividing the lounge from the hall, looking north.

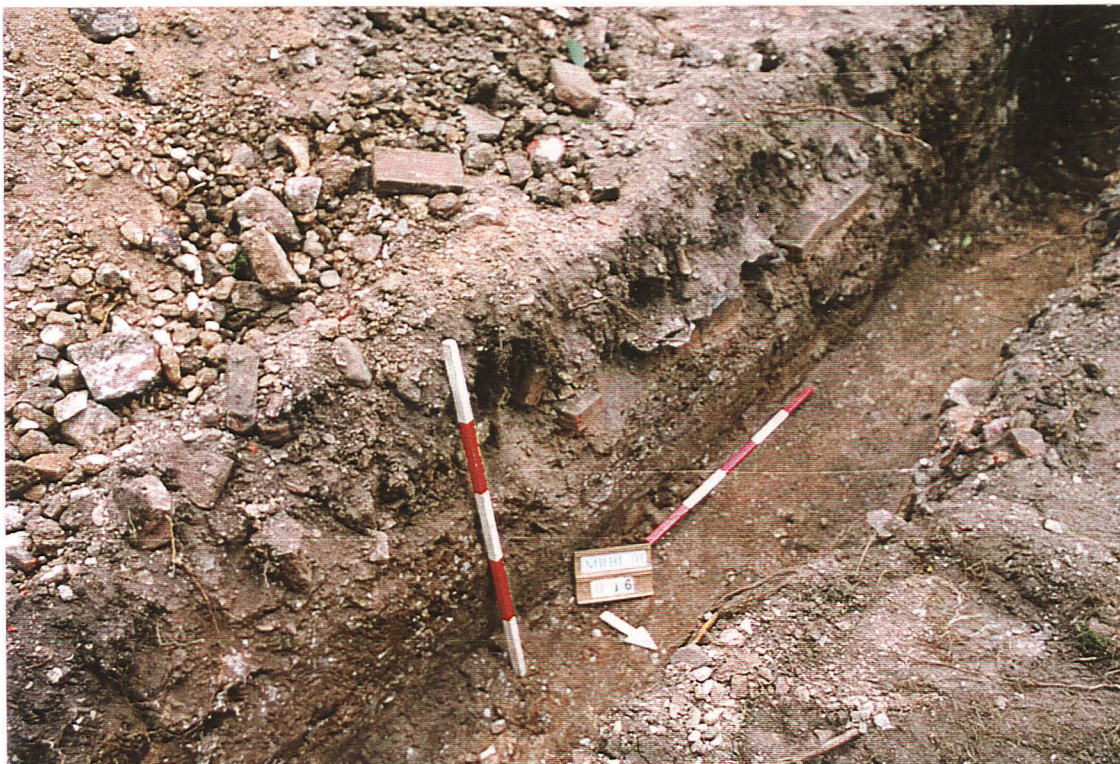
Plate 5. Wall [015] (located adjacent to the vertical scale) and floor [016] in the foundation trench for the south wall of the garage, looking SW.

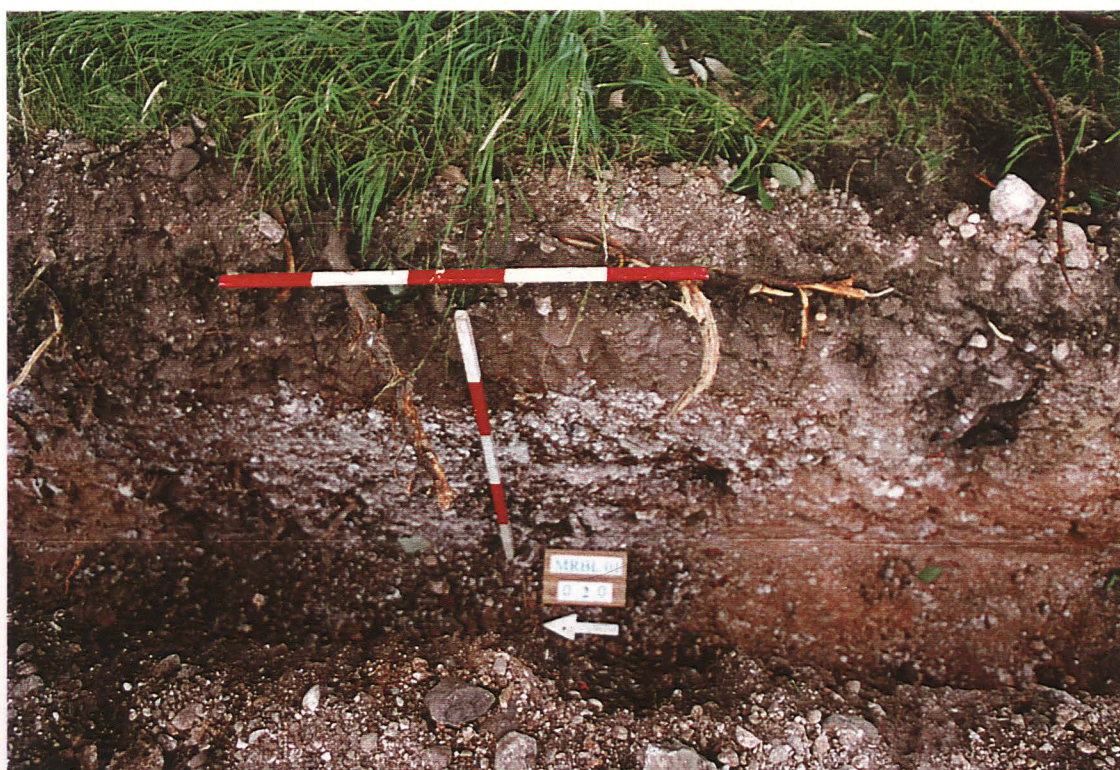
Plate 6. Pit [020] and ?posthole [022] in the foundation trench for the east wall of the garage, looking east.
