Standing Building Appraisal Survey

No's 9 & 11 East Street, Crowland, Lincolnshire

PART II -Figures & Plates

23767 Standing Building Appraisal: No's 9 & 11 East Street, Crowland, Lincs

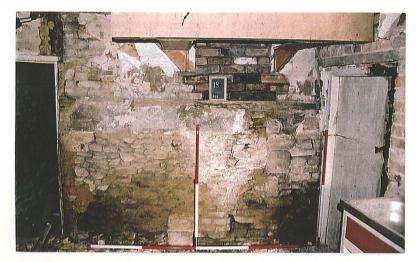
Plate 1: North elevation of Room C showing stone pinning. Stud visible above top right corner of door to Room B on the left of frame

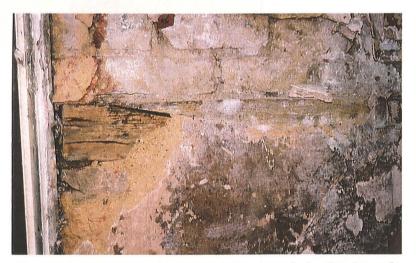
Plate 2: Detail of bridled-scarf joint to rail topping stone pinning. Doorframe of access through to Room B on the left of frame

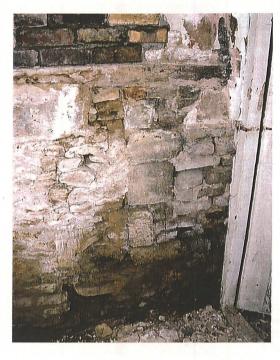
Plate 3: Detail of change in build of stone pinning

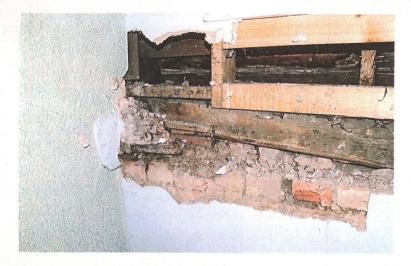
Plate 5: Wall plate and repair, southeast corner of Room Ai

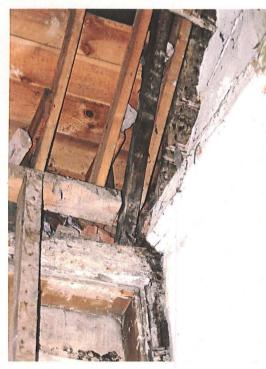
Plate 6: Room Bi, southwest corner, Frame A showing principal post, wall plate, tie-beam and probable principal rafter assembly

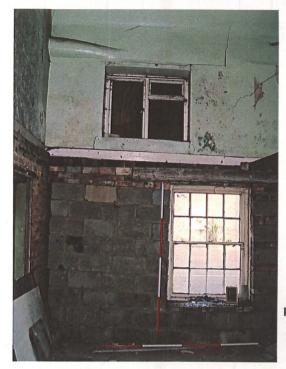
Plate 7: Frame showing bulge in the render of the northwest corner of Room Bi, indicating the possible re-use of a jowl headed post

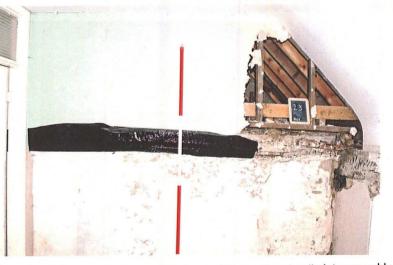
Plate 8: Room Aii, showing repaired tie-beam of Frame B and wall plate assembly

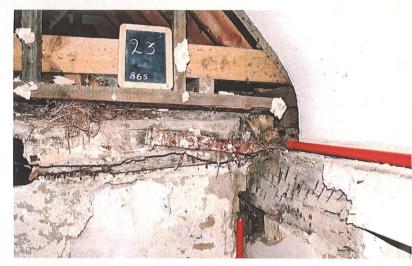
Plate 9: As Plate 8, closer detail showing iron strap repair

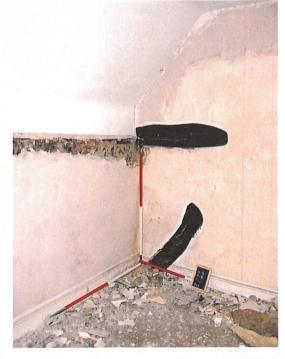
Plate 10: Blacked brace and tie-beam, Frame C, visible in east wall of Room Aii

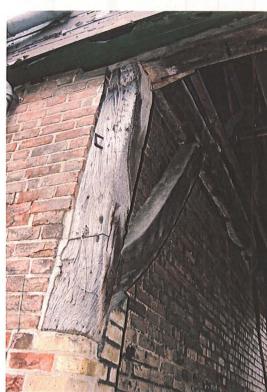
Plate 11: Frame C, principal post, brace, wall plate and tie beam showing upper-face

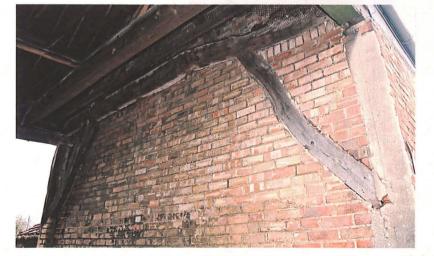
Plate 12: Frame C, frame taken from East Street showing replaced brace and tie-beam

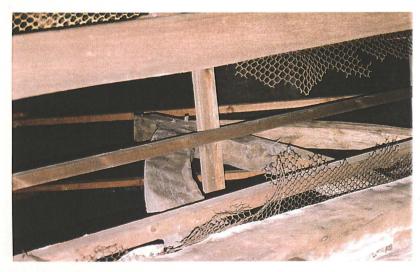
Plate 13: Frame C, showing crown post and tension braces

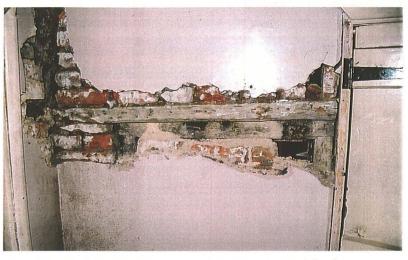
Plate 15: Room D, north wall, wooden rail/lintel over pegged doorframe

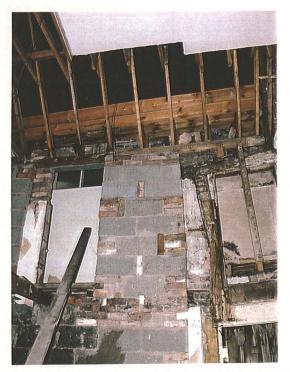
Plate 14: Room Bi, south wall, showing wall plate and stud with area of possible original infill to left of stud (partially obscured by Phase VI block work)

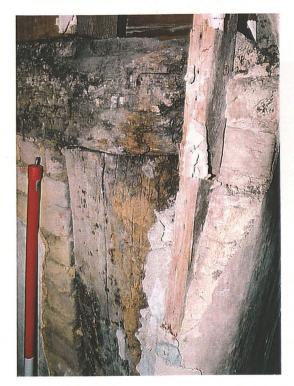
Plate 16: Principal post of Frame B exposed at top of current stair

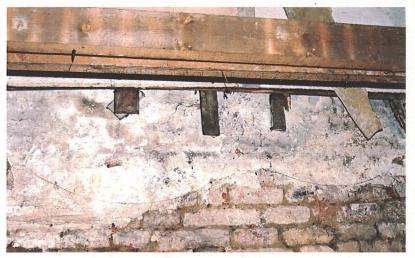
Plate 19: Room Bi; bases of Phase III stud partition

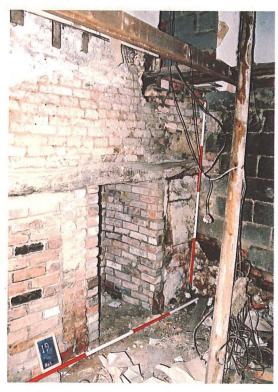
Plate 18: Room B; Phase II brick chimney showing oak lintel

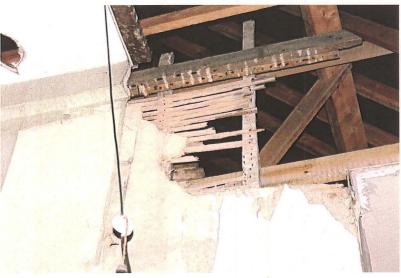
Plate 20: Room Bi; top of Phase III stud partition showing hand-split lath and plaster

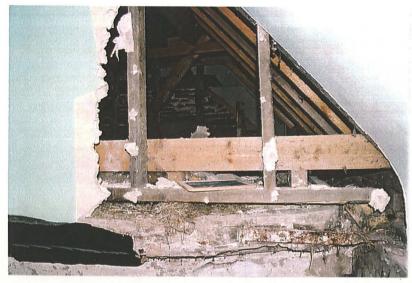
Plate 21: Rear of Phase III stud partition seen through opening-up in Room Aii

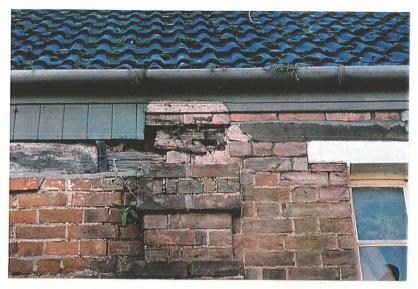
Plate 23: Detail of rusticated pier showing decayed wall plate. The timber with mortice is not *in situ*

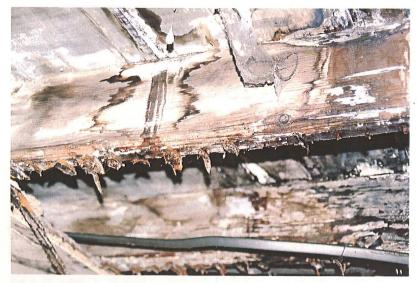
Plate 25: Ceiling joists of Room C showing ovolo scratch moulding

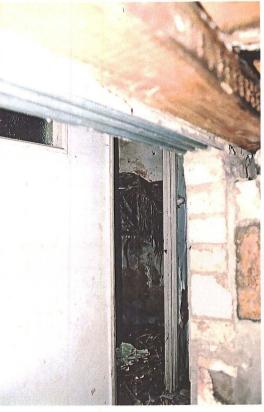
Plate 27: Thatch course or fleeking seen through doorway through to Room Ci

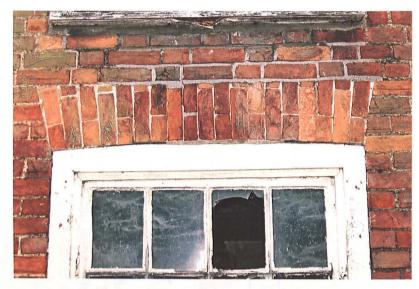
Plate 28: Detail of flat-camber window arch of No 11 East Street

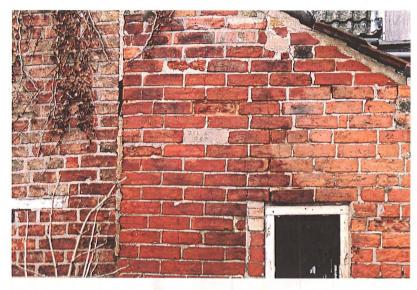
Plate 30: Detail of Phase IVB extention to No 11 showing '1957' plastic repair

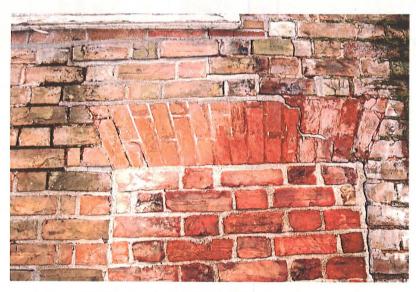
Plate 29: Detail of flat door arch of No 9 East Street

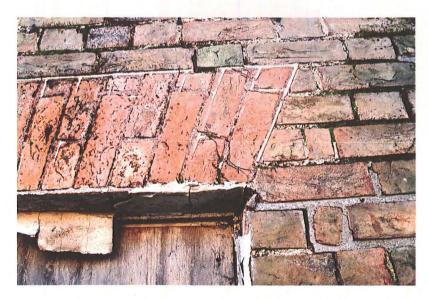
Plate 31: Detail of flat arch to window of No 9 showing tuck pointing

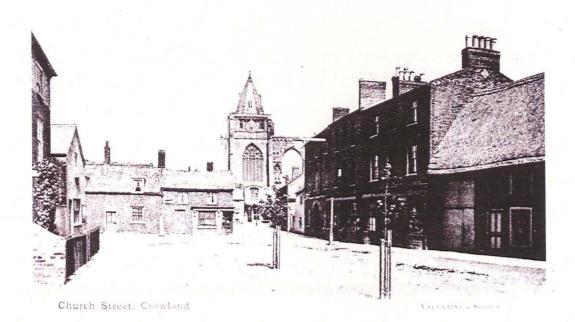
Plate 32: Local postcard showing East Street prior to the construction of the war memorial. No 11 is on the right hand side as having a thatched roof with a simple ridge

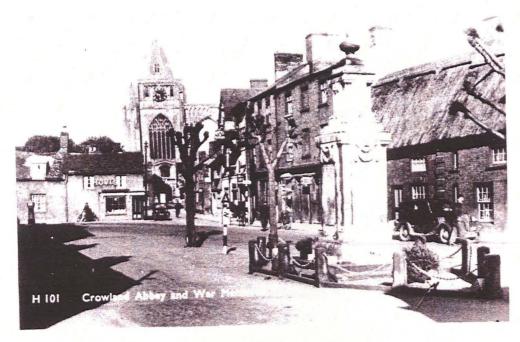
Plate 33: A later postcard taken after construction of the war memorial and showing details of both cottages. The roof appears to have been re-thatched with a more decorative ridge. The windows at first floor level appear to be eight pained; and a window is shown where the current central door has been inserted
