Burton, Main Street, Mains Replacement Scheme

Archaeological Watching Brief

Report prepared for Anglian Water Services Ltd

LAS Report No. 610

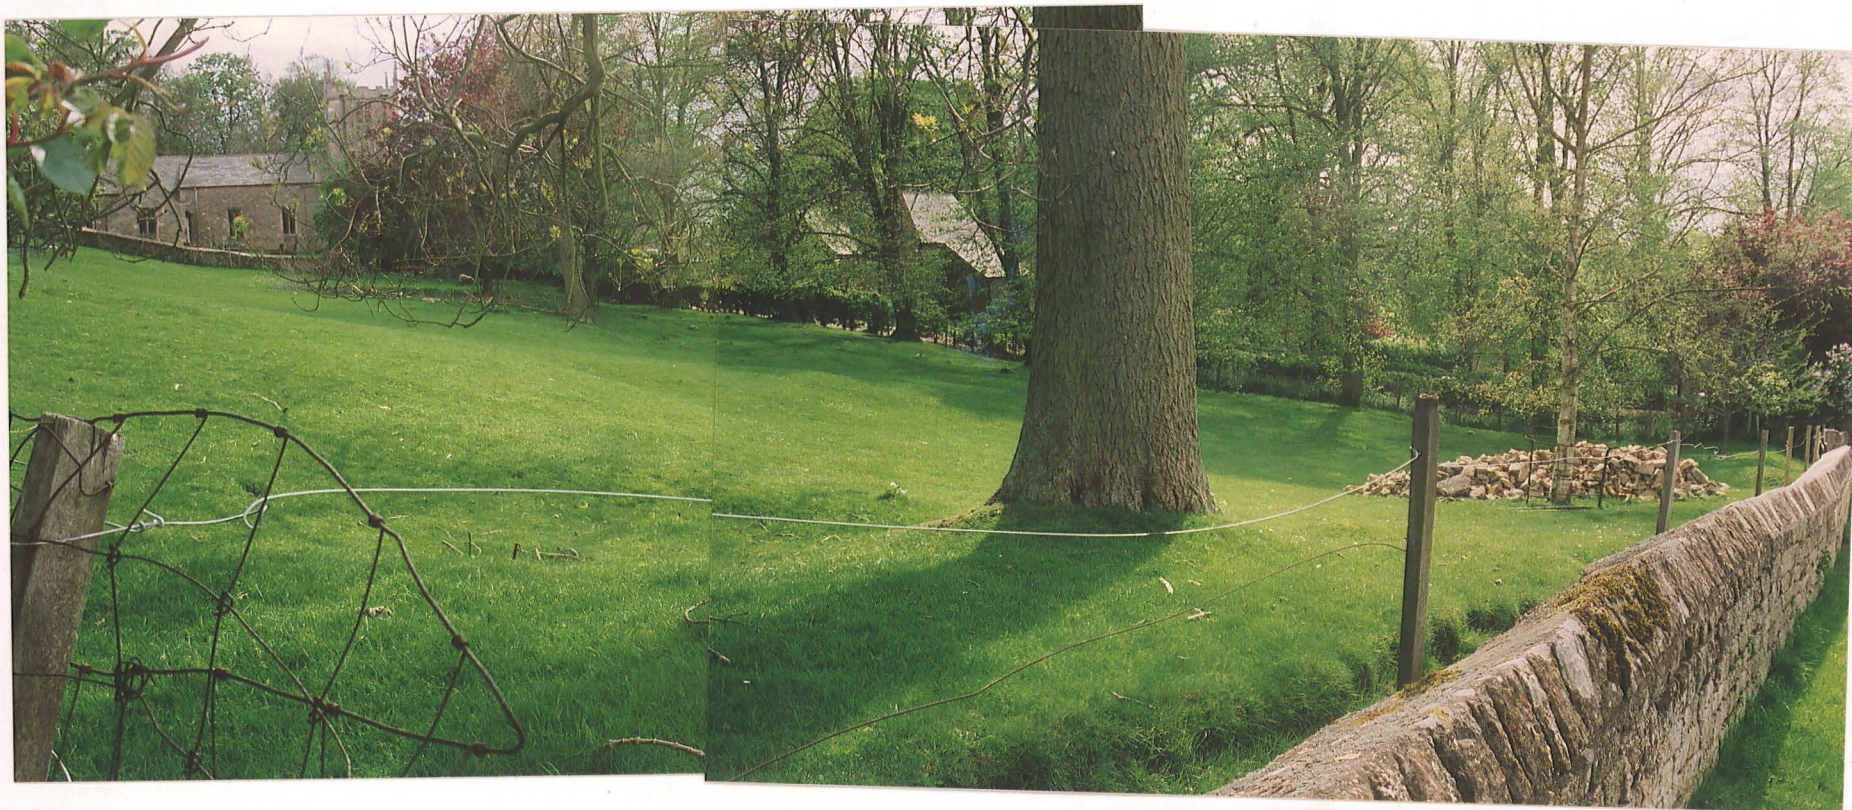
2. Opposite Denton's Cottage (1, Hillside Cottage), the bedding layer for the road lies on a 0.9m thick layer of clay, overlying ironstone. The thick clay is not present immediately west of the cottage, where it is replaced by brown clay loam with bands of ironstone. This observation is beside a depression in the surface of the adjacent pasture field, and may mark a backfilled quarry or consolidation of a natural valley (Pl. 1).

Pl. 1 The depression in the pasture field beside the lane to the church coincided with an area of backfill 2, below Main Street (looking SW towards St. Vincent's Church).

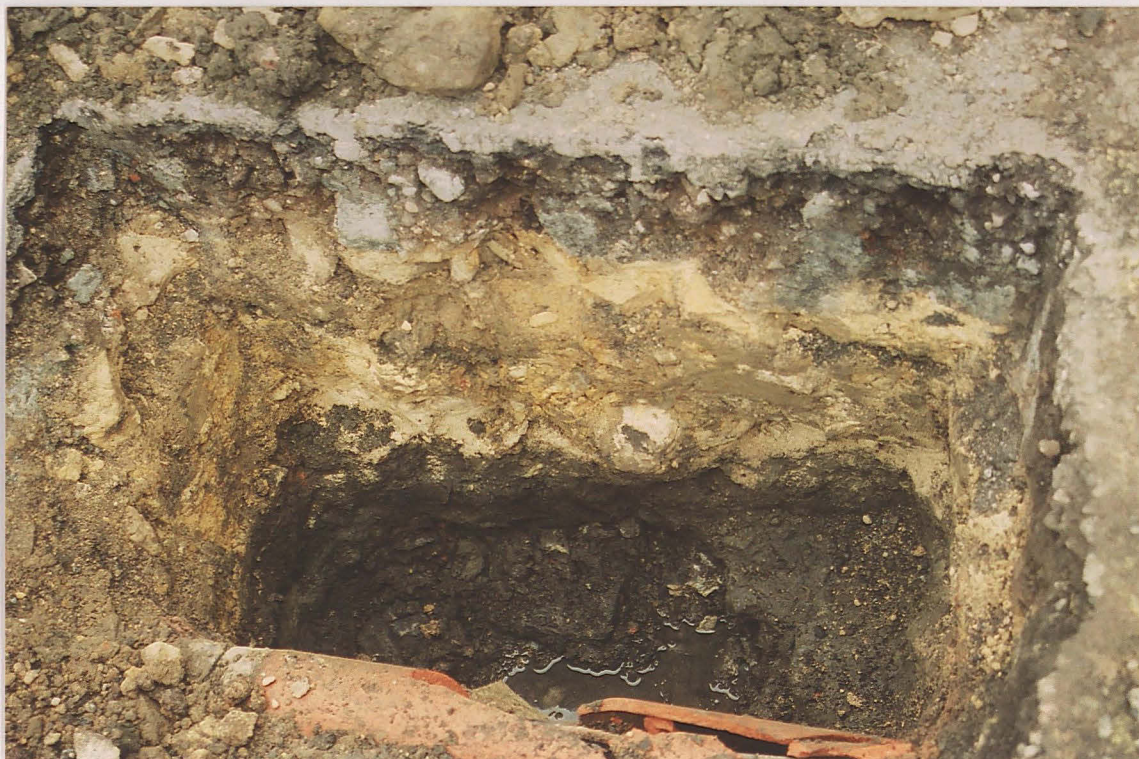
4. To the east of the junction with Manor Lane, the tarmac covered a 0.4m thick layer of stone rubble, with yellow clay below.
5. To the north of Rosewalk, the various tarmac and asphalt layers of the modern road amounted to a thickness of about 0.15m. Beneath this was a 0.4 5m thick dense spread of limestone lumps, laid to consolidate the underlying 0.3m thick black silt deposit (Pl. 2). The silt appeared to be fill of a roadside ditch or culvert, and the backfill contained four sherds of eighteenth century pottery (Appendix 1). Flat limestone pieces at the trench base may have formed part of a lined culvert, but this could not be confirmed.

PI. 2 Black silt and possible limestone culvert at the trench base at 5.

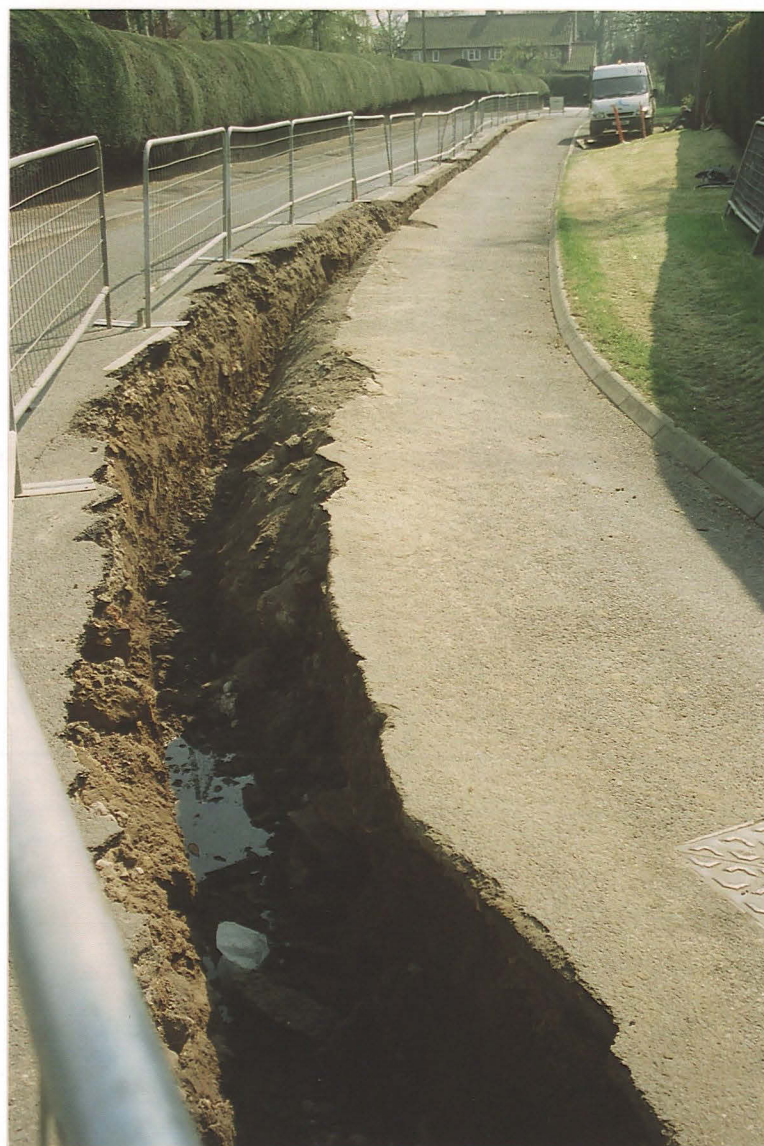
6. Beyond the first sharp bend, east of Lindisfarne, the trench cut through a NW-SE aligned stone culvert. This probably connected with a culvert from further up the hill.

PI. 3 Main Street, looking south from near Beechcroft. The stone rubble in the right trench face is the remains of a disturbed stone culvert 6; a spur of this culvert is visible in the foreground.

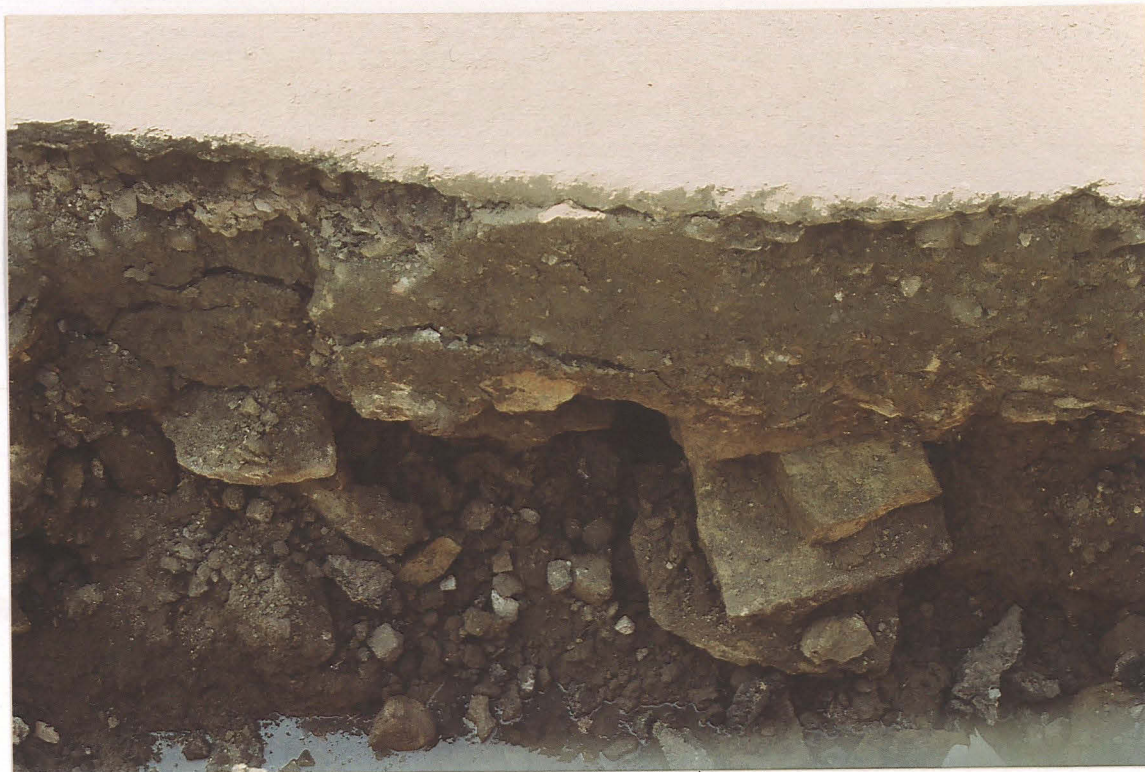
7. To the east of Beechcroft, an eastern spur from the NW-SE aligned culvert was seen (Pls. 3 and 4).

Pl. 4 Culvert 7, looking west.

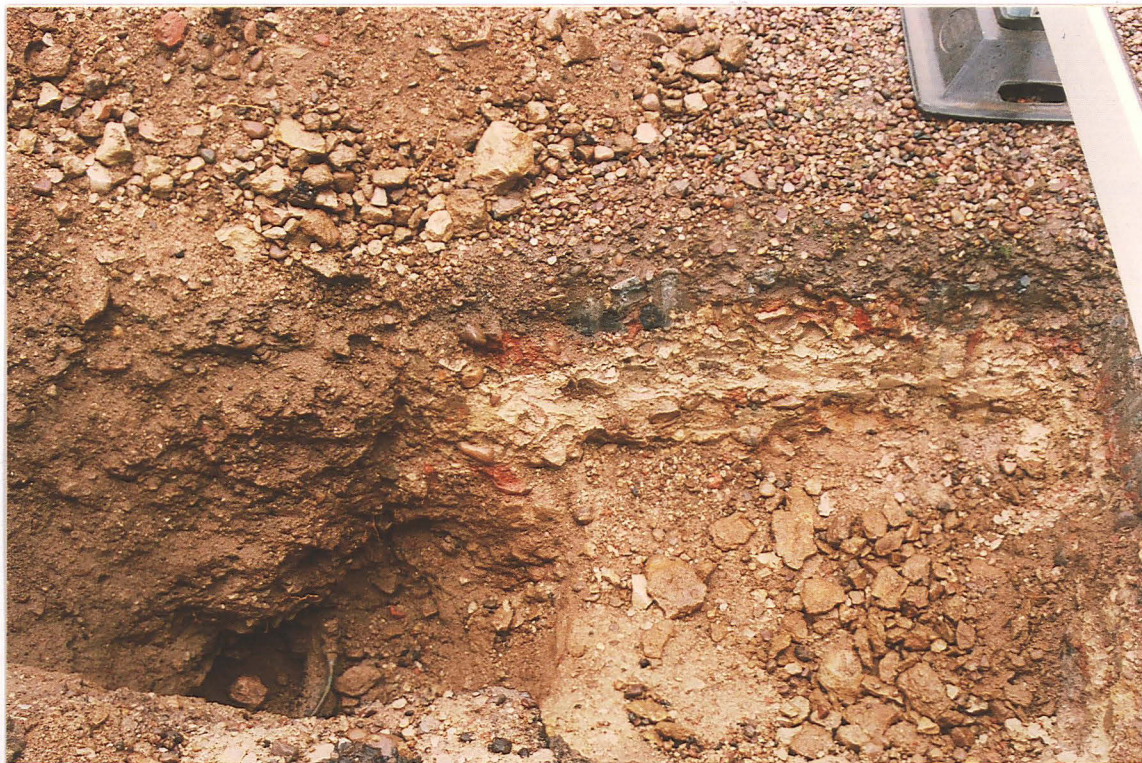
11. Beside Deeping Cottage, the trench cut through layers of limestone chip, brick rubble and fine gravel which had been earlier yard surfaces (Pl. 5). This area had formed part of the village street layout, and some of the material may have been laid as roadstone. Beneath the hardcore was a clay deposit with small stones; it was unclear whether this was a naturally occurring layer.

Pl. 5 Gravel and limestone surfaces of yard or former street, 11.

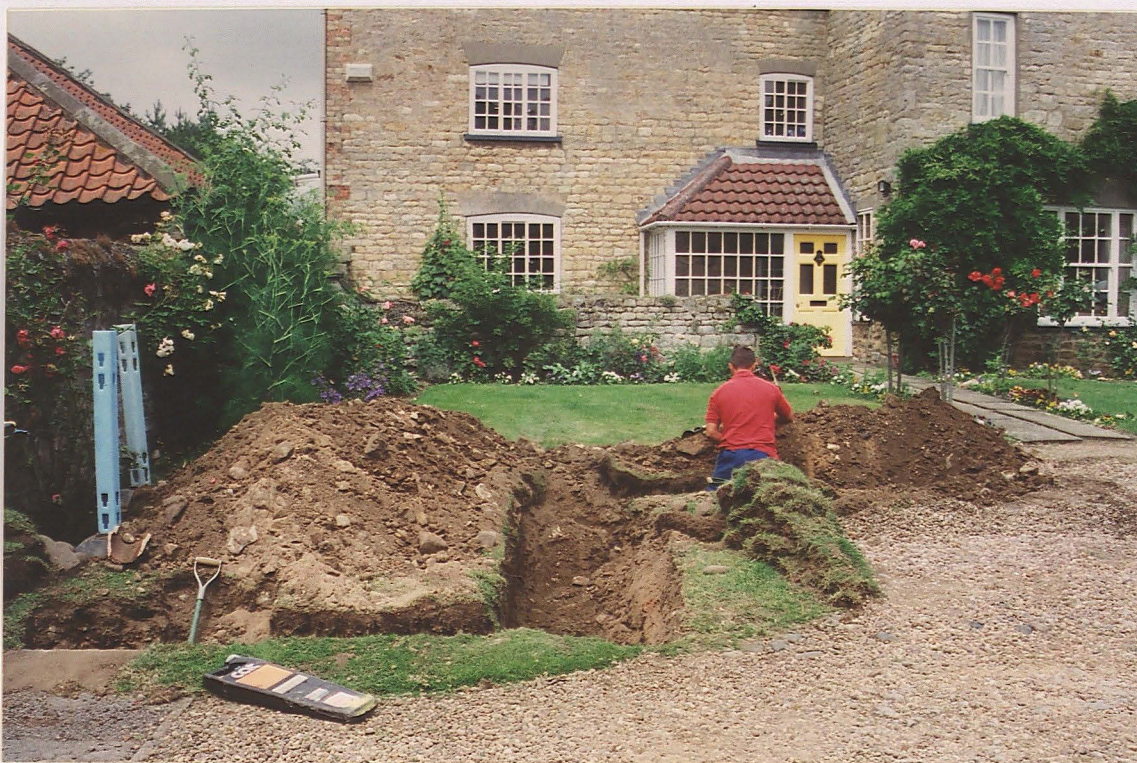
12. To the NE of Beechwood, the trench remained almost entirely within the backfill of its predecessor (Pl. 6). The spoil contained disturbed cobbles and limestone rubble, interpreted as earlier metalling of the yard or of an abandoned village street.

Pl. 6 Short length of open-cut trench 12 to NE of Beechwood (looking NW towards Mexborough).

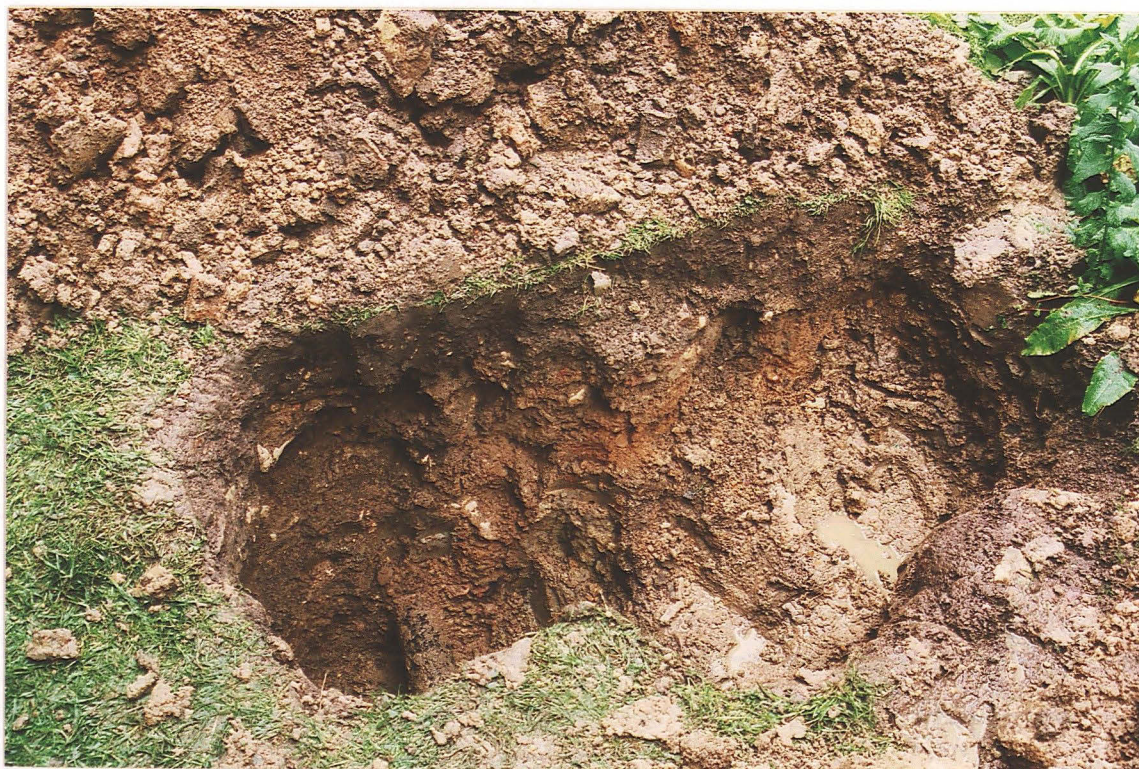
14. A moling access pit excavated to the rear of No. 2 Hall Yard revealed gravelly clay (Pl. 7). Post-medieval finds were collected from the spoil heap, but no features were seen.

Pl. 7 Gravelly clay beside the dark backfill of the existing pipe trench at 14, behind No. 2 Hall Yard.

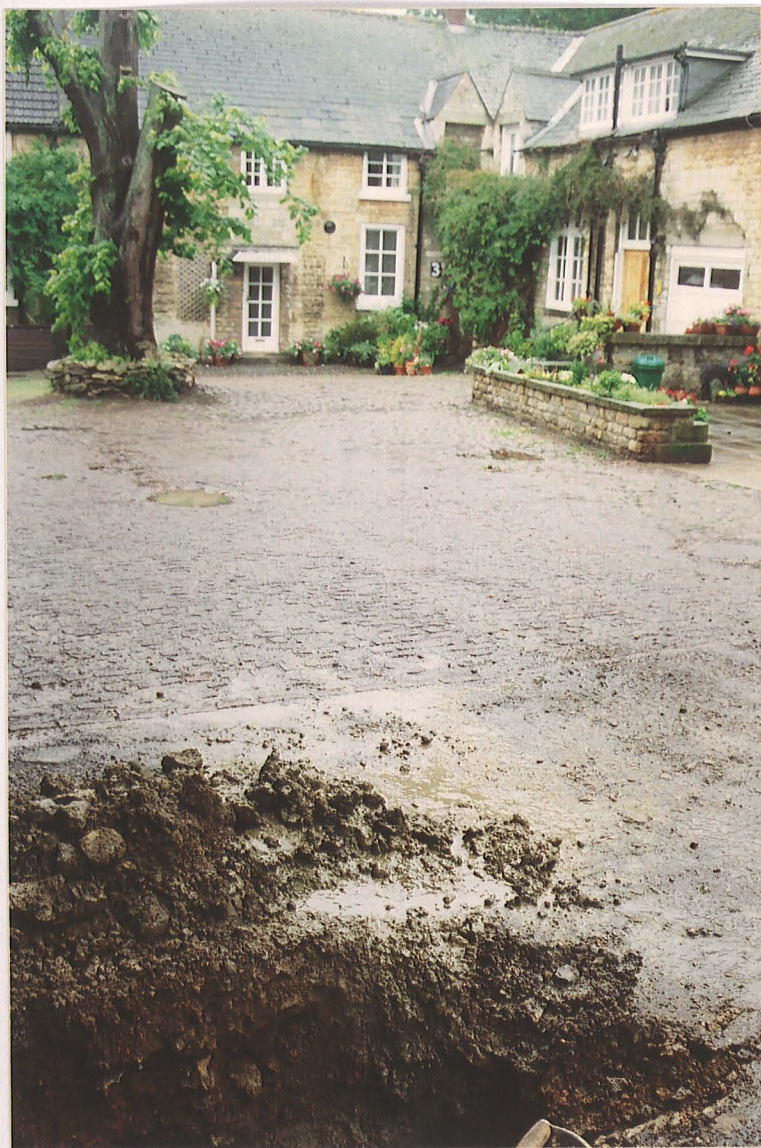
15. Within Hall Yard, the access hole was excavated at a point severely disturbed by existing services (Pls. 8 and 9). Yard surfaces and spreads of brick and stone rubble produced a combined thickness of 0.4m of made ground, beneath which was sandy clay.

Pl. 8 Hall Yard, showing the existing setts and cobbles in the disturbed spoil at 15 (looking west).

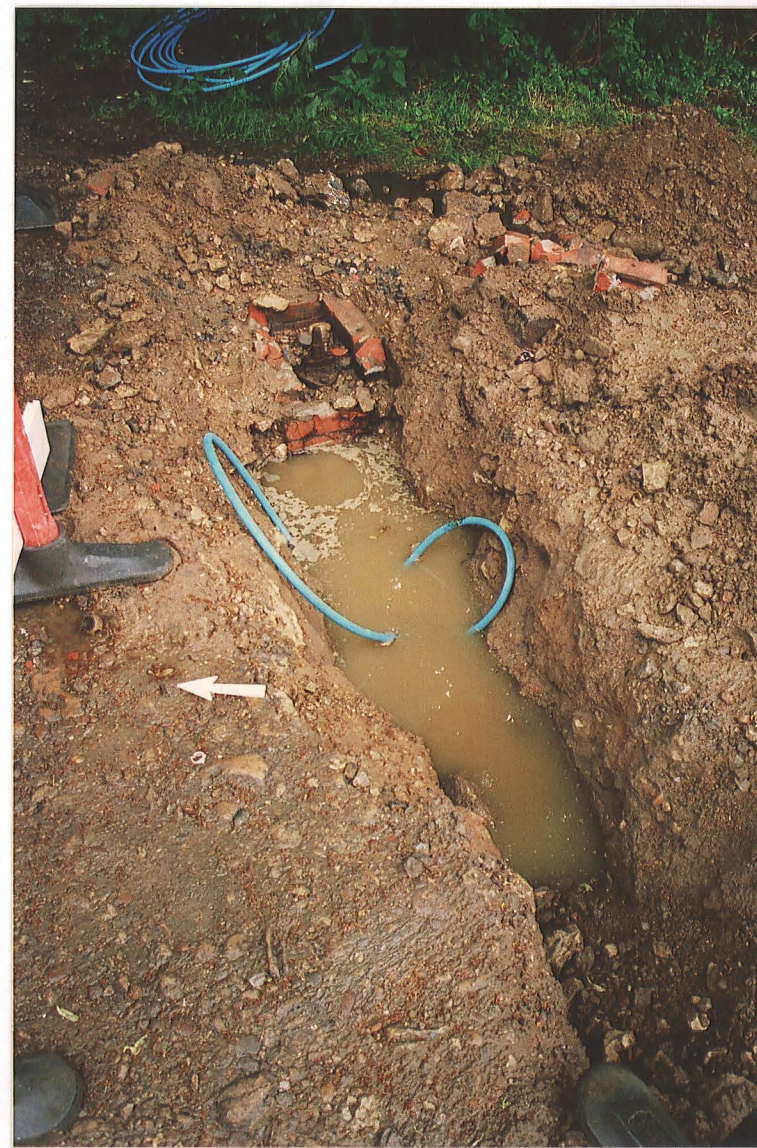
Pl. 9 Remains of yard or road cobbling at 15, in Hall Yard.
