LINDSEY ARCHAEOLOGICAL SERVICES

St. Edith's Church, Little Carlton near Louth
(NGR: TF 4037 8536)

Introduction

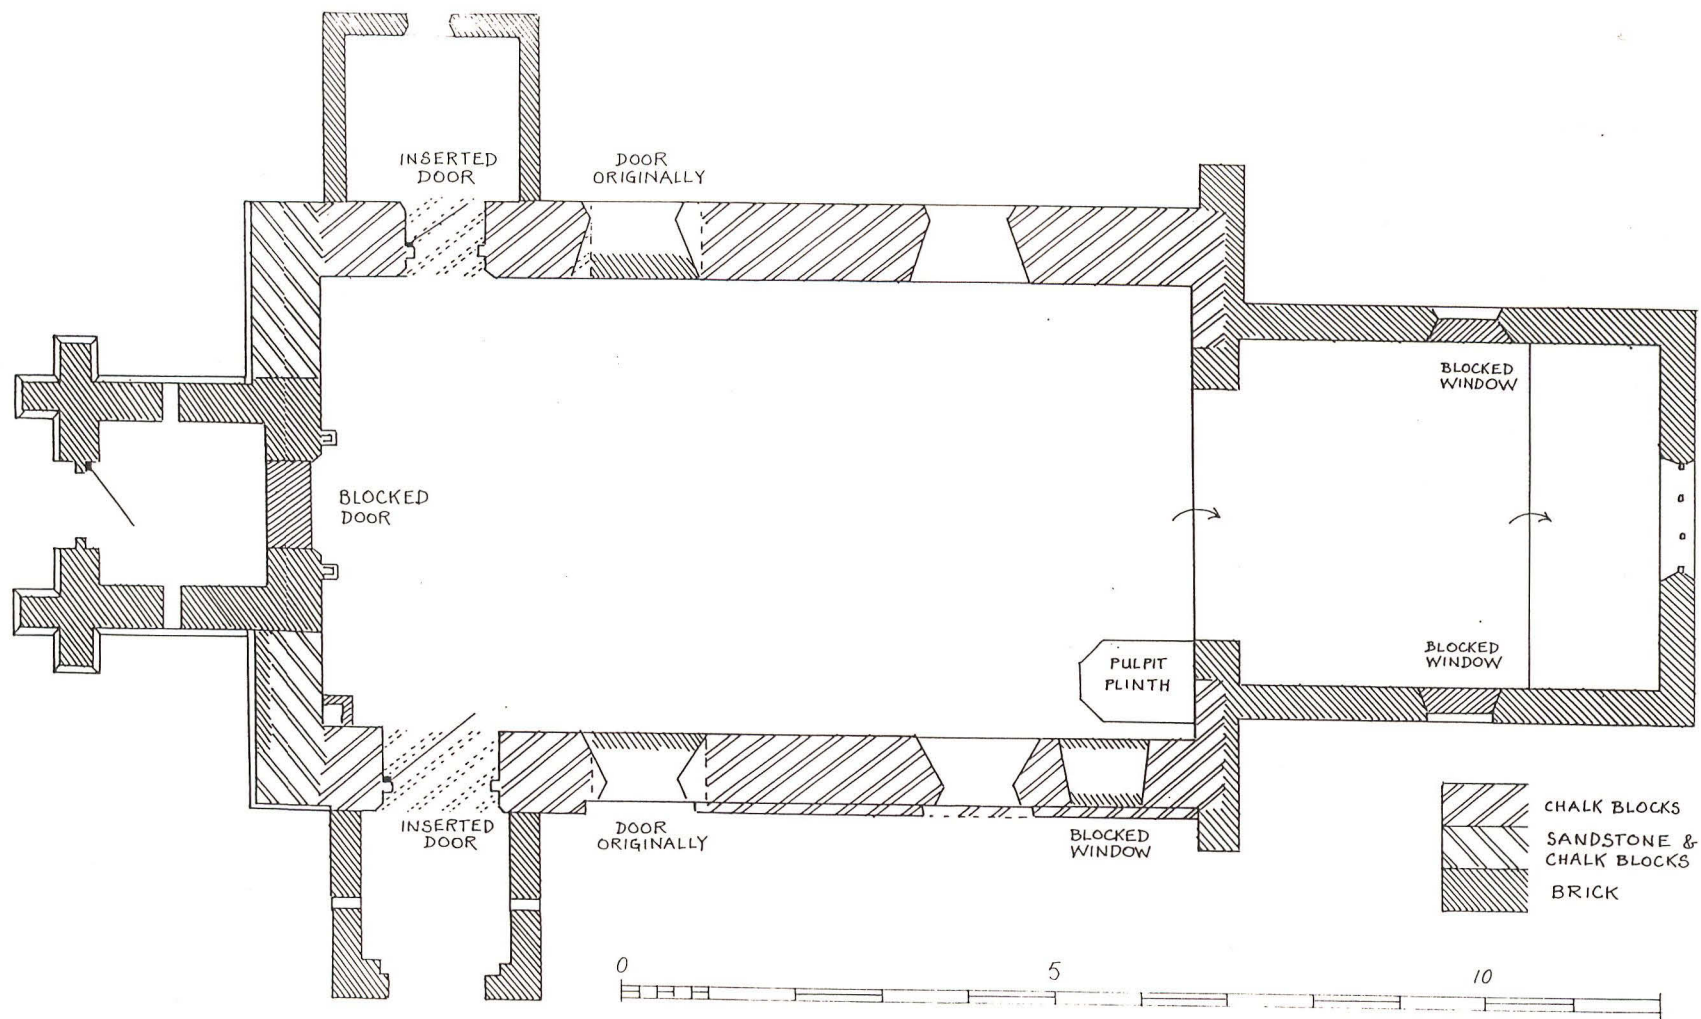
Fig. 1 Little Carlton St Edith. Ground plan, incorporating information obtained during watching brief. (Surveyed and drawn by M.Clark)

A measured ground plan of the building was made at the outset and interior wall plaster was stripped by archaeologists from selected parts of the nave and chancel walls. All the information obtained during the watching brief has been added to the plan shown in Fig.1.

Nothing of the medieval work was visible from the chancel side (Pl.29). Pl. 30 shows the brick construction of the arch was similar to that used in the nave and vestry doorways. The whole elevation had been clad in brick to provide a bond for the chancel walls. Fig. 1 shows how the brick end buttresses were constructed to enclose the chalk nave wall and tie in the chancel to the nave (see also Pls 29 and 30).

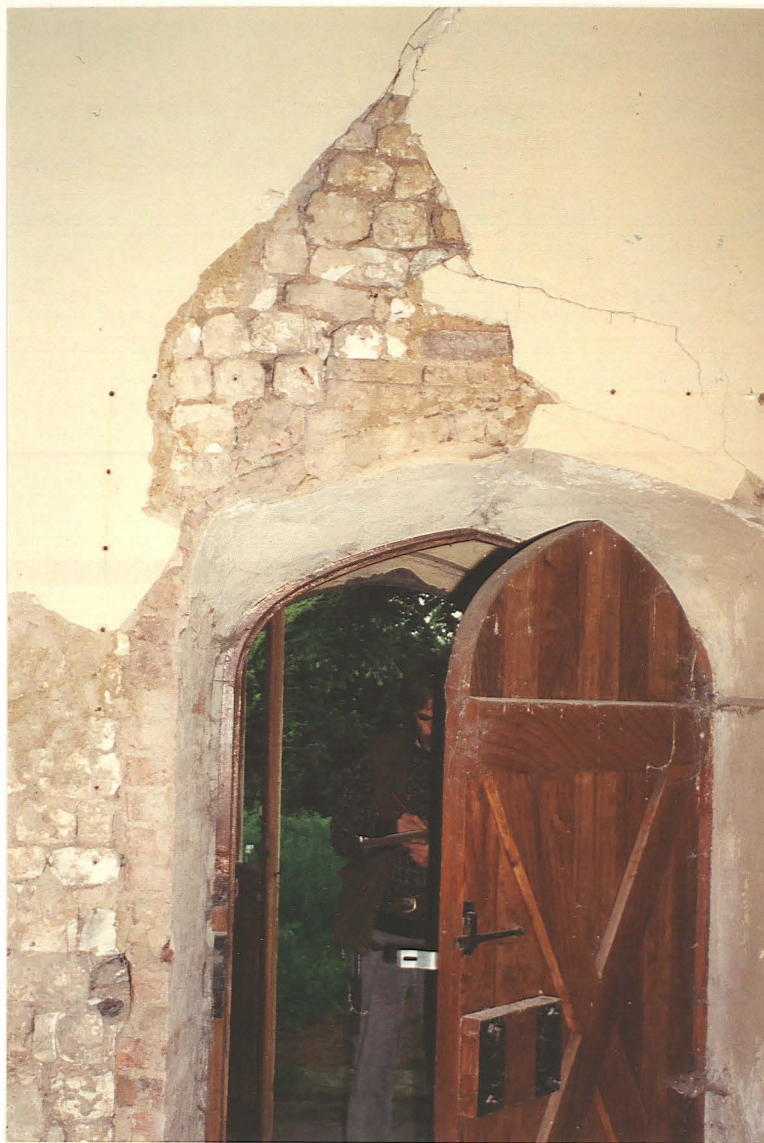
A blocked doorway was revealed 0.8m east of the porch, within the 1.5m width of the existing window opening. An iron pintle, which was the lower hanging for the door (Pl. 6), was found on the west side, slightly above the height of the plinth at c.0.95m above internal floor level, set into the wall. The doorway had been blocked with rubble smaller than that used in the nave wall construction and it is assumed that the blocking was contemporary with the construction of the porch and the new door to the west in 1837.

Pl.6. Nave south wall, (porch to left). Recess shows position of blocked doorway. Lower door pintle found on left side, just above demolition level.

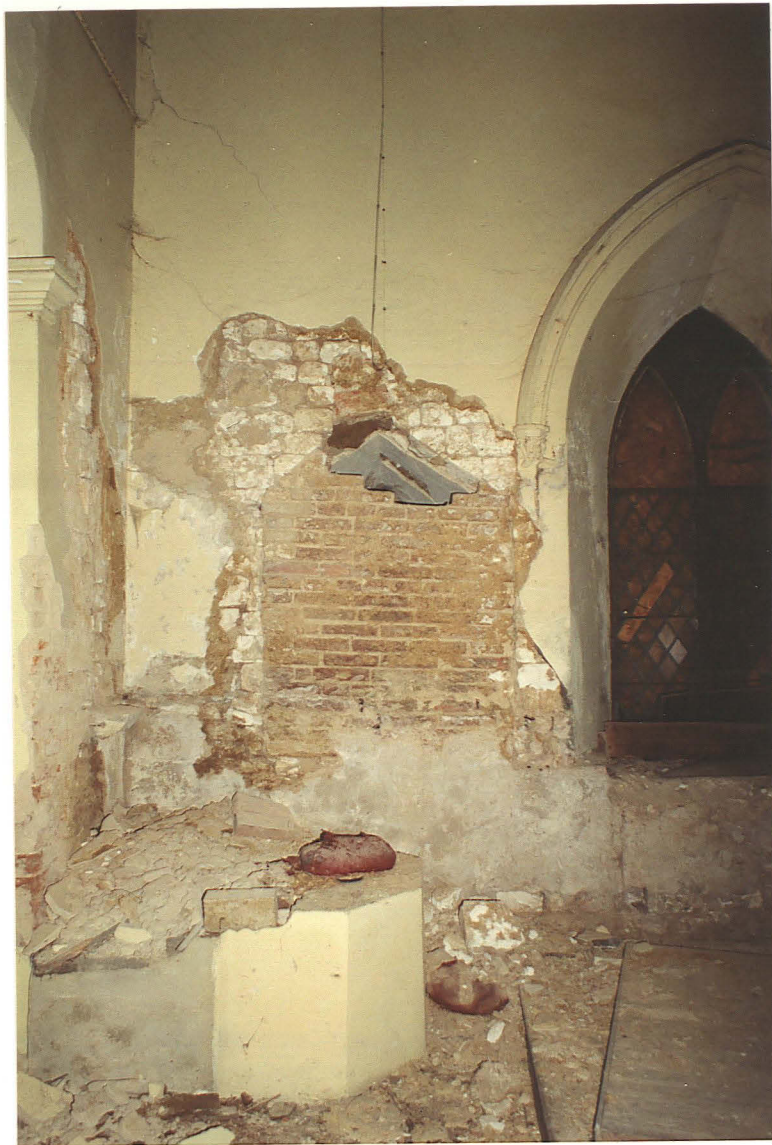
Pl.8. East window partially unblocked. Damaged pulpit dias in foreground.

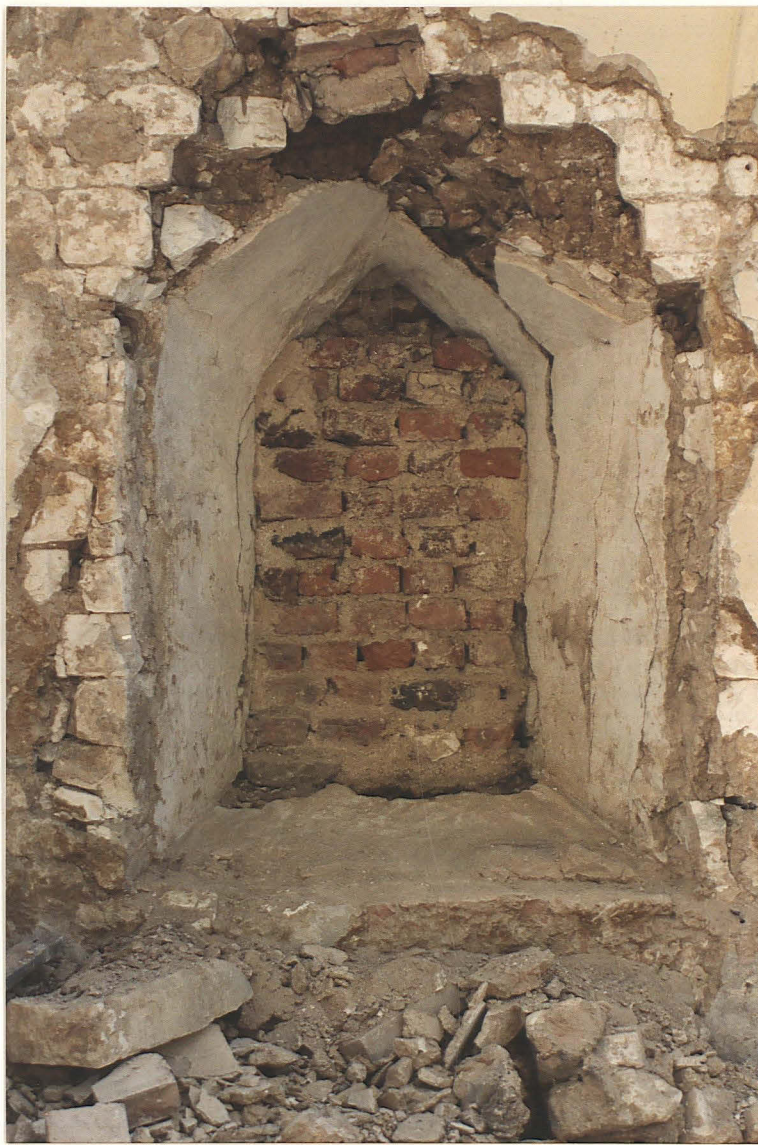
The window had been blocked with bricks flush to the external face of the nave wall, at some time prior to the application of the cement rendering, and the blocking was invisible on the outside of the church. This brickwork was not plastered internally so the opening never functioned as a niche (Pl. 9). The void had been filled with loose rubble and bricked up. A fragment of clear hand-blown window glass was found amongst the loose rubble infill, possibly seventeenth-eighteenth century in date (Pl. 10).

Pl.9. East window - after removal of brick blocking.

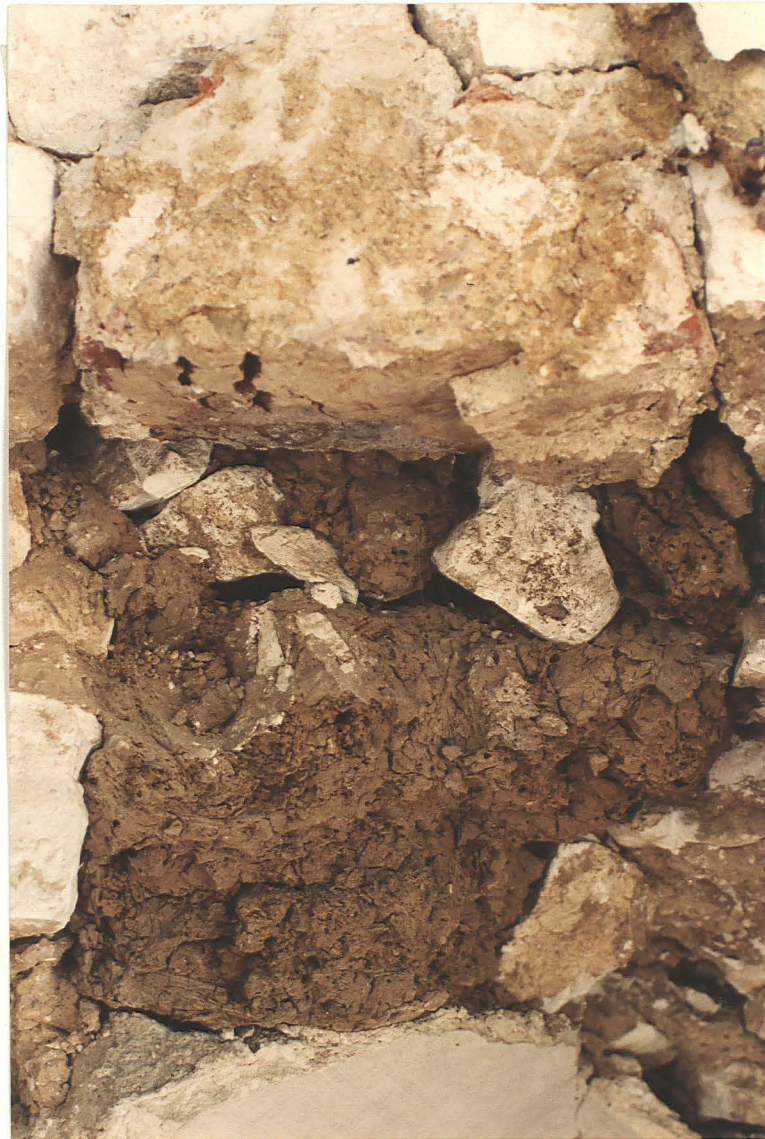
Pl.11. Close up of mud infill.

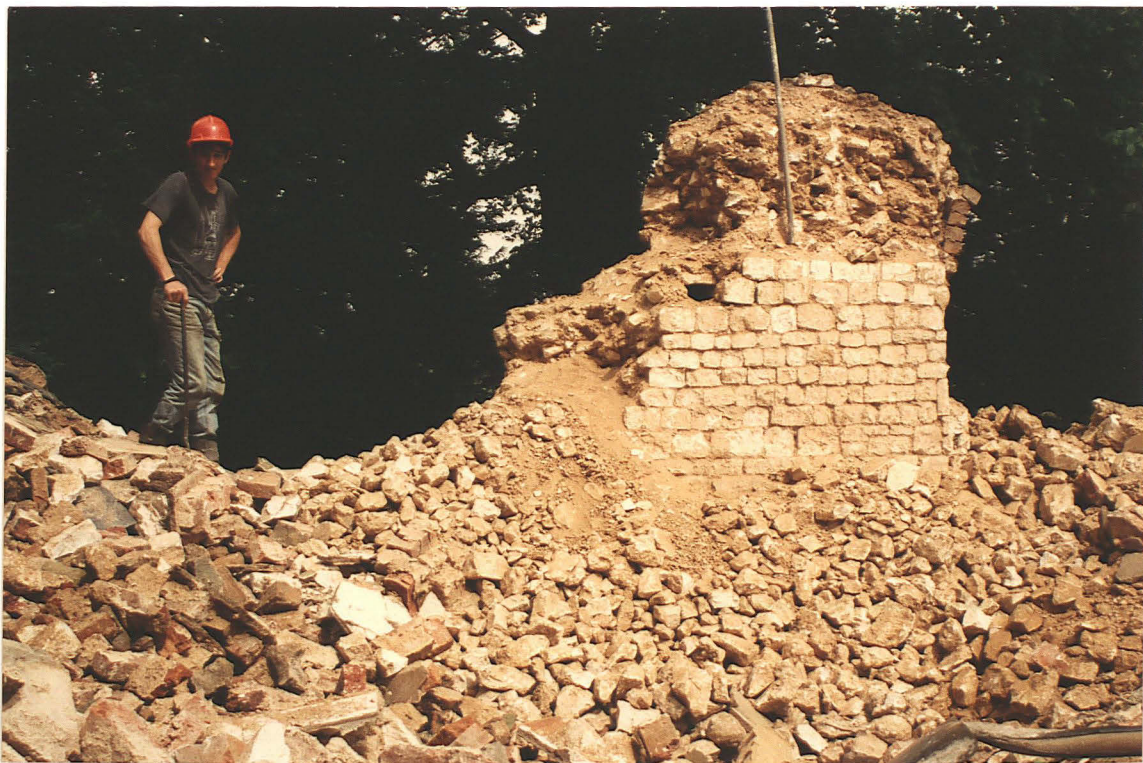
Only the central part of the north wall was observed during demolition. Its fabric was identical to that of the south wall and a putlog (scaffold) hole was recorded on both the internal and external faces of the wall (Pls 17 and 18). These photographs also show the chalk rubble core construction of the wall.

Pl.17. Nave north wall (interior), showing chalk coursing, putlog hole and rubble core.

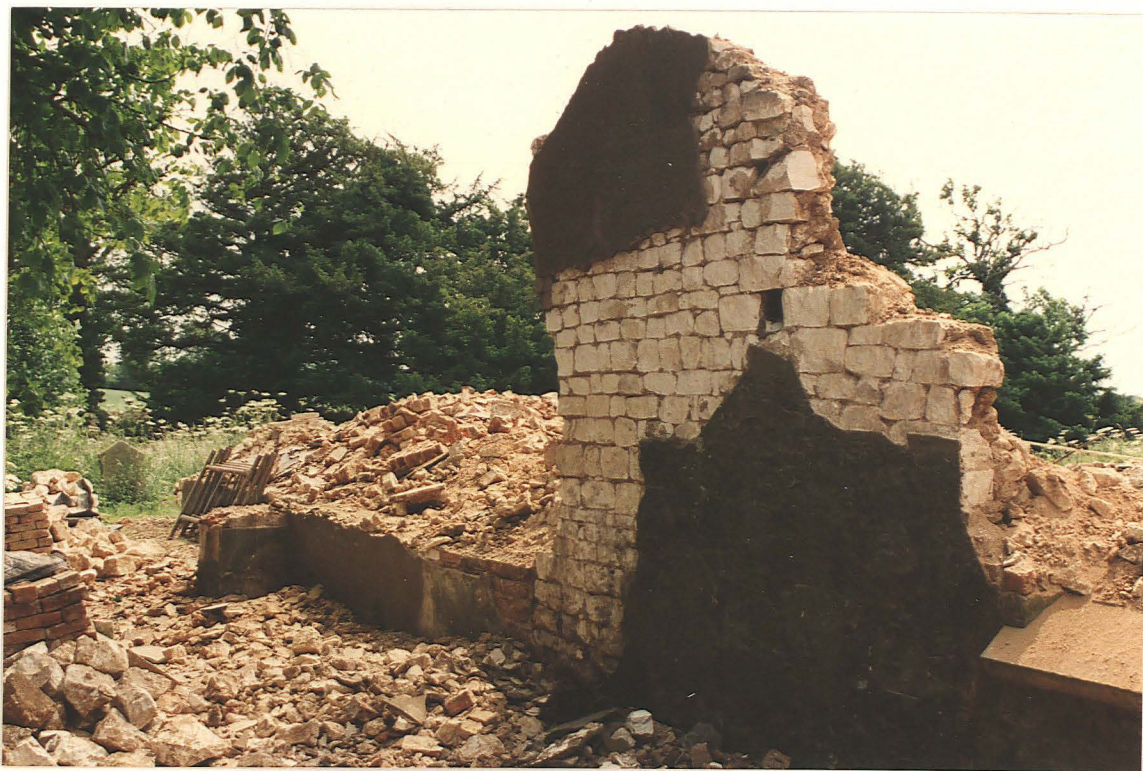
Pl.18. Nave north wall (exterior), showing chalk coursing, putlog hole and rubble core.

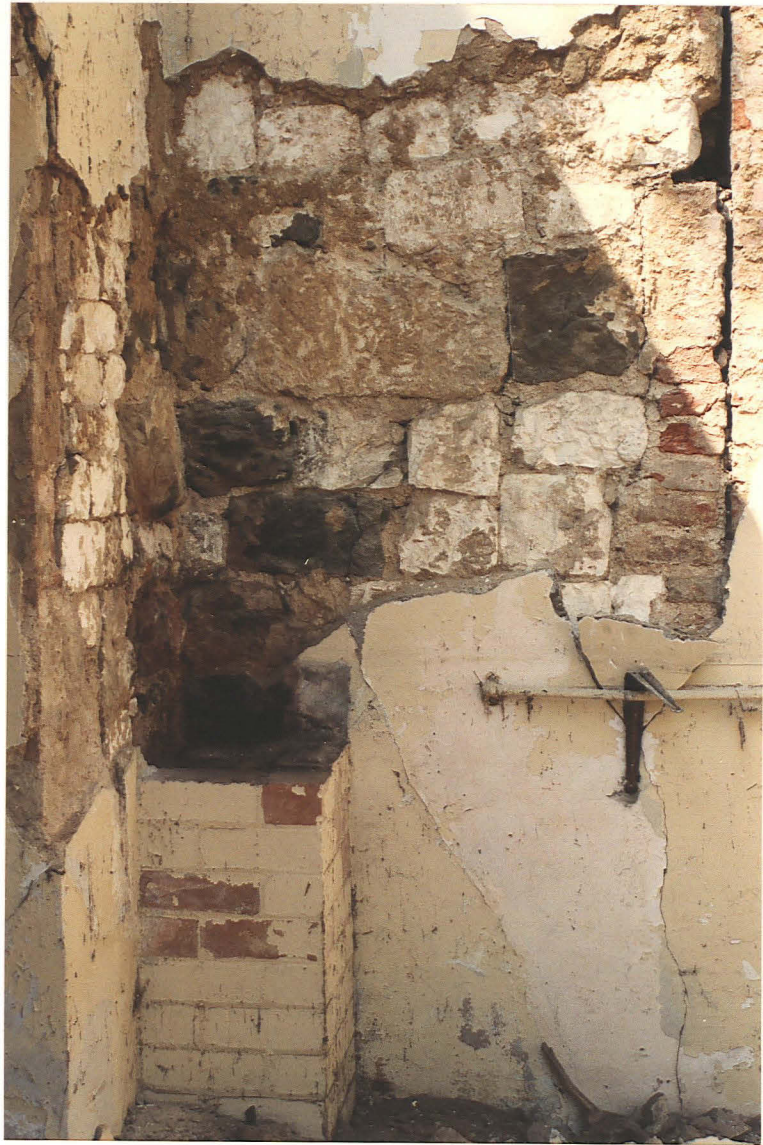
Pl. 20 also shows the remains of a brick heating flue in the corner of the nave, and scorching of the stonework above was clearly visible (Pl. 21).

Pl.20. Brick heating flue at south west corner of nave.

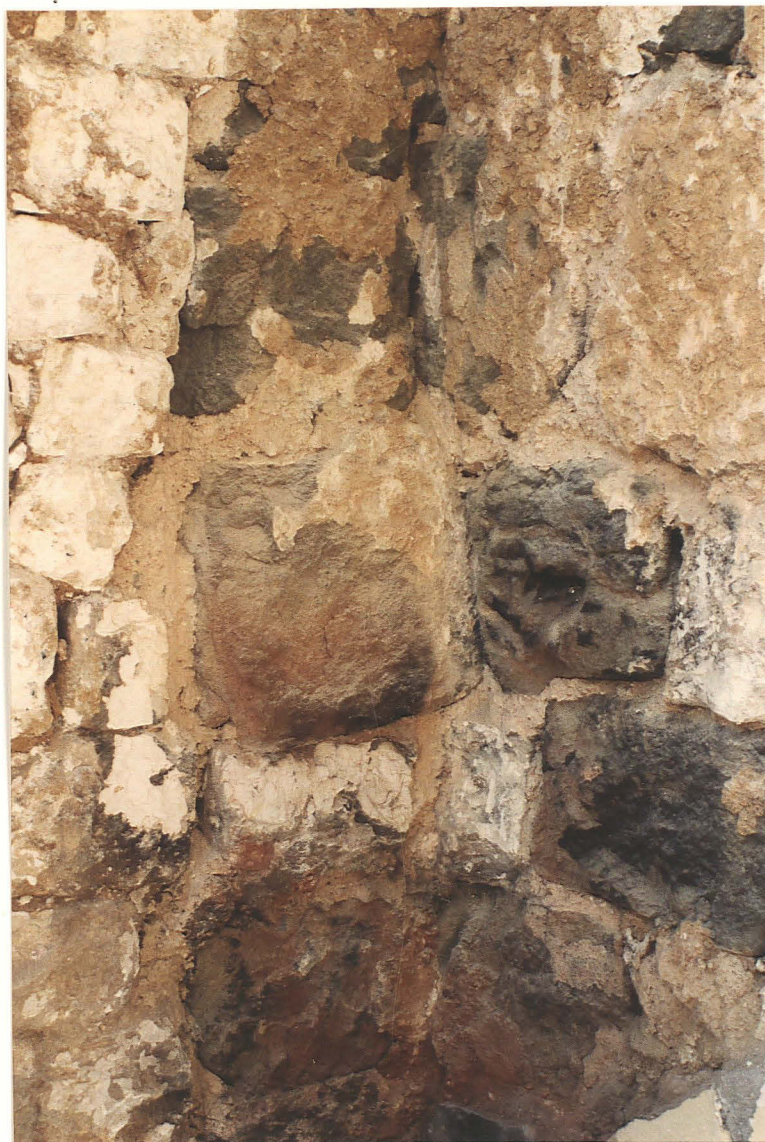
Pl.21. Burnt stonework above heating flue, south west corner of nave.

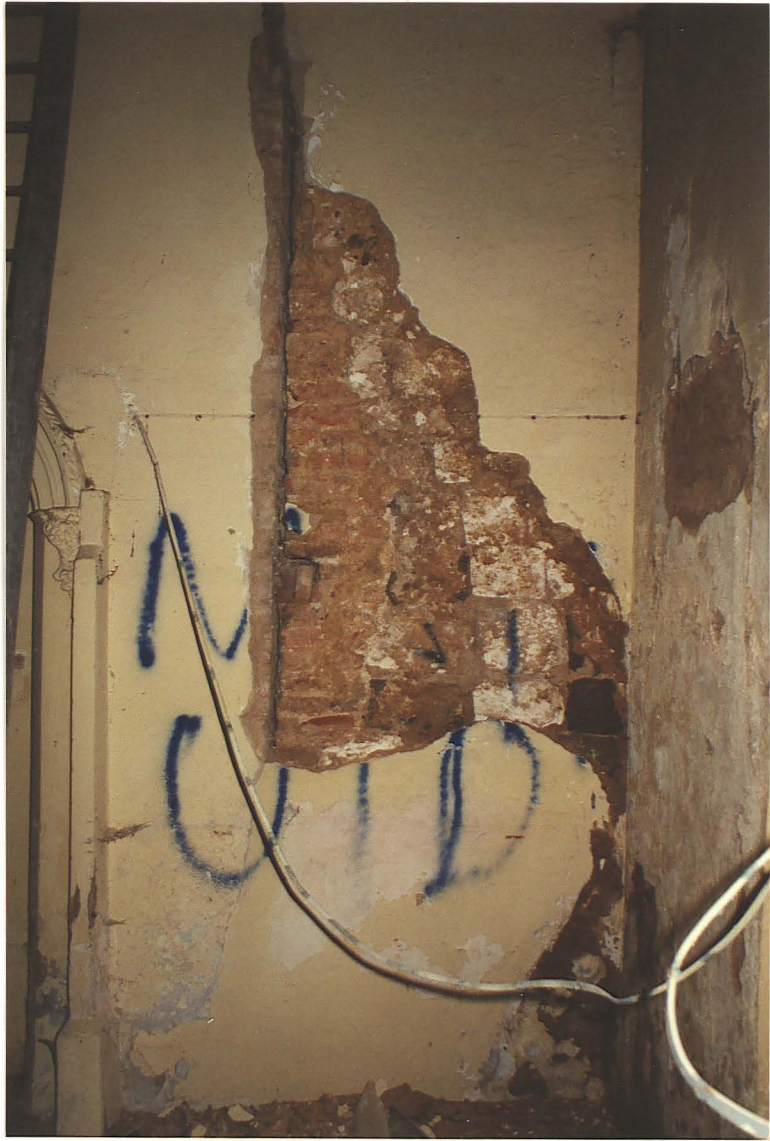
All evidence for a medieval tower arch had been removed when the brick tower was constructed in 1837. A large hole was punched through the wall and straightened up with brickwork (Pls. 20 and 22). The new tower was inserted into the nave wall, its east wall flush with the end of the nave. It was a completely free-standing structure, not bonded in to the nave (Pl. 25). The lack of bonding reinforces the view that there may have been structural problems at this end of the church. Perhaps the medieval tower had pulled away from the nave, causing the damage to the nave described above.

Pl.22. Brick patching of west wall of nave with inserted brick tower (left).

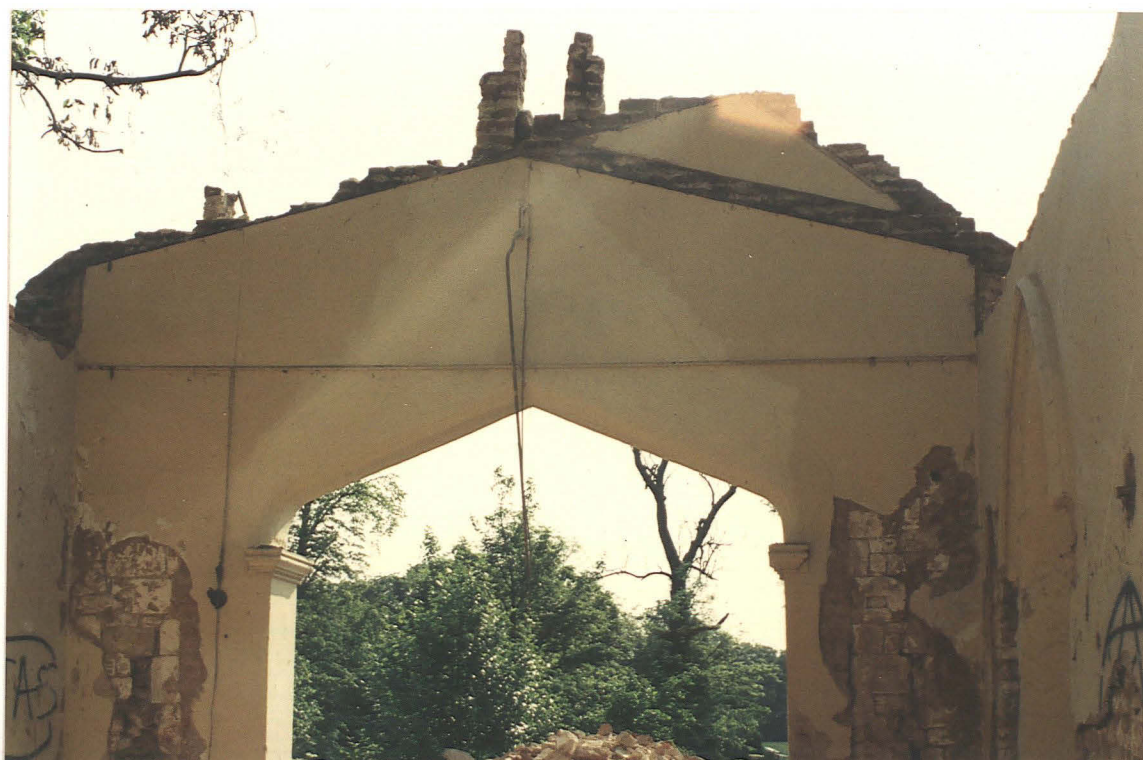
The plasterwork at the east end of the nave was stripped to reveal the original chalk walls. The chancel arch had been completely removed and replaced with a brick arch in 'Tudor' style. It was supported on brick piers c.0.5m square which flanked the chalk wall, leaving an opening of 2.90m (Pls 26-28). The original opening would have been of a similar size. It is possible that moulded chalkwork found in the chancel wall were the remains of the medieval chancel arch (see below). Pl. 27 shows the junction between brickwork and chalk indicating that the whole of the gable had been rebuilt, removing all evidence for the medieval chancel arch. A rectangular cavity is visible in one of the chalk blocks, possibly for keying into another block, in a former use.

Pl. 27. South side of chancel arch showing brick facing of new arch. Note brickwork above the chalk and re-used chalk block.

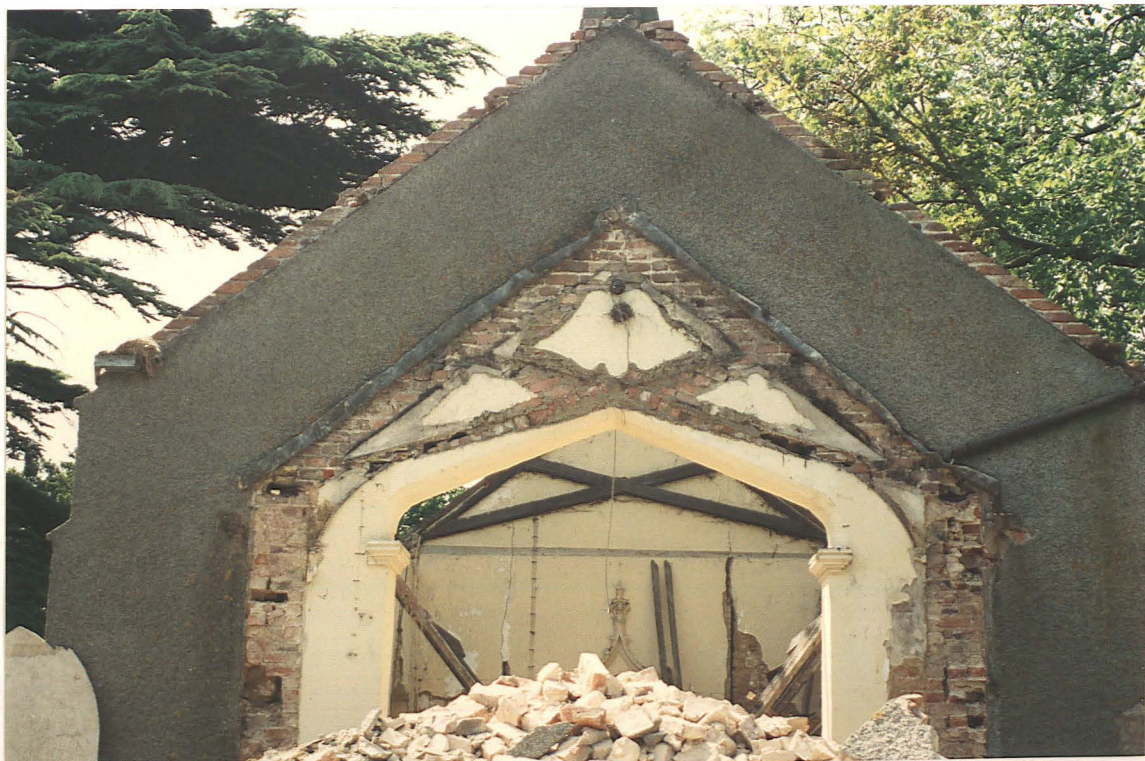
Pl. 29. Chancel arch looking towards nave after demolition of chancel. Note complete absence of any chalk and bonding for the chancel walls.
