# LINDSEY ARCHAEOLOGICAL SERVICES

**AUBOURN OLD CHURCH:  
ARCHAEOLOGICAL MONITORING OF A NEW  
ACCESS PATH AND ELECTRICITY CABLE TRENCH**

Geoff Tann  
Lindsey Archaeological Services  
15th August 1994

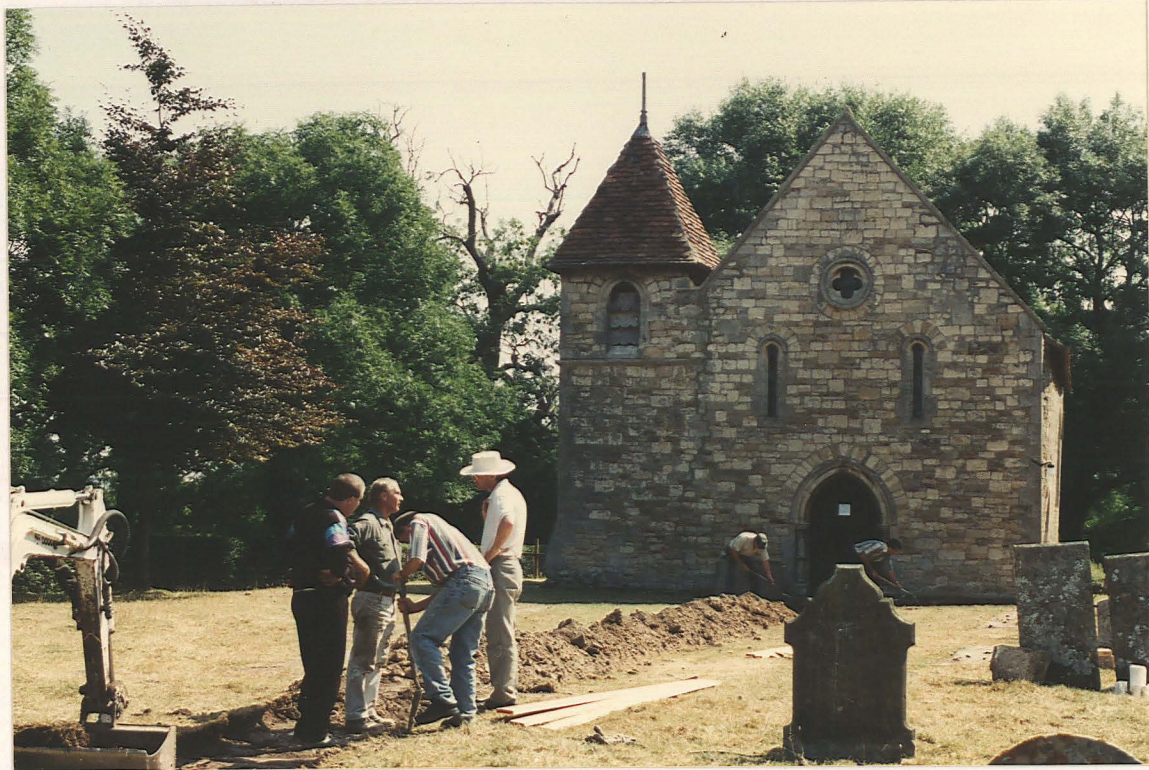
Pl. 1 Aubourn church from the west side, showing the remaining structure

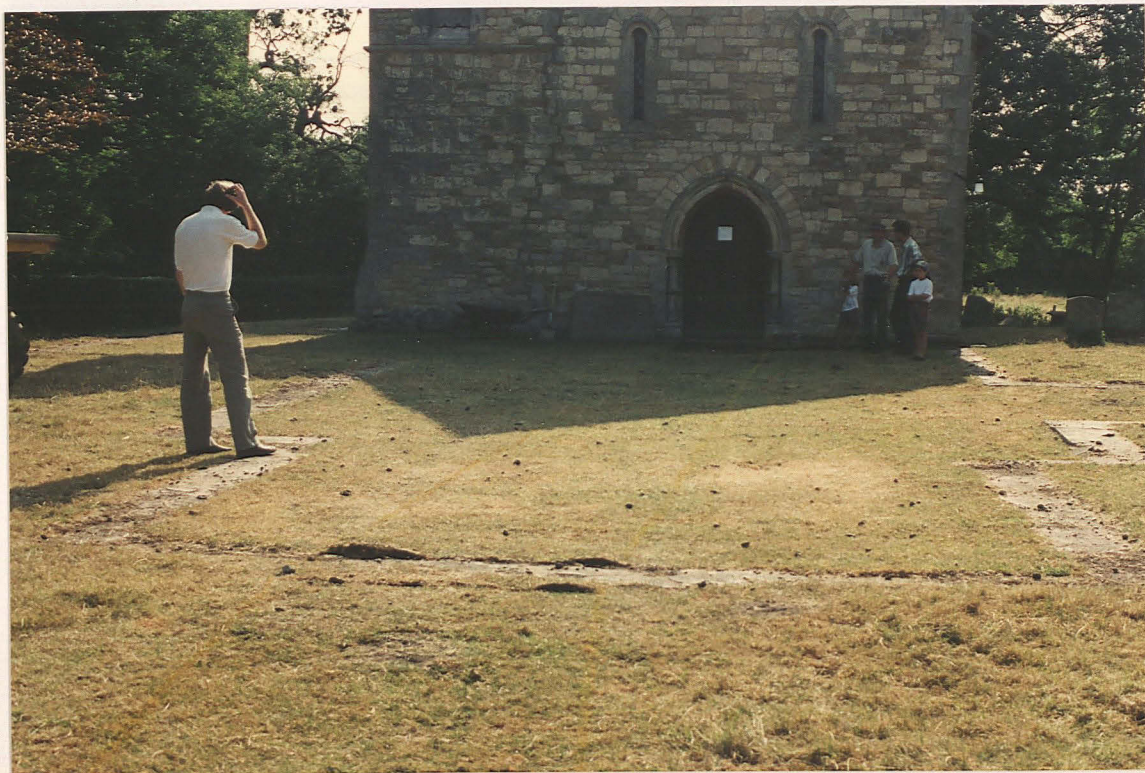
Pl. 2 Concrete marking of demolished walls, west side of church (yellow lines indicate new path position)

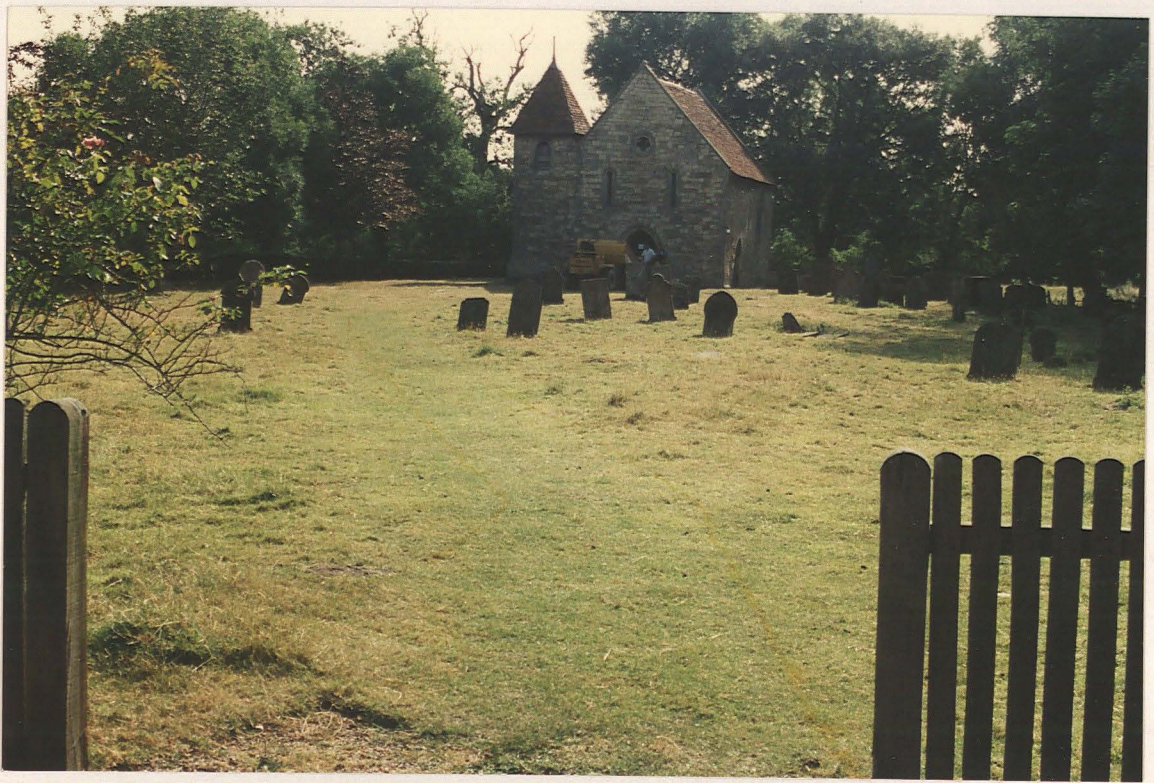
The churchyard of the medieval church has upstanding tombstones and is grazed by sheep. The approach to the building becomes muddy and poorly drained in wet weather and plans were prepared for the construction of a path between the north door and the Aubourn Hall Estate carpark (Pl. 3). The Diocesan Advisory Committee placed a proviso on the application, requiring an archaeological presence during part of the work, which was endorsed by the Chancellor in the approved Faculty. Lindsey Archaeological Services was commissioned by the Parochial Church Council to observe the limited excavation for the path across the interior of the dismantled church and archaeological monitoring by the author took place on 23rd July 1994.

Pl. 3 The Graveyard (yellow lines marking route of new path to church gate)

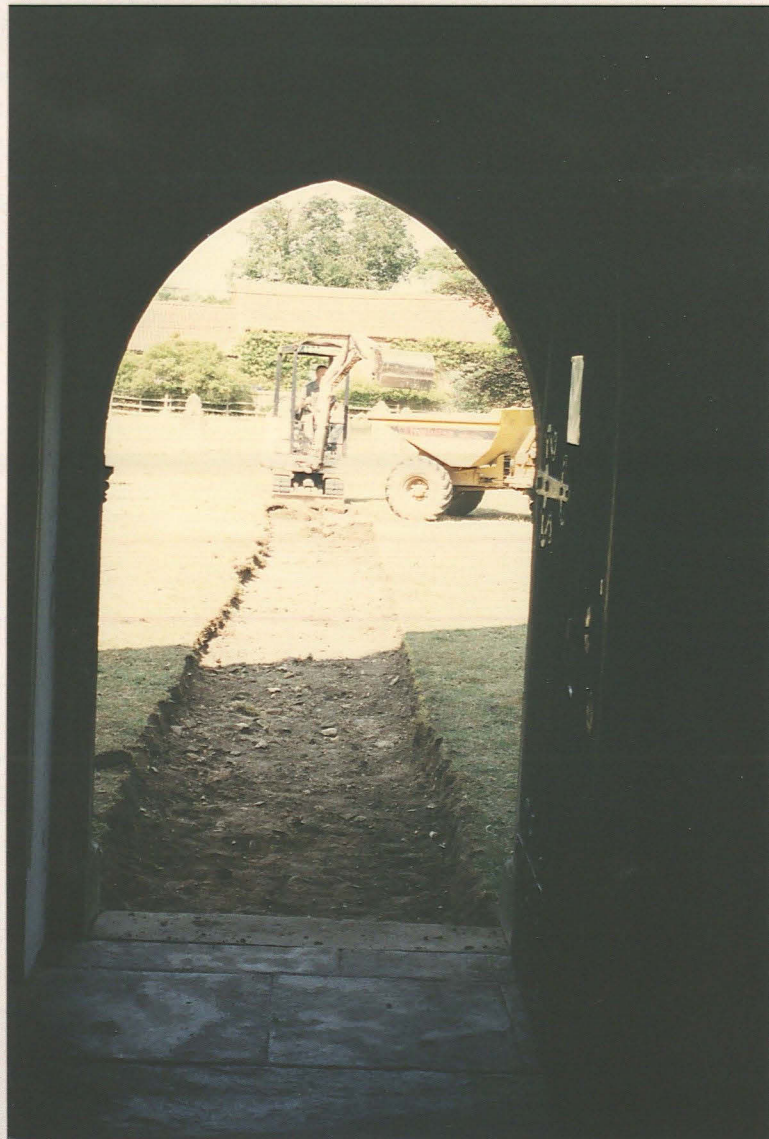
The groundwork consisted of removal of turf and soil to a depth of about 0.25m from the church threshold across the dismantled building, using a small machine with a 1m toothless bucket (Pl. 4). Spoil was removed and tipped into a depression around the south-western edge of the churchyard which is probably the remains of a boundary ditch. A 0.25m wide bucket was then used to cut a deeper trench (varying from about 0.25m to about 0.9m deep) along the south side of the path excavation to bury a replacement electricity supply cable (Pls. 5 and 6). The cable trench left the path and deflected around the SW corner of the upstanding building before entering beside the SW doorway. Where the trench needed to cross a wall foundation a hole was drilled below the capping cement and brickwork but above the surviving stone foundations. The path excavation showed that the west door threshold of the remaining building had been repositioned on a base of clay roof tile fragments and concrete (1), presumably when the building was reduced in size in the mid 19th century. A broad area, almost 2.5m east-west immediately in front of the entrance, appeared to have been dug out and backfilled (2); the stone pieces were less dense than further west. The

Pl. 4 Excavation of the path, viewed from inside the west door

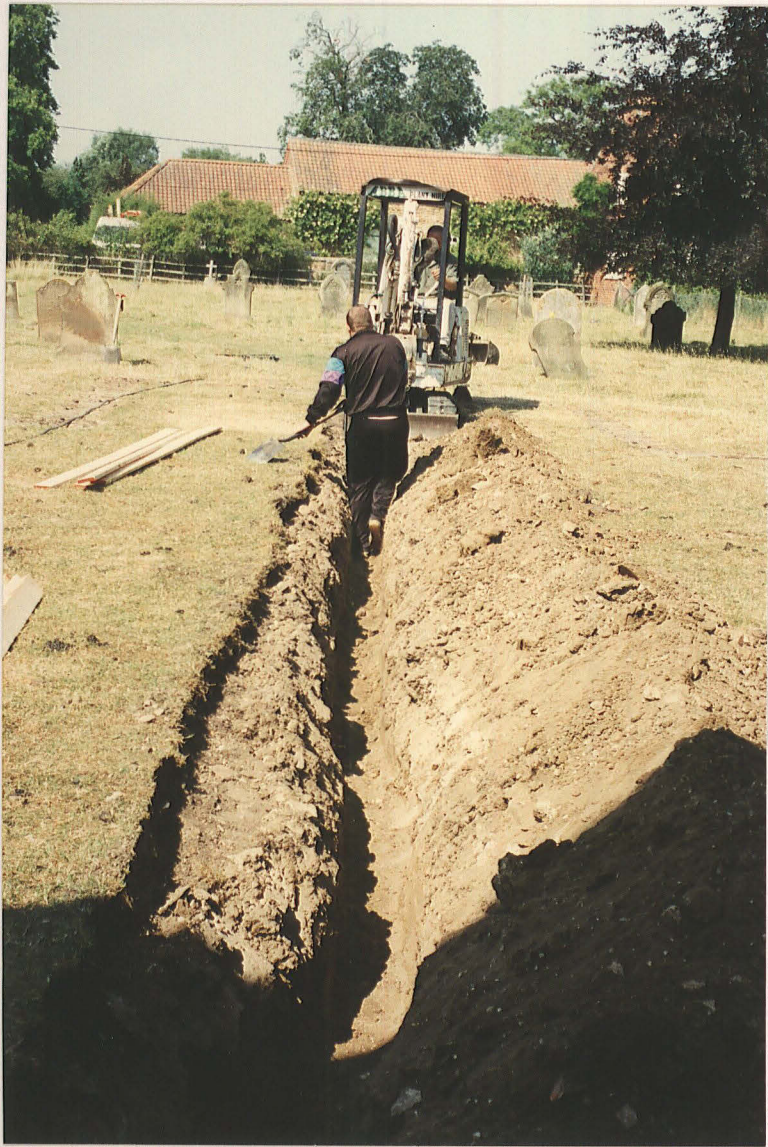
Pl. 5 Excavation of the cable trench across the former nave area

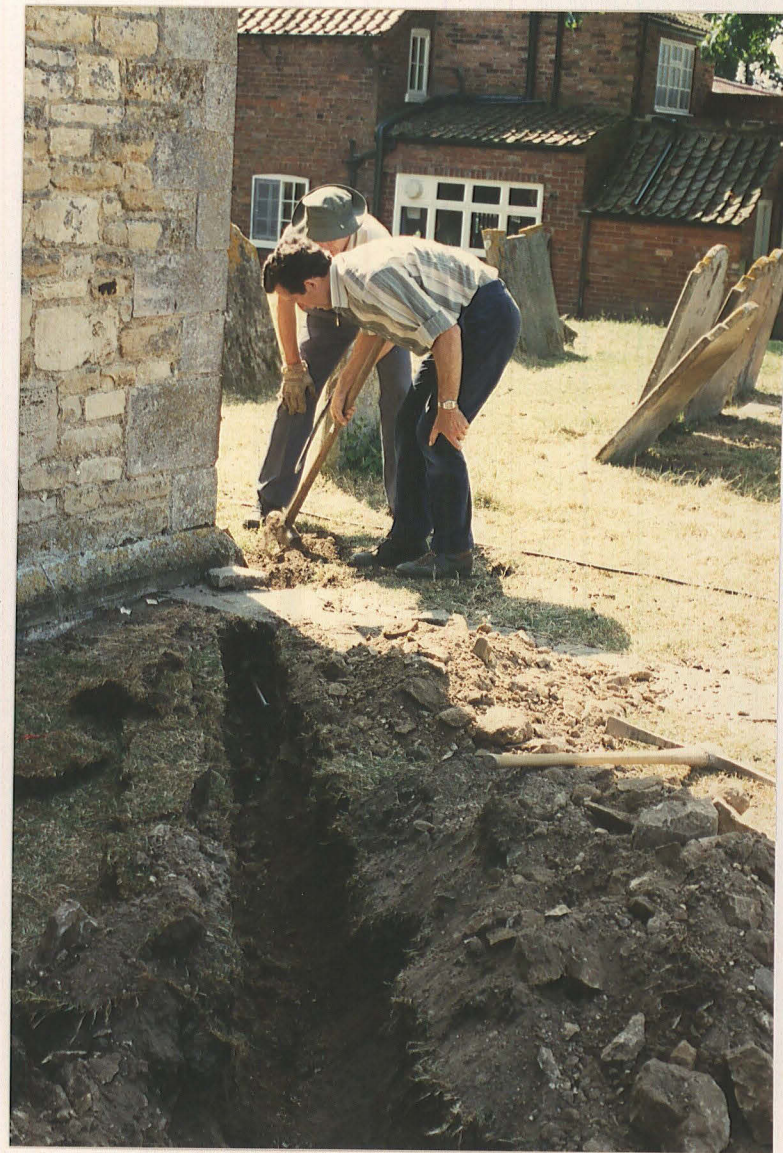
Pl. 6 The cable trench at the SW corner of the church

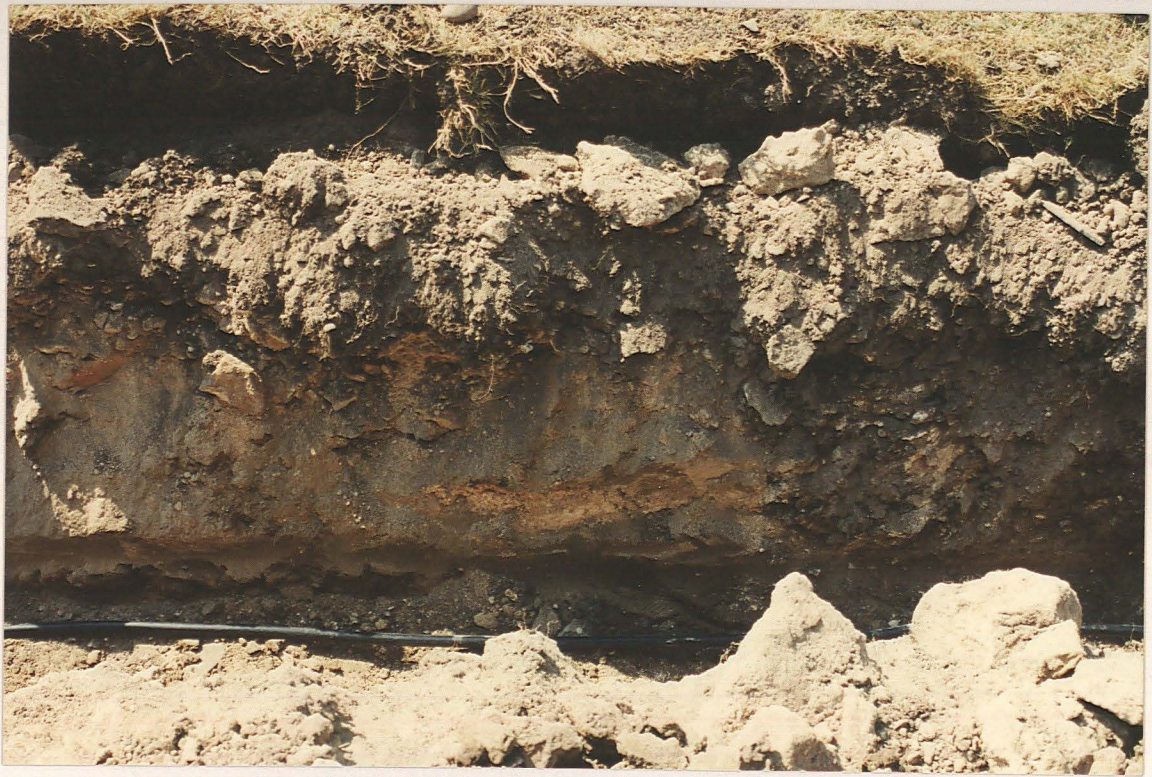
The western part of the nave had been disturbed by several late 19th - early 20th century small refuse pits containing metal containers such as oil cans and paint tins. Deposits of ash and broken roof tiles (5) seen in the deeper trench may have been equally recent (Pl. 7). A single archaeological feature was revealed at the edge of the pipe trench (6). Two courses of mortared red handmade bricks with no frog lay 0.3m below the present surface, aligned east-west (Pl. 9). The dimensions were 235mm x 70mm x 95-110mm and may have been late 18th century in date. Four end to end bricks were exposed but the original length of the structure could not be determined, neither could its function be guessed.

Pl. 7 Mortar dump 4 (left) and 20th century rubbish pit (left) in cable trench south section

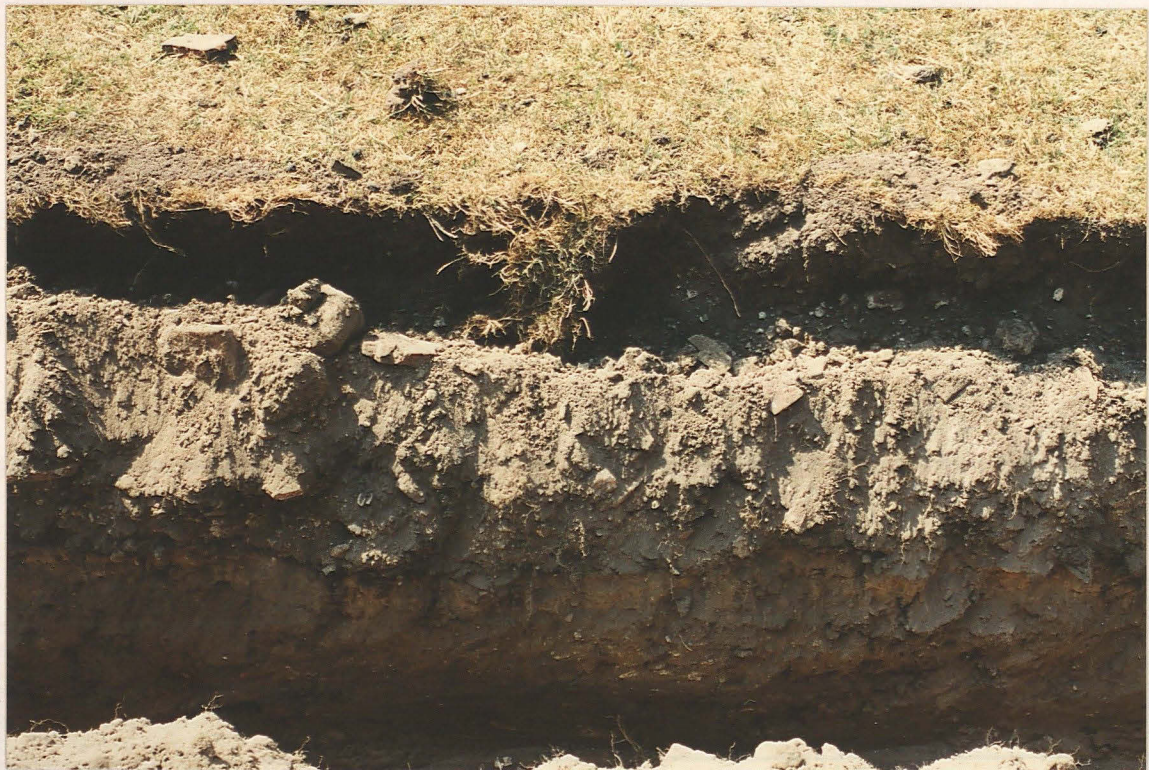
Pl. 8 Cable trench section within nave area, looking north

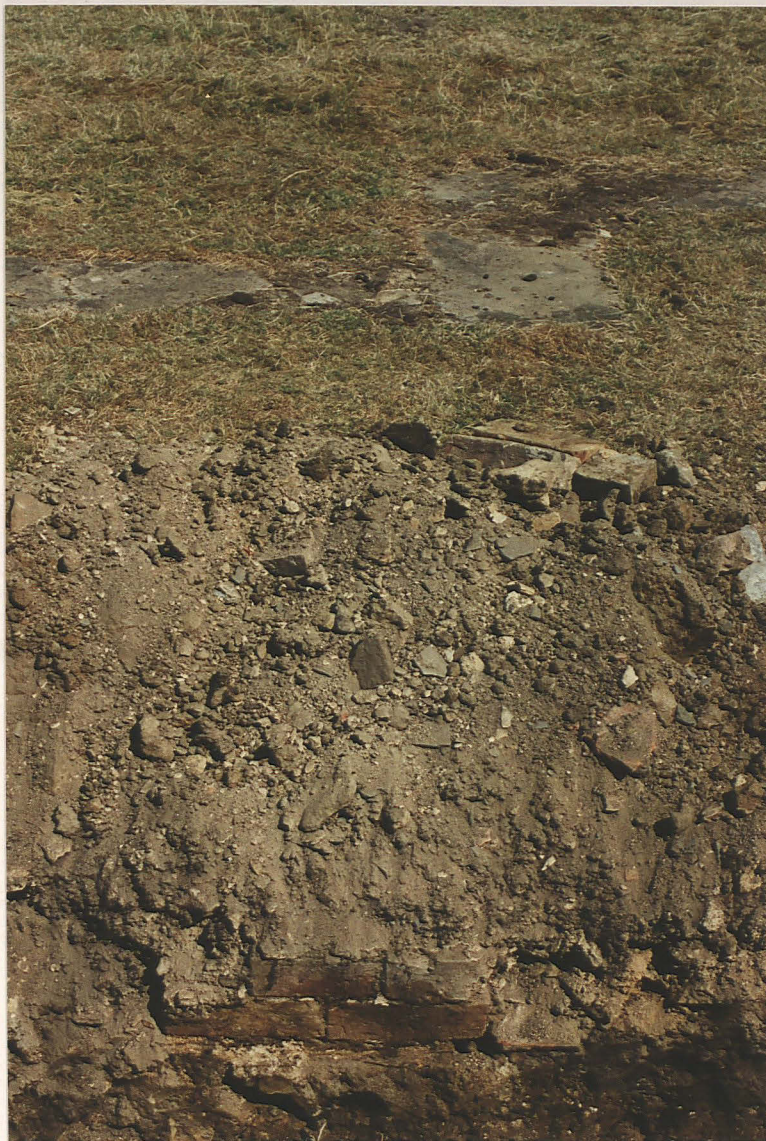
Pl. 9 Brick foundation 6 in top of north path section

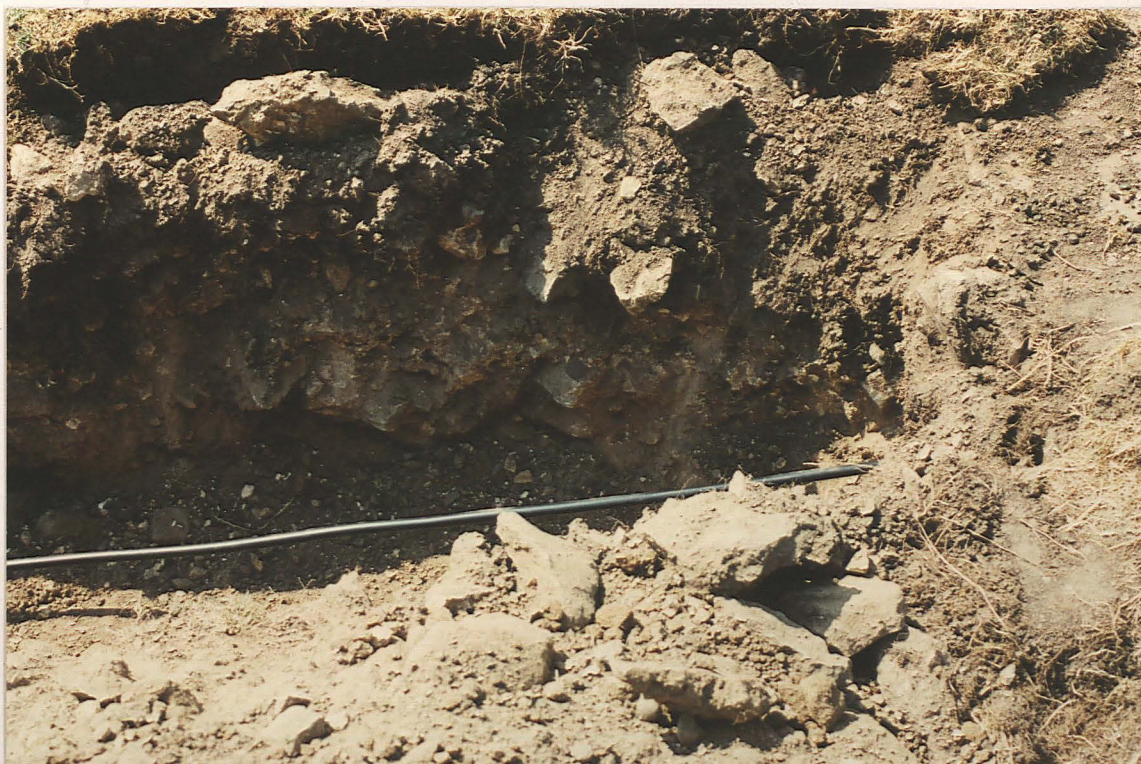
No unmarked foundations were discovered during the groundworks and the actual width of the dismantled walls was not revealed. A dense deposit of mortar and limestone rubble at the western end of the medieval building immediately inside the nave area seemed to be waste material from robbing the wall; it was not a broad *in-situ* foundation (Pl. 10). The construction of the path and the excavation of the cable trench did not appear to cause any damage to medieval archaeological deposits on the site.

Pl. 10 Stone rubble and mortar beside west wall of demolished nave (looking south)
