**Scampton St. John the Baptist's Church**

**Archaeological Monitoring**

**Removal of the Lady Chapel Floor**

**April 1994**

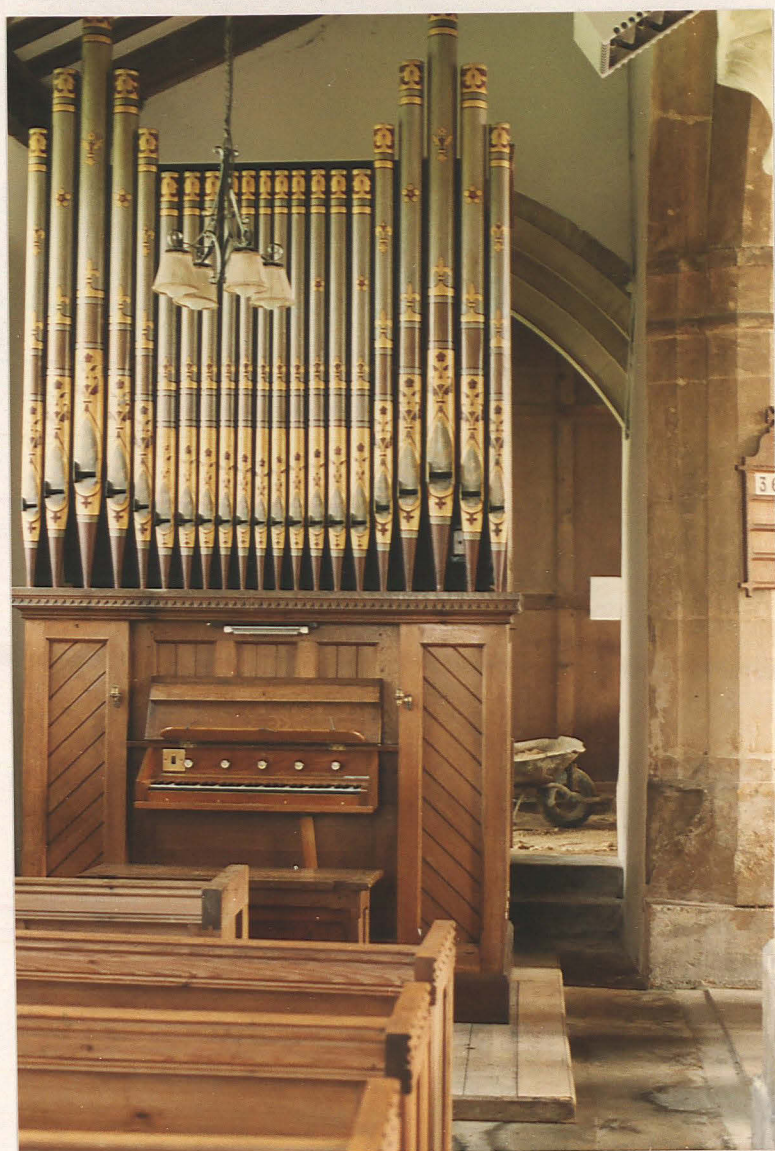
The organ at Scampton Church has been replaced by another model donated by a Methodist Church (Pl. 1). The old organ had been positioned in the Lady Chapel, to the north of the Chancel and beside the panelled vestry area; the replacement has been sited in the North Aisle, freeing space for a small chapel intended to commemorate the RAF presence at Scampton Airfield and in the village.

**Pl. 1 The replacement organ in the North Aisle, with panelled Lady Chapel in background**

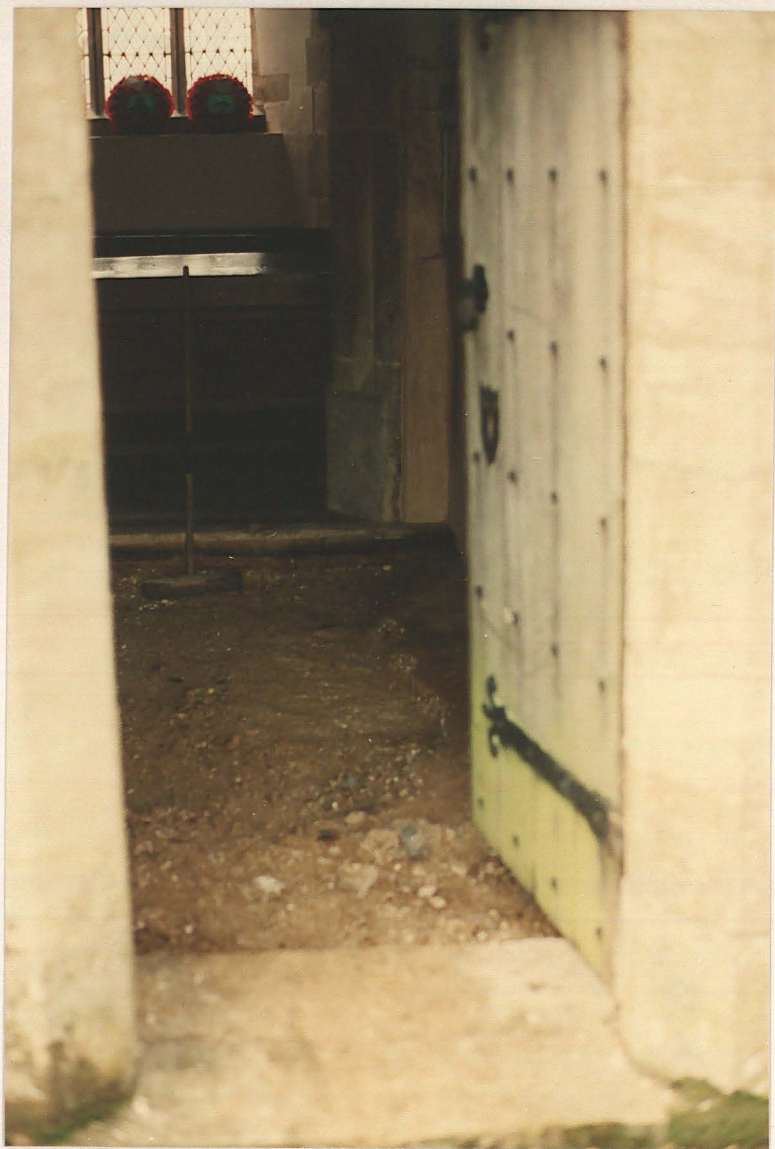
The author was present during the removal of the floor base by builders on 21st April 1994 (Pl. 2). The wooden blocks within the Lady Chapel had been removed but their impressions remained on a compacted bedding layer of dark brown sandy mortar, 15-20mm thick (Pl. 3). This surface overlay a thick deposit of mortar containing much larger inclusions of limestone and either gypsum or lime. The depth of this layer was not discovered but it was in excess of 0.12m; it continued below the base of the excavation (Pl. 4). The limestone chips seemed to be of a similar size and appeared to be introduced as hardcore rather than representing fragments of masonry dressed on the site or damaged during demolition.

**Pl. 2 The Lady Chapel, seen through the north doorway**

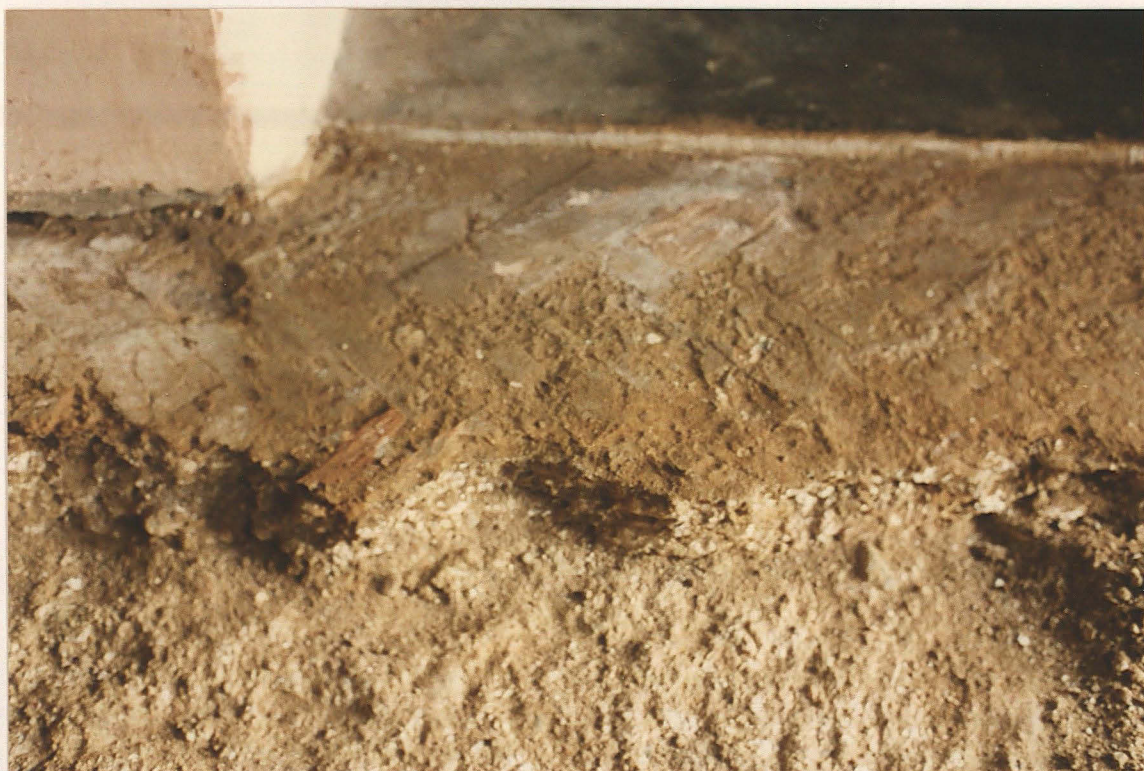
**Pl. 3 Wooden block impressions on the mortar floor base**

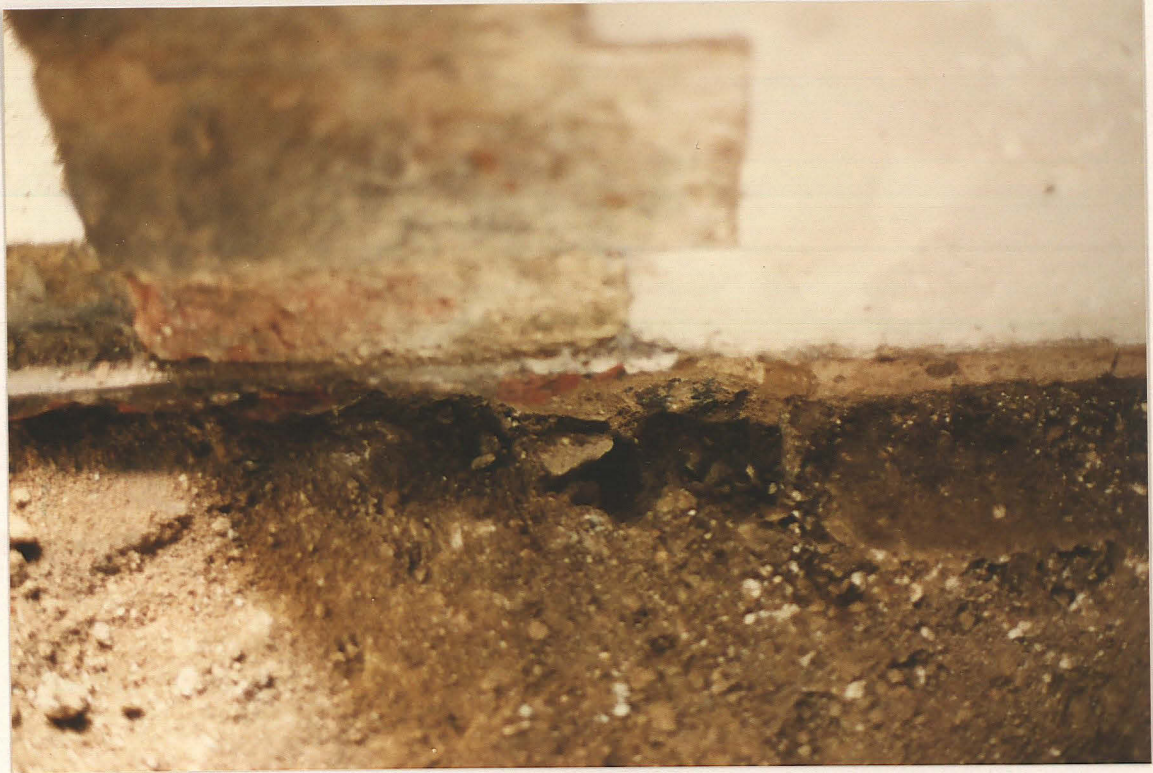
Little structural detail was exposed by the works in the Lady Chapel, but this supported the record of the present building closely reflecting the foundations of its predecessor. A small stone offset was found on the north side of the arch from the North Aisle but insufficient was visible to record in detail (Pl. 3). The stone steps leading into the North Aisle had been placed onto the mixed chalk and mortar layer. Large stone blocks continued from the Aisle archway and below the narrow north doorway. Underneath the window, the foundation

**Pl. 4** Stone offset below mortar floor base to east of doorway

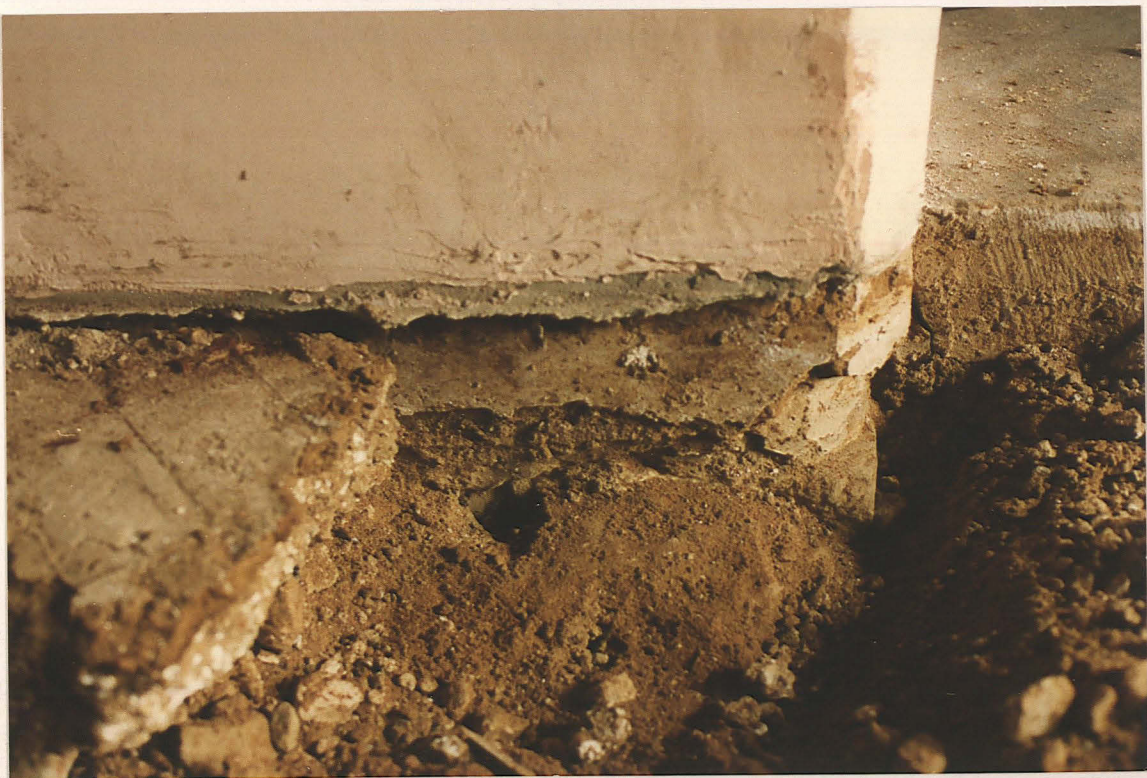
seemed to be of smaller stone pieces, possibly a remnant of the earlier chapel. All the wall remains had a 0.03m layer of sandy mortar below 0.02m of render; both presumably pre-date the block floor and possibly also the 1876 alterations (Pl. 5).

**Pl. 5** Underlying deposit of mortar and stone rubble, to south of North Aisle arch
