MANOR FARM, COLSTERWORTH. ARCHAEOLOGICAL WATCHING BRIEF AND STANDING BUILDING REPORT

Site Code:	MIFC03
NGR:	SK 9300 2396.
Planning Ref.	S02/0198/22
Accession No.	2003.15

Report prepared for Mansion Court Properties. by Alex Brett

> > August 2003

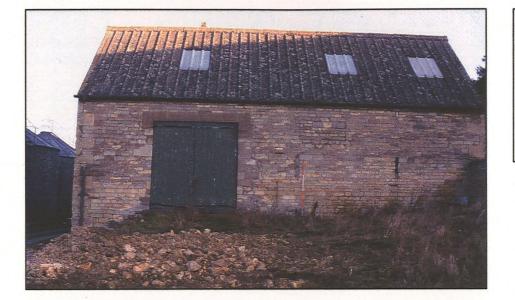
Pl. 1 Southern elevation of barn. Note revetted path leading up to double doors. Looking north.

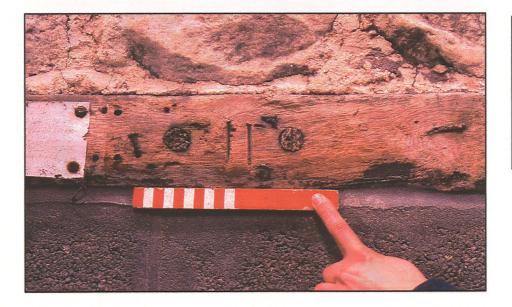
Pl. 2 Carpenters mark from lintel over northern (blocked) door of barn. (Scale 20cm) Looking north.

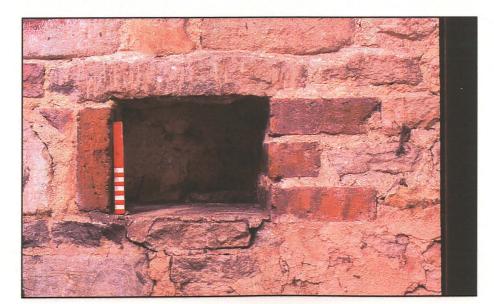
Pl. 3 Brick and stone built cupboard in northern wall of barn. (Scale 20cm) Looking north.

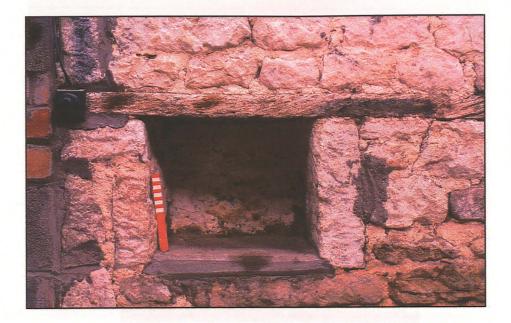
Pl. 4 Stone and timber built cupboard from north wall of barn. (Scale 20cm) Looking north.

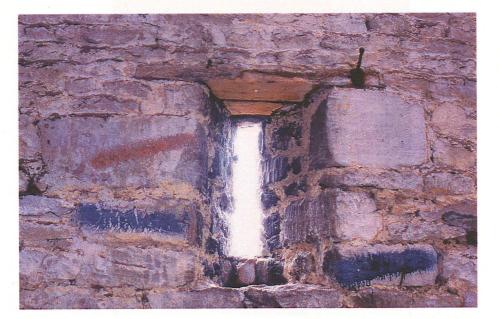
Pl. 5 South eastern 'splay' window from barn. This was the only unblocked example. Looking south.

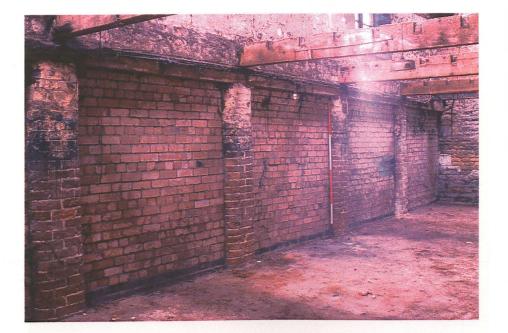
Pl. 6 Western wall of wagon shed, showing openings and later blocking walls. Looking north west.

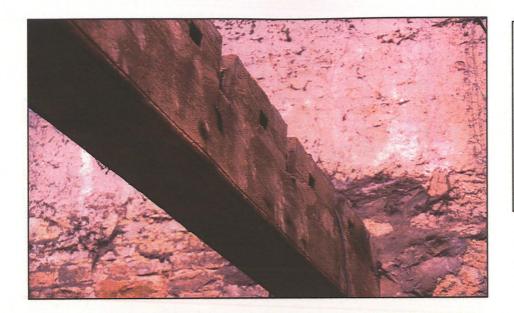
Pl. 7 Re-used beam from ceiling of Room 1. Note smaller un-used mortices, and beading on lower corners. Looking north east

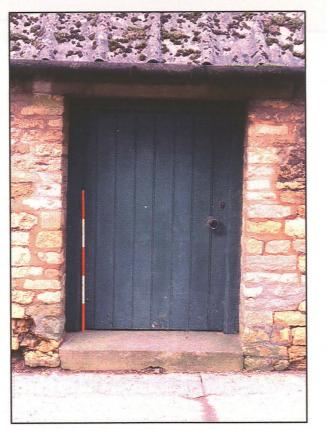
Pl. 8 Ornate door in eastern wall of structure. The decorative nature suggests this may have been for domestic use. Looking west.

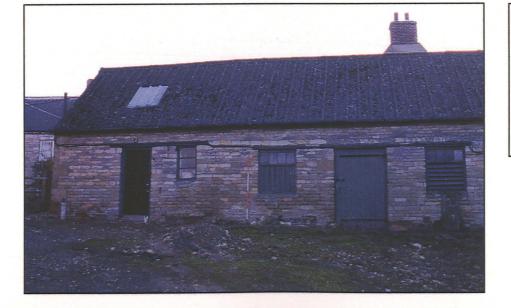
Pl. 9 Northern end of western elevation. None of these interiors could be examined. Looking east.

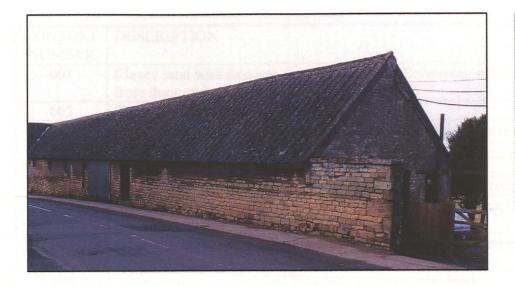
Pl. 10 Eastern side of structure; note wall continued to form property boundary. Looking south west.
