LINDSEY ARCHAEOLOGICAL SERVICES

14 Market Place, Alford, Lincs.

Archaeological Appraisal

LAS Report No. 689

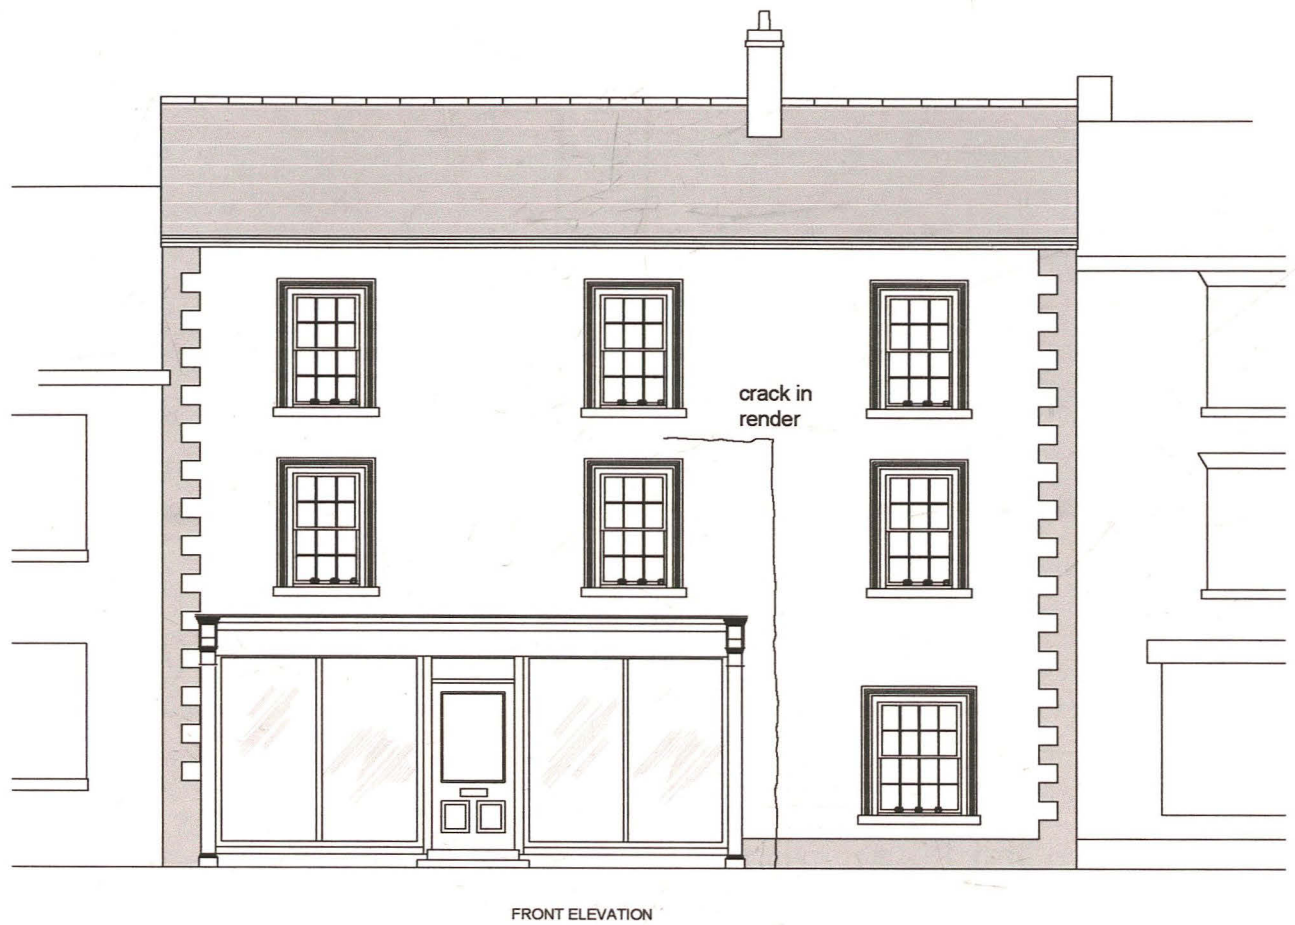
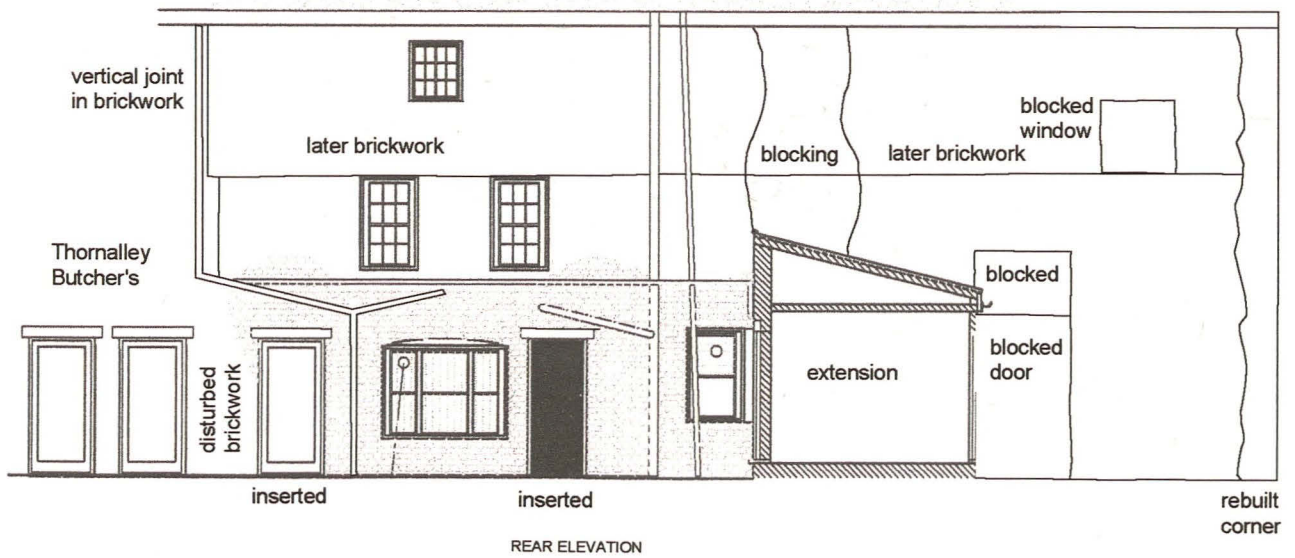
Fig. 2 Front and rear elevations showing later alterations to fabric. Based on drawings supplied by Kirsop Chartered Building Surveyors.

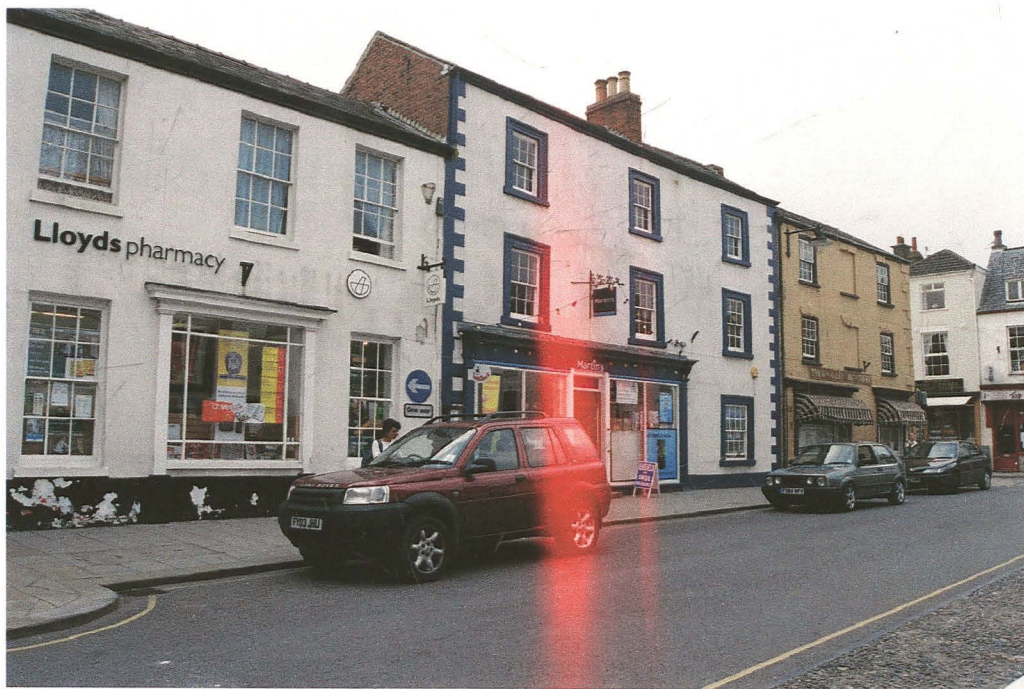
On the front elevation there are three windows at first and second floor level and on the ground floor the modern shop frontage, comprising door and window, sit beneath two of the windows with the north window intact (Pl. 1). The façade is rendered and has false, painted, quoins and moulded plaster window surrounds. The window sills are probably stone but have been painted. The windows frames themselves are vertical sliding sash windows, modern replacements of the originals. The northernmost bay is offset at an angle to the remainder of the building on the front elevation and there is a tell-tale vertical crack in the render which runs adjacent to the shop fascia and over the top of the first floor central window (Pl. 2).

Pl. 1 14 Market Place Alford. Front elevation.

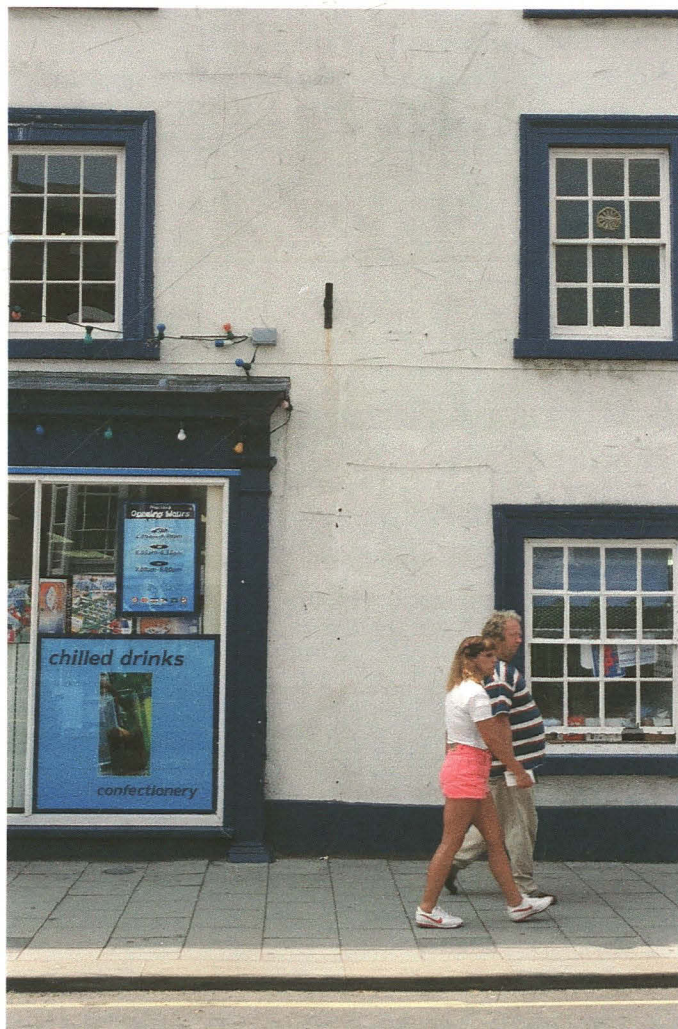
Pl. 2 Front elevation detail showing crack in render to north side of shop front, rising above first floor window.

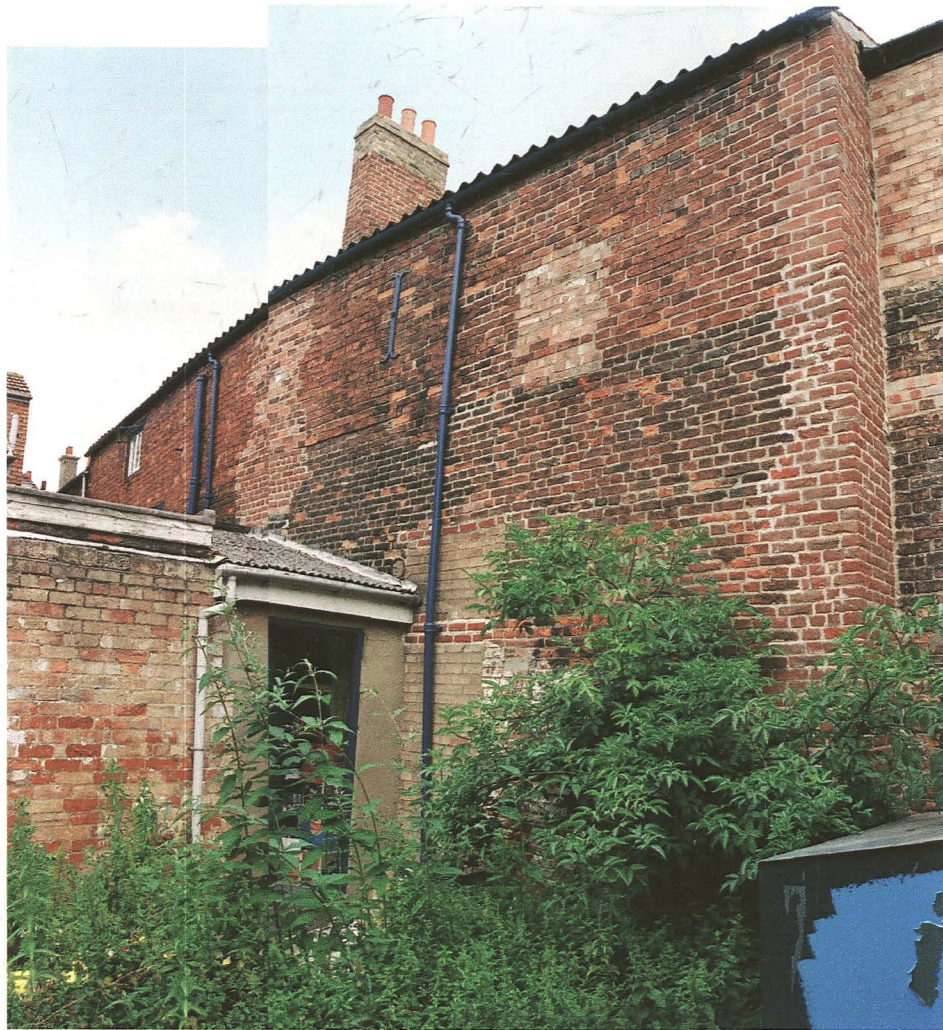
The rear elevation is divided by a 20th century extension that bridges the gap between the building and a range of outbuildings. It is not rendered and shows that the top floor is of a different brick to the ground and first floors (Pl. 3). At ground floor level there is a mid 20th century blocking (in yellow brick) of a door, partially built across by the later extension with a blocked window adjacent, as if the door had replaced it. At first floor level there are at least

two window blockings with further two window blockings at second floor level. The south-west corner of the building has been completely rebuilt. It is clear that the south gable end, visible above the roof height of Lloyd's, is in the same brick as the added storey, as is the brickwork of the chimney stack (Pl. 3).

Pl. 3 Rear elevation, looking north east. Note blockings at upper levels, rebuilt south west corner and modern extension between the main building and outbuildings (left).

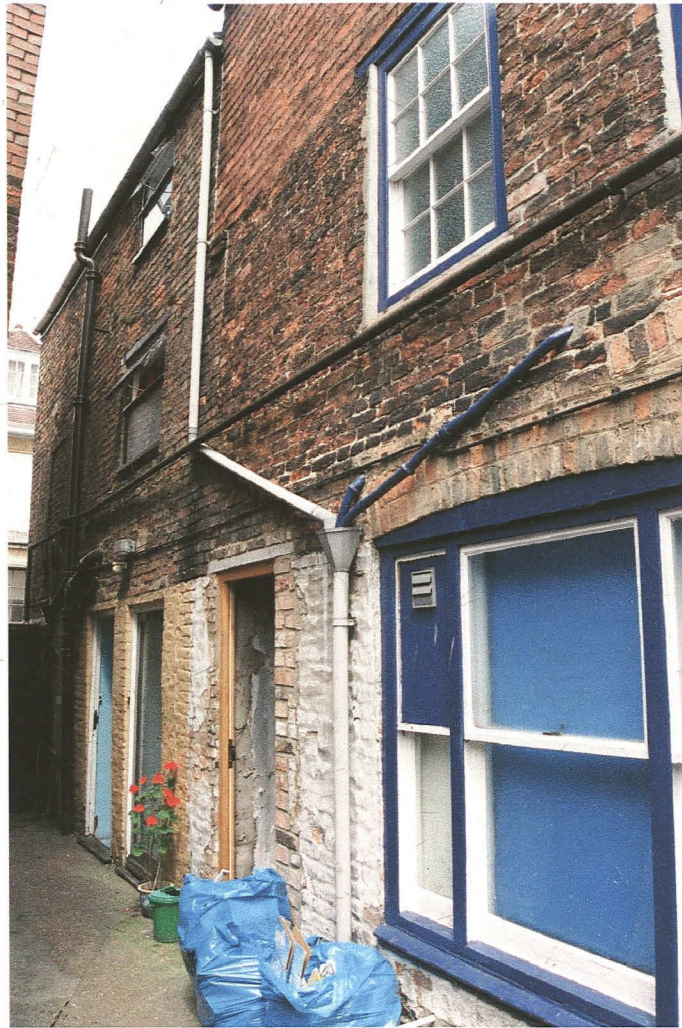
Pl. 4 Rear elevation north end, showing inserted door and vertical joint in brickwork (right of white drainpipe). Note red brickwork of upper storey.

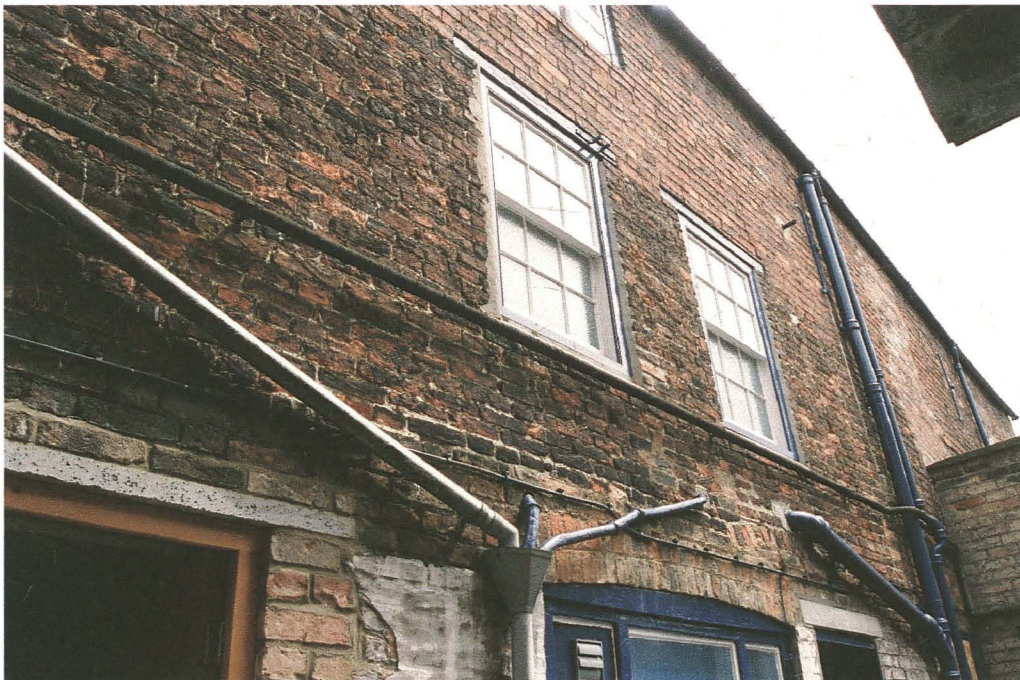
To the north of the extension is a vertical joint in the brickwork which runs from ground to the top of the first floor. There is also a joint at the north end of the building next to Thornalley Butcher's but this is only visible at first floor level because the brickwork below has been much altered. At ground floor level there is an inserted door at the north end which gives access to a staircase. There is a large inserted window and another inserted door to the south. These sit below a relieving arch for a door at ground floor level (Pl. 4). At first floor level are two replacement sash windows and above, at second floor level, is a horizontal sliding sash window just below the eaves, the only second floor window on the rear of the building (Pl. 5).

Pl. 5 Rear elevation looking southeast, showing red brickwork of upper storey and new first floor sash windows.

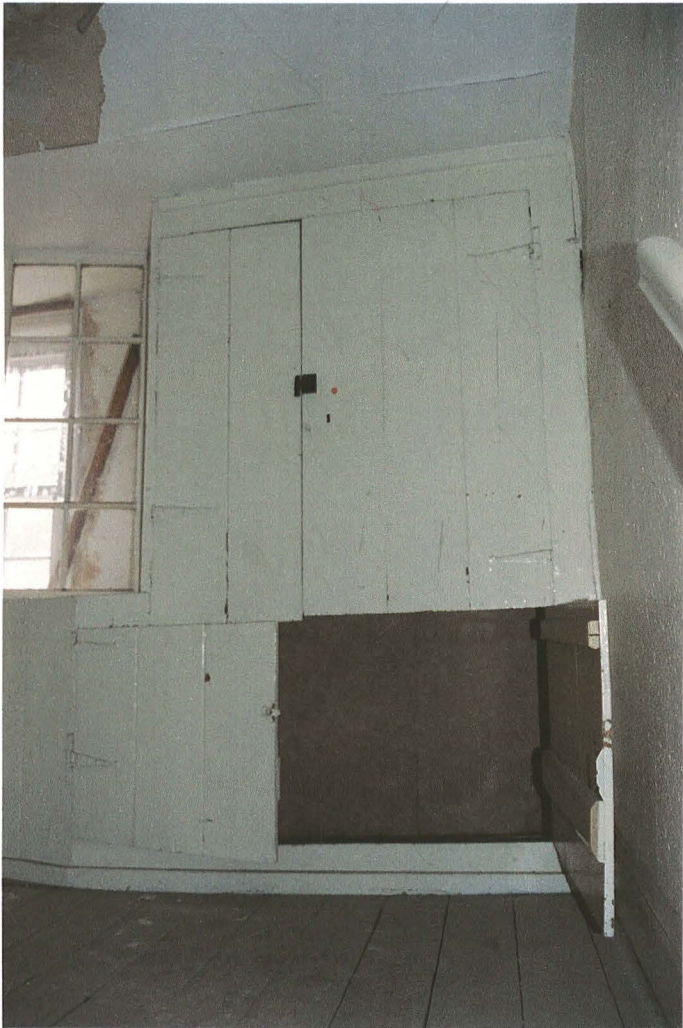
rear wall and a botched arrangement of partition wall allowing shared lighting from the bathroom window (Pl. 6). The cupboards reuse old timber and have early strap hinges on the doors. The curving wall on this landing indicates that the present layout may replace a former stair access. An 18th century door gives access onto this inner landing with an inserted window to provide borrowed light. This door should be reused. (Pl. 7). The landing leads through a door to a second landing leading to the bathroom, overlooking the rear and a small bedroom overlooking the Market Place, both within the north bay. The bedroom has serious structural problems in the far corner and was not investigated. There is a small walk-in cupboard in the north-west corner of the room over the stair well (Pl. 8). The sash window is a modern replacement. The bathroom retains a fireplace with cast iron surround which appears to be 19th century in style (Pl. 9). This is served by the rear chimney stack to the building that serves the north bay.

Pl. 6 Inserted cupboard on first floor landing. Note strap hinges and angled window providing borrowed light from sash window in bathroom.

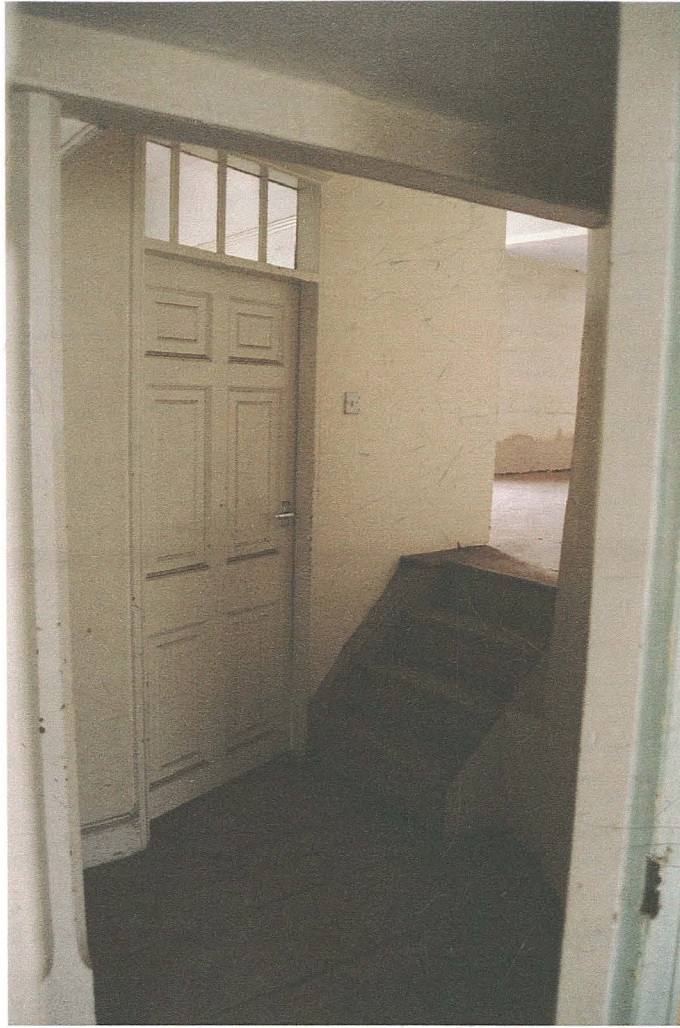
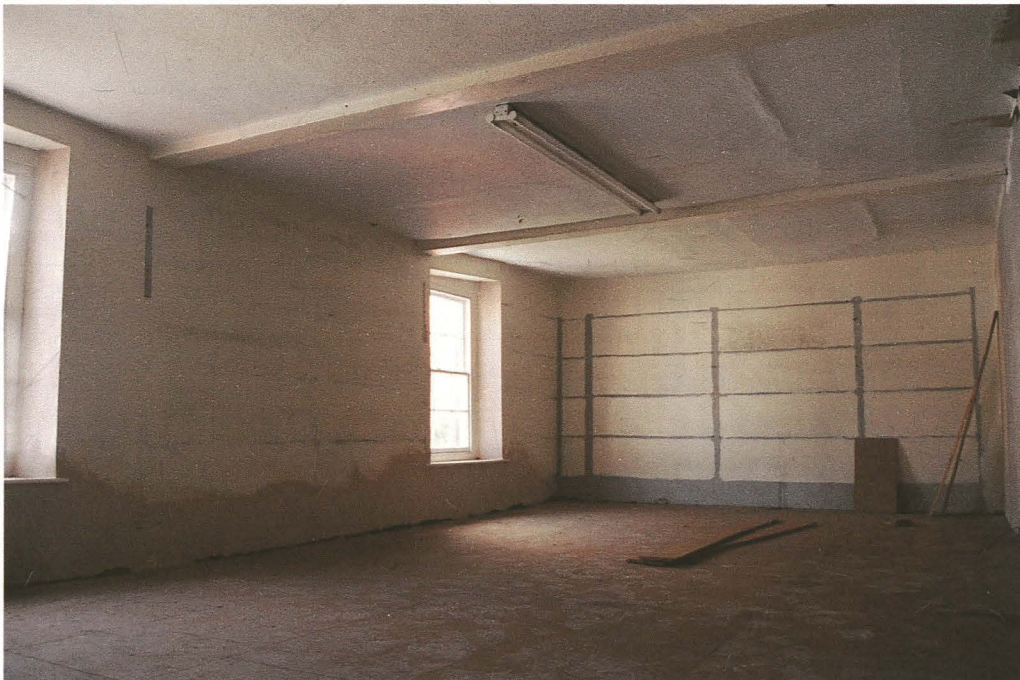
The landing currently gives access via four steps through the thick party wall up to the front room extending across the central and southern bays (Pls 10 and 11). The floor is clad in particle board and the walls have been recently plastered and papered. The two front sash windows are recent replacements. There is a chimney stack between the north and central bays serving three chimneys. This stack is contained within the central bay and serves fireplaces in the central bay only.

Pl. 10 First floor inner landing showing steps up to southern bedroom. Door to left of stairs leads to small front bedroom.

Pl. 11 First floor large front bedroom, looking south

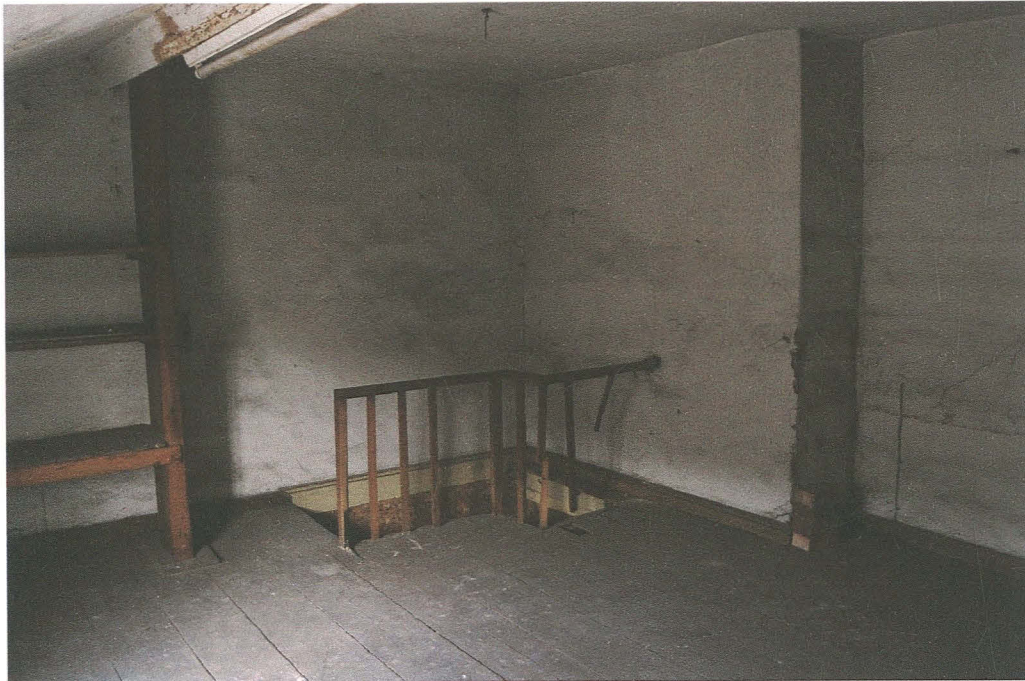
Access to the second floor is via two stairs. The stair in the northern bay, which has been inserted, leads to a room above (Pl. 12). It has broad floor boards 10 1/2" wide. The chimney stack which served the fireplace in the bathroom lies on this side of the party wall but there was never a fireplace at this level, only a soot box (Pl. 13). An inserted access on the east side of the chimney breast gave access to the first floor rear room whose floor is at a much lower level than the second floor bedroom. Inspection of the rear wall of this room shows no obvious blockings (Pl. 14).

Pl. 12 Second floor rear bedroom, with stair in northeast corner.

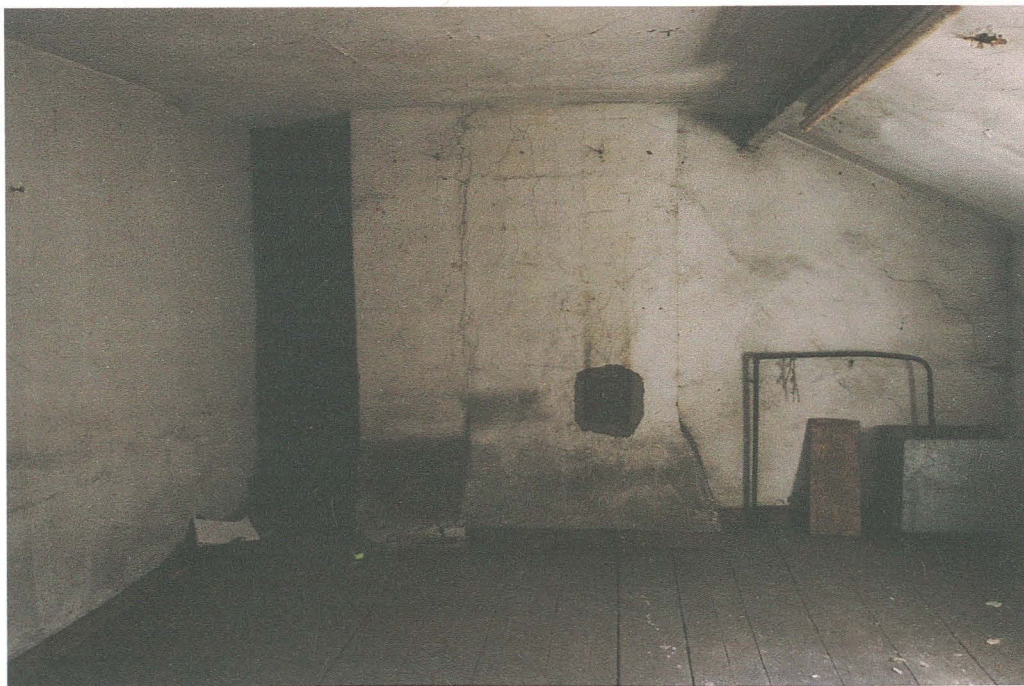
Pl. 13 Second floor rear bedroom, looking south, showing firestack with inserted soot box and opening to left of firestack which overlooks the inaccessible rear large room.

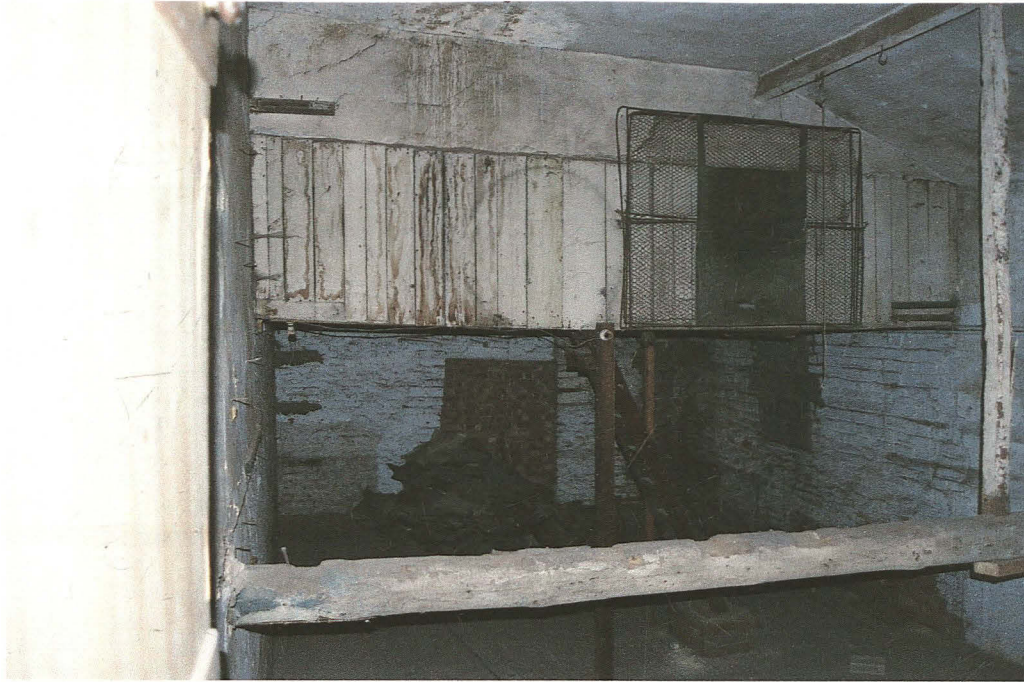
Pl. 14 Rear room straddling the first and second storeys, with mezzanine accessed by a ladder. Looking south. Note modern blocking in south wall which would have led into the adjacent property, Lloyds Chemists.

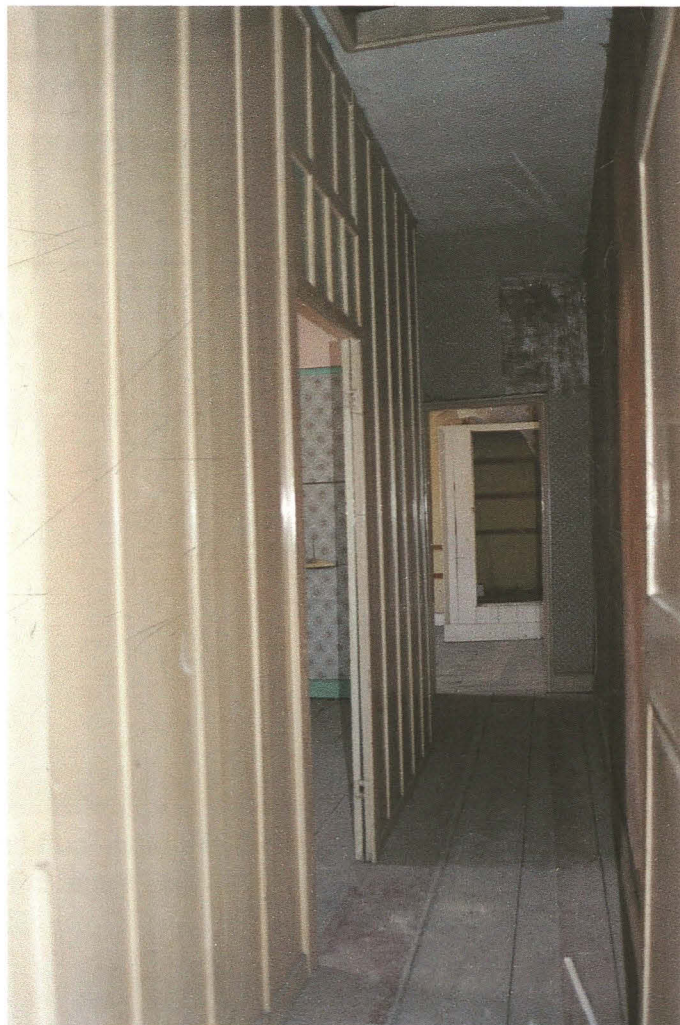
southernmost room and retaining privacy in the central room (Pl. 15). There is a firestack on the north wall with a fireplace on its west side (Pls. 16 and 17). The surround has been removed. A built-in cupboard has been constructed in the alcove on the east side of the firestack. The doors have original strap hinges.

Pl. 15 Corridor leading to south bedroom. Note wood panelling of central bedroom west wall to left.

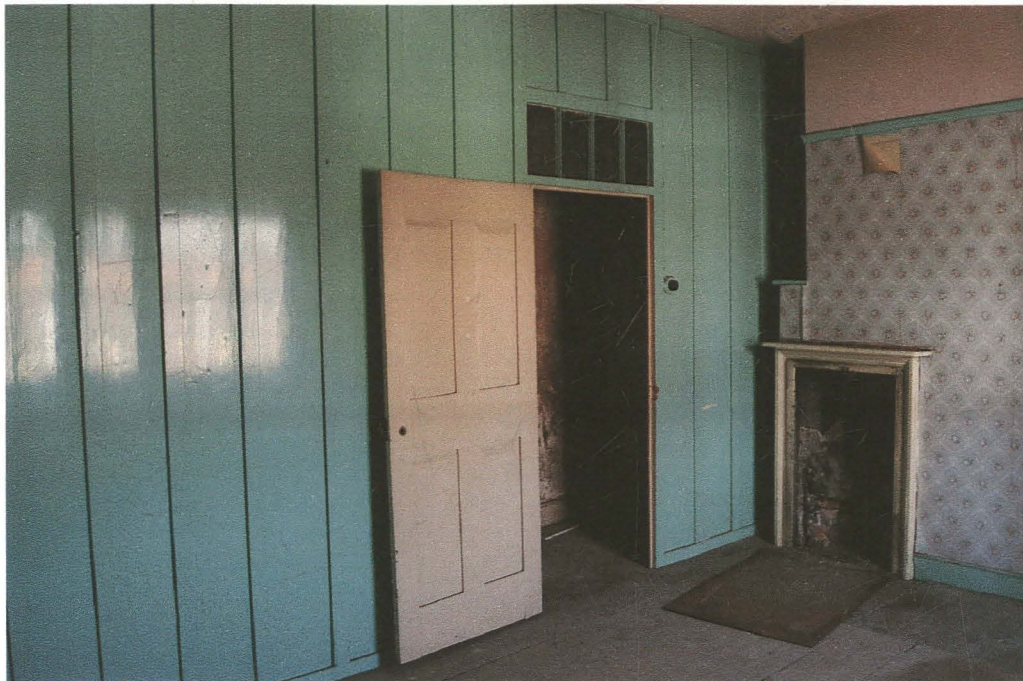
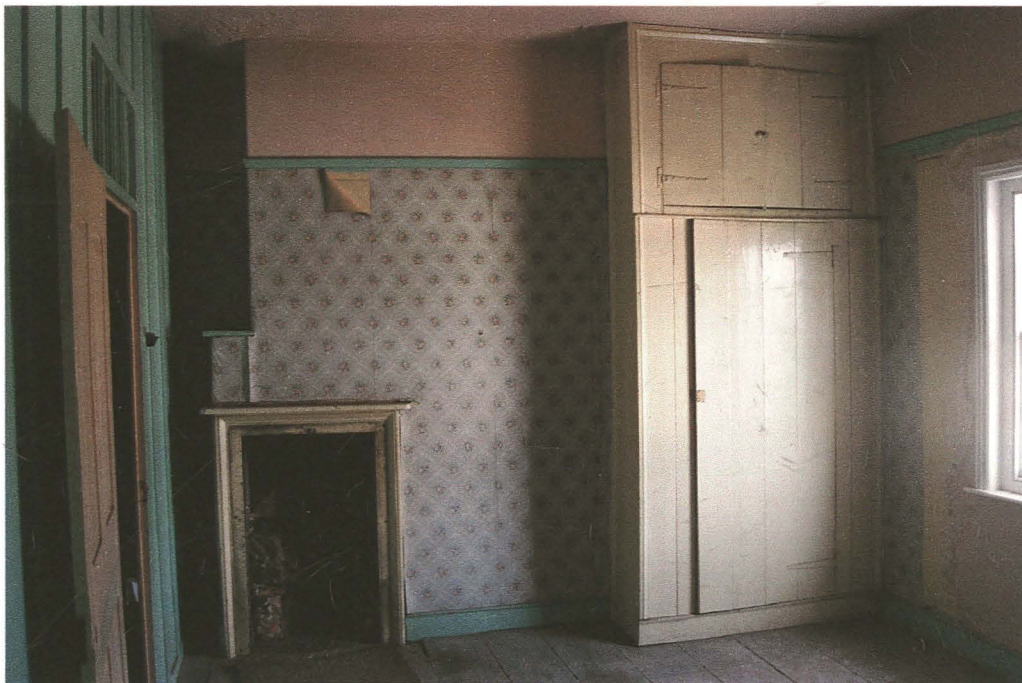
Pl. 16 Second floor middle bedroom. Note inserted panelling to form corridor access to south bedroom and fireplace on north wall (surround removed).

Pl. 17 Second floor middle bedroom. North wall with built in cupboard on east side of chimney stack. Note strap hinges.

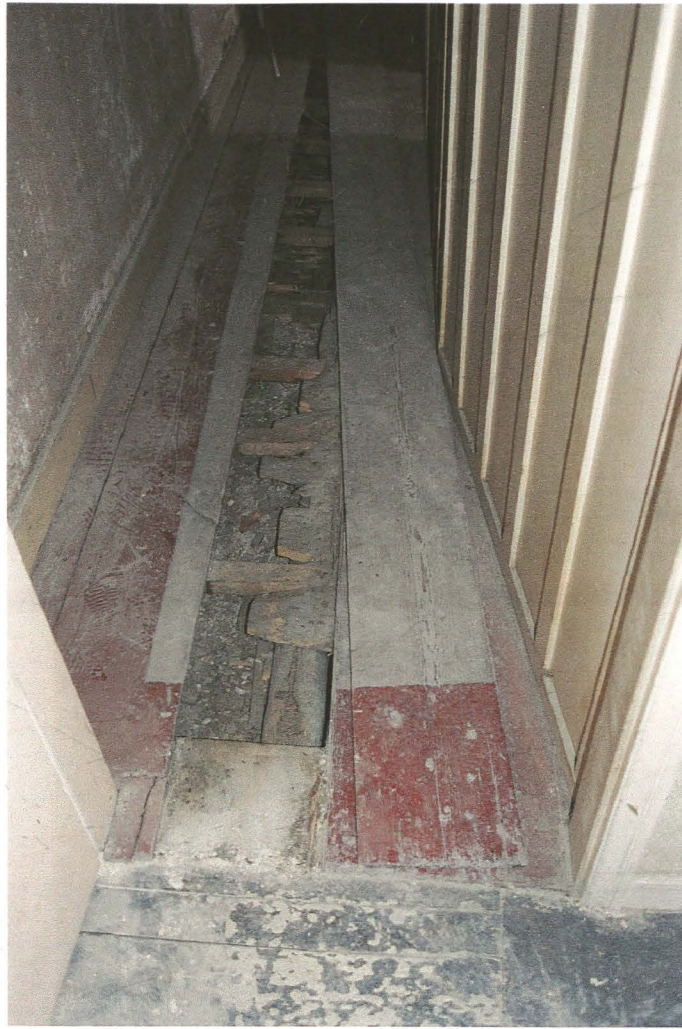
The corridor floorboards continue through into the central bedroom but removal of a loose board revealed an earlier set of boards beneath which run at right angles to the present boards. These have been partially cut away (Pl. 18).

Pl. 18 Second floor corridor with floorboard removed revealing earlier floorboards, partially sawn off. Looking north.

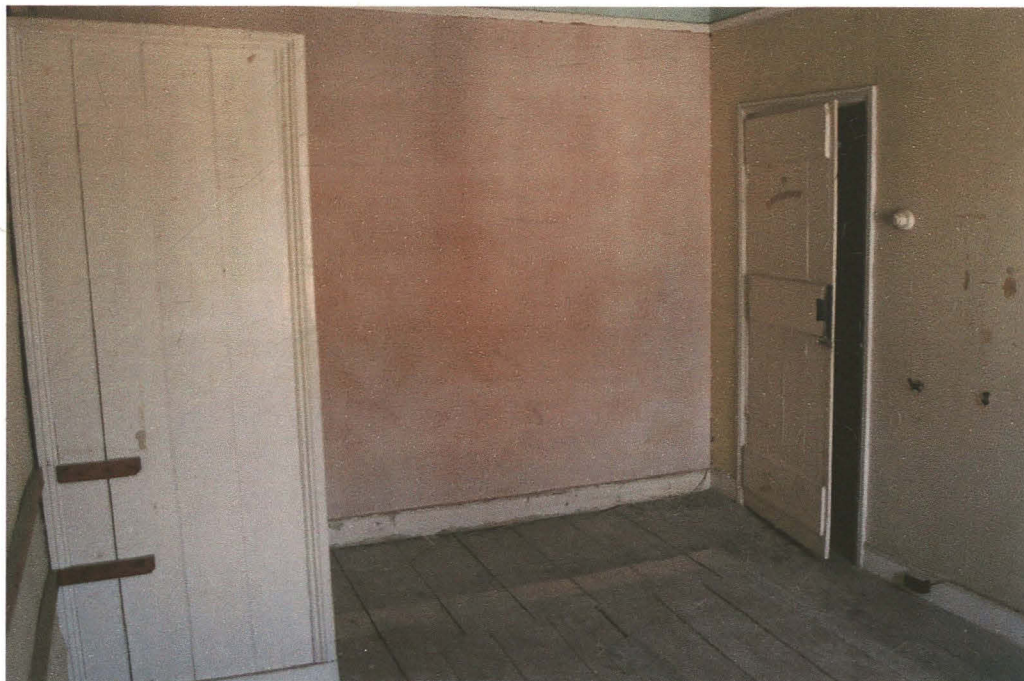
There is a lath and plaster partition wall between the central and southern bedroom. Access is via a good early door (Pl. 19) and there is an inserted late 19th century cupboard in the southwest corner of the room. The rear (west) wall of the room has recently been replastered (Pl. 20).

Pl. 19 Second floor south bedroom. Note replaced floorboards along west wall. Looking west.

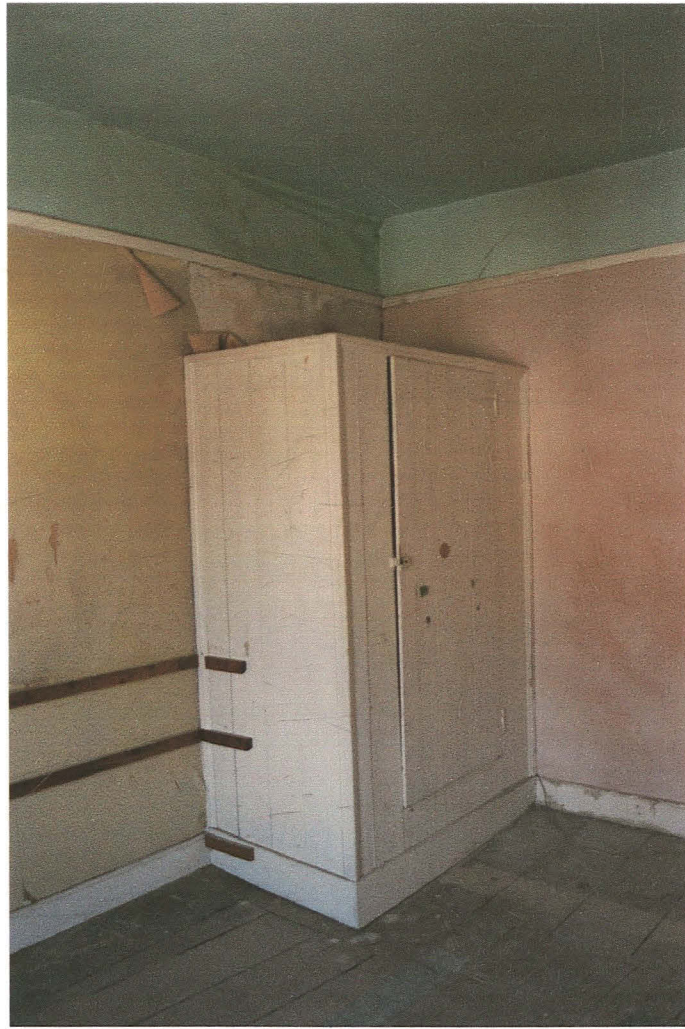
Pl. 20 Second floor bedroom, inserted cupboard in southwest corner.
