**ARCHAEOLOGICAL WATCHING BRIEF
AT ST MARGARET'S CHURCH
ROUGHTON
LINCOLNSHIRE
(RSM03)**

**Work Undertaken For
Benton & Co Architects**

July 2003

APS Report No. 105/03

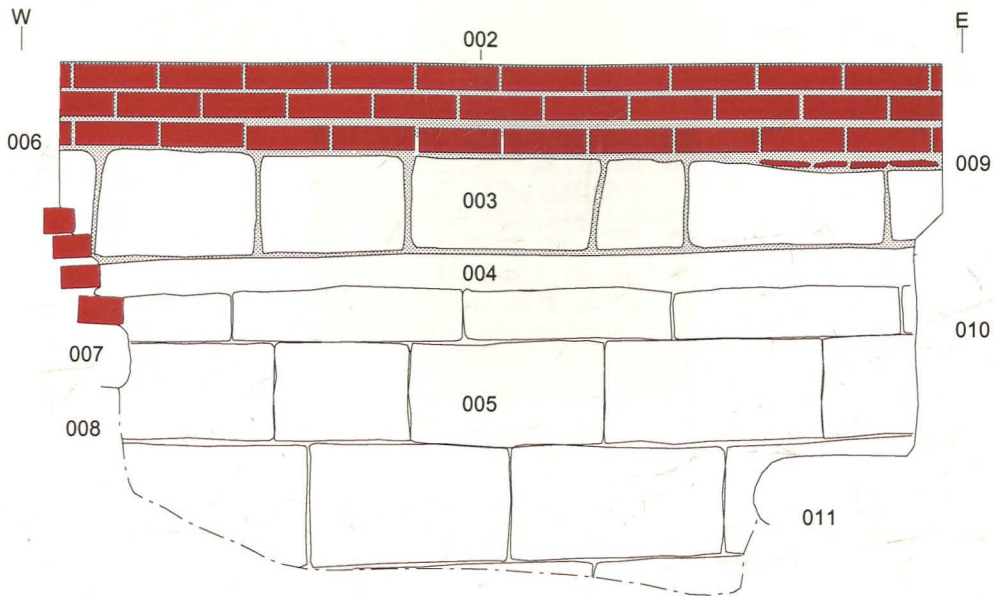
Section 1: South face of tower

The earliest part of the south wall of the tower exposed in the drainage trenches was its foundation (Fig. 5, Sect. 1). Four courses of ashlar greensand blocks measuring up to 0.54m x 0.34m were exposed (005). Overlying these was a

0.10m thick layer of dark greyish brown sandy silt containing sparse mortar fragments (004). It was not clear how far into the wall this layer extended. Overlying it was a single course of ashlar greensand blocks (003), which measured up to 0.48m x 0.22m in size. Above (003) was an area of brickwork (002).

Butting up to the south wall of the tower in the southwest corner was a brick buttress (006). It rested on a foundation comprising a single course of ironstone blocks (007). Below this was medium brown clayey sand (008), which may have formed the backfill for a construction trench for the tower foundation (005) (Fig. 5, Sect. 1).

Butting up to the eastern end of the tower wall was the west wall of the nave and its southwest corner buttress. The foundation of these two structural elements comprised a single course of rough dressed limestone and sandstone blocks with occasional tile fragments and flint cobbles (011). Two of the blocks appeared to have chamfered edges, indicating that they were re-used. The lower section of the west wall of the nave comprised dressed greensand and limestone blocks, which measured up to 0.55m x 0.25m in size (010). The upper section of this wall (009) was constructed of limestone blocks and was separated from (010) by a chamfered course that extended round the whole of the south wall of the nave (Fig. 5, Sect. 1).

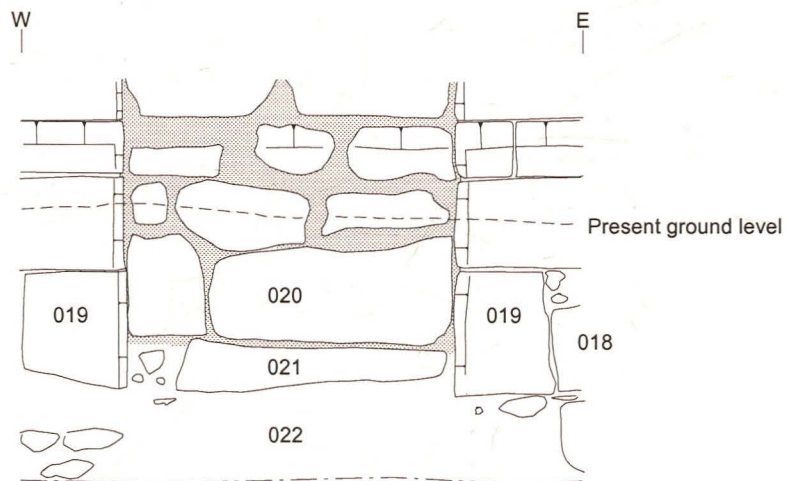
Section 2: Blocked door in south wall of nave

A blocked doorway was present in the south wall of the nave (Fig. 5, Sect. 2; Pl. 4). The jambs of the doorway consisted of dressed limestone blocks with chamfered edges leading into the aperture (019). Part of the original limestone doorstep remained *in situ* (021). Beneath the doorstep was a bedding deposit of mixed yellowish brown and dark brown sand and sandy silt containing frequent pebbles and limestone fragments (022). The blocking of the doorway itself comprised rough dressed blocks of limestone and greensand (020).

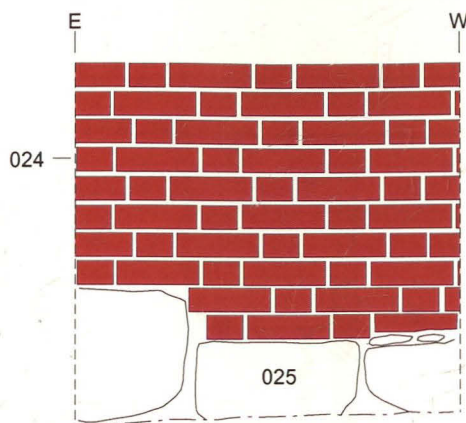
Section 4: North wall of chancel

The north wall of the chancel was constructed in Flemish bond brickwork (024) (Fig. 6, Sect. 4). A single course of roughly dressed greensand and ironstone blocks (025) was observed as the foundation of this wall.

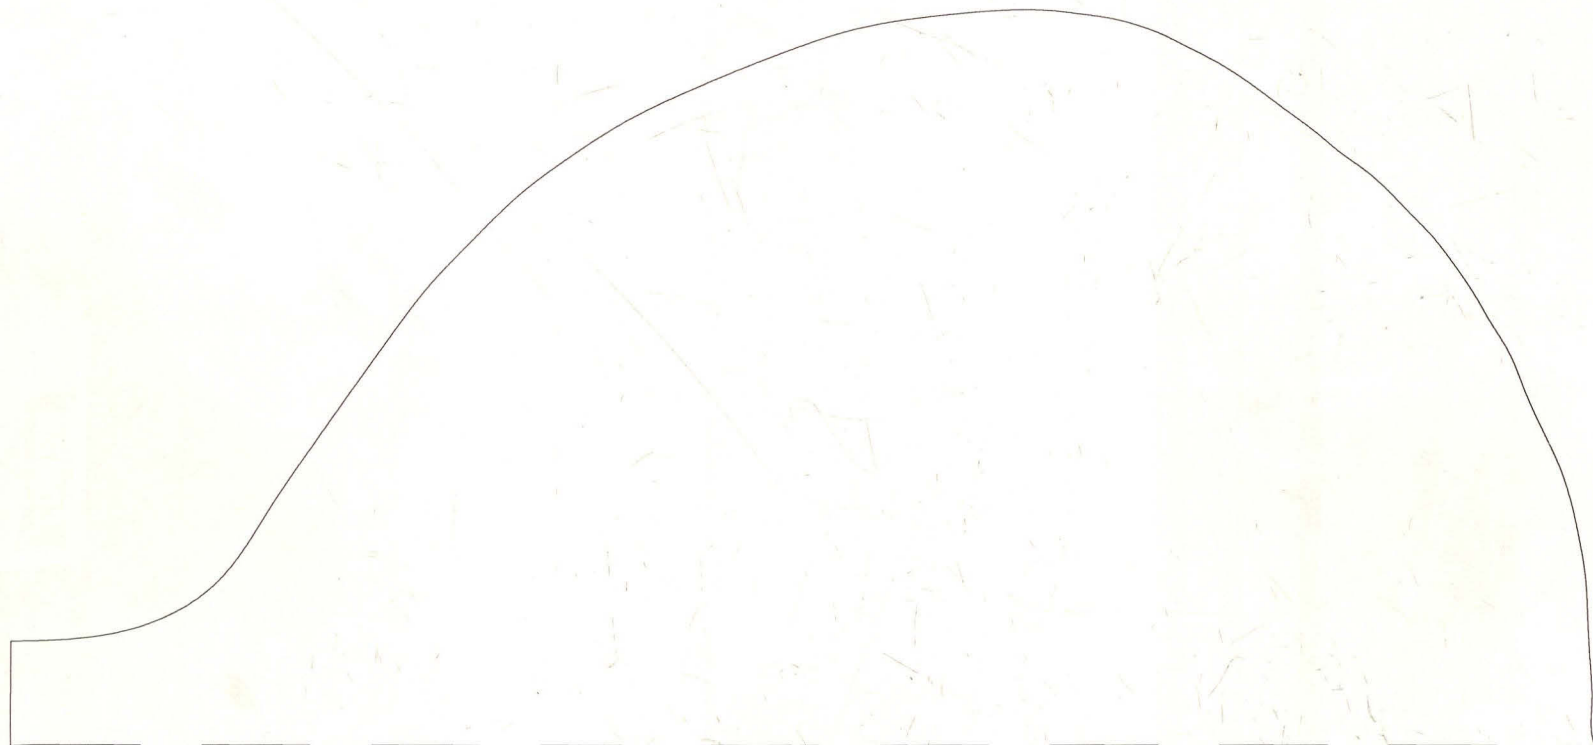
Figure 8. Sketch profile of worked stone in context (027)

The lower part of the northeast corner buttress of the nave comprised roughly dressed greensand and ironstone blocks and brick (026). A fragment of worked stone, possibly part of a window mullion, had been re-used in its western face. The foundation of this buttress (027) consisted of dressed and irregular limestone blocks. Two fragments of rounded worked stone were present in the eastern face of the foundation, with a third piece present on the west side (Figs. 4 and 8; Pl. 5). These fragments were similar to the one present in the foundation of the south nave wall and appeared to be parts of a column or large moulding.

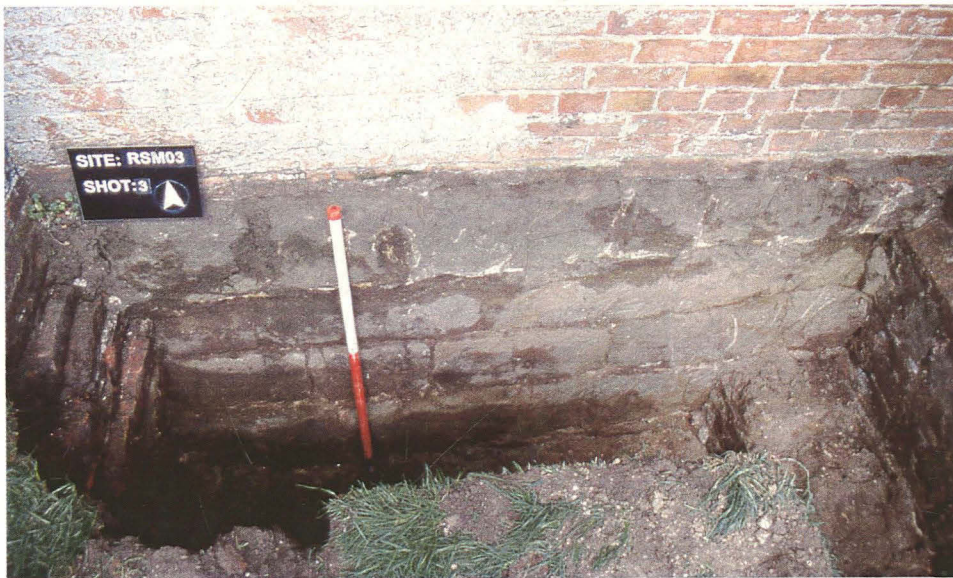
Plate 2 Section 1 looking north, showing foundations of the south wall of the tower.

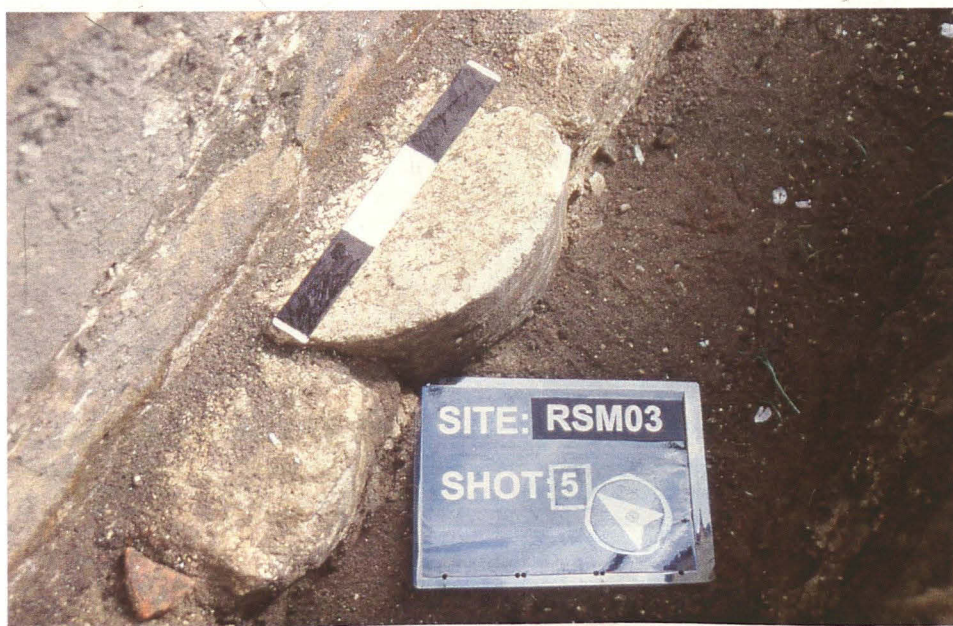
The foundation (013) of the south wall of the nave was observed as a single course of rough and dressed limestone and ironstone blocks and contained fragments of post-medieval tile. A single fragment of worked limestone, apparently part of a column or large moulding, was incorporated within the foundation (Pl. 3). Deposits below the foundation were not exposed and it appeared to be butted by the homogenised graveyard soil (017) to the south.

The presence of re-used moulding fragments in the foundations of both the nave south wall (013) and northeast buttress (027) suggest that these had been rebuilt at some point in the church's history. The similarity between the worked stones in these two locations may indicate that foundations were constructed as part of the same rebuilding phase, although this hypothesis cannot be proven. However, the presence of a fragment of post-medieval tile in the south nave wall foundation (013) indicated that at least part of it was rebuilt in that period.

Plate 3 Worked stone fragment in the foundation (013) of the south wall of the nave.

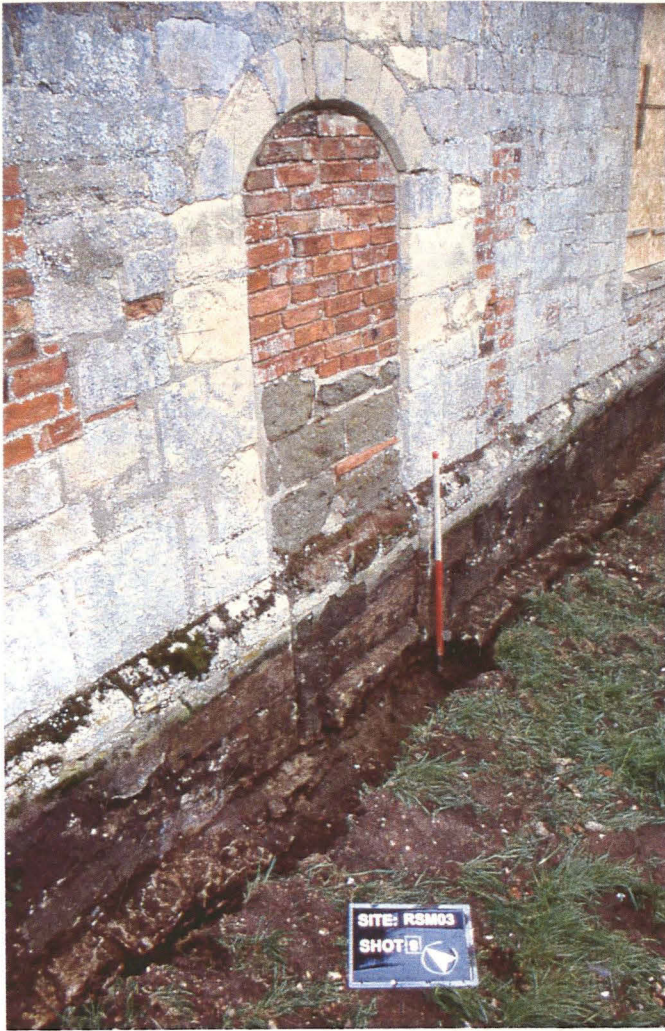
The surviving Transitional (late 12th century) doorway in the south nave wall indicates that not all of the wall had been rebuilt. This doorway was still in use at the time of Nattes drawing in 1791 with a surrounding porch also present. The doorway was blocked and the porch removed at some time after that date, possible during the 1870 restoration. No evidence of the former porch was identified during the watching brief.

Plate 4 Blocked doorway in the south wall of the nave.

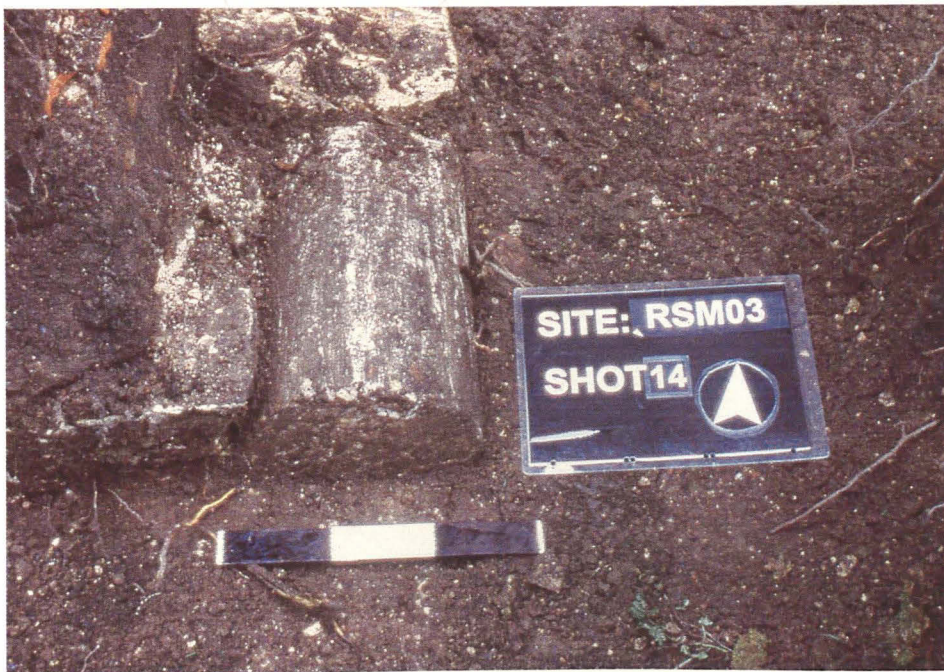
Plate 5 Worked stone fragment in foundation (027) of the northeast nave buttress.

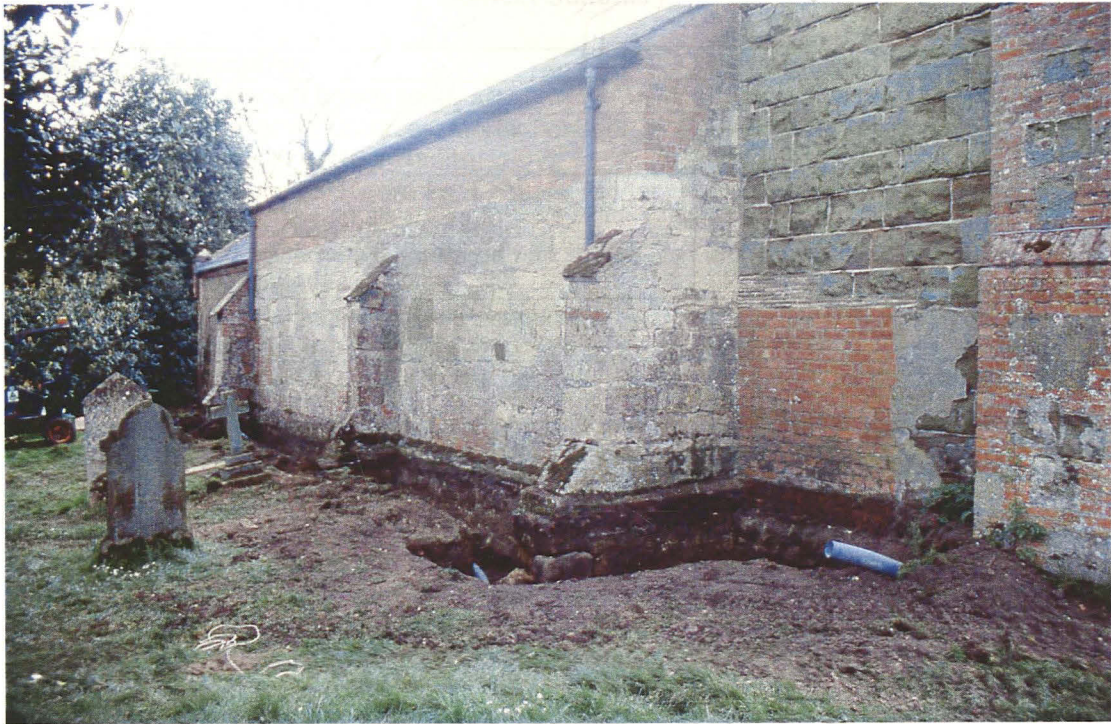
The upper part of the north wall of the nave was constructed from roughly dressed greensand and limestone blocks (034), which measured up to 0.47m x 0.32m. This section of the wall included a chamfered step course, mirroring the one on the south side of the nave (Fig. 6, Sect. 5). The lower part of the wall comprised roughly dressed greensand and ironstone blocks (028) of a similar size to those in the upper part of the wall. The foundation (029) of the north nave wall consisted of a single course of irregular limestone blocks (Fig. 4; Fig. 6, Sect. 5). A possible construction cut (032) was visible along part of the length of the wall. Its fill (031), which appeared to underlie the wall foundation (029), comprised medium yellowish brown sand with frequent limestone fragments (Fig. 4).

Plate 6 General view of the trench along the north wall of the nave, looking southeast.

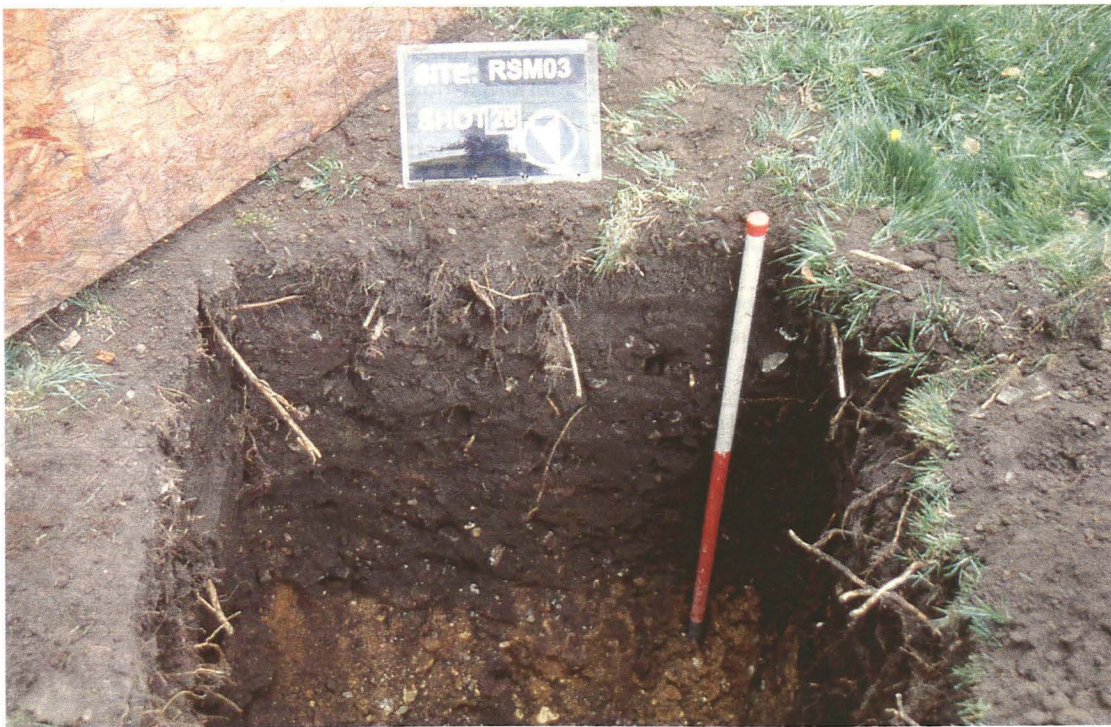
The earliest deposits exposed during the watching brief were located in the two soakaway pits (Fig. 2). Natural brownish orange glaciofluvial sand and gravel (038) was exposed up to a thickness of 0.42m in the base of both pits (Fig. 6, Sects. 7–9).

Overlying the natural deposits in the two soakaways was a homogenised dark brownish grey silty sand graveyard soil (037). This deposit was recorded up to a thickness of 0.72m (Fig. 6, Sects. 7–9). Although human bones were observed within this layer, and an *in situ* burial was present in Soakaway Pit 2, no grave cuts could be recognised. Due to the lack of visible grave cuts and the method of mechanical excavation it was not possible to record the burial in plan.

Plate 7 Section 9 in Soakaway Pit 2, looking south.
