**93/95, EASTGATE, LOUTH,
LINCOLNSHIRE**

**PHOTOGRAPHIC BUILDING
SURVEY REPORT**

Site code	EGLO 03
NGR:	TF 53299 38749
LCCM Acc No:	2003.378
Planning Ref:	N/105/00553/02

December 2003

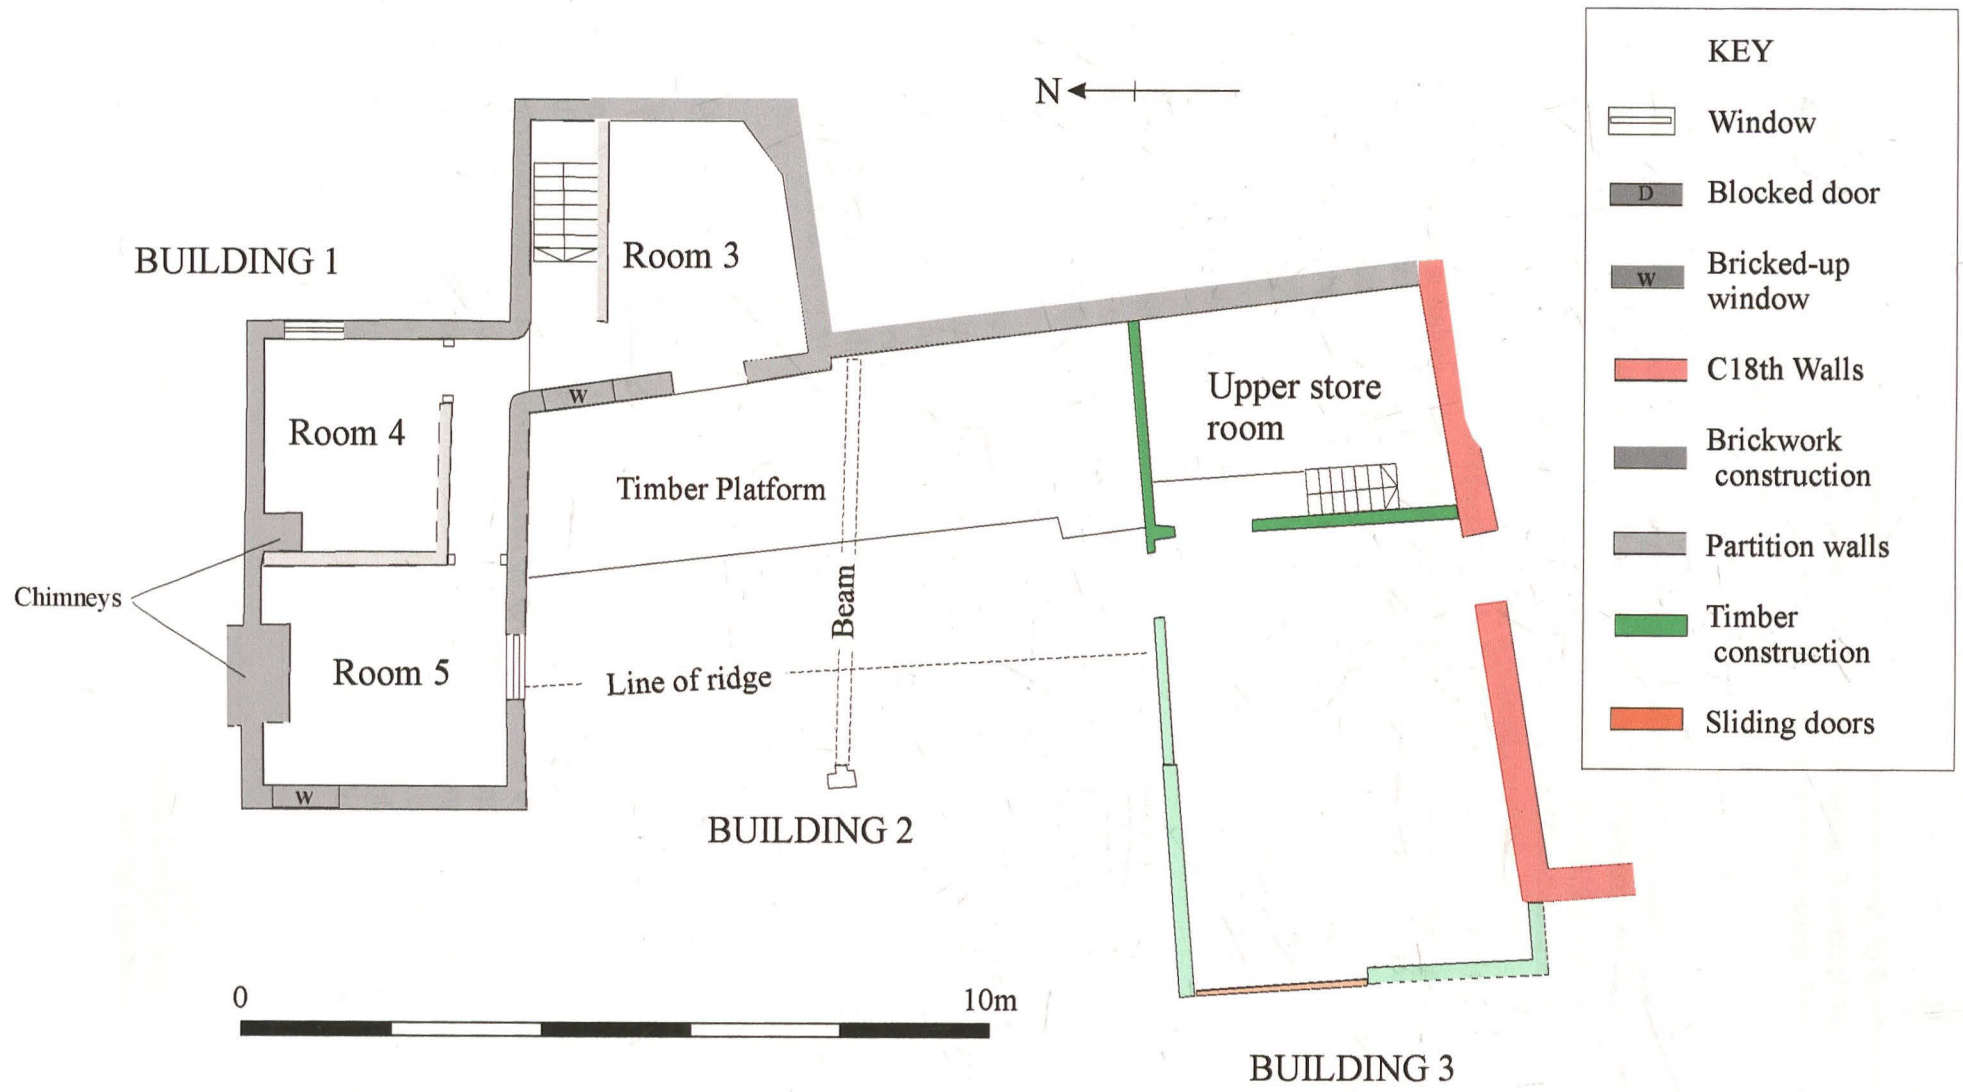
Fig. 4: Plan of the first floor level of Buildings 1-3. Scale 1:100

Room 3. This room was located in the southern part of building 1, on the first floor, immediately above room 2. Modern access to this room was gained from the timber platform in Building 2, through an opening in the west wall. This opening appears to have originally been a window with a timber lintel. The west wall exhibited another bricked-up window to the north of the modern opening.

Rooms 4 & 5. The upper storey of the northern part of Building 1 consisted of two rooms and a short corridor linking them to the landing at the top of the stairs from room 2. The smaller of the two rooms (4) had a window in the east wall, and, excluding some shelving, was empty. The western of these rooms (5) had a window in the south wall and evidence of a blocked up window in the west wall. This room was also empty.

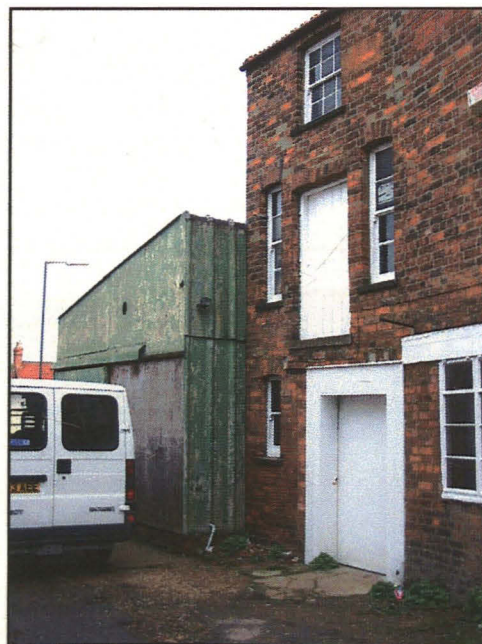
Plate 3 (right): view of the
rear of 93, Eastgate where
the outbuildings are abutted.

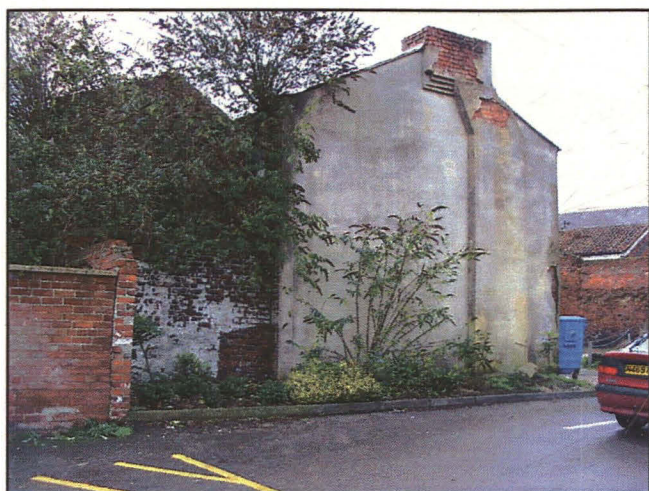
windows, etc. The floors within Building 1 were constructed of timber floorboards and joists and the ceilings were of plastered lathe construction. Internal walls, including stud and lathe partition walls were mostly plastered, although in many cases plasterwork had become damp and was badly deteriorated. The exterior of the north wall had a modern render.

Plate 4 (left): General view of the north elevation of building 1, looking SW.

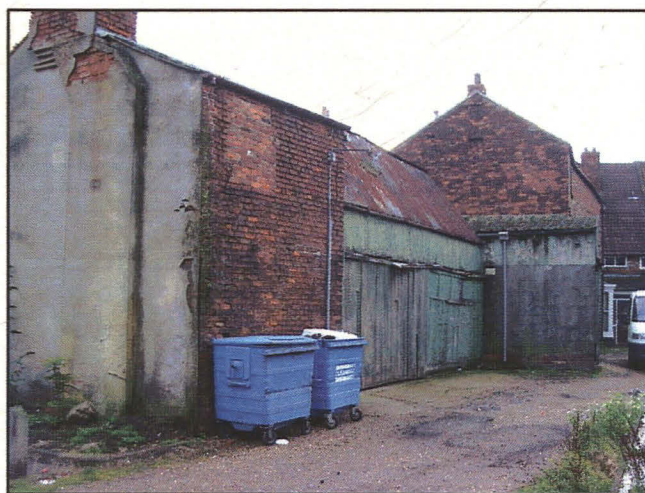
Plate 5 (right): General view of the surveyed buildings, looking SE.

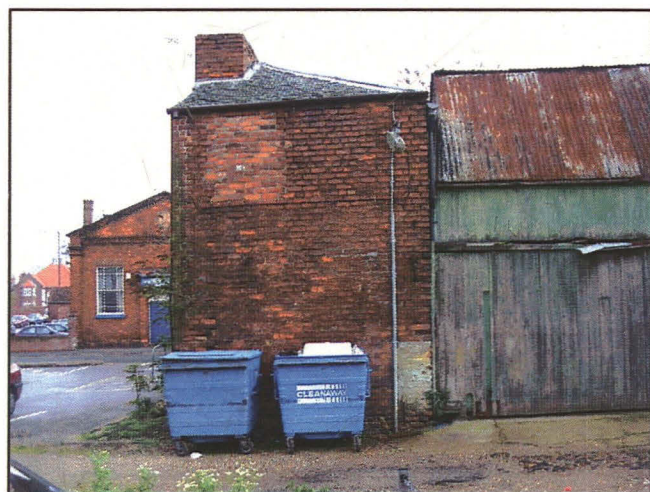
Plate 6 (left): West facing elevation of building 1, looking east.

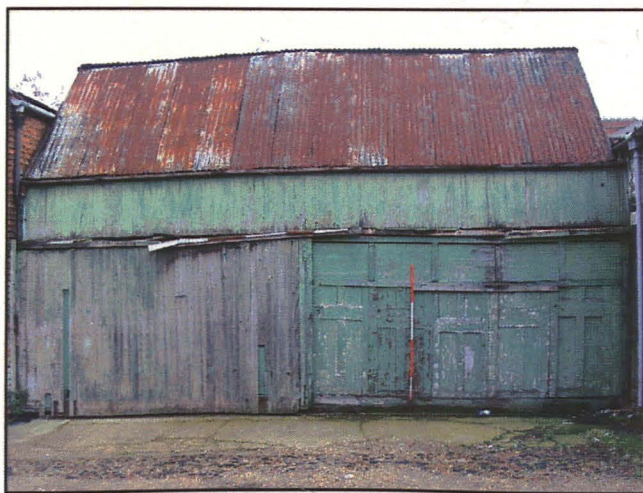
The west wall of this structure appeared, as originally constructed, to have been open, suggesting an earlier use of this building as stabling/garaging. A central wooden post on the west side, which now divides two sliding doors, evidences this. The most recent use of this structure was as storage space.

Plate 7 (right): West facing elevation of building 2, looking east.

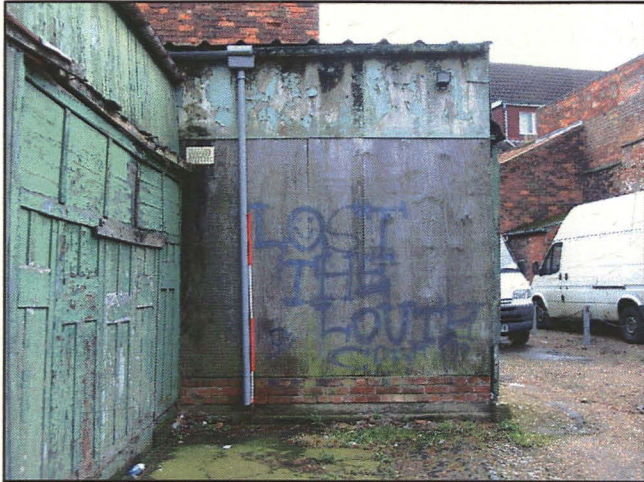
Building 3. This appears to be the most recent of the three structures, and was again a lean-to that utilized the north wall of the 18th century structure and the eastern property boundary (which was heightened with breeze blocks). Its exterior walls (on the north and west sides) were constructed of timber on a three-course brick dwarf wall. It had a corrugated asbestos roof and a poured concrete floor. It was divided into two rooms (and from building two) by timber stud walls. In the eastern room, a staircase led to a first floor storeroom. The western room had a plasterboard ceiling. It appeared to be in use as overflow storage space from the electrical appliance shop which occupied the rest of the property, although a former use as a workshop was evidenced by the benches and tools left here.

Plate 8 (left): North facing elevation of building 3, looking south.

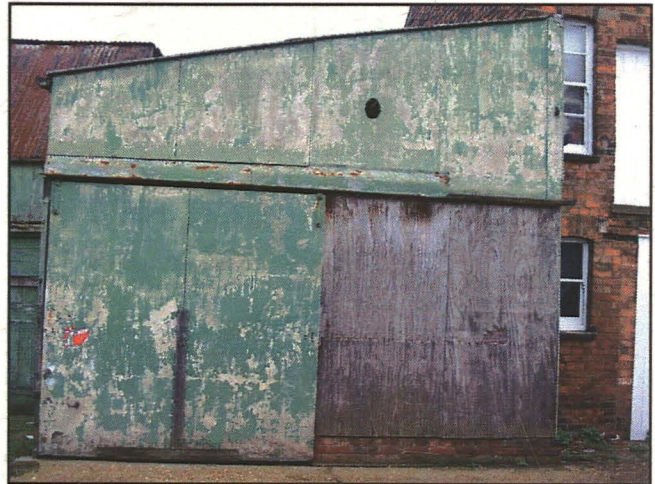
Plate 9 (right): West facing elevation of building 3, looking east.

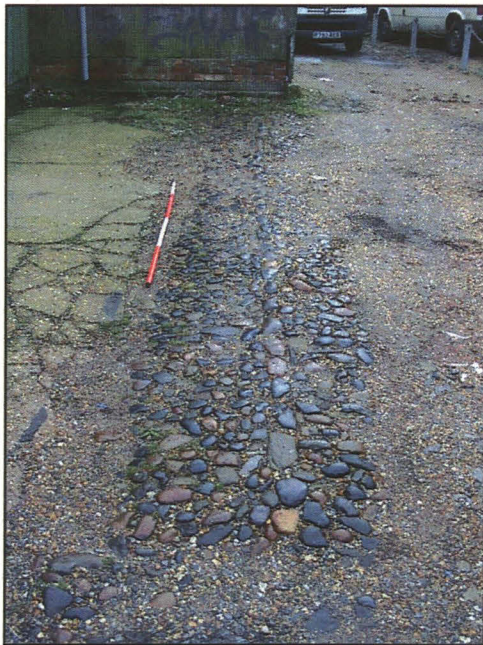
Plate 10 (left): Small area of extant cobbles to the west of building 2, looking south

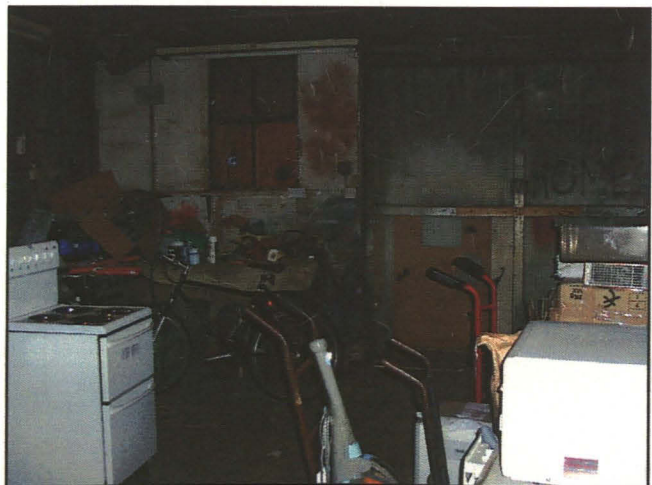
Plate 11 (right): Interior view of building 3, looking west.

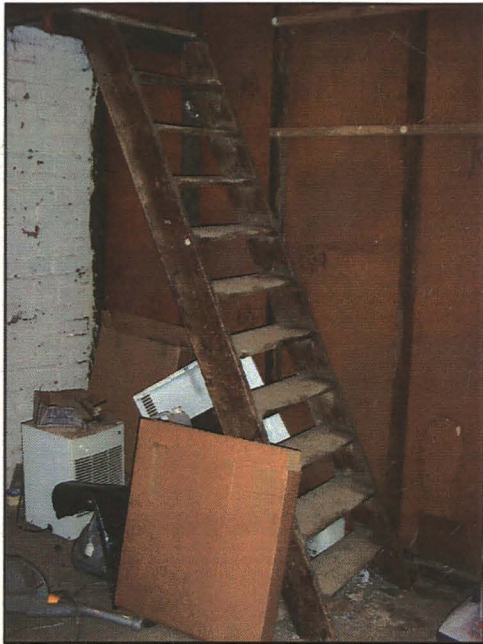
Plate 12 (above):
Staircase in east room of
building 3, looking SW.

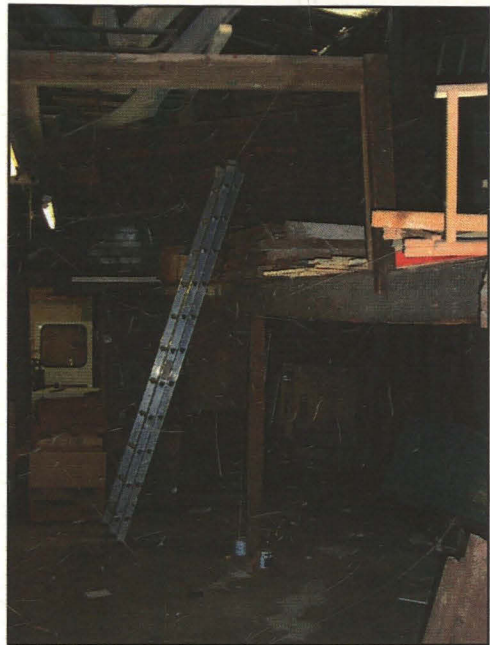
Plate 13 (above):
Interior view of building
2, looking north.

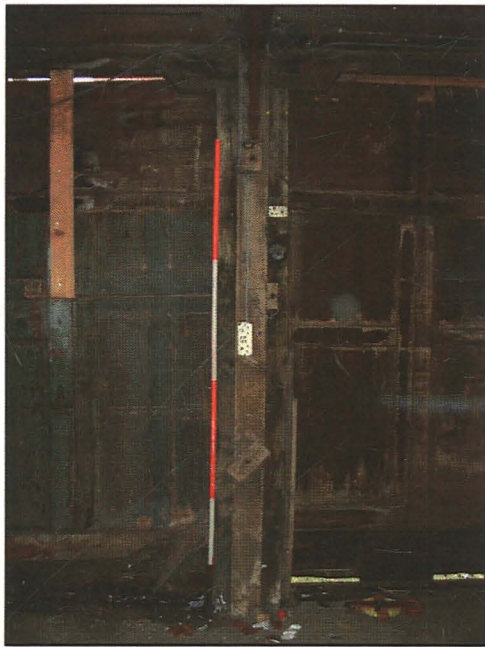
Plate 14 (left): Timber
supporting post in the
middle of the west side
of building 2.

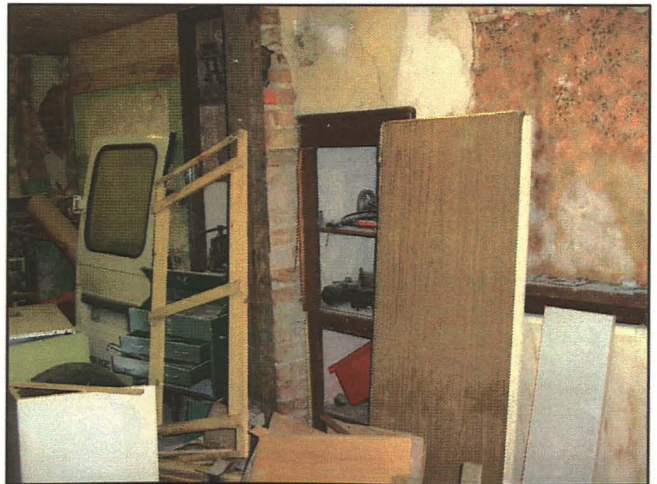
Room 1. This room was located in the northern part of building 1, on the ground floor. It appears to have originally been built as two rooms (part of the partition survives on the north side and there is evidence of a blocked-up fireplace), but had been knocked-through and was in use as a large storeroom/workshop. One window survived in the east wall, and there was evidence that another window here had been bricked-up. The modern entrance, double doors from building 2, appeared to be recent inserts (with a timber lintel), while an original doorway (with a brick arched lintel) approximately 1m to the east had been bricked-up.

Plate 15 (right): Interior
view of room 1 in
building 1, looking NW.
