**St. Leodegar's Church Wyberton**

**Archaeological Watching Brief**

**St. Leodegar's Church Wyberton**  
**Archaeological Watching Brief**  
**(TF 329 408)**

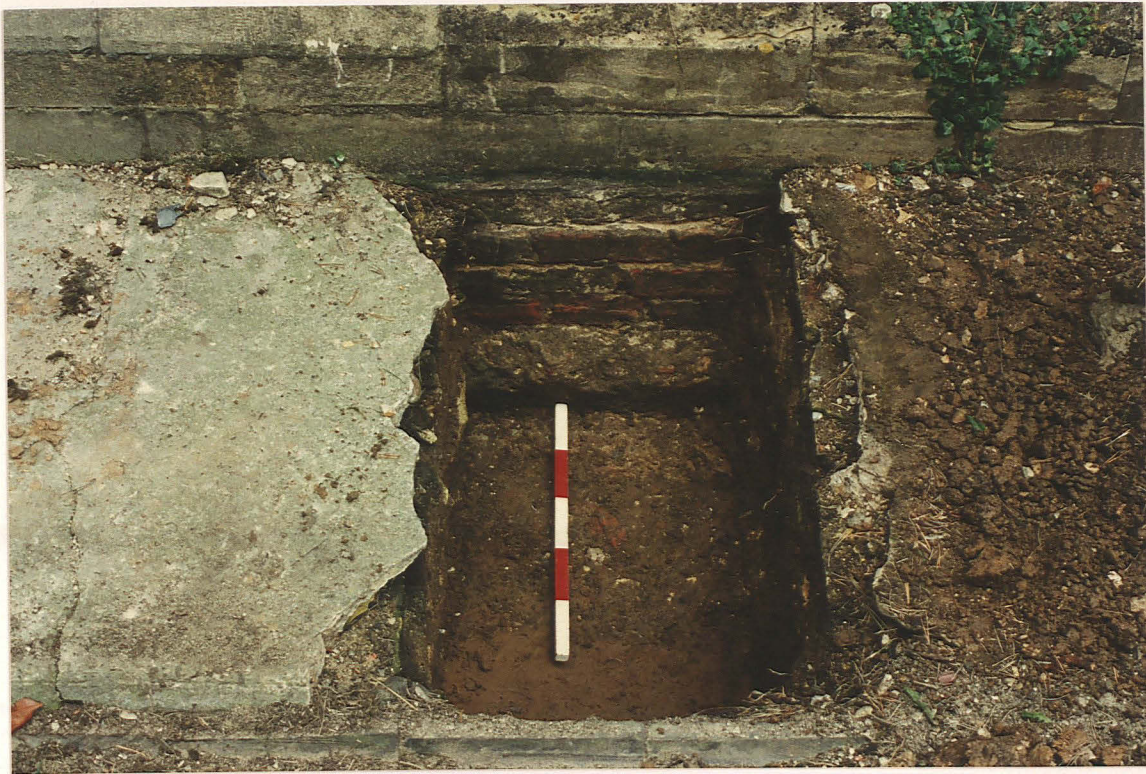
The test pit revealed the concrete and brick underpinning carried out by George Gilbert Scott in 1881. The clearly visible nineteenth century foundation trench was 0.30m wide and contained small pieces of brick rubble and mortar flecks mixed with the backfilled soil. It had been dug through clean brown clayey soil (Pls. 9,10).

**Pl. 9. Test pit 1 showing brick and concrete underpinning.  
(Scale 0.50m)**

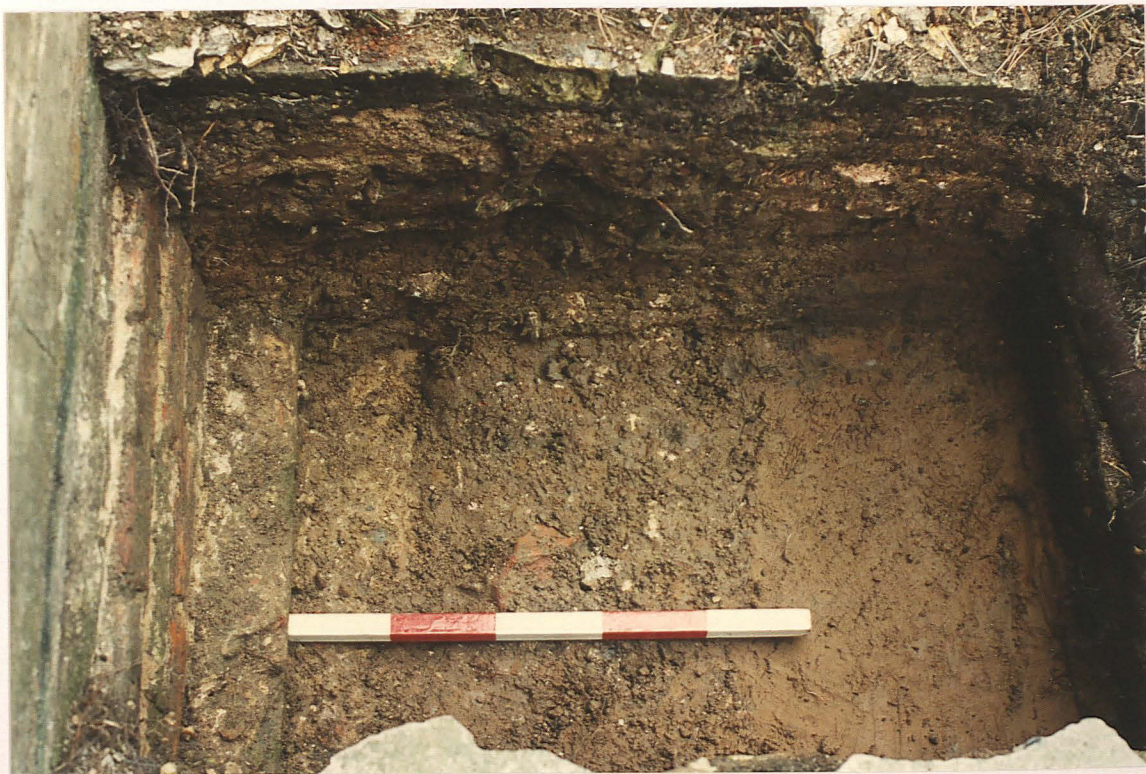
**Pl. 10. Test pit 1. Foundation trench for 19th century underpinning.  
(Scale 0.50m)**

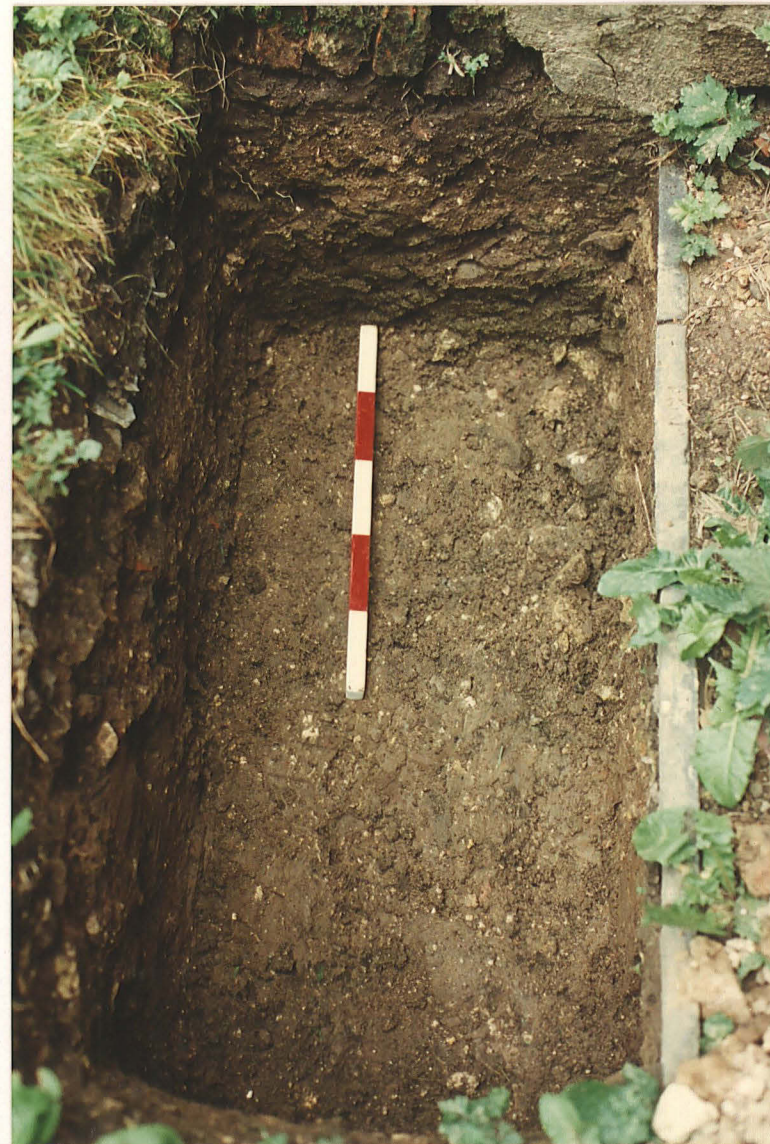
The test pit revealed the concrete underpinning of the aisle carried out in 1916 (LAO Sheer 9 W44). The trench was too small to show any foundation trench (Pls. 11-13).

Pl. 13. Test pit 2 showing brick and concrete underpinning.

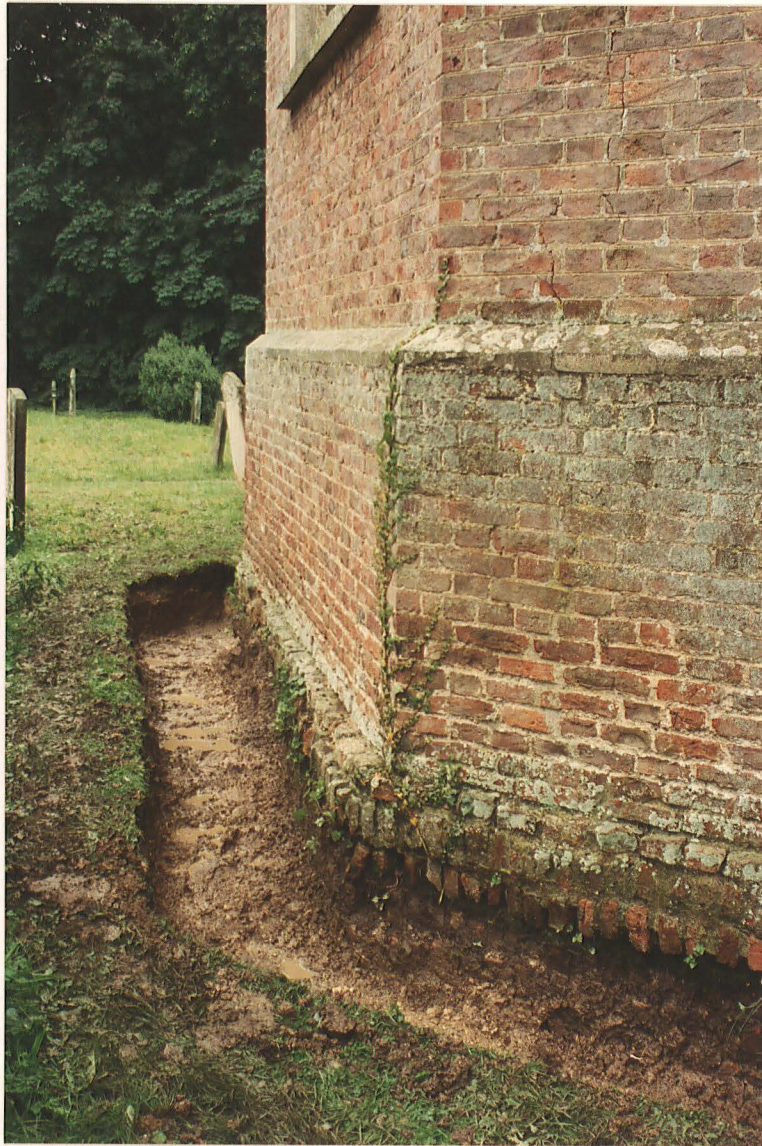
The test pit on the north side of the apse showed that the brick foundations were extremely shallow and there was no sign of the medieval chancel. A slight variation in soil colour and texture was noted on the east side of the hole which may have been the backfill of a grave (Pl. 14).

Pl. 14. Test pit 3 on N side of apse showing absence of foundations.

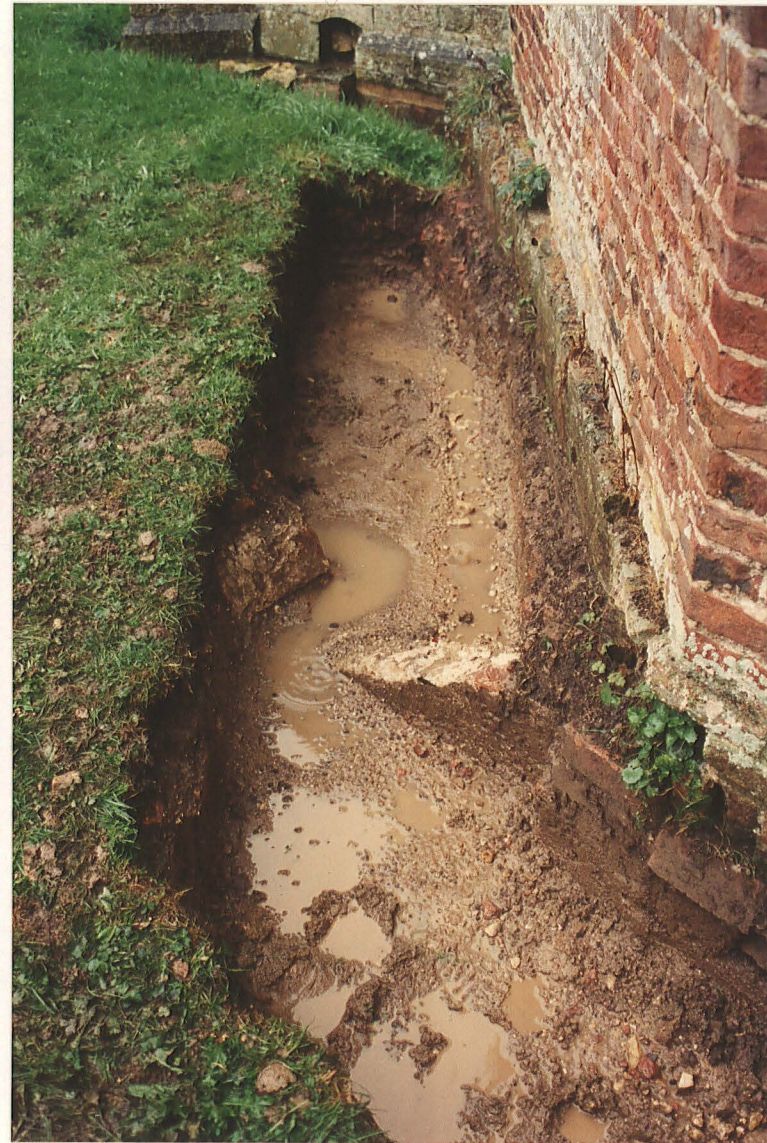
The present chancel is a half-octagonal brick structure, built with red, handmade bricks measuring 226mm x 109mm x 56mm. The wall is offset by a course of header bricks which project 0.10-0.15m, overlying two header courses set on edge. Below present ground level are three further brick courses apparently built on a layer of mixed soil, forming a very shallow foundation (Pl. 15). The proposed drainage trench around the apse was left at a maximum depth of 0.40m so that the foundations would not be undermined. The trench did not disturb the expected foundations or floor of the medieval chancel, which, from the level of the associated tower crossing (see below) was deduced to have been at least 0.15m deeper than the bottom of the drainage trench.

PI. 15. Apse E wall showing shallow foundations.

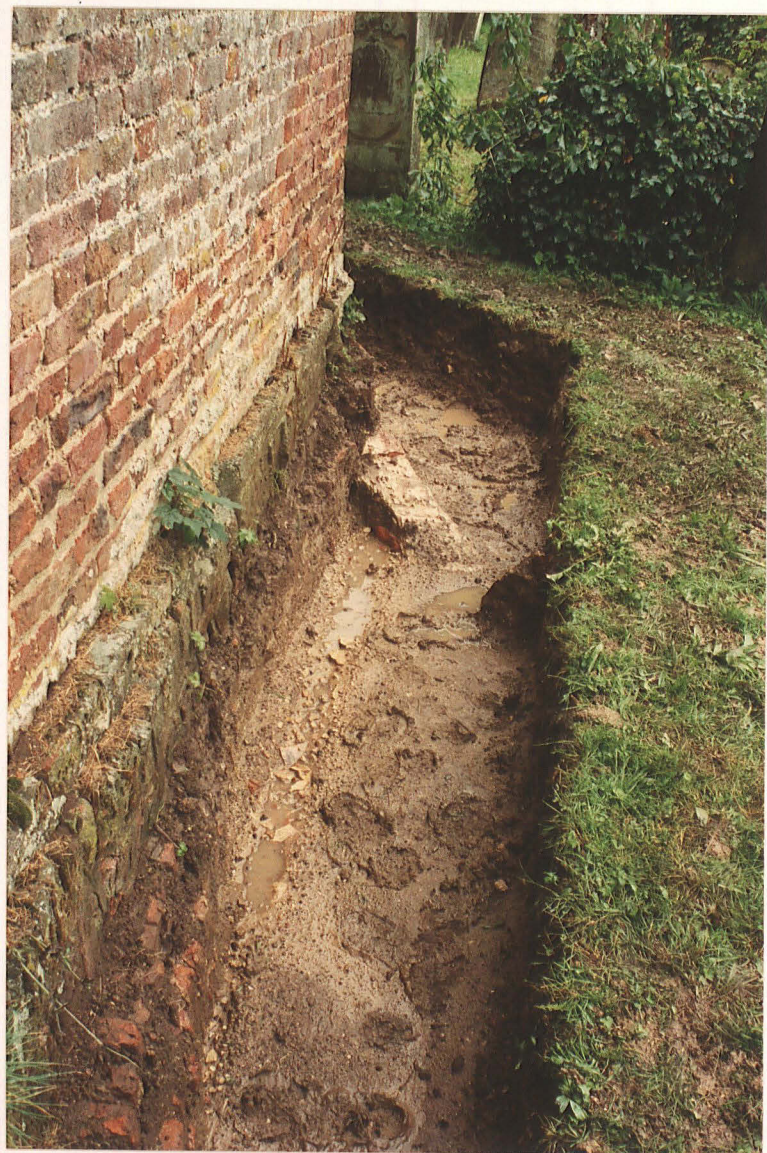
The only feature observed around the apse was a projecting line of brickwork at the south-east angle, in line with the east wall of the apse, possibly the remnant of a setting out course during construction (Pls. 16, 17).

PI. 16. Apse SE angle showing remains of setting out course.  
(looking W).

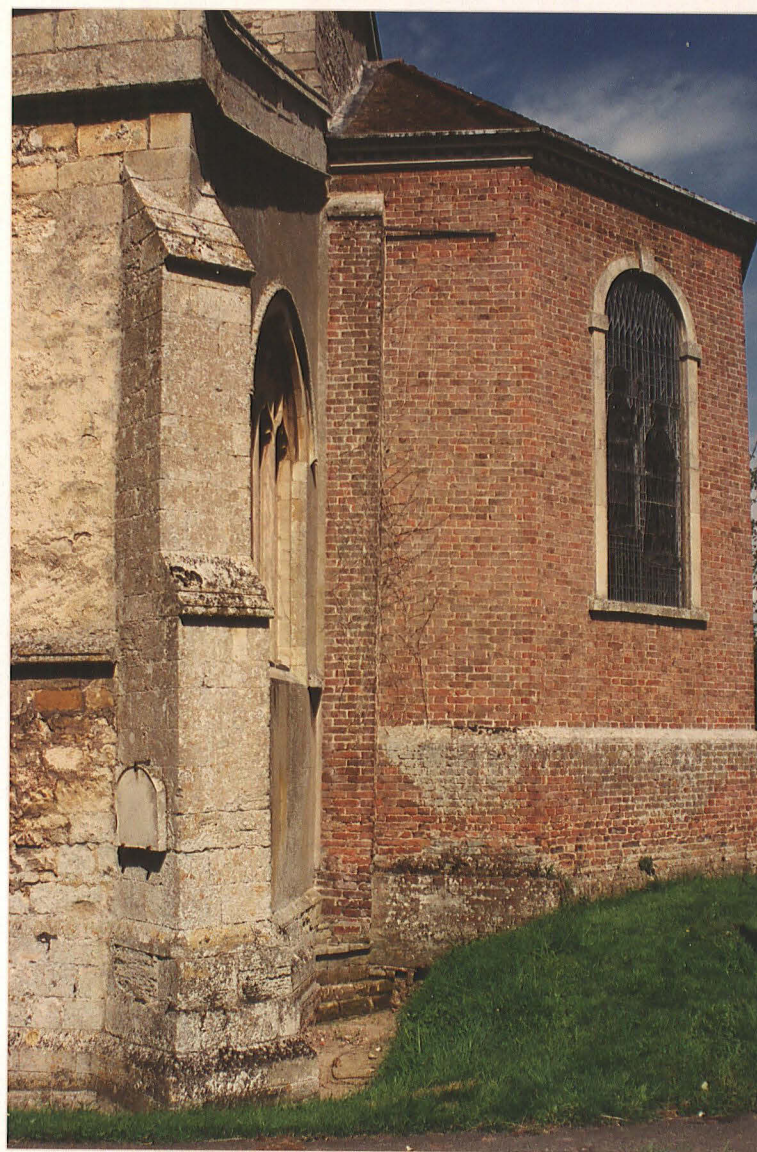
Pl. 17. Apse SE angle showing remains of setting out course.  
(looking E).

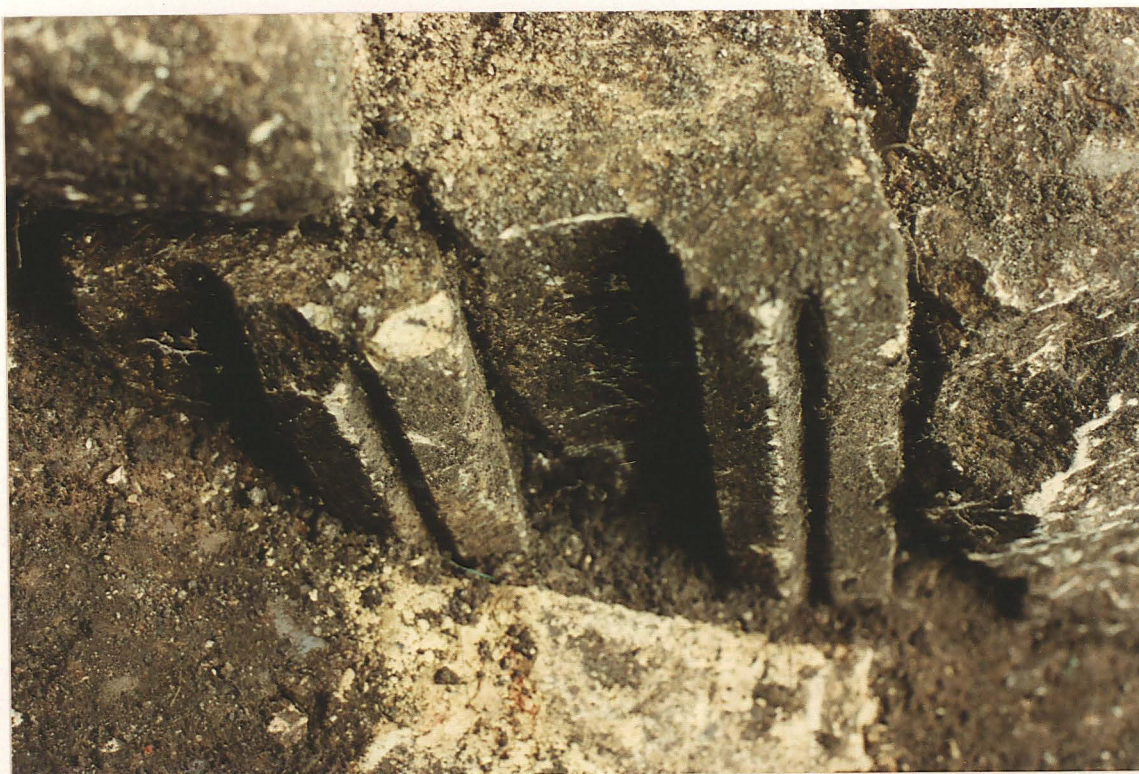
The foundations on the north side of the tower comprise an arrangement of pitched limestone blocks bonded in a cream coloured mortar. They incorporate at least three re-used architectural fragments provisionally identified as pieces of window jambs, not earlier than the late 13th century in date (Pls. 35,36) (11) which might have been part of the underpinning by Gilbert Scott. The architectural fragments may have come from the removed west windows.

Pl. 35. Underpinning (11) beneath tower N wall.

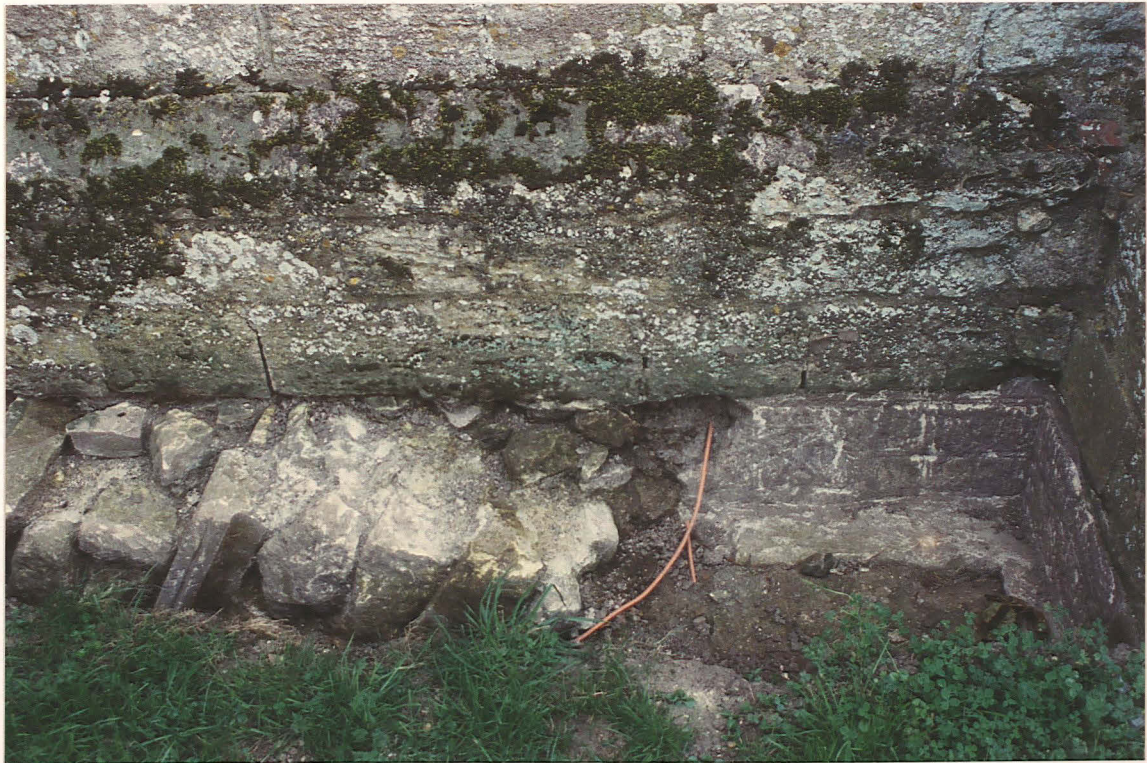
Above (11) were irregular courses of stone rubble (10) which also overlie (9), offset 0.32m from the tower wall with a visible height of 0.35m above the trench base (Pl. 37). It extended from the tower buttress westwards as far as a recent electricity cable where another phase (later?) of underpinning was observed (Pl. 38).

**Pl. 37. Rubble packing (10) above (11) overlying nave foundations.**

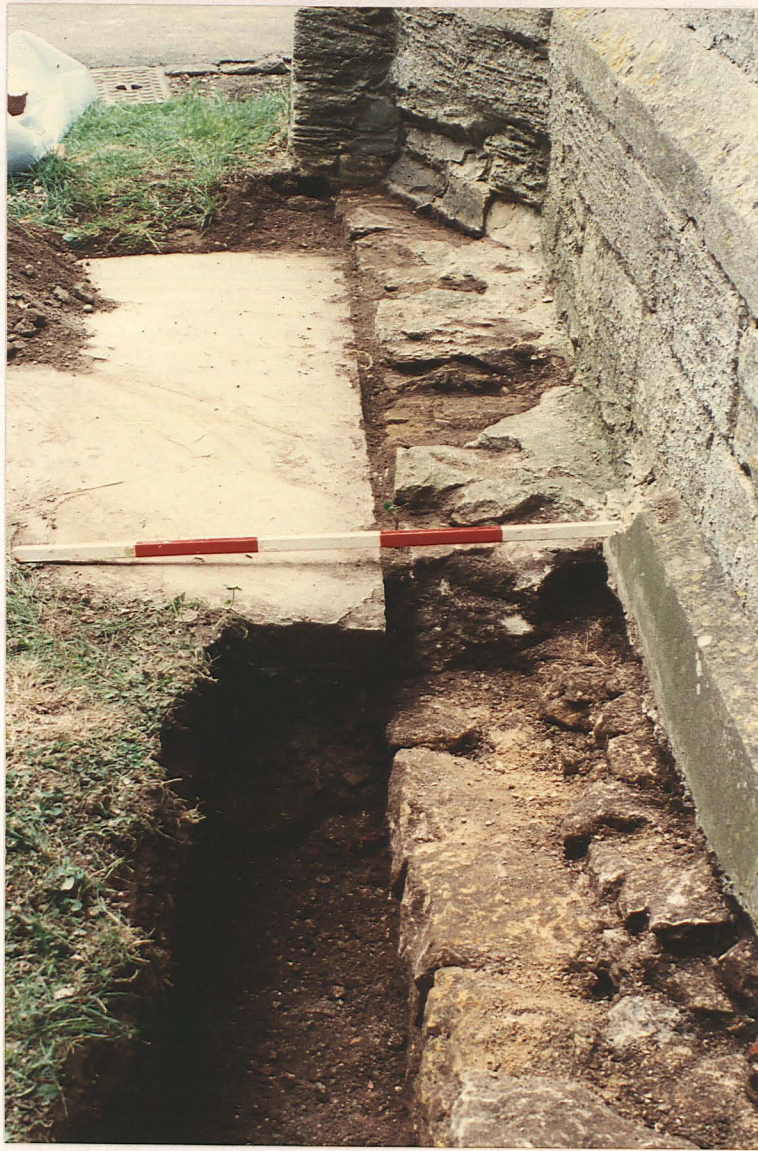
**Pl. 38. Rubble packing (10) above (11) and later repair (R).**

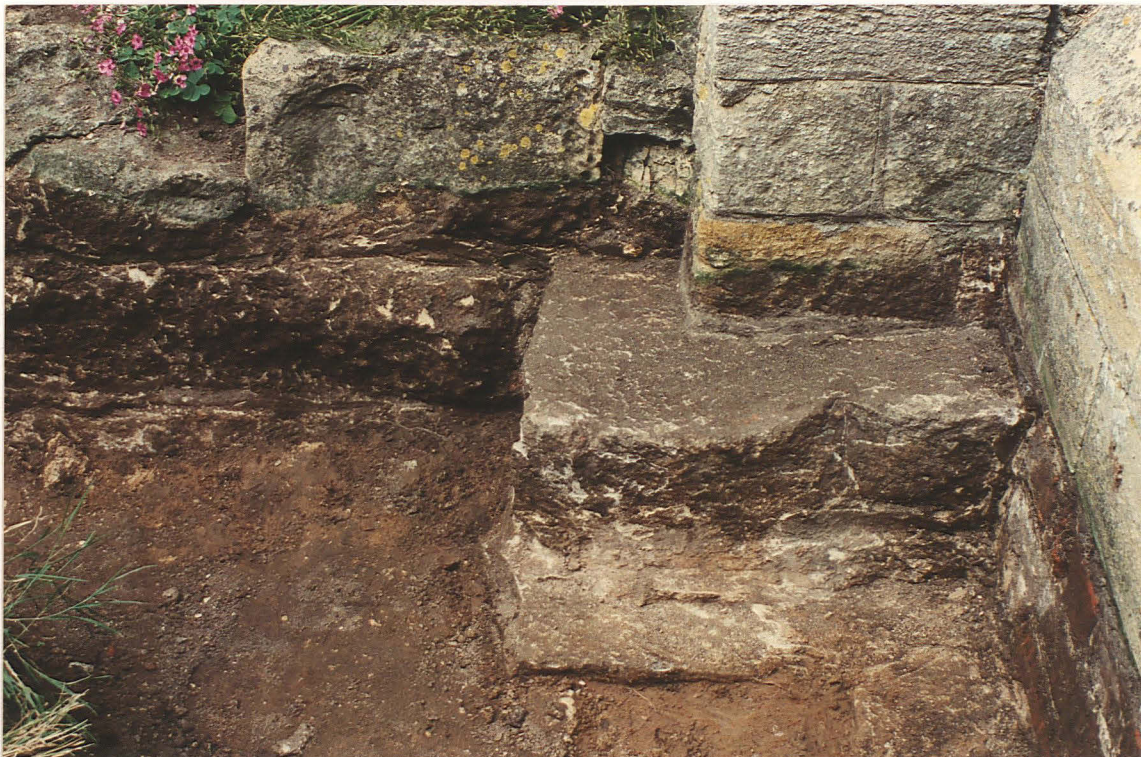
The foundation beneath the tower south wall (12) comprised large yellow limestone blocks bonded with yellow mortar and repaired with bricks on the uppermost course, 0.5m above the trench base (Pl. 39). It overlies the foundations beneath the buttress at the south-west angle of the former nave which comprised two courses of limestone blocks bonded with white mortar (13 (Pl. 40)). The visible dimensions were 0.5m north-south and 0.53m west to east; 0.25m depth of the foundation was exposed. Stone foundations (14) to the south, consisting of two north-south aligned limestone blocks (1.04m north-south) and offset 0.18m from the aisle wall, seemed contemporary (Pl. 41). Together these foundations mark the position of the medieval nave and aisle which predated the 15th century tower and south aisle.

PI. 39. Tower S wall foundation.

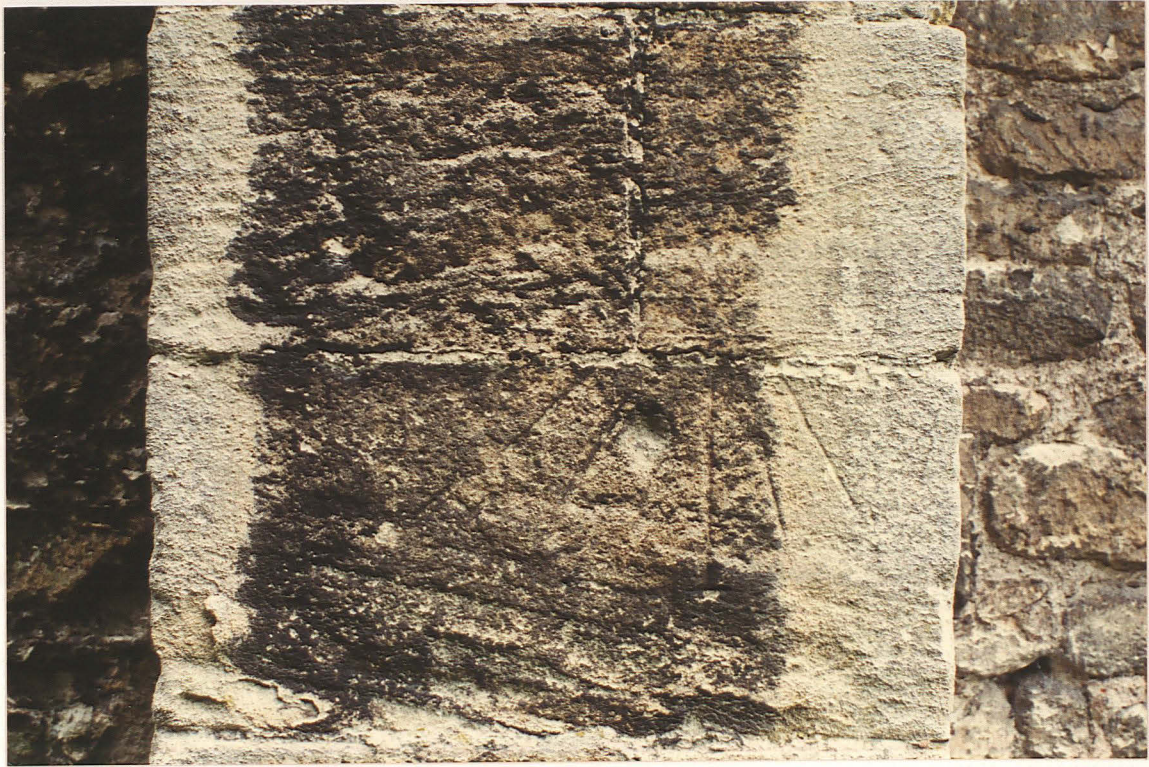
A scratch sundial was recorded on the south face of this buttress (Pl. 45). It straddles two stones and is therefore presumed to post-date the construction of this fifteenth century buttress. A second scratch sundial has been noted on the internal face of the tower south wall, evidence that stone was reused in the construction of the tower in 1420 (Church Guidebook).

PI. 45. Scratch sundial on S face of S aisle buttress.

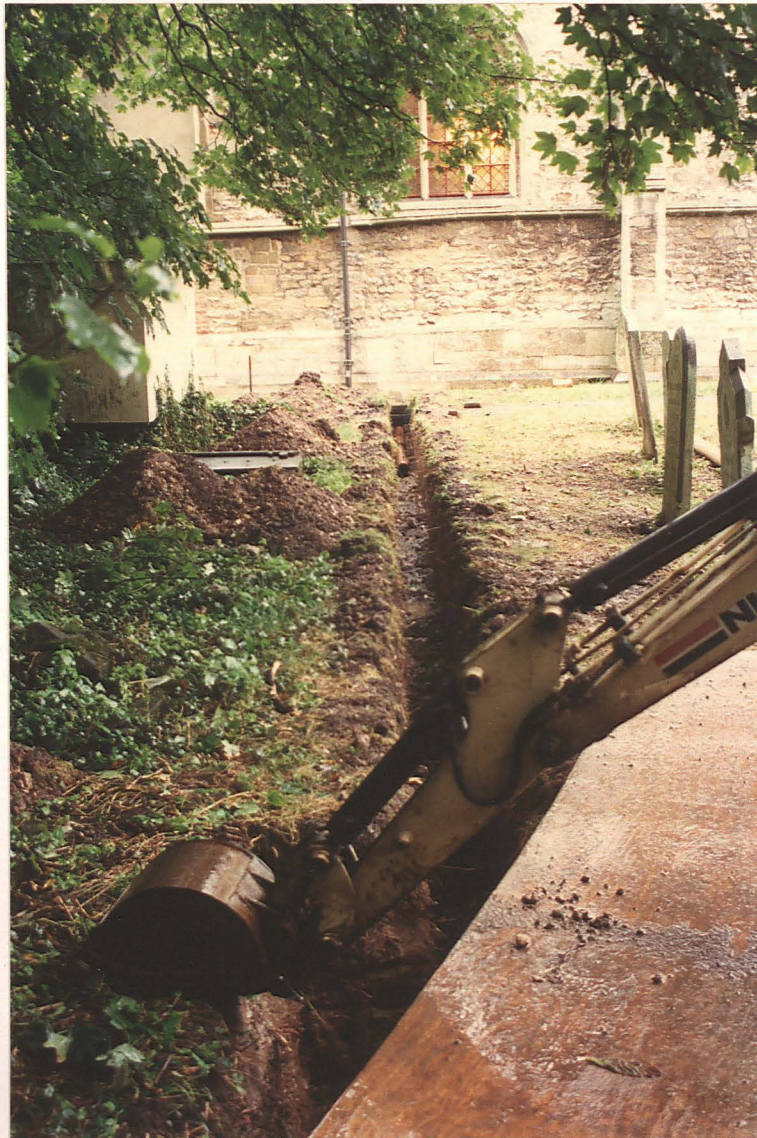
Inspection of the soakaway trench which was dug from the south aisle towards the south boundary of the churchyard revealed nothing of archaeological interest. The trench sides showed disturbed soil as might be expected in a churchyard and a few pieces of human charnel were seen, although no obvious grave cuts were present (Pl. 46). There was limited

PI. 46. Soakaway trench running S of church.
