**Beckingham, All Saints Church, Lincs.
Archaeological Watching Brief**

Site Code: ASCB 05

LAS Report No. 879

November 2005

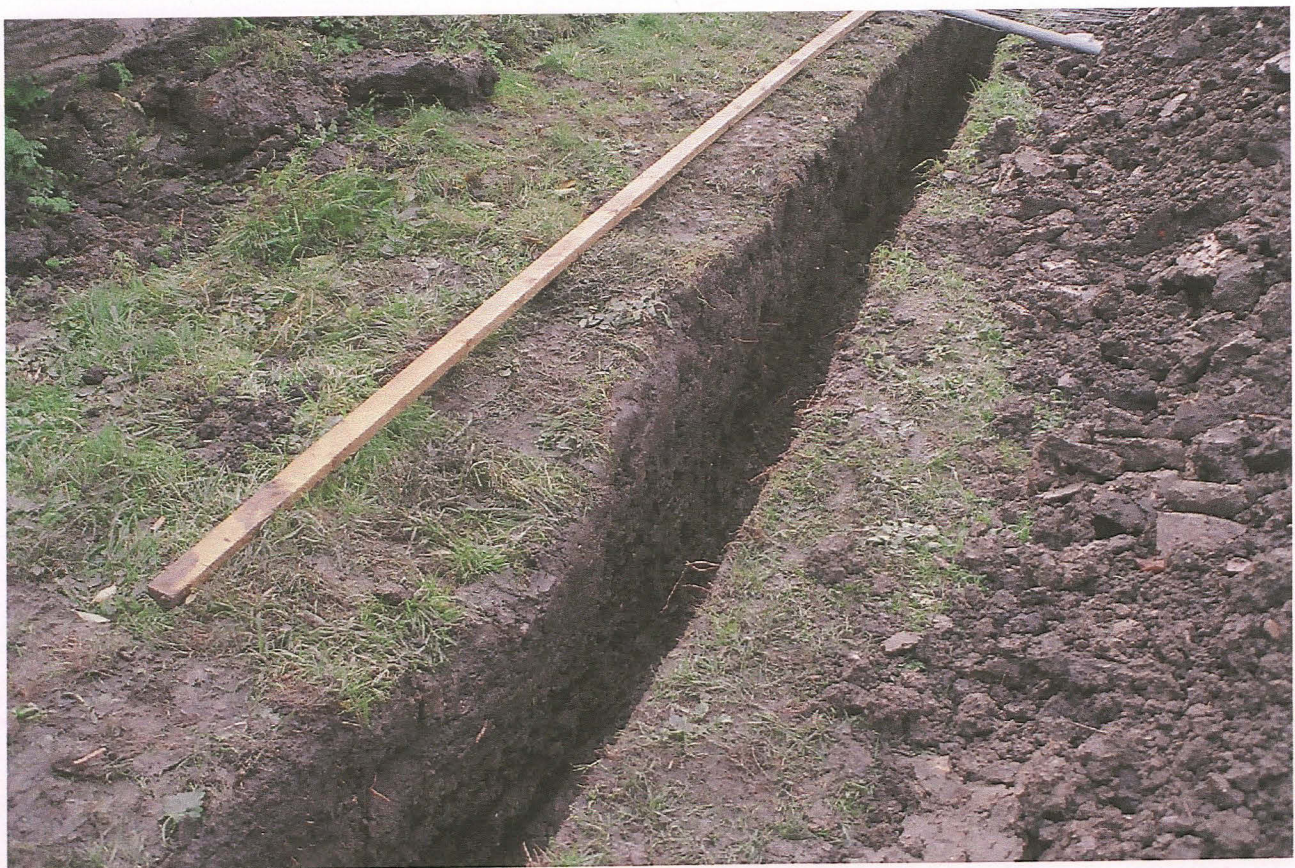
Two drainage trenches were excavated leading from either side of the chancel to soakaways. They were c.6m in length and 0.30m wide. Their depth varied from 0.30m next to the chancel wall to 0.60m at the soakaway. No discernable topsoil or subsoil was noted with a single mid grey/brown clay silt continuing to a depth in excess of the developers final formation level. Where the drainage trenches abutted the church, they revealed modern red-brick underpinning. Several fragments of human bone were noted during the monitoring. The fragments were mainly small pieces of adult femur, tibia and an almost complete chondrocranium from the skull of an adult.

Pl. 2 Looking south along the excavated drainage trench on the southern side of the church

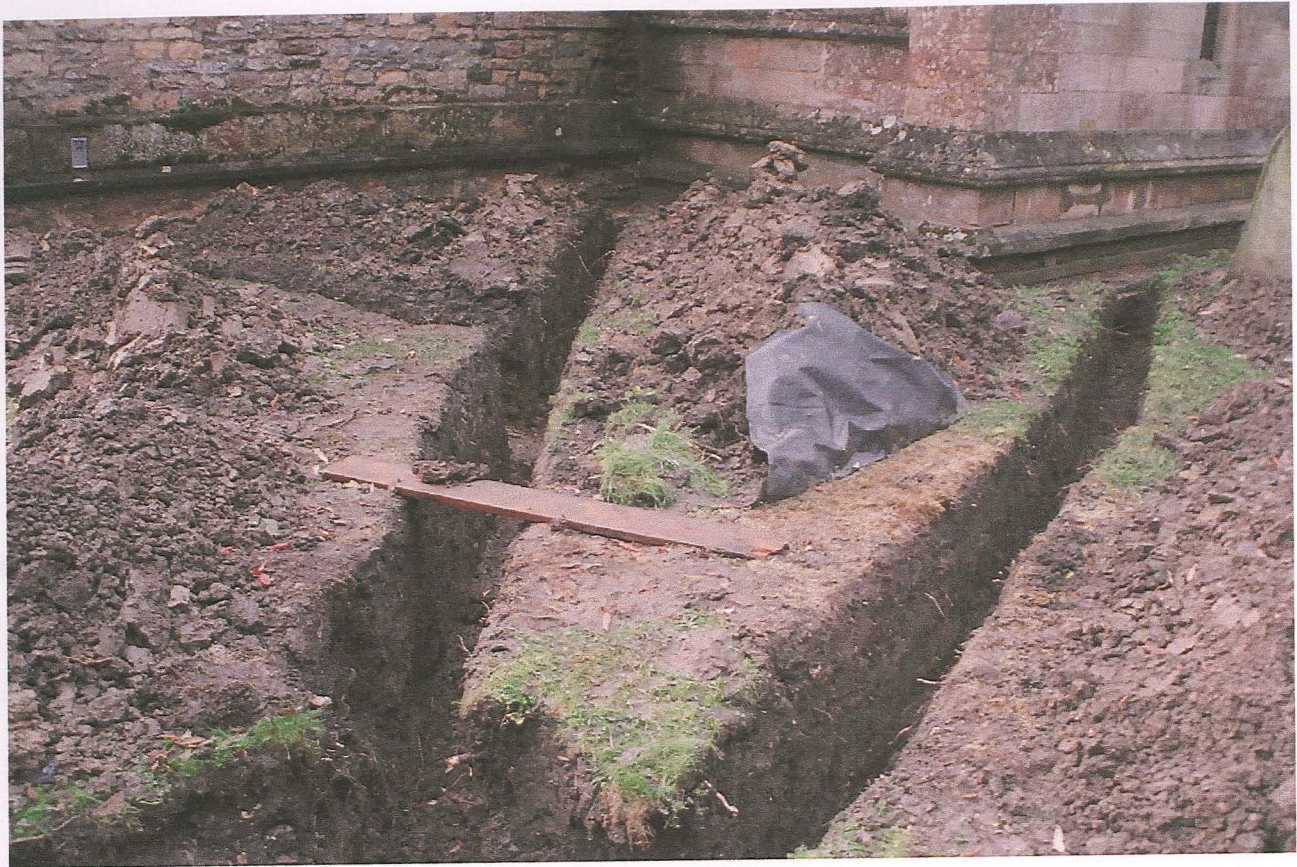
Pl. 3 Drainage trenches on the northern side of the church

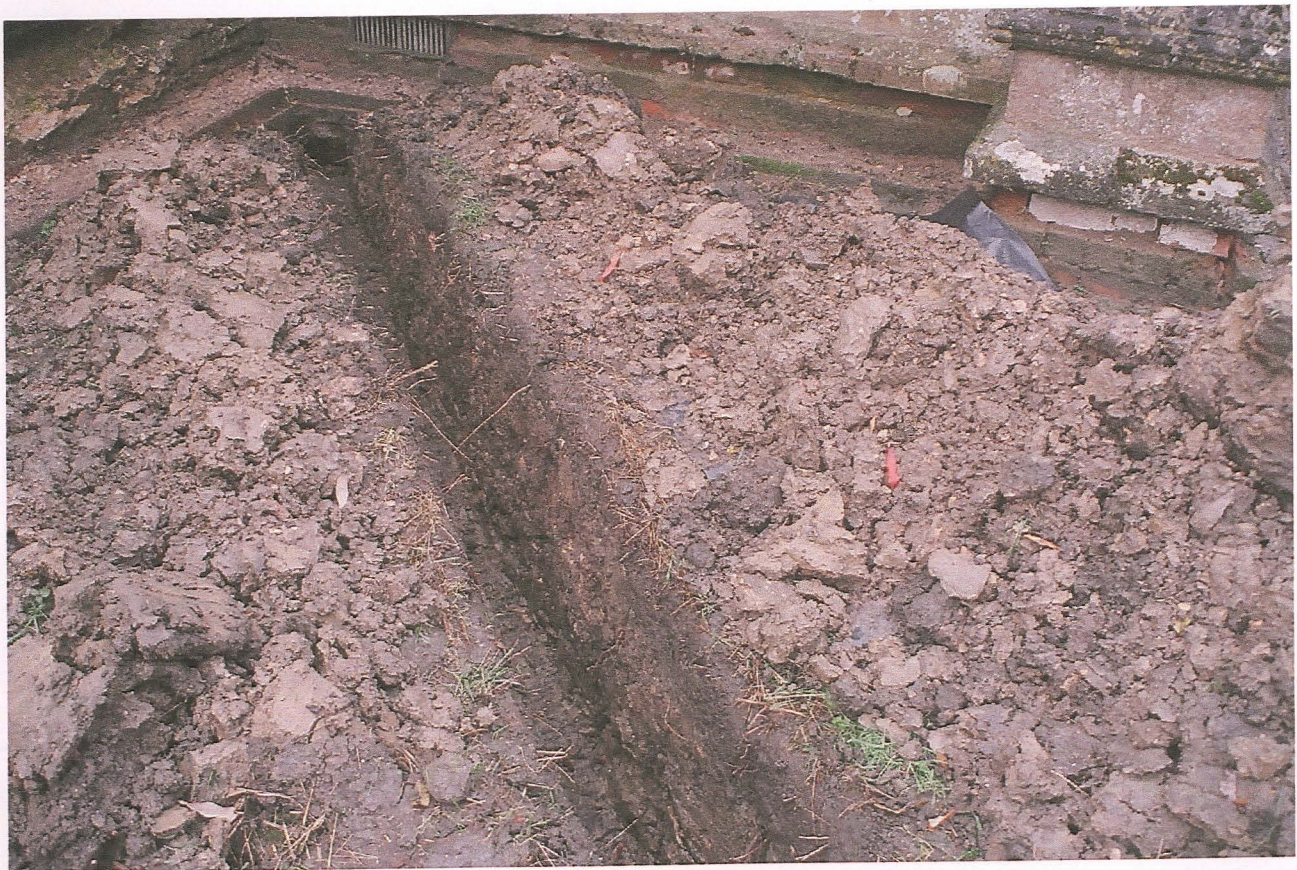
Pl. 4 View looking south at a the trenching on the northern side of the church
