**Hall Farm, Harpswell, Lincs.  
Archaeological Watching Brief**

**Report For  
Mr and Mrs M. Tatam**

**LAS Report No: 905**

**March 2006**

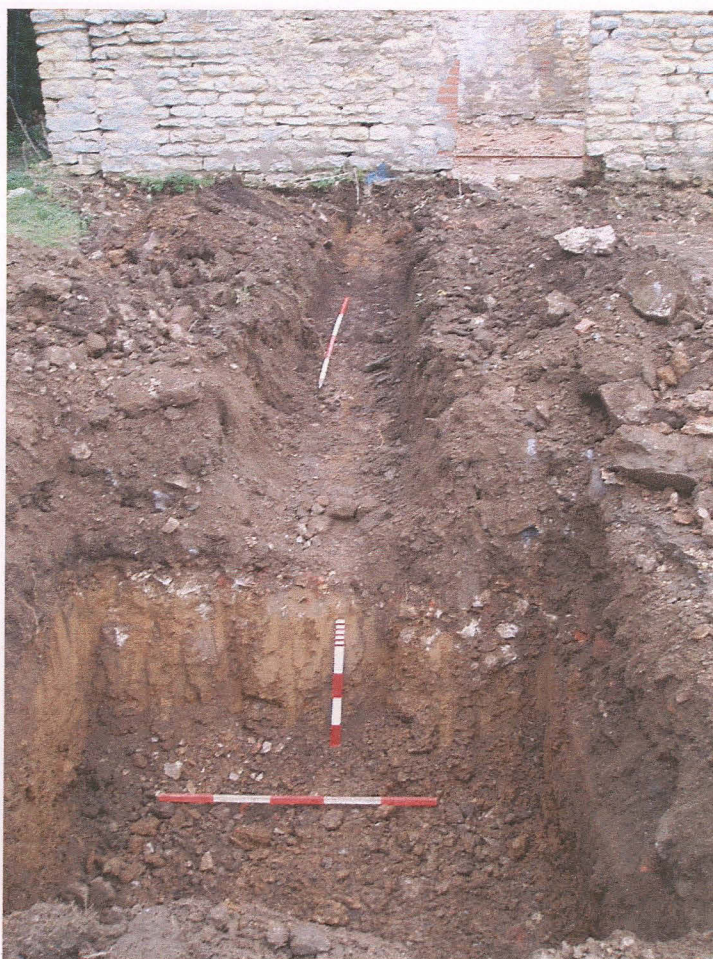
Trench 1 ran 6m westwards from the western side of the building and into a soakaway 1.2m x 1.2m and 1.2m deep (Fig. 2), (Pls. 2, 3). In the section of the soakaway three different materials were evident, a re-deposited topsoil (100), a possible external rubble surface (101), and the natural orange clay with limestone brash (102). An outlet for an internal drain was evident on the outer face of the west wall at the east end of Trench 1 (Pl.3).

Evidence of an external surface was seen in the section of the soakaway trench to the west of the stables. This was made up of limestone, brick and tile fragments probably just spread roughly over the clay natural. The area was apparently raised in the late 1960's or early

Pl. 2 West facing section of the soakaway at the end of Trench 1. Scales 2m, 1m and 0.50m.

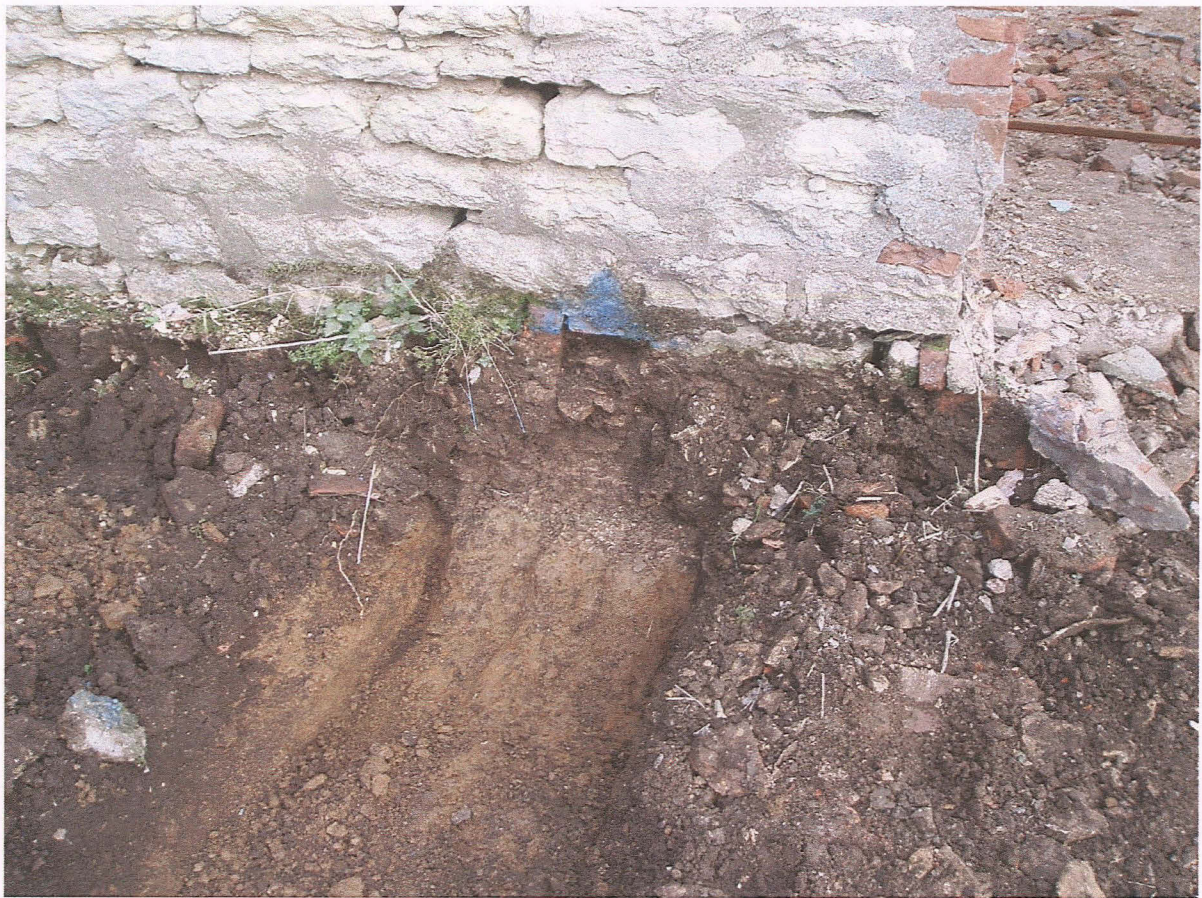
Pl. 3 Trench 1 at the east end with the exit of the internal drain through the limestone wall.

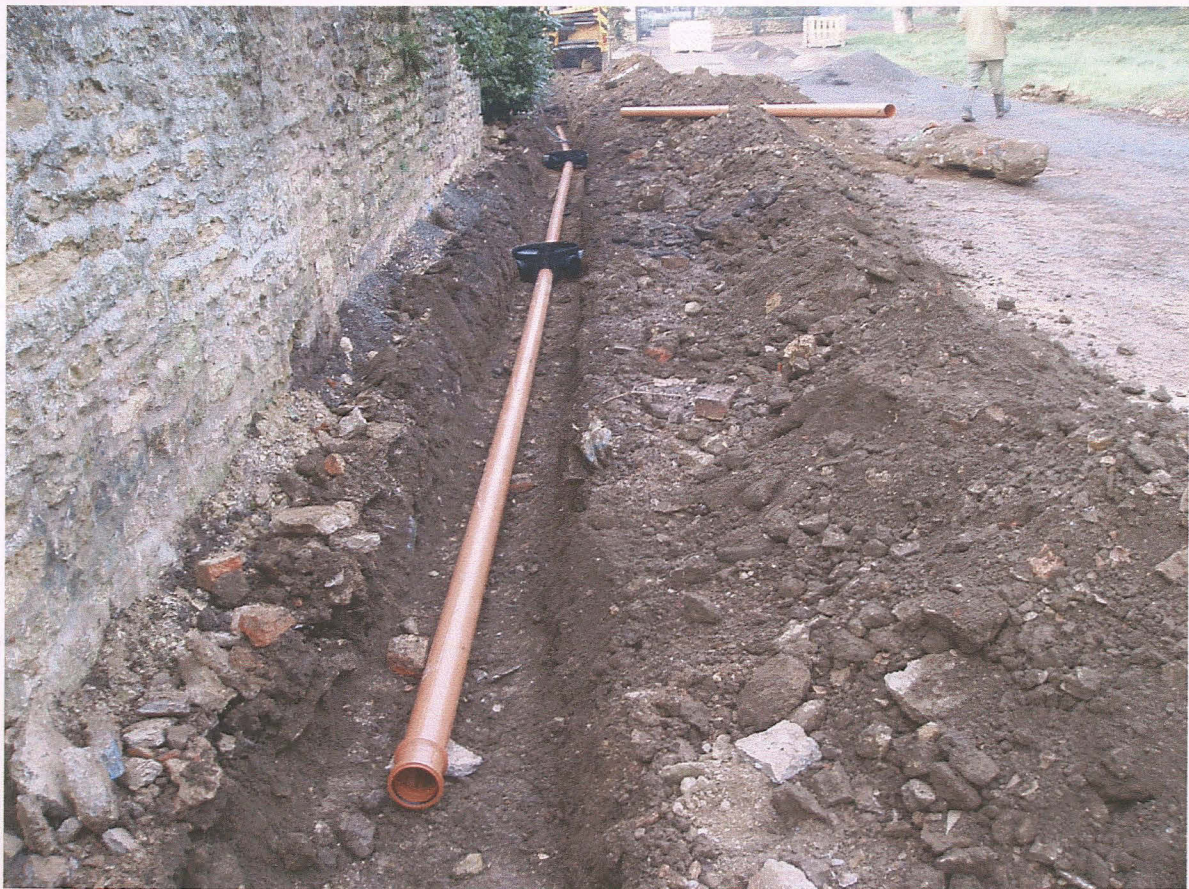
Trench 3 was machined along the length of the eastern wall and a further 25m to the north to a depth varying from 0.50m to 0.90m (Pls. 4, & 5). This also contained layers (104), (105), and (102).

Pl. 4 Trench 3 at the south end.

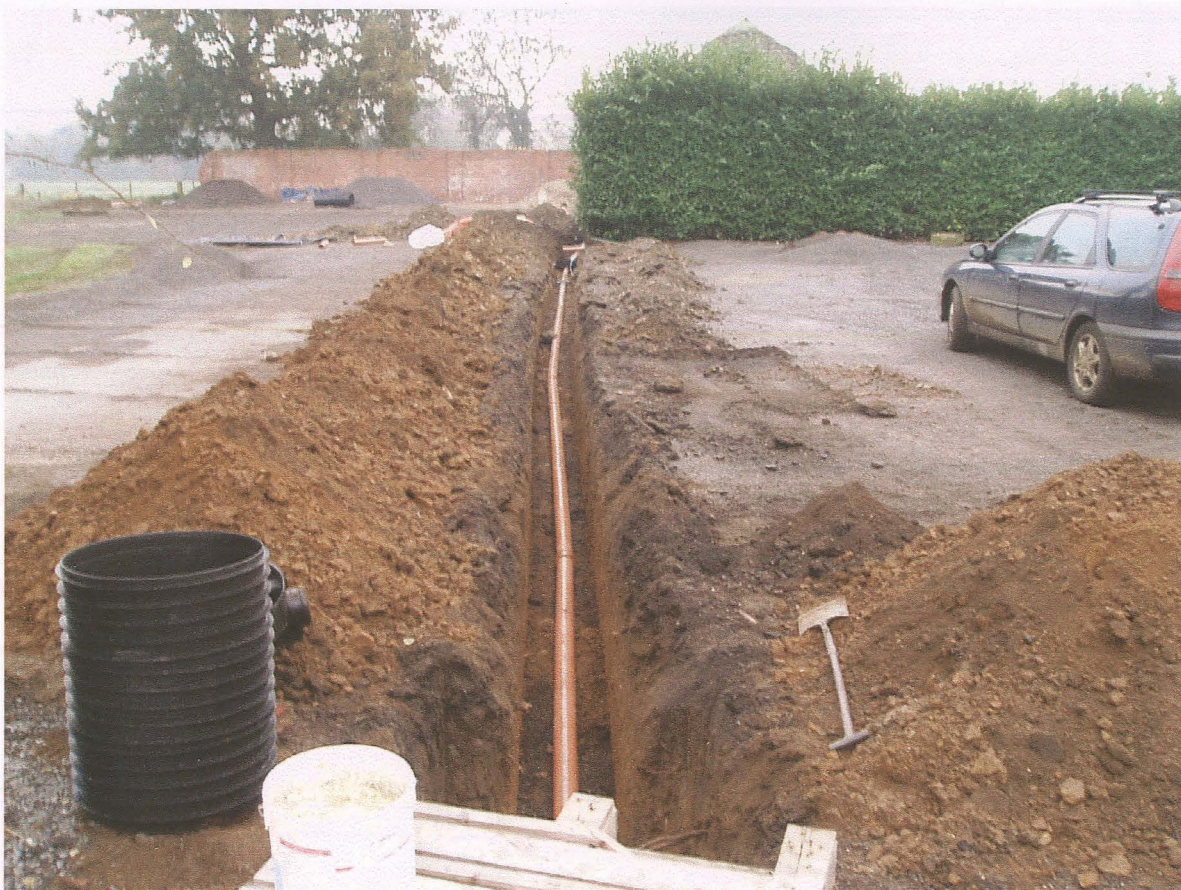
Pl. 5 Trench 3 from the north end.

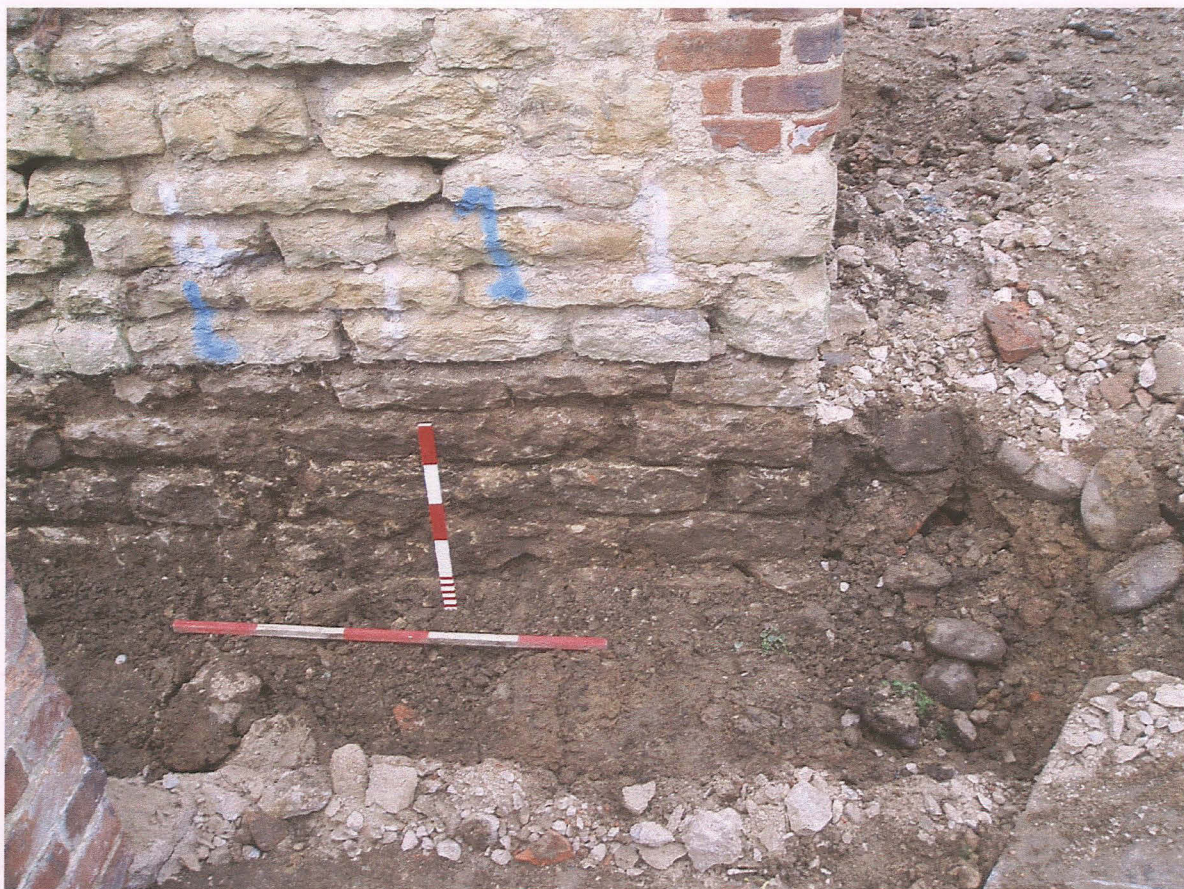
Trench 4 was machined alongside the south wall to investigate the foundation (Pl. 6, 7 & 8). The section at the east end of the trench revealed re-deposited topsoil (100), overlying an external cobble-stoned surface (106). This surface was cut by the later insertion of drains running into a manhole, also at the south-east corner of the building.

Pl. 6 trench 4 with the limestone foundation of the south wall and the large cobbles showing in the section on the right hand side. View from the south. Scales 1m and 0.50m.

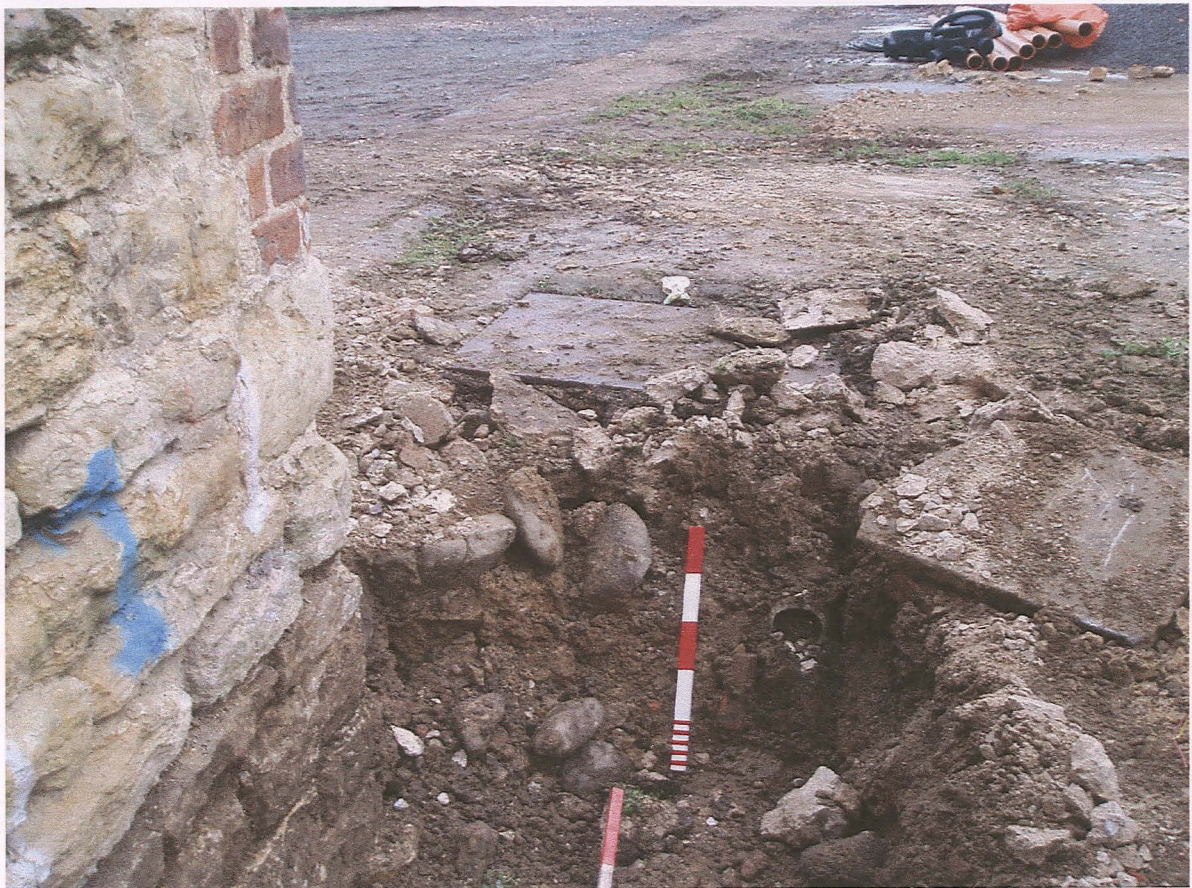
Pl. 7 The section at the east end of trench 4 with the large cobbles and the disturbance from the later drain and manhole.

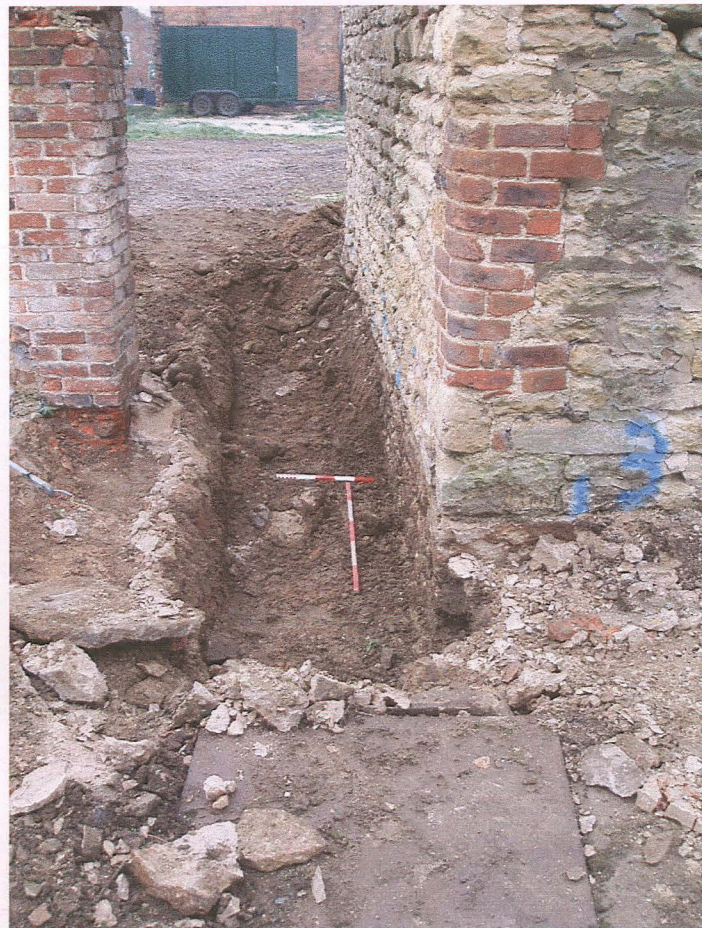
Pl. 8 The foundations of the south wall in Trench 4. View from the east. Scales 1m and 0.50m.

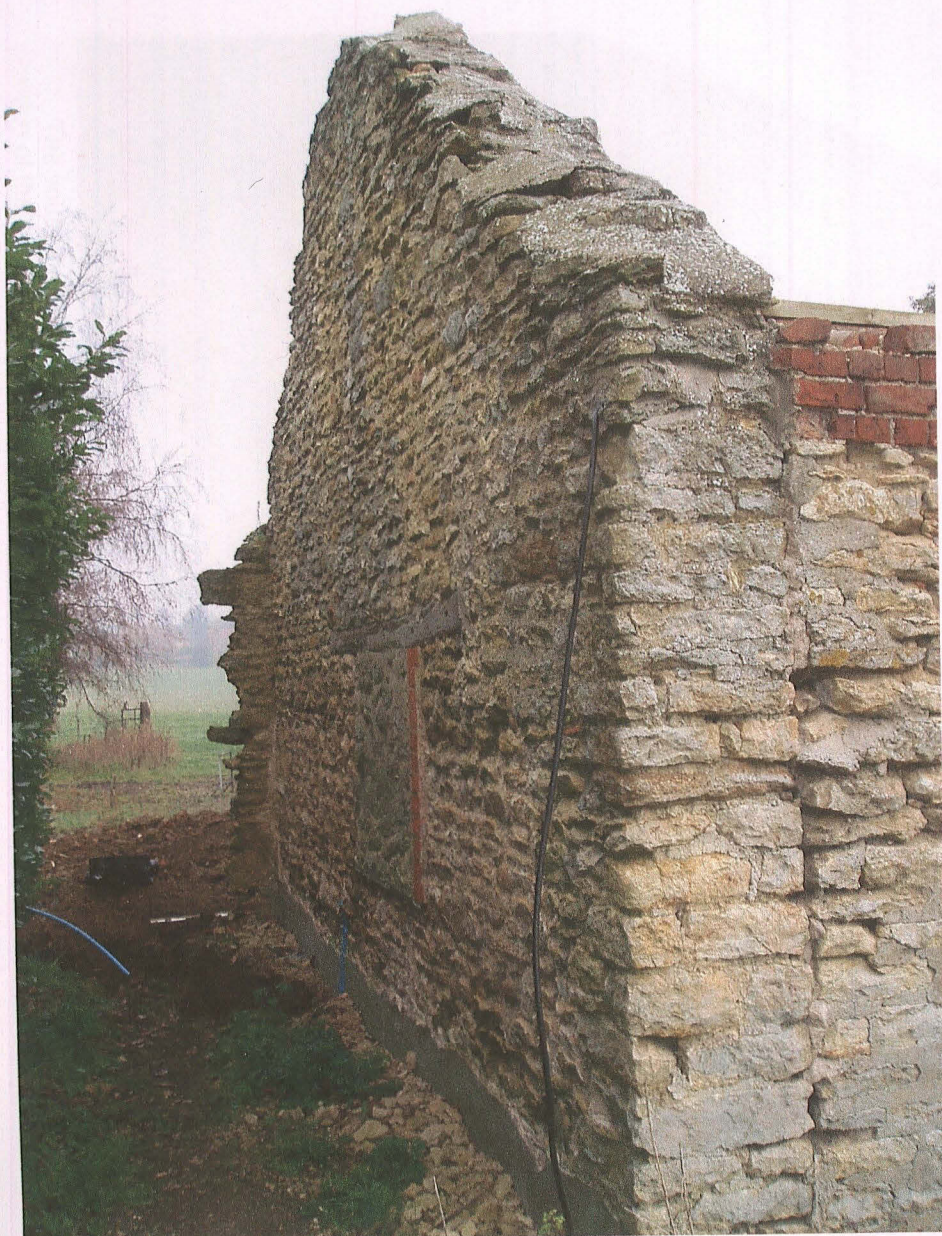
The northern gable was actually the south gable of a demolished building. The west side has a finished face whereas the east end has a northern return (demolished). This suggests that the building to the north of the stable may have been a barn or cart-shed open to the west. There is a blocked doorway west of centre of the wall which was partially blocked to form a

Pl. 9 The external elevation of the north wall. Oblique view from the north west corner, showing the butt joint of the west wall.

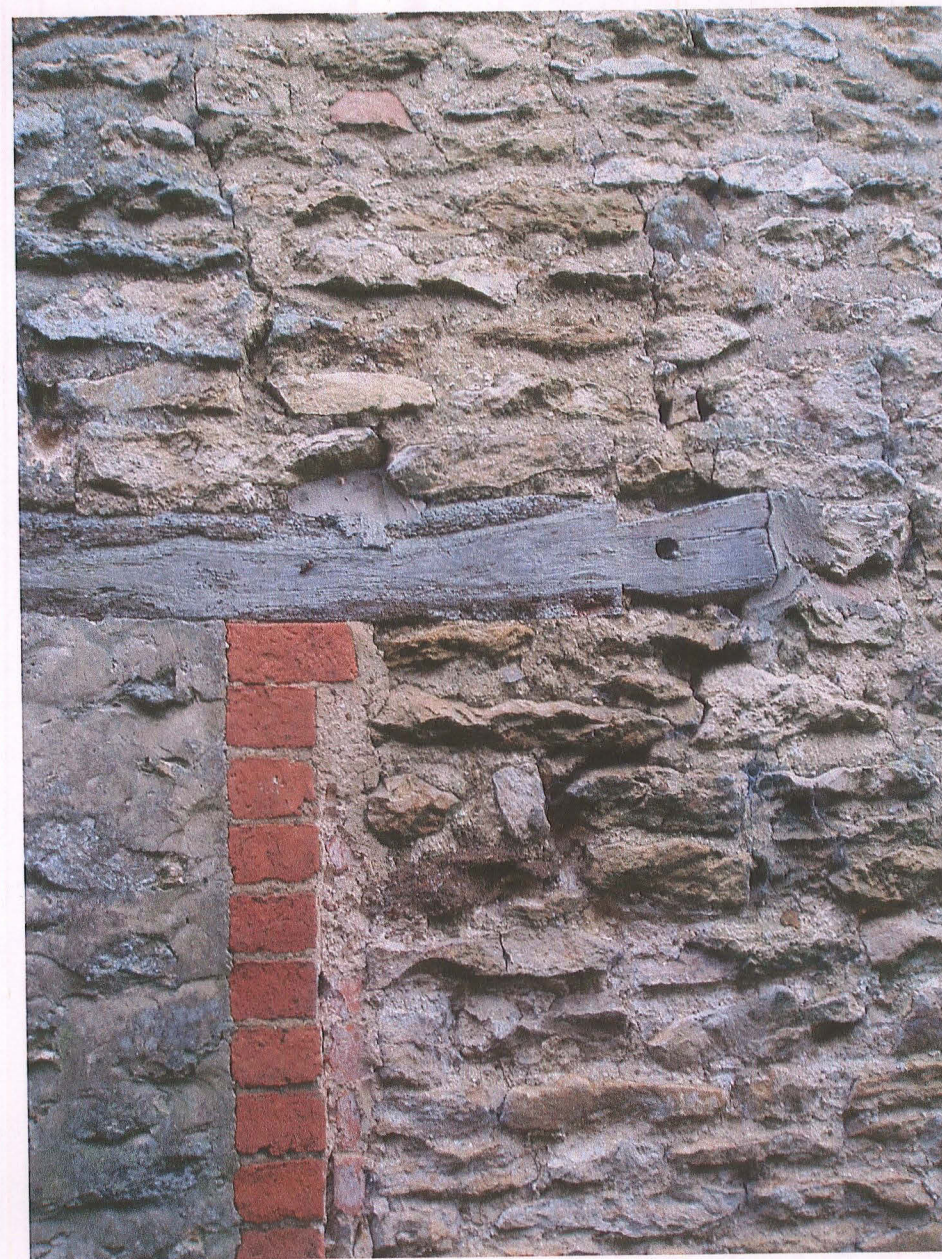
window which in turn was blocked. The window jambs are finished in red brick with a re-used timber lintel over.

Pl 10 Detail of the brick lining of the window in the north wall with re-used timber lintel above.

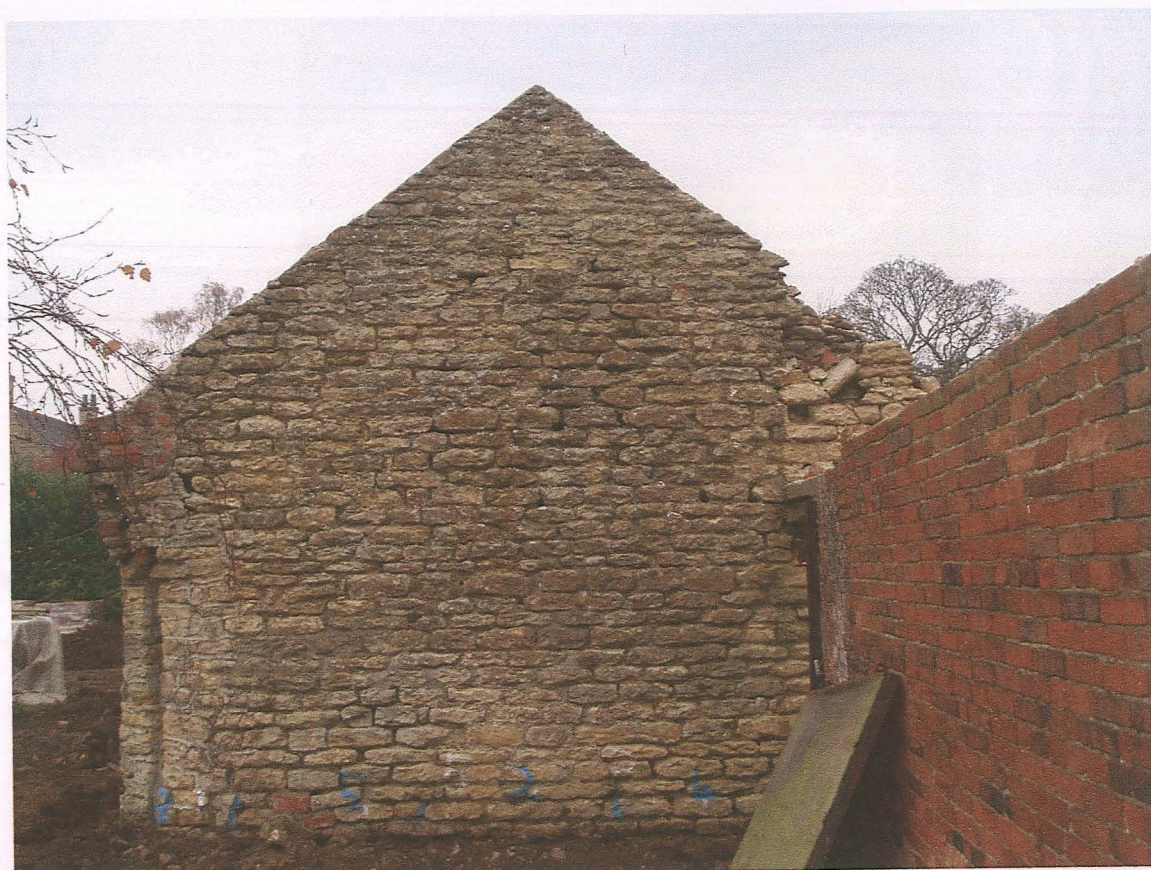
The south gable shows mortar differences to the upper part of the wall consistent with the raising of the roof-line. The south-west angle has been rebuilt to remove the sharp right-angled corner and produce a 45 degree angle, presumably either as a safety measure to protect horses or just to make the most of a restricted access to the rear of the stables. A rebate remains in this corner after a vertical timber has been removed, possibly a part of a frame to accommodate some form of entrance. The east end of the south wall has been rebuilt as described in the east wall account.

Pl. 11 The external elevation of the south wall.

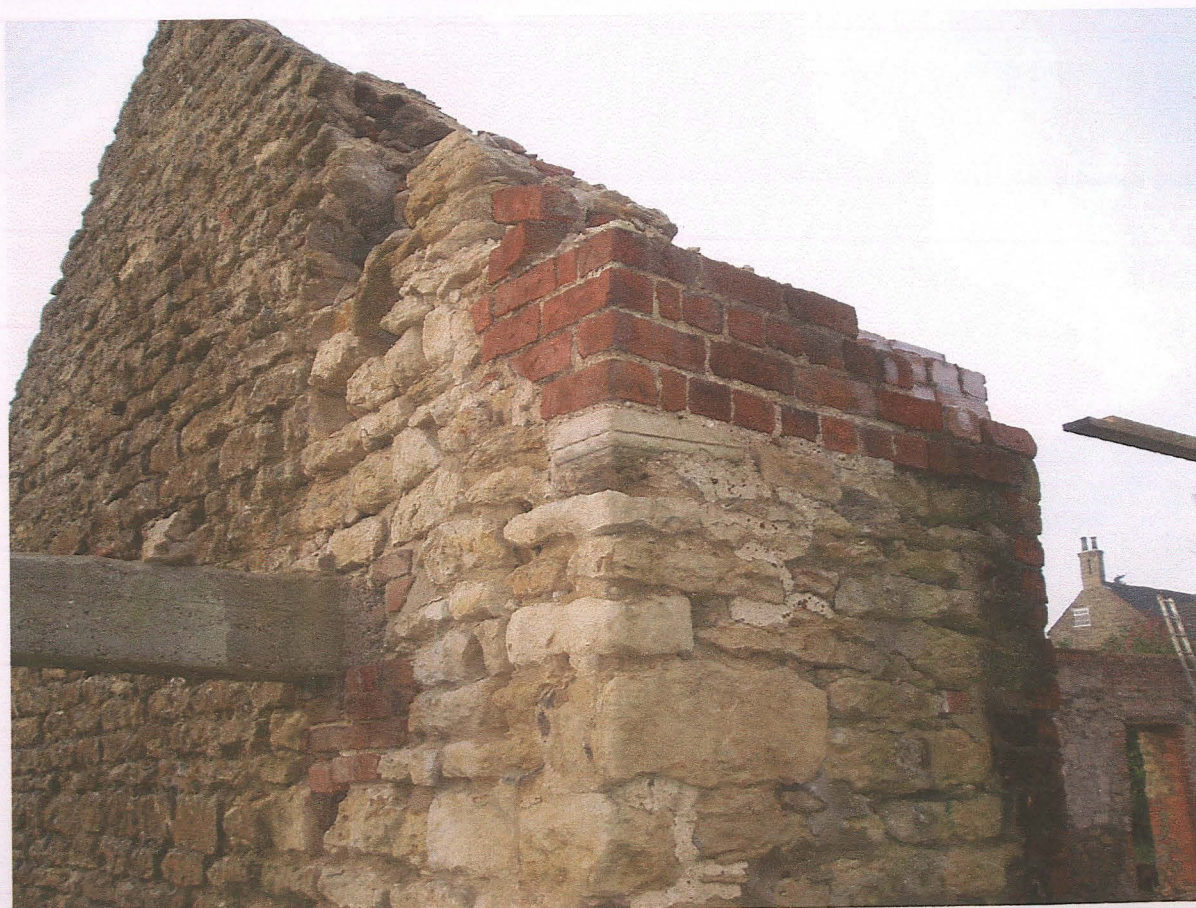
A concrete lintel has been inserted into the end of the south wall and across to the brick wall at right-angles to the south wall to form an entrance.

Pl 12 The south-east corner with the re-used limestone fragments set in the corner and showing the position of the concrete lintel.

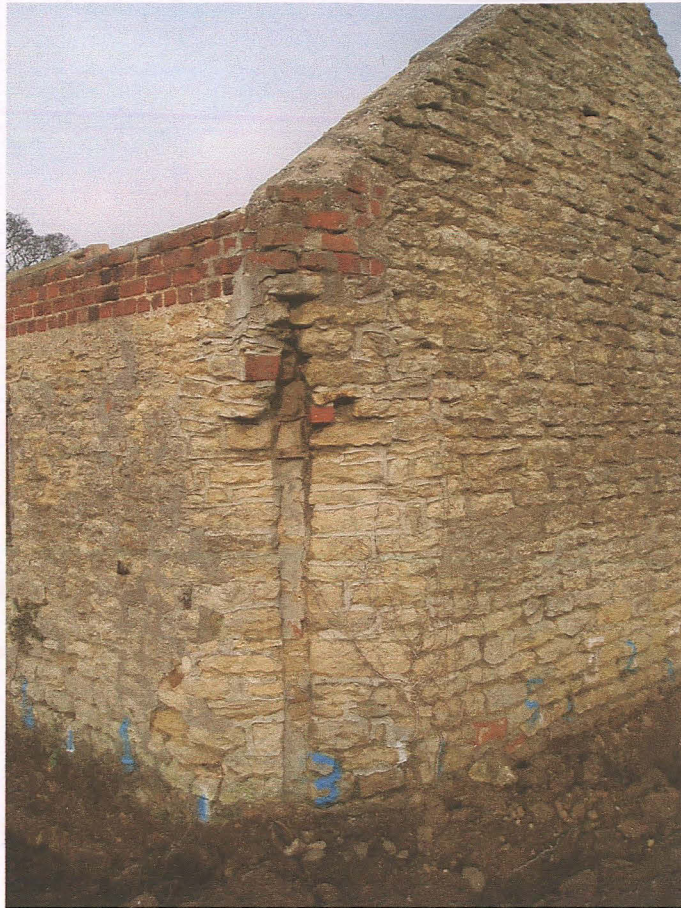
Pl. 13 The re-built south-west corner with the slot for the timber frame.

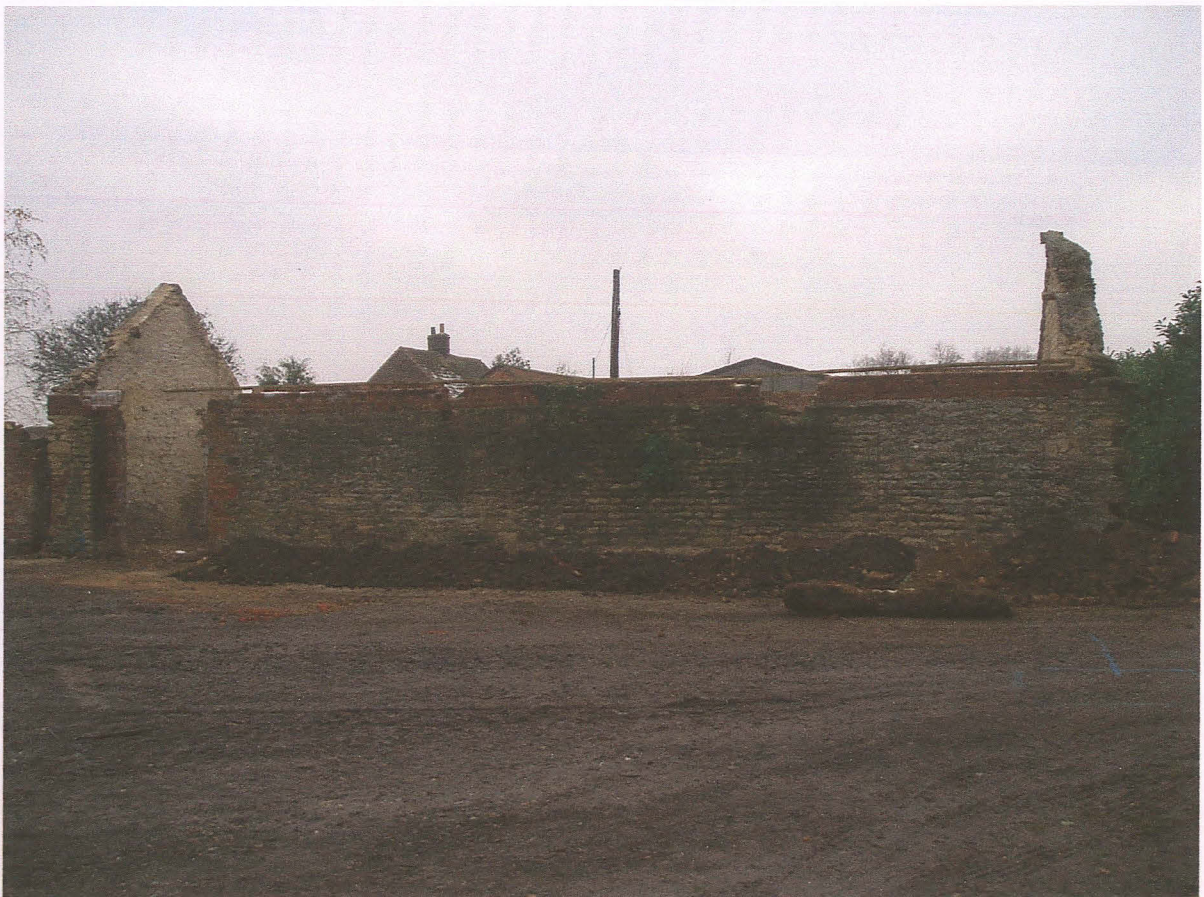
The east elevation has been raised in height with courses of red brick. A blocked entrance with wooden lintel is evident approximately 3 metres south of the north end of the wall with a large scar that suggests that a much greater section of the wall had to be rebuilt at that time. A few header bricks have been used at the base of this entrance as part of the blocking. There is an inserted entrance towards the south end of the elevation with red bull-nosed reveal on the external face. The section of wall between this entrance and the south-east angle has been re-built and includes a re-used limestone architectural fragment and red bull-nosed bricks. The rebuild projects c. 0.11m from the wall.

Two breaks in the added brickwork along the top of the wall are possibly the positions of the intermediate timber trusses.

Pl. 14 The east elevation with spoil from Trench 3 along its length.

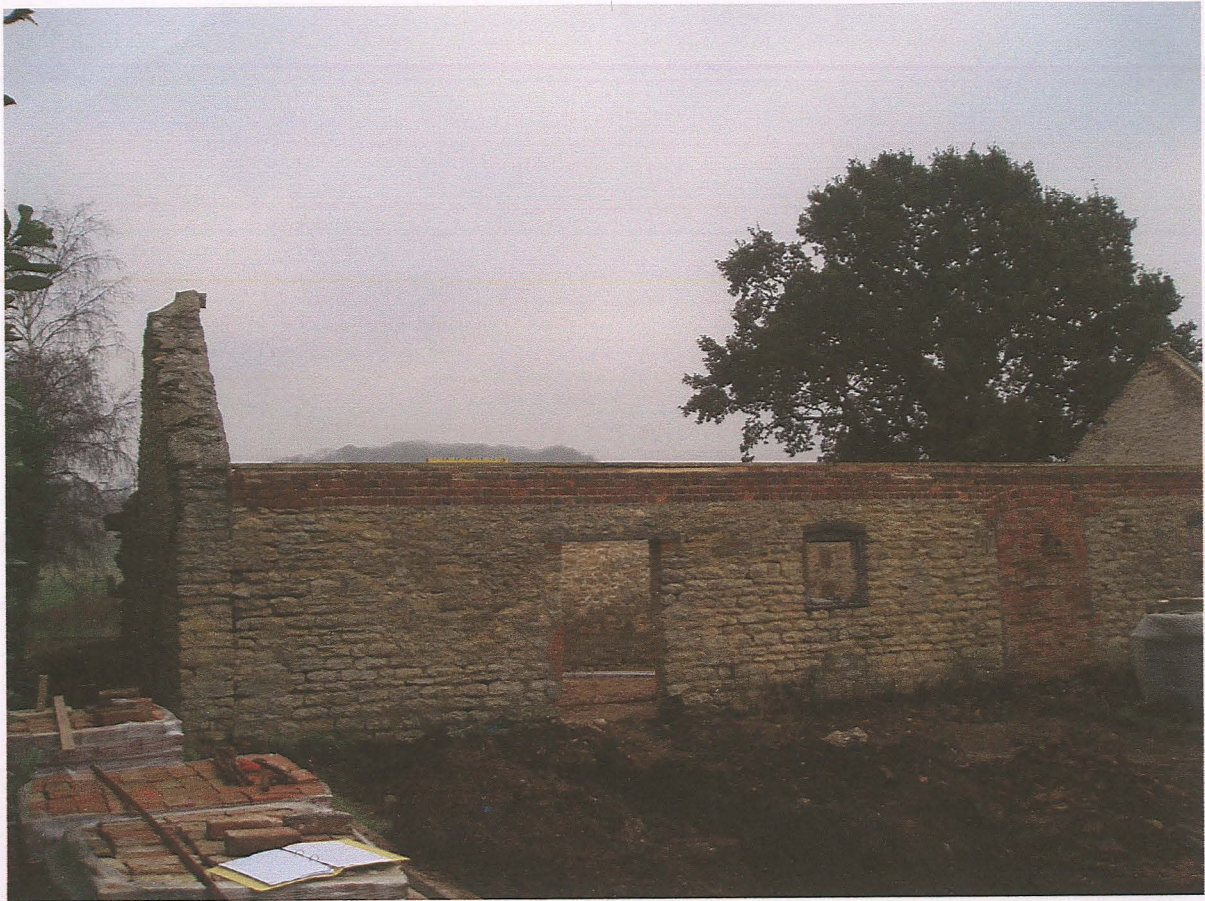
The west wall as it stands includes two existing cottage-style windows with a single row of header bricks to form an arch over the window. These are 0.89m high x 0.80m wide and retain one timber of the window frame. A doorway of similar style but with a double row of header bricks over the doorway has been blocked using bricks of a very similar type to those used to increase the height of the walls and to raise the roof-line. A new entrance has been added at the north end of the stable with a timber lintel over. The wall has been increased in height to accommodate the new roof height evident on the two gable ends.

Pl. 15 The west elevation with existing and blocked doorways and windows. Also shows the butt joint at the north west corner.

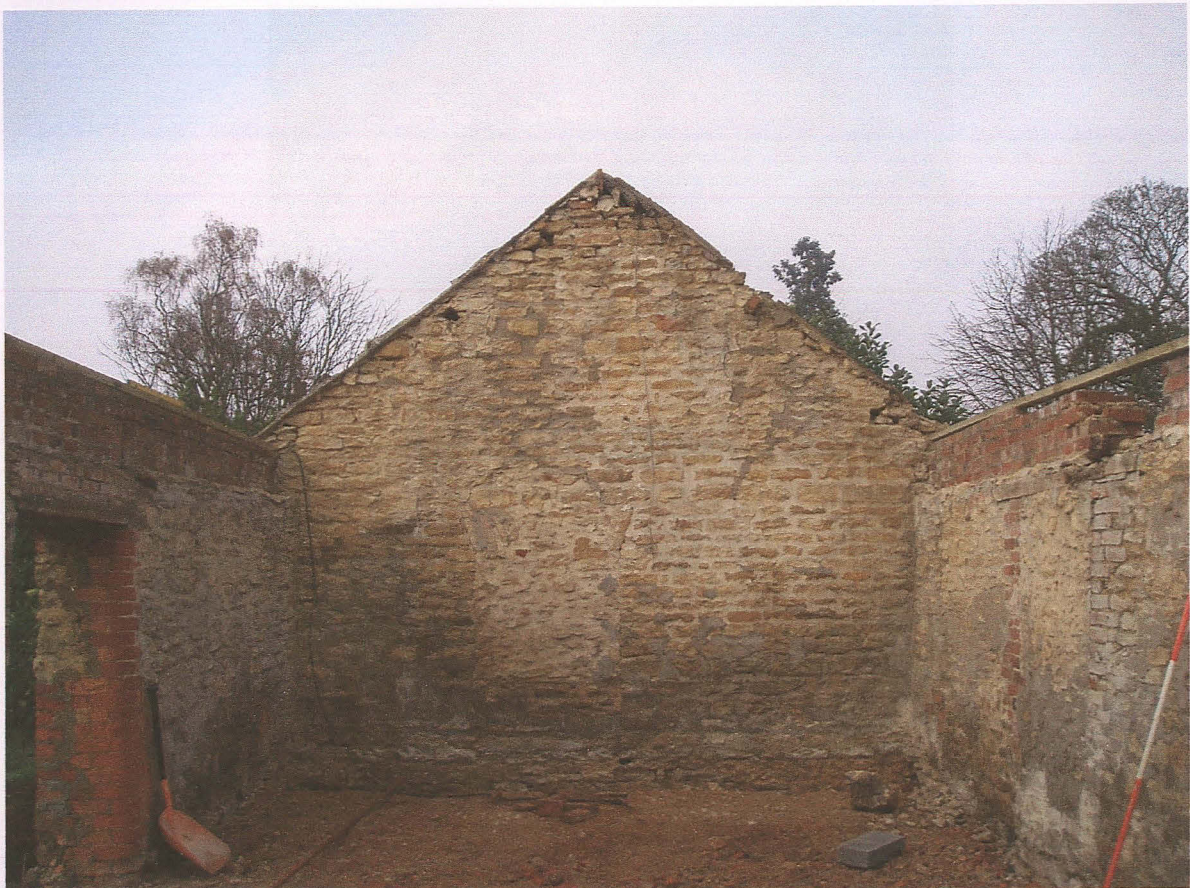
The internal face of the north wall contains a doorway which has then been partially blocked to form a window before being blocked completely. This is the external face of the opening with limestone voussoir above it. Differences in the limestone and mortar build near the top of the wall indicate that the roof-line was raised.

Pl. 16 The internal elevation of the north wall with the blocked window and the scar from an earlier doorway.

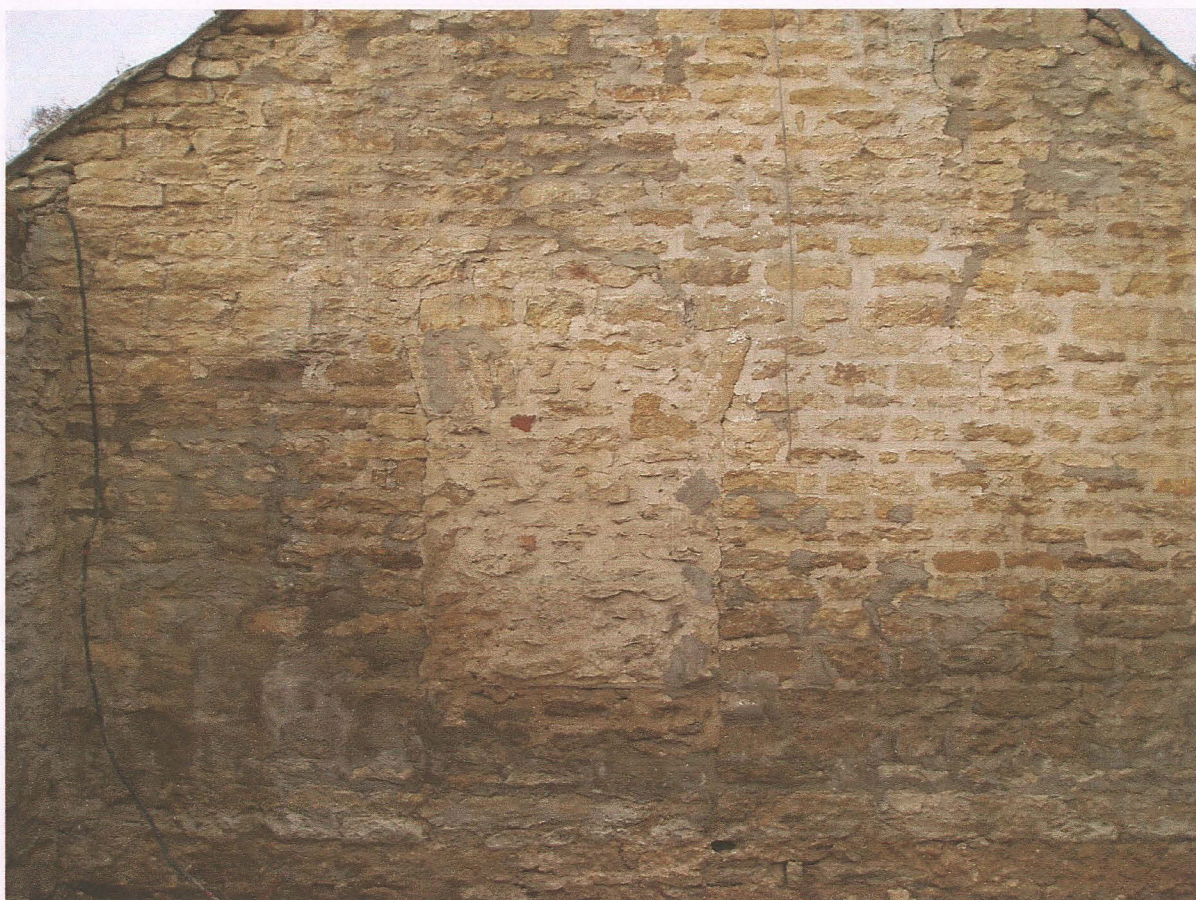
Pl. 17 Detail of the internal elevation of the north wall with the upper detail of the window / doorway.

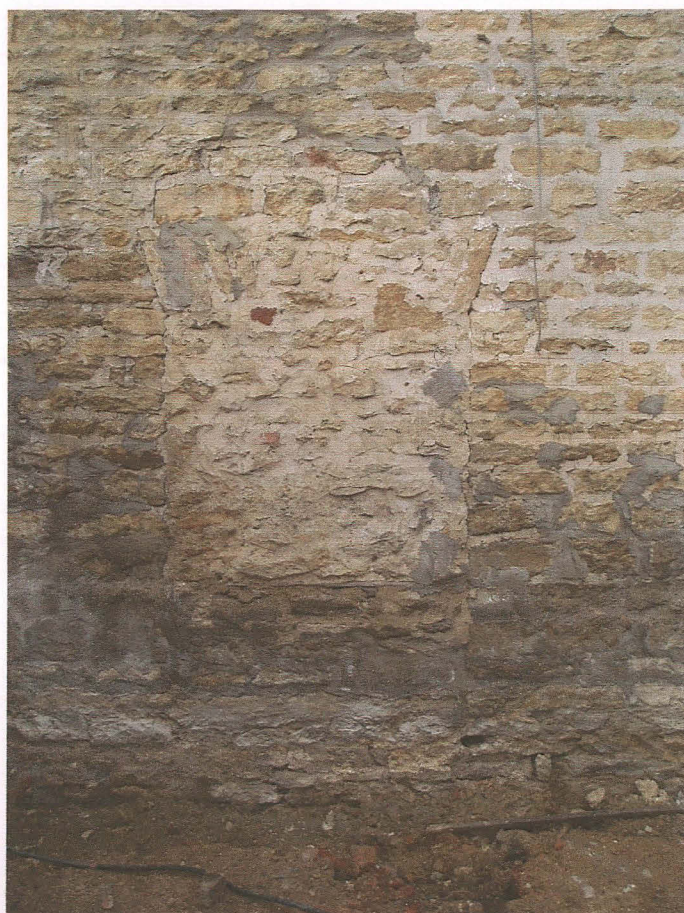
Pl. 18 Detail of the internal elevation of the north wall with the upper detail of the window / doorway.

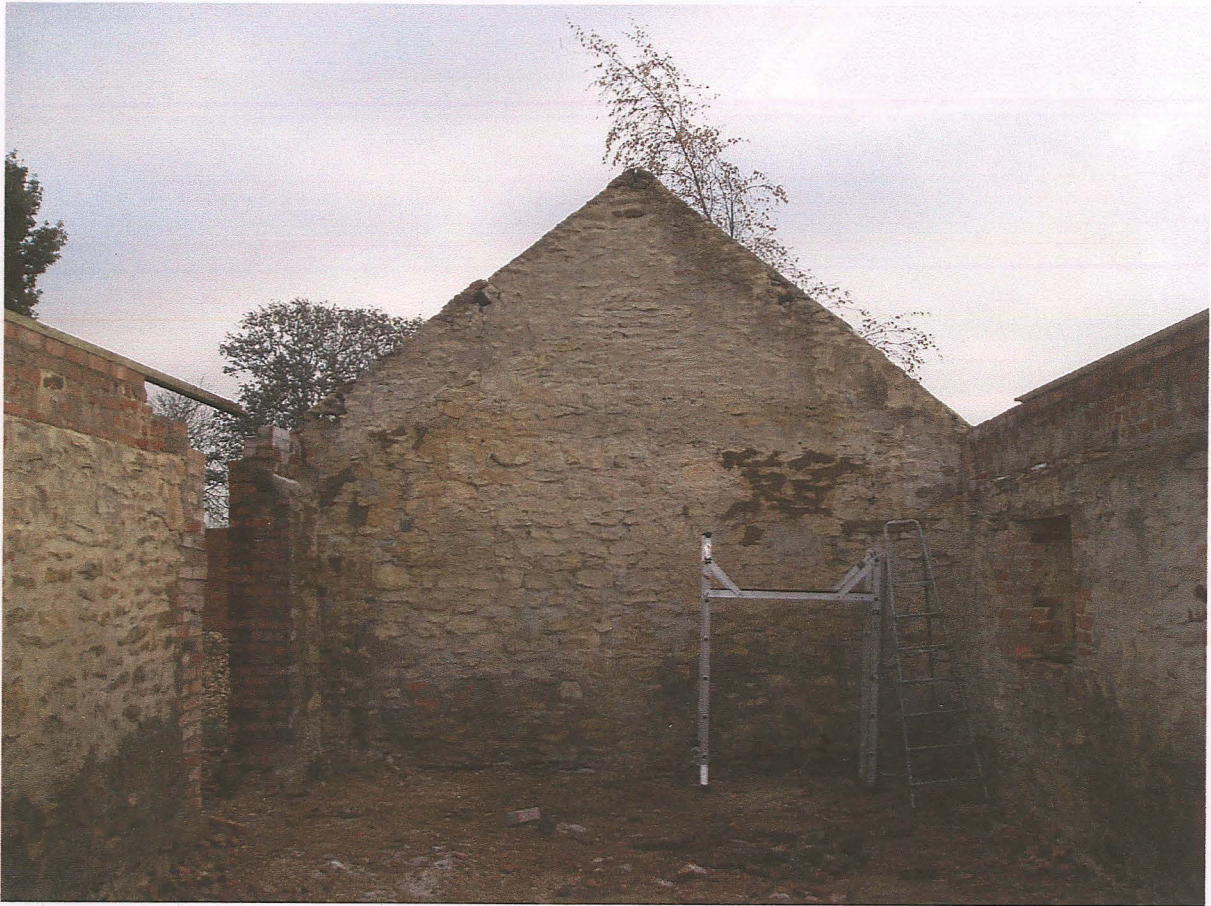
The internal elevation confirms the raising of the gable-end seen on the opposite gable. A timber lintel spans the south-west angle to support the angled corner seen on the outside of the wall.

Pl. 19 The internal elevation of the south wall.

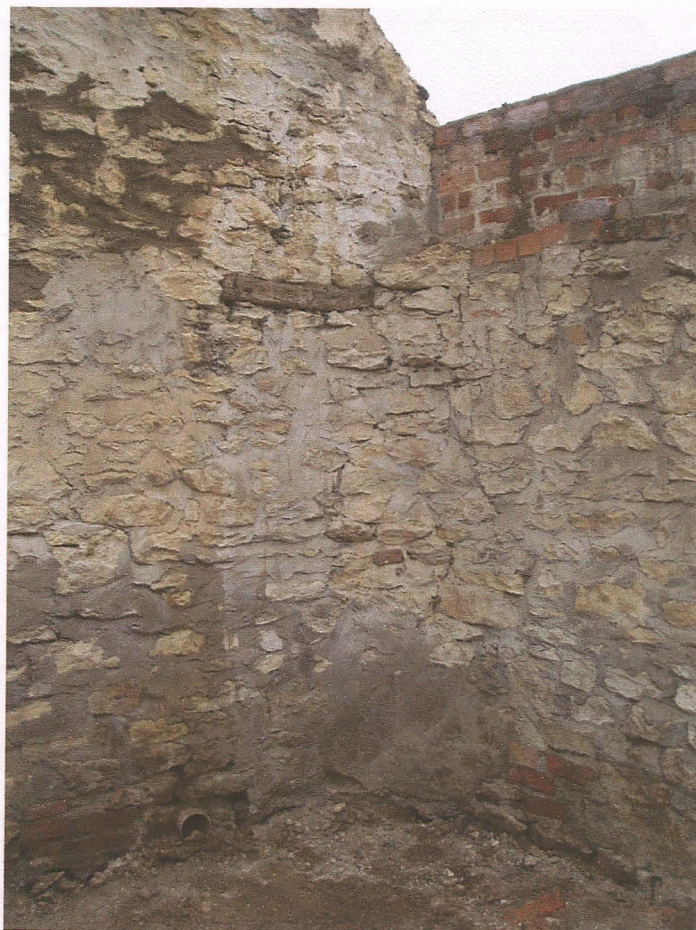
Pl. 20 Internal detail of the re-built south-west corner, with wooden lintel over.

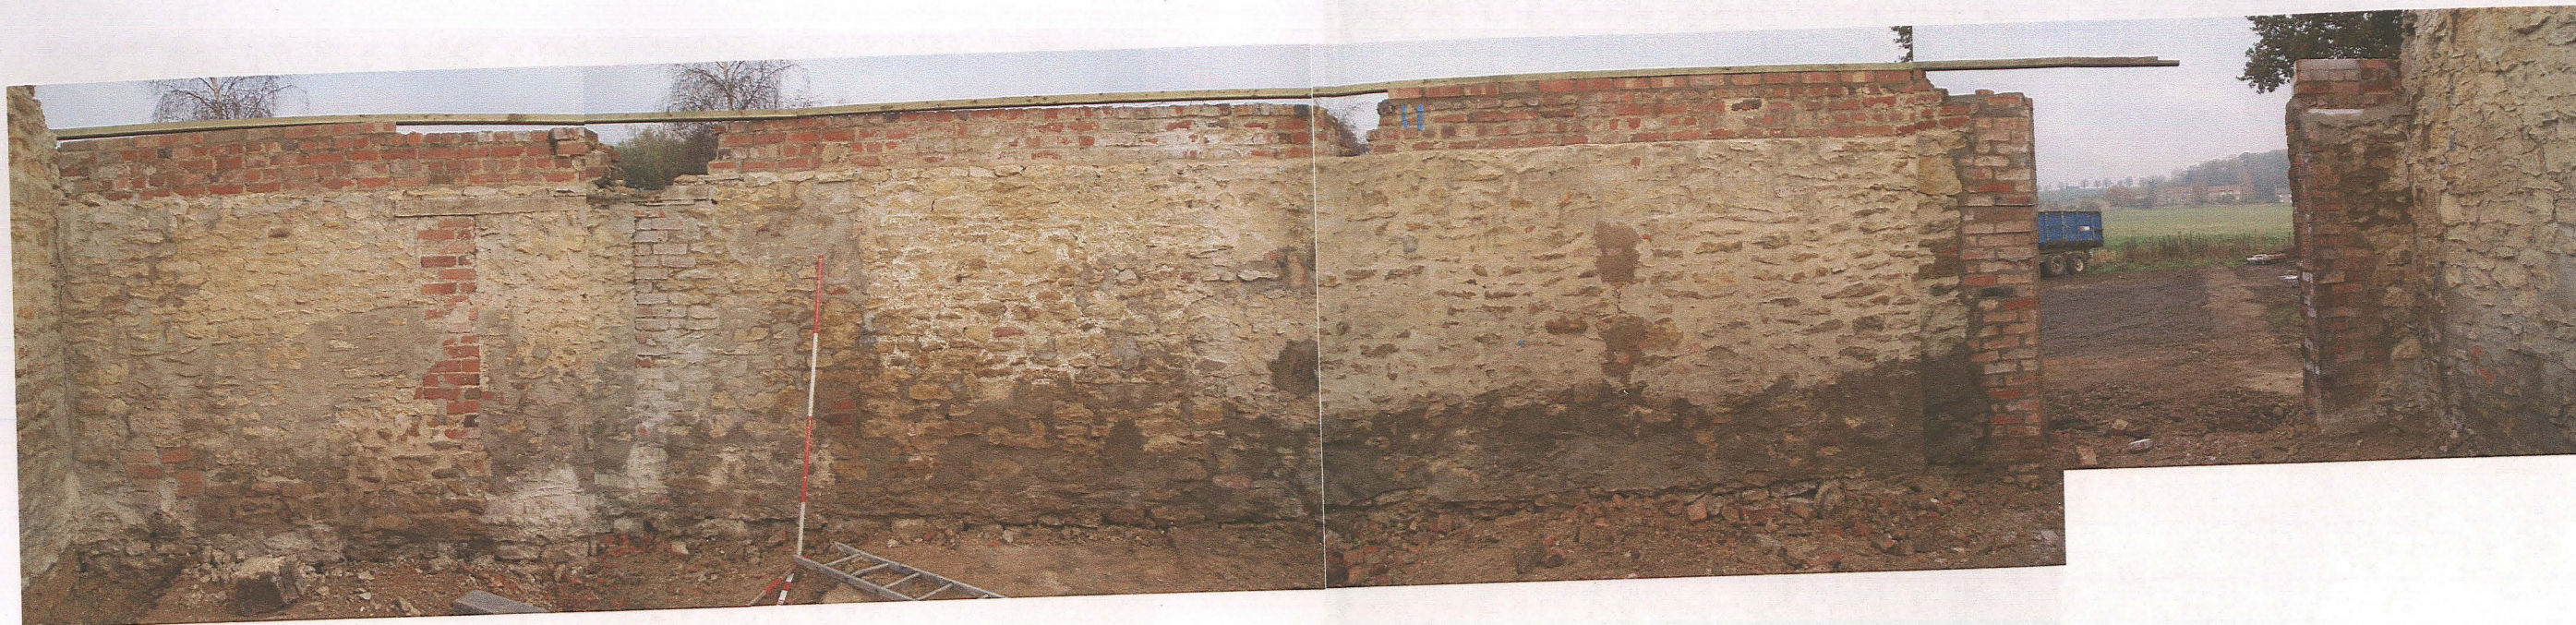
The openings recorded on external face are present internally although the entrance at the south end has been finished using standard bricks internally.

The blocked entrance towards the north end of the east wall had brick jambs added when it was inserted and a very considerable section of the wall had to be re-built for this insertion. The later blocking of this entrance left the timber lintels intact.

Pl. 21 Composite view of the east wall internal elevation.
