**Hall Farm, Harpswell, Lincs.  
Archaeological Watching Brief**

**Report For  
Mr and Mrs M. Tatam**

**LAS Report No: 905**

**March 2006**

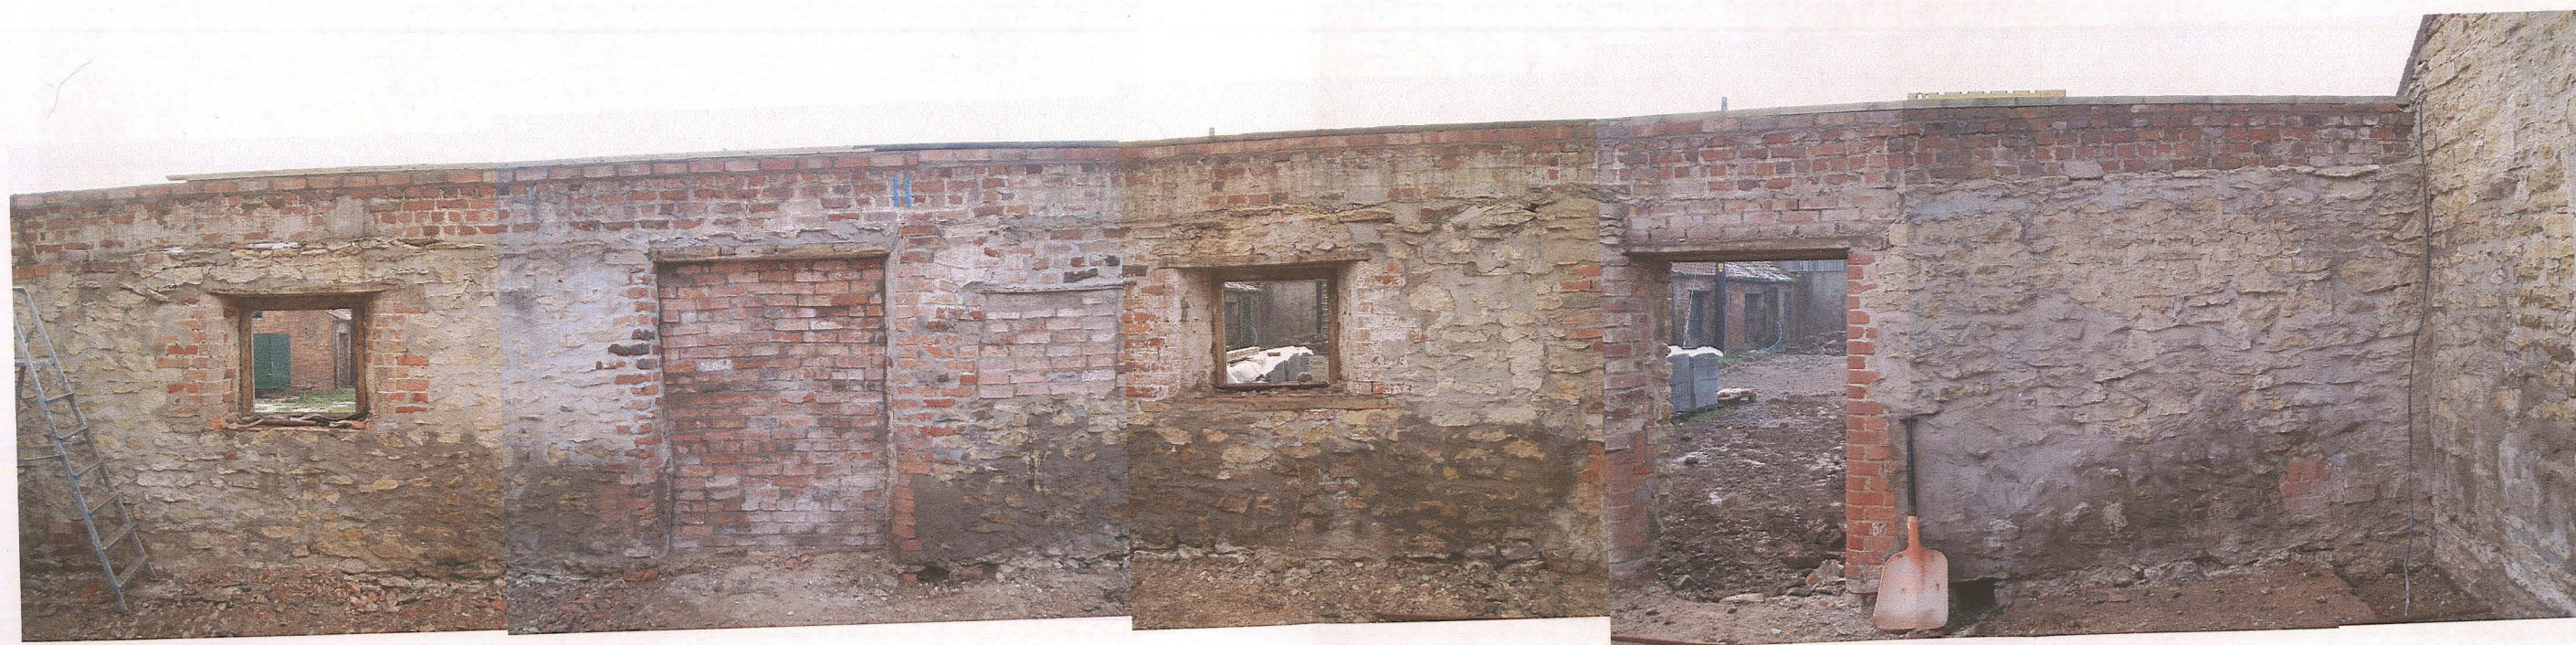
The two cottage-style windows have bull-nosed internal jambs which are splayed. This maximises the available light from these rather small windows. Both windows have a timber lintel over them. A central doorway with timber lintel over has bull-nosed brick jambs and was blocked only on the outside face leaving a rebate in the internal face. A blocked window which was not seen on the external elevation can clearly be seen between the blocked doorway and the northern most of the two cottage windows. This window has a very thin lintel over and is blocked with bricks.

Pl. 22 Composite view of the west wall internal elevation.

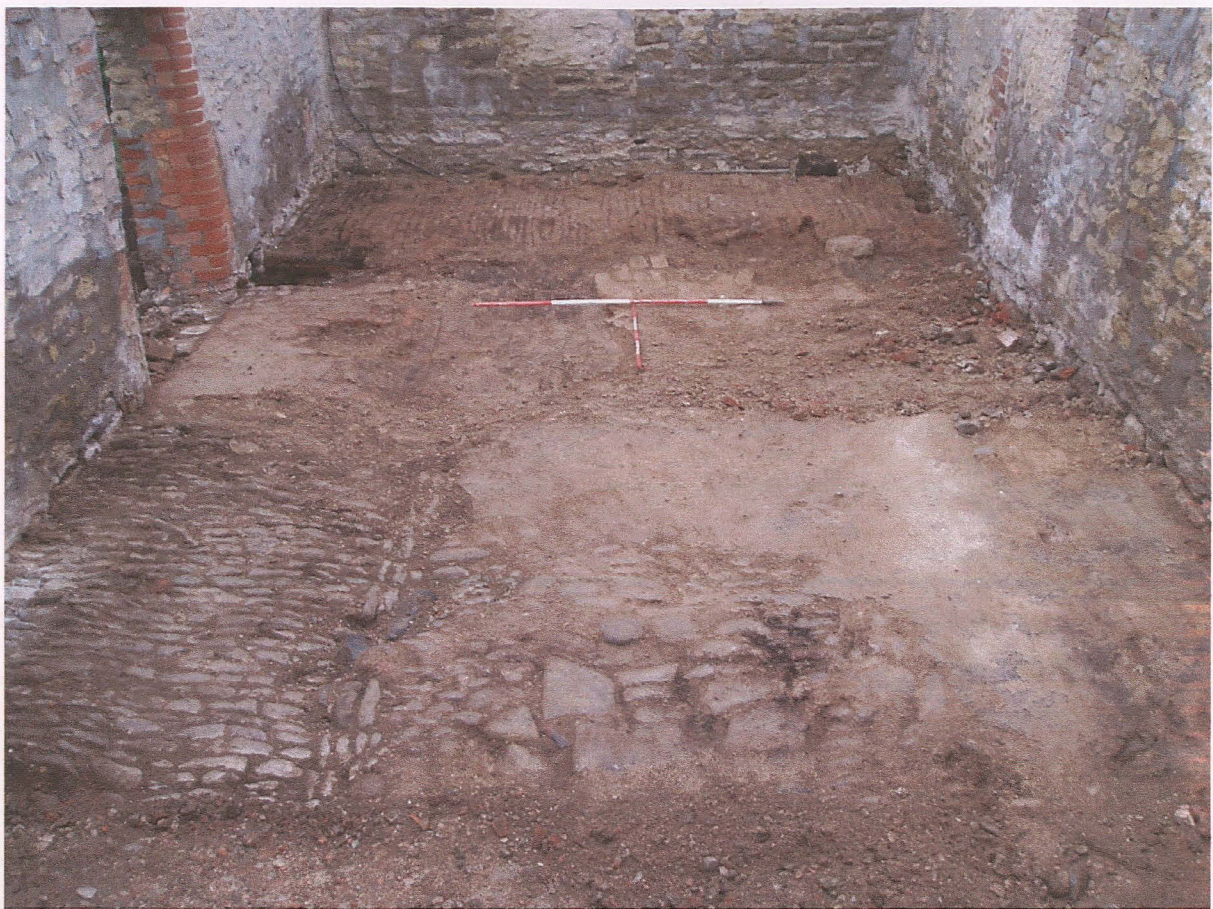
The stable had a variety of different floor surfaces. At the north end a small area of similar size to a single stall was seen with a surface comprising of re-used flooring bricks laid on edge. The surface sloped from the north towards a drain approximately 2.5m from the north wall and running east/west to a hole through the west wall. The drain was edged with timber and had been partly back-filled with bricks and had a large Yorkstone slab cover possibly still *in situ*.

Pl. 23 The surfaces at the north end of the stable, with the limestone cobbling in the foreground. Scales 2m and 1m.

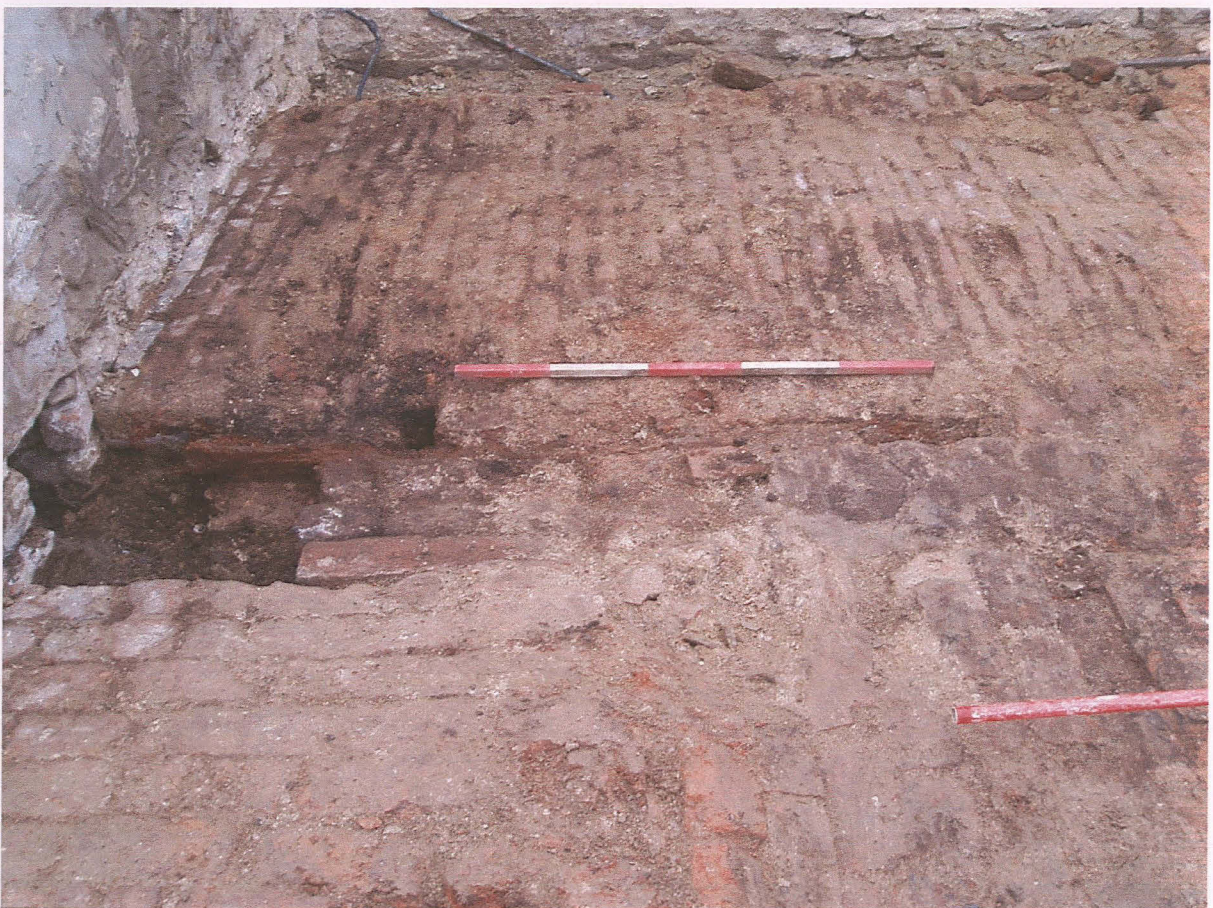
Pl. 24 Partially excavated internal drain with the timber edging and the later filling and levelling. Scale 1m.

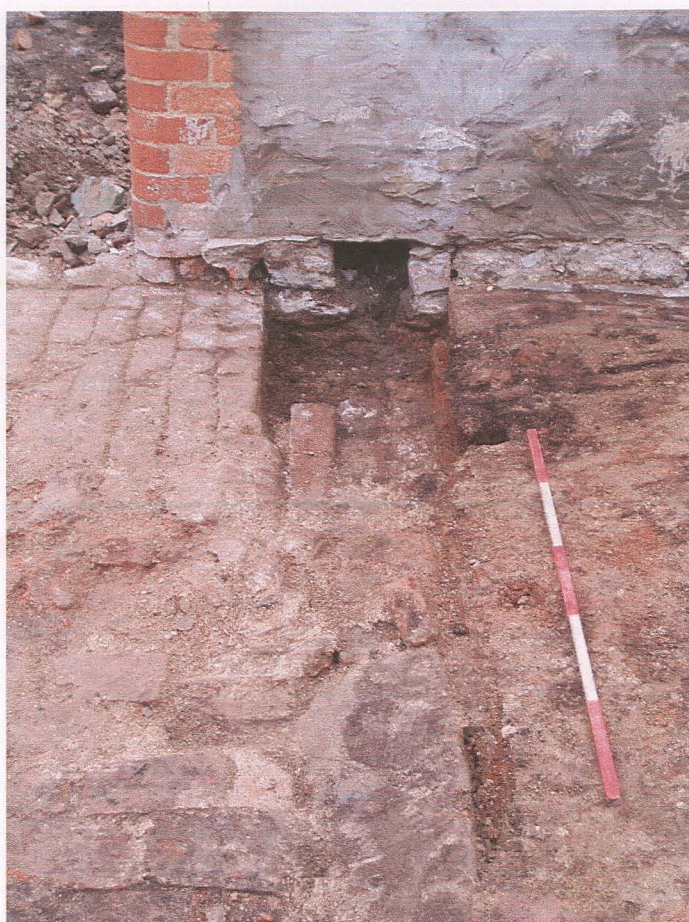
Pl. 25 Detail of the internal drain. View from the east.

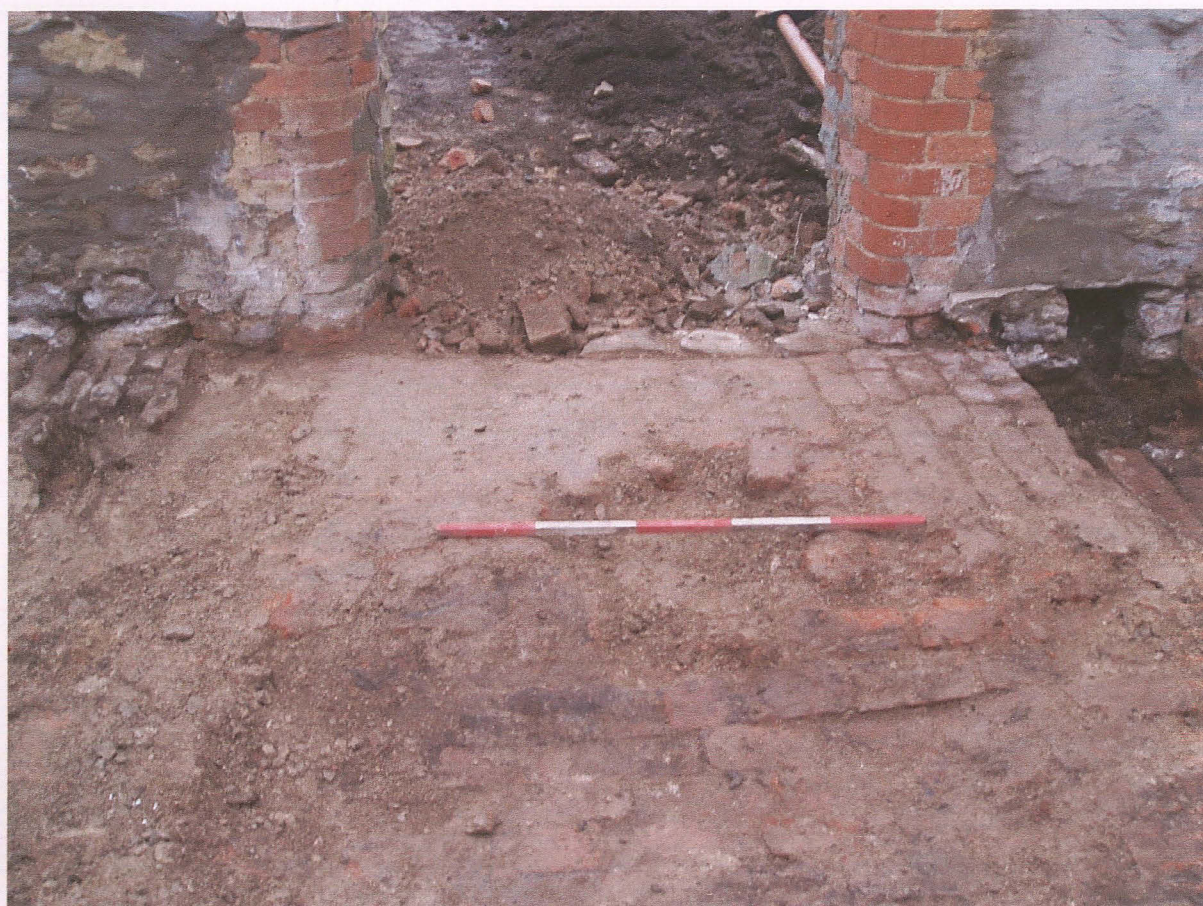
A brick threshold was constructed probably at the time of the insertion of the brick-lined entrance at the northern end of west wall. This was made up of bricks laid flat to form a rectangle with a brick surround. Although these bricks are of a different size to the flooring bricks used in the north end, they are of very similar date and the threshold was probably laid as part of that same refurbishment.

Pl. 26 The brick pad inside the west entrance.

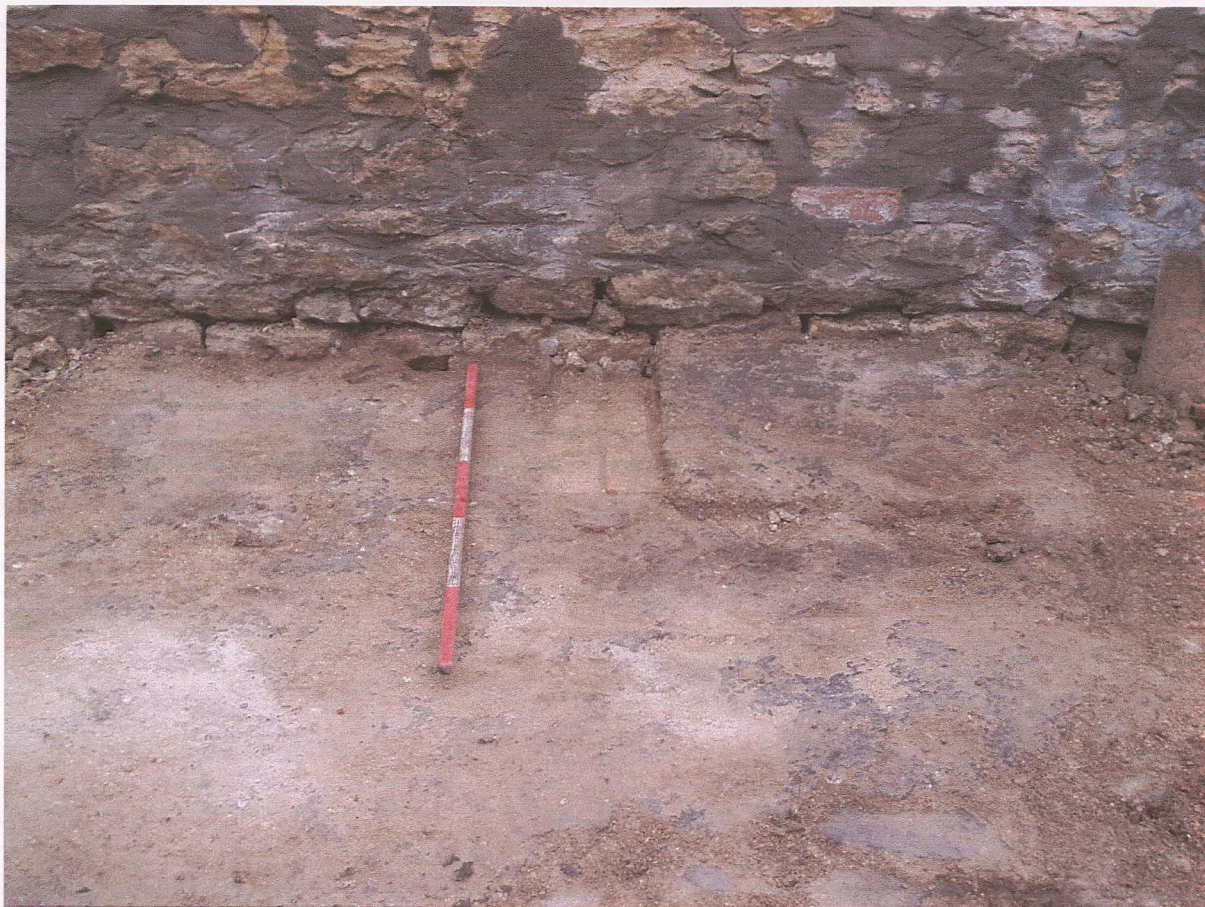
The remainder of the stable floor consists of limestone fragments laid on edge in a bed of soil. These stones, particularly when worn, created a cobbled surface which in much of the stable was at least partly screeded at a later date. Three rows of these limestone fragments have been laid along the length of the building approximately 1.3m from the west wall. By laying the remainder of the floor with the cobbles running in the opposite direction and sloping slightly down towards the central runs of cobbles, they created a crude open drain along the length of the stable and towards the timber edged drain at the northern end of the building.

Pl. 27 The concrete screed over the limestone cobbles with the foundation of the brick partition against the east wall

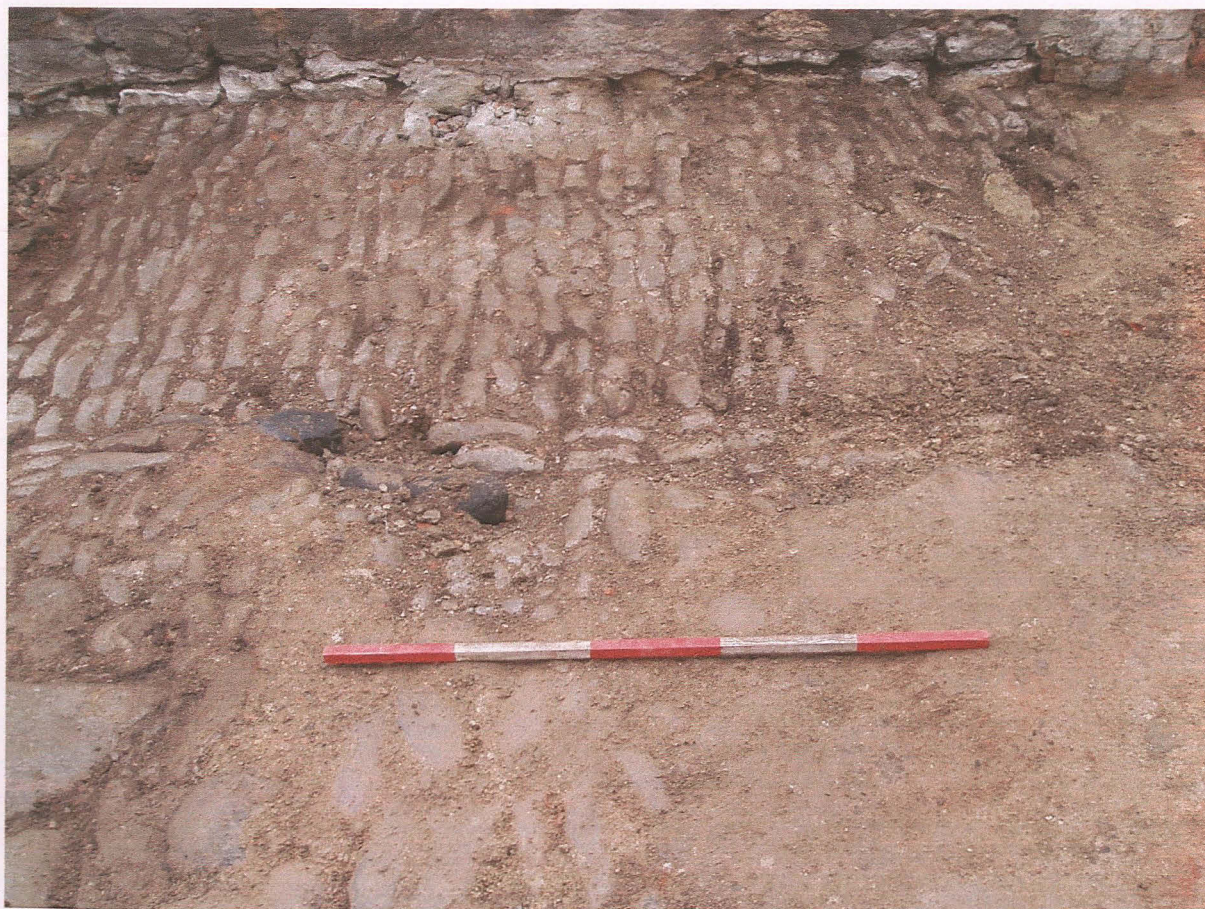
Pl. 28 the area of limestone cobbles to the south of the west entrance with detail of the cobbles used to form a central drain.
