**St. Martin's Church, Waithe, Lincs.
Archaeological Watching Brief**

**Report for
Lee Holmes Architectural & Design Consultancy
(on behalf of the Churches Conservation Trust)**

LAS Report No. 987

May 2007

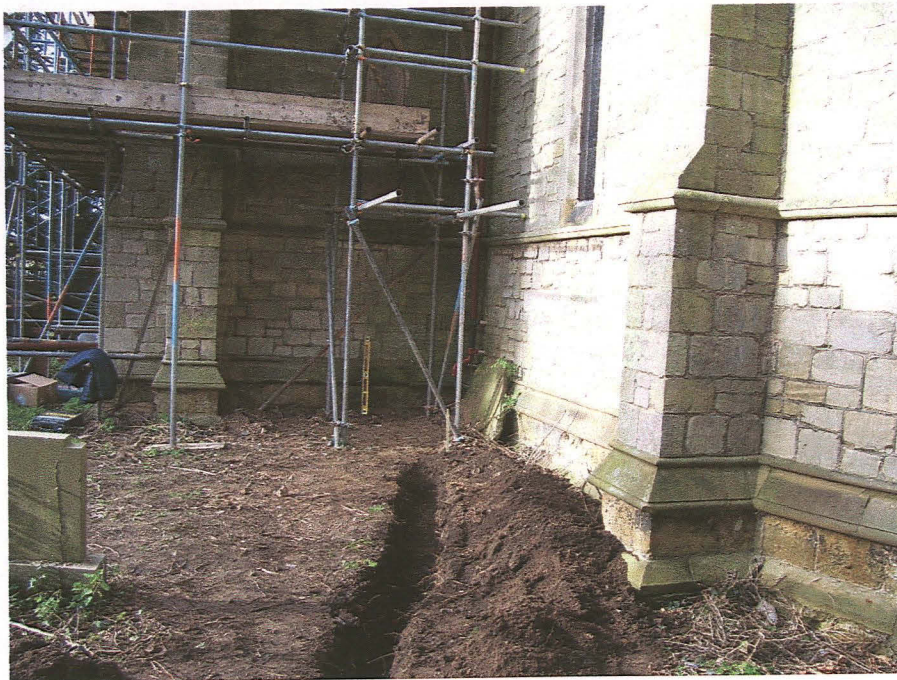
Pl. 2 Western end of the new drain trench to the south of the chancel (looking west).

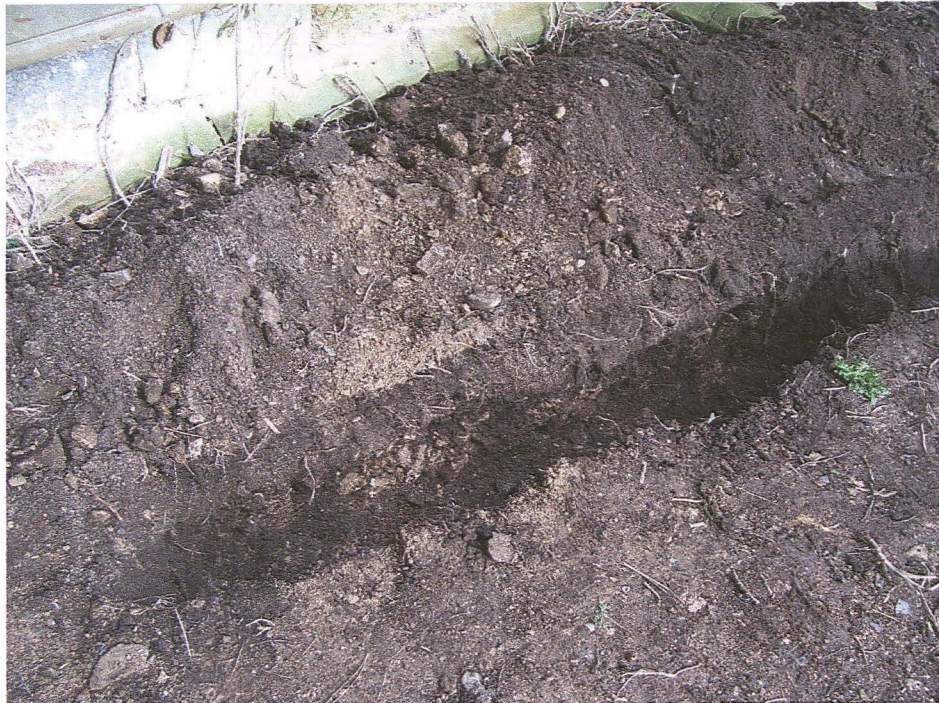
Within about 1m of the chancel wall, the drain trench encountered a 0.17m thick spread of mortar and limestone chips **2** below the topsoil. This was interpreted as construction or repair debris, almost certainly associated with the 1860 chancel. This layer covered a loose dark brown loam with red clay inclusions **3**, which probably represents the backfill of one or more graves.

Pl. 3 Limestone chips and mortar debris in the new drain trench south of the chancel (looking north).

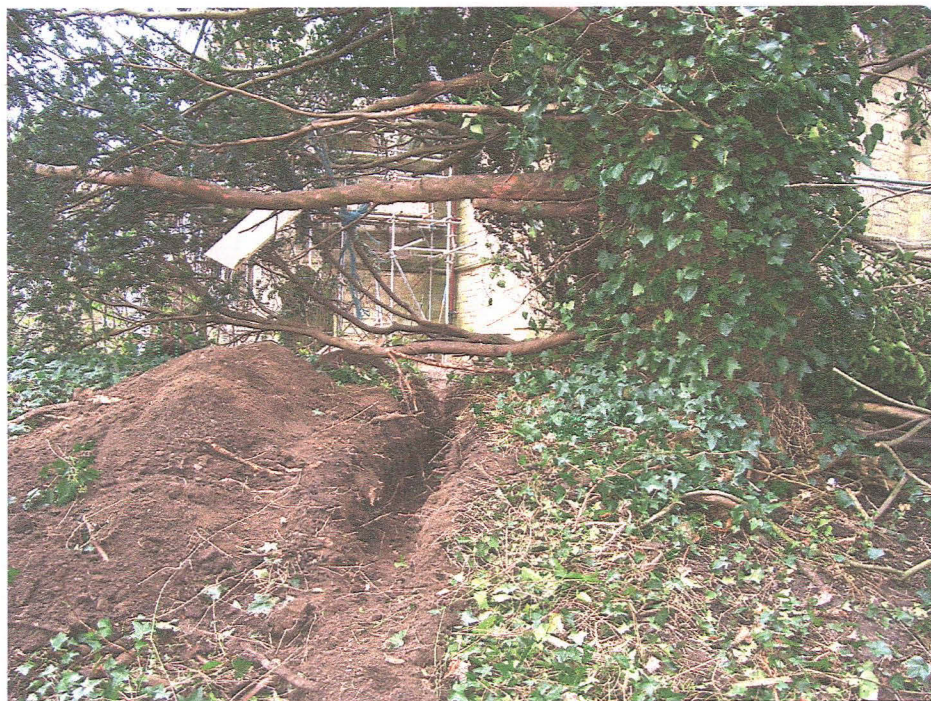
About 5m east of the tower, the trench cut into a light brown clay loam **4**. This was also assumed to be mixed grave fill. The clay content of the layer became less noticeable further east, but this may have been affected by differing moisture levels near the tree roots on the slope.

Pl. 4 Eastern end of the new drain trench to the south of the chancel (looking west).

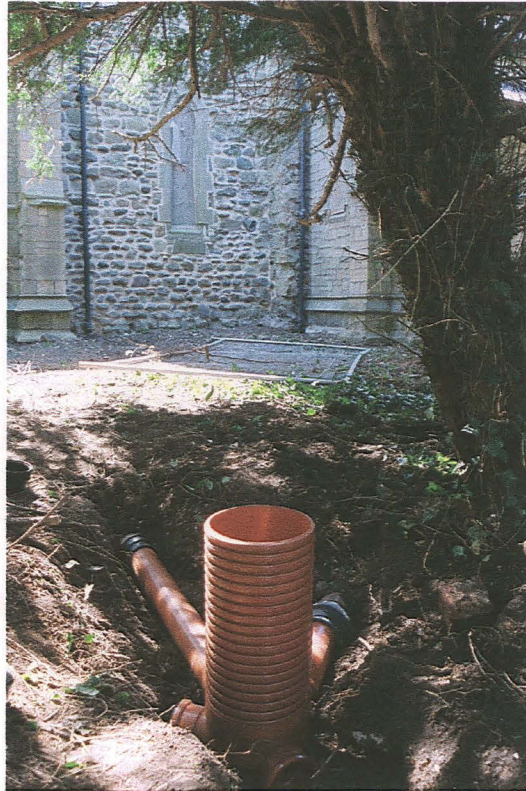
This trench located an existing glazed drain serving a rainwater pipe at the north-western corner of the tower, and joining the drain from the chancel.

PI. 5 New drain junction north of the tower (looking south, showing rainwater pipes beside the tower).

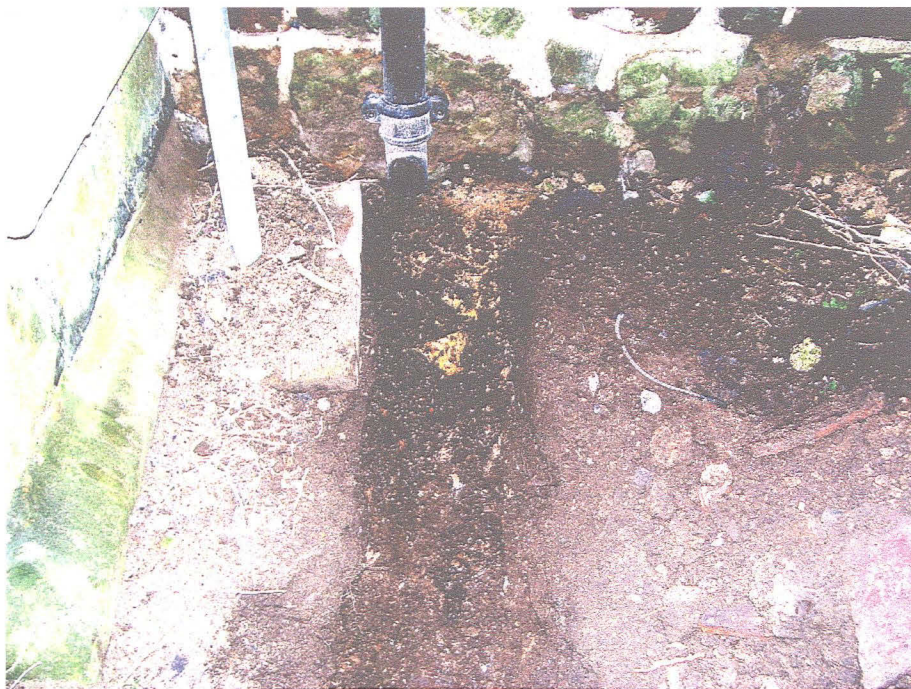
A 0.3m wide and 0.25m deep trench was excavated to the north of the tower, positioned beside the buttress at the end of the chancel. Under the thin topsoil, the trench revealed a 1.3m wide spread of loose roof tiles and mortar **6** adjacent to the buttress; these are fifteenth to eighteenth century in date and are assumed to derive from demolition of the previous chancel (Appendix 2). The layer covered the tower's 0.2m wide offset foundation **7** of ironstone rubble.

PI 6. Ironstone rubble foundation at the base of the tower, looking south.

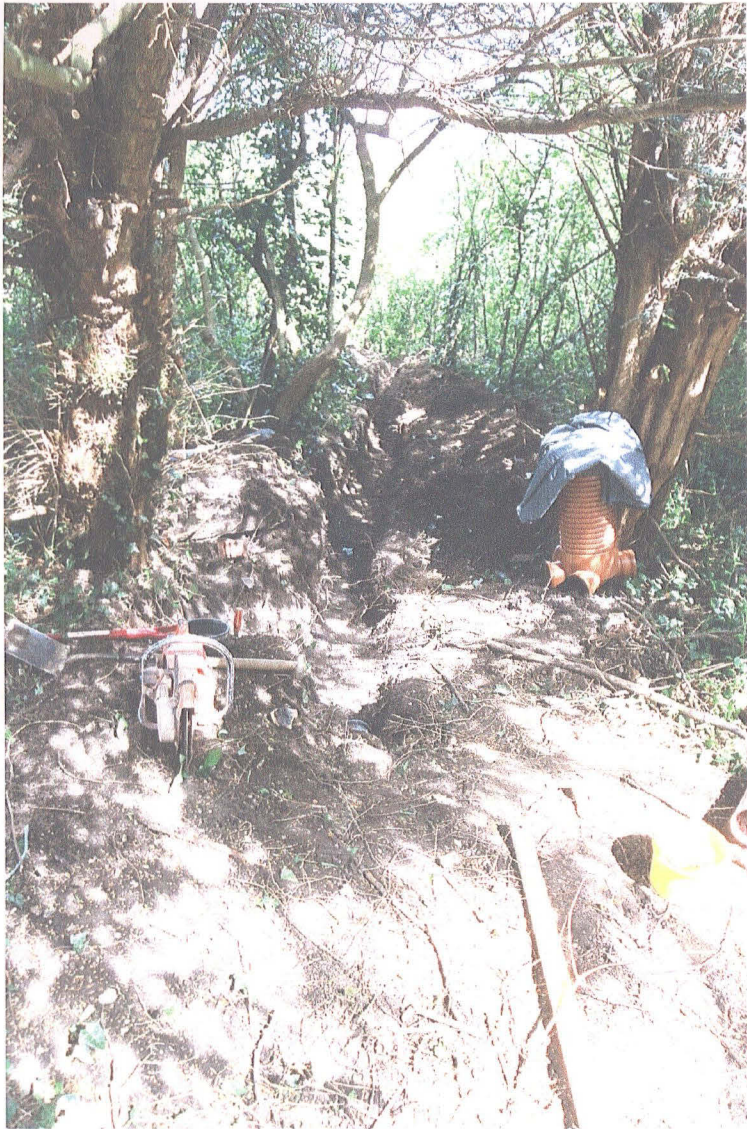
The existing drain was located, and then cut at intervals to permit thorough cleaning and connection with drains from the tower and nave. It was then extended northwards through an area of bushes and saplings to the drain along the northern boundary of the churchyard. No trace of any boundary feature or upcast bank was identified.

PI. 7 Course of the new drain trench leading to the northern churchyard boundary ditch (looking north).

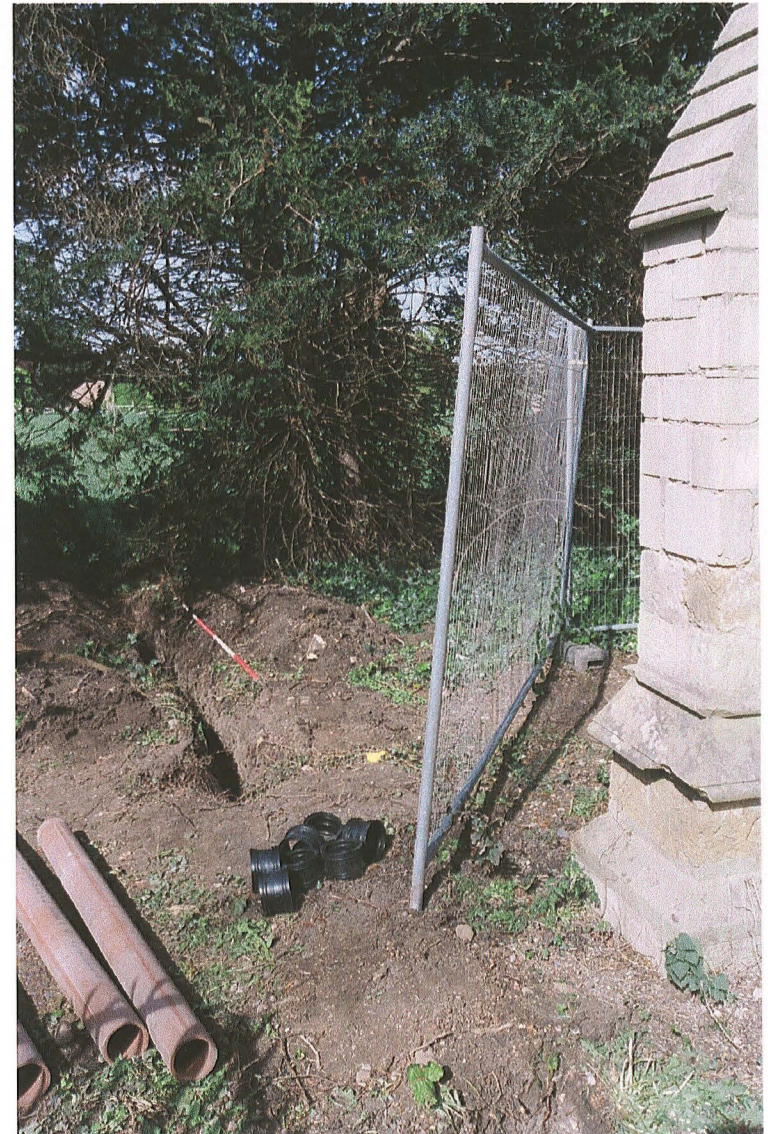
A 0.25m wide trench was excavated 0.5m deep across the churchyard to the west of the southern side of the nave, for a distance of 7m to the western boundary wall. It re-used the line of an existing drain, which passed through a culvert in the wall, to issue into the edge of the adjoining field. The topsoil **1** in this area was 0.18m thick, above a light brown loam **8**.

PI 8. Drain trench extending from south of the nave to the western churchyard boundary (looking west).
