## **MANOR FARM HIGH STREET MARTON**

(Accession No. 150.94)

### **Archaeological Watching Brief**

**S.P. GELDER BUILDERS**

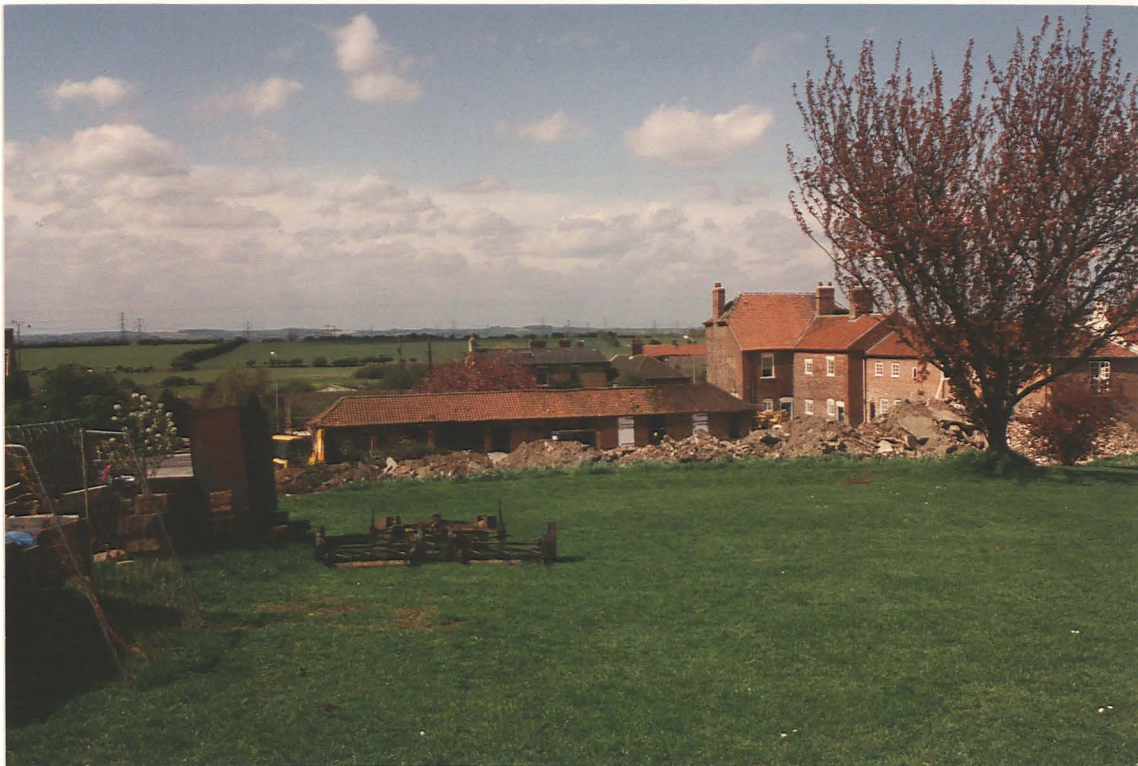
The development site covered an area of c.0.35ha with the Inn and coachhouse along the northern boundary formed by Tillbridge Lane and stable block to the west, parallel to Main Street (Pl. 1). The whole plot, together with land to the east lies below the present level of Tillbridge Lane (Pl. 2). The land drops in level by c.2.9m from east to west and by 1.3-1.5m from north to south.

Pl. 1 General view of development site, view west

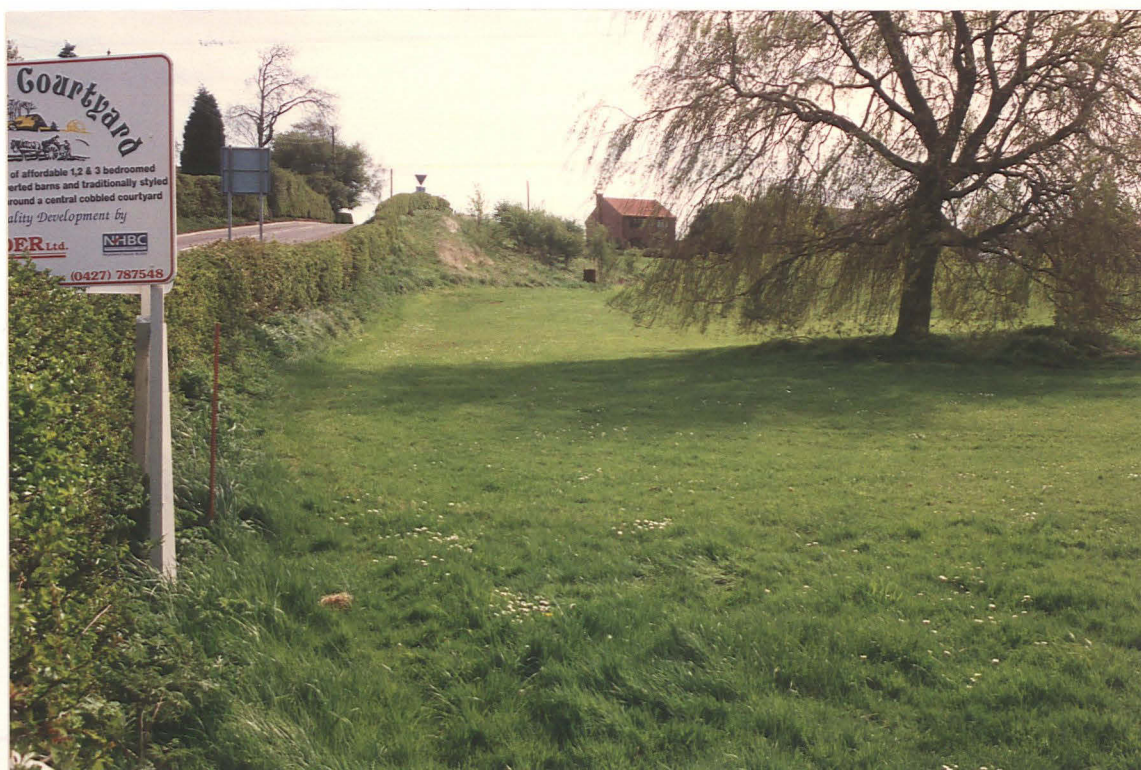
Land adjacent to the Tillbridge Lane, overlooking the development area did not follow the steep gradient of the road (Pl. 2). There appeared to be two flattish terraces, one above the site to the east and one on which the new housing was being constructed. The land was probably levelled and filled, creating two flattish terraces, perhaps when the 18th century complex was constructed. Terracing in the past would have removed any archaeological remains which may have been present, and would account for the lack of subsoil in the areas observed, and the absence of archaeological remains.

Pl. 2 Area east of development looking east along Tillbridge Lane showing difference in ground levels

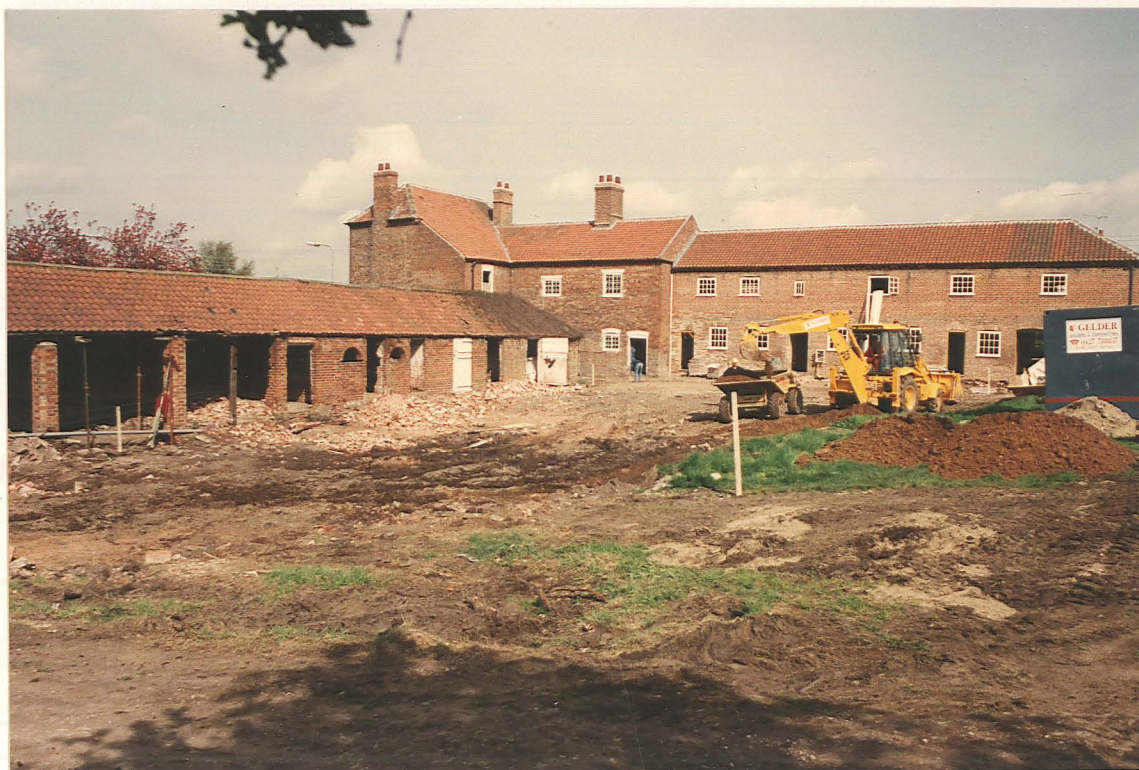
The main purpose of the Watching Brief was to monitor groundworks in the courtyard area of the development. This area was formerly occupied by garages, with concrete bases built after the Second World War and demolished prior to the site visit in April 1994 (Pl. 3). A dark wet area of ground at the south end of the courtyard marked the position of an old soakaway (Pl. 4). This area was to be paved and no further monitoring was carried out.

Pl. 3 Ground clearance of courtyard area of development, view north

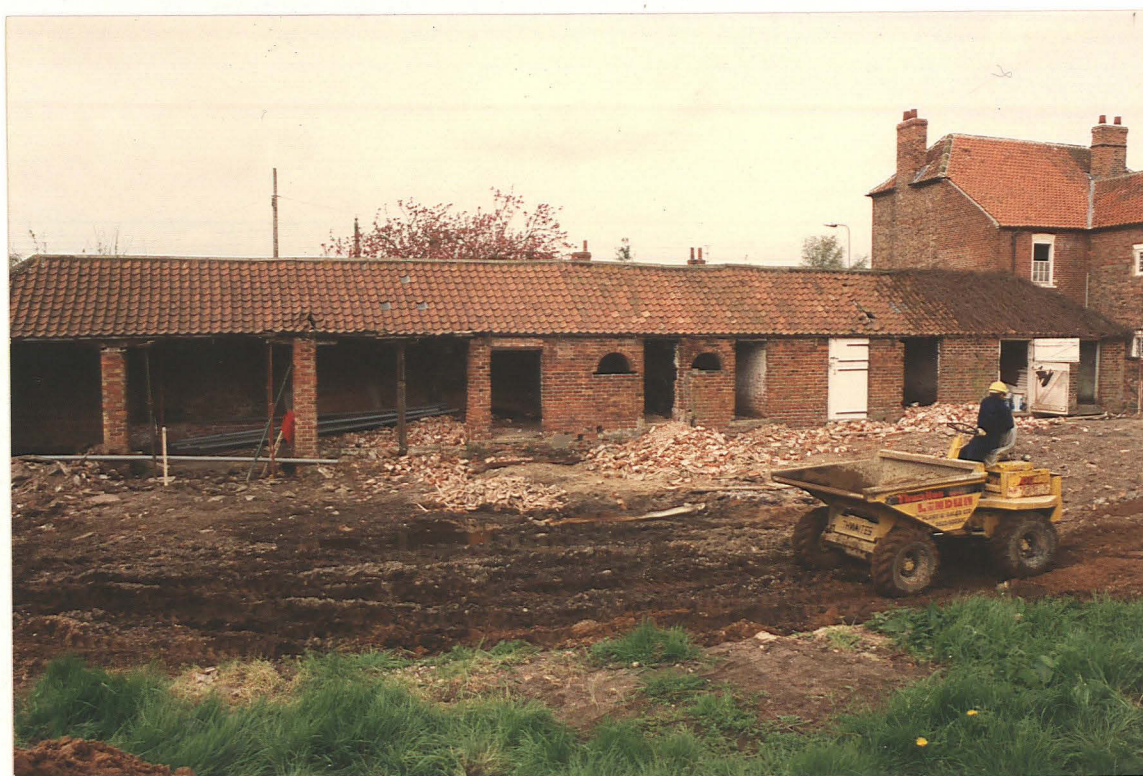
Pl. 4 Ground clearance of courtyard showing dark area of old soakaway. Stables behind

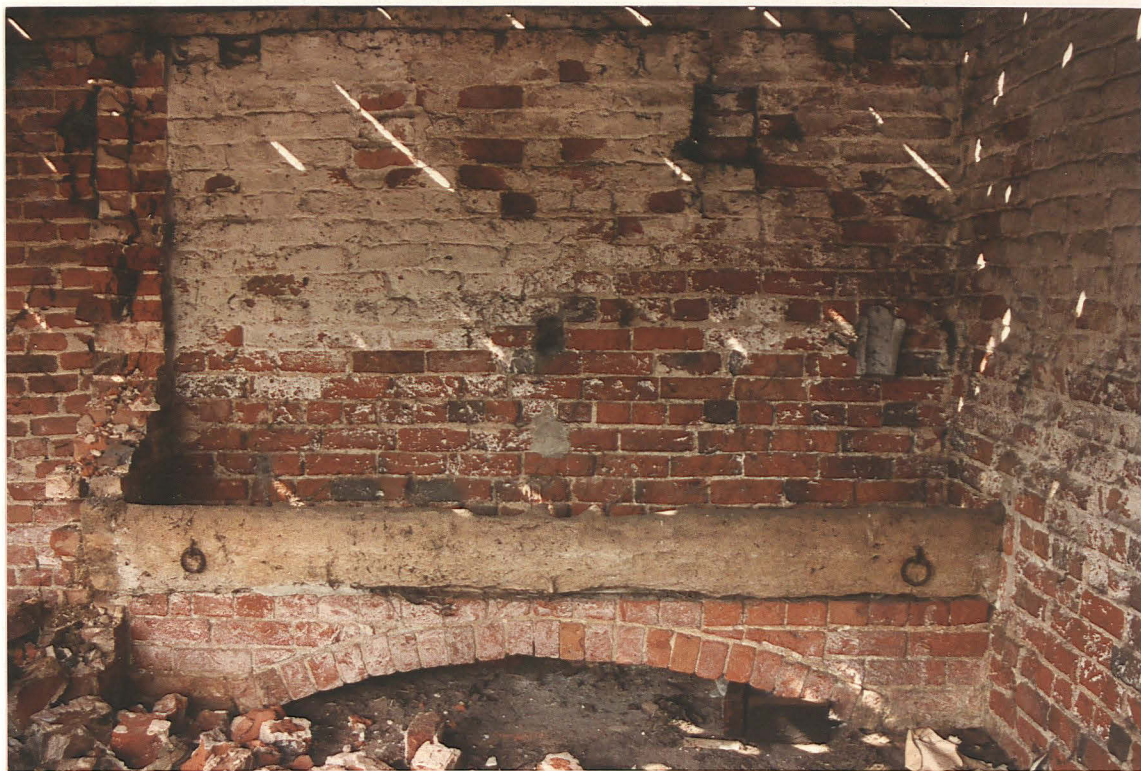
The stables on the west side of the development were in a poor state of repair. The brickwork appeared to be 18th century in date and contained some overfired headers. A trough in the southern half of the block was photographed (Pl. 5).

Pl. 5 Trough inside stable block

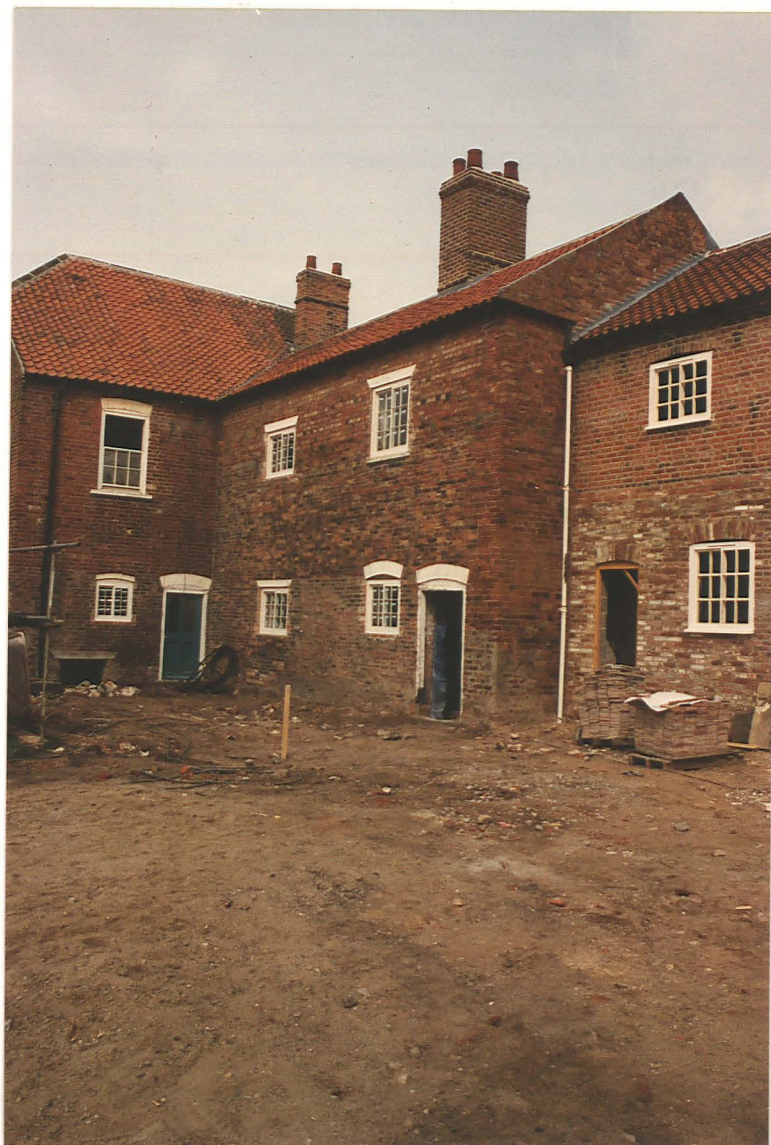
Ground to the north and north-east of the soakaway was levelled in advance of building works. Prior to levelling the ground at the north end of the courtyard appeared to have a dark soil feature running across it (Pl. 6). On excavation this was shown to be the line of a modern drain (Pl. 8). The rest of the cleaned area comprised clean orange-brown sand, which was interpreted as a natural deposit.

Pl. 6 North end of site prior to levelling

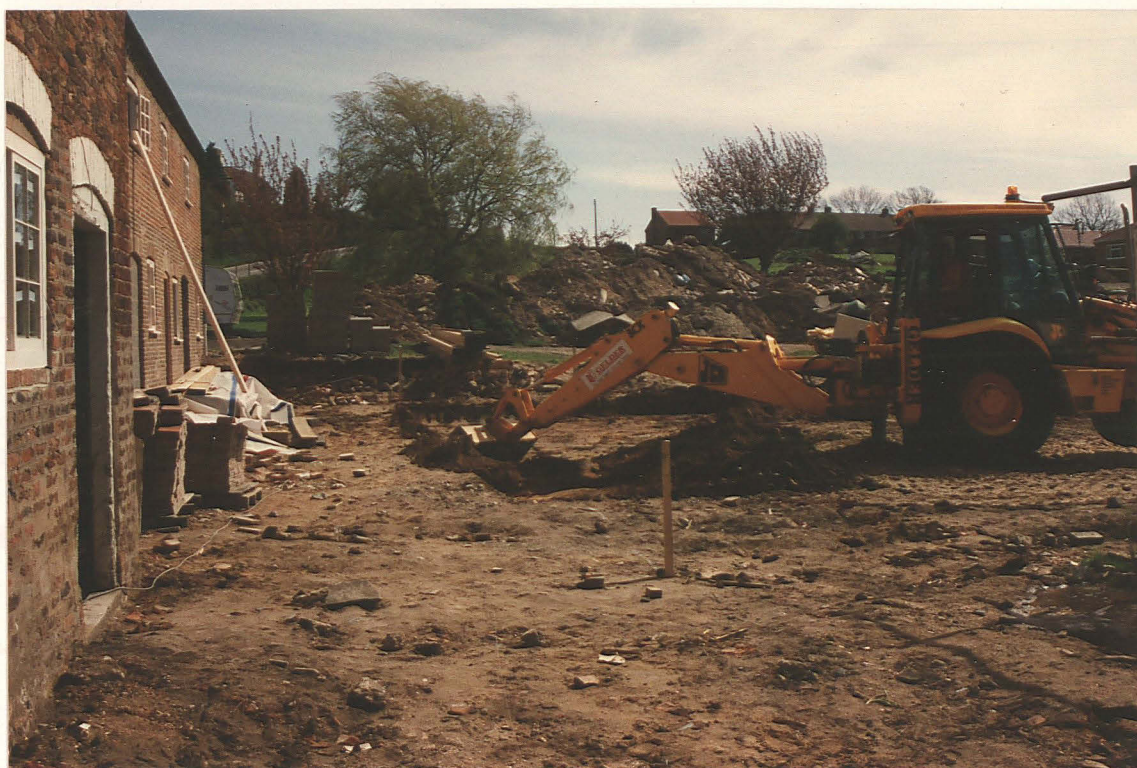
Pl. 7 Levelling of ground for house plot no. 5

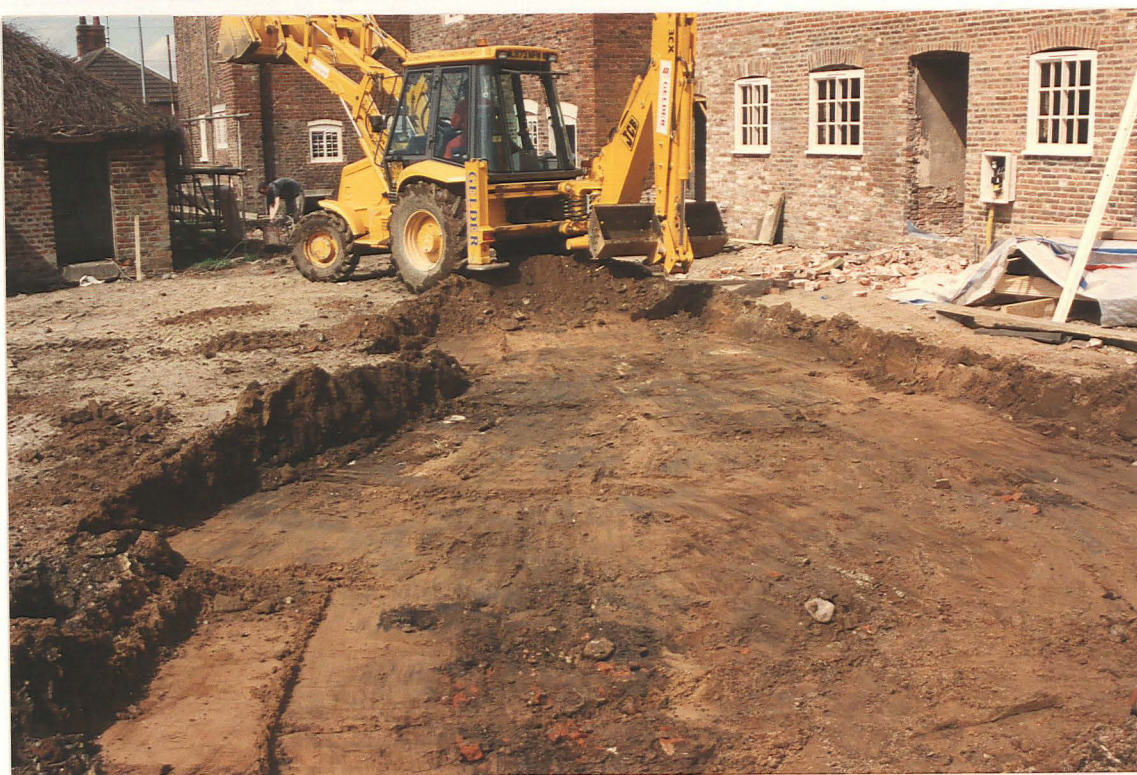
Pl. 8 Levelling showing natural sand cut through by modern drain

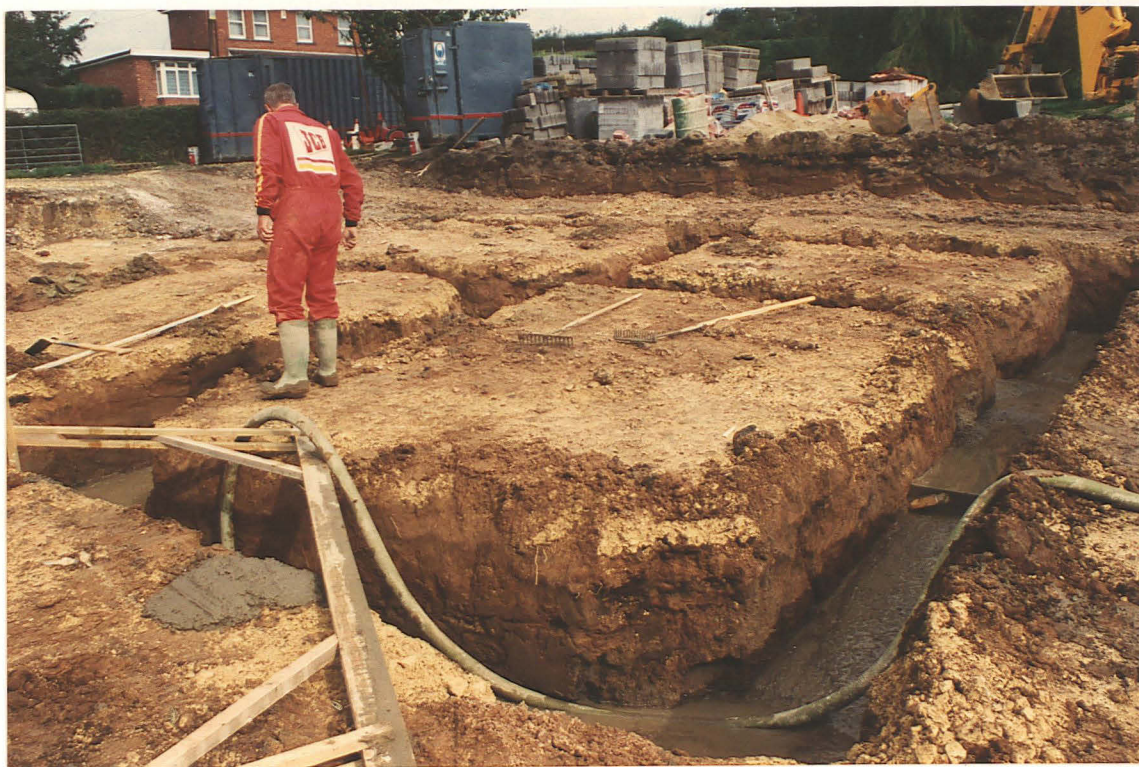
A second visit was made to the site in September 1994 when foundations for the new houses on the east side of the courtyard were being dug. This confirmed that the clean orange brown sand was natural and overlay deposits of red and grey clay (Pls. 9 and 10). By this time restoration of the coach house, the Inn and the stable block had been substantially completed and record photographs were taken of some of the features (Pls. 11-16).

Pl. 9 Foundation trenches for houses 5 and 6 showing natural wind blown sand overlying Mercia Mudstone, view NW.

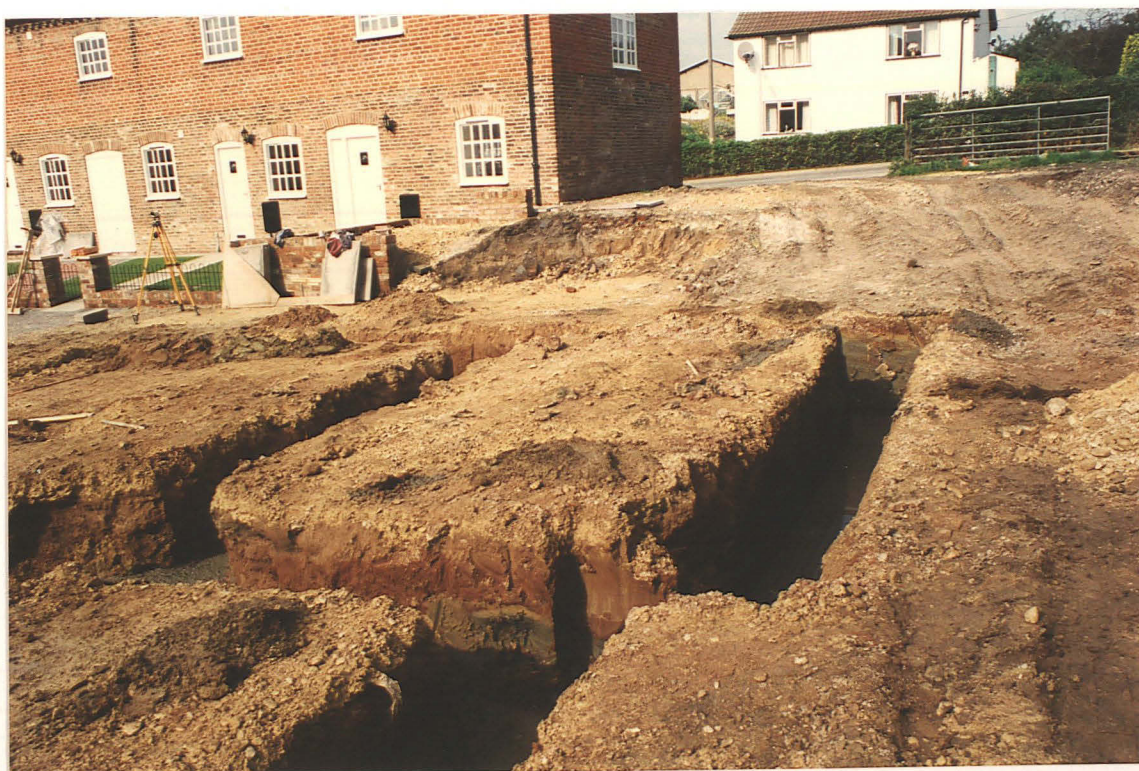
Pl. 10 Foundation trenches for houses 5 and 6 showing natural wind blown sand overlying Mercia Mudstone, view north.

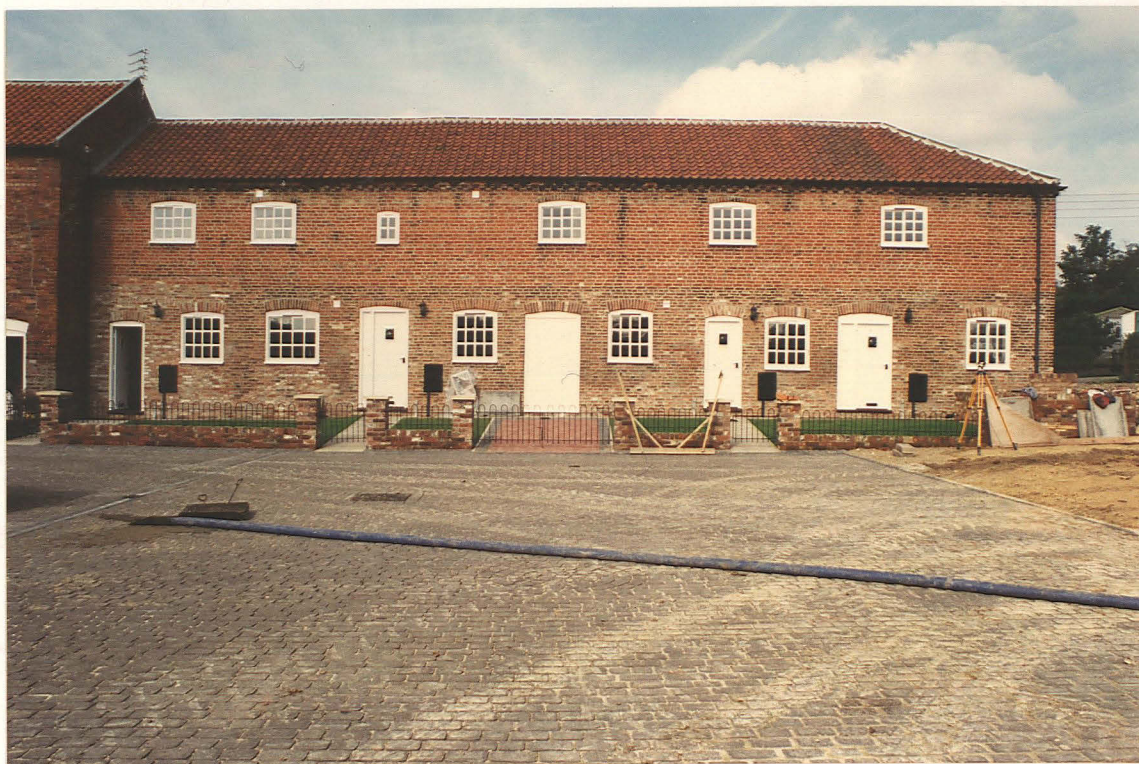
Pl. 11 Courtyard and house units 1-4 after completion of restoration

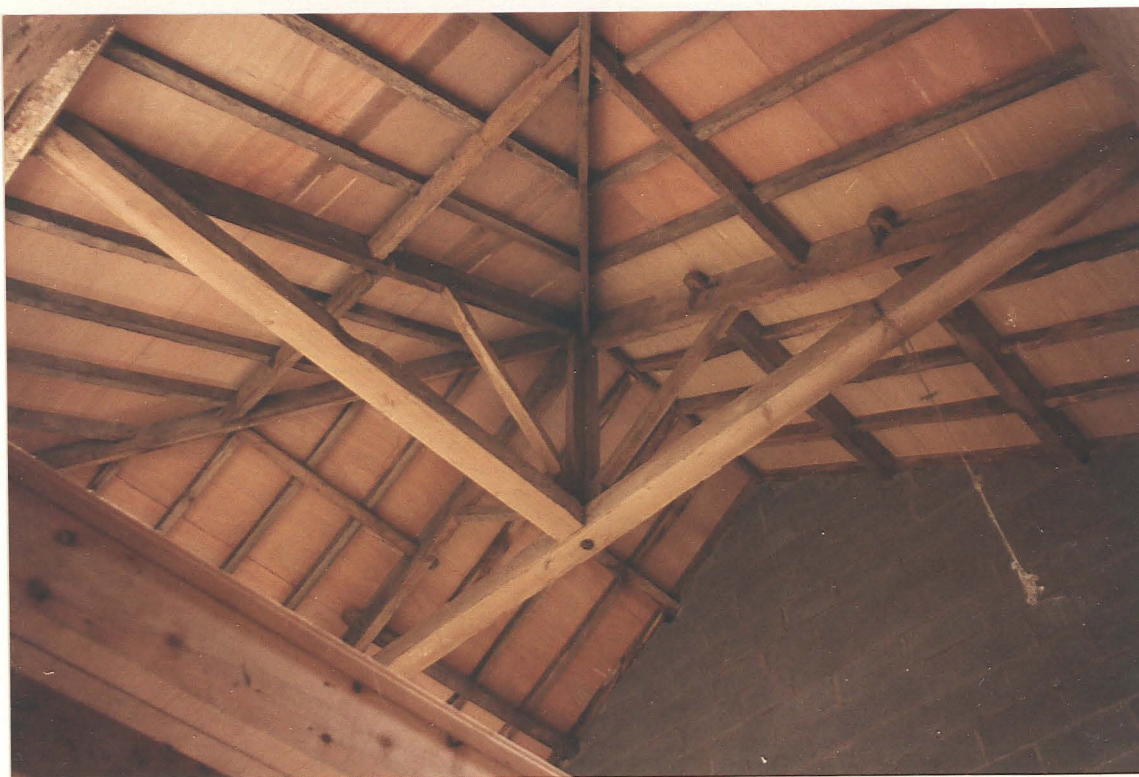
Pl. 12 Roof construction in Unit 4, view south

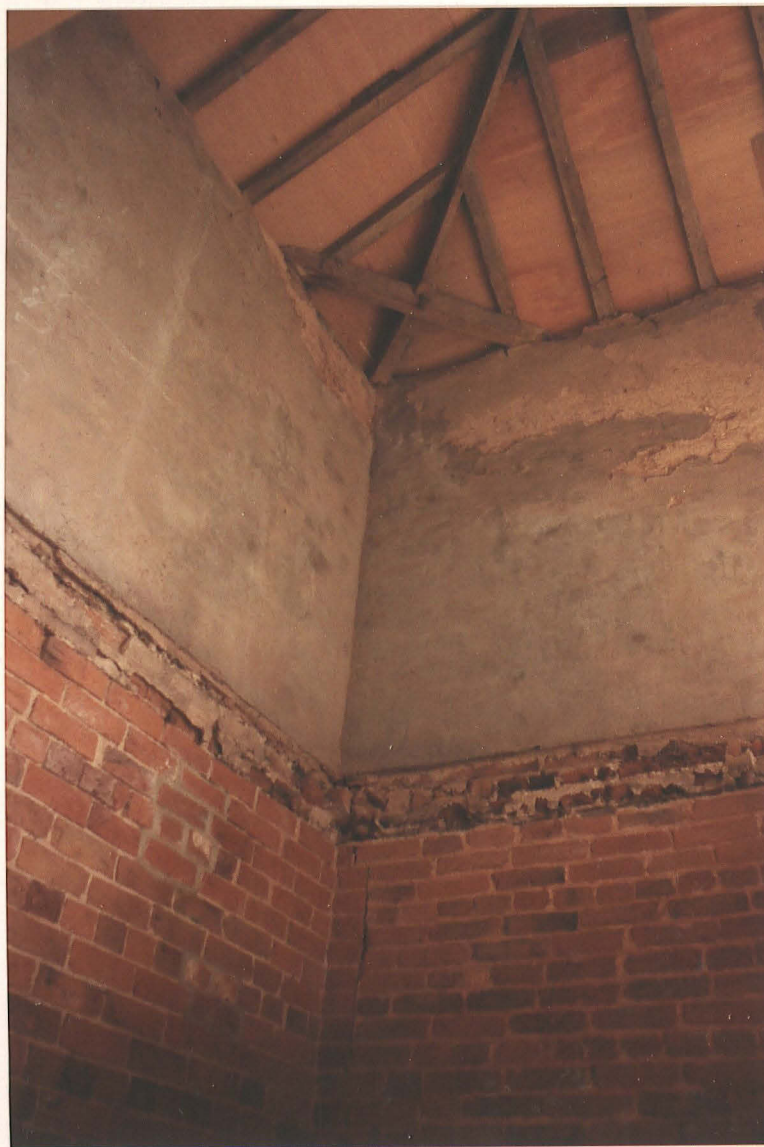
Pl. 13 Roof construction in Unit 4, NW corner

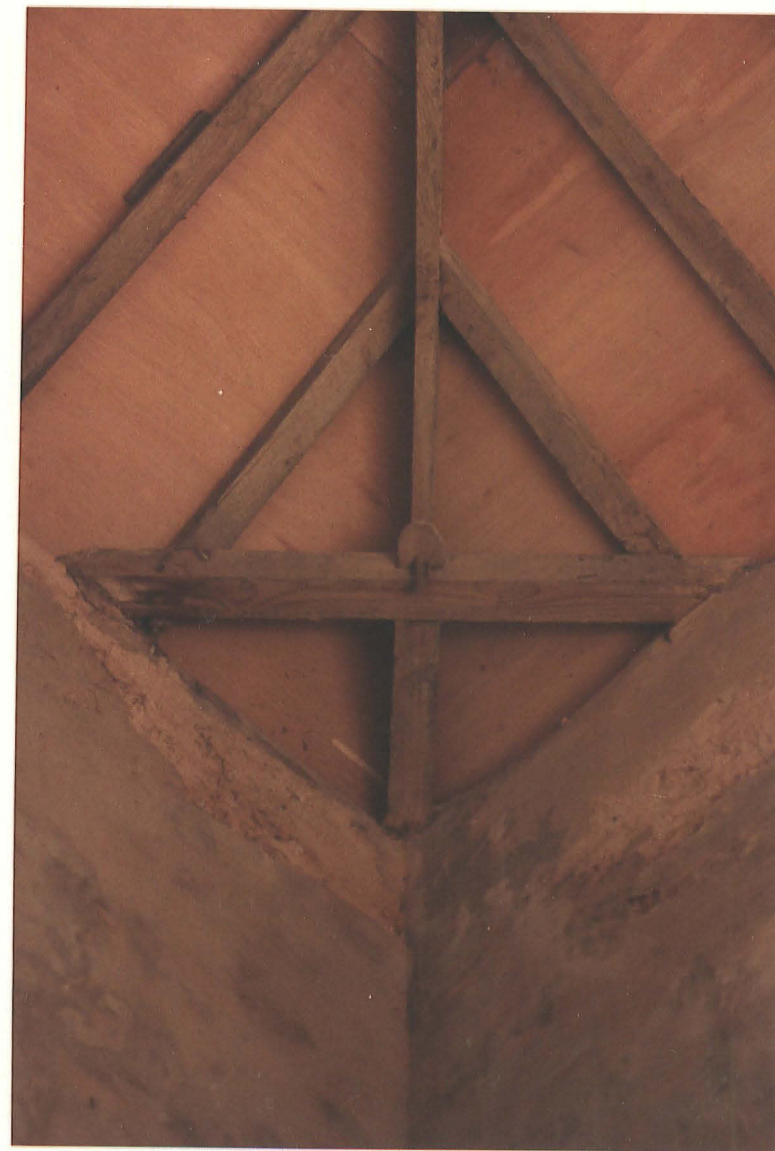
Pl. 14 Roof construction in Unit 4, NW corner showing detail of dragon beam

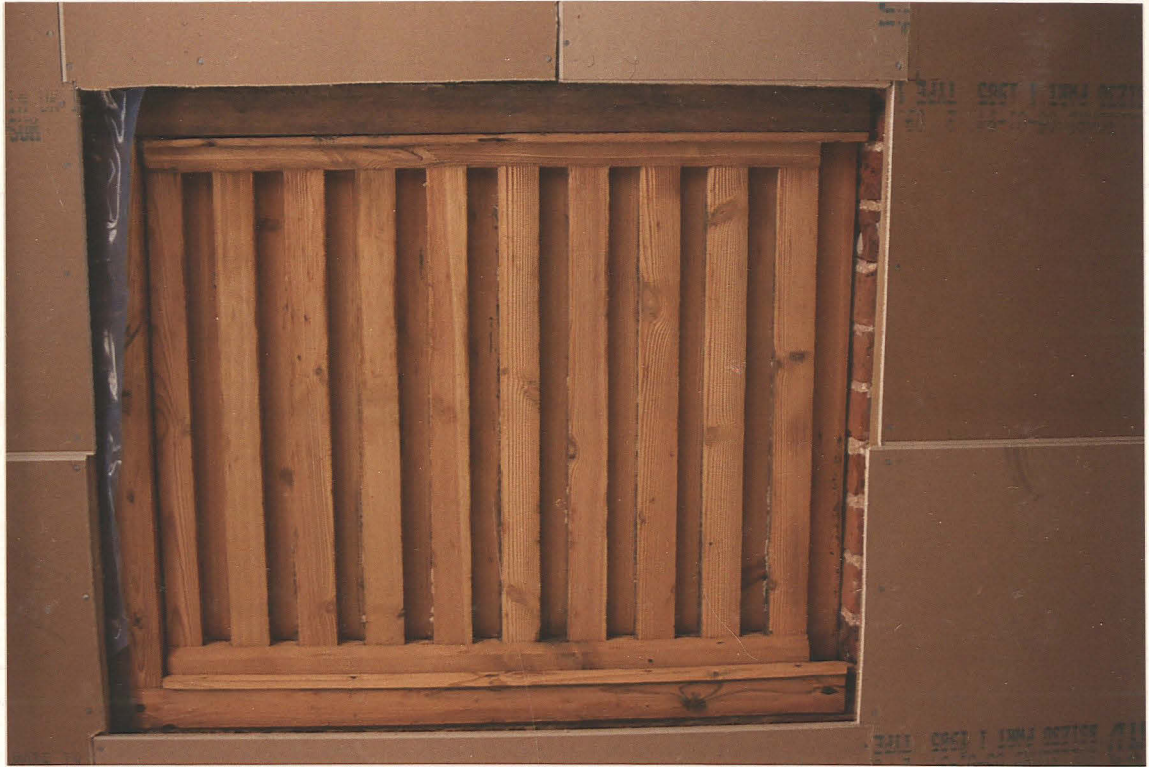
Pl. 15 Detail of slatted window vent in south wall of Unit 1 (former barn).

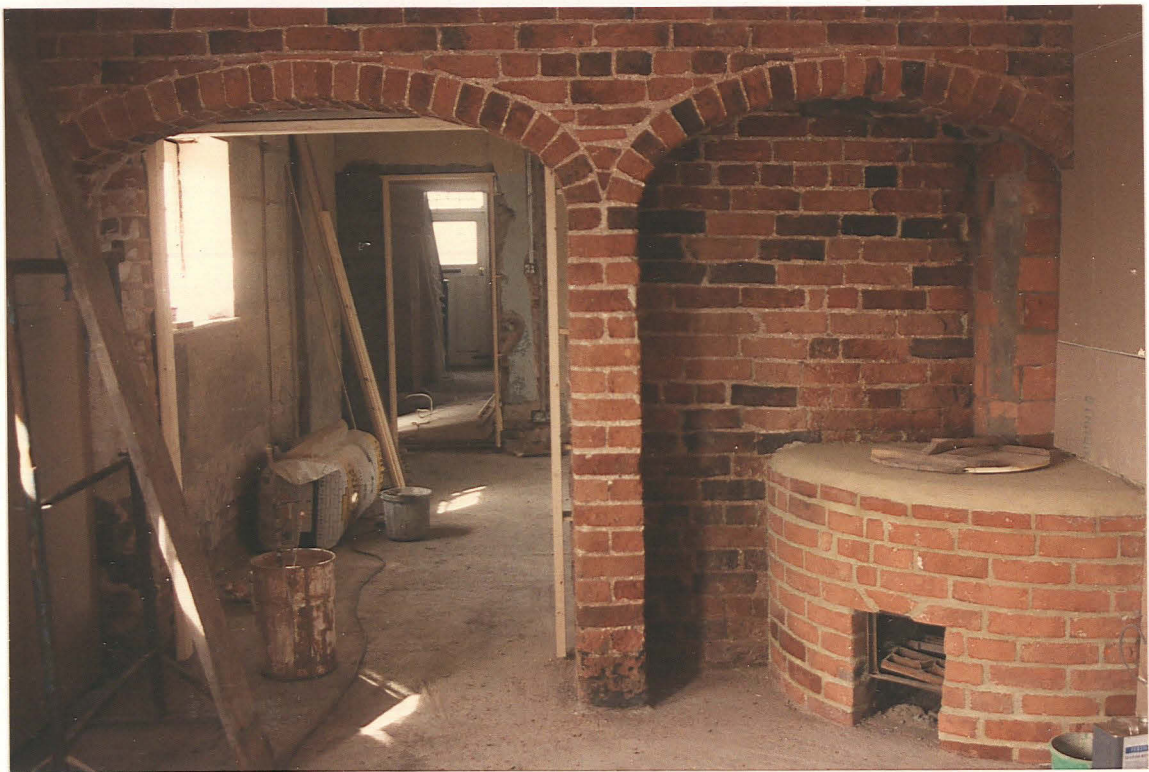
Pl. 16 Restored copper in guest house extension

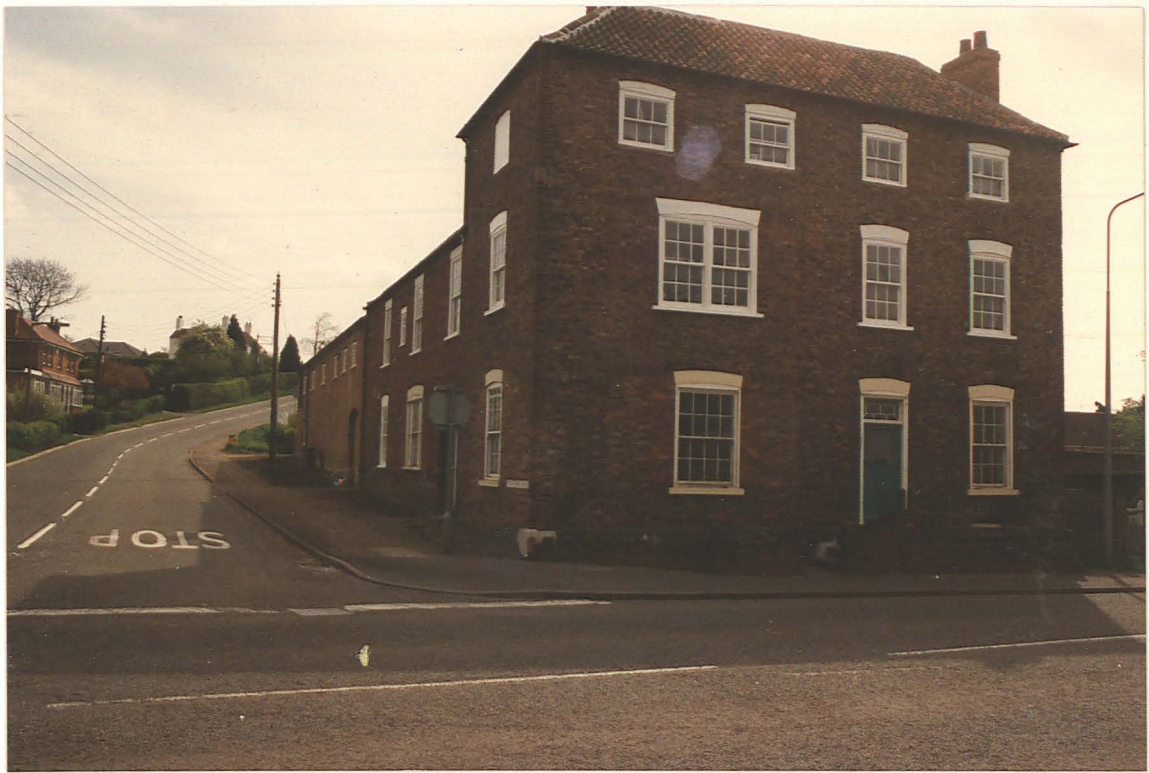
Pl. 17 Manor farm, general view east

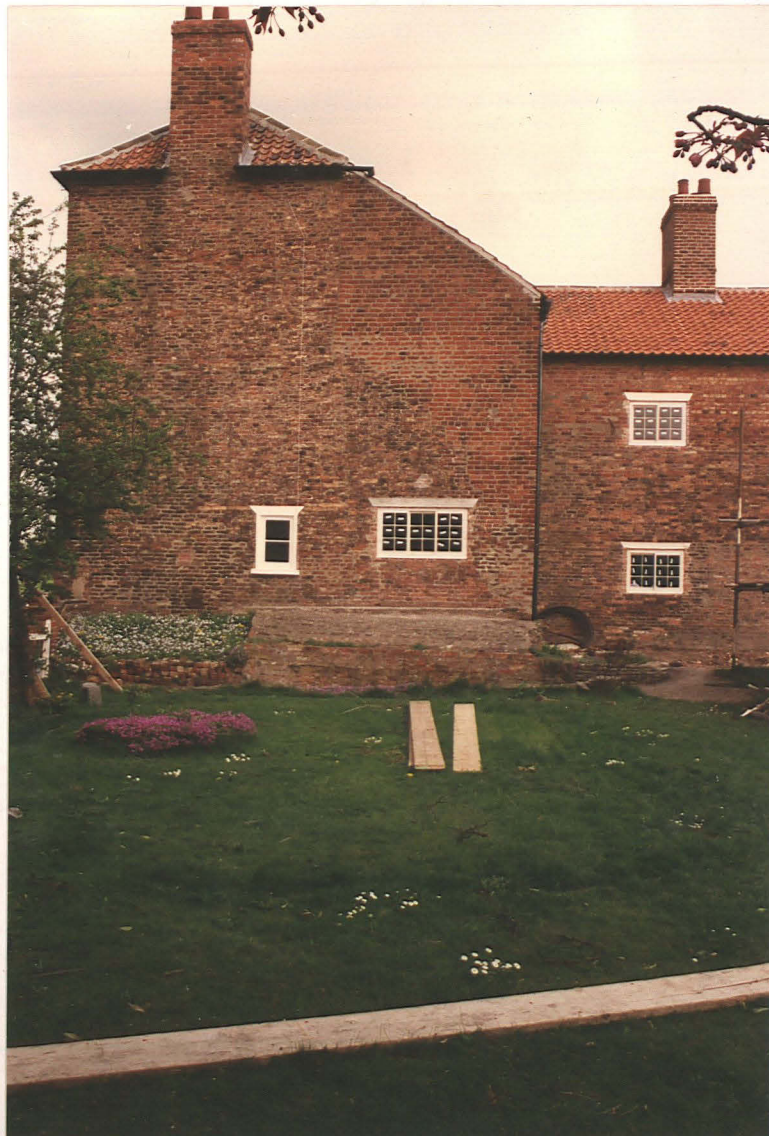
Pl. 18 South elevation showing single storey extension with added first storey, note extension to right has also been raised.

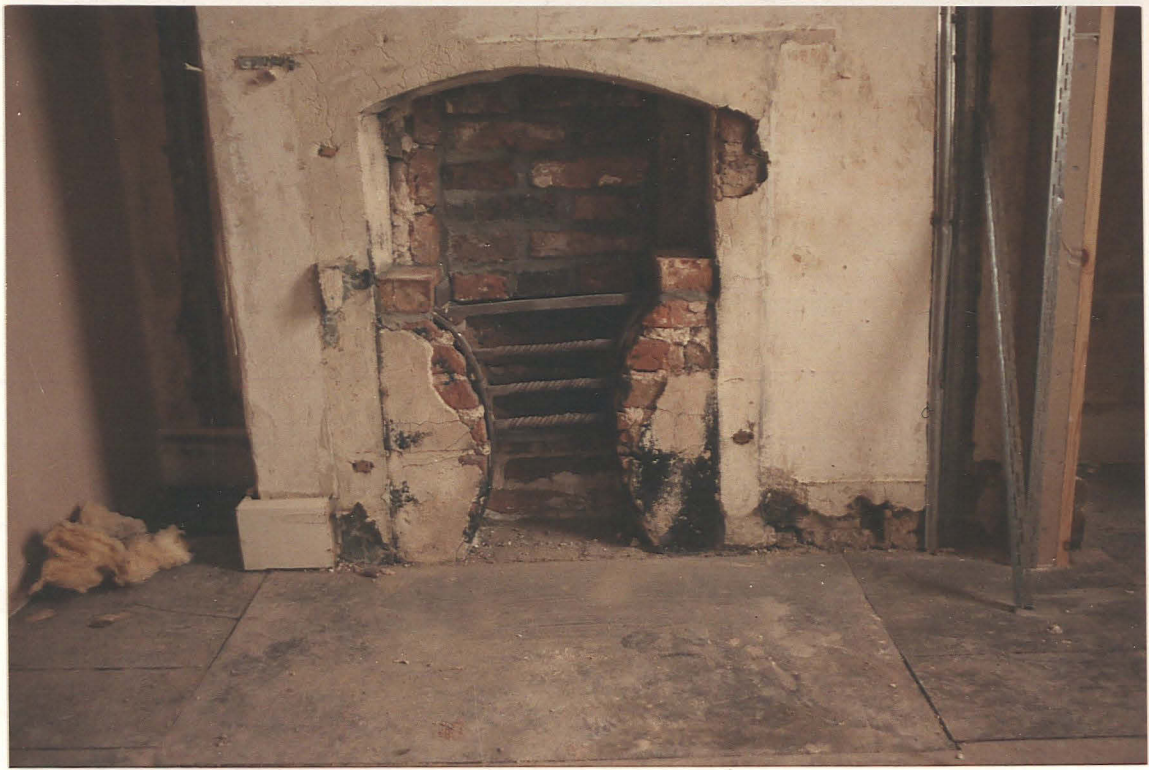
Pl. 19 18th century cast iron fireplace revealed during restoration work in bedroom on second floor

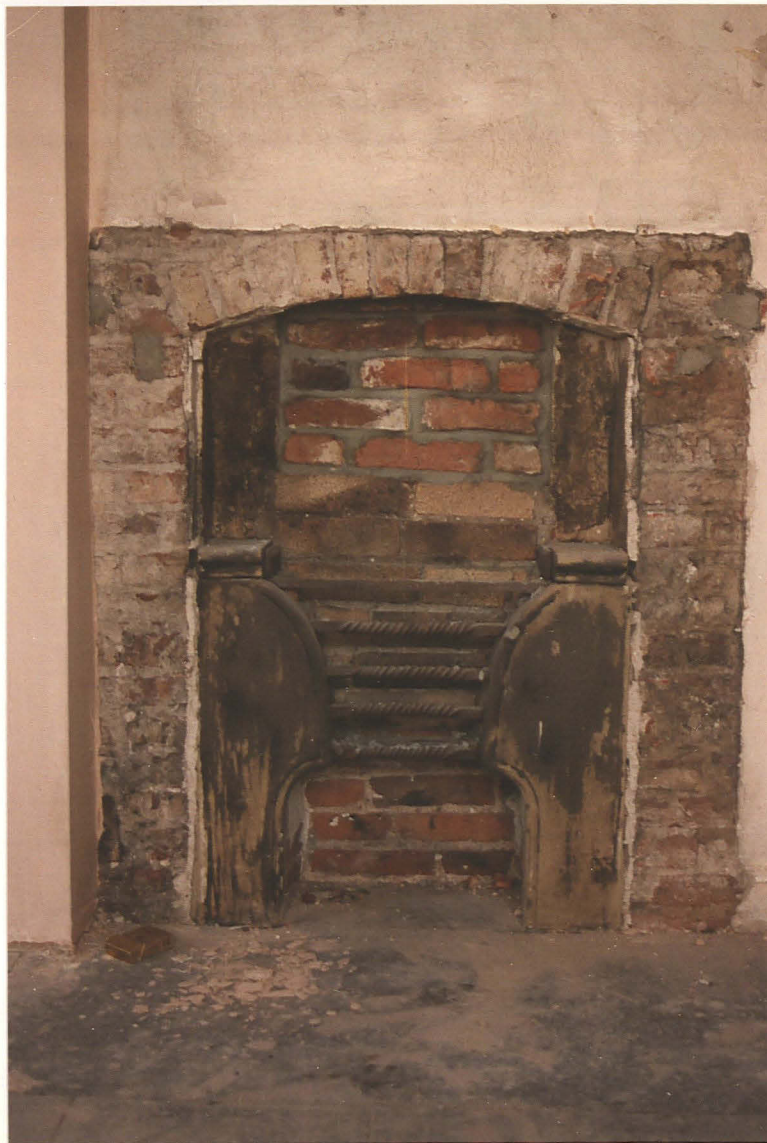
Pl. 20 18th century cast iron fireplace revealed during restoration work in bedroom on first floor

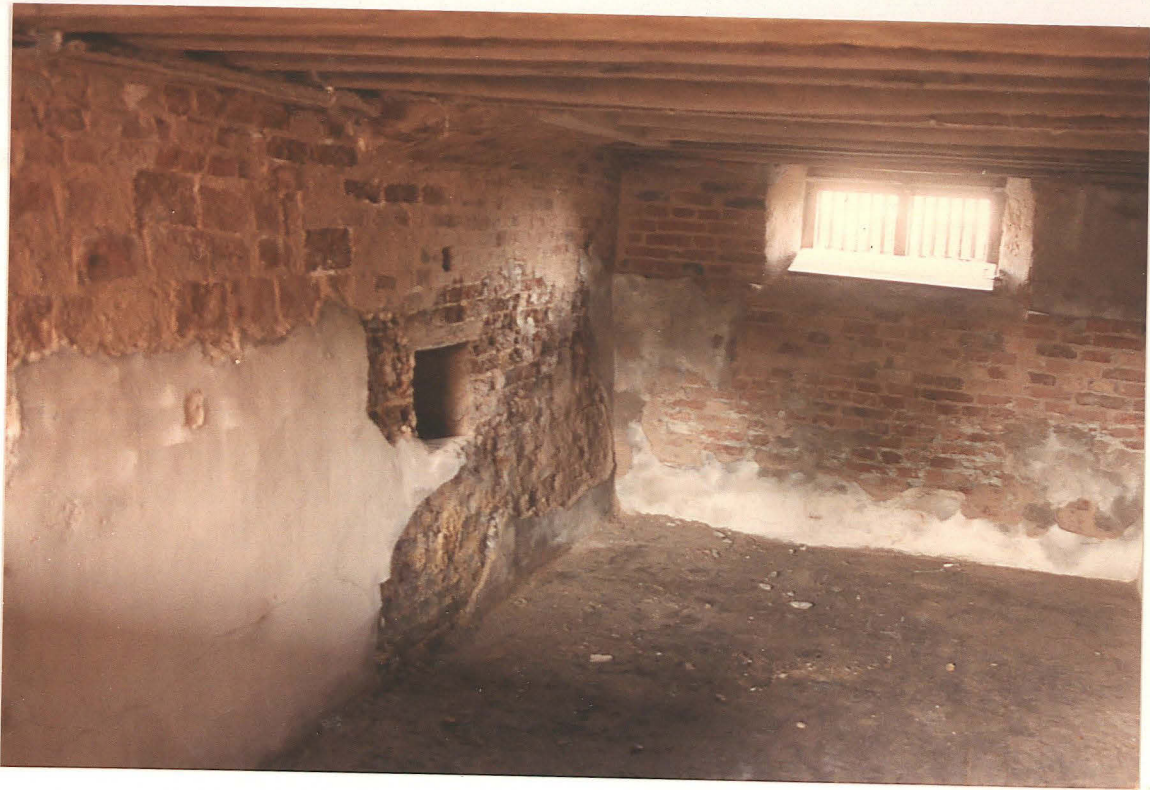
Pl. 21 Cellar in basement of main building showing early brickwork in cross wall, probably pre-dating 18th century building, view west
