All Saints Church Greetwell, Lincs. Archaeological Watching Brief NGR: TF014 716 Site Code: GASC 06 LCNCC Museum Accession No. 2006. 234

LAS Report No. 997

September 2007

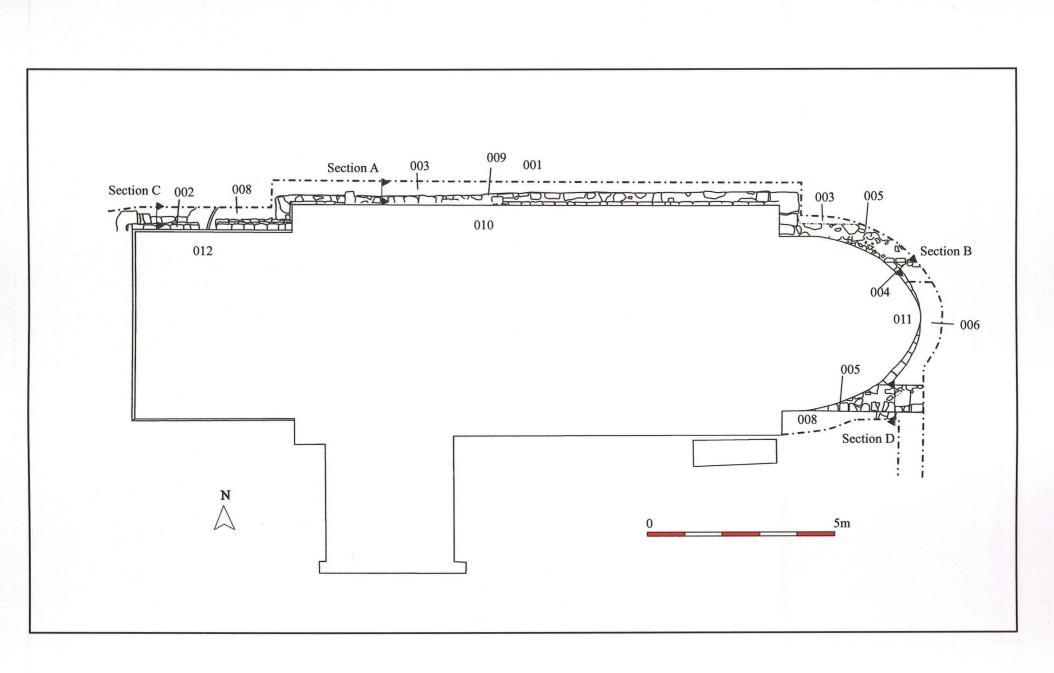
The tower (012) is believed to be of 13th century date (Stocker and Everson 2006, 165). Adjacent to the northern side of the tower (012) the topsoil lay above a brown (4/3 10YR) limestone fragment rich sandy silt (007). This, in turn, sealed a dark yellowish brown (4/4 10YR) sandy silt (008) interspersed with limestone and sandstone fragments. All three deposits abutted the tower's foundations (002). The chamfered plinth around the tower is one course in depth and is visible at ground level. It sits on a foundation, off-set in two stages. The upper stage comprises two courses of rough dressed limestone and sandstone blocks. Two courses of the lower off-set were recorded at the base of the excavated trench but its total depth is unknown. The junction of the tower and the nave north wall (PI. 5) shows clearly that the tower footings 002 have been added to the earlier nave. This relationship was also seen in the standing fabric of the nave and tower (010 and 012). The only surviving piece of chamfered plinth on the nave wall was found at this north-west angle (PI. 6). It lies one course below the level of the tower plinth. The remainder of this course, along the nave north wall has been completely robbed out (PIs 7 and 8).

A thick deposit of dark yellowish brown (4/4 10YR) sandy clay 003 lay beneath the topsoil 001 on this side of the church. Within this deposit there was a moderate quantity of limestone and sandstone rubble. Both deposits butted up to the lower portion of the nave wall 011 and its off-set foundation 009 (Pls 7,8, 10). A large assemblage of medieval pottery fragments and peg tiles, dating to the early to mid 13th century, was recovered *c*.4m west of the north-east corner of the nave in deposit 003.

Fig. 3 Archaeological remains recorded in the French drain

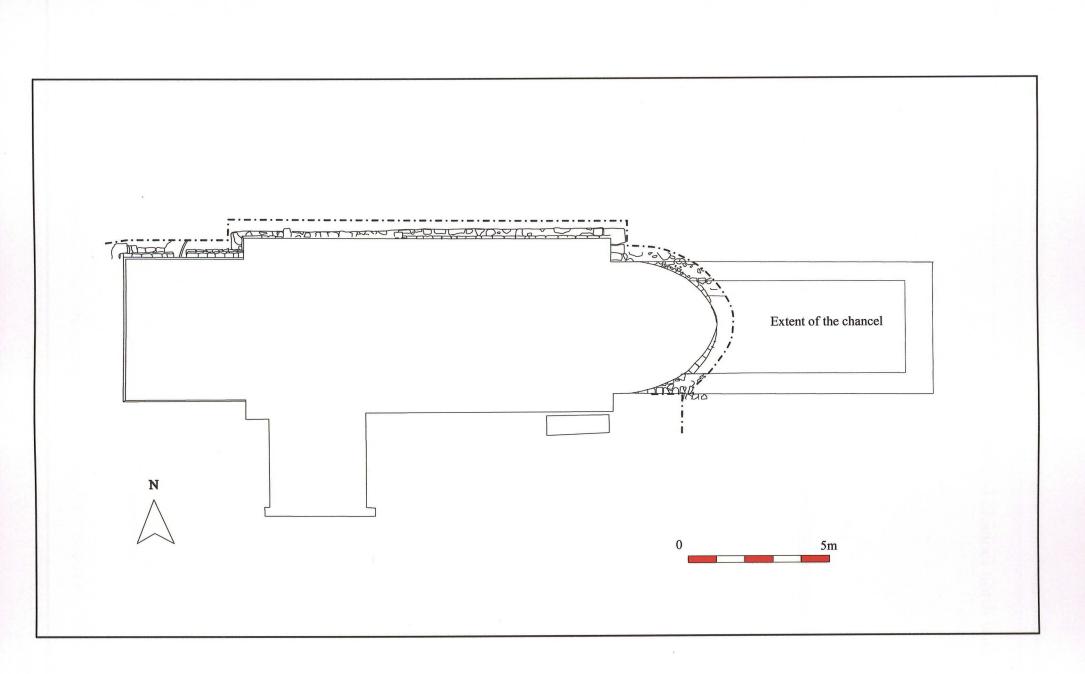
Most of this chancel was not exposed during the installation of the French drain but could be seen on the surface as a slight earthwork within the churchyard. An area of turf measuring $0.30m \times 0.30m \times 0.17m$ was lifted at the south- east corner of the earthwork and confirmed the presence of the southeast corner of the chancel. The raised area of ground measured 11.50m from the end of the nave and was 4.70m in external width.

Excavation of French drains around the perimeter of a church, results in the isolation of the building from the surrounding ground deposits. It is therefore important to record that relationship and also the relationship of the different elements of the building to one another, which are not always evident above ground. At Greetwell the tower is clearly later in construction than the nave and this was confirmed below ground. It is of note that the plinth course of the nave, which had almost all been robbed, was one course lower than that around the tower. This course would have been visible above ground and reflects the higher ground levels at the west end of the church. At the east end of the nave the foundations appear to have been contemporary with those of the demolished chancel. The length of the chancel was established as being 11.50m, almost the length of the nave, which is 13m in length (Fig. 4). This is unusually long.

Fig. 4 Extent of the chancel as recorded in the churchyard

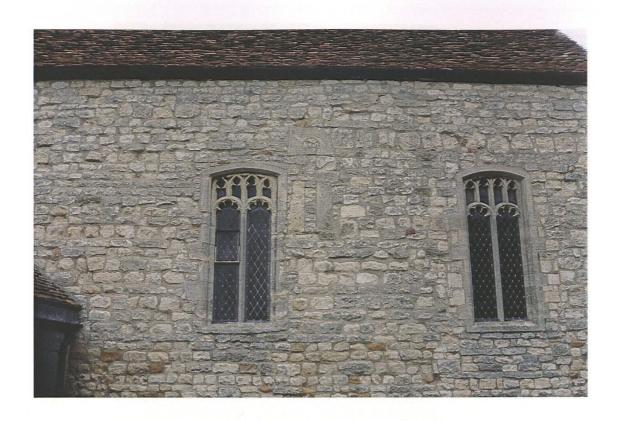
The settlement at Greetwell is mentioned in the Domesday Survey of 1086 when it was recorded that there was a church and priest. The village survives only as a series of earthwork remains and went into decline from at least the 15th century. It was finally abandoned in the first half of the 18th century; the remains are protected as a Scheduled Ancient Monument. The church is situated on the west side of these remains to the south of Greetwell Hall and is not part of the scheduled area but is Listed Grade 1 (Pl. 1). The origins of the church lie in the pre-Conquest period. There is some 11th century fabric still surviving in the building such as the keyhole window in the south wall of the nave (Pls. 2 and 3).

PI.3 Nave south wall, location of the keyhole window.

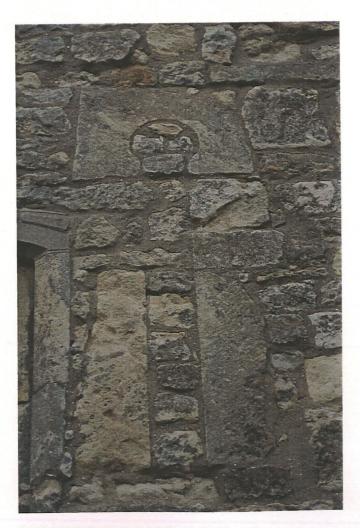
PI. 4 Keyhole window in nave south wall

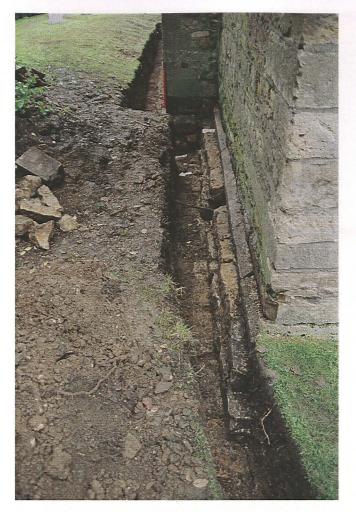
PI. 5 Tower north wall footings,002, looking east. Scale 1m

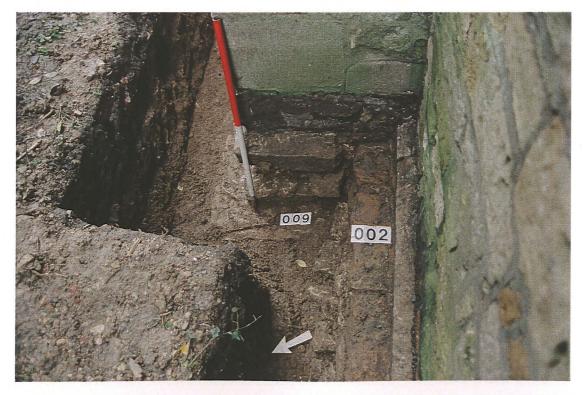
Pl. 6 Junction of the tower north wall footings, 002, and the nave footings, 009, looking east. Scale 1m.

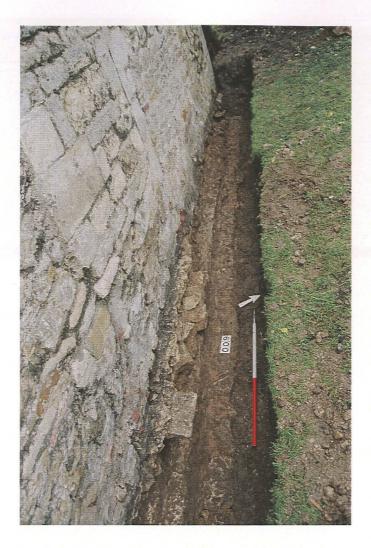
Pl. 7 Nave north wall footings, 009, looking west. Scale 1m.

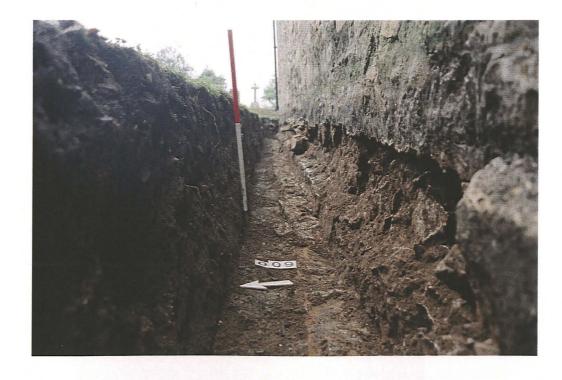
PI. 8 Nave north wall. Robbed out plinth course and foundations below, looking east. Scale 1m

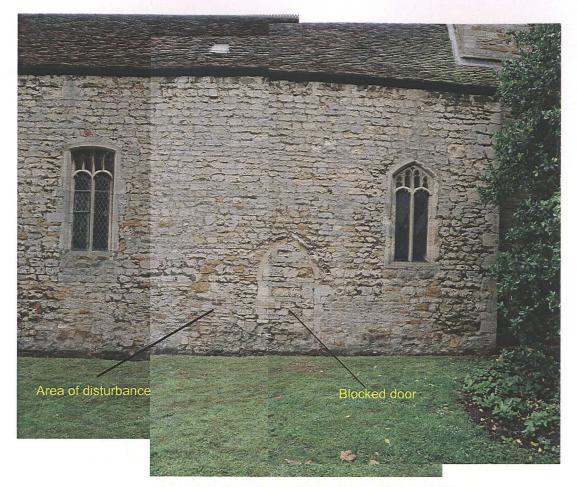
There is a blocked door in the nave north wall (010), opposite the present south entrance to the church (Pl. 9). The jambs and head are still present and are in keeping with a 12-13th century date.

Immediately east of the blocked door is a disturbed area in the wall fabric which may indicate a further door blocking, which would pre-date the outlined door (PI. 9). Neither the blocked door nor the disturbed area to the east retained any evidence of a threshold (PI. 10). It was also noted that the windows on this elevation have been replaced and are shorter than the original openings (PI. 10).

Pl. 9 Blocked doorway and area of disturbance to the east in the north wall of the nave.

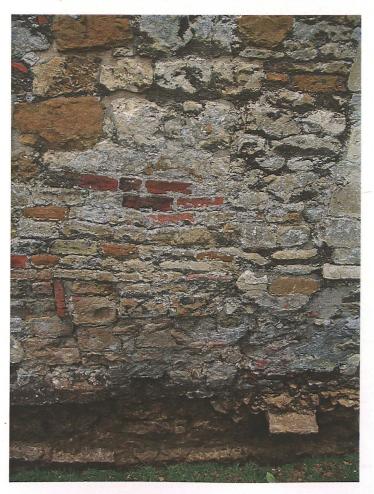
PI. 10 Detail showing robbed out plinth course beneath area of disturbance

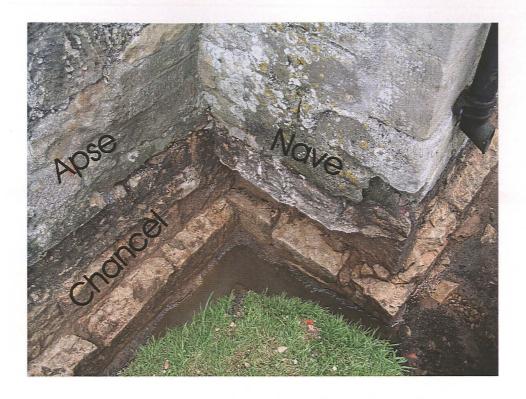
The foundations at the junction of the nave east wall and the medieval chancel look identical and they may be contemporary (PI. 11). The chancel foundations comprise rough-dressed sandstone and limestone blocks bonded with a creamy sandy mortar (005). The wall thickness measured 0.80m and survived to a height of 0.47m above the off-set. The apse footings (004) sit on top of these demolished walls (PIs 12 and 13). The apse (011), measures 4.60m in width x 3.70m in length. The trench for the French drain between the chancel walls was dug entirely within the backfill of the apse foundations which contained stone rubble with some tile and pottery fragments (006). One piece of diamond shaped glass of possible Georgian date and 3 darker pieces of medieval glass were recovered from this context. No floor surfaces associated with the medieval chancel were visible in the side of the French drain trench.

Pl. 11 Junction of nave north wall and chancel footings with apse built on top of chancel

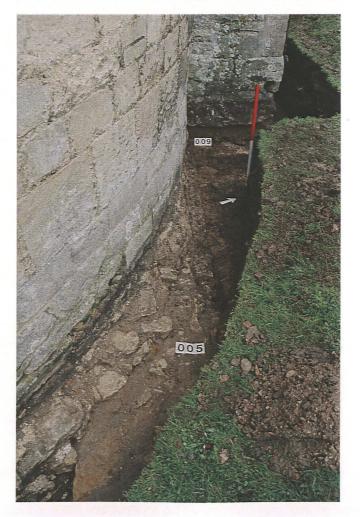
The apse walls (004) were constructed not as a semi-circle but as a curving footing which came to a point, suggesting that the footing was simultaneously being laid from the north and south side of the nave.

Pl. 12 Apse footings 004 overlying the chancel north wall foundations, 005, looking west. Scale 1m.

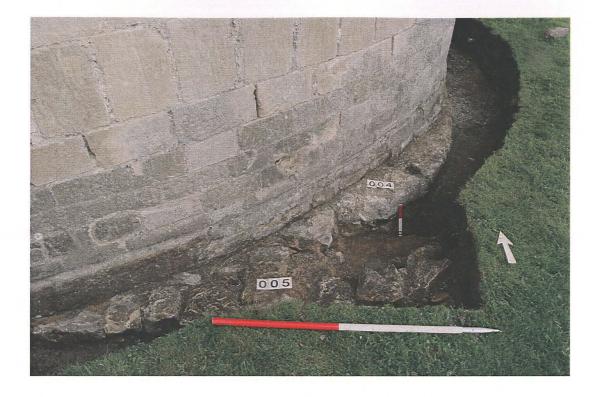
Pl. 13 Drainage trench at south side of apse, looking north, scale 1m

It had been intended to continue the French drain around the south side of the apse but in order to preserve the relationship of the apse foundations overlying the earlier chancel it was decide to divert the trench and the reposition the soakaway. An earlier drain had already been positioned across the chancel wall, causing some damage to the foundations. The new French drain was dug through the same place so as to cause the minimum of new damage (PI. 14). The drain did not cut through the chancel north wall but stopped on the north side of the apse (PI. 12). The soakaway to the north west of the church drains the run along the nave and tower north walls. The soakaway to the south-east of the church drains the run around the remainder of the apse, which cuts through the south wall of the

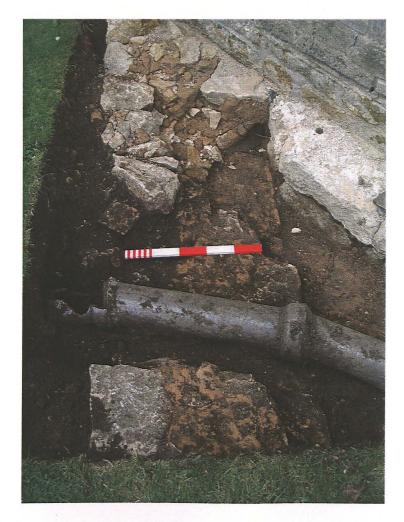
PI. 14 Chancel south wall footings cut by drainage pipe, looking west. Scale 0.50m
