**The Coffee Shop Project,
Belton House NT, Grantham, Lincolnshire.**

Archaeological Watching Brief

Report no. 525

September 2007

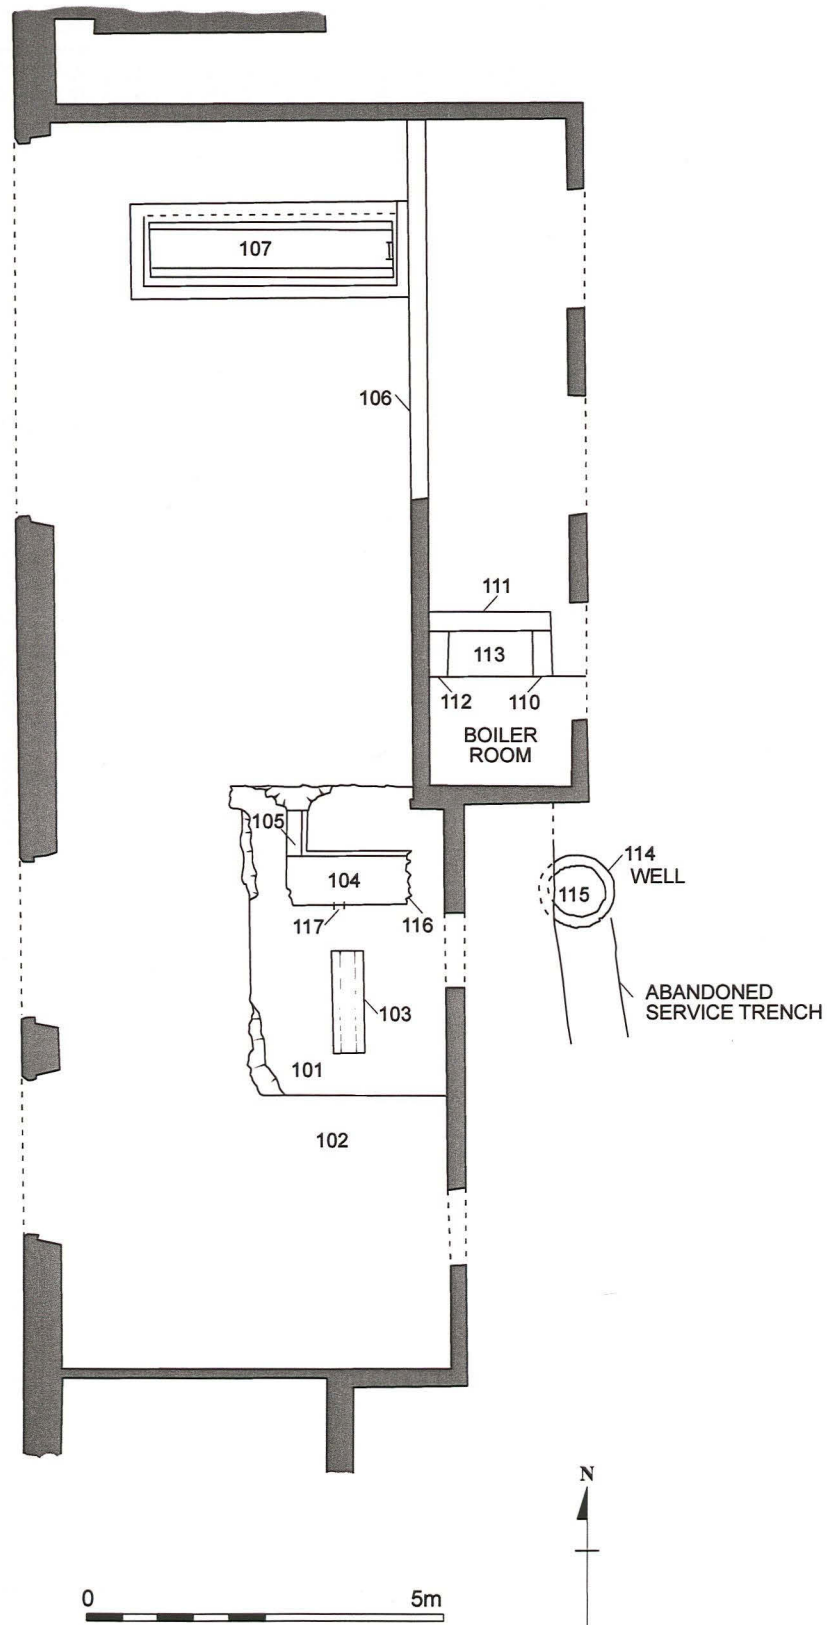
The development area consists of a rectangular structure, approximately 18m by 8m, oriented north to south and east to west respectively (Figure 2).

A service trench was excavated from the south-east end of the development, continuing east for approximately 15m before turning to connect to the mains supply 13m further south.

Figure 2: Plan of the Old Stable Block (scale: 1:100)

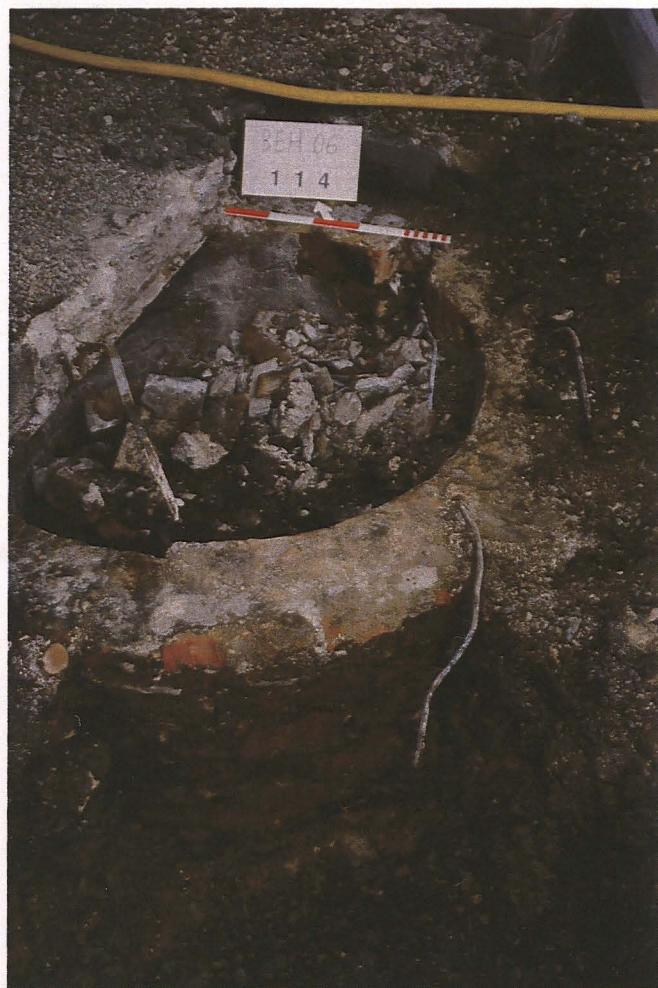
Although it was not possible to place this feature within any specific phase, its location immediately adjacent to the Old Stable Block suggests it may be contemporary with at least some part of the structure.

Constructed from red bricks, well 114 was 0.7m in diameter and over 0.37m in depth (depth of excavation). The brick work was arranged with headers radiating outwards and bonded by a pale grey mortar. Four courses of bricks were revealed, exposed within the northern approach of an abandoned service trench. The top edge of the bricks and the internal surface were covered in a concrete render that was degraded and cracked, perhaps as a result of constant submersion in water. A small, narrow, ephemeral channel was noted in the western side of well 114, oriented towards Phase 1 features 103, 104 and 105 within the Old Stable Block. This may possibly indicate that well 114 was a source of water for these internal features.

Plate 1: Well 114

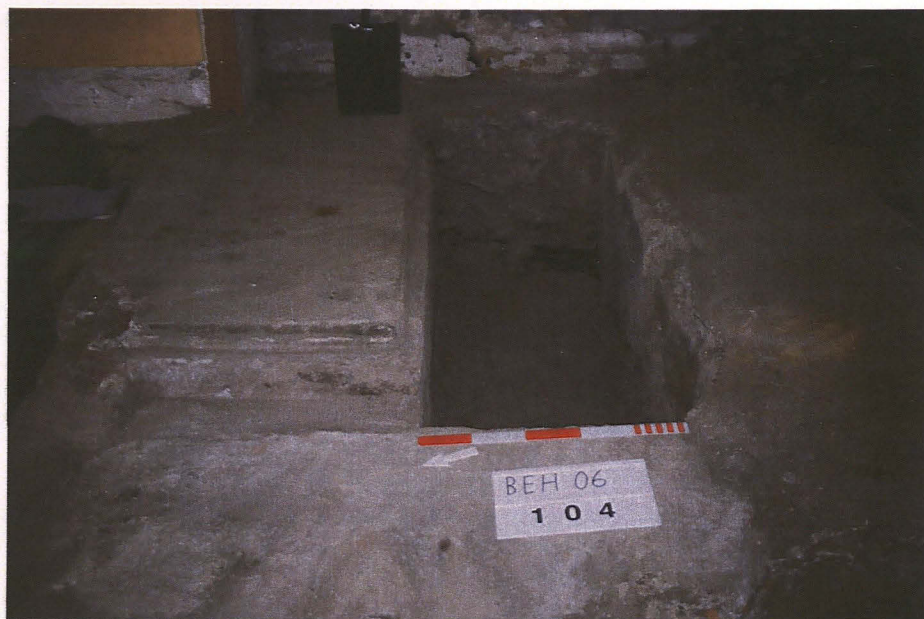
Adjacent to pit 103 was pit 104, measuring c.1.7m in length by 0.75m in width and 0.56m deep. Oriented east to west and located towards the northern end of 102, pit 104 had vertical sides, descending to a flat base where a 0.1m diameter ceramic pipe (117) was located, feeding in from the southern side of 104. The north side of pit 104 had a small narrow ledge running along the top, approximately 0.06m deep, forming the upper ledge of channel feature 105 at the north-west end of 104. The eastern extent of pit 104 also contained the remains of single fill 116, which comprised mid brown grey silty sand with frequent rubble inclusions.

Channel 105 comprised a small rectangular slot, 0.65m in length by 0.3m in width and 0.1m deep. This shallow feature may represent an overspill channel, feeding off, and contemporary with, possible large water containment feature 104.

Plate 2: Water containment pit 104
