**RESULTS OF AN ARCHAEOLOGICAL PHOTOGRAPHIC RECORDING  
AND WATCHING BRIEF OF FARM HOUSE, HIGH ROAD, MOULTON,  
LINCOLNSHIRE**

NGR TF 3030 2492

PLANNING APPLICATION REFERENCE: H13/0724/03/OUTL

Site Code: FHHRM06  
Accession No.: LCNCC 2006.104  
OASIS ID mmarchael-35562

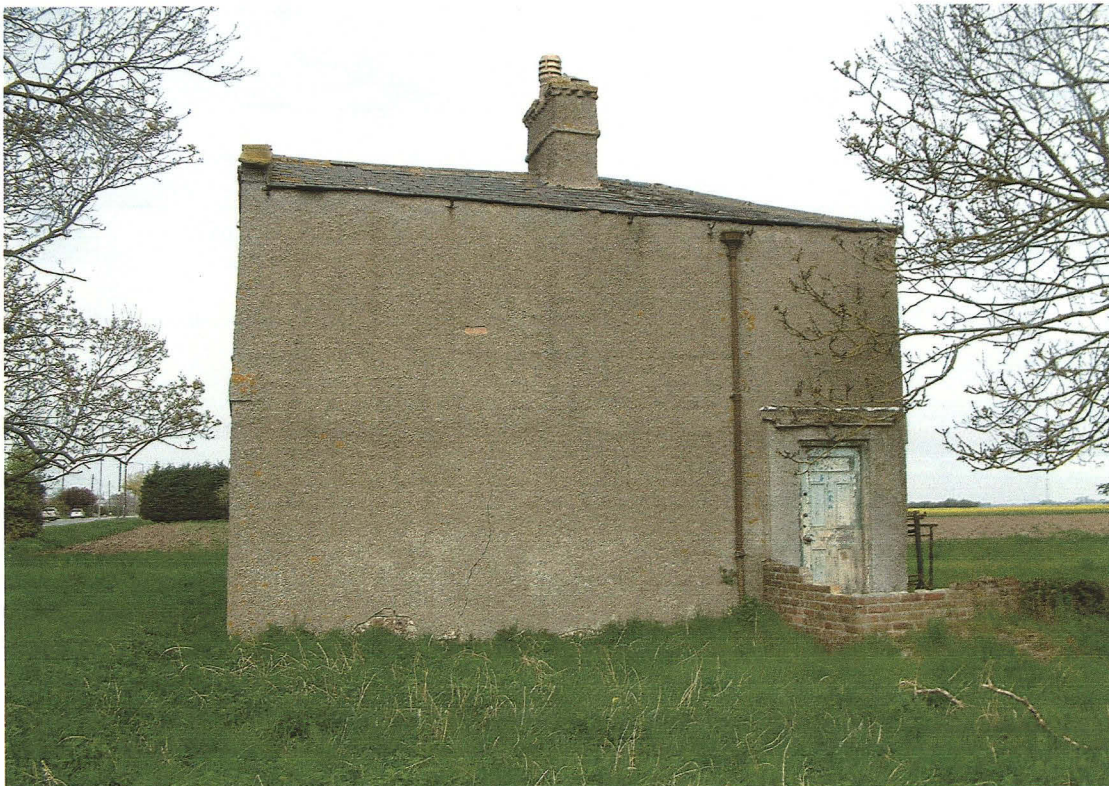
- 6.5 The eastern elevation of the building (Plate 1) shows a wooden entrance door at the northern end with the remnants of a porchway above and a brick surround of 20<sup>th</sup> century date. Note the iron downpipe. The roof is slate with a central chimney stack.

Plate 1. Eastern elevation of Moulton Farm House looking west.

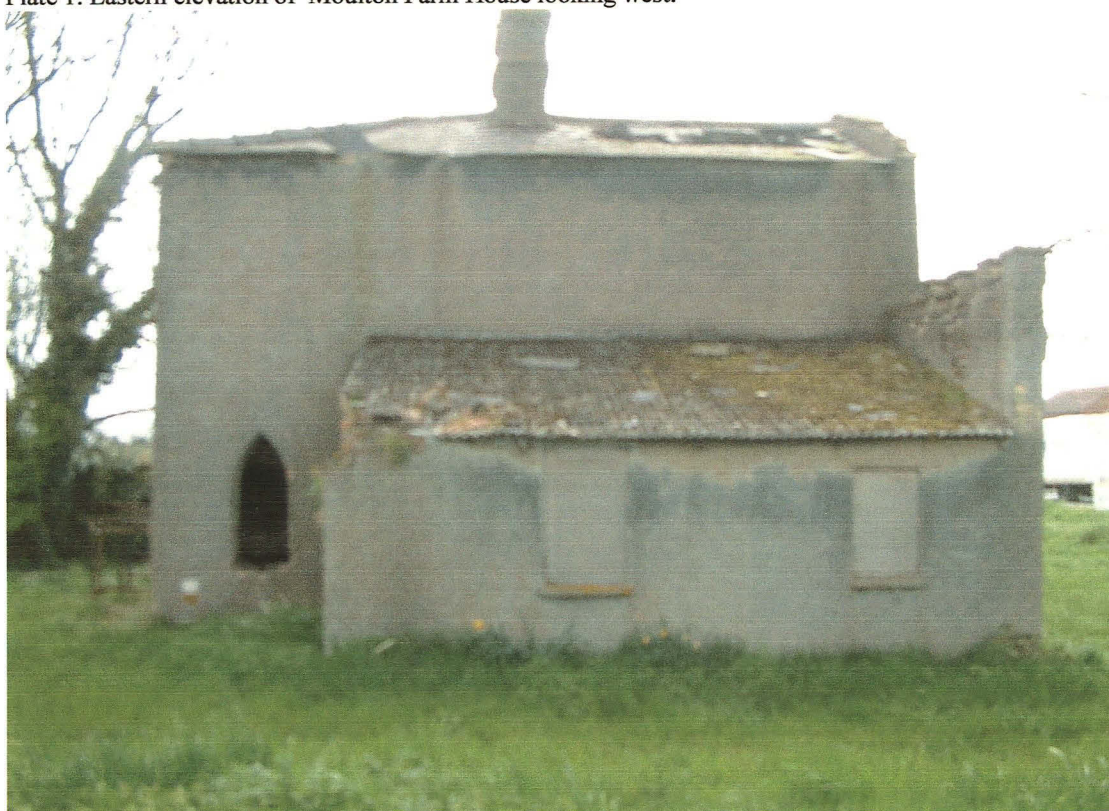
- 6.6 The western elevation (Plate 2) indicates the presence of a single storey lean-to, with a concrete corrugated roof which is considered to be an early 20th century addition. There is no access between the lean-to and the main building. To the northern end of this elevation is a pointed window, date uncertain but likely to be original (Plate 3). Structurally the extension is of poor condition (Plate 4). It contains a water boiler (Plate 5). The roof of the farmhouse is structurally unsound with slates missing at the southern and northern ends.

Plate 2. Western elevation of Moulton Farm

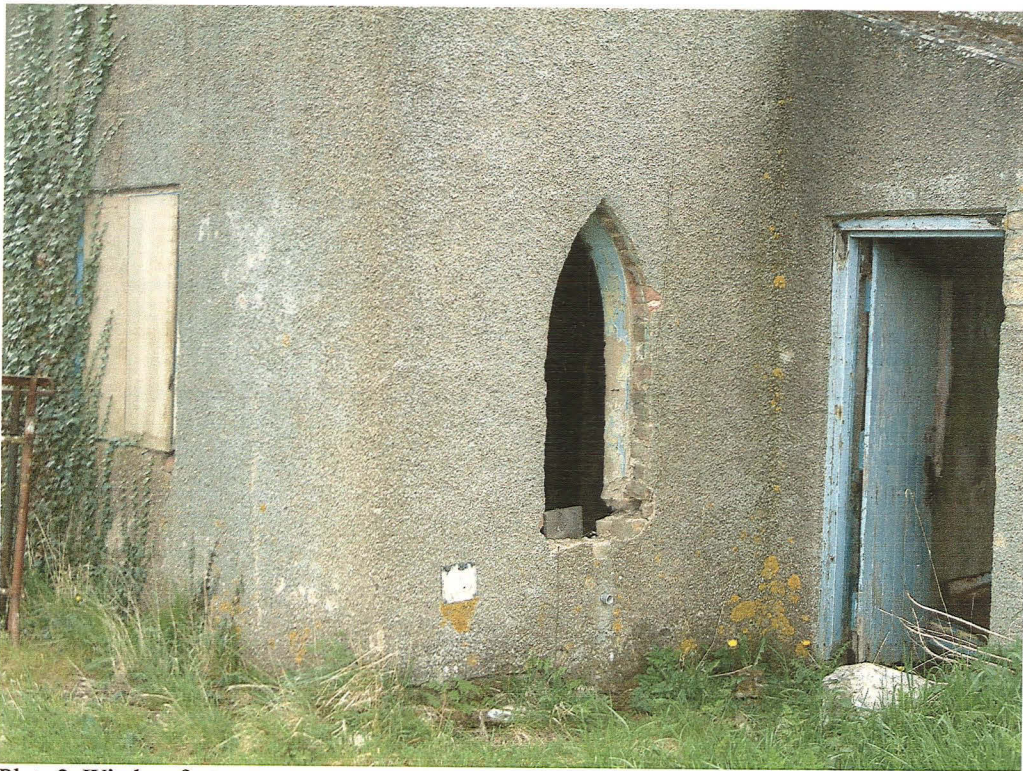
Plate 3. Window feature.

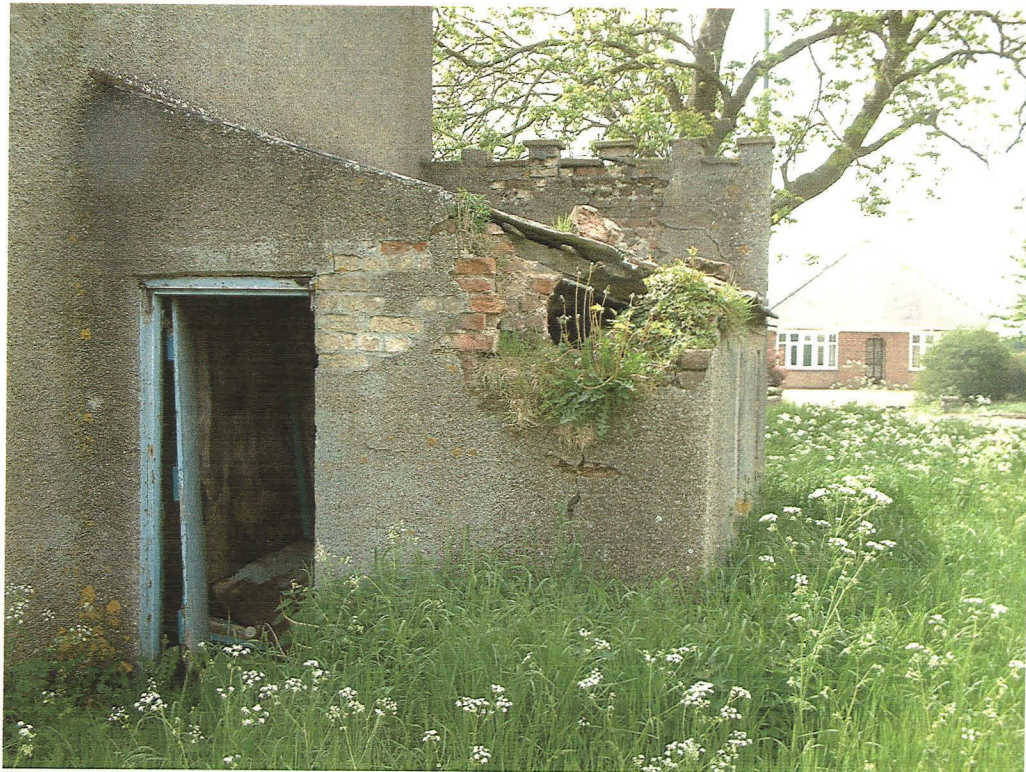
Plate 4. Showing poor condition of roof in extension.

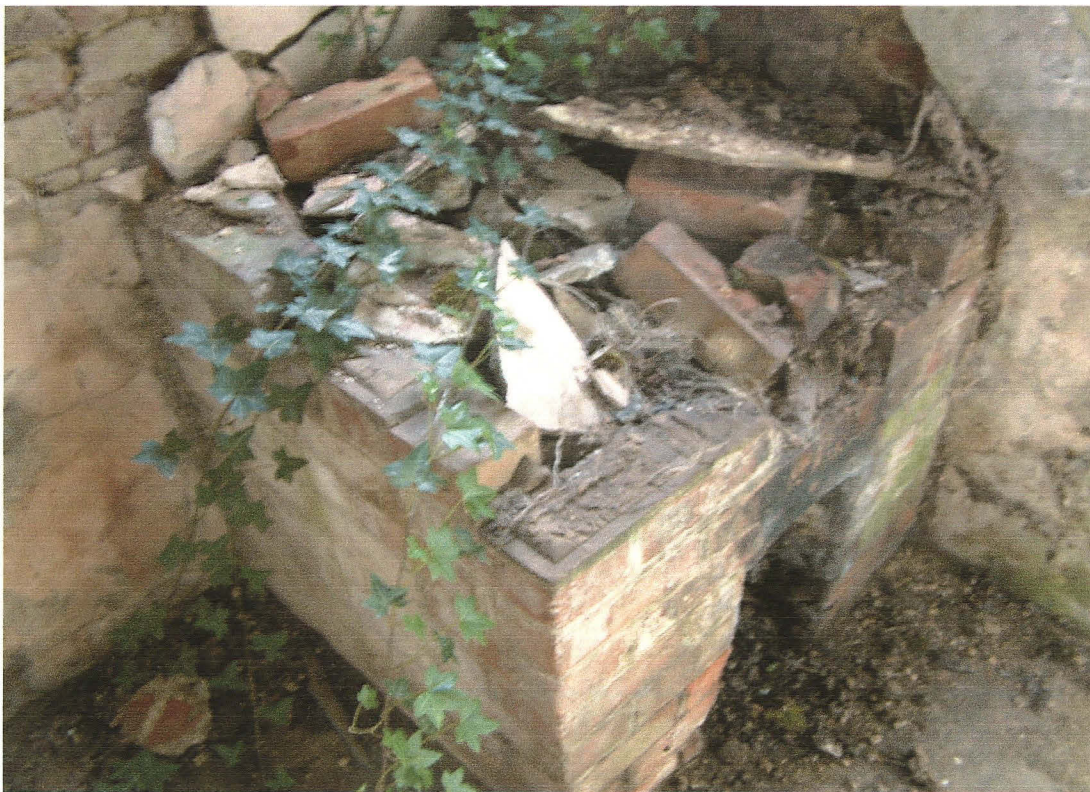
Plate 5. Remains of old water boiler in extension

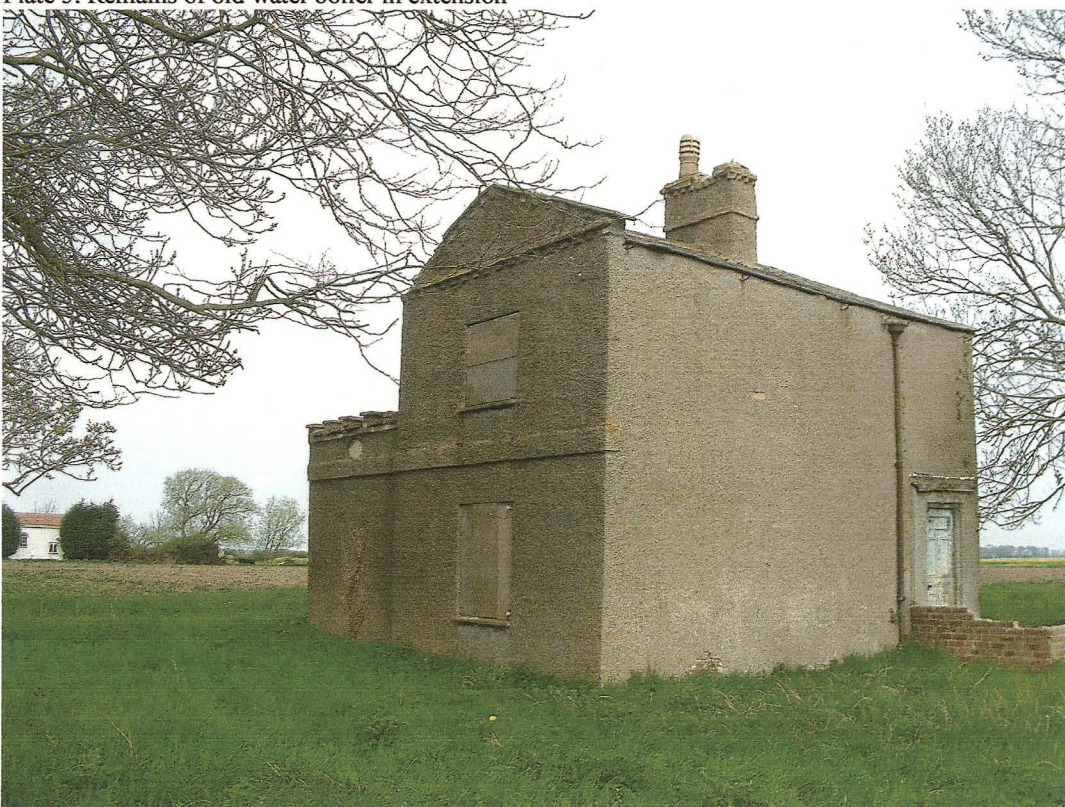
Plate 6. View of the southern elevation.

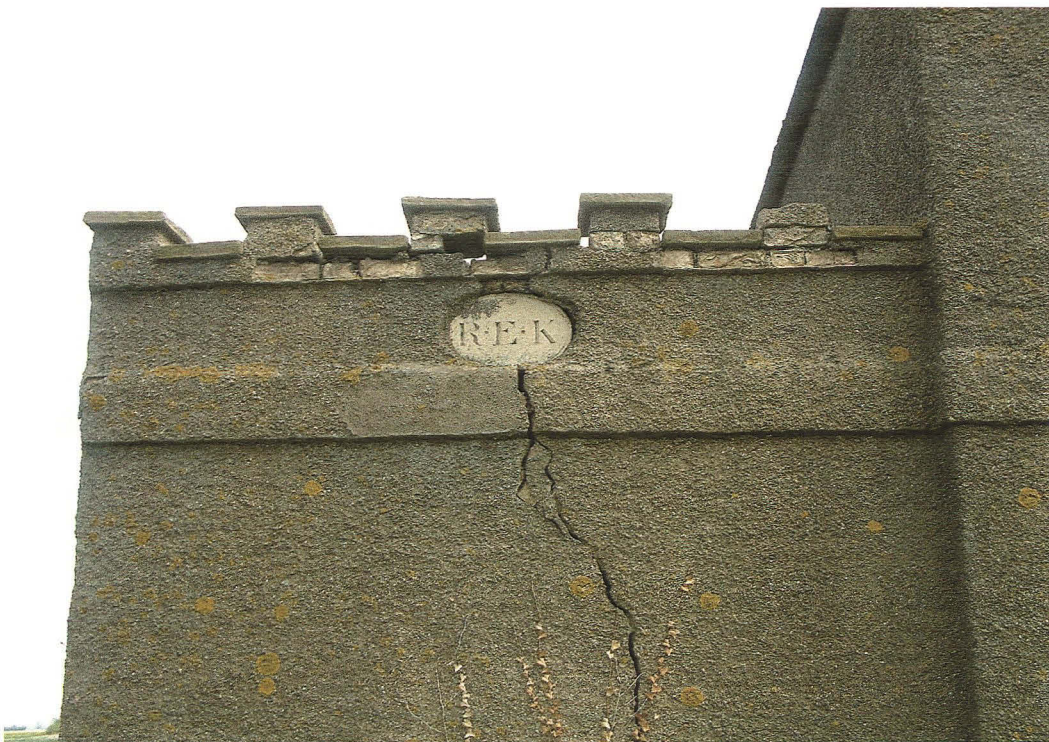
- 6.7 On the front (southern) elevation, the small extension is fronted by a castellated brick addition (Plates 6 & 7). The centre of this front shows a stone with the initials R.E.K. presumably the owner or builder at the time. The northern elevation (Plates 8 & 9) shows two boarded up windows.

Plate 7. Name stone and castellations

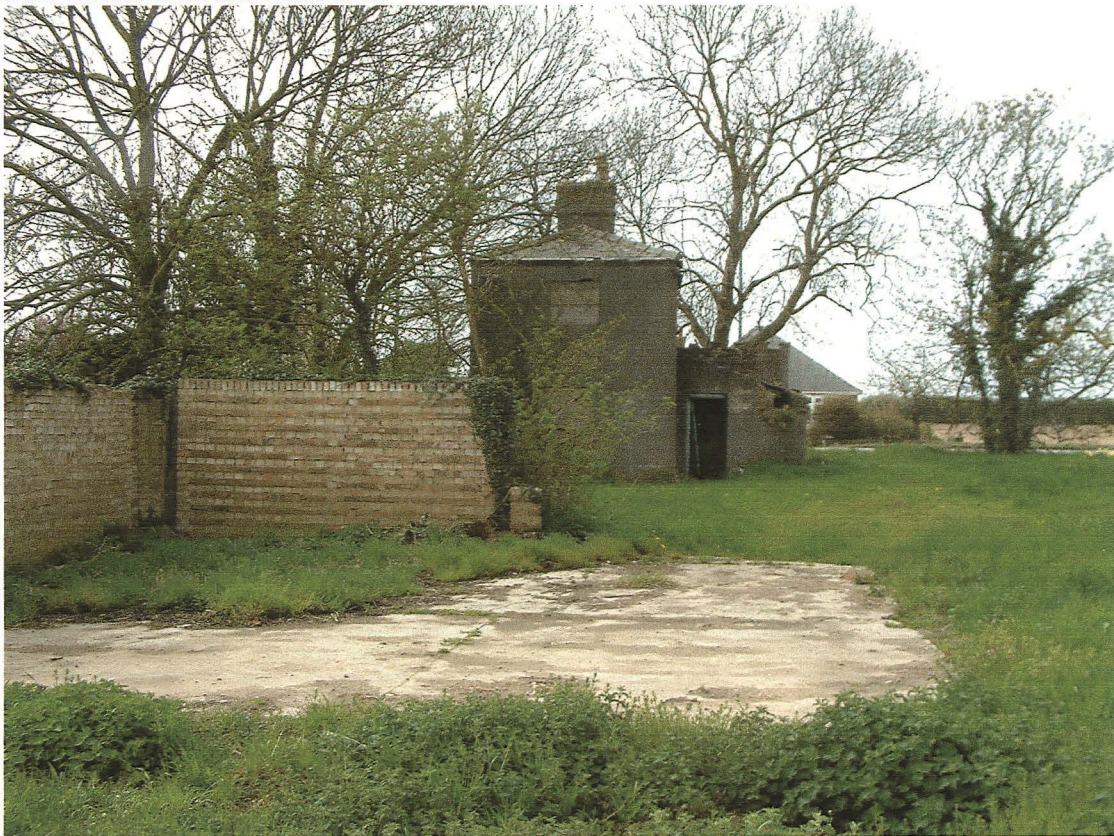
Plate 8. Northern elevation showing concrete floor of building demolished some years previously

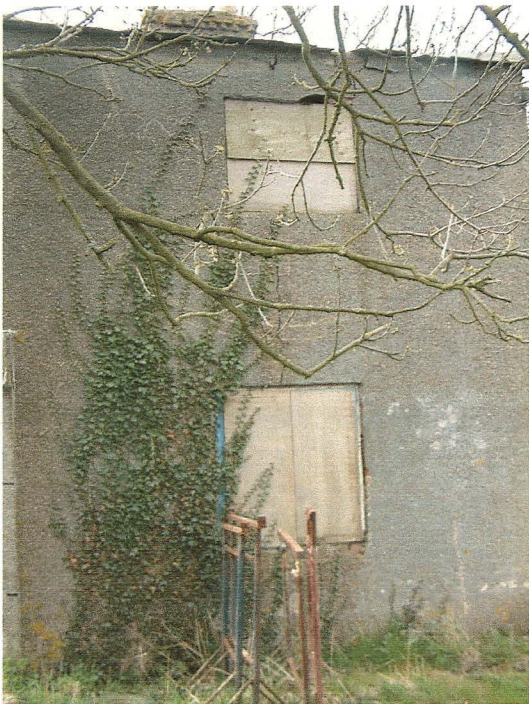
Plate 9. Close up shot of the northern elevation .

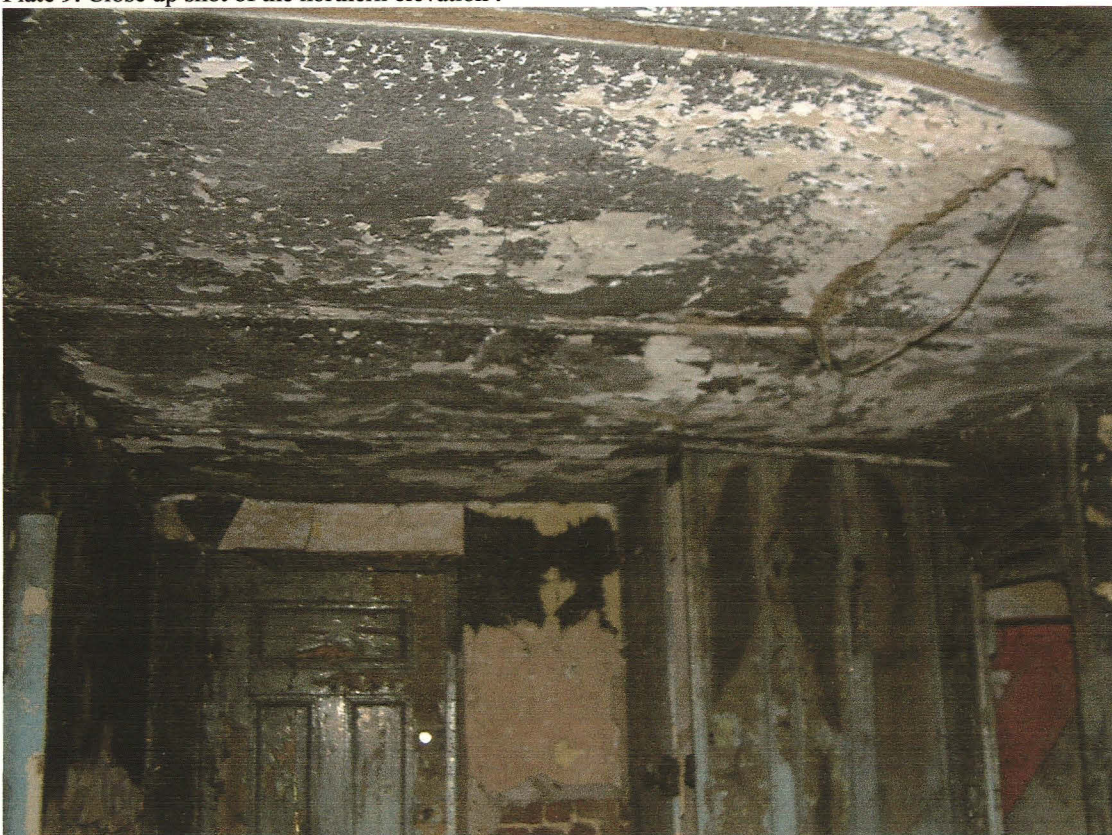
- 6.8 As indicated previously in the agreed specification, the structure was deemed to be too dangerous to enter safely for any great period of time for a full recording. The property had been damaged by fire (Plate 10) and the roof, upper floors (Plate 11) and staircase were unsound (Plate 12). Each room was assessed for its risk and whether it had any features of architectural interest. The southern end of the building was inaccessible because of the collapsed roof and upper floor.

Plate 10. Showing fire damaged ceiling.

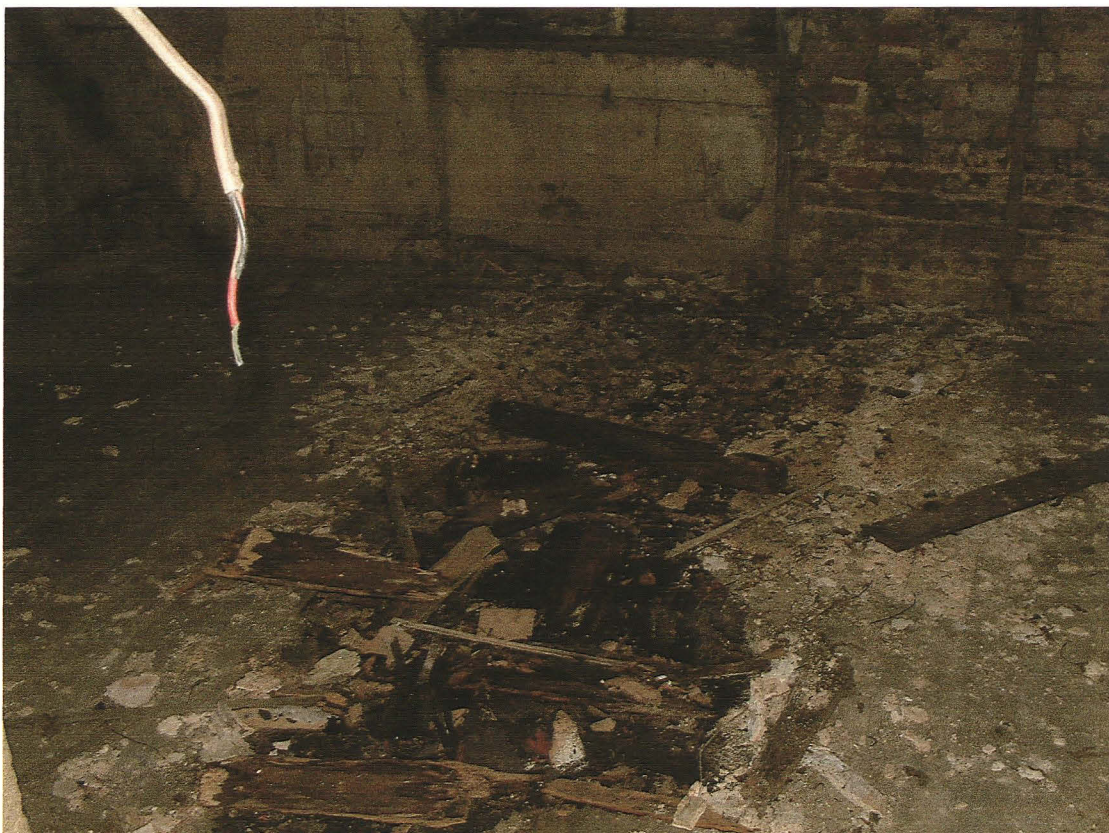
Plate 11. Showing the collapsed upper floor and rotten joists.

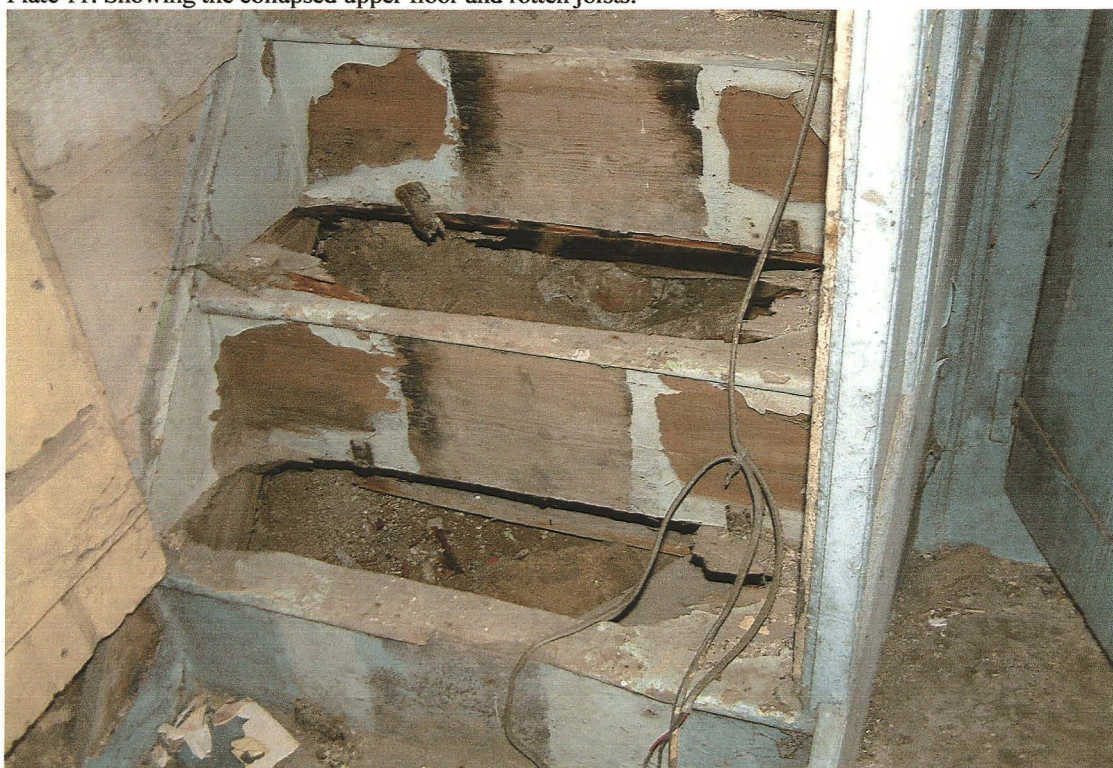
Plate 12. Showing collapsed stair treads apparent all the way to the top of the flight.

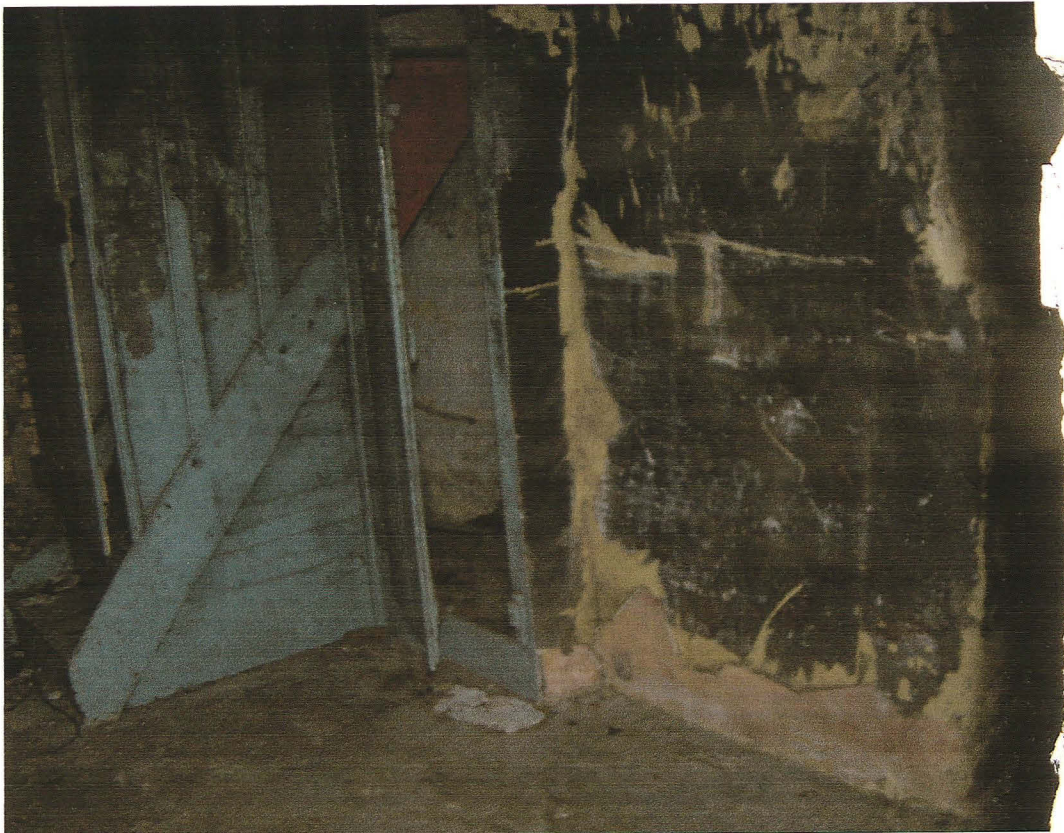
Plate 13. Showing bricked fireplace, staircase and cupboard under stairs.

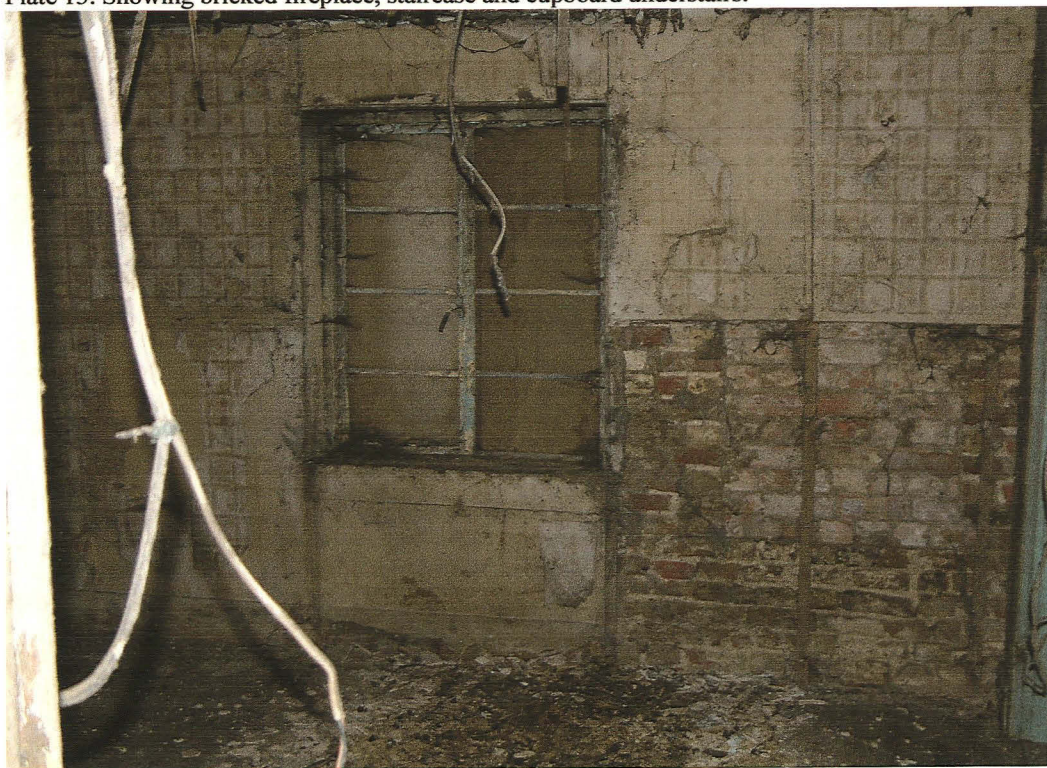
- which had been ripped out. This room was photographed from the doorway as the lathe and plaster roof had caved in (Plate 14).
- 6.10 The upper floors were inaccessible and photographed from the third stair. They appear to have been used as bedrooms, given the décor of pink walls and pink and white patterned wallpaper. The roof had collapsed in, on the southern room (Plate 15) showing lathe and plaster ceiling. The door appeared original and floorboards appeared to be 20<sup>th</sup> century (Plate 16).

Plate 14. Shot of kitchen on the southern side of the property.

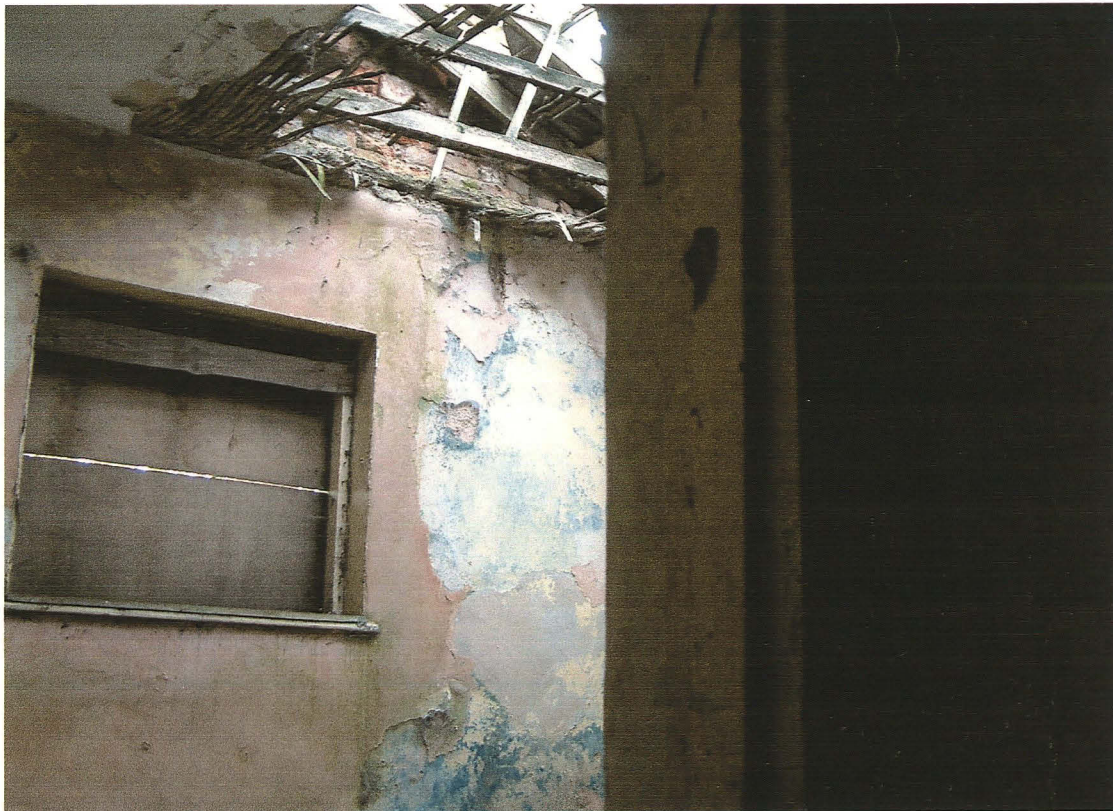
Plate 15. Southern bedroom showing the collapsed in roof and lathe and plaster ceiling

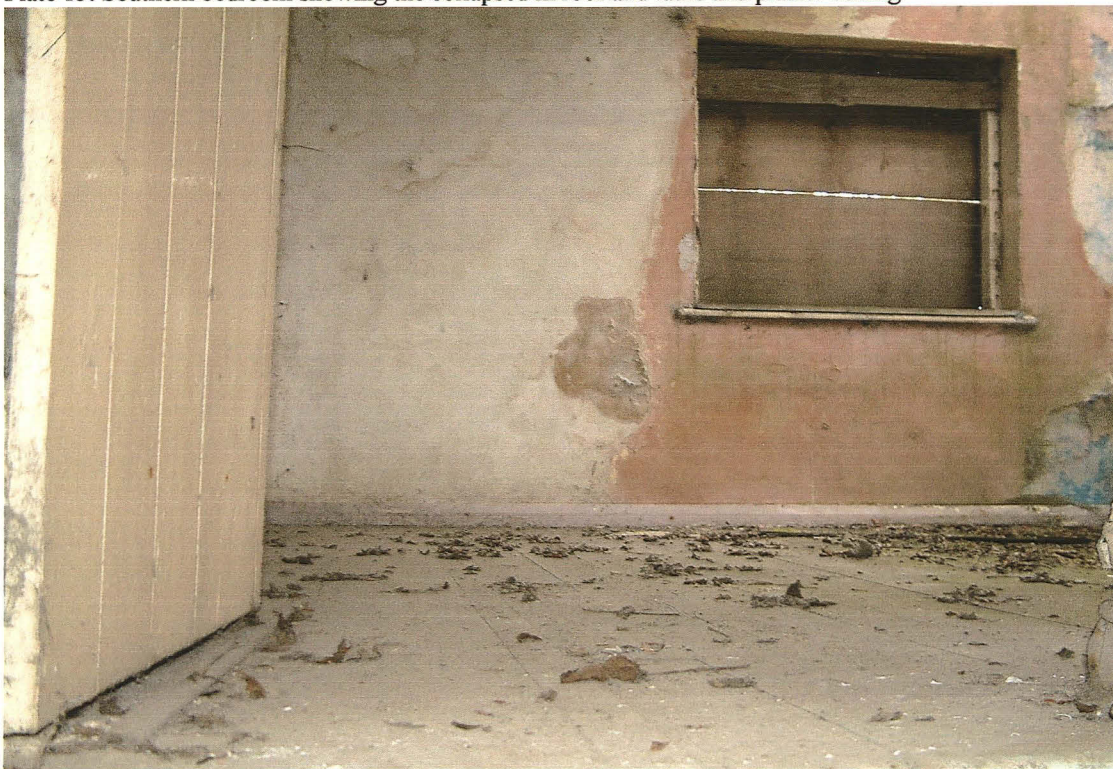
Plate 16. Showing original door.

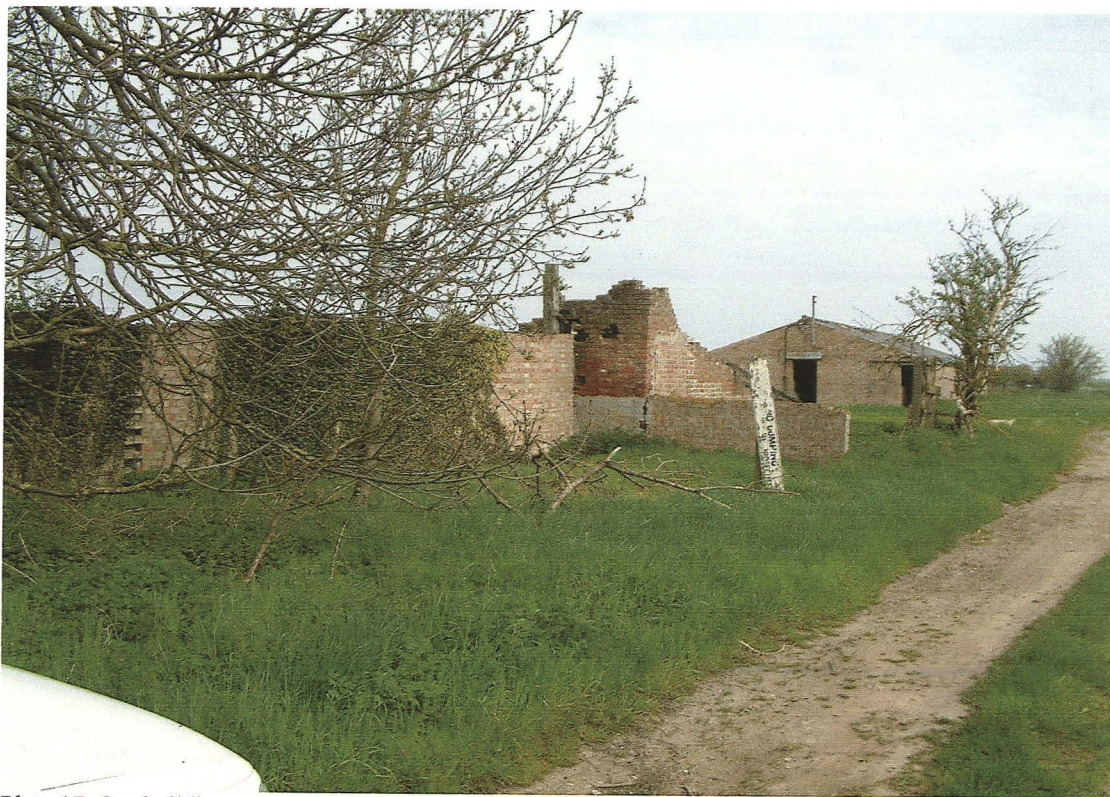
- 6.11 Outbuildings were present on the site which were to be demolished to make way for the new property. To the north of the farm house (Plates 8 & 17 & Figure 2), a brick built collapsed barn of 19<sup>th</sup> century date with 20<sup>th</sup> century repairs was present.

Plate 17. Out buildings to north of property, buildings in foreground to be demolished.

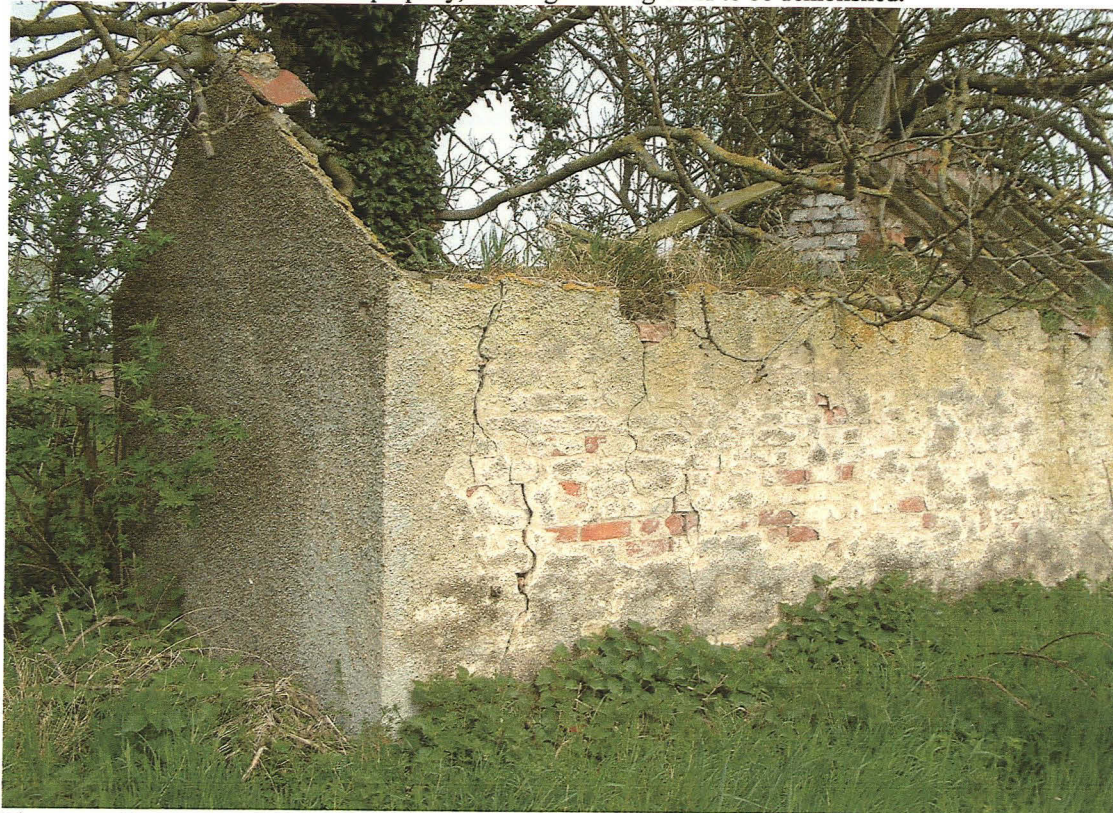
- 6.12 To the northeast of the farmhouse, a garage block (Plate 18 & Figure 2) of 19<sup>th</sup> century date was in bad decay with its roof missing and trees growing within it.

Plate 18. Old garage block to be demolished at north side of property.

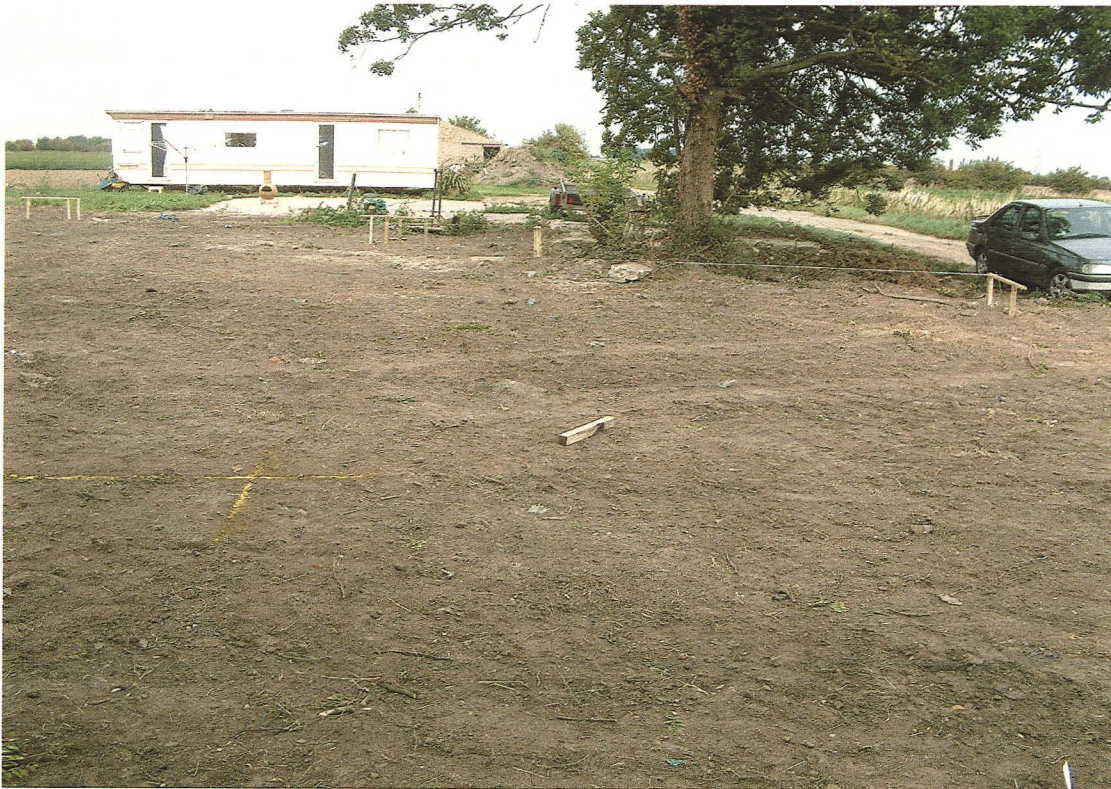
Plate 19. Site after demolition.

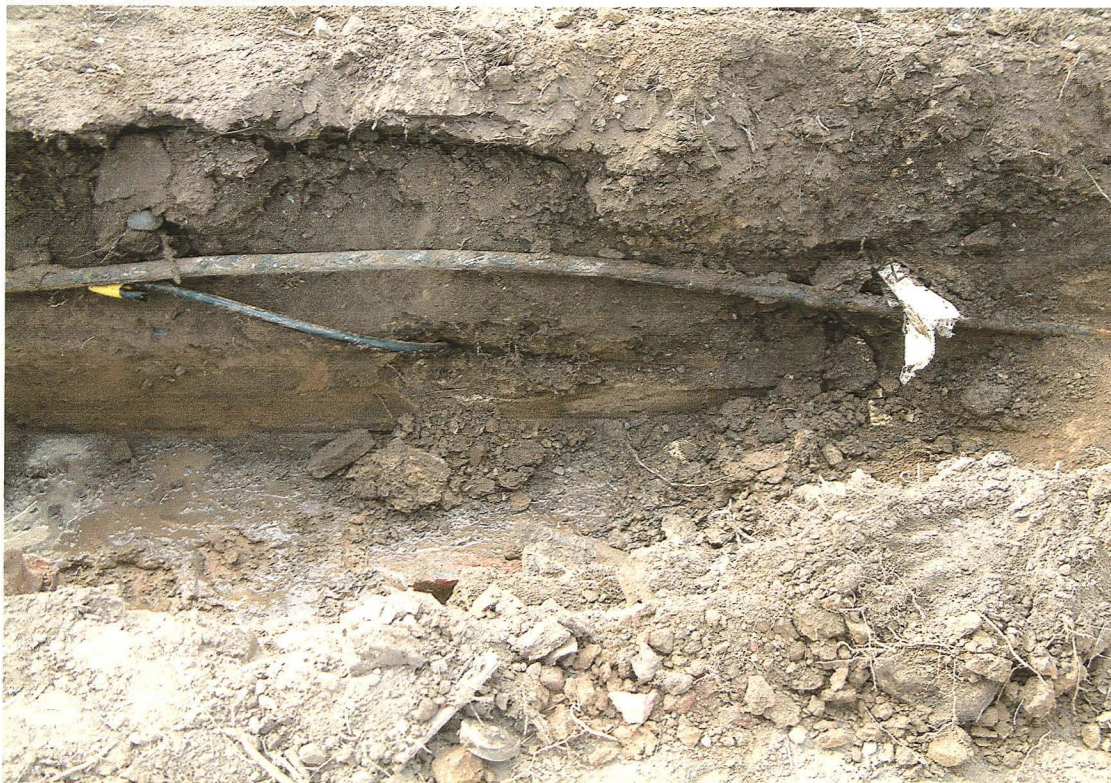
Plate 20. Showing old service pipes and cables.

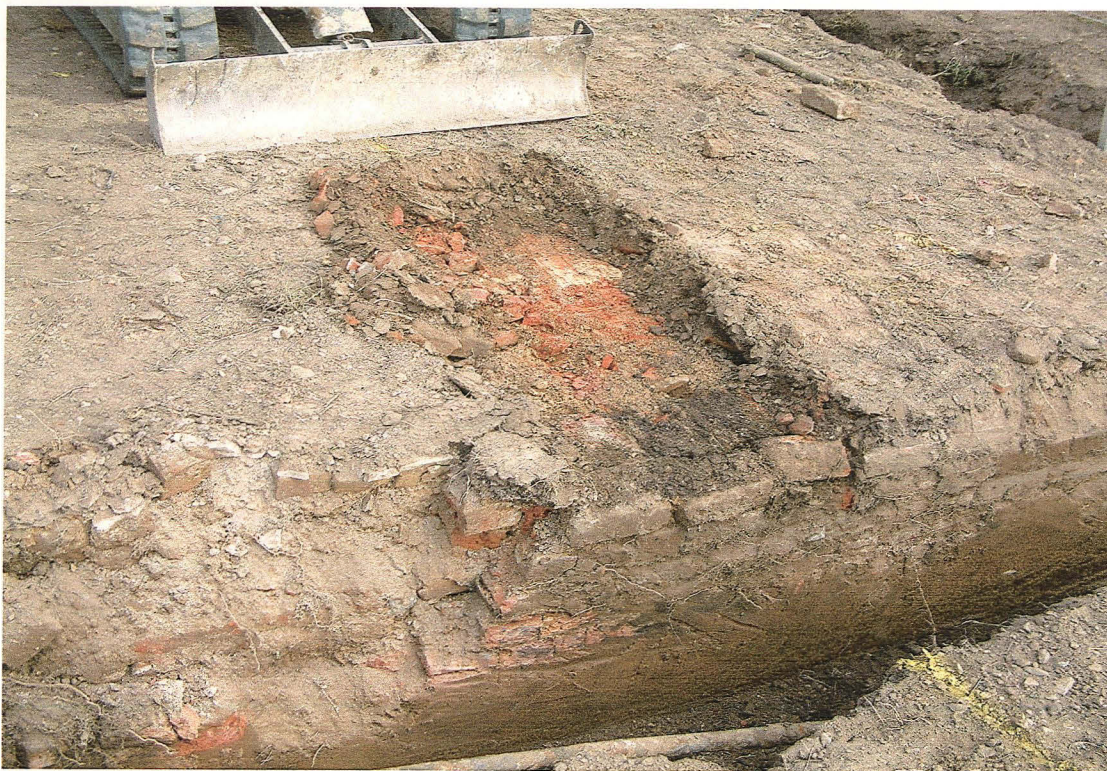
- 6.16 This sealed a brown silty sand (102) which was considered to be the natural geology and seen at a depth of 0.7m below the original ground surface (0.2m had already been removed during site clearance). In places, the original footings were still in situ and parts of these were left (see Plates 21 & 22).

Plate 21. Showing old footings of demolished building left in situ.

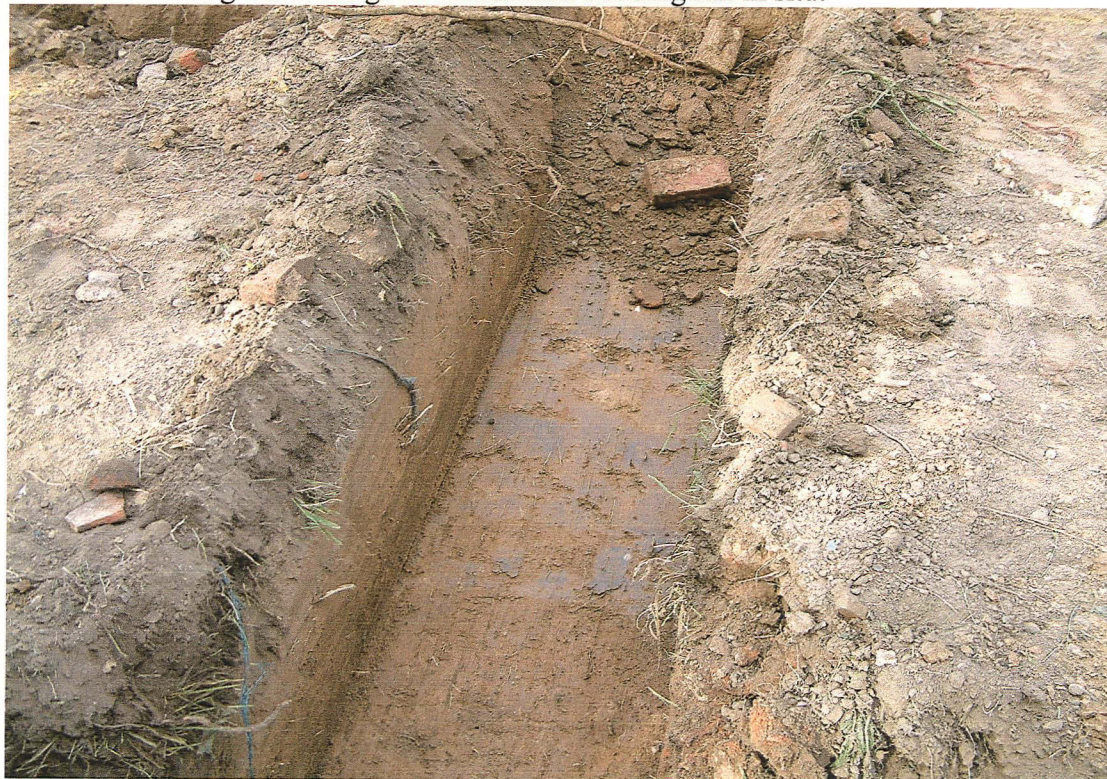
Plate 22. General shot of footings.
