LINDSEY ARCHAEOLOGICAL SERVICES

St Wulfram's Church Grantham Archaeological Watching Brief

Site Code: GSW 94

October 1995

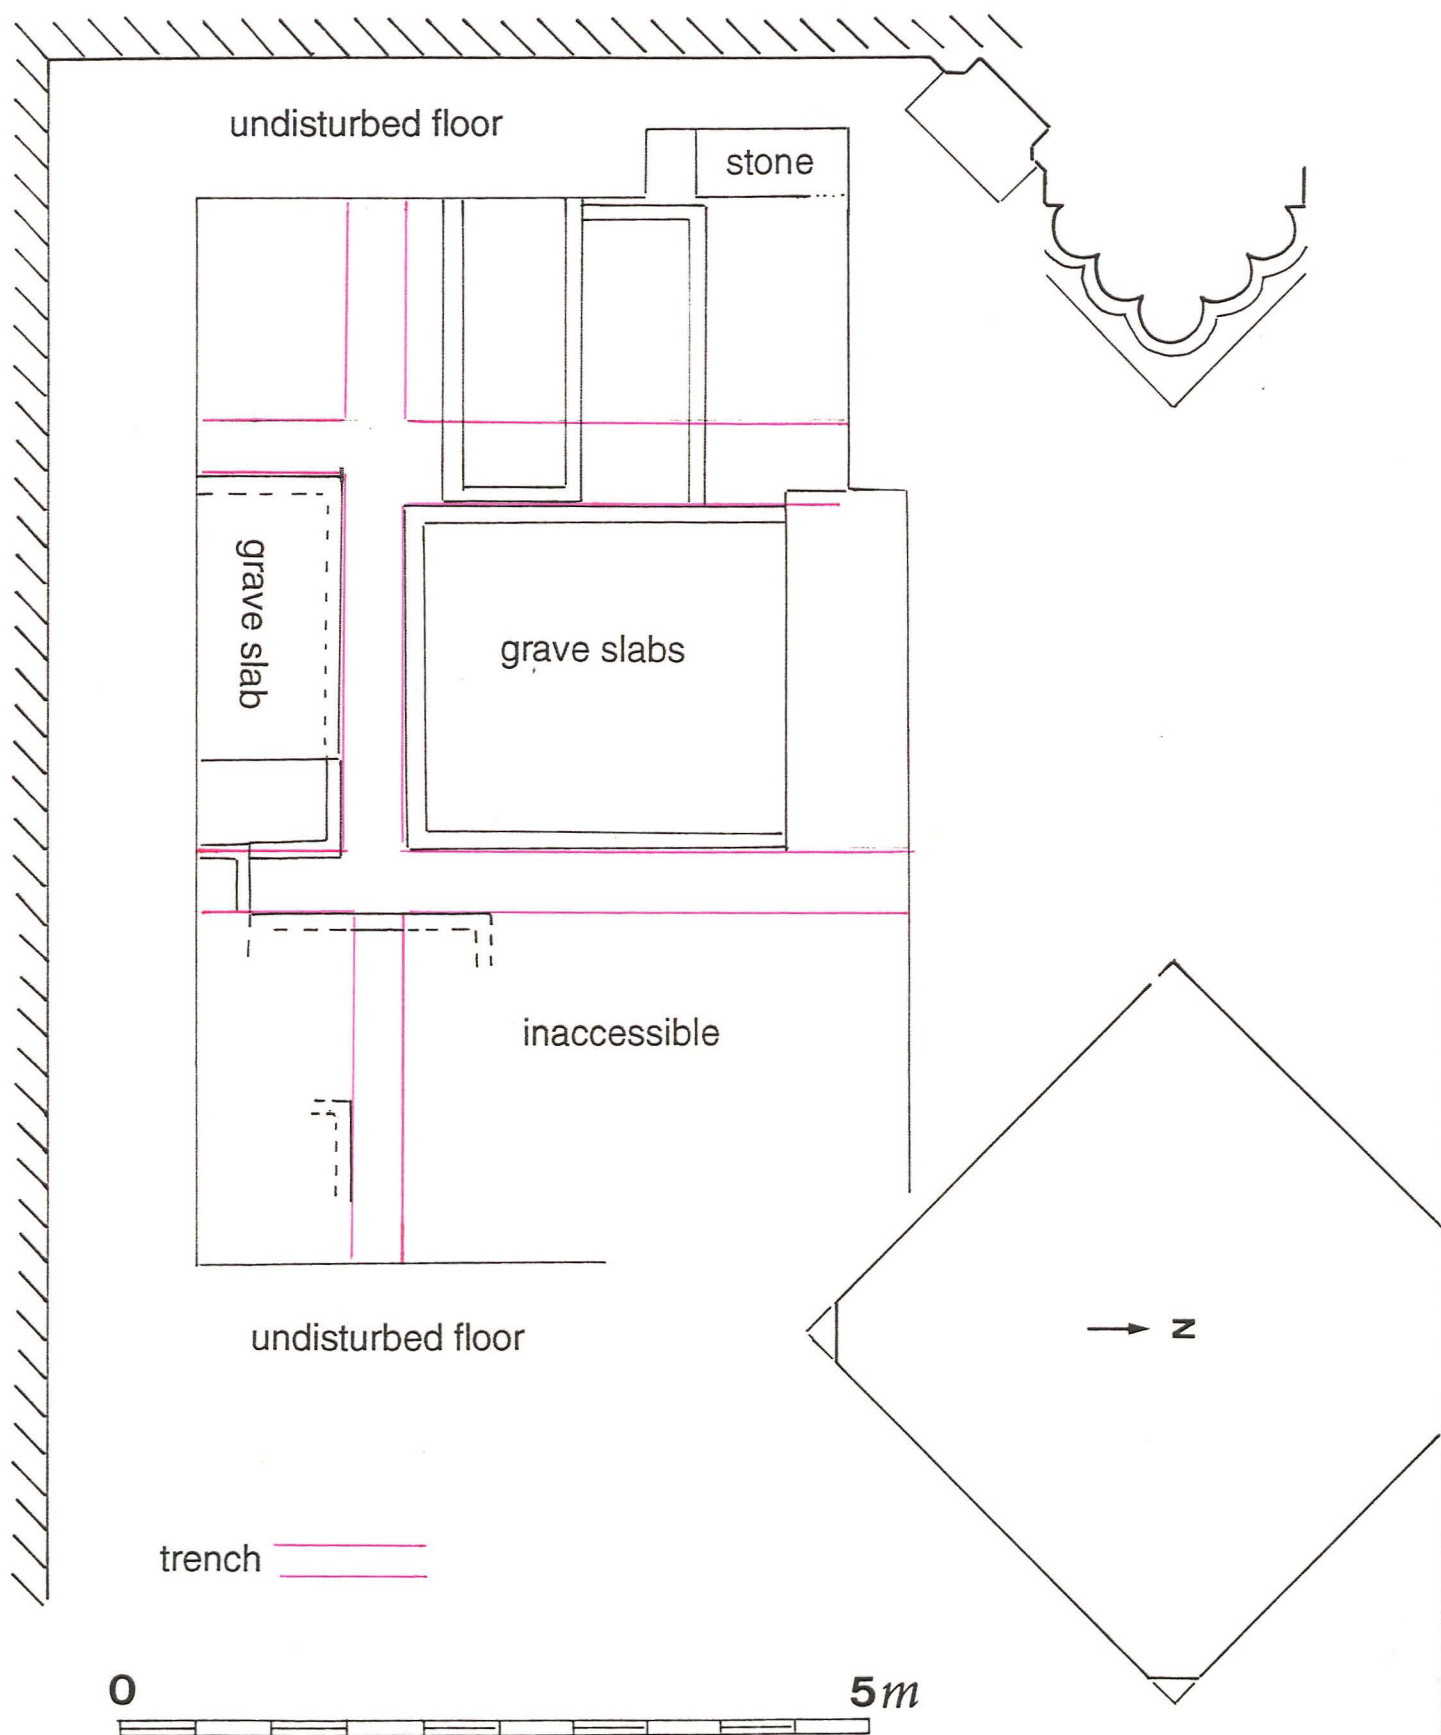
Removal of the crushed limestone bedding revealed at least 8 brick vaults (Fig. 2). A row of three was visible along the west wall of the aisle (Pl. 3).

The eight recorded vaults had completely removed any earlier deposits and no further monitoring of the building works was carried out inside the church.

Fig. 2 Sketch drawing of vaults revealed beneath south aisle floor. Position of foundations for toilets and office based on drawing kindly supplied by Bond and Read. (N. Field)

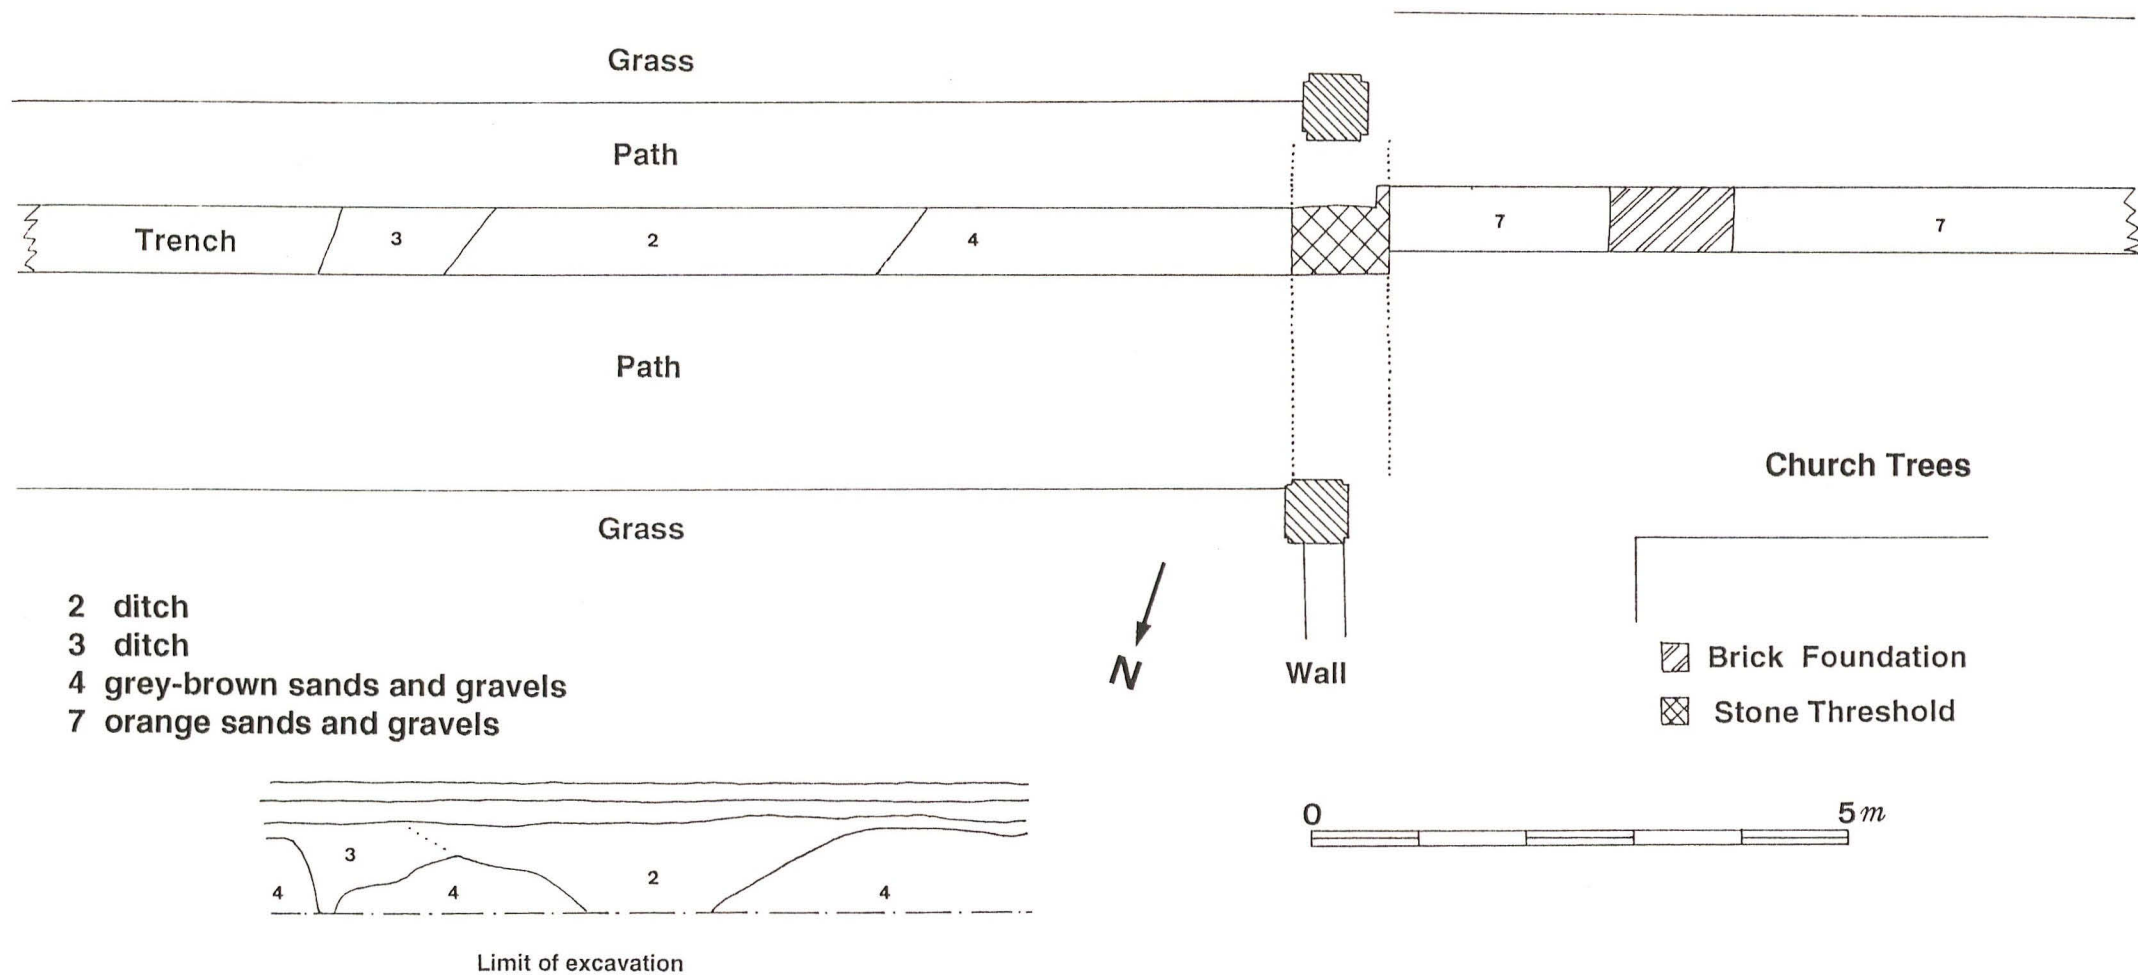
The trench west of the church cut through layers of grey-brown sand and gravel, remarkable for a churchyard, where one usually finds dark humic soil riddled with graves. At a distance of 25.10m from the West Door were two ditches, crossing the trench apparently running NE-SW (Fig. 3, Pl. 12). (The trench width was too narrow to ascertain their precise orientation.) The larger of the two lay to the west and cut through the backfilled smaller ditch. Its fill was an orange-brown sand.

A stone threshold was observed immediately beneath the flagstones which cross the churchyard entrance (Fig. 3, Pl. 13).

At a point 2.30m west of the gates is a brick foundation 1.20m wide and 0.40m deep, comprising 5 courses of brick. It followed in line with the east wall of the Hurst's Almshouses (Fig. 3, Pl. 14).

Fig. 3 Plan and section drawing of part of the pipe trench to either side of churchyard entrance (N. Field/ M. McDaid)

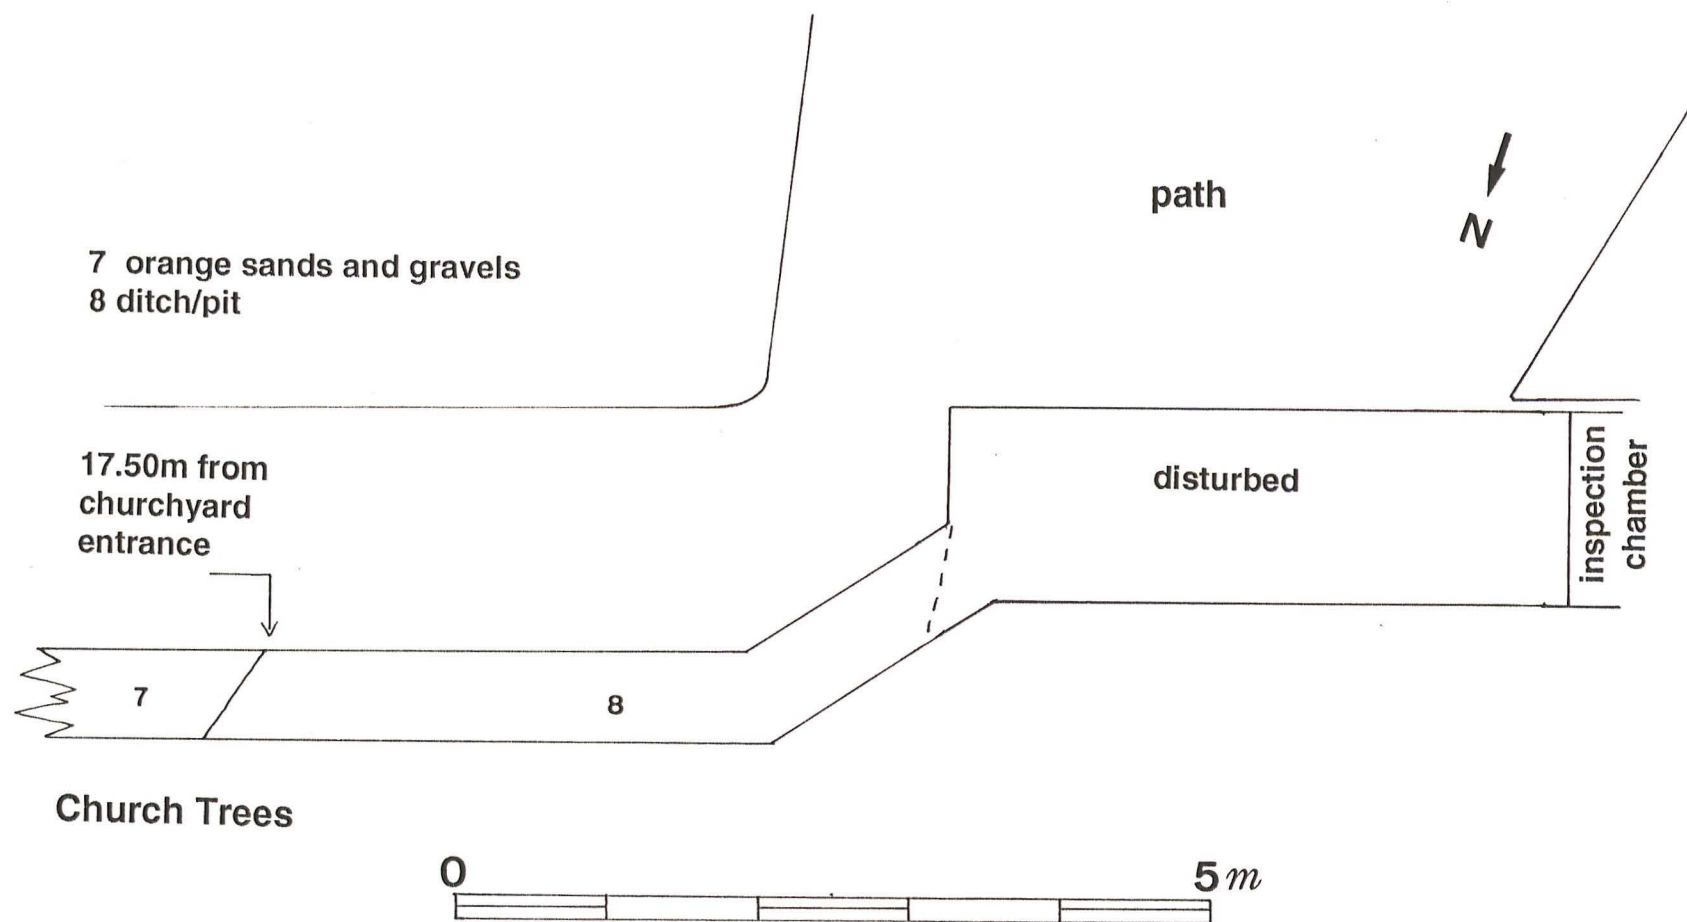
It was at the junction of the two footpaths that the trench fill changed. West of the churchyard gates the trench cut through orange sands and gravels which gave way at a point 16.70m west of the gates to darker mixed soils, possibly marking the line of another ditch (Fig. 4, Pls. 16,17,18). Unfortunately, this part of the trench was badly disturbed by tree roots and other service trenches. It was from the spoil of this darker soil that three plain pieces of pottery in a hard shell tempered fabric (two body sherds and a base) were retrieved. They were identified as Lincoln Kiln Type fabric dating to the late 9th-late 10th century. These were the only finds from the sewer trench.

Fig. 4 Plan showing location of possible ditch or pit at west end of pipe trench (N. Field/ M. McDaid)

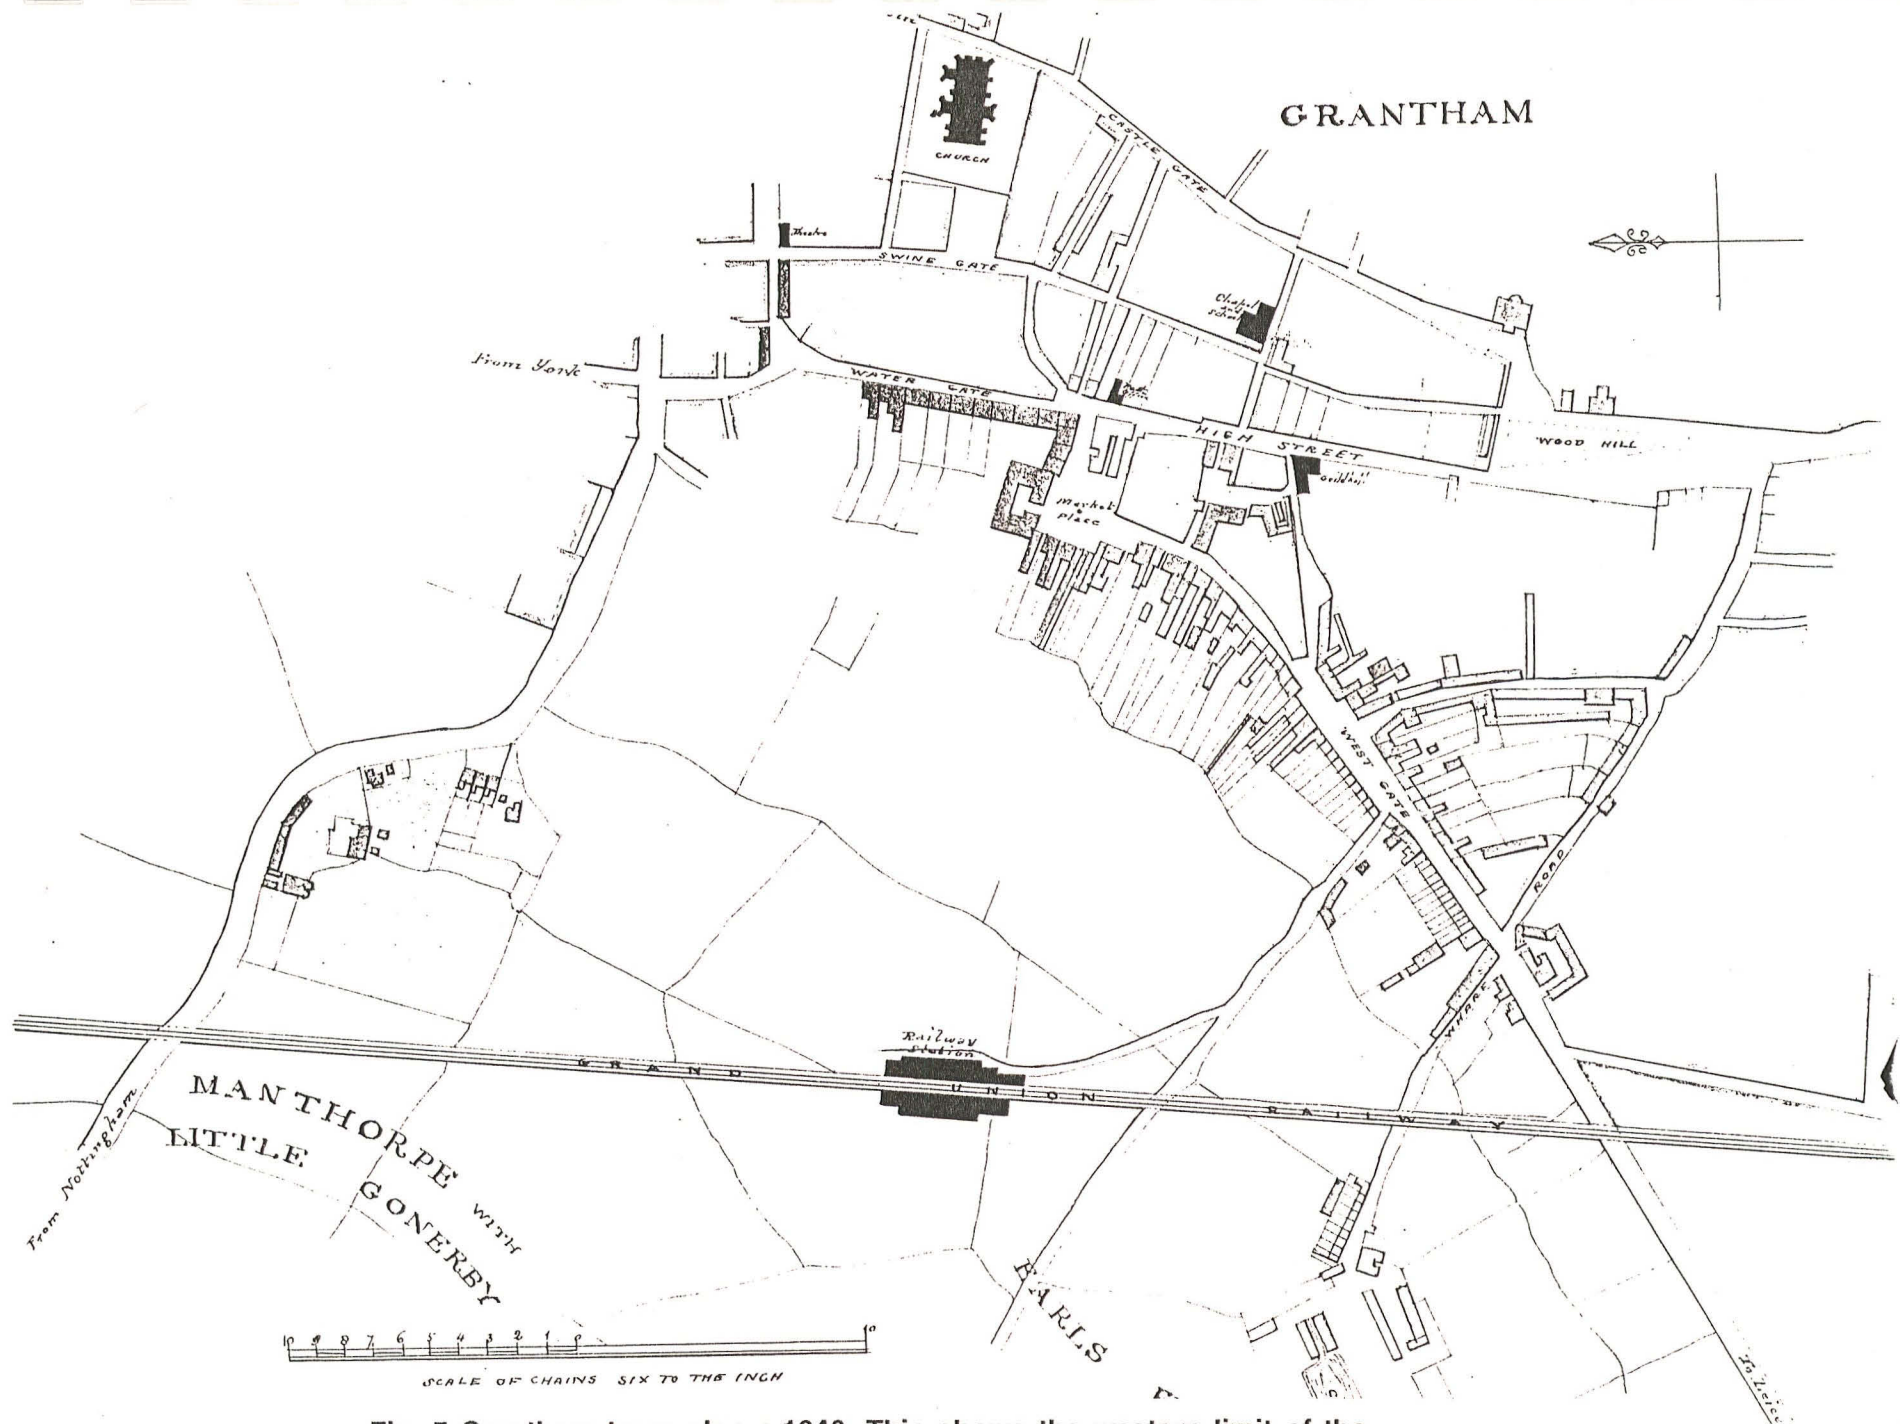
There was no direct evidence for former use of the land as a market or area of habitation. It is of note that an early town map of around 1840 (Fig. 5) shows the churchyard boundary before it was extended. If there was a market area it could have been in the block of land now occupied by the almshouses and other buildings, together with the open space, lying between the churchyard and Swinegate.

Fig. 5 Grantham town plan c.1840. This shows the western limit of the churchyard as a straight boundary running N-S.

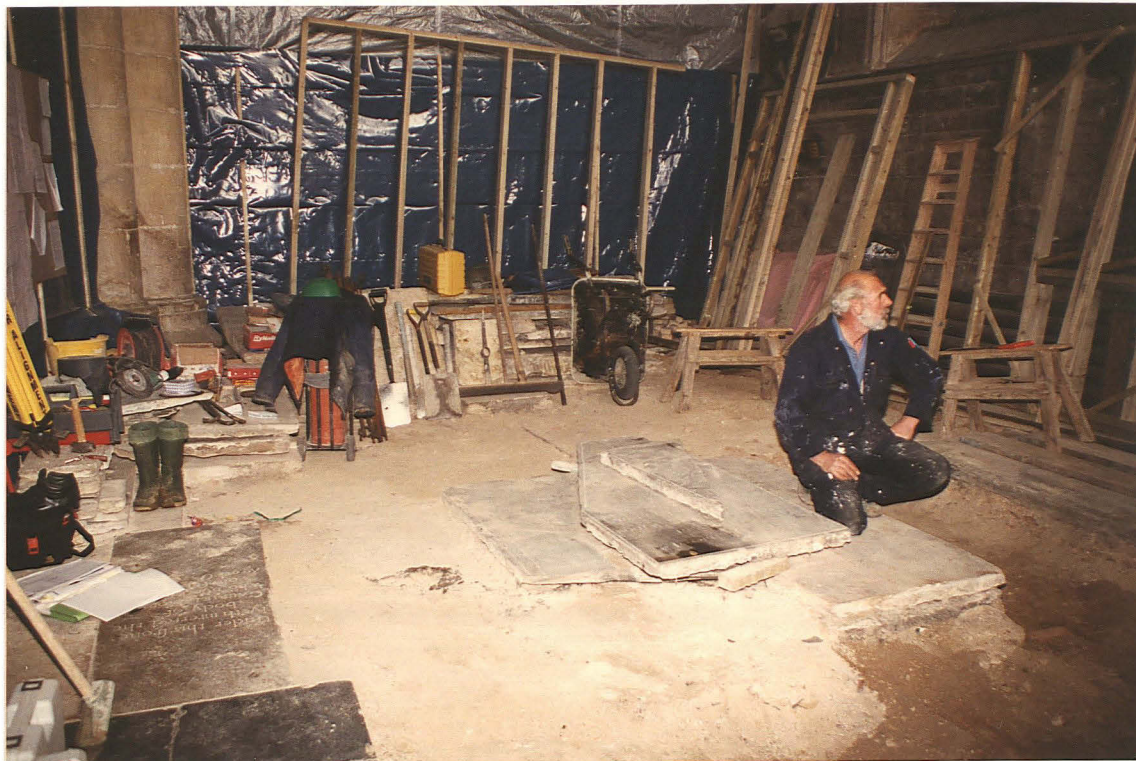
Pl. 1 General view of south aisle looking E after removal of floor and grave slabs

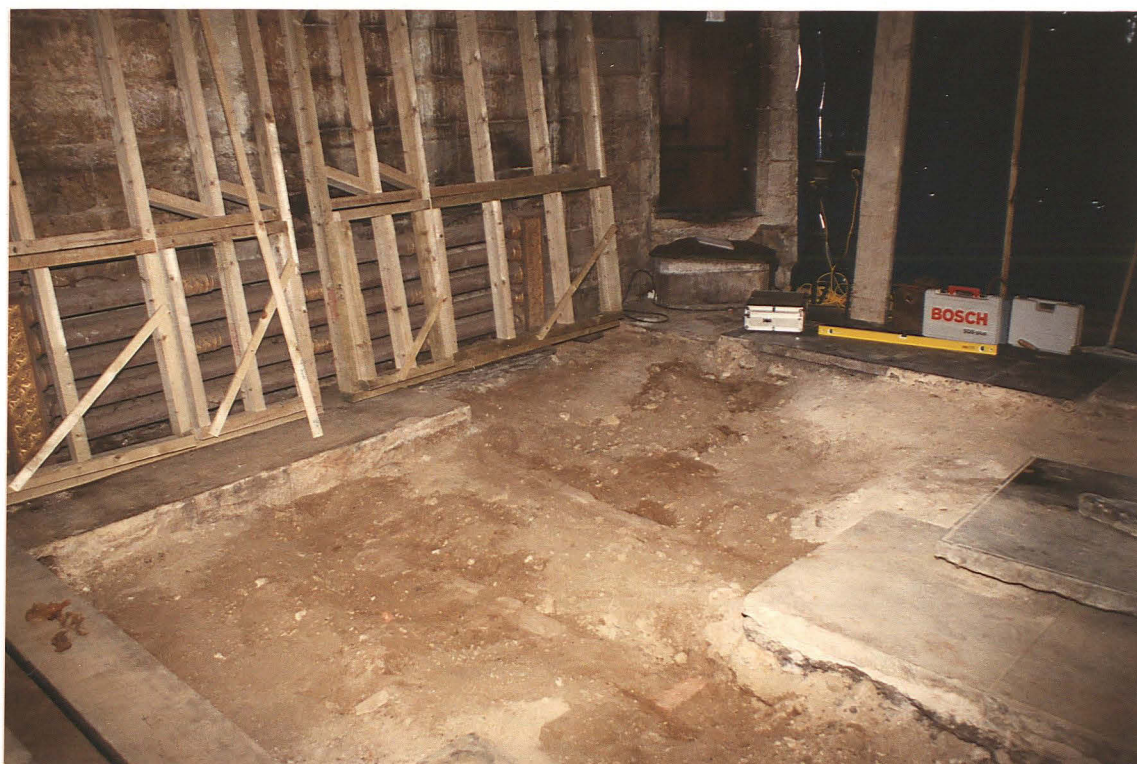
Pl. 2 W end of area after removal of floor makeup, showing traces of brick cross walls, in area of proposed toilets

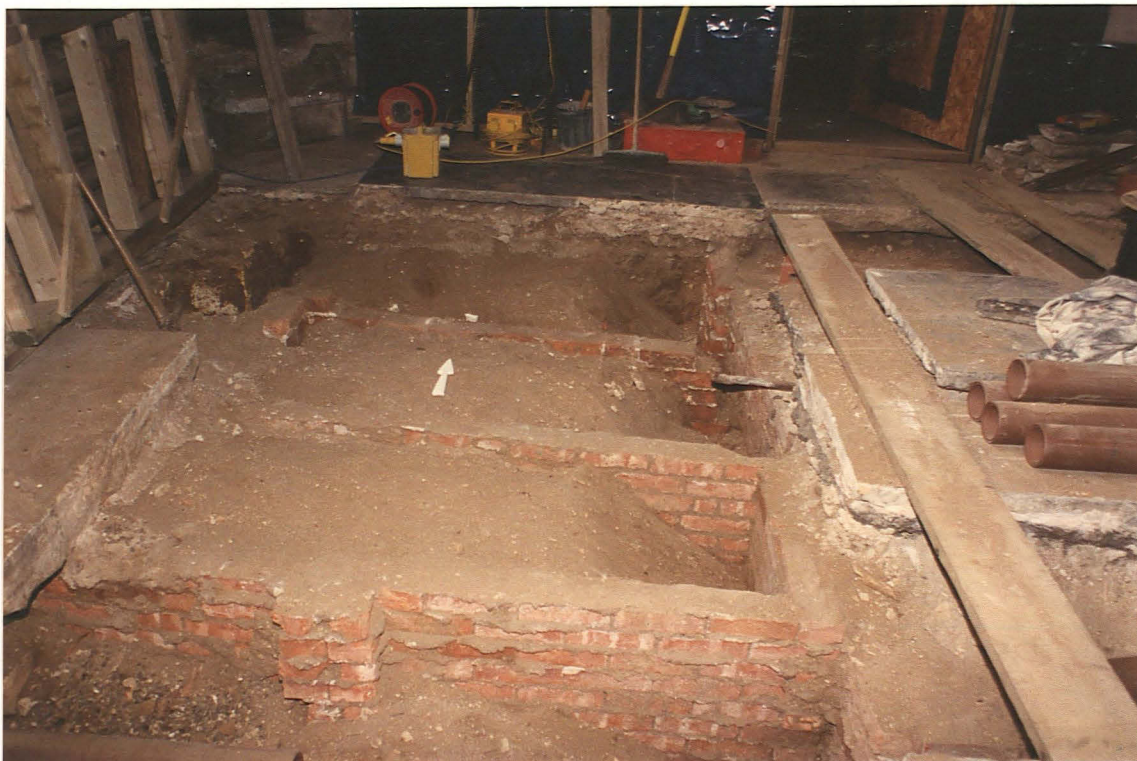
Pl. 3 Same area as Pl. 2 after excavation of soil along line of cross wall between office and toilets, revealing row of brick-lined vaults.

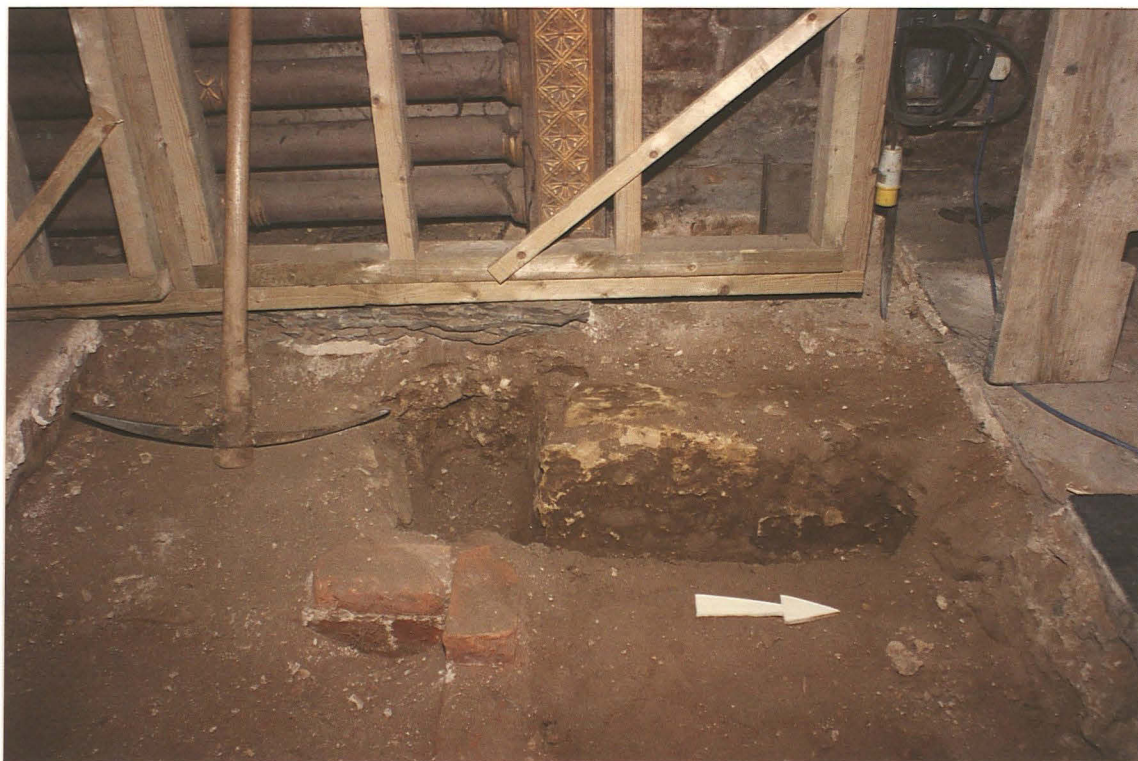
There was a large limestone block in the NW corner of the cleared area, close to the present west wall of the aisle (Pl. 4). This had been exposed by the contractors but was not investigated further.

Pl. 4 Large limestone block in NW corner of aisle

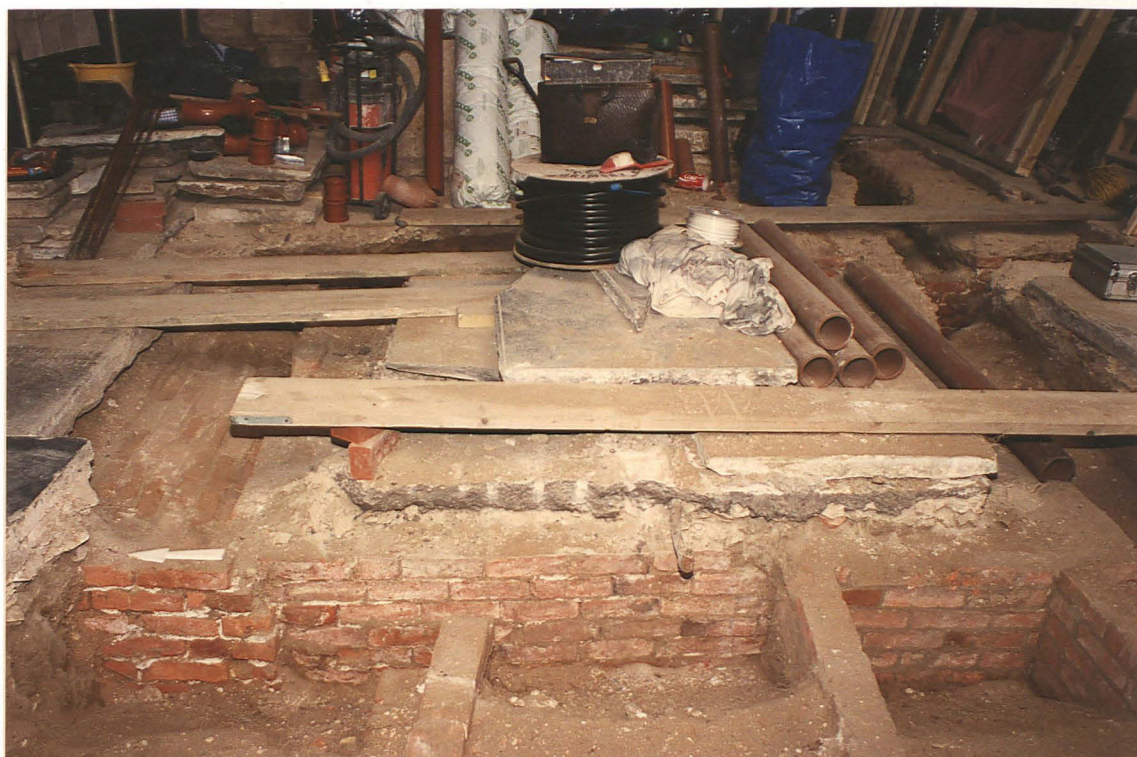
The vault walls on the west side of the aisle butted a double vault in the centre of the floor, beneath the two undisturbed grave slabs (Pls. 3,5). This in turn cut the edge of a grave to the north whose barrel vaulted capping was undisturbed (Pl. 5). It is not known if all the graves were originally sealed in a similar manner. The central graves also cut through a further brick lined vault to the SE (Pls. 6,7).

Pl. 5 Central area showing double brick vault cutting earlier barrel vaulted grave to N and butted by vaults, shown in Pl. 3, to W

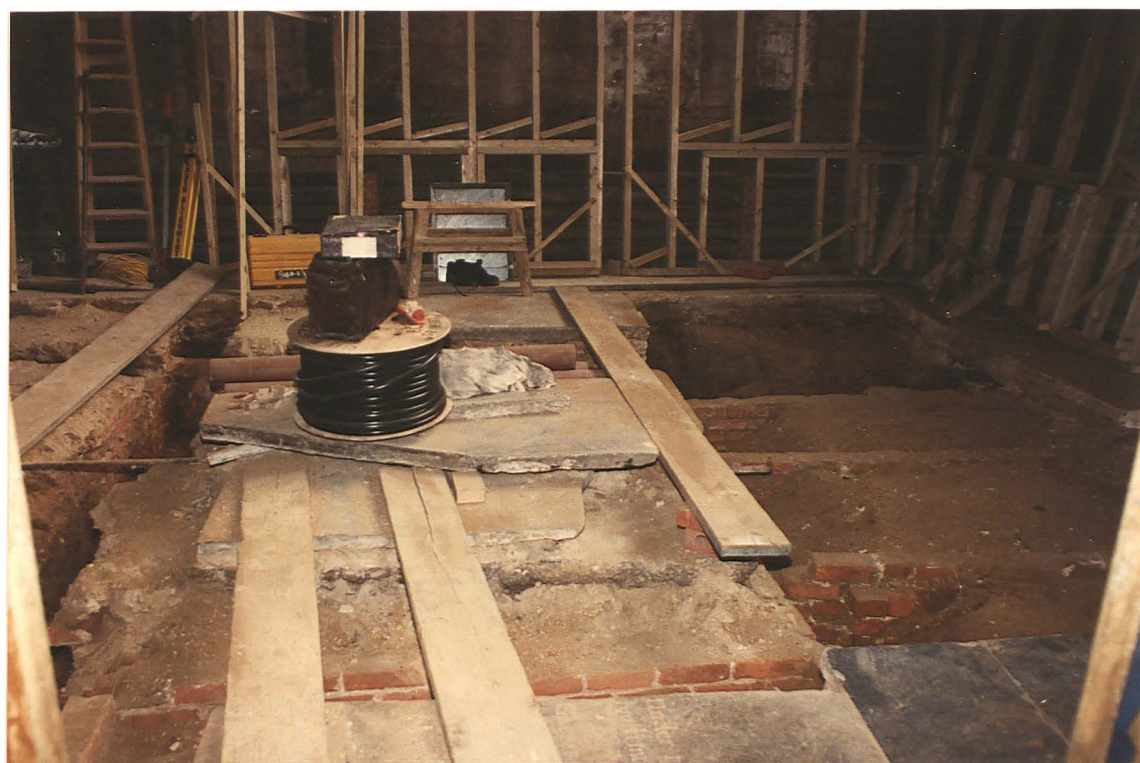
Pl. 6 General view looking S

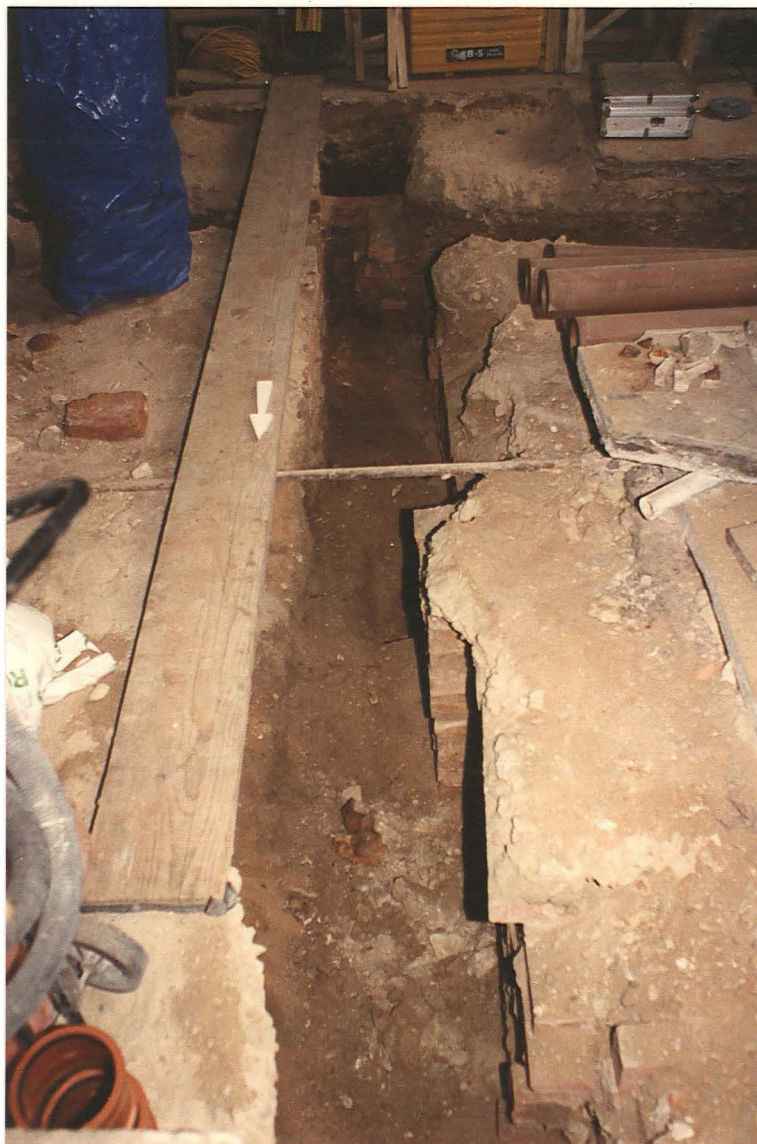
Pl. 7 Foundation trench for office E wall, looking S, showing edge of double vault and vault beyond

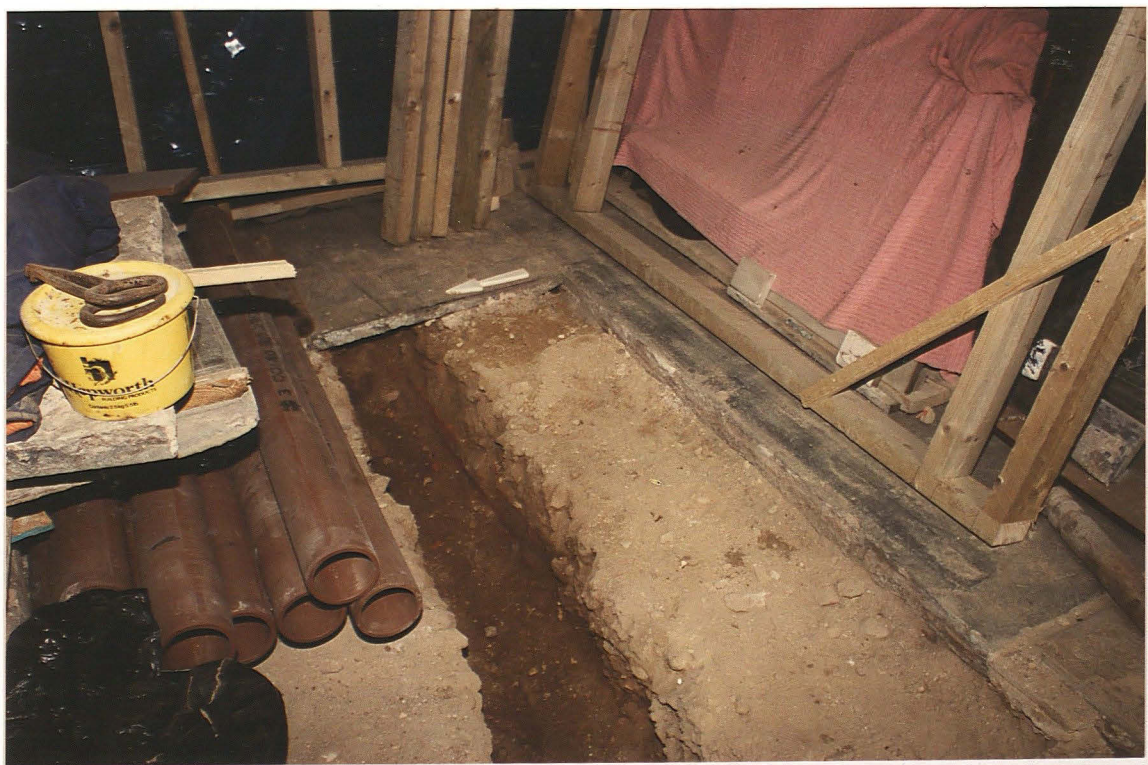
A foundation trench running east (for the store area) located a further brick vault on its south side (Pl. 8).

Pl. 8 Foundation trench along S wall of store showing edge of brick vault

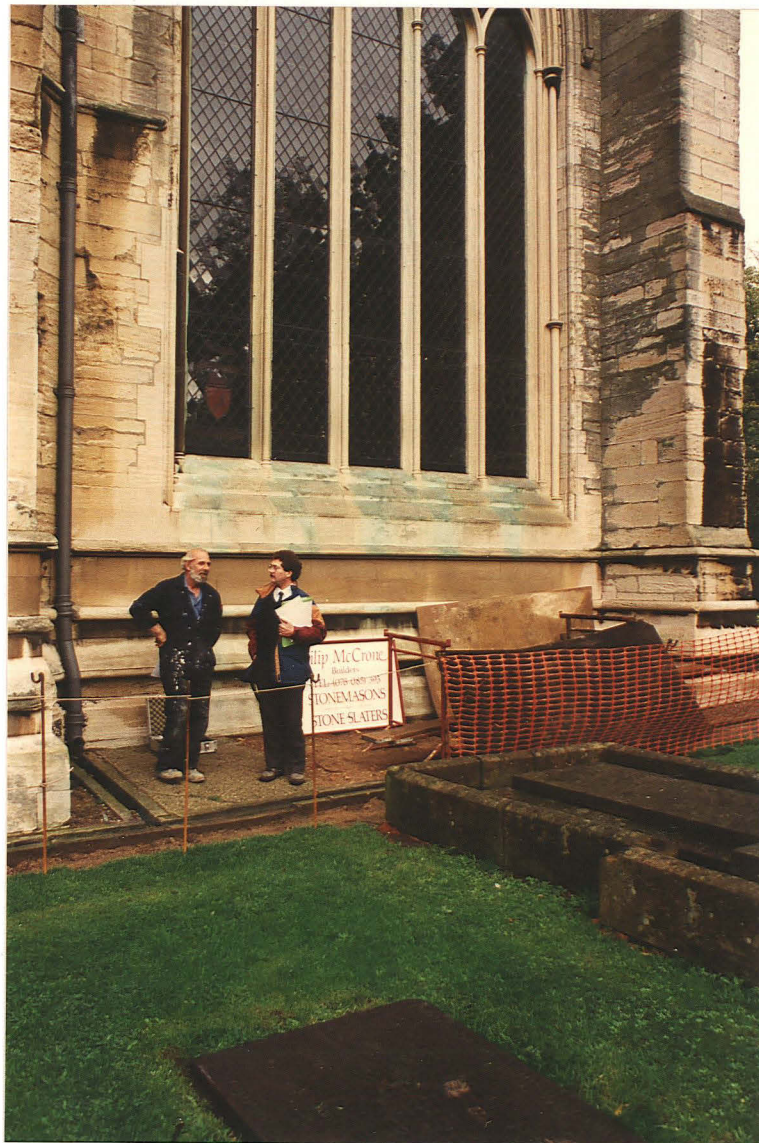
Pl. 9 South aisle W wall showing concrete apron between buttresses.

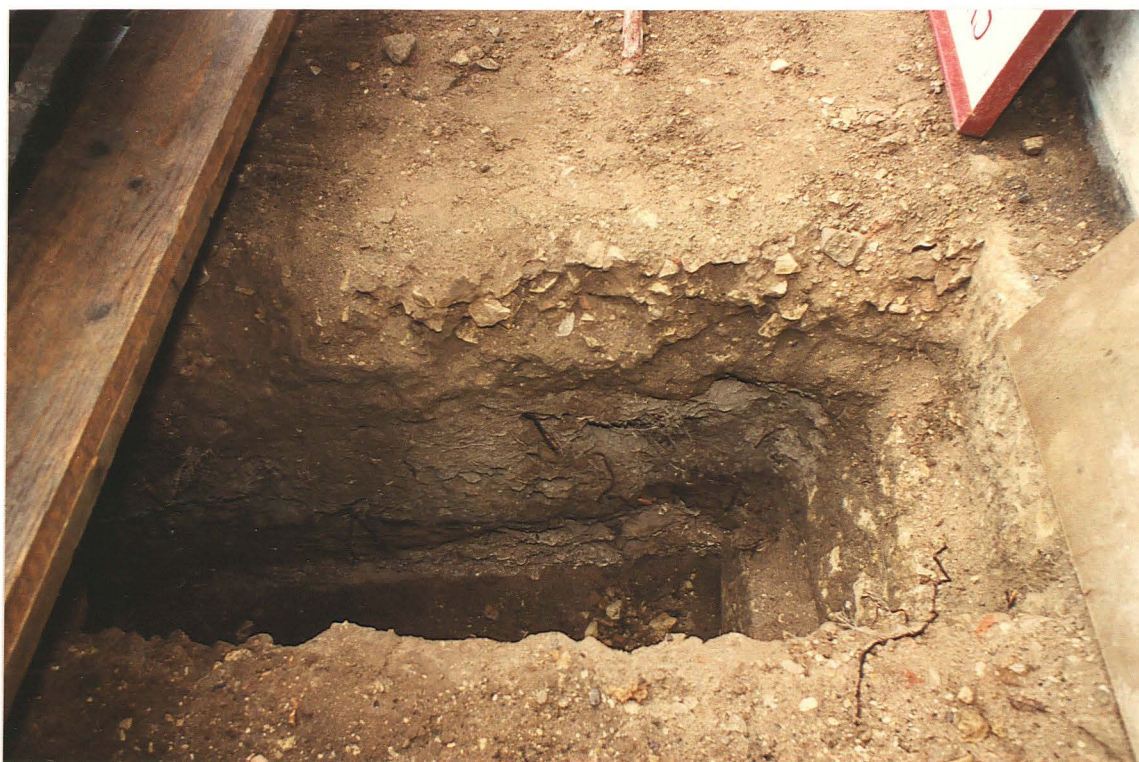
The sewer and water pipes were inserted beneath the foundations of the west wall of the south aisle. Only 0.30m length of the aisle wall was exposed in the trench outside. It is 2m wide above ground level with offset foundations visible in the trench (Pls. 9,10). Material visible in the trench which turned northwards running along the edge of the concrete apron between the buttresses appeared to be backfill of the church foundations. The sewer trench then turned west at the west door running along the existing path, through the churchyard gates, past the almshouses to join an inspection chamber west of Swinegate (Fig. 1, Pl. 11).

Pl. 10 Sewer trench perpendicular to aisle W wall, showing off-set footings

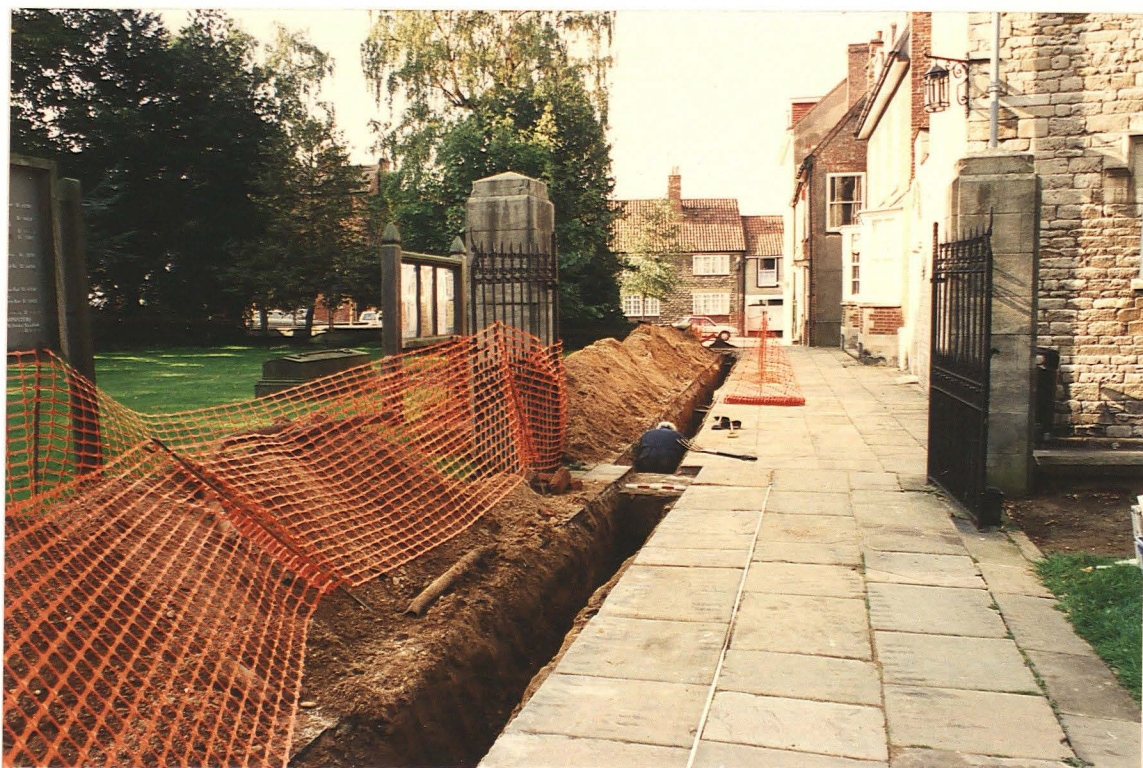
Pl. 11 Sewer trench looking W towards Swinegate

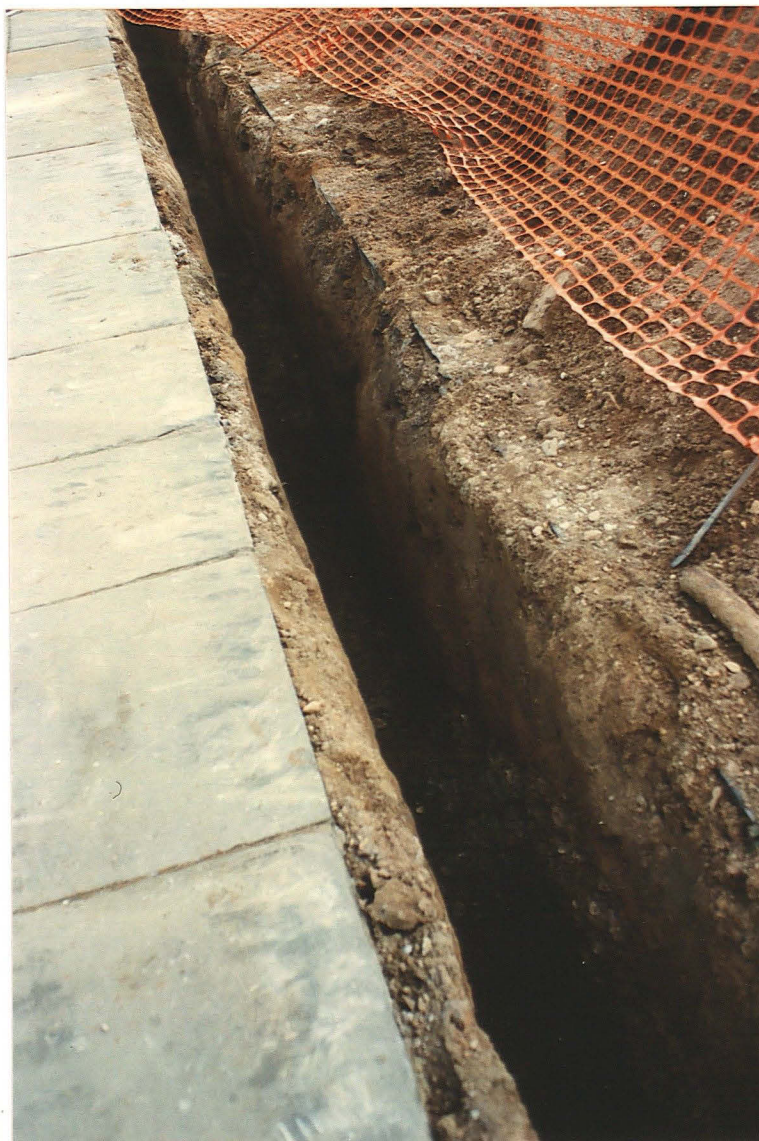
Pl. 12 N-S ditch in sewer trench east of churchyard entrance

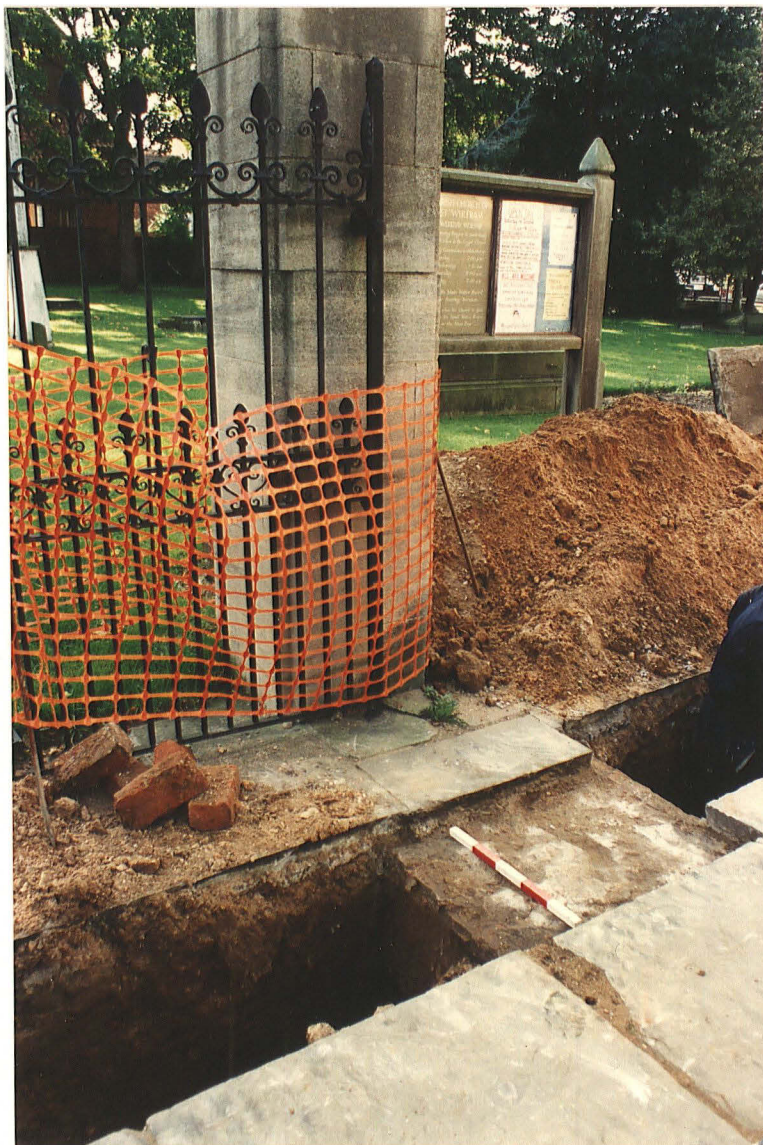
Pl. 13 Threshold stone beneath modern paving slabs marking entrance to churchyard

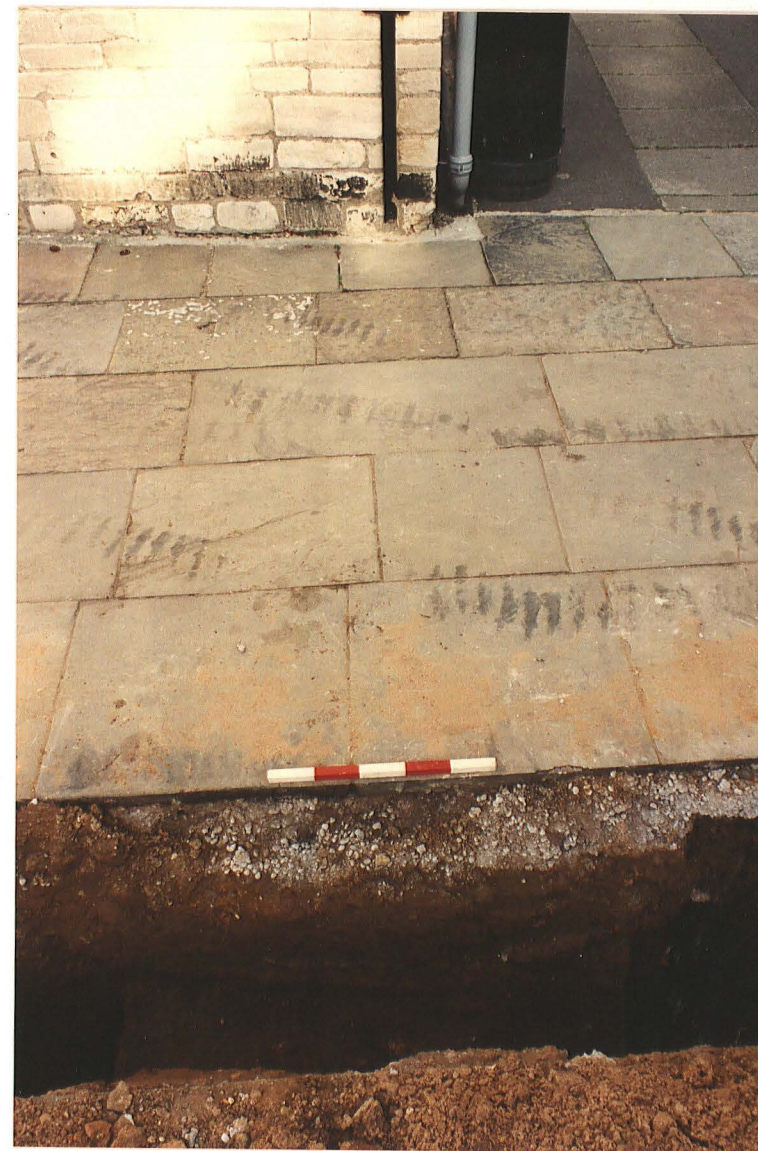
Pl. 14 Brick foundations in line with corner of almshouses W of churchyard entrance
