LINDSEY ARCHAEOLOGICAL SERVICES

St Wulfram's Church Grantham Archaeological Watching Brief

Site Code: GSW 94

October 1995

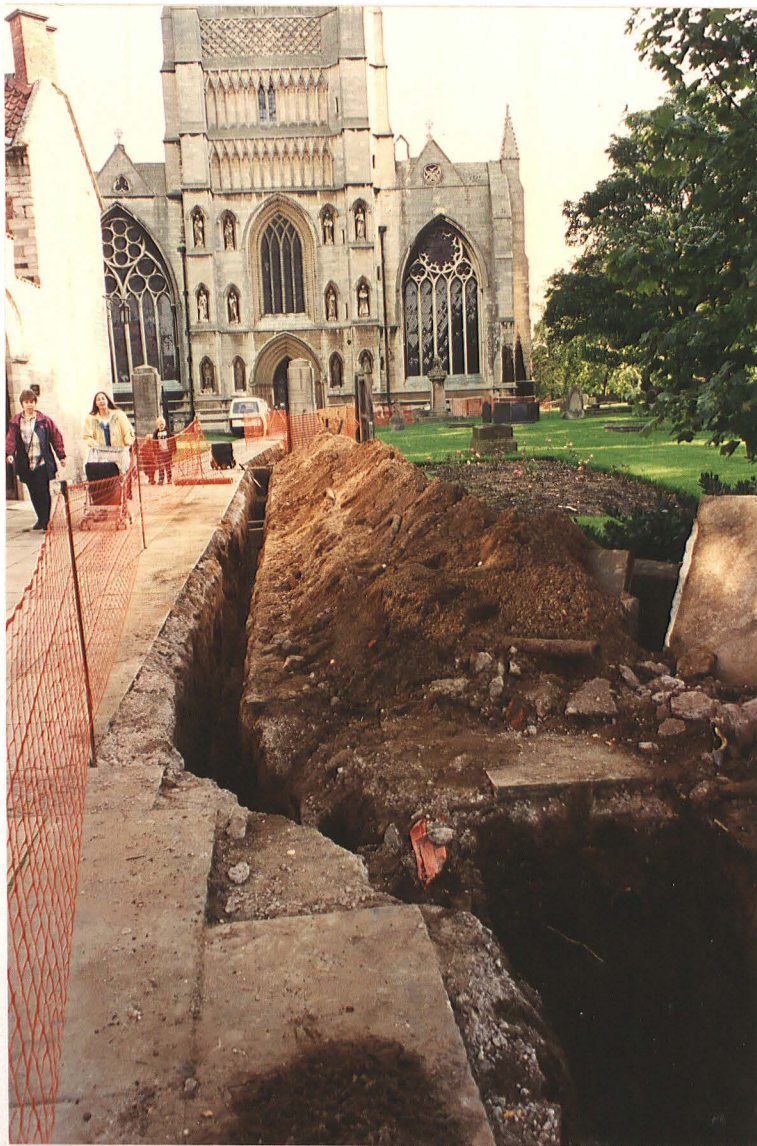
The trench continued along the south side of the footpath until it reached the junction with the smaller footpath leading off in a south-westerly direction. At this point the trench made a slight dog leg before continuing a further 4.60m to end at the brick inspection chamber adjacent to the retaining wall of the lawned area Pl. 15).

Pl. 15 Sewer trench looking E towards church

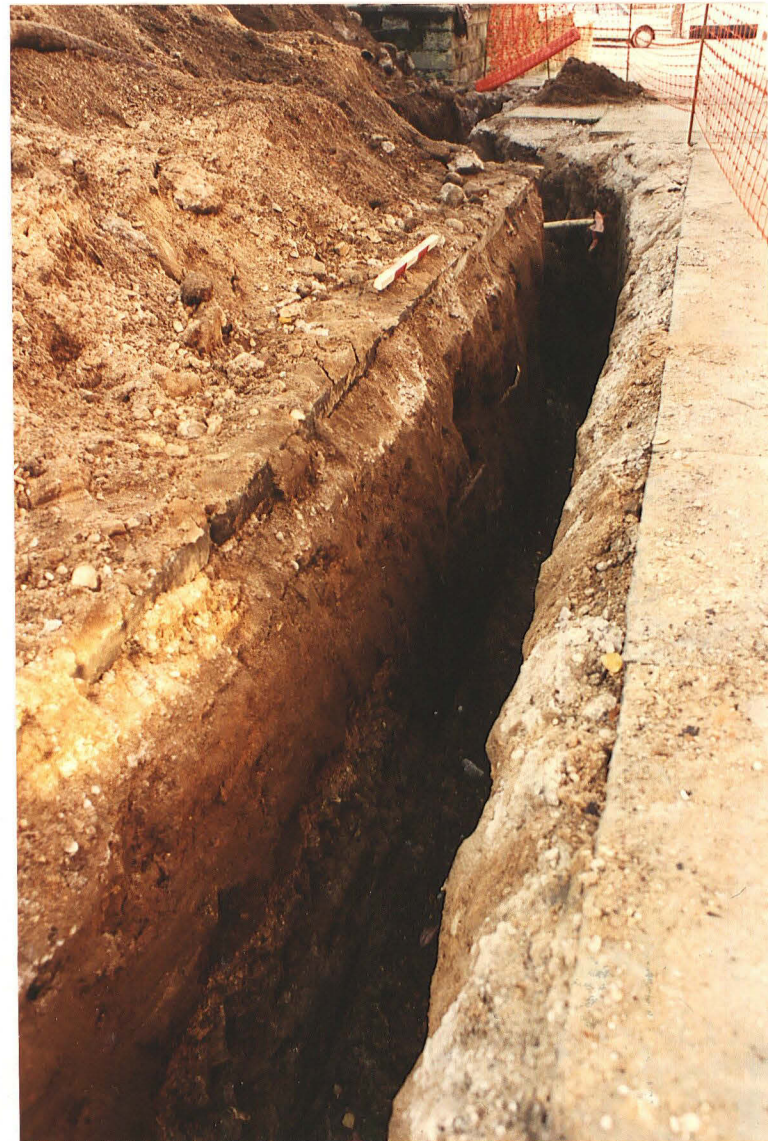
Pl. 16 Pit or ditch at junction with footpath looking W

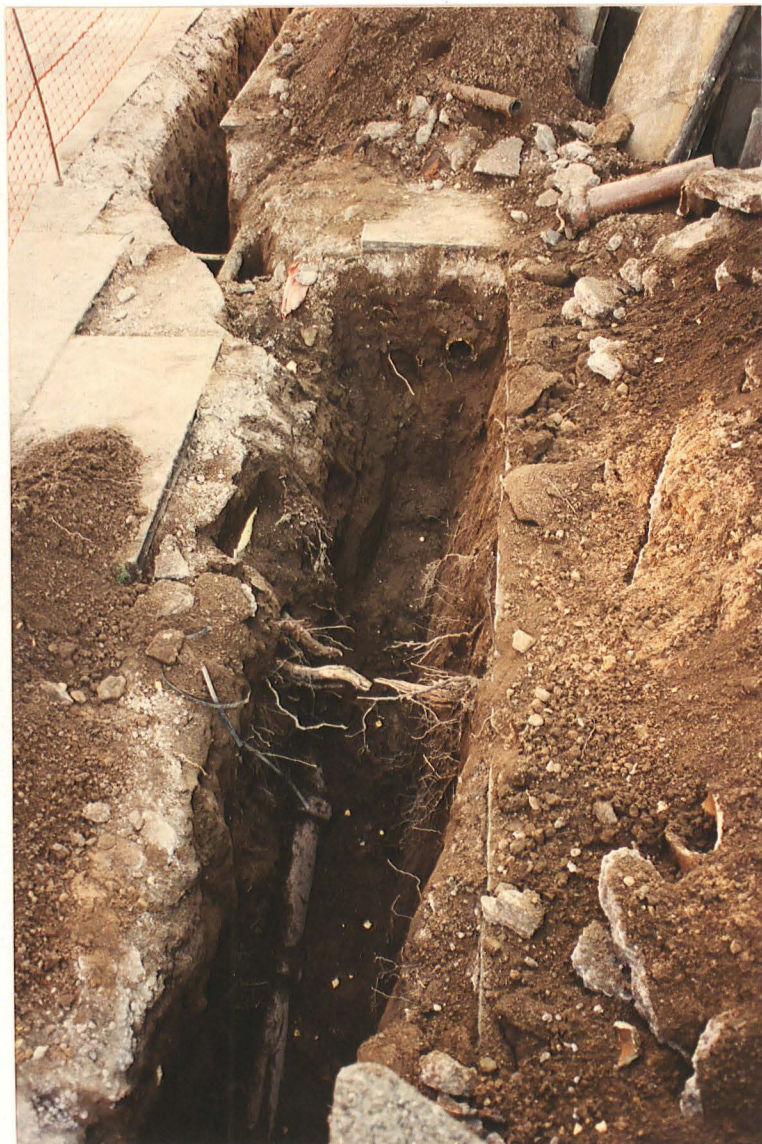
Pl. 17 Pit or ditch at junction with footpath looking E showing disturbance from earlier services and tree roots

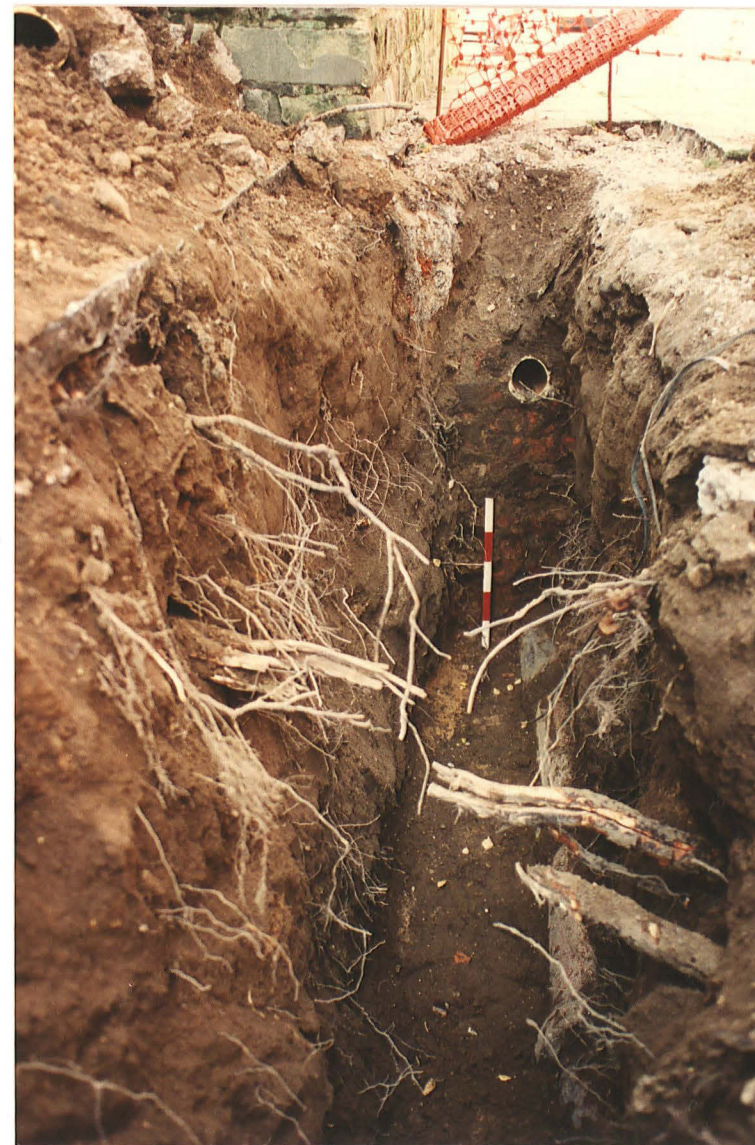
Pl. 18 End of trench at junction with brick inspection chamber, looking E towards Swinegate
