**Church of St Nicholas,  
Carlton Scroop with Normanton, Lincs.  
Archaeological Watching Brief**

**REPORT**

**LAS Report No. 1087**

**November 2008**

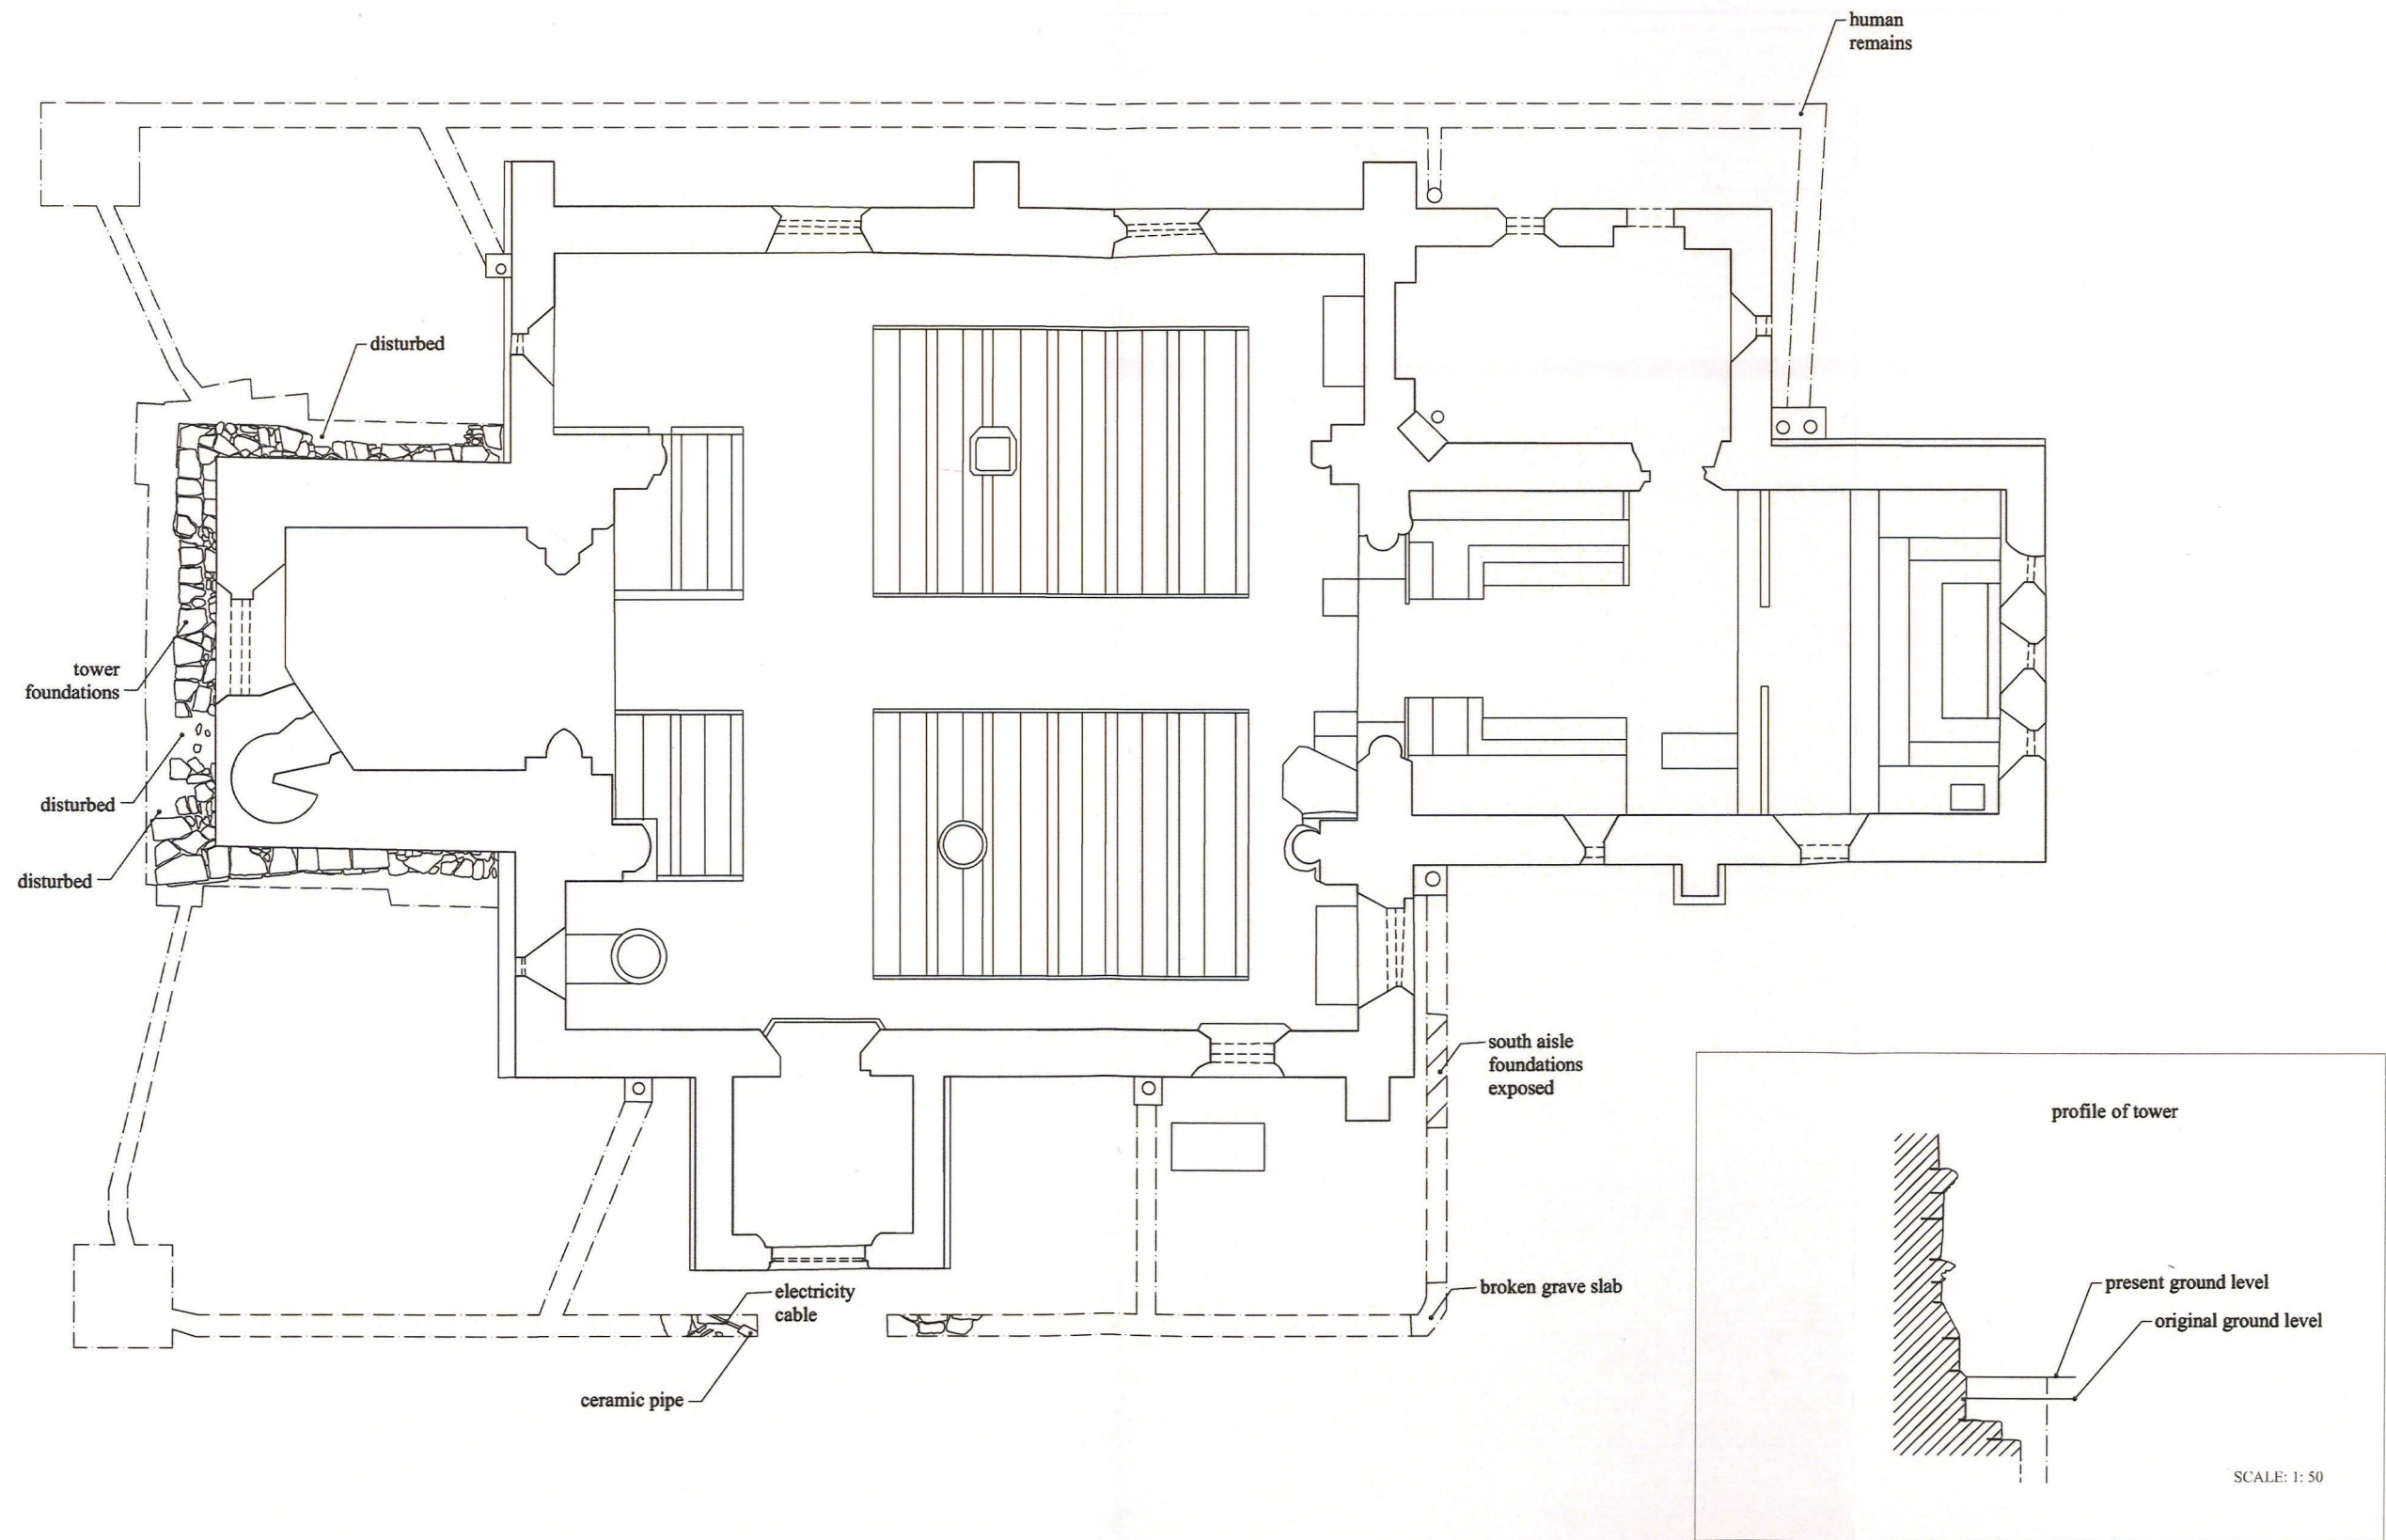
Fig.2 Normanton Church location of drainage works.

The excavations exposed foundations of existing elements of the building, the tower, the south porch and the south aisle. There were no finds such as pottery sherds, except for a small piece of window lead, which was not retained. No graves were disturbed during the works although the almost-complete remains of a single individual were dug up near the vestry. The bones were completely jumbled and had clearly been disturbed during previous excavation for drains. All human remains were retained by the contractors for reburial in the churchyard.

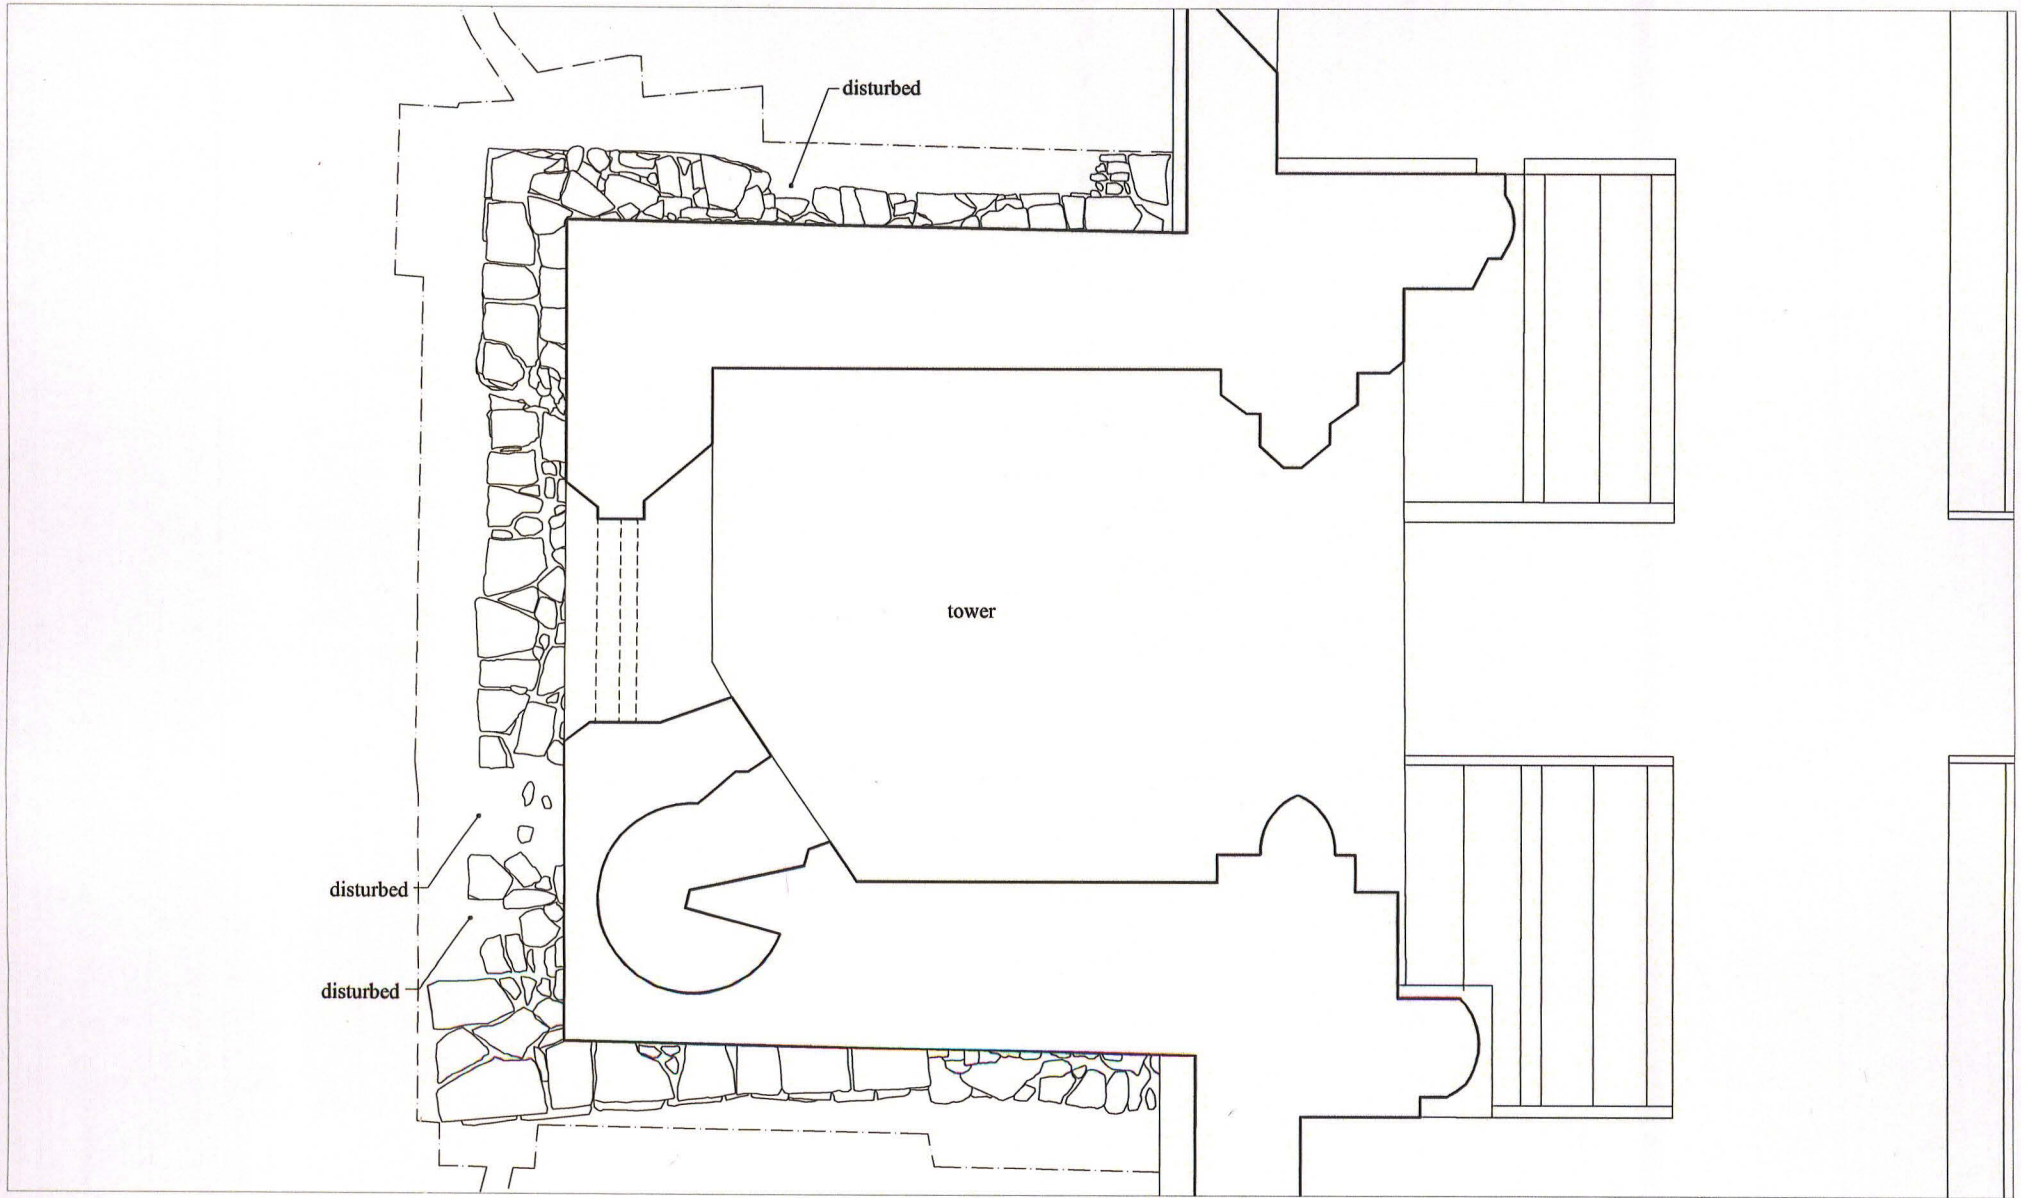
Fig.3 Tower foundations.

The drainage trench was dug around the three sides of the tower with connections to both soakaways (Pls 15 and 16). The ground level around the tower was not much higher than when it was originally constructed, just covering the offset foundation. On the north side of the tower the foundations were 0.60m wide at the junction with the north aisle widening to 0.70m at the tower north west corner (Pl. 17). The north aisle foundations appeared to be contiguous with those of

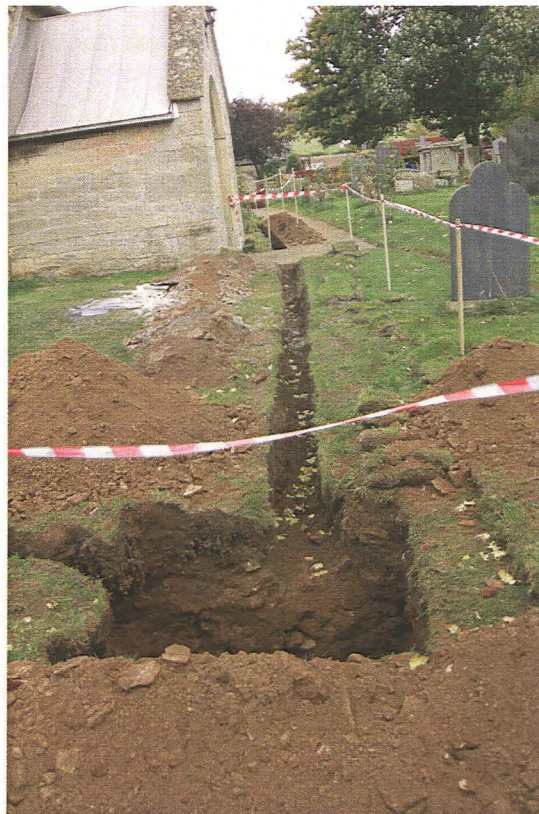
The drainage trench was dug south from the angle between the south aisle and the chancel, 0.45m from the wall, to a point 6m south of the south aisle (Pl. 6). Removal of the old drain at the base of the rainwater pipe revealed the foundations of both the chancel and the south aisle. The chancel foundation had a narrow offset of 3cm at the ground surface. At 0.38m below ground level was an offset foundation 0.20m wide, extending to an unknown depth below the base of the drainage trench.

Pl. 6 Drain trench along south side of the church , looking east

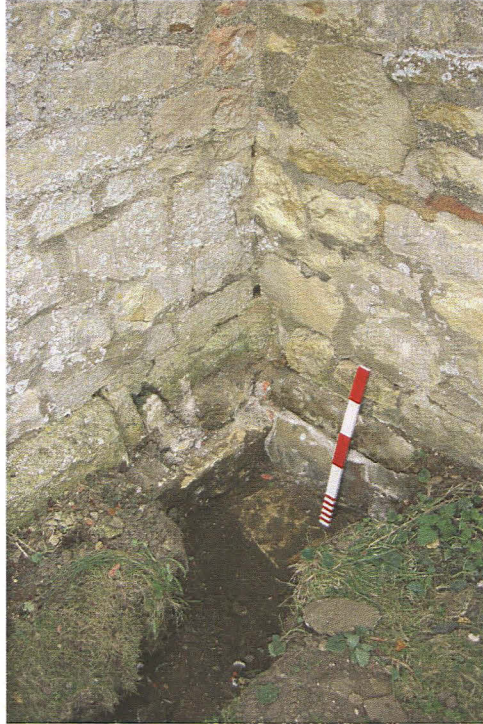
Large limestone blocks in the nave wall had been cut into for the attachment of the south aisle, which has a chamfered plinth 0.18m in height resting on a foundation offset by 0.09m, extending to an unknown depth below the base of the drainage trench (Pls 7 and 8). The quoins of the nave wall are visible higher up the aisle wall. The foundations were more clearly seen on the aisle south wall where the wall plinth rested on dressed blocks 0.80m high with two offsets each 0.20m wide, the upper being 0.08m high, the lower extending to an unknown depth below the base of the drainage trench (Pls 9 and 10).

Pl. 7 Junction of south aisle and chancel foundations, looking north, scale 0.50m

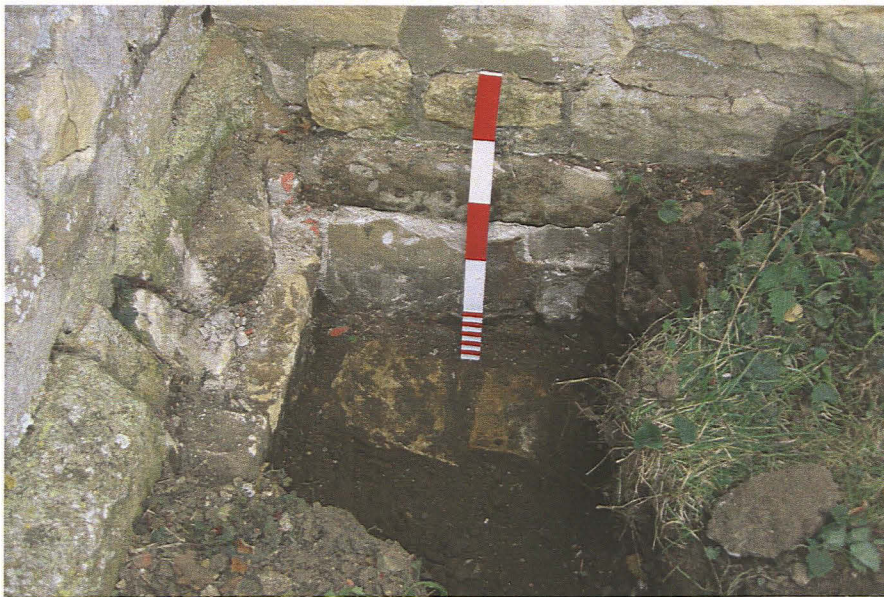
Pl. 8 South aisle and chancel foundations detail , looking north, scale 0.50m

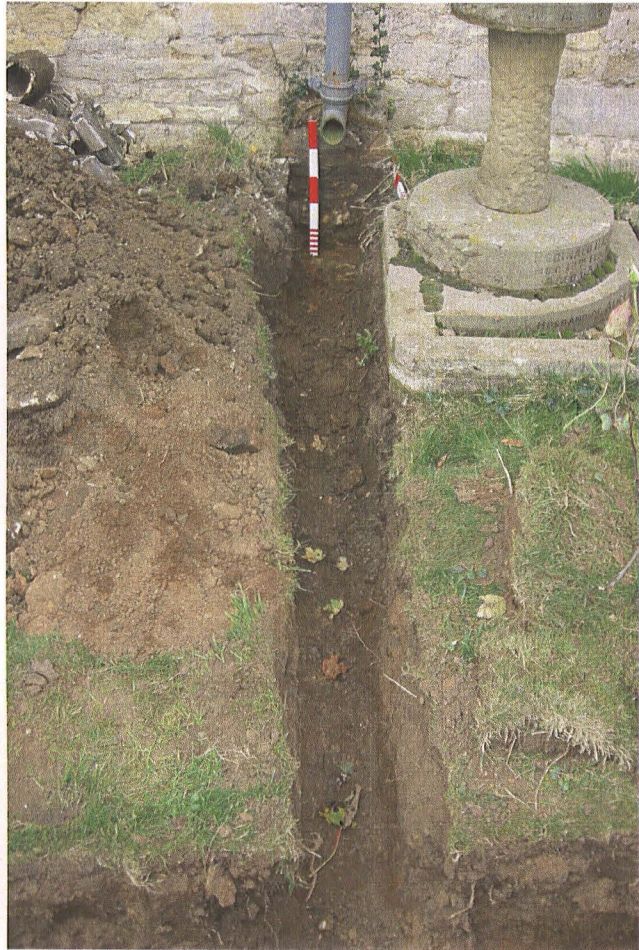
Pl. 9 Drain run on south wall of south aisle

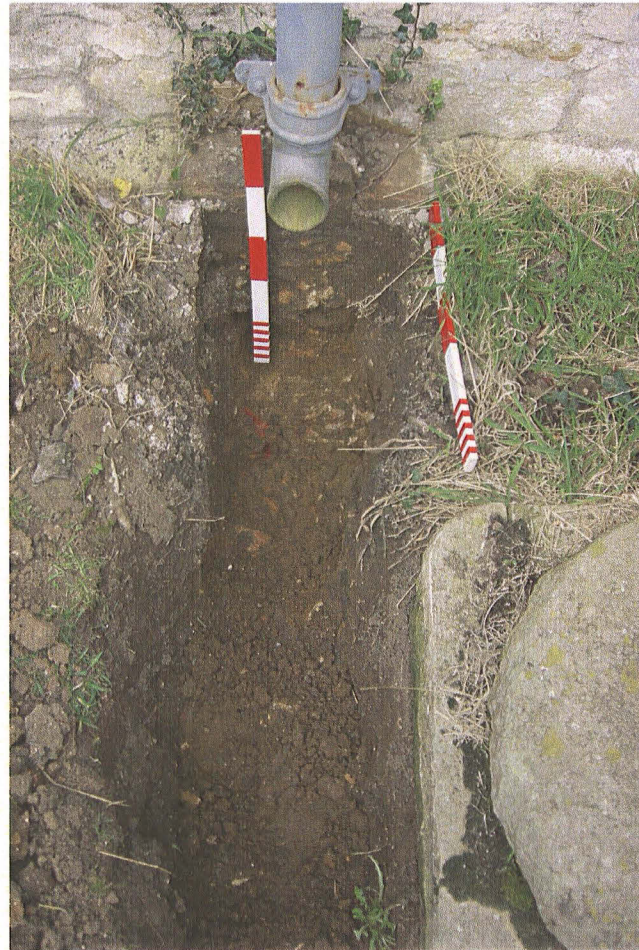
Pl. 10 South aisle foundations, scales 0.50m

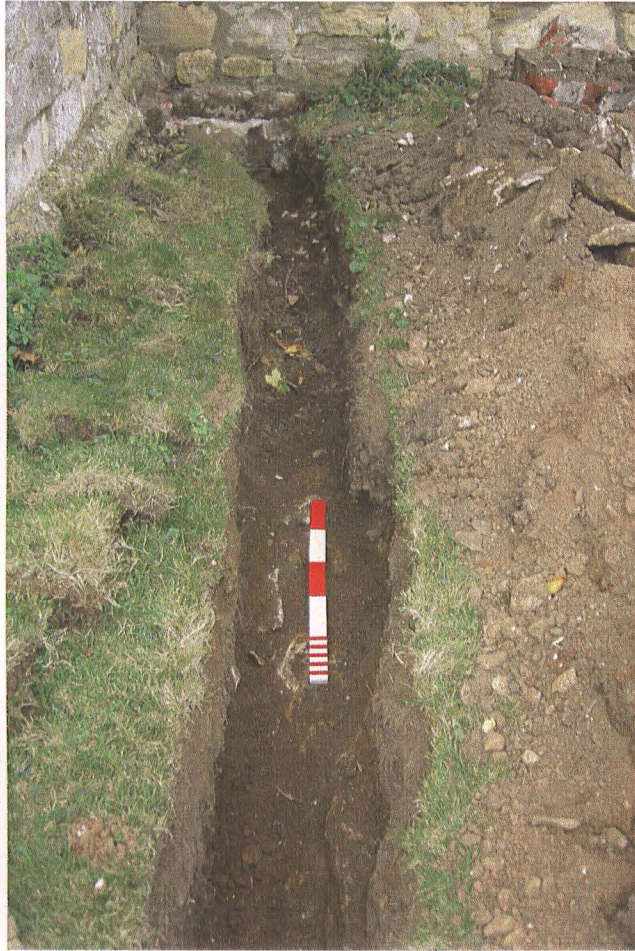
Stonework in the base of the north-south trench was interpreted as the foundations of the south aisle east wall (Pl. 11). At the point where the trench turned west along the south side of the church, just north of the footpath, were two pieces of a broken grave slab, 0.28m below the ground. The inscription was almost illegible but contained the words [mem] ory ....[a]ged 42 years.... [Cath] arine their .....wh[o].....i [ca...]. The classical border suggests an 18<sup>th</sup> –early 19th century date (Pl. 12).

Pl. 11 Drain run on south aisle east wall, scale 0.50m

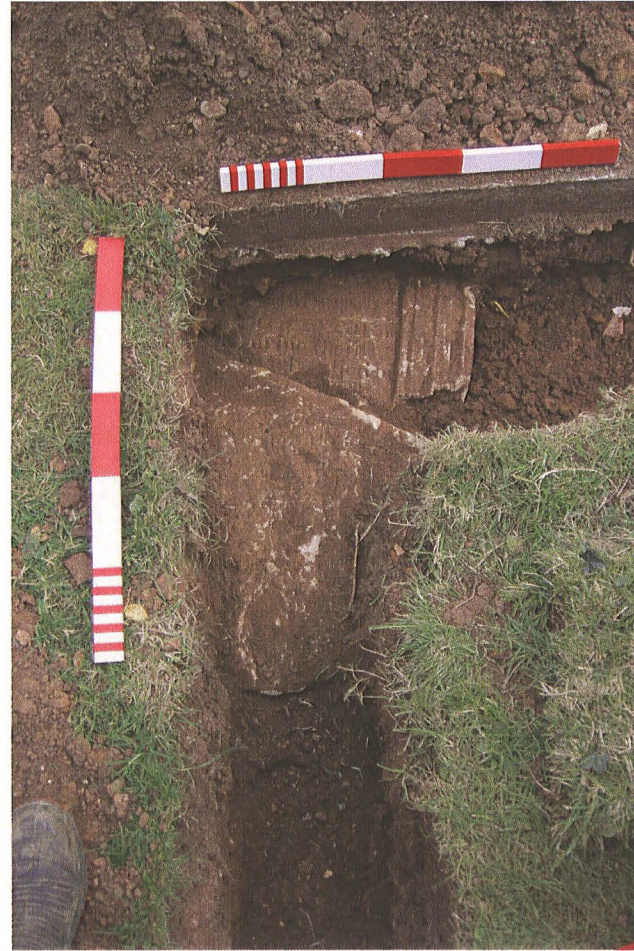
Pl. 12 Broken grave slab looking south, scales 0.50m

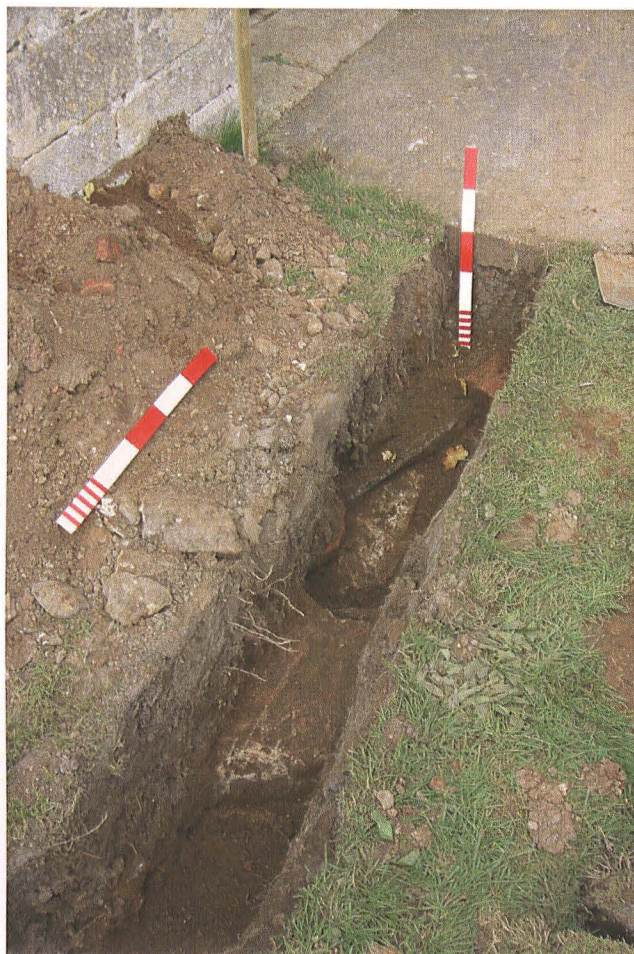
Large stones were noted in the trench base extending 1.40m to either side of the porch entrance, which were part of its foundations (Pls 13 and 14). An electric cable on the west side obscured some of the stonework.

Pl. 13 Porch foundations, south-west corner, looking north-east

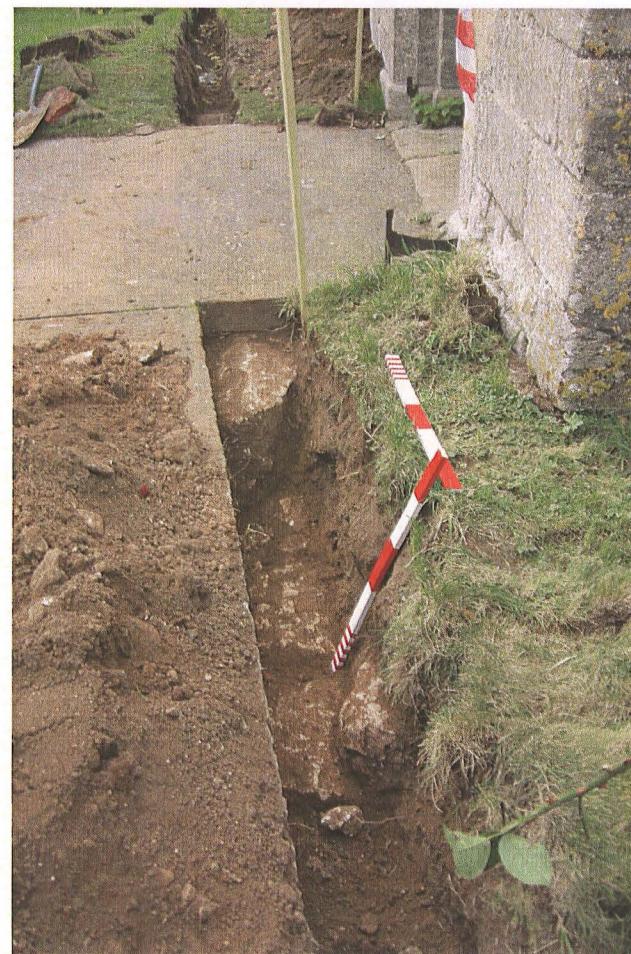
Pl. 14 Porch foundations, south-east corner, looking north-west

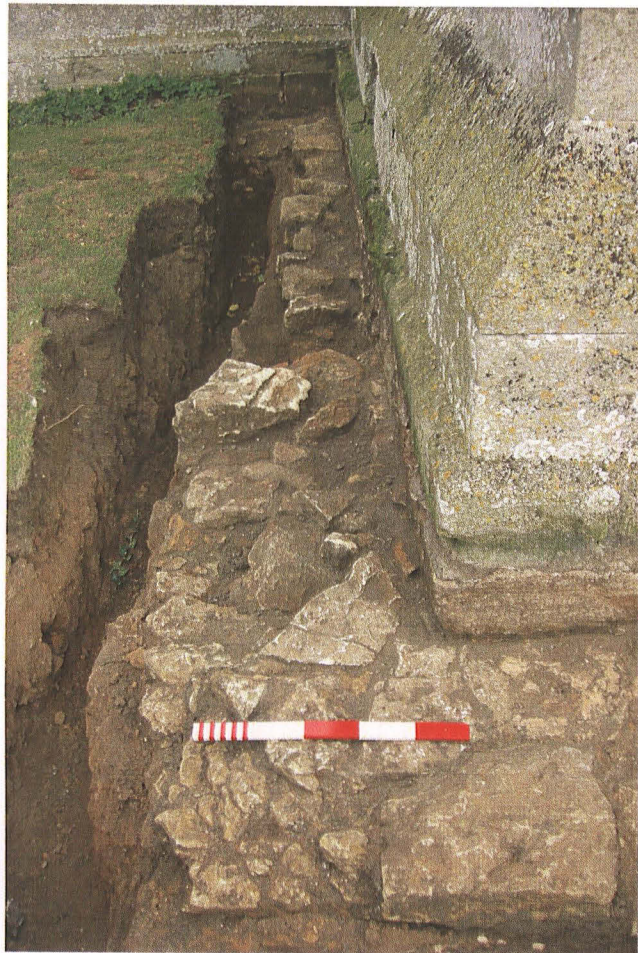
Pl. 17 Tower and north aisle drain trench

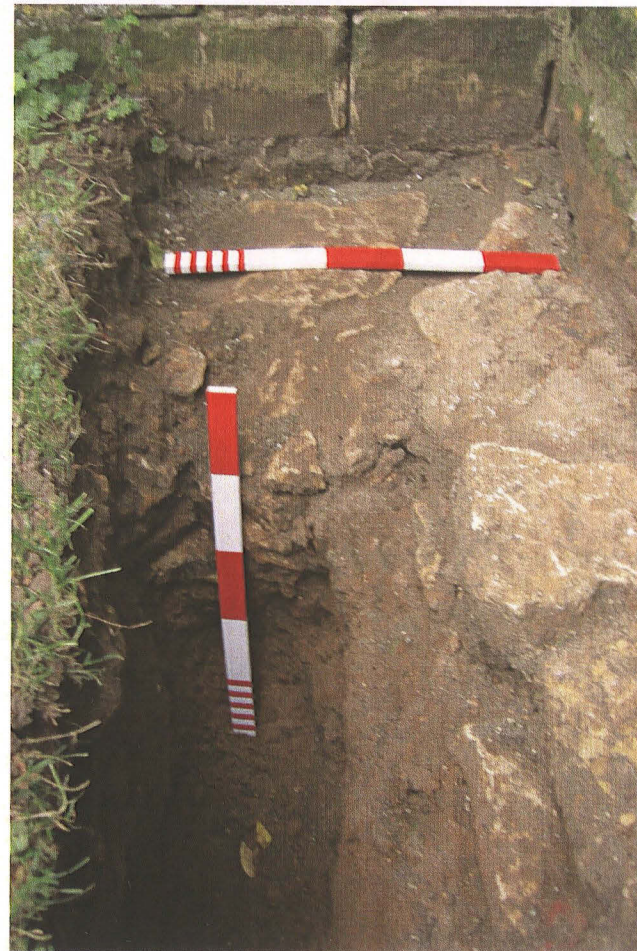
the tower but were 0.30m wide (Pl. 18). An area of the foundations 1.40m east of this corner had been disturbed and several stones had been removed (Pl. 19). The resulting hole had been filled with a mix of clay and coal fragments.

Pl. 18 Junction of tower and north aisle foundations

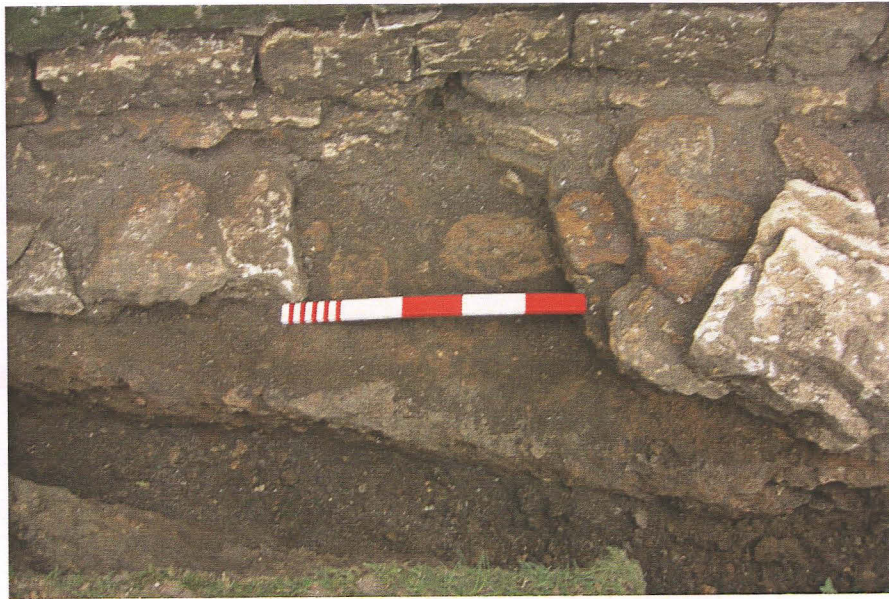
Pl. 19 Damaged area of tower north foundations, after removal of infill soil, scale 0.50m

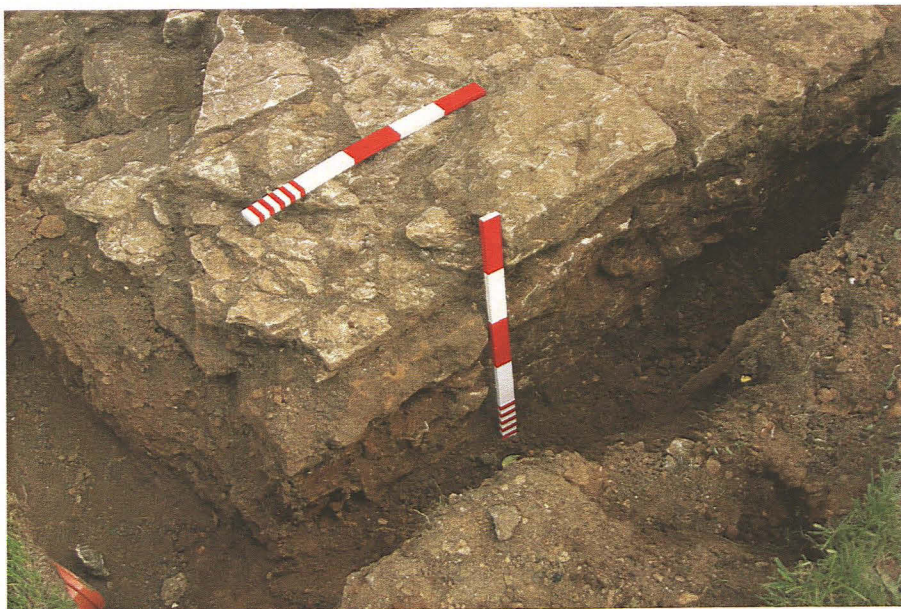
The foundations along the west side of the tower widened from 0.70m at the north end (Pls 17 and 20) to 0.90m at the south-west corner (Pl 21). It is assumed that the foundations were particularly robust here in order to support the internal stair. An area just south of the northwest corner was disturbed at the point where the foundations widened (Pl. 22). The foundations were more extensively disturbed north of the south-west angle.

Pl. 20 Tower foundations, north-west angle, scales 0.50m

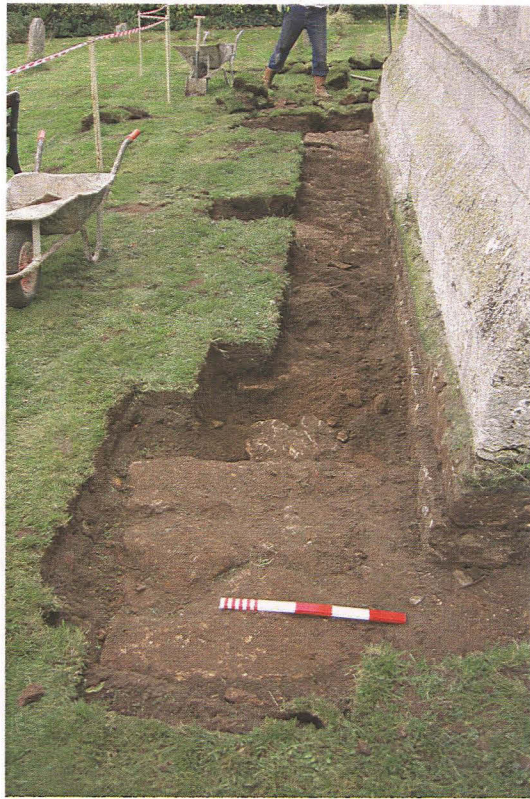
Pl. 21 Tower west foundations, looking north

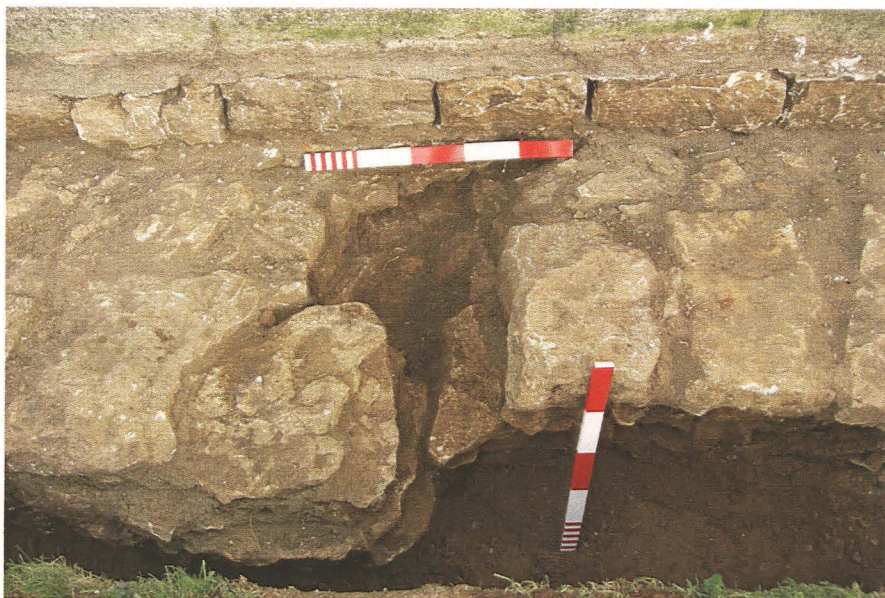
Pl. 22 Tower west foundations, disturbed area near north-west angle, looking east

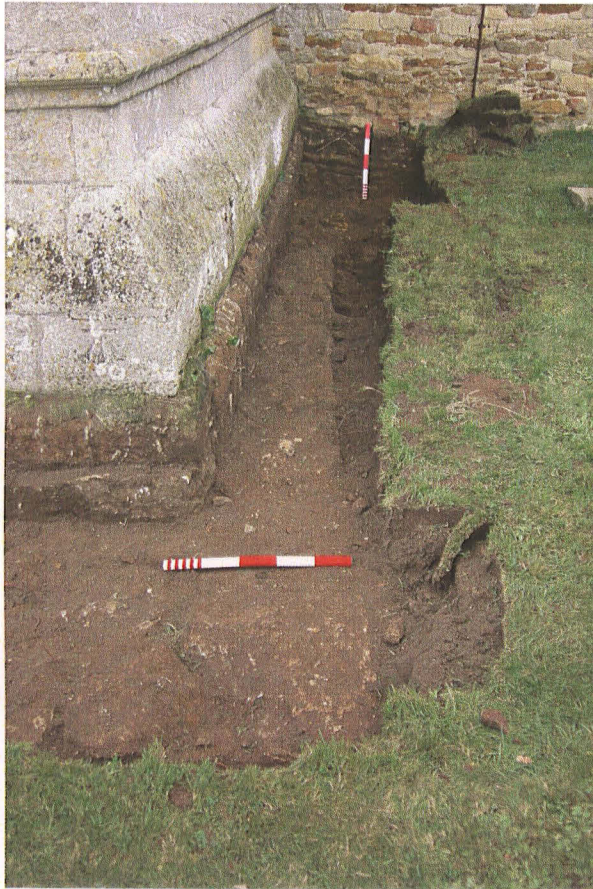
On the south side of the tower the foundations were a minimum of 0.50m deep and 0.43m wide at the south-west angle, tapering to 0.30m close to the junction with the south aisle wall (Pl. 23). The upper course of the foundations had been removed close to the junction, with the south aisle. Elsewhere at least three courses of foundation were exposed, the lower two courses being offset by c.0.15m from the uppermost course (Pls 24 and 25). Unlike the north aisle it was clear that the tower abuts the south aisle wall and is of later construction. The south aisle foundation was offset by only 0.05m at a point just below the tower plinth course (Pl. 26).

Pl. 23 Tower south foundations, looking east

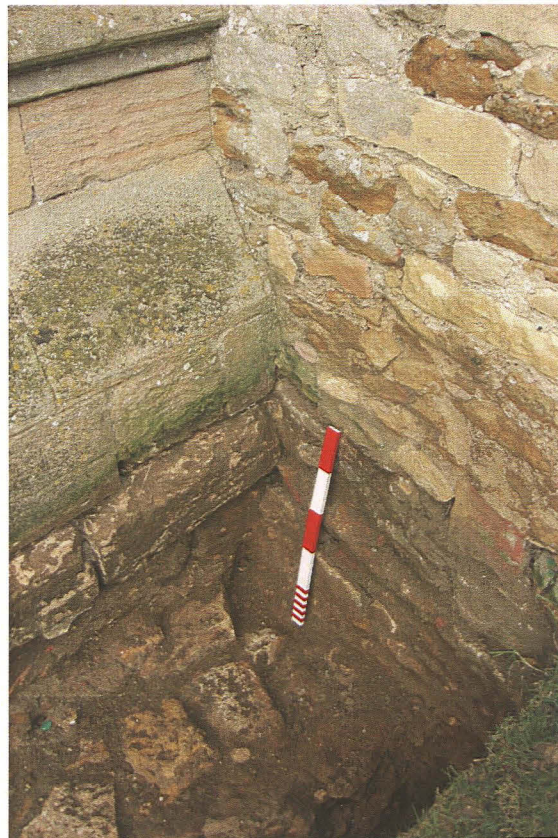
Pl. 26 Junction of tower and south aisle foundations, scale 0.50m
