A REPORT TO THE CHURCHES CONSERVATION TRUST MAY 2010

St. MARGARET'S CHURCH HACEBY LINCOLNSHIRE

ARCHAEOLOGICAL WATCHING BRIEF

MJAS REPORT No.: 564

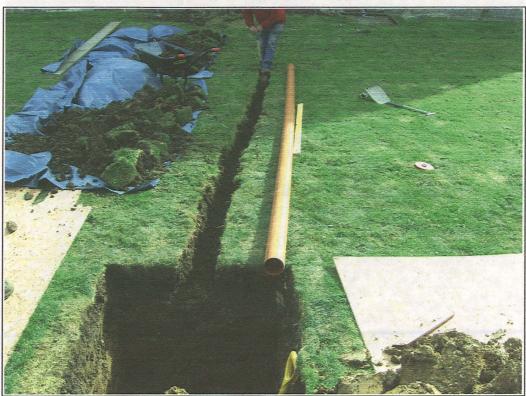
Plate I: Area A - General view of the trench for the new soak-away (looking south).

The new soak-away was located approximately 12m to the north of the church, midway along its northern length, and comprised a shallow c. 300mm deep trench leading to an approximately 1.2m^3 soak-away. Ground level here descended to the north.

Excavation of the soak-away revealed natural clay ([003]) approximately 1m below ground level. The excavation of the pipe trench for the soak-away revealed a compacted concentration of apparently east-west aligned limestone fragments ([004] - 1.30m wide) lying approximately 2.70m to the north of the north church wall. Sealing natural and stonework [004] was subsoil deposit [002], an undated, c. 800mm thick light, yellow/brown clay with frequent small angular limestone fragments. Sealing [002] was topsoil deposit [001] (ground level -c. 66.50m OD north & 67m OD south).

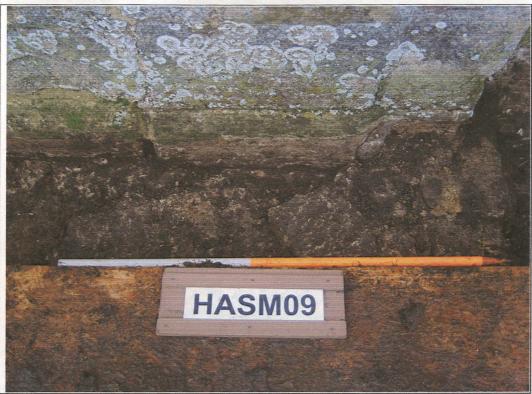
Plate II: View of limestone foundation [004] that may represent part of a now demolished north church aisle (looking south & overhead - scale is 1m).

On the north side of the church, excavation revealed further elements of stonework [004] initially found in the trench for the new soak-away. [004] was aligned north-south and was 1.30m wide and comprised two visible courses of roughly rectangular limestone fragments, bonded with a pale brown sandy lime mortar. The foundation ran north from beneath the existing church.

Excavation revealed parts of a probably rectangular shaped linear foundation on the north side of the church that may represent the remnants of a now demolished north aisle of similar dimensions to the churches existing south aisle. A slightly raised rectangular linear earthwork visible at ground level and appearing to follow the projected line of the newly discovered foundations may support the aisle theory.

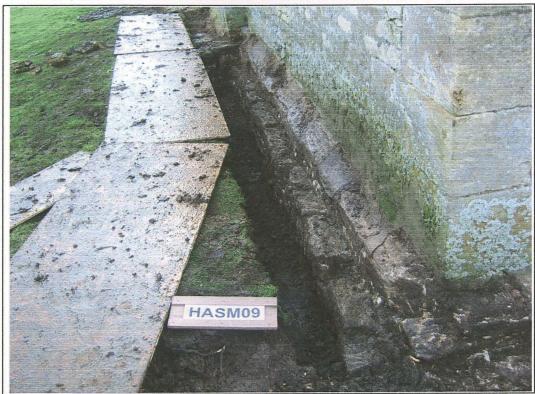
Excavation of the drainage trench immediately to the west of [004], around the church tower, revealed that the tower was of later construction than foundation [004] as here the tower foundations ([005] - two courses of roughly hewn and un-bonded limestone fragments projecting c. 200mm out from the church walls) clearly overlay foundations [004].

A chamfered string-course ([006] - previously buried & showing rainwater damage/spalling) was revealed on top of foundations [005]. On the south side of the church, at the point where the tower meets the south aisle, excavation revealed the south aisle is of later construction than the tower (at the string-course level) and similarly, the porch was shown to be a later addition to the south aisle.

Plate III: General view of excavations at the base of the north tower wall showing the previously buried chamfered string course & projecting stone foundations [005]. Foundation [004] is visible at the very top of the photograph (looking east).

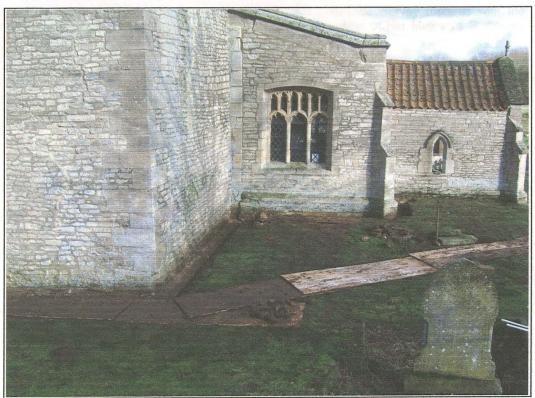
Plate IV: General view of excavations on the south side of the church (looking east).
