**HISTORIC BUILDING RECORDING AT  
59 SOUTH STREET  
CROWLAND  
LINCOLNSHIRE  
(CSSB10)**

Report Compiled by  
Vicky Mellor BSc (Hons)

Planning Application: H02-0800-09  
National Grid Reference: TF 2410 1008  
OASIS Reference Number: archaeo11-80274

A.P.S. Report No: **68/10**

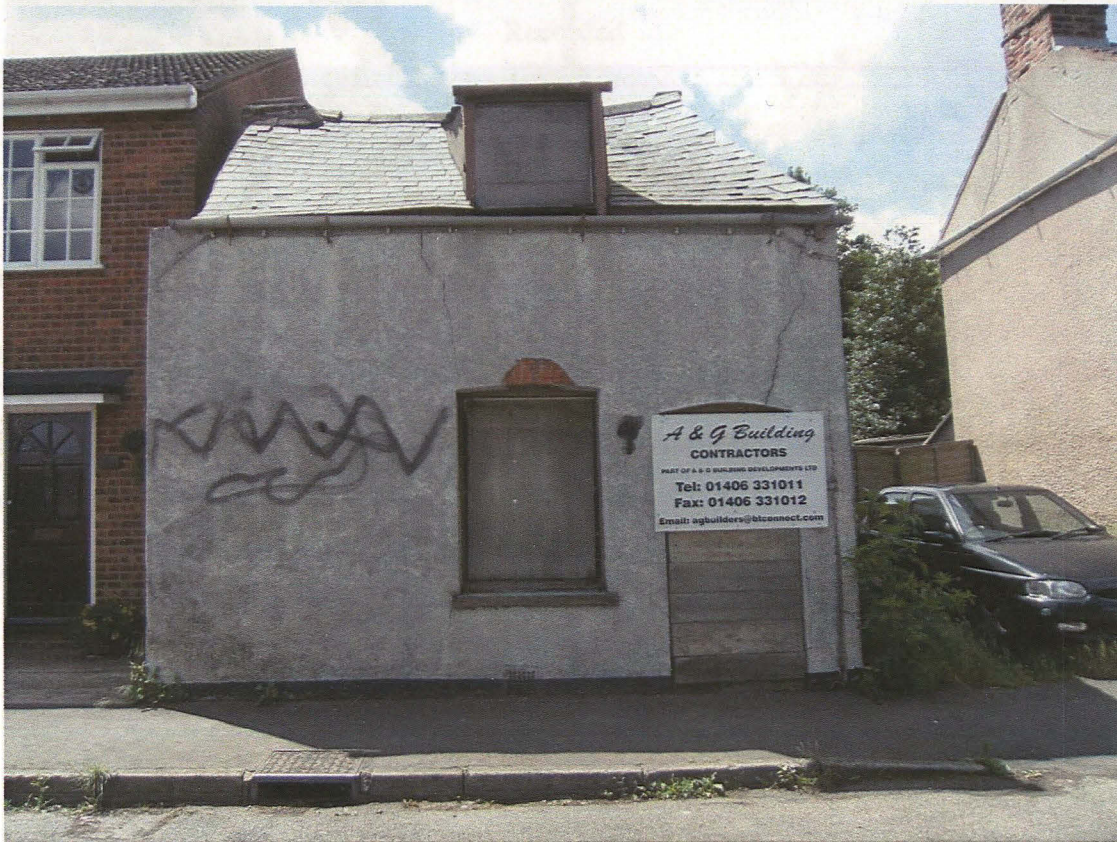
*Plate 5 Frontage of building, east elevation fronting on to South Street, looking west*

Cracks were noted in the render of the east elevation, particularly above the ground floor window and door.

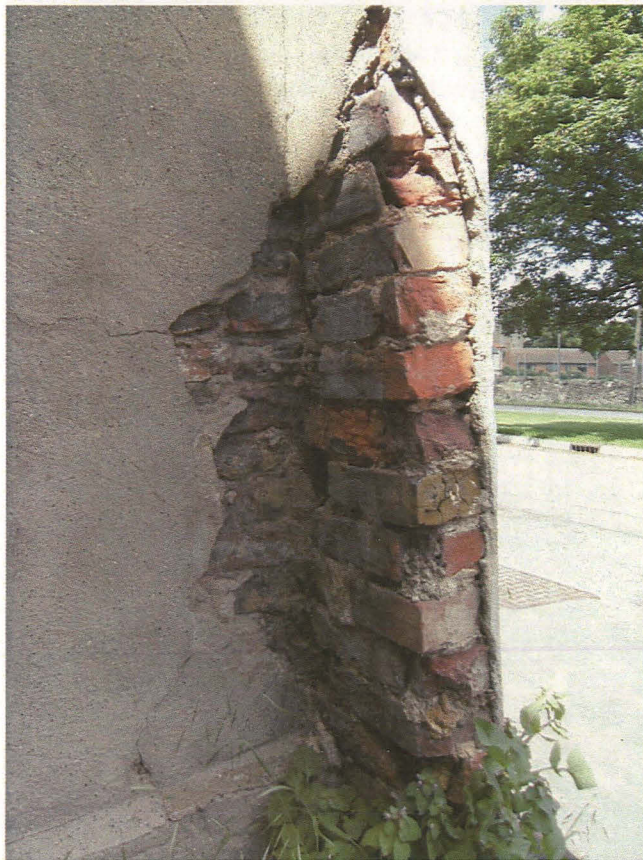
None of the handmade bricks of the south gable end were fully exposed here, but it was possible to measure the thickness of some of these, some being 50mm thick and others 60mm. Additionally, one brick in this wall had a possible diagonal skintling or hack mark. Surveys of dated buildings in the King's Lynn area (Norfolk) indicated that bricks with diagonal skintlings dated before about 1780 (James and Rose nd). It was noted by the South Holland Conservation Officer that some of the bricks of this building were of dimensions which suggested a pre-1776 date, but insufficient brickwork was exposed to provide any conclusive dating of brickwork in various parts of the building.

Bricks of the projecting wall were more clearly exposed. These were also handmade, and one of these bricks was over fired producing a clinkered end with a pronounced green-glazed appearance, and measured 225mm x 110-120mm x 60mm. Some of the other bricks of this wall had pronounced horizontal skintlings or hack marks, and one of these bricks measured 240mm x 110mm x 65mm. The horizontal skintlings may hint at a date after about 1780 for the projecting wall (James and Rose nd).

*Plate 8 Detail of south gable end, showing exposed brickwork of southern wall and projecting wall at southeast corner of building, looking northeast*

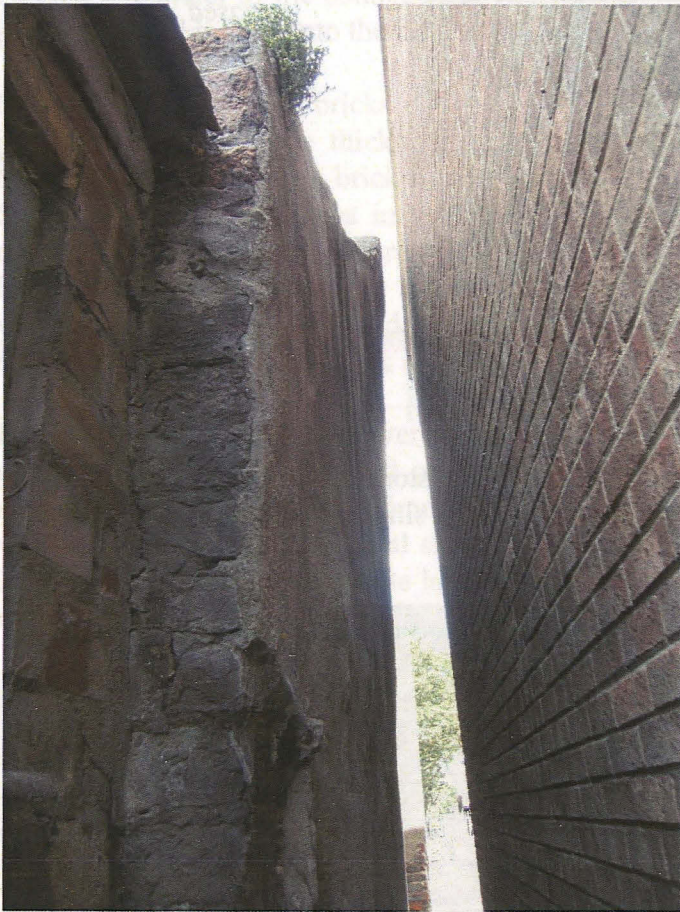
Some of the brickwork at the southwest corner of Room 2a was visible due to a gap in the render (Plate 11). The handmade bricks of this corner each measured >190mm x 100mm x 60-66mm and some horizontal skintling marks were evident on these (Plate 12). Again these skintling marks may perhaps indicate a date of 1780 or later.

*Plate 11  
Detail of  
exposed  
brickwork in  
southern  
gable end of  
cottage,  
looking east*

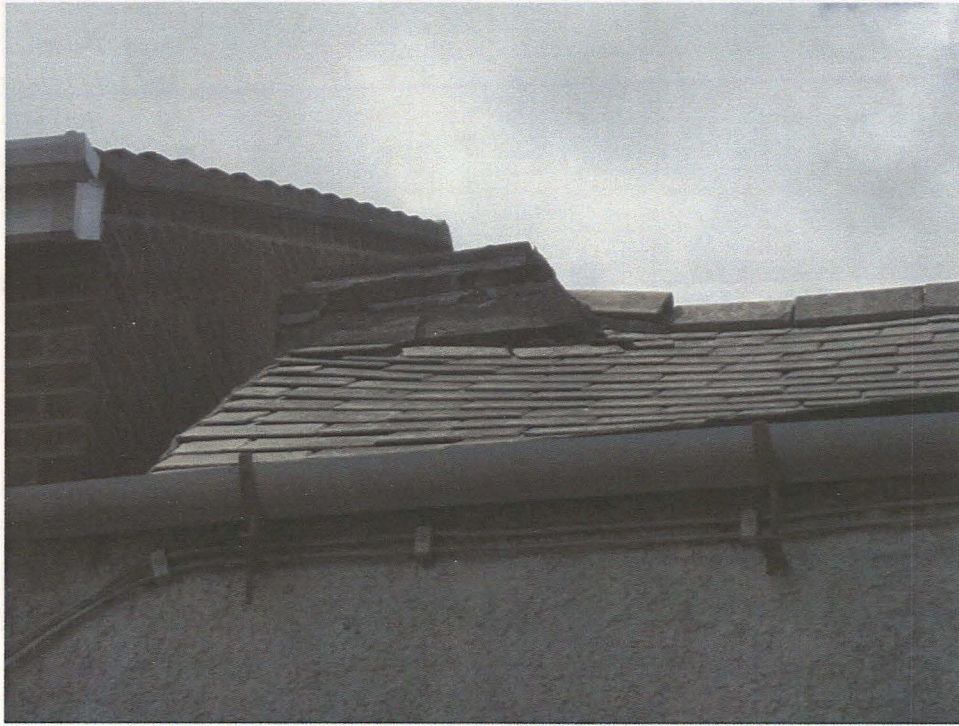
At the apex of the south gable end were the remains of a chimney, which had been largely removed recently. Due to the proximity of the neighbouring property to the south this was not clearly visible from the south, but could be seen from the street frontage (Plate 13). Two courses of brickwork remained above the roofline, but these bricks were too distant to allow identification of their type.

*Plate 13  
Detail of  
remnants of  
recently-  
removed  
chimney at  
south gable  
end of  
building,  
looking west*

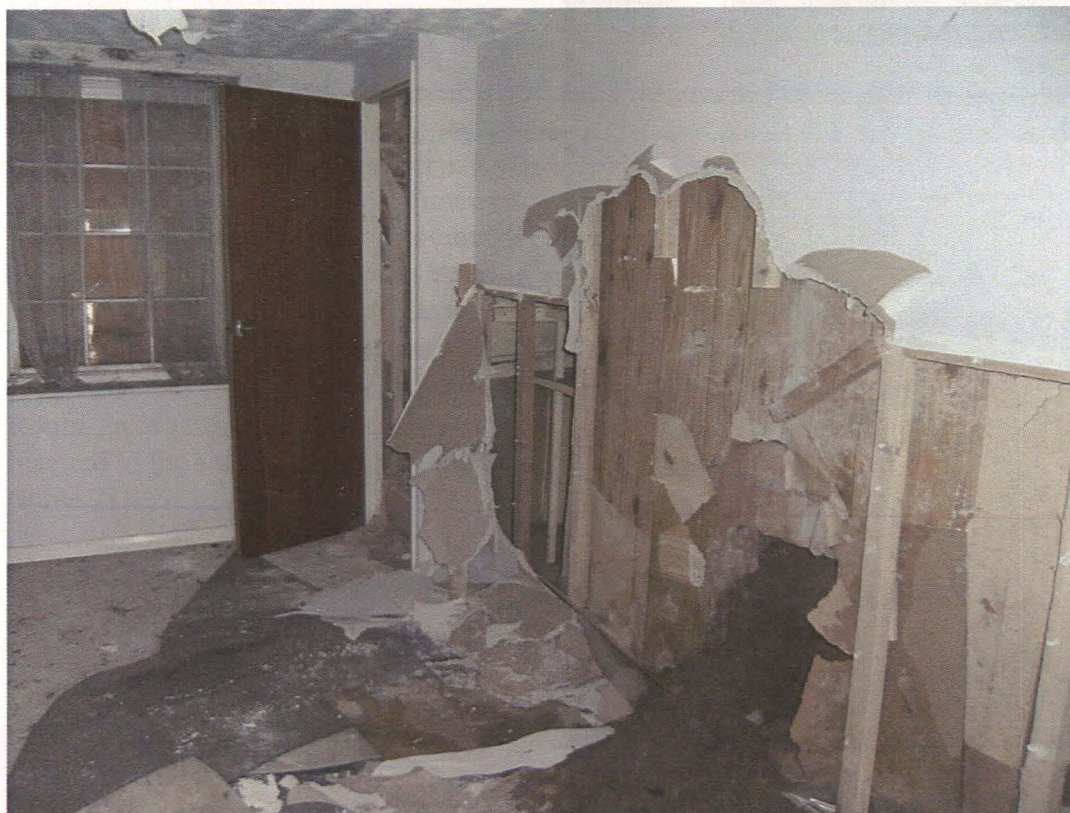
Plasterboard covering the southern wall of the room had been partly broken and removed, revealing the remains of a central fireplace and alcoves to either side of the chimney breast (Plate 23).

Plate 23  
Interior of  
Room 1a,  
showing  
recesses and  
fireplace  
behind stud  
partition  
wall, looking  
southeast

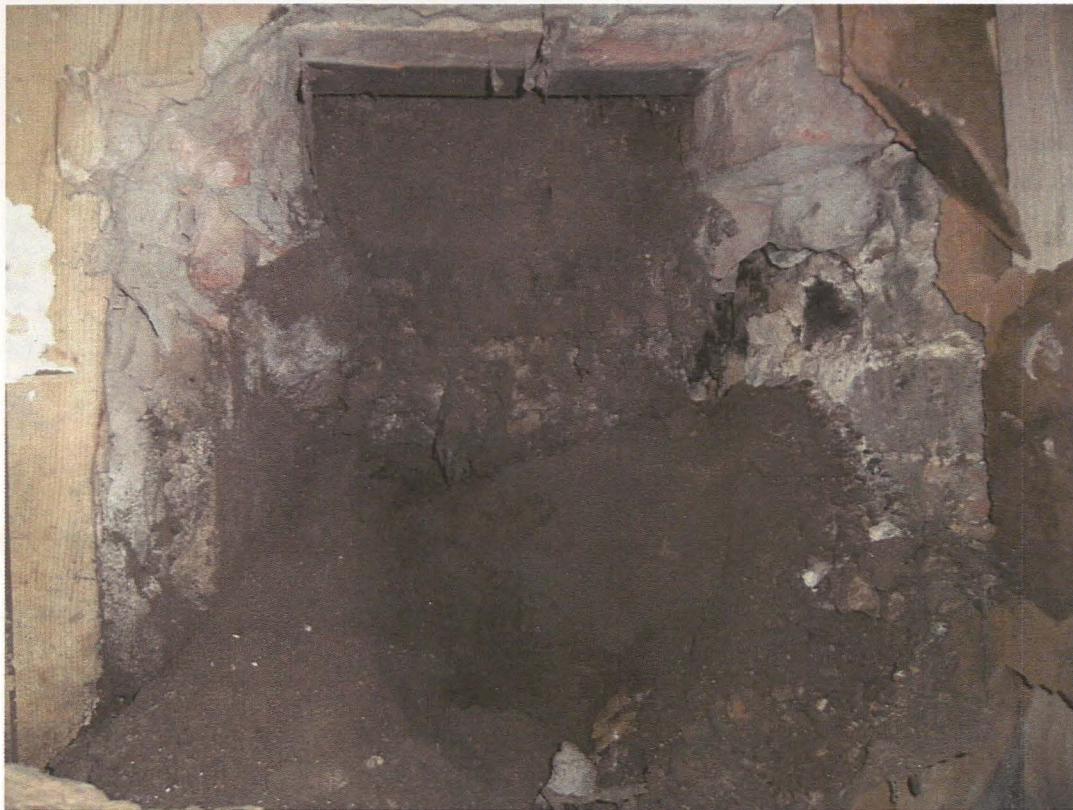
Little of the fireplace was visible due to a large quantity of soot and rubble within it, but some brickwork was visible surrounding a small opening (Plate 24). This brickwork appeared to have been the subject of 20<sup>th</sup> century alterations or rebuilding. No evidence for a surround to the fireplace was apparent.

*Plate 24  
Interior of  
Room 1a,  
detail of  
exposed  
portion of  
fireplace  
behind stud  
partition  
wall, looking  
south*

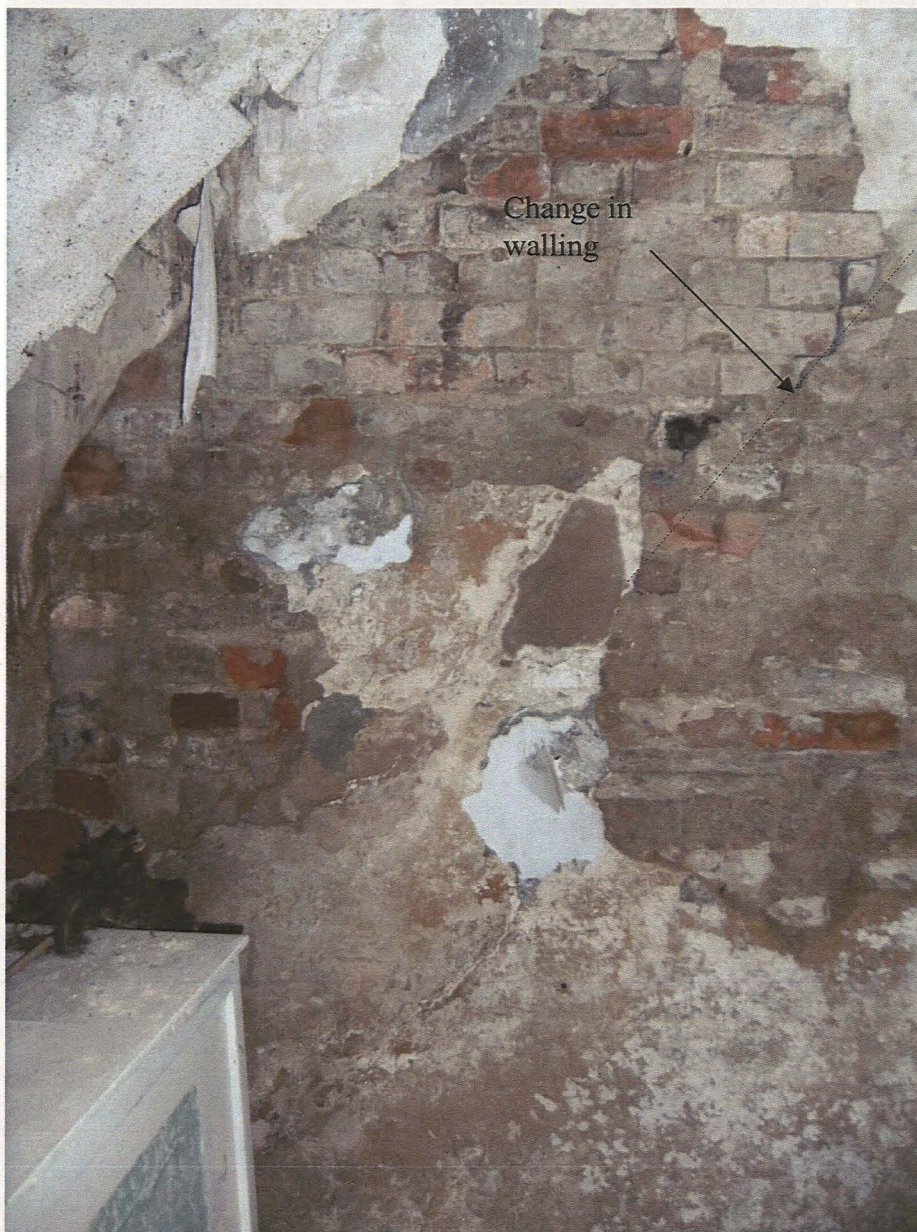
Change in  
walling

On the whole, the brickwork of the northern wall was of handmade brick in English Bond, with alternate rows of headers and stretchers, although the bonding was rather variable (Plates 34-36). A horizontal course of wood was recorded in this wall, approximately 1.00-1.10m above the floor. One brick below the wood course of this wall was c.100mm x 55mm, and another brick above the wood measured 110mm x 56mm. A change in the brickwork was recorded at the west of the wall, above the level of the wood course. This appeared to mark a former roofline of the cottage. Some of the bricks used in this part of the had clear horizontal skintling marks, one of these bricks measuring 210mm x 64mm, and another 223mm x 61mm. A brick possibly of the same type was 108mm wide. A brick which lacked any skintling measured 230mm x 65mm. Several of the bricks in this part of the wall had what appeared to be kiss marks, although it was not entirely clear if these variations in colour might instead be as a result of the remnants of plaster on the wall or other surface deposits. The bricks of this wall with horizontal skintlings may post-date around 1780 (James and Rose nd).

Plate 36  
Interior of  
Room 1b,  
detail of  
brickwork in  
north wall,  
looking north

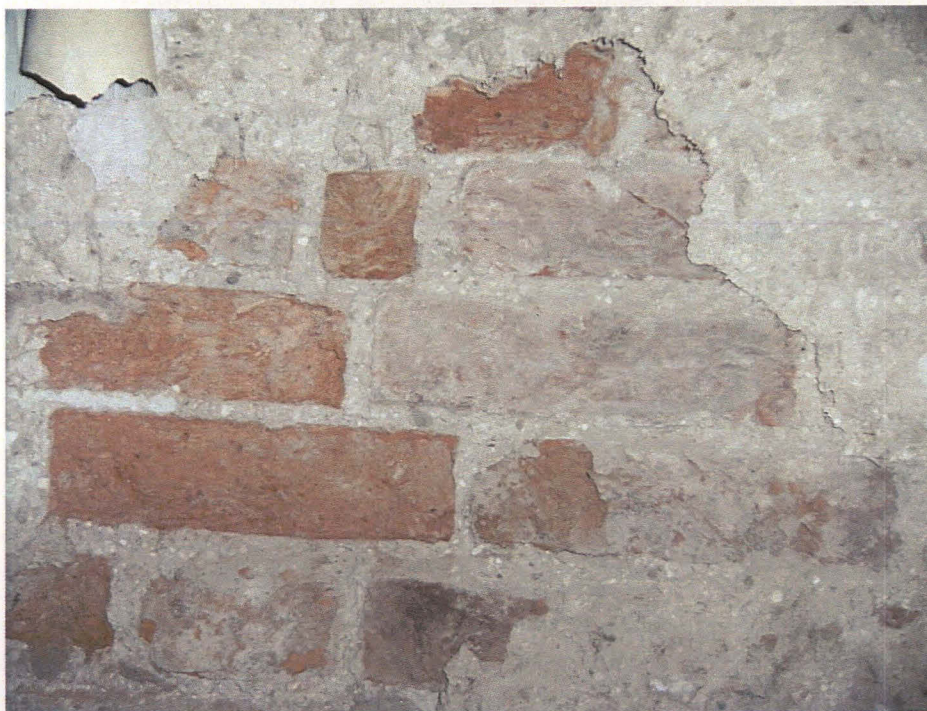
A small patch of brickwork was visible in the southern gable end of the room (Plate 44). At least one header row was evident, and sample brick measurements were taken of two stretcher bricks: 219mm x 58mm and 220mm x 60mm.

*Plate 44  
Interior of  
Room 1b,  
detail of  
exposed  
brickwork of  
south wall,  
looking south*

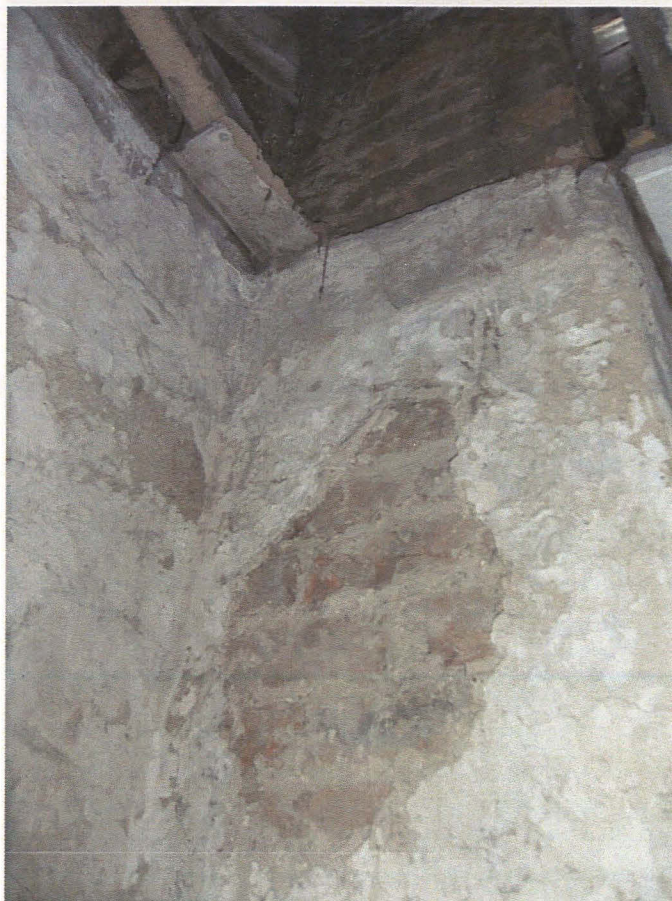
Part of the brickwork of the chimney in the south wall was exposed (Plates 45 & 46). Many of these bricks had horizontal skintlings, again hinting at a date after around 1780. It was only possible to measure the depth of these bricks, which was 58mm.

*Plate 45 Interior of Room 1b, detail of chimney showing exposed brickwork, looking west*

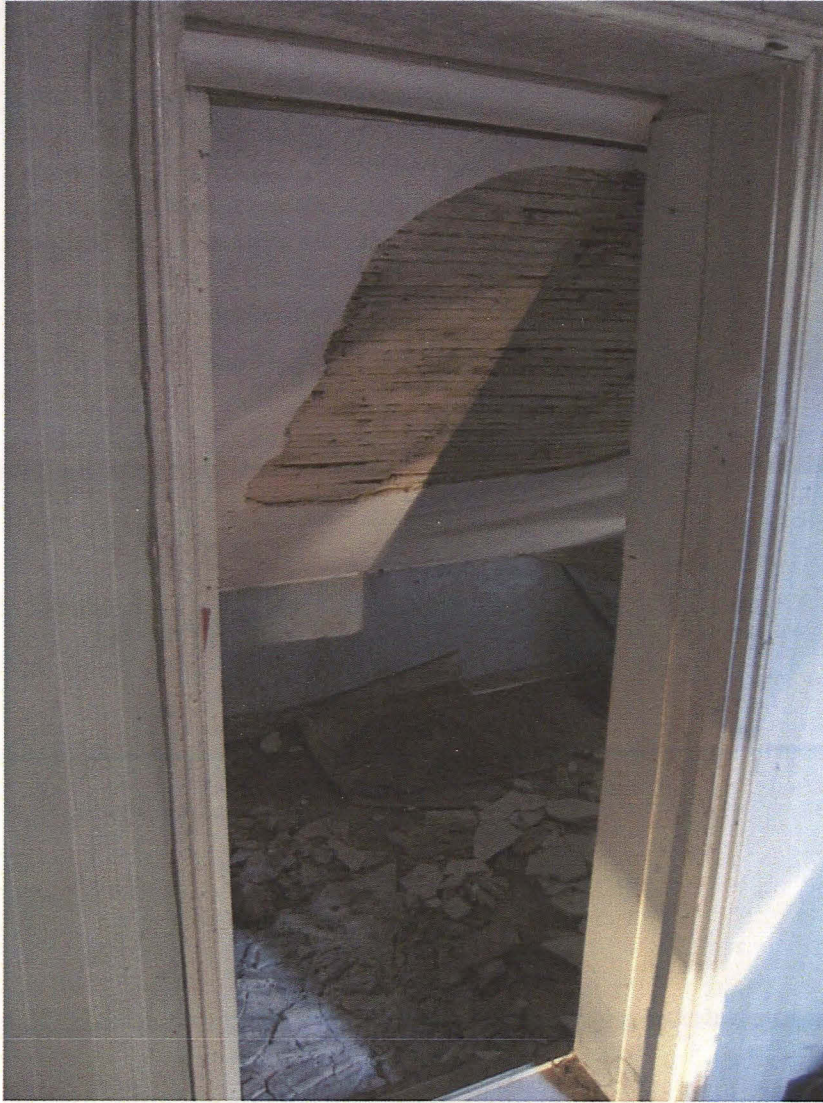
Room 2b was accessed via a doorway with a step down from Room 1b (Plates 47 & 48). As a hole was observed in the flooring of Room 2b this was not entered, but recorded from this doorway.

*Plate 48 Interior of Room 2b, looking northwest*

Much of the plaster of the sloping ceiling of Room 2b had come away, revealing laths behind (Plates 48-50). A single window was present in the north wall (Plate 49).

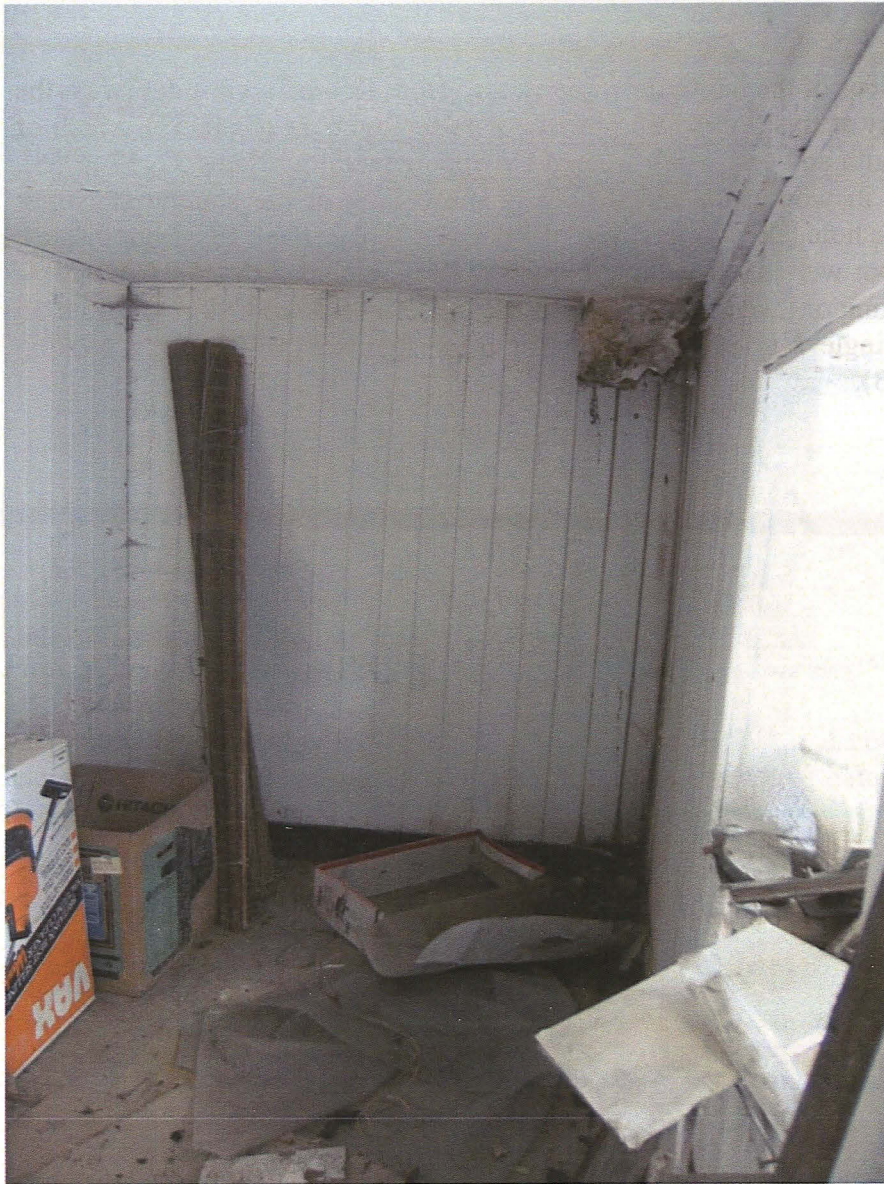
*Plate 53  
Interior of  
Room 2A,  
showing wood  
panelling,  
window and  
hole in corner  
of ceiling,  
looking south*
